Memorandum

To: Scot Sokolowski, NAVFAC MIDLANT
From: David Brayack, Tetra Tech
Date: December 30, 2021
Re: Annual LUC Inspection and Operation Summary Report: Sites 1, 2, 3, and 4 – NWIRP Bethpage
Revision 1
Contract/CTO Number: N6247016D9008/WE13

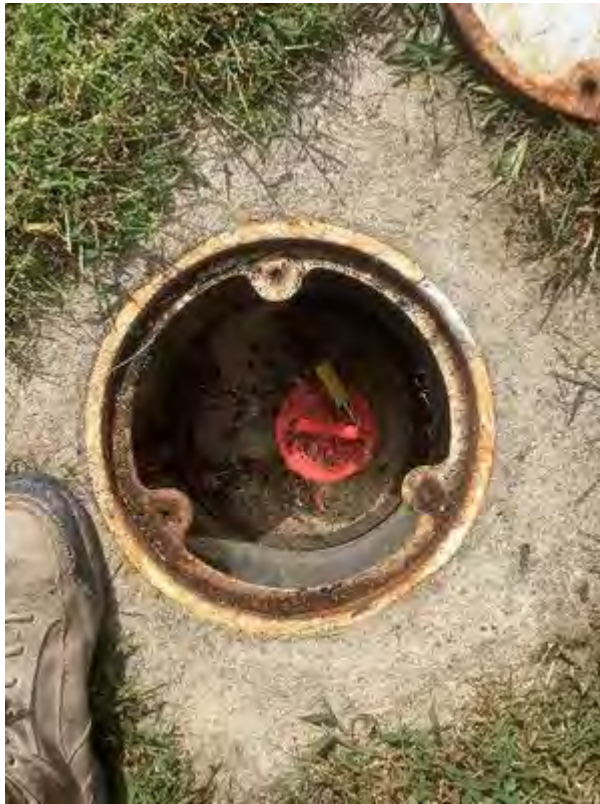
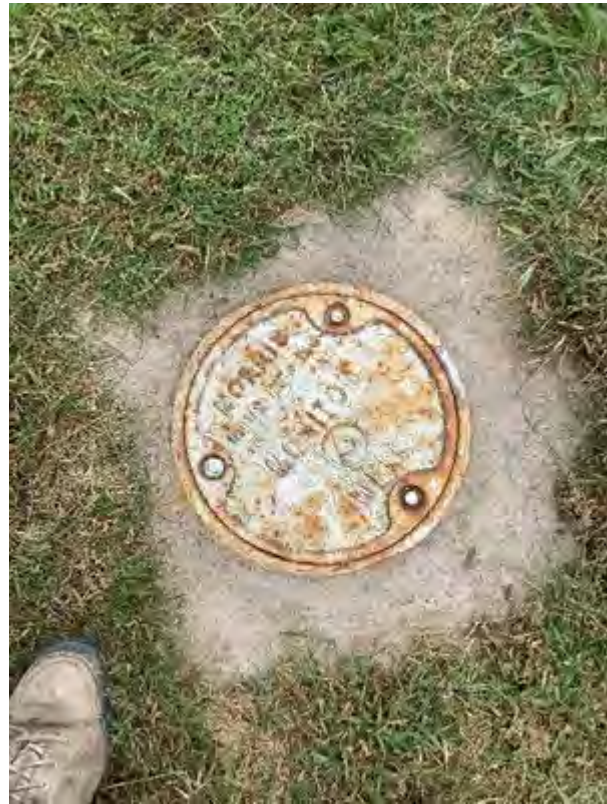
Client: Navy CLEAN	Facility: NWIRP Bethpage
Project Number: 112G08005-WE13	Location: Bethpage, New York
Date: September 21, 2021 13:10	Personnel: Beau Benfield
Well ID: RE124D2	Well Location: 202685.97 1122972.34
Well Status: Other	Screen Interval: 730-750
WELL INVENTORY CONDITION	
Concrete pad in acceptable condition i.e. no cracks?	YES
Manhole cover present and in working condition?	YES
All bolts on manhole present and not stripped?	YES
Well plug present, locked and in good working condition?	YES
OVERALL CONDITION:	GOOD
Notes (Explain if answered No to any of the above)

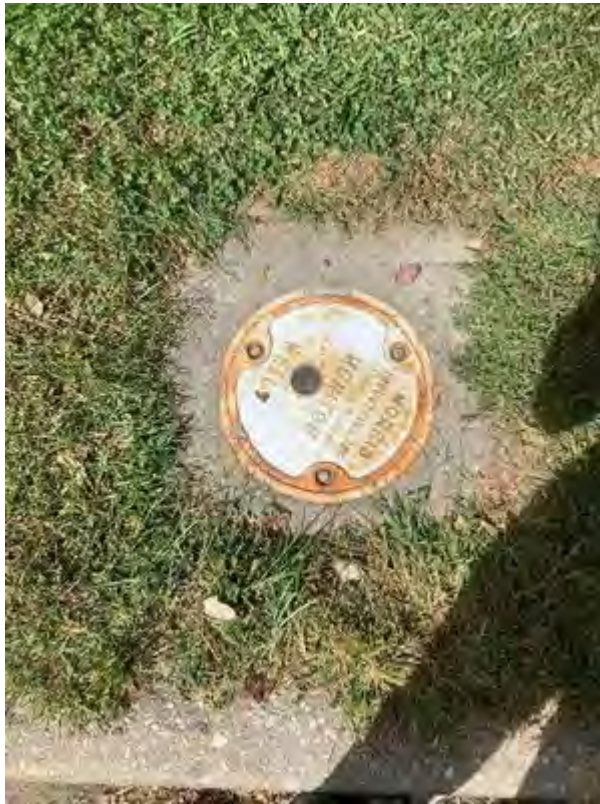
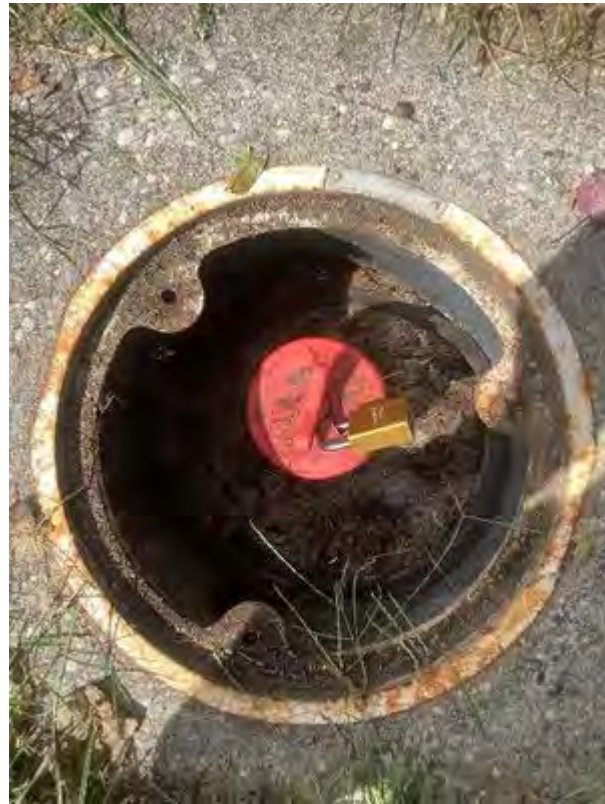
Client: Navy CLEAN	Facility: NWIRP Bethpage
Project Number: 112G08005-WE13	Location: Bethpage, New York
Date: September 21, 2021 12:58	Personnel: Beau Benfield
Well ID: RE114D1	Well Location: 201728.64 1124289.94
Well Status: Other	Screen Interval: 535-550
WELL INVENTORY CONDITION	
Concrete pad in acceptable condition i.e. no cracks?	YES
Manhole cover present and in working condition?	YES
All bolts on manhole present and not stripped?	YES
Well plug present, locked and in good working condition?	YES
OVERALL CONDITION:	GOOD
Notes (Explain if answered No to any of the above)

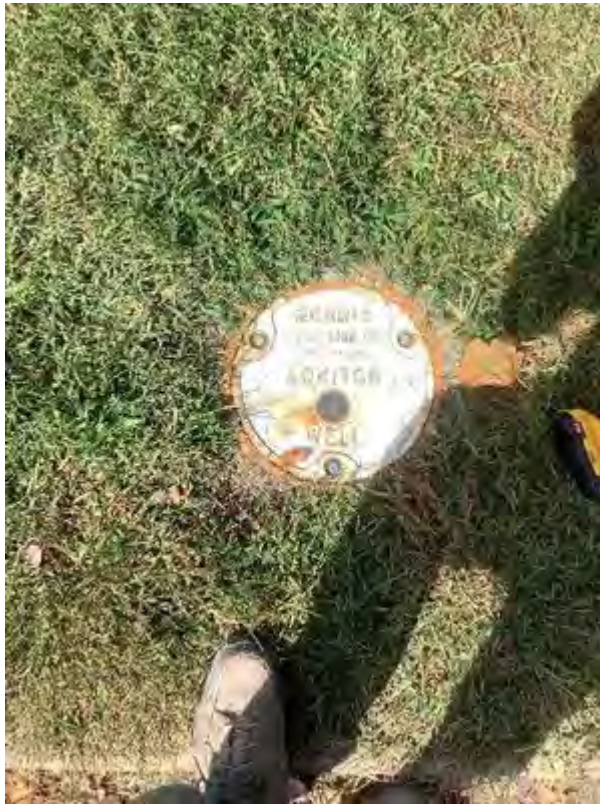
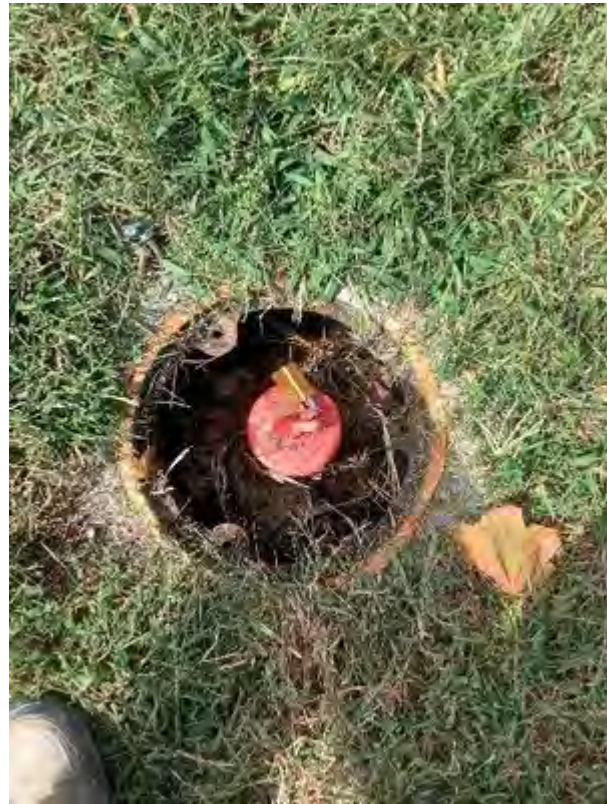
Client: Navy CLEAN	Facility: NWIRP Bethpage
Project Number: 112G08005-WE13	Location: Bethpage, New York
Date: September 21, 2021 12:57	Personnel: Beau Benfield
Well ID: RE114D2	Well Location: 201710.25 1124365.4
Well Status: Other	Screen Interval: 610-630
WELL INVENTORY CONDITION	
Concrete pad in acceptable condition i.e. no cracks?	YES
Manhole cover present and in working condition?	YES
All bolts on manhole present and not stripped?	YES
Well plug present, locked and in good working condition?	YES
OVERALL CONDITION:	GOOD
Notes (Explain if answered No to any of the above)

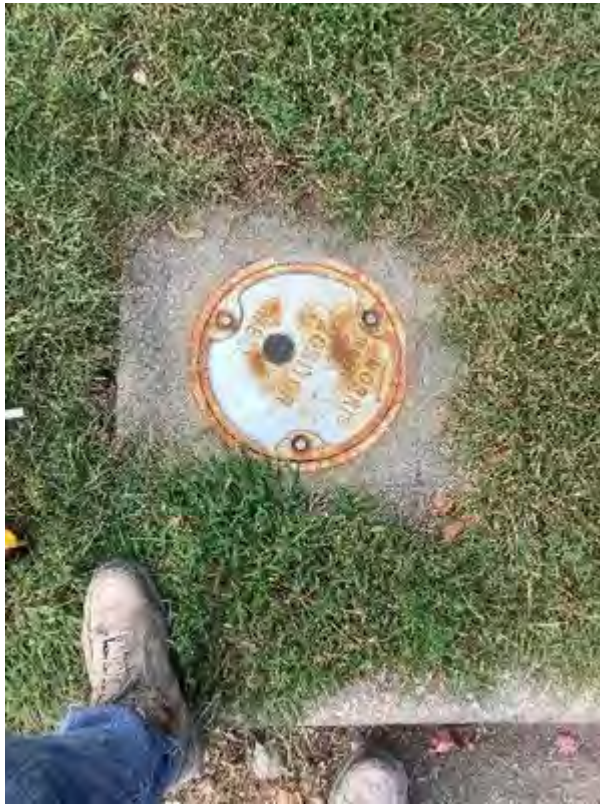
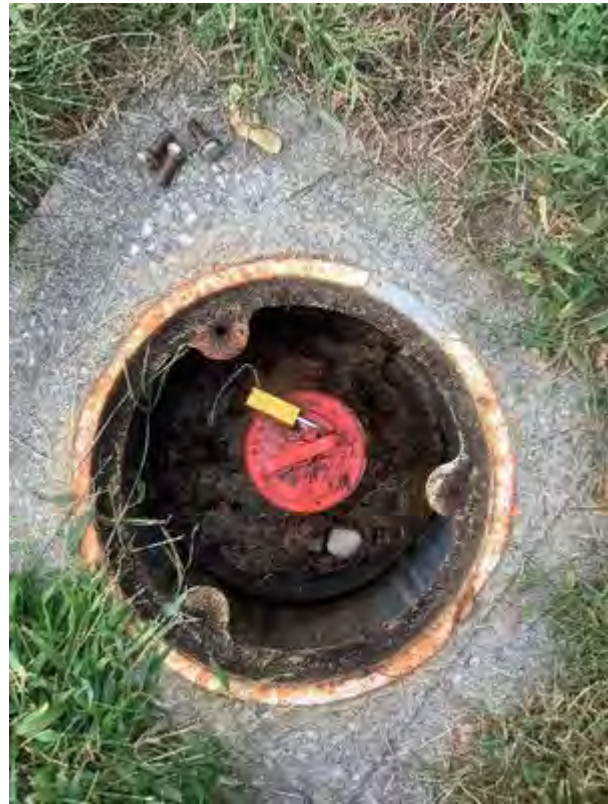
Client: Navy CLEAN	Facility: NWIRP Bethpage
Project Number: 112G08005-WE13	Location: Bethpage, New York
Date: September 21, 2021 12:55	Personnel: Beau Benfield
Well ID: RE114D3	Well Location: 201719.48 1124277.84
Well Status: Other	Screen Interval: 700-720
WELL INVENTORY CONDITION	
Concrete pad in acceptable condition i.e. no cracks?	YES
Manhole cover present and in working condition?	YES
All bolts on manhole present and not stripped?	YES
Well plug present, locked and in good working condition?	YES
OVERALL CONDITION:	GOOD
Notes (Explain if answered No to any of the above)

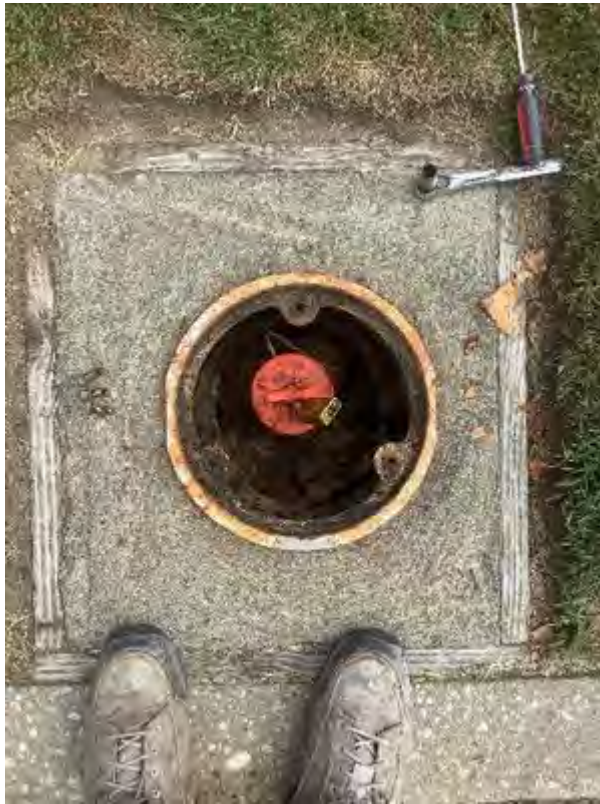
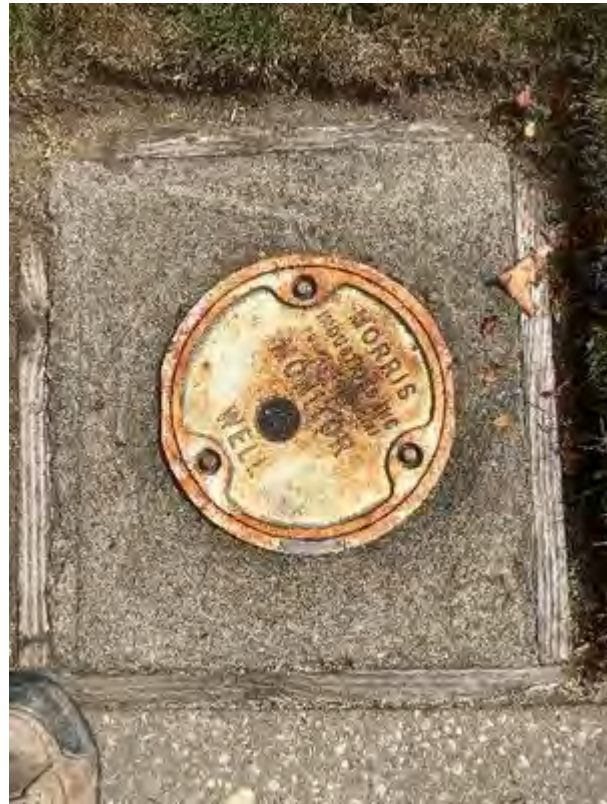
Client: Navy CLEAN	Facility: NWIRP Bethpage
Project Number: 112G08005-WE13	Location: Bethpage, New York
Date: September 21, 2021 12:48	Personnel: Beau Benfield
Well ID: BPOW 4-2R	Well Location: 200691.91 1123200.04
Well Status: Other	Screen Interval: 725-765
WELL INVENTORY CONDITION	
Concrete pad in acceptable condition i.e. no cracks?	YES
Manhole cover present and in working condition?	YES
All bolts on manhole present and not stripped?	YES
Well plug present, locked and in good working condition?	YES
OVERALL CONDITION:	GOOD
Notes (Explain if answered No to any of the above)

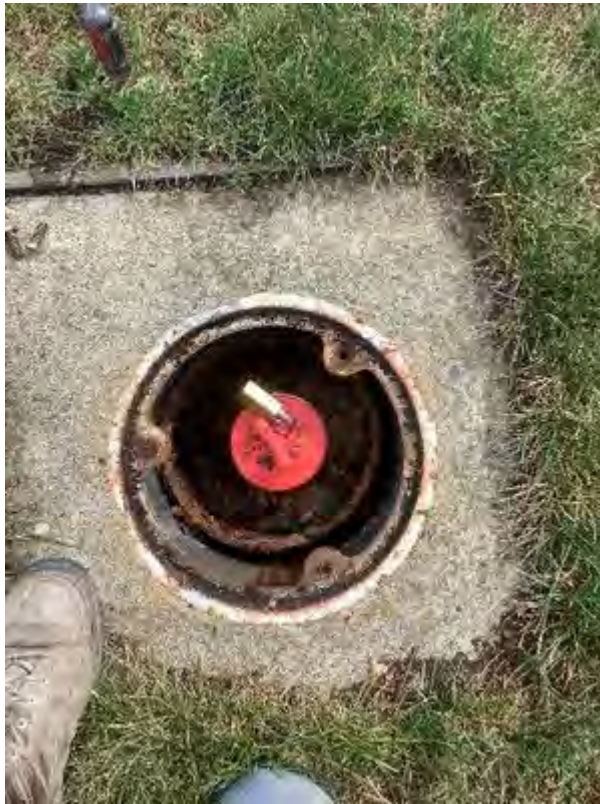
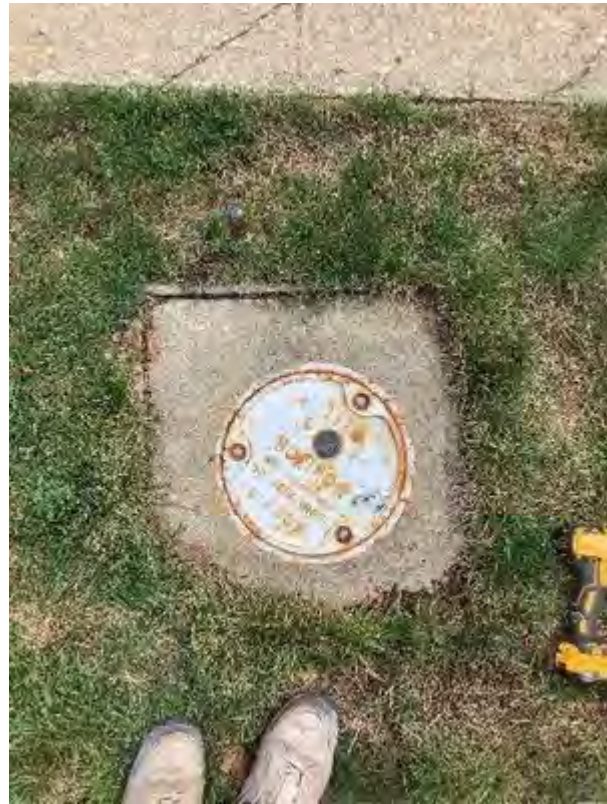
Client: Navy CLEAN	Facility: NWIRP Bethpage
Project Number: 112G08005-WE13	Location: Bethpage, New York
Date: September 21, 2021 12:39	Personnel: Beau Benfield
Well ID: BPOW 4-1R	Well Location: 200281.26 1123067.51
Well Status: Other	Screen Interval: 652-692
WELL INVENTORY CONDITION	
Concrete pad in acceptable condition i.e. no cracks?	YES
Manhole cover present and in working condition?	YES
All bolts on manhole present and not stripped?	YES
Well plug present, locked and in good working condition?	YES
OVERALL CONDITION:	GOOD
Notes (Explain if answered No to any of the above)

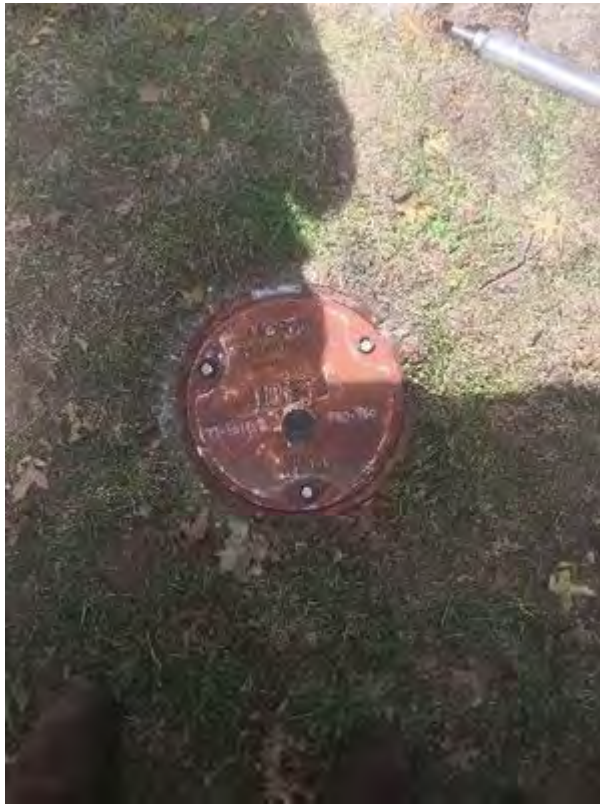
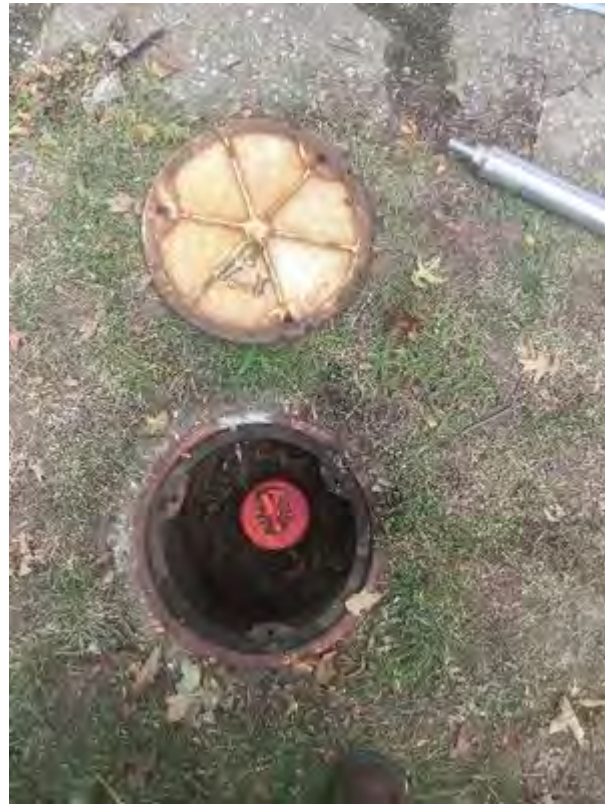
Client: Navy CLEAN	Facility: NWIRP Bethpage
Project Number: 112G08005-WE13	Location: Bethpage, New York
Date: September 21, 2021 12:12	Personnel: Noah Sprouse
Well ID: TT101D2	Well Location: 203545.377 1125454.308
Well Status: Other	Screen Interval: 740-760
WELL INVENTORY CONDITION	
Concrete pad in acceptable condition i.e. no cracks?	YES
Manhole cover present and in working condition?	YES
All bolts on manhole present and not stripped?	YES
Well plug present, locked and in good working condition?	YES
OVERALL CONDITION:	GOOD
Notes (Explain if answered No to any of the above)

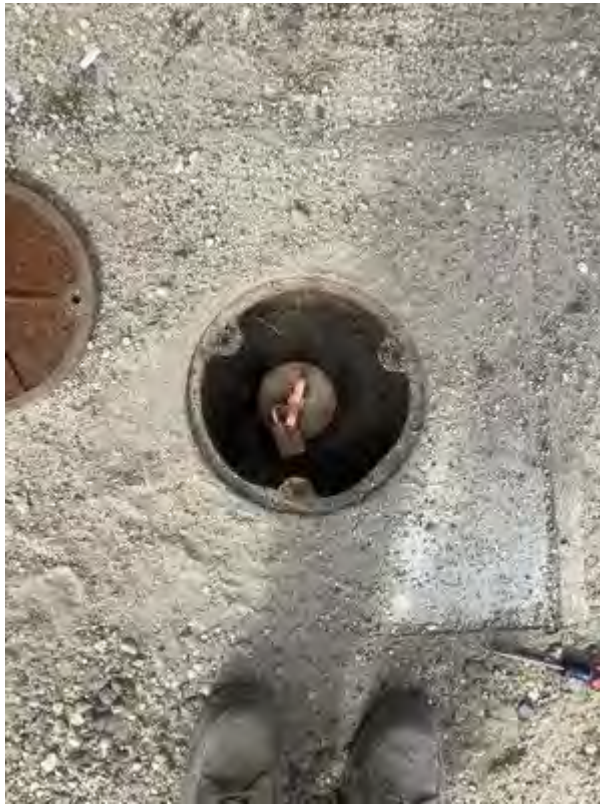
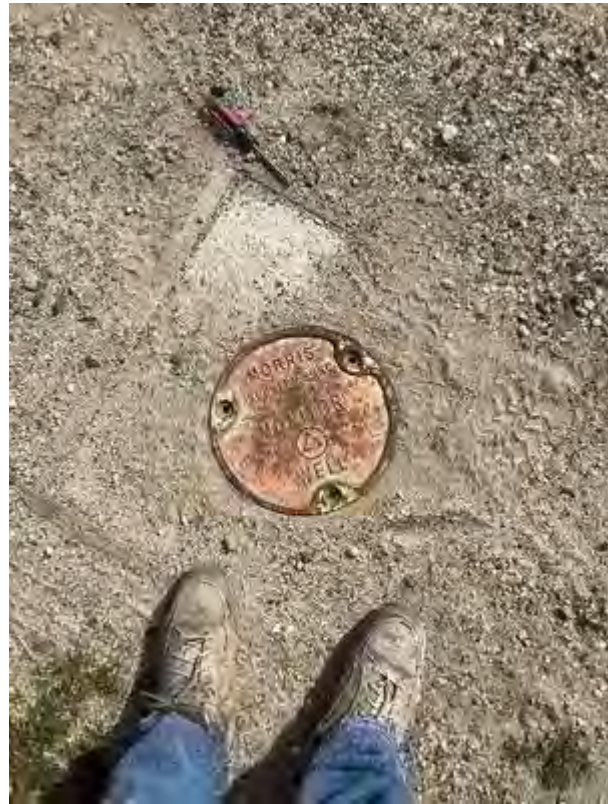
Client: Navy CLEAN	Facility: NWIRP Bethpage
Project Number: 112G08005-WE13	Location: Bethpage, New York
Date: September 21, 2021 11:09	Personnel: Beau Benfield
Well ID: RE128D1	Well Location: 200556.421231 1129214.87395
Well Status: Other	Screen Interval: 660-680
WELL INVENTORY CONDITION	
Concrete pad in acceptable condition i.e. no cracks?	YES
Manhole cover present and in working condition?	YES
All bolts on manhole present and not stripped?	NO
Well plug present, locked and in good working condition?	YES
OVERALL CONDITION:	FAIR
Notes (Explain if answered No to any of the above) Could not thread bolts through manhole cover

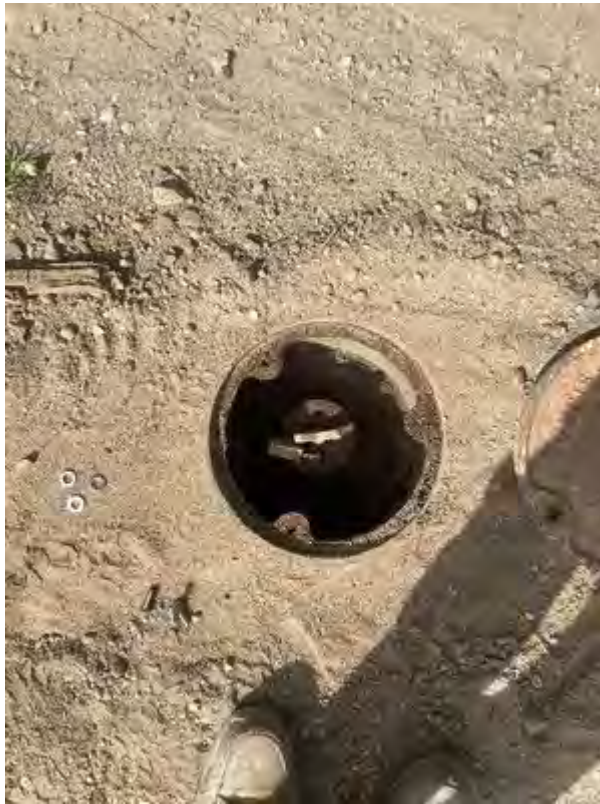
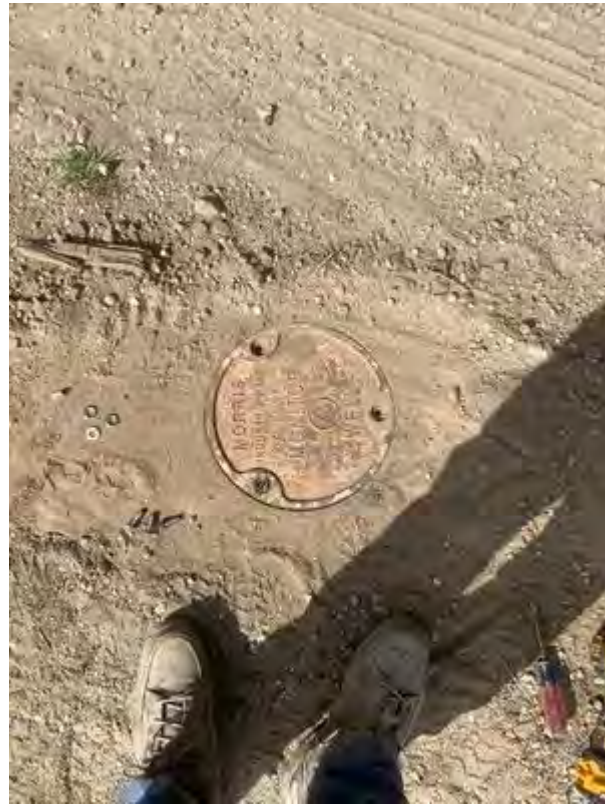
Client: Navy CLEAN	Facility: NWIRP Bethpage
Project Number: 112G08005-WE13	Location: Bethpage, New York
Date: September 21, 2021 11:01	Personnel: Beau Benfield
Well ID: RE128D2	Well Location: 200537.7 1129203.48
Well Status: Other	Screen Interval: 735-755
WELL INVENTORY CONDITION	
Concrete pad in acceptable condition i.e. no cracks?	YES
Manhole cover present and in working condition?	YES
All bolts on manhole present and not stripped?	NO
Well plug present, locked and in good working condition?	YES
OVERALL CONDITION:	FAIR
Notes (Explain if answered No to any of the above) Bolts would not thread into manhole cover

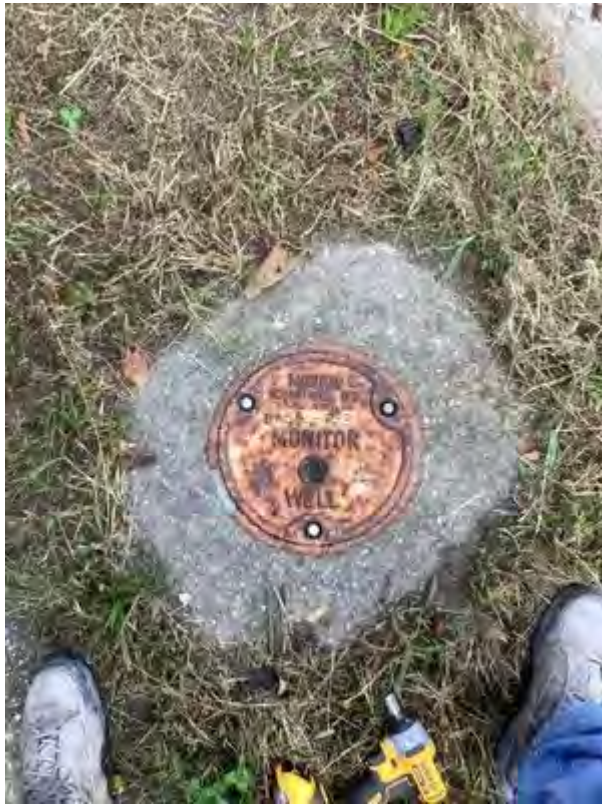
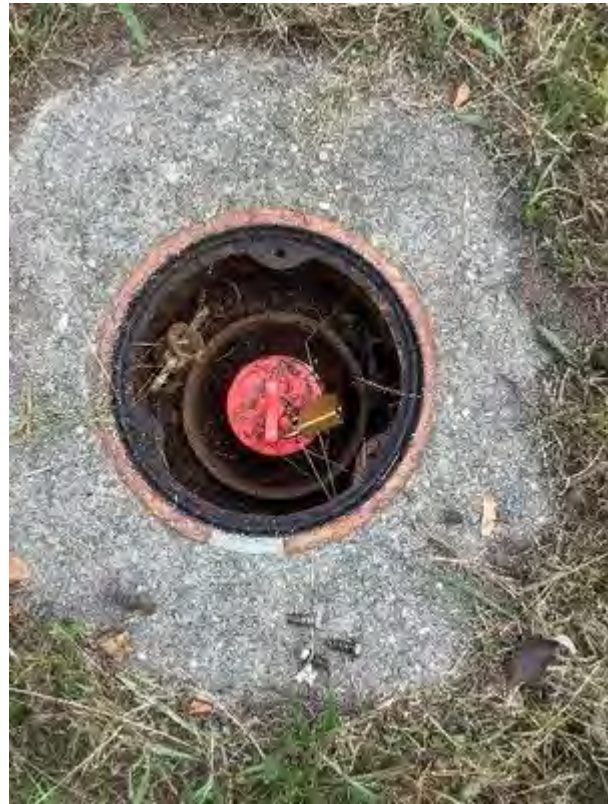
Client: Navy CLEAN	Facility: NWIRP Bethpage
Project Number: 112G08005-WE13	Location: Bethpage, New York
Date: September 21, 2021 10:41	Personnel: Beau Benfield
Well ID: BPOW 2-3	Well Location: 199725.231 1127377.781
Well Status: Other	Screen Interval: 564-594
WELL INVENTORY CONDITION	
Concrete pad in acceptable condition i.e. no cracks?	YES
Manhole cover present and in working condition?	YES
All bolts on manhole present and not stripped?	YES
Well plug present, locked and in good working condition?	YES
OVERALL CONDITION:	GOOD
Notes (Explain if answered No to any of the above)

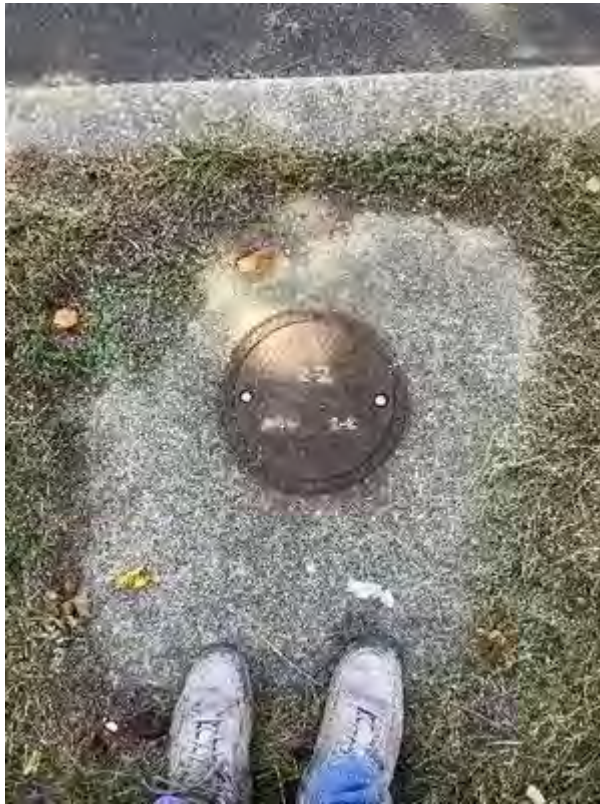
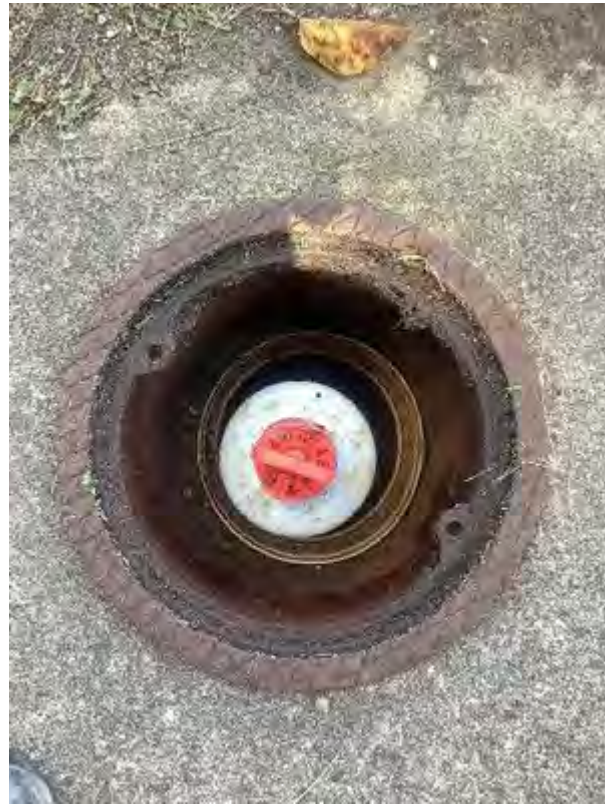
Client: Navy CLEAN	Facility: NWIRP Bethpage
Project Number: 112G08005-WE13	Location: Bethpage, New York
Date: September 21, 2021 10:33	Personnel: Beau Benfield
Well ID: BPOW 2-2	Well Location: 199726.254 1127412.832
Well Status: Other	Screen Interval: 455-495
WELL INVENTORY CONDITION	
Concrete pad in acceptable condition i.e. no cracks?	YES
Manhole cover present and in working condition?	YES
All bolts on manhole present and not stripped?	YES
Well plug present, locked and in good working condition?	YES
OVERALL CONDITION:	GOOD
Notes (Explain if answered No to any of the above)

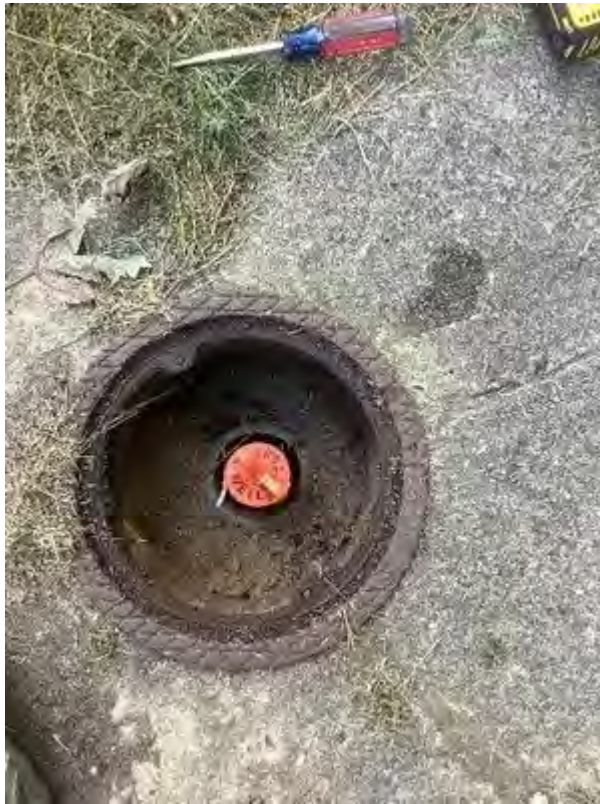
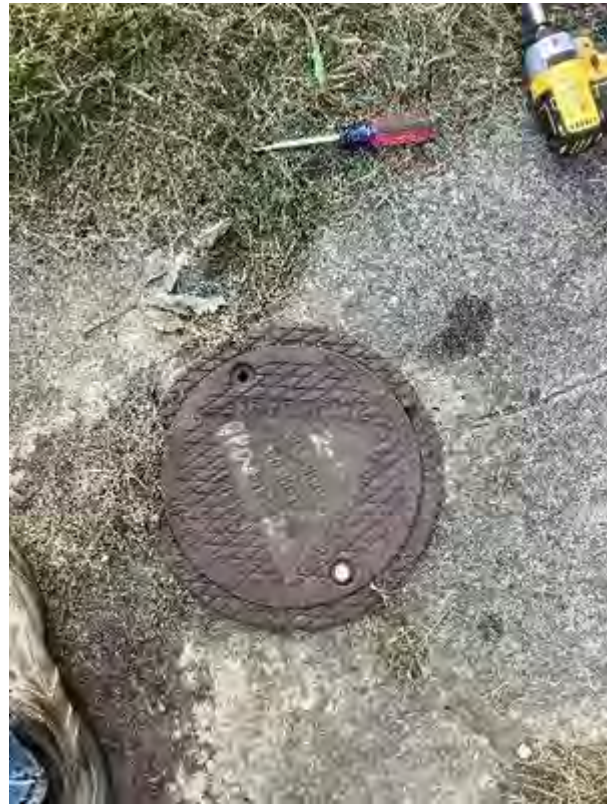
Client: Navy CLEAN	Facility: NWIRP Bethpage
Project Number: 112G08005-WE13	Location: Bethpage, New York
Date: September 21, 2021 10:31	Personnel: Beau Benfield
Well ID: BPOW 2-1	Well Location: 199726.122 1127424.086
Well Status: Other	Screen Interval: 356-396
WELL INVENTORY CONDITION	
Concrete pad in acceptable condition i.e. no cracks?	YES
Manhole cover present and in working condition?	YES
All bolts on manhole present and not stripped?	NO
Well plug present, locked and in good working condition?	YES
OVERALL CONDITION:	GOOD
Notes (Explain if answered No to any of the above) Threaded part of bolt broken off inside manhole cover.

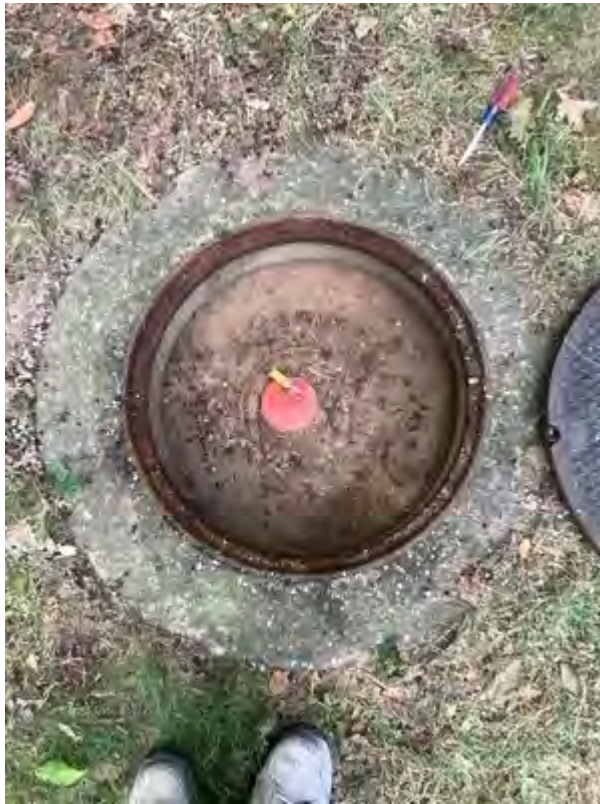
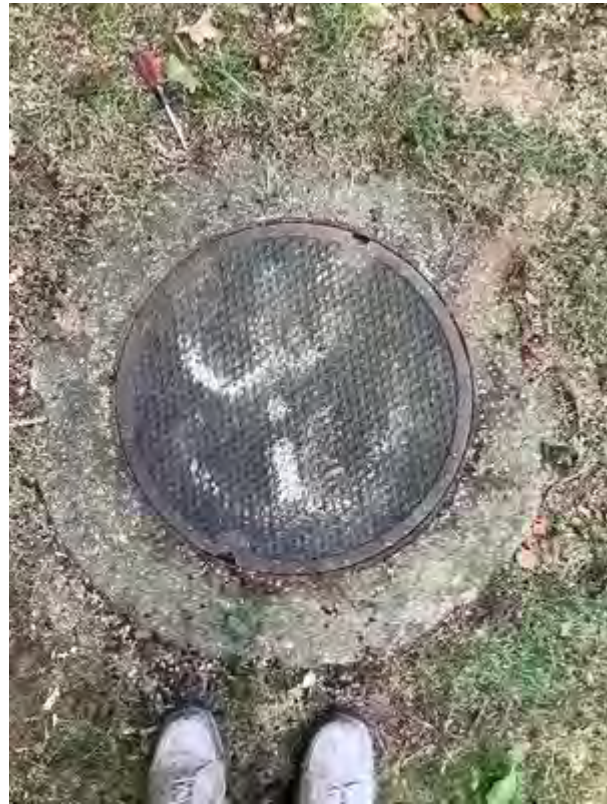
Client: Navy CLEAN	Facility: NWIRP Bethpage
Project Number: 112G08005-WE13	Location: Bethpage, New York
Date: September 21, 2021 10:13	Personnel: Beau Benfield
Well ID: BPOW 3-3	Well Location: 199565.166 1125394.146
Well Status: Other	Screen Interval: 580-620
WELL INVENTORY CONDITION	
Concrete pad in acceptable condition i.e. no cracks?	YES
Manhole cover present and in working condition?	YES
All bolts on manhole present and not stripped?	YES
Well plug present, locked and in good working condition?	YES
OVERALL CONDITION:	GOOD
Notes (Explain if answered No to any of the above)

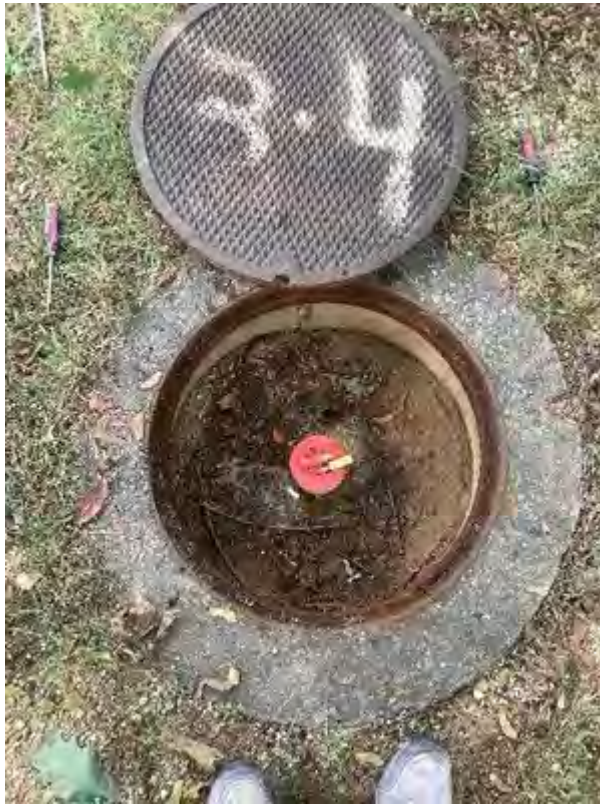
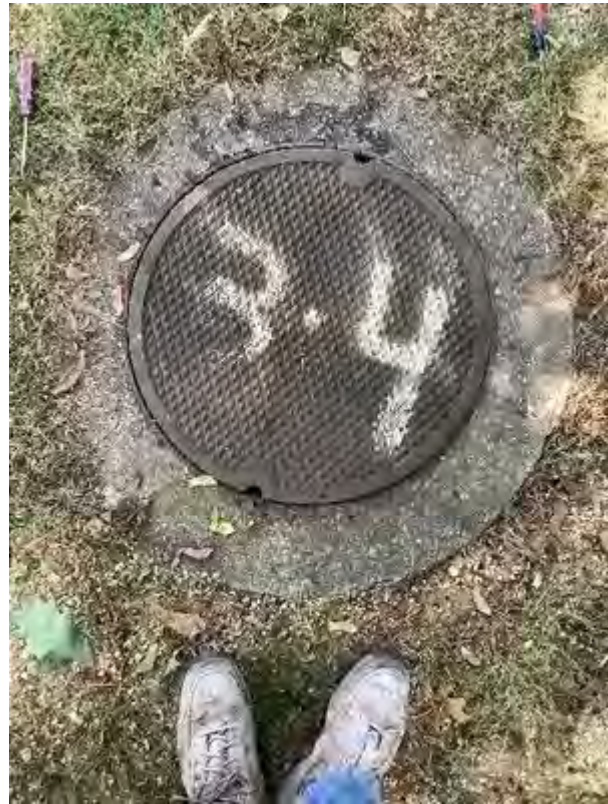
Client: Navy CLEAN	Facility: NWIRP Bethpage
Project Number: 112G08005-WE13	Location: Bethpage, New York
Date: September 21, 2021 10:05	Personnel: Beau Benfield
Well ID: BPOW 3-4	Well Location: 199566.193 1125377.086
Well Status: Other	Screen Interval: 640-690
WELL INVENTORY CONDITION	
Concrete pad in acceptable condition i.e. no cracks?	YES
Manhole cover present and in working condition?	YES
All bolts on manhole present and not stripped?	YES
Well plug present, locked and in good working condition?	YES
OVERALL CONDITION:	GOOD
Notes (Explain if answered No to any of the above)

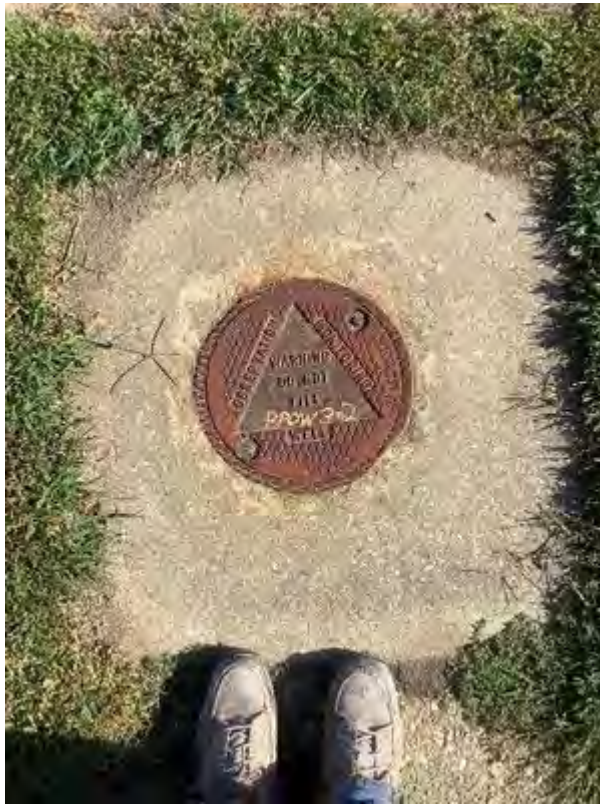
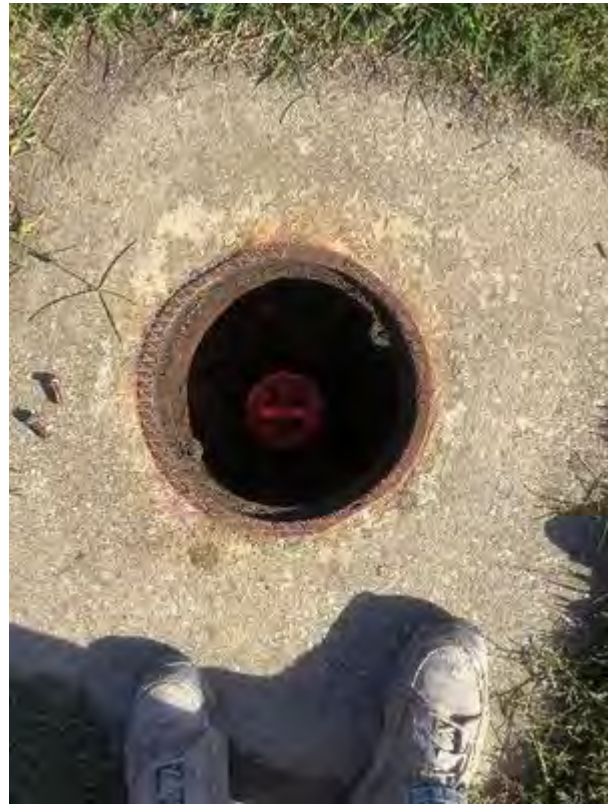
Client: Navy CLEAN	Facility: NWIRP Bethpage
Project Number: 112G08005-WE13	Location: Bethpage, New York
Date: September 21, 2021 09:46	Personnel: Beau Benfield
Well ID: BPOW 3-2	Well Location: 198664.297 1124757.479
Well Status: Other	Screen Interval: 612-647
WELL INVENTORY CONDITION	
Concrete pad in acceptable condition i.e. no cracks?	YES
Manhole cover present and in working condition?	YES
All bolts on manhole present and not stripped?	YES
Well plug present, locked and in good working condition?	YES
OVERALL CONDITION:	GOOD
Notes (Explain if answered No to any of the above)

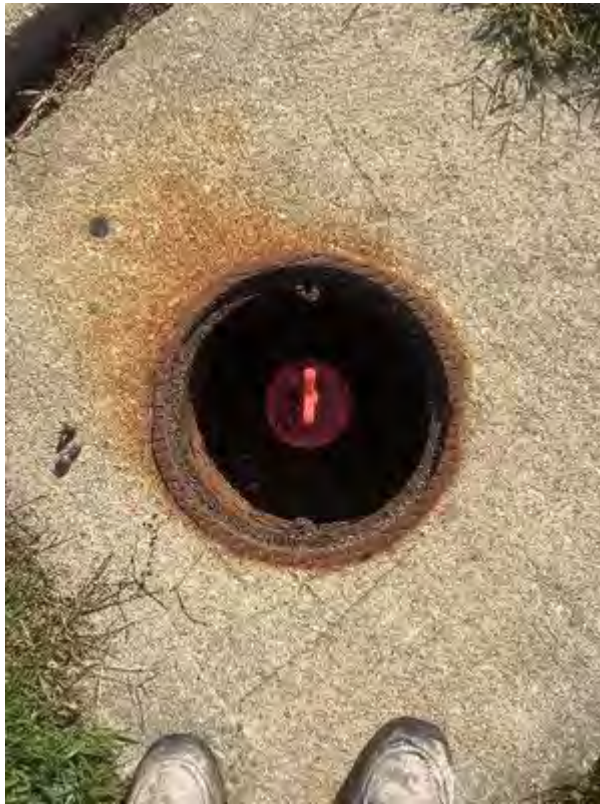
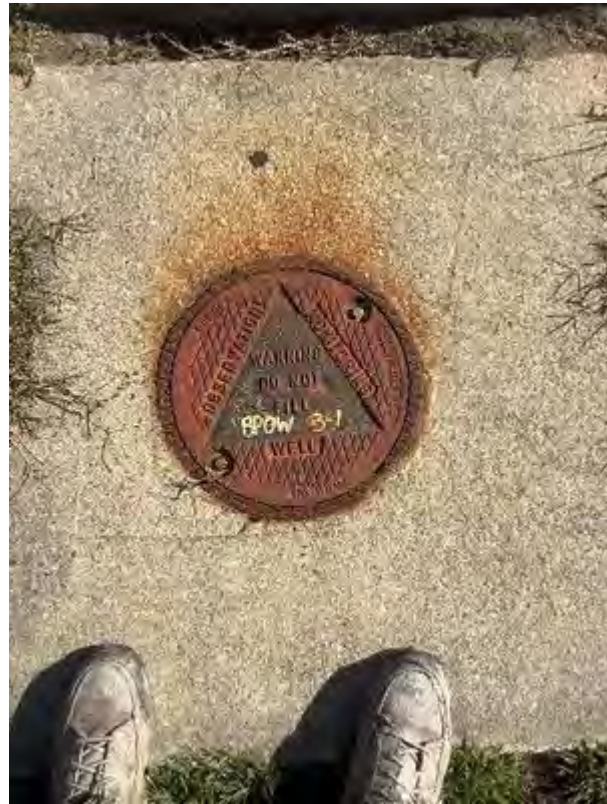
Client: Navy CLEAN	Facility: NWIRP Bethpage
Project Number: 112G08005-WE13	Location: Bethpage, New York
Date: September 21, 2021 09:32	Personnel: Beau Benfield
Well ID: BPOW 3-1	Well Location: 198628.43 1124804.492
Well Status: Other	Screen Interval: 426-516
WELL INVENTORY CONDITION	
Concrete pad in acceptable condition i.e. no cracks?	YES
Manhole cover present and in working condition?	YES
All bolts on manhole present and not stripped?	YES
Well plug present, locked and in good working condition?	YES
OVERALL CONDITION:	GOOD
Notes (Explain if answered No to any of the above)

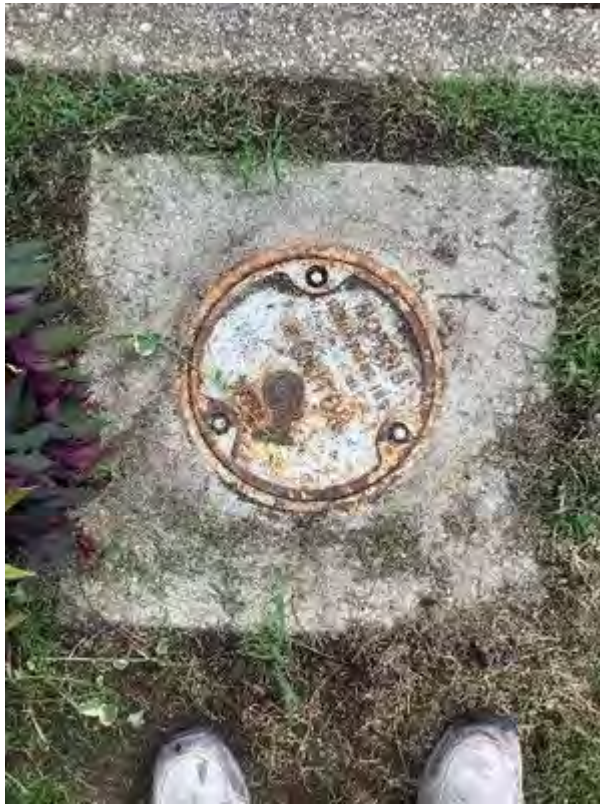
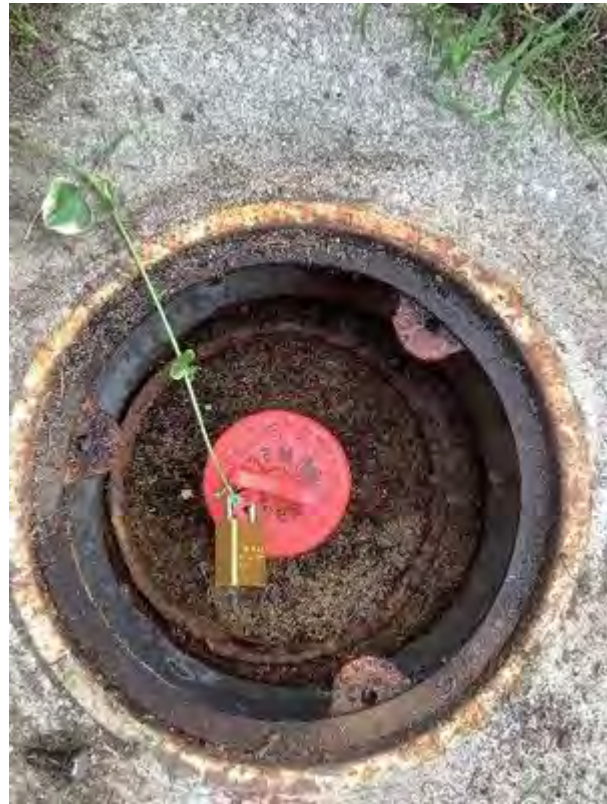
Client: Navy CLEAN	Facility: NWIRP Bethpage
Project Number: 112G08005-WE13	Location: Bethpage, New York
Date: September 21, 2021 09:13	Personnel: Beau Benfield
Well ID: BPOW 5-6	Well Location: 197327.15 1126285.56
Well Status: Other	Screen Interval: 585-610
WELL INVENTORY CONDITION	
Concrete pad in acceptable condition i.e. no cracks?	YES
Manhole cover present and in working condition?	YES
All bolts on manhole present and not stripped?	YES
Well plug present, locked and in good working condition?	YES
OVERALL CONDITION:	GOOD
Notes (Explain if answered No to any of the above)

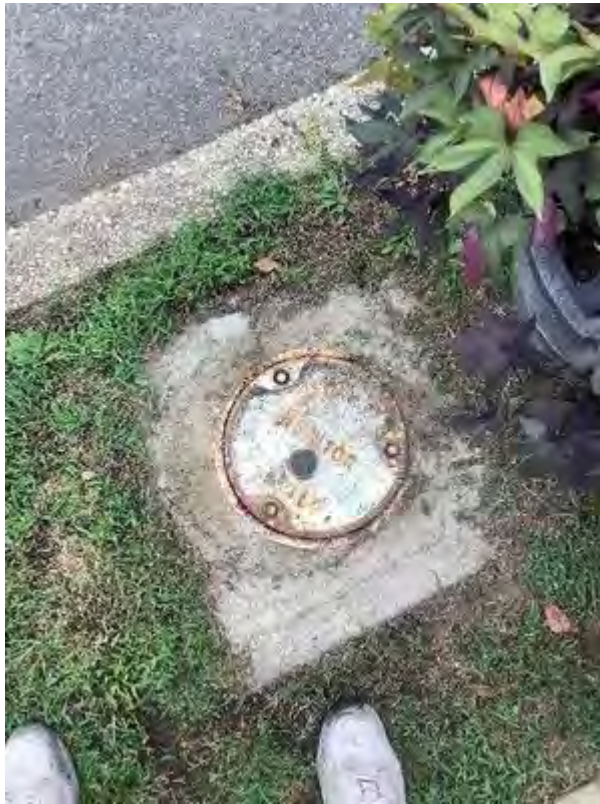
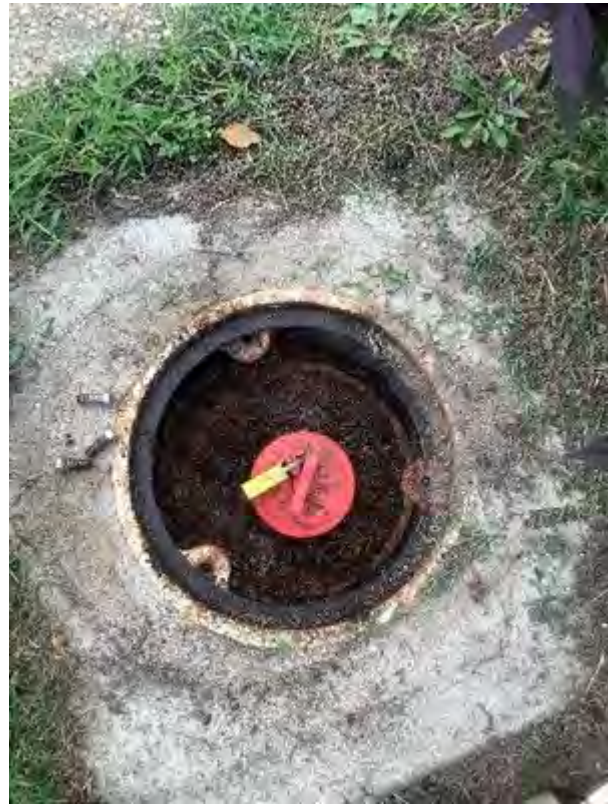
Client: Navy CLEAN	Facility: NWIRP Bethpage
Project Number: 112G08005-WE13	Location: Bethpage, New York
Date: September 21, 2021 09:10	Personnel: Beau Benfield
Well ID: BPOW 5-5	Well Location: 197285.18896 1126291.26851
Well Status: Other	Screen Interval: 515-540
WELL INVENTORY CONDITION	
Concrete pad in acceptable condition i.e. no cracks?	YES
Manhole cover present and in working condition?	YES
All bolts on manhole present and not stripped?	YES
Well plug present, locked and in good working condition?	YES
OVERALL CONDITION:	GOOD
Notes (Explain if answered No to any of the above)

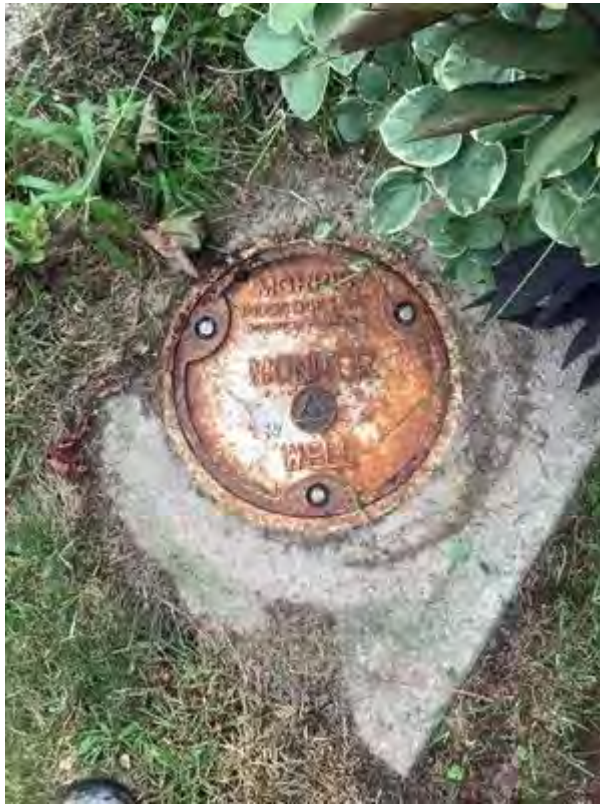
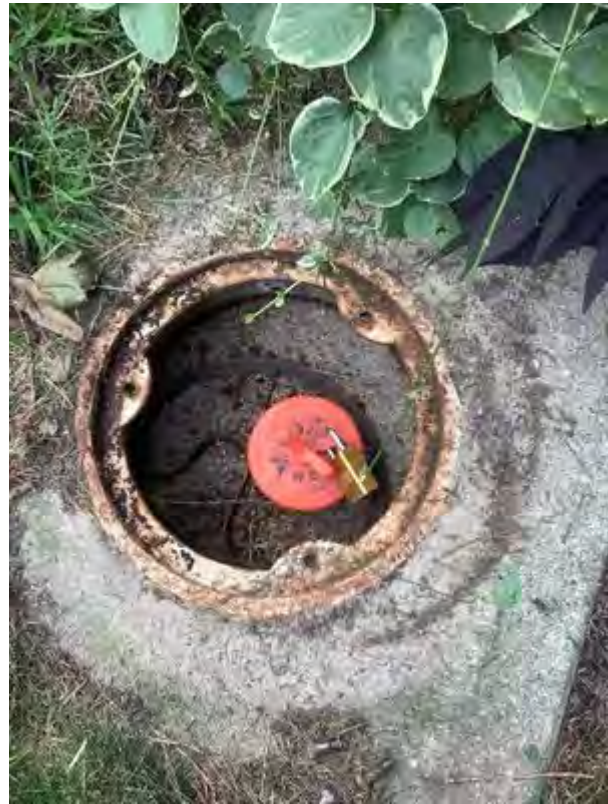
Client: Navy CLEAN	Facility: NWIRP Bethpage
Project Number: 112G08005-WE13	Location: Bethpage, New York
Date: September 21, 2021 09:00	Personnel: Beau Benfield
Well ID: RE118D1	Well Location: 197298.81 1126290.8
Well Status: Other	Screen Interval: 765-790
WELL INVENTORY CONDITION	
Concrete pad in acceptable condition i.e. no cracks?	YES
Manhole cover present and in working condition?	YES
All bolts on manhole present and not stripped?	YES
Well plug present, locked and in good working condition?	YES
OVERALL CONDITION:	GOOD
Notes (Explain if answered No to any of the above)

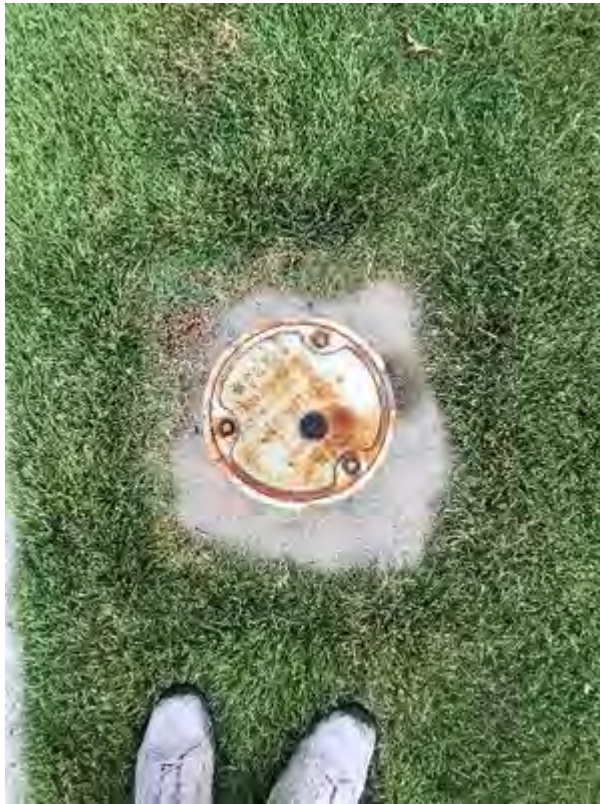
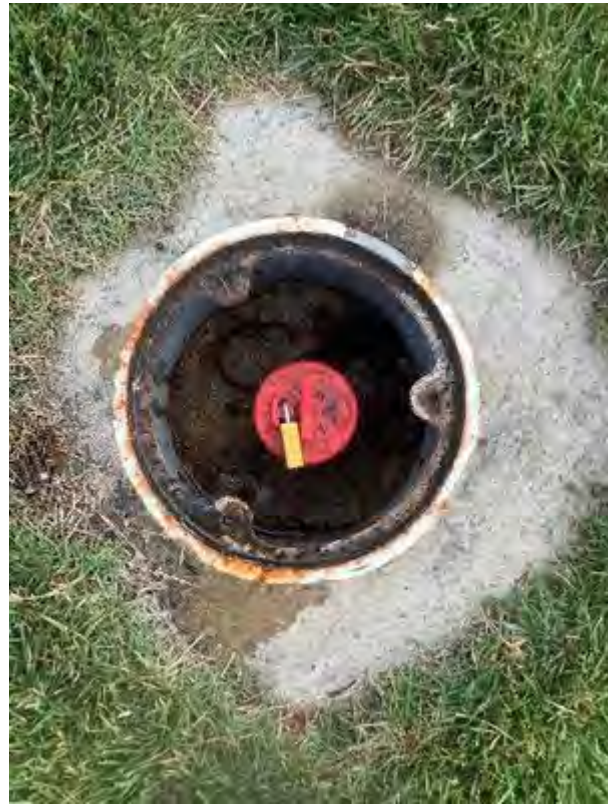
Client: Navy CLEAN	Facility: NWIRP Bethpage
Project Number: 112G08005-WE13	Location: Bethpage, New York
Date: September 21, 2021 08:48	Personnel: Beau Benfield
Well ID: RE133D1	Well Location: 193975.82 1126227.64
Well Status: Other	Screen Interval: 560-580
WELL INVENTORY CONDITION	
Concrete pad in acceptable condition i.e. no cracks?	YES
Manhole cover present and in working condition?	YES
All bolts on manhole present and not stripped?	YES
Well plug present, locked and in good working condition?	YES
OVERALL CONDITION:	GOOD
Notes (Explain if answered No to any of the above)
