Memorandum

To: Scot Sokolowski, NAVFAC MIDLANT
From: David Brayack, Tetra Tech
Date: December 30, 2021
Re: Annual LUC Inspection and Operation Summary Report: Sites 1, 2, 3, and 4 – NWIRP Bethpage
Revision 1
Contract/CTO Number: N6247016D9008/WE13

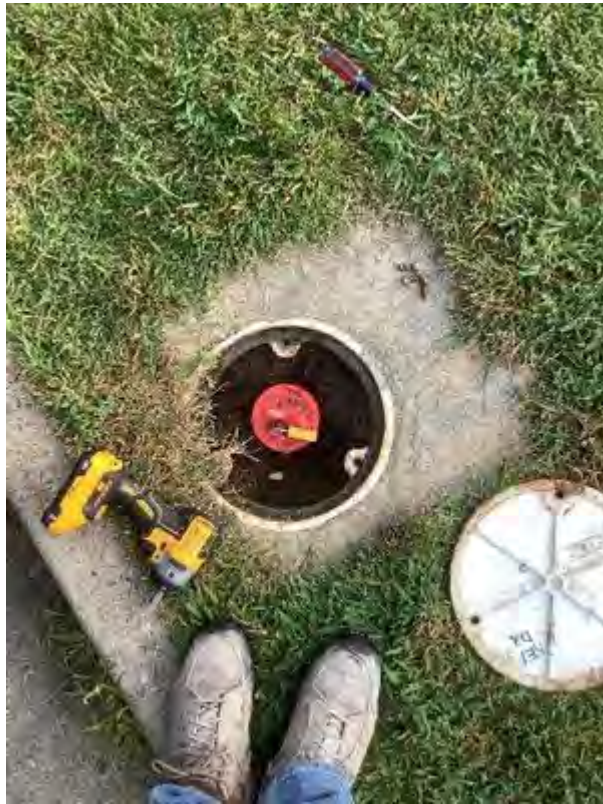
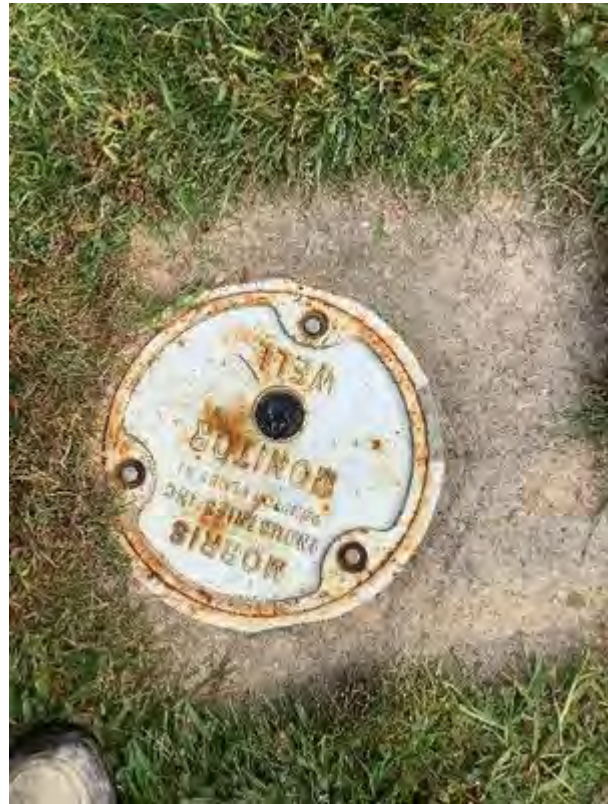
Client: Navy CLEAN	Facility: NWIRP Bethpage
Project Number: 112G08005-WE13	Location: Bethpage, New York
Date: September 21, 2021 08:46	Personnel: Beau Benfield
Well ID: RE133D2	Well Location: 193991.82 1126227.06
Well Status: Other	Screen Interval: 780-800
WELL INVENTORY CONDITION	
Concrete pad in acceptable condition i.e. no cracks?	YES
Manhole cover present and in working condition?	YES
All bolts on manhole present and not stripped?	YES
Well plug present, locked and in good working condition?	YES
OVERALL CONDITION:	GOOD
Notes (Explain if answered No to any of the above)

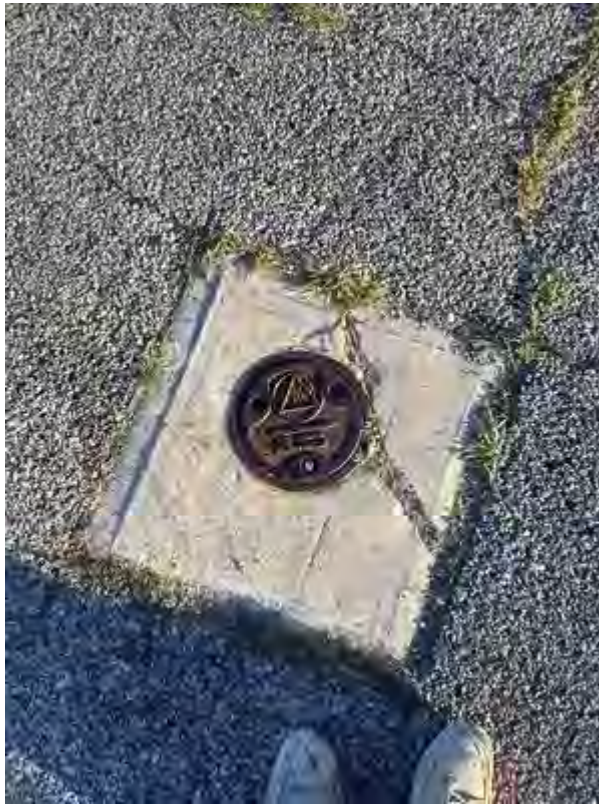
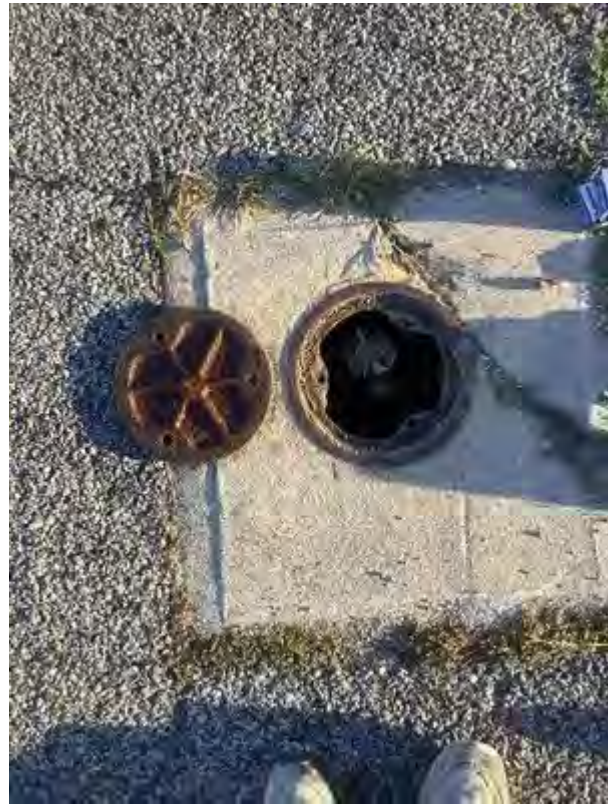
Client: Navy CLEAN	Facility: NWIRP Bethpage
Project Number: 112G08005-WE13	Location: Bethpage, New York
Date: September 21, 2021 07:34	Personnel: Beau Benfield
Well ID: BPTTAOC22MW09	Well Location: 214007.819715 1123539.30462
Well Status: Other	Screen Interval: 52-62
WELL INVENTORY CONDITION	
Concrete pad in acceptable condition i.e. no cracks?	NO
Manhole cover present and in working condition?	YES
All bolts on manhole present and not stripped?	YES
Well plug present, locked and in good working condition?	YES
OVERALL CONDITION:	FAIR
Notes (Explain if answered No to any of the above) New bolts could not be threaded through manhole cover

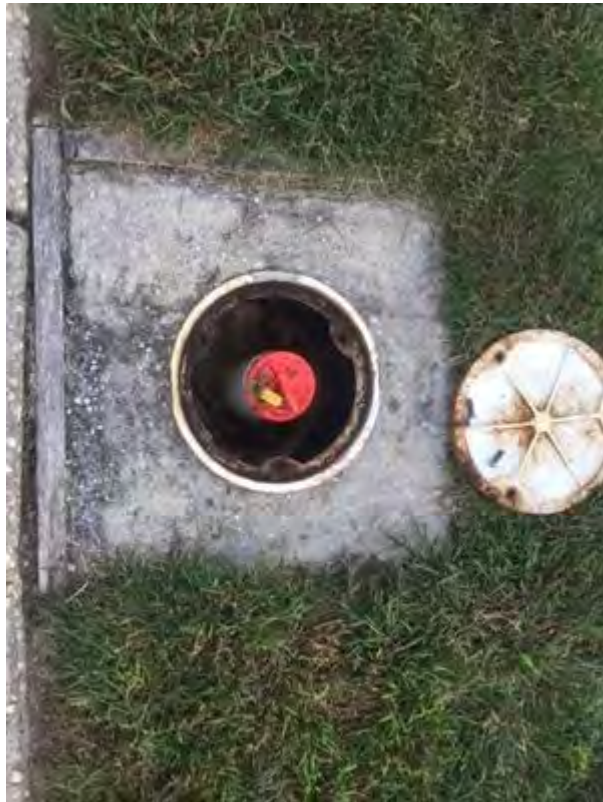
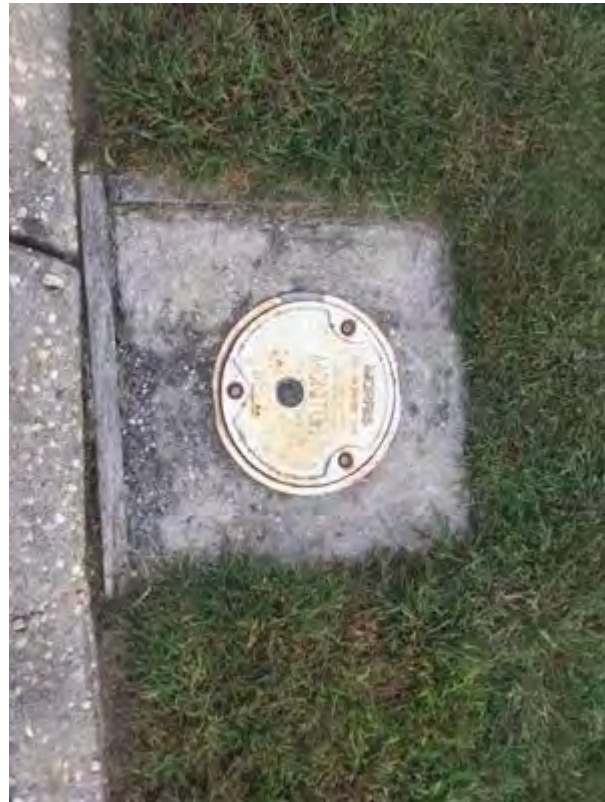
Client: Navy CLEAN	Facility: NWIRP Bethpage
Project Number: 112G08005-WE13	Location: Bethpage, New York
Date: September 20, 2021 11:31	Personnel: Wyatt Bostick
Well ID: RE122D1	Well Location: 207818.19 1124982.01
Well Status: Other	Screen Interval: 520-540
WELL INVENTORY CONDITION	
Concrete pad in acceptable condition i.e. no cracks?	YES
Manhole cover present and in working condition?	YES
All bolts on manhole present and not stripped?	YES
Well plug present, locked and in good working condition?	YES
OVERALL CONDITION:	GOOD
Notes (Explain if answered No to any of the above)

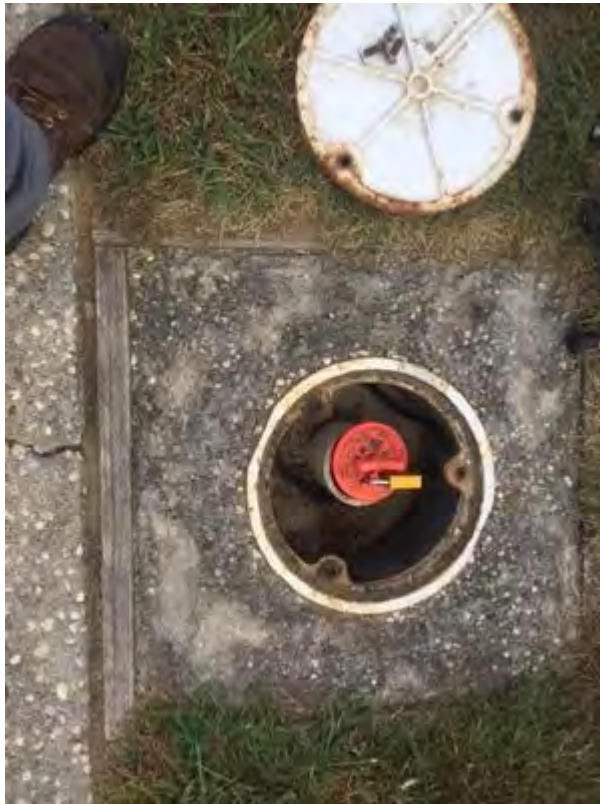
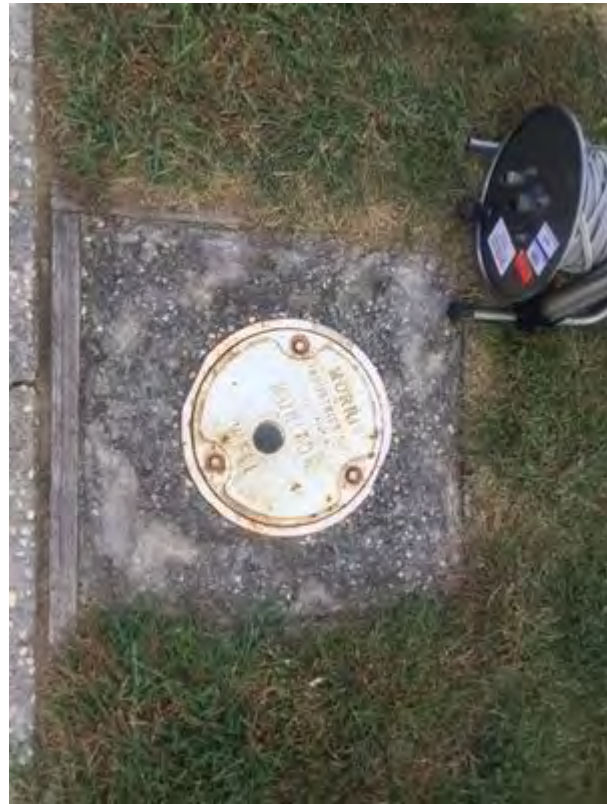
Client: Navy CLEAN	Facility: NWIRP Bethpage
Project Number: 112G08005-WE13	Location: Bethpage, New York
Date: September 20, 2021 11:28	Personnel: Wyatt Bostick
Well ID: RE122D2	Well Location: 207788.843682 1124978.90771
Well Status: Other	Screen Interval: 590-610
WELL INVENTORY CONDITION	
Concrete pad in acceptable condition i.e. no cracks?	YES
Manhole cover present and in working condition?	YES
All bolts on manhole present and not stripped?	YES
Well plug present, locked and in good working condition?	YES
OVERALL CONDITION:	GOOD
Notes (Explain if answered No to any of the above)

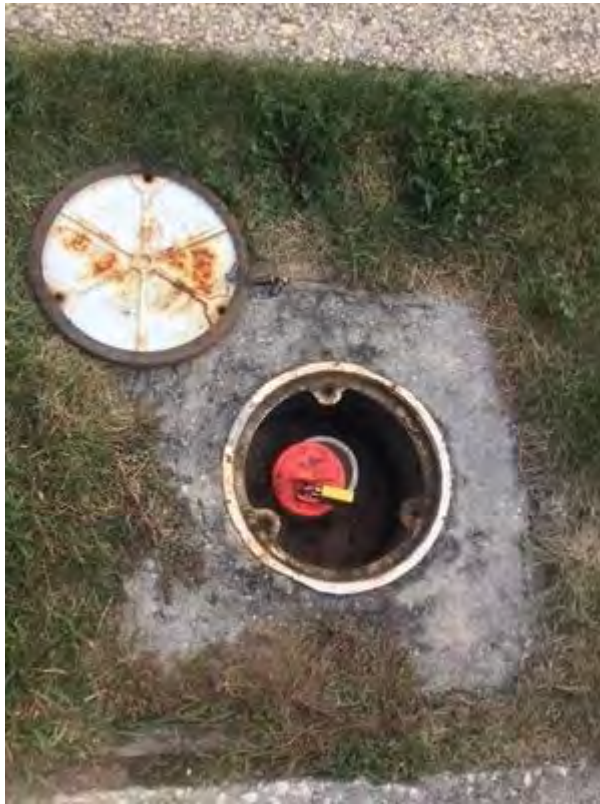
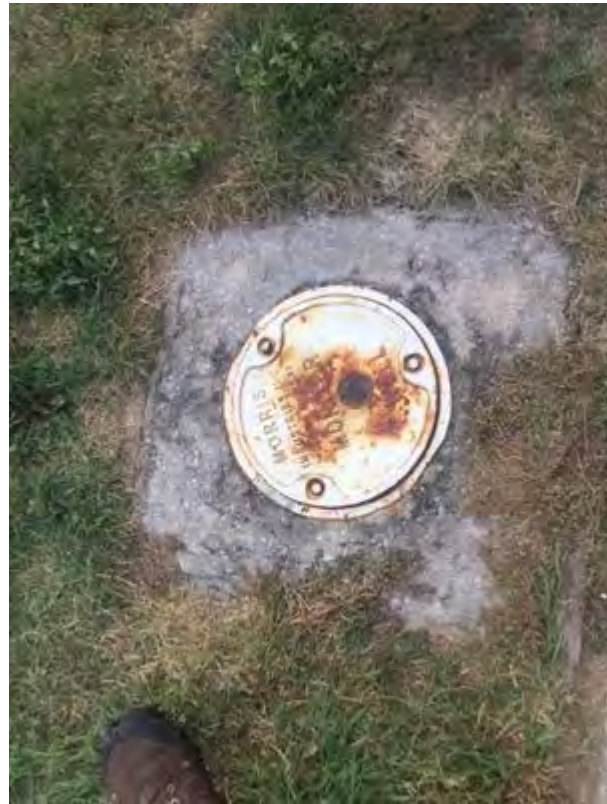
Client: Navy CLEAN	Facility: NWIRP Bethpage
Project Number: 112G08005-WE13	Location: Bethpage, New York
Date: September 20, 2021 11:25	Personnel: Wyatt Bostick
Well ID: RE122D3	Well Location: 207774.52 1124980.63
Well Status: Other	Screen Interval: 715-735
WELL INVENTORY CONDITION	
Concrete pad in acceptable condition i.e. no cracks?	YES
Manhole cover present and in working condition?	YES
All bolts on manhole present and not stripped?	YES
Well plug present, locked and in good working condition?	YES
OVERALL CONDITION:	GOOD
Notes (Explain if answered No to any of the above)

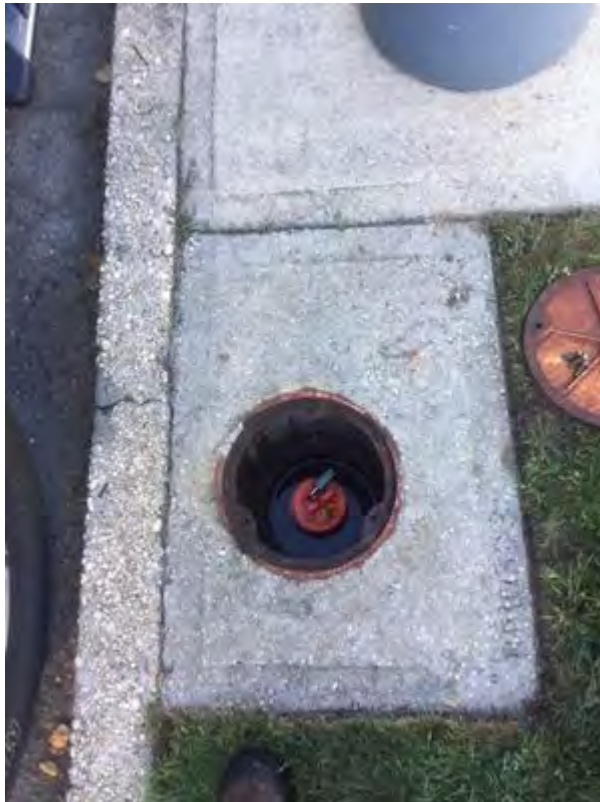
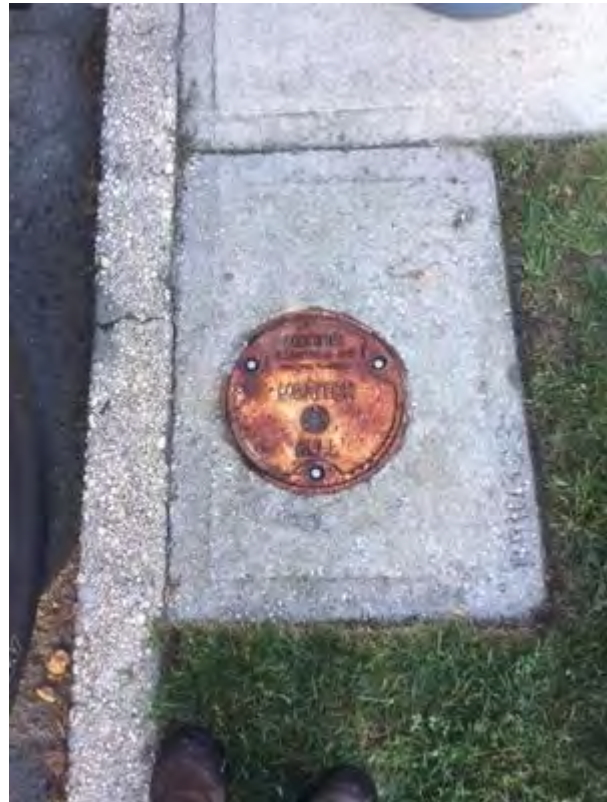
Client: Navy CLEAN	Facility: NWIRP Bethpage
Project Number: 112G08005-WE13	Location: Bethpage, New York
Date: September 20, 2021 08:25	Personnel: Wyatt Bostick
Well ID: RE103D3	Well Location: 206693.459 1125144.905
Well Status: Other	Screen Interval: 715-730
WELL INVENTORY CONDITION	
Concrete pad in acceptable condition i.e. no cracks?	YES
Manhole cover present and in working condition?	YES
All bolts on manhole present and not stripped?	NO
Well plug present, locked and in good working condition?	YES
OVERALL CONDITION:	FAIR
Notes (Explain if answered No to any of the above) All bolts stripped, needs fill

*All wells in Fair/Poor condition will be repaired and/or addressed prior to the next Annual Well Inventory to the extent practicable

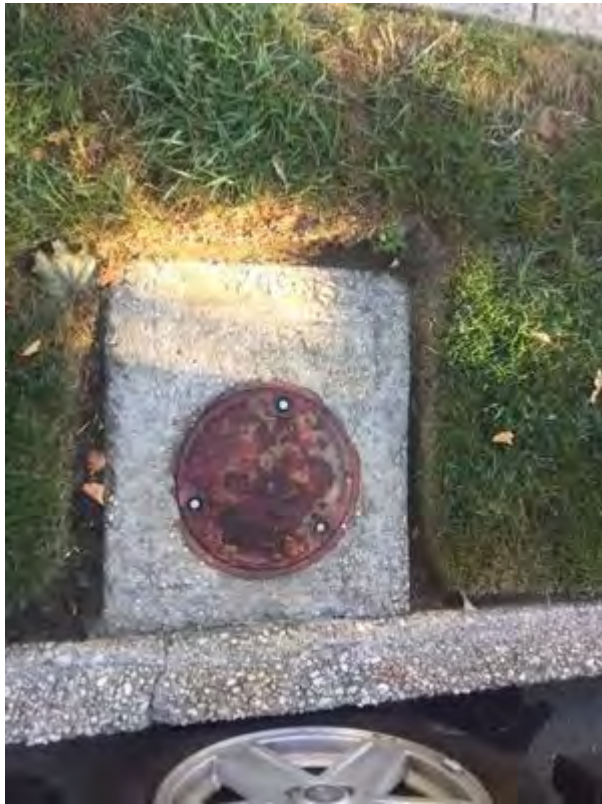
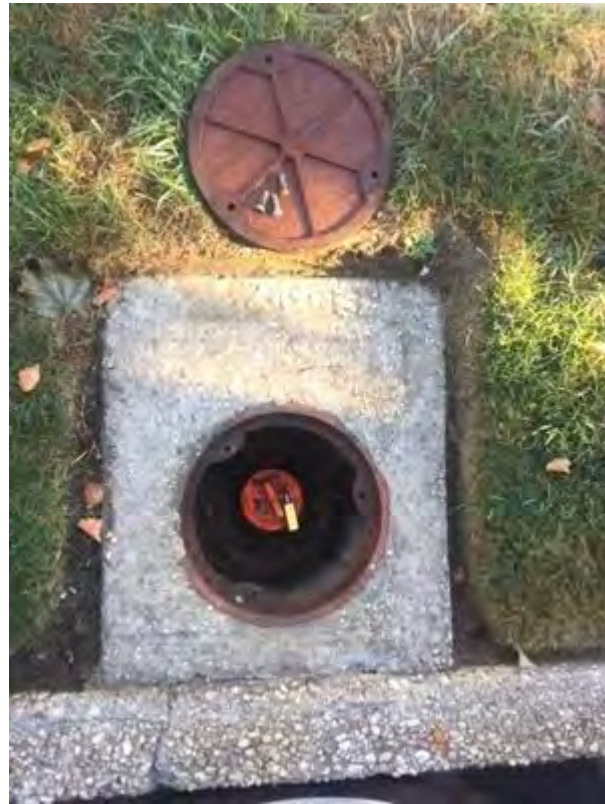
Client: Navy CLEAN	Facility: NWIRP Bethpage
Project Number: 112G08005-WE13	Location: Bethpage, New York
Date: September 20, 2021 08:22	Personnel: Wyatt Bostick
Well ID: RE103D2	Well Location: 206692.993 1125160.339
Well Status: Other	Screen Interval: 653-673
WELL INVENTORY CONDITION	
Concrete pad in acceptable condition i.e. no cracks?	YES
Manhole cover present and in working condition?	YES
All bolts on manhole present and not stripped?	NO
Well plug present, locked and in good working condition?	YES
OVERALL CONDITION:	FAIR
Notes (Explain if answered No to any of the above) All bolts stripped

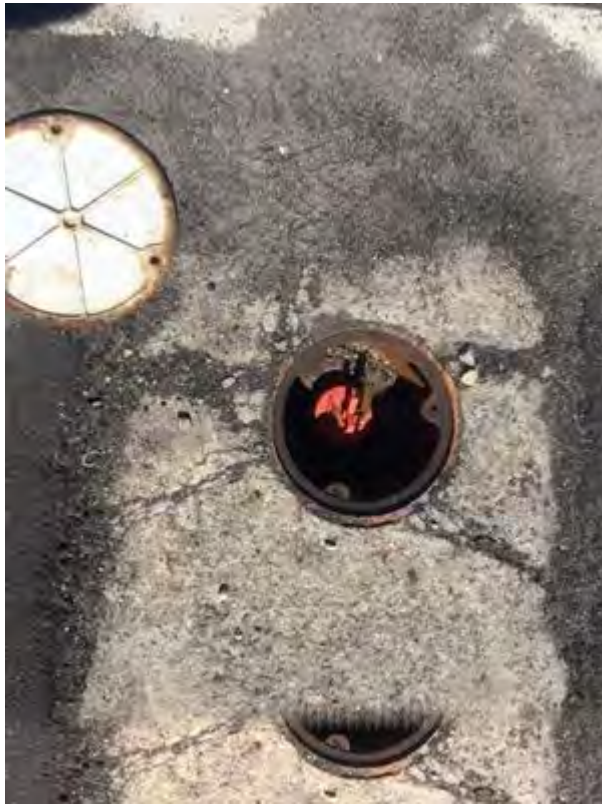
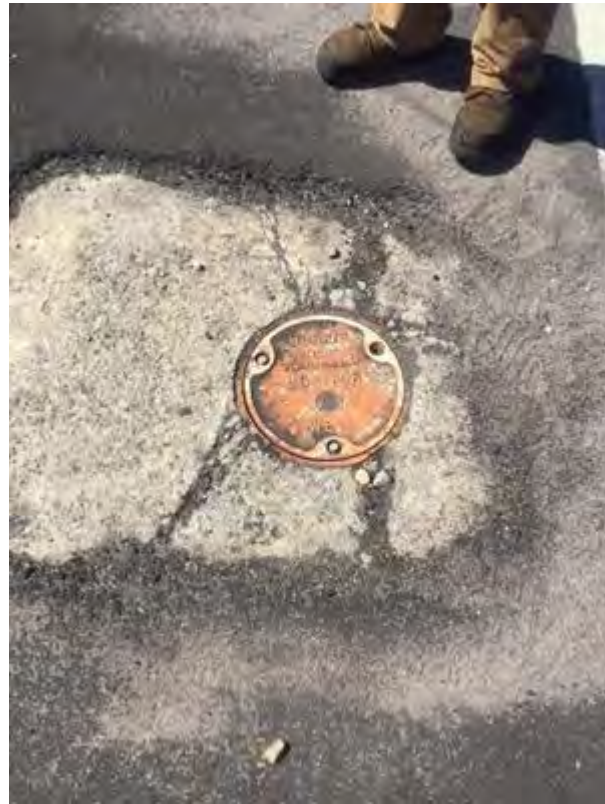
Client: Navy CLEAN	Facility: NWIRP Bethpage
Project Number: 112G08005-WE13	Location: Bethpage, New York
Date: September 19, 2021 13:00	Personnel: Wyatt Bostick
Well ID: BP-TT-MW202D1	Well Location: 215078.6 1122982.4
Well Status: Other	Screen Interval: 425-440
WELL INVENTORY CONDITION	
Concrete pad in acceptable condition i.e. no cracks?	NO
Manhole cover present and in working condition?	YES
All bolts on manhole present and not stripped?	NO
Well plug present, locked and in good working condition?	YES
OVERALL CONDITION:	FAIR
Notes (Explain if answered No to any of the above) Snapped bolt

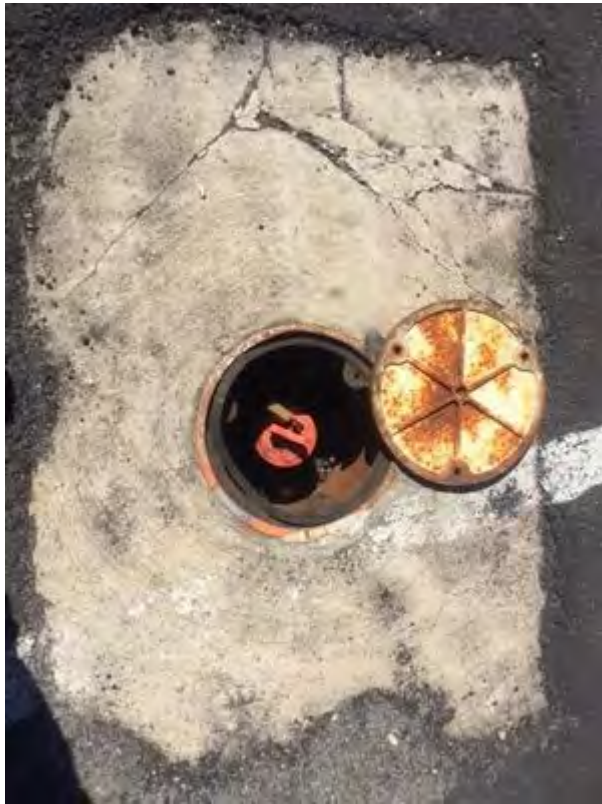
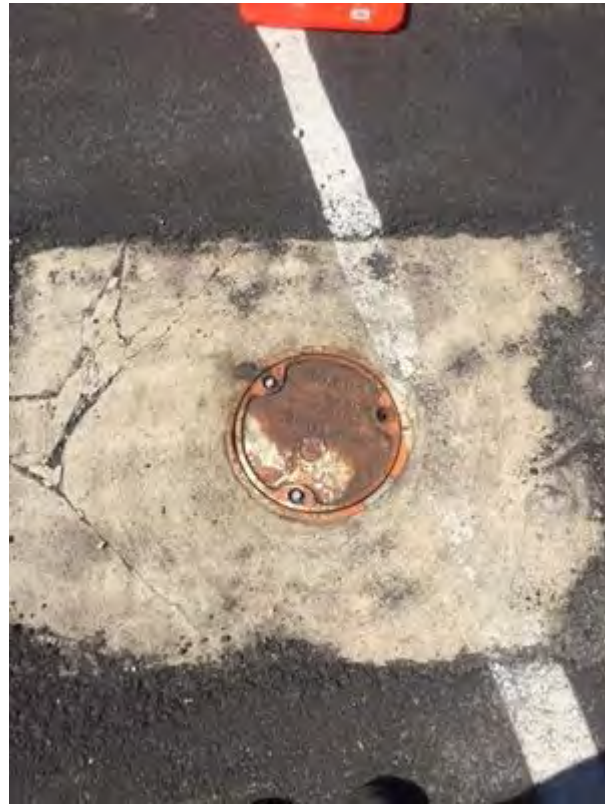
Client: Navy CLEAN	Facility: NWIRP Bethpage
Project Number: 112G08005-WE13	Location: Bethpage, New York
Date: September 19, 2021 12:30	Personnel: Wyatt Bostick
Well ID: BP-TT-MW202D	Well Location: 215062 1122983.6
Well Status: Other	Screen Interval: 335-350
WELL INVENTORY CONDITION	
Concrete pad in acceptable condition i.e. no cracks?	YES
Manhole cover present and in working condition?	YES
All bolts on manhole present and not stripped?	NO
Well plug present, locked and in good working condition?	YES
OVERALL CONDITION:	FAIR
Notes (Explain if answered No to any of the above) Snapped bolt

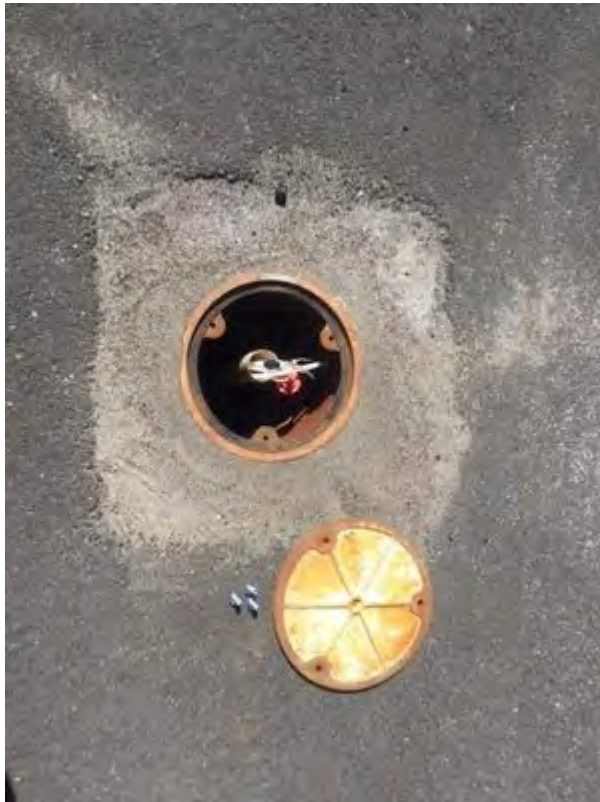
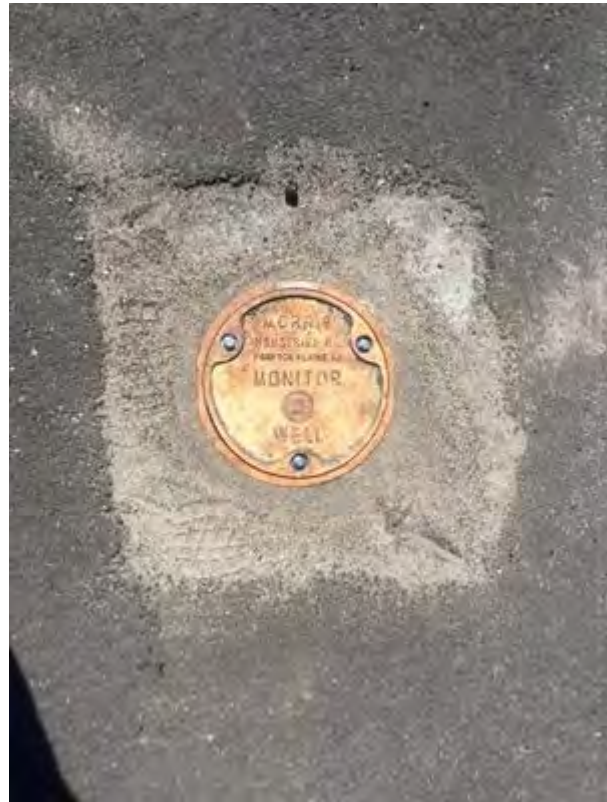
Client: Navy CLEAN	Facility: NWIRP Bethpage
Project Number: 112G08005-WE13	Location: Bethpage, New York
Date: September 19, 2021 12:21	Personnel: Wyatt Bostick
Well ID: BP-TT-MW202I	Well Location: 215088.1 1122994.8
Well Status: Other	Screen Interval: 140-150
WELL INVENTORY CONDITION	
Concrete pad in acceptable condition i.e. no cracks?	YES
Manhole cover present and in working condition?	YES
All bolts on manhole present and not stripped?	YES
Well plug present, locked and in good working condition?	YES
OVERALL CONDITION:	GOOD
Notes (Explain if answered No to any of the above) New

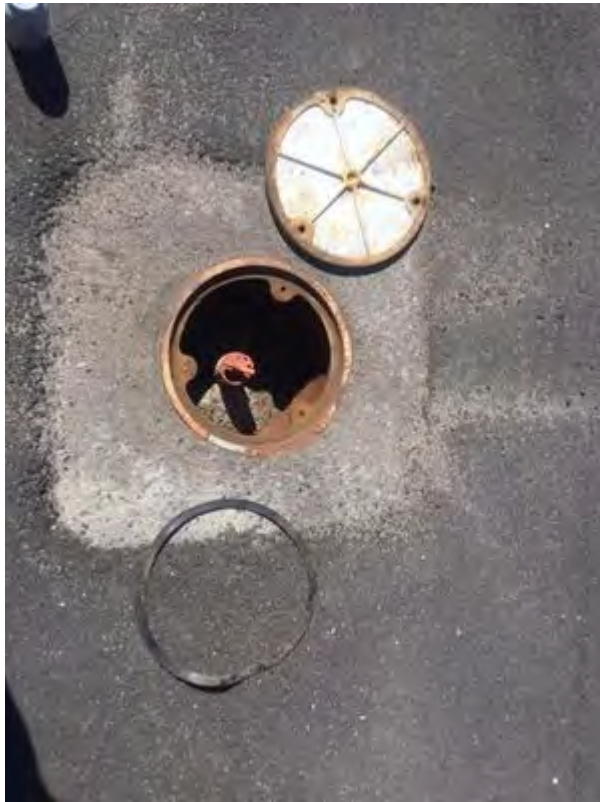
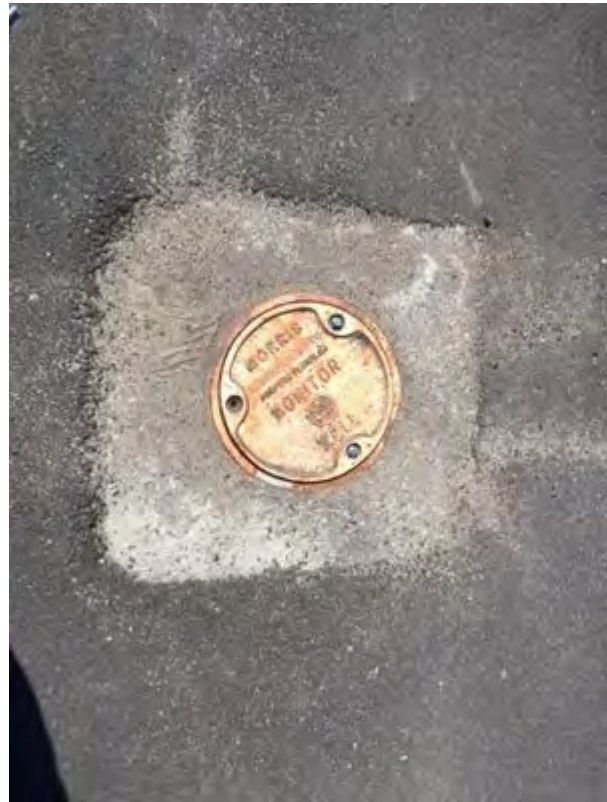
Client: Navy CLEAN	Facility: NWIRP Bethpage
Project Number: 112G08005-WE13	Location: Bethpage, New York
Date: September 19, 2021 12:08	Personnel: Wyatt Bostick
Well ID: BP-TT-MW202S	Well Location: 215099.9 1122993.3
Well Status: Other	Screen Interval: 54-64
WELL INVENTORY CONDITION	
Concrete pad in acceptable condition i.e. no cracks?	YES
Manhole cover present and in working condition?	YES
All bolts on manhole present and not stripped?	NO
Well plug present, locked and in good working condition?	YES
OVERALL CONDITION:	FAIR
Notes (Explain if answered No to any of the above) Snapped bolt

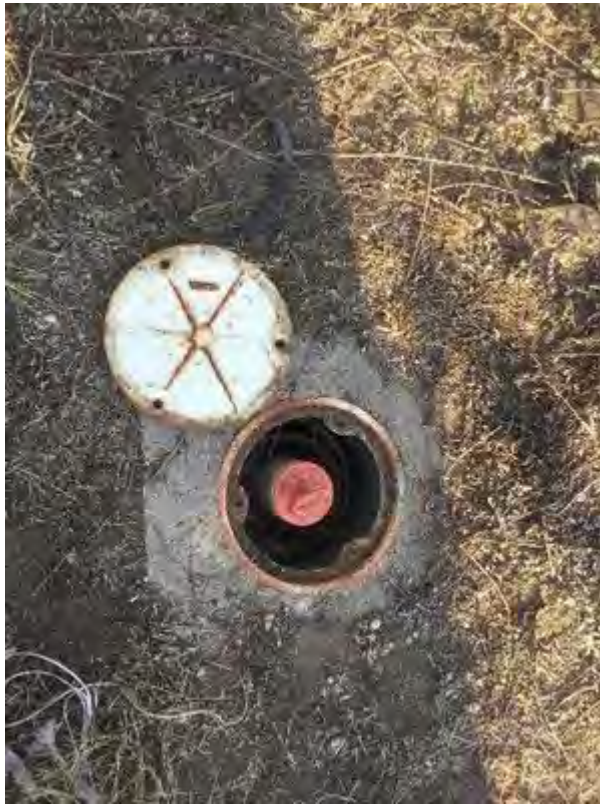
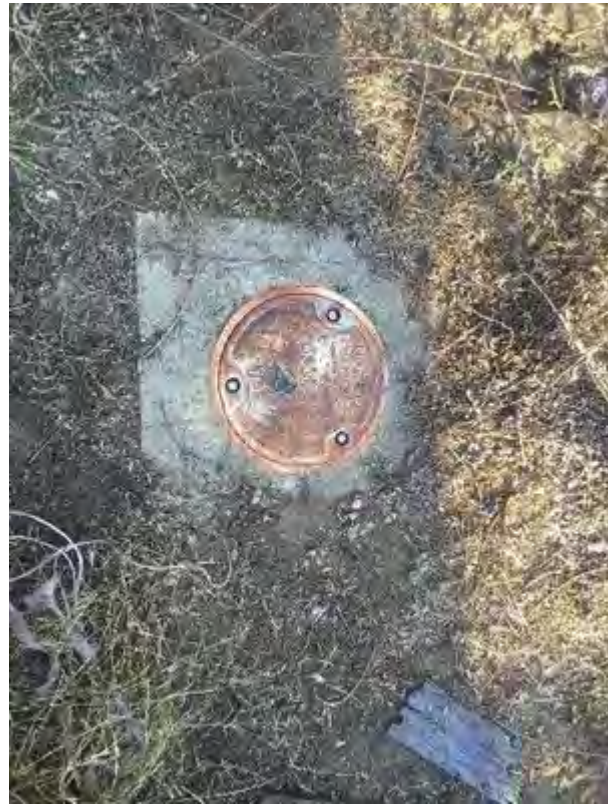
Client: Navy CLEAN	Facility: NWIRP Bethpage
Project Number: 112G08005-WE13	Location: Bethpage, New York
Date: September 18, 2021 17:33	Personnel: Wyatt Bostick
Well ID: RE123D2	Well Location: 209887.34 1124886.22
Well Status: Other	Screen Interval: 635-655
WELL INVENTORY CONDITION	
Concrete pad in acceptable condition i.e. no cracks?	YES
Manhole cover present and in working condition?	YES
All bolts on manhole present and not stripped?	YES
Well plug present, locked and in good working condition?	YES
OVERALL CONDITION:	GOOD
Notes (Explain if answered No to any of the above) Could use fill

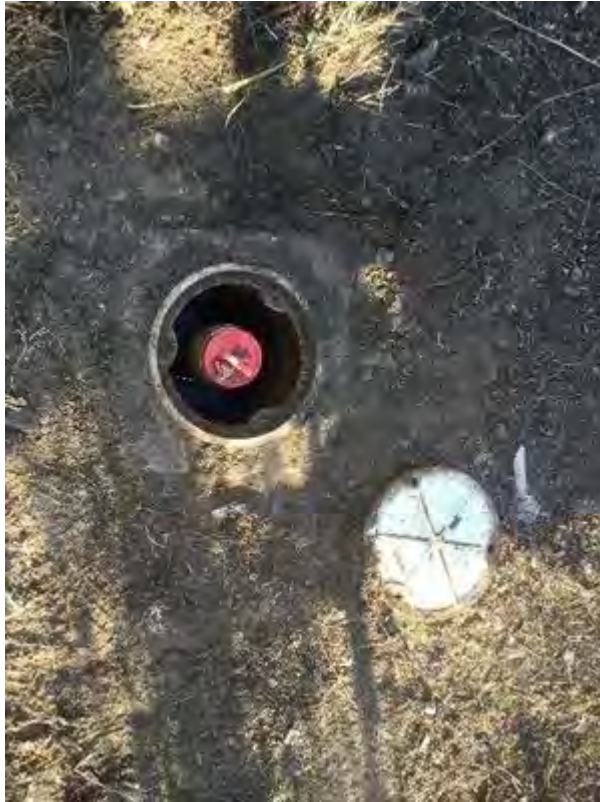
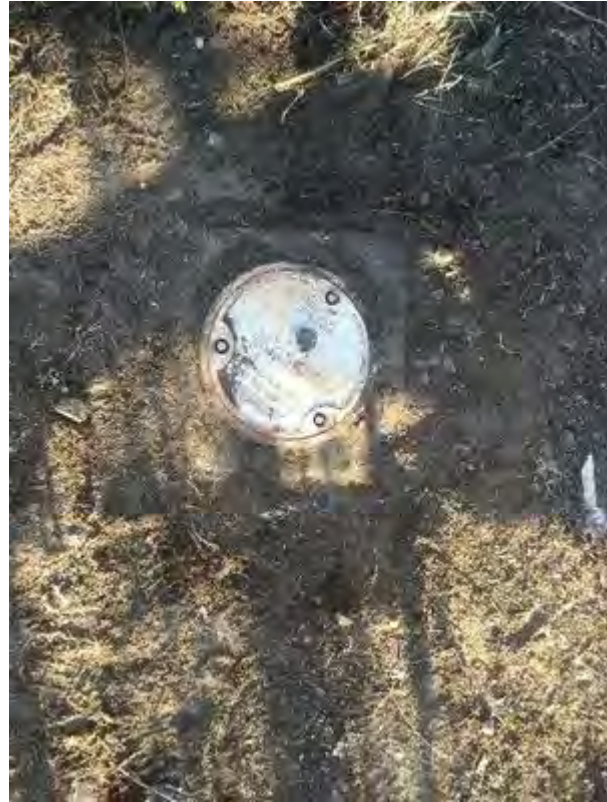
Client: Navy CLEAN	Facility: NWIRP Bethpage
Project Number: 112G08005-WE13	Location: Bethpage, New York
Date: September 18, 2021 17:28	Personnel: Wyatt Bostick
Well ID: RE123D1	Well Location: 209894.44 1124871.2
Well Status: Other	Screen Interval: 480-500
WELL INVENTORY CONDITION	
Concrete pad in acceptable condition i.e. no cracks?	NO
Manhole cover present and in working condition?	YES
All bolts on manhole present and not stripped?	YES
Well plug present, locked and in good working condition?	YES
OVERALL CONDITION:	FAIR
Notes (Explain if answered No to any of the above) Below grade, needs fill

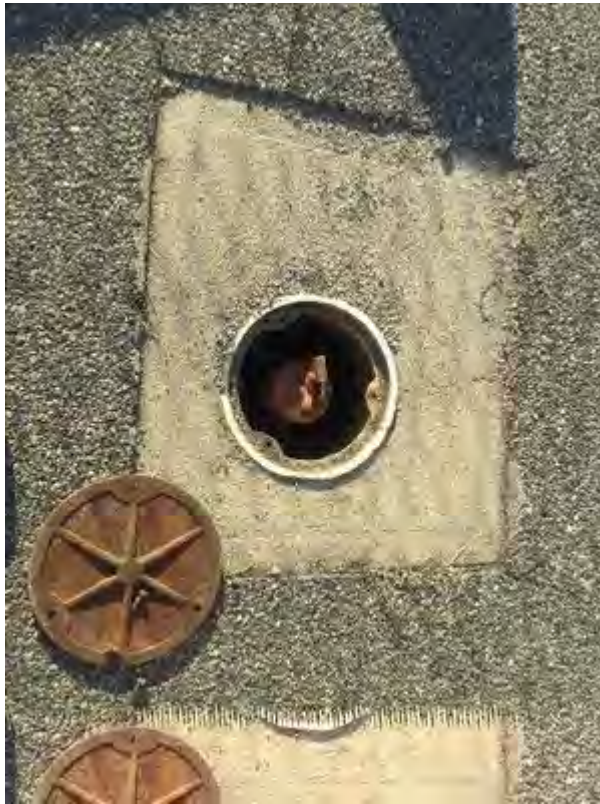
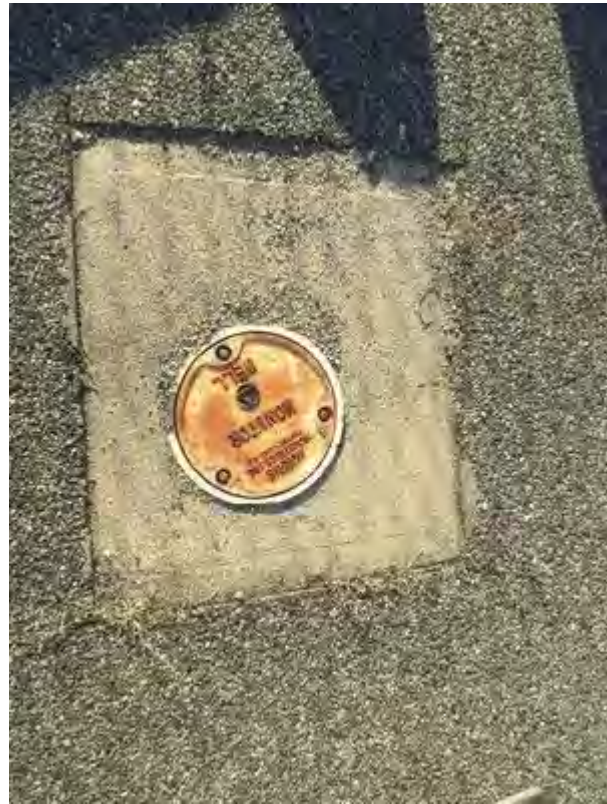
Client: Navy CLEAN	Facility: NWIRP Bethpage
Project Number: 112G08005-WE13	Location: Bethpage, New York
Date: September 18, 2021 17:24	Personnel: Wyatt Bostick
Well ID: RE123D3	Well Location: 209912.23 1124860.24
Well Status: Other	Screen Interval: 815-835
WELL INVENTORY CONDITION	
Concrete pad in acceptable condition i.e. no cracks?	YES
Manhole cover present and in working condition?	YES
All bolts on manhole present and not stripped?	NO
Well plug present, locked and in good working condition?	YES
OVERALL CONDITION:	GOOD
Notes (Explain if answered No to any of the above) Stripped bolt, Could use fill

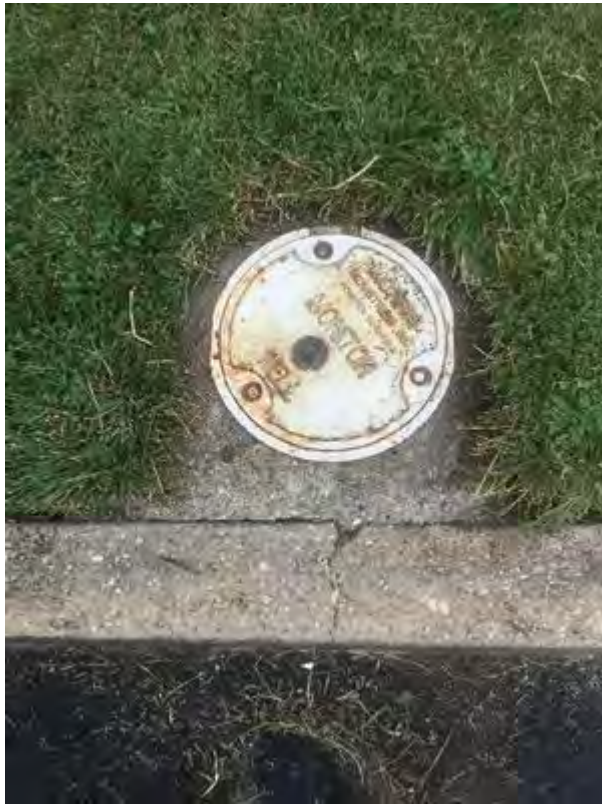
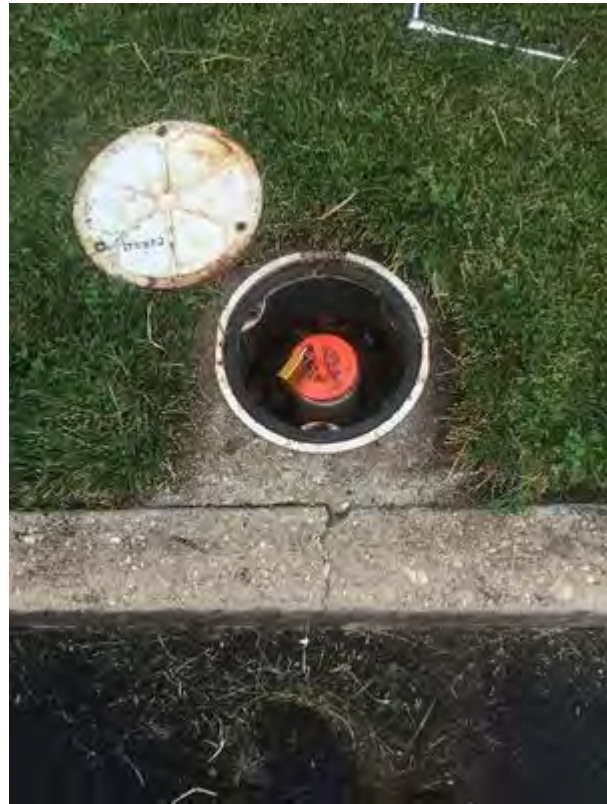
Client: Navy CLEAN	Facility: NWIRP Bethpage
Project Number: 112G08005-WE13	Location: Bethpage, New York
Date: September 17, 2021 11:05	Personnel:
Well ID: RE108D2	Well Location: 207,663.29 1,125,484.08
Well Status: Other	Screen Interval: 630-650
WELL INVENTORY CONDITION	
Concrete pad in acceptable condition i.e. no cracks?	YES
Manhole cover present and in working condition?	YES
All bolts on manhole present and not stripped?	YES
Well plug present, locked and in good working condition?	YES
OVERALL CONDITION:	GOOD
Notes (Explain if answered No to any of the above)

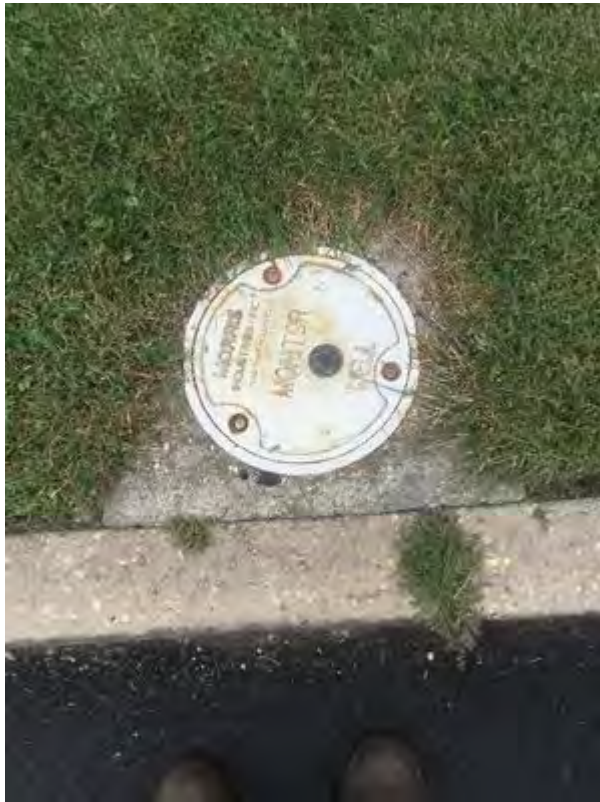
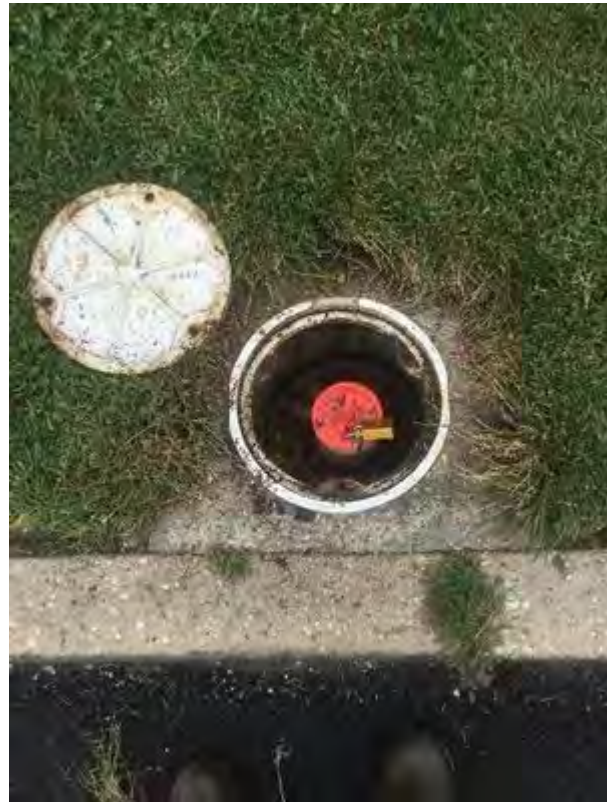
Client: Navy CLEAN	Facility: NWIRP Bethpage
Project Number: 112G08005-WE13	Location: Bethpage, New York
Date: September 17, 2021 11:02	Personnel:
Well ID: RE108D1	Well Location: 207,665.03 1,125,499.54
Well Status: Other	Screen Interval: 530-550
WELL INVENTORY CONDITION	
Concrete pad in acceptable condition i.e. no cracks?	YES
Manhole cover present and in working condition?	YES
All bolts on manhole present and not stripped?	YES
Well plug present, locked and in good working condition?	YES
OVERALL CONDITION:	GOOD
Notes (Explain if answered No to any of the above)

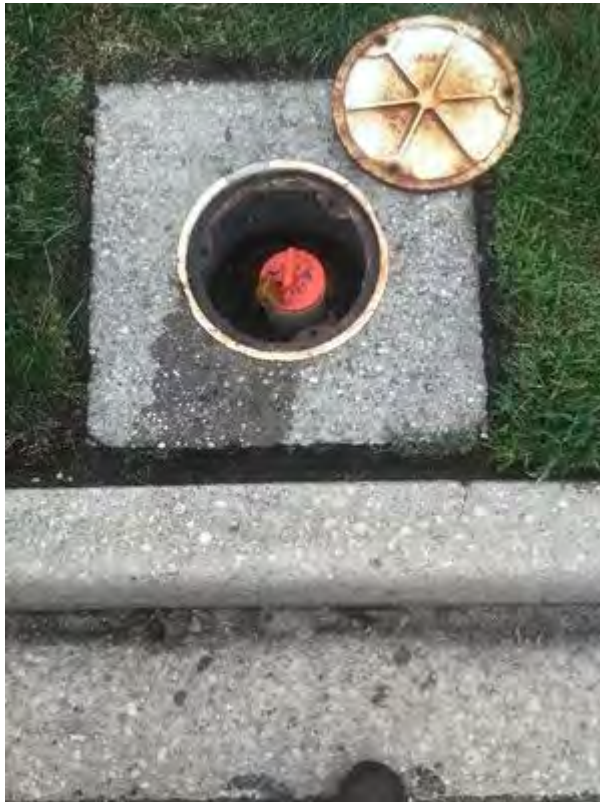
Client: Navy CLEAN	Facility: NWIRP Bethpage
Project Number: 112G08005-WE13	Location: Bethpage, New York
Date: September 17, 2021 08:22	Personnel: Vince Shickora
Well ID: RE105D2	Well Location: 205,064.02 1,126,652.42
Well Status: In Use (Confirmed)	Screen Interval: 730-750
WELL INVENTORY CONDITION	
Concrete pad in acceptable condition i.e. no cracks?	YES
Manhole cover present and in working condition?	YES
All bolts on manhole present and not stripped?	YES
Well plug present, locked and in good working condition?	YES
OVERALL CONDITION:	GOOD
Notes (Explain if answered No to any of the above)

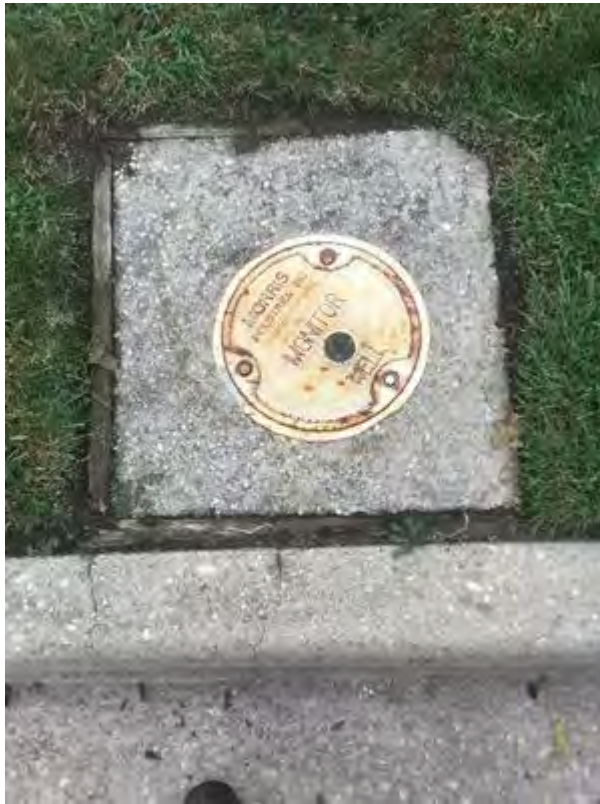
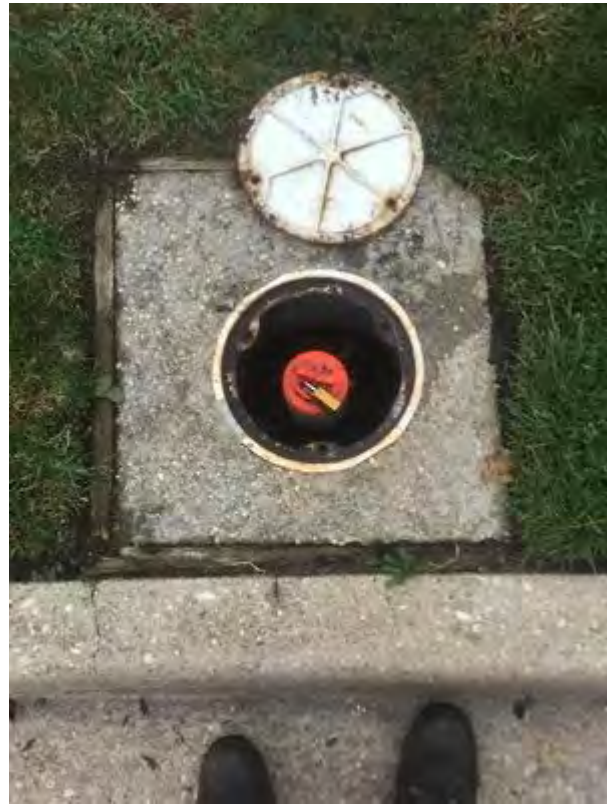
Client: Navy CLEAN	Facility: NWIRP Bethpage
Project Number: 112G08005-WE13	Location: Bethpage, New York
Date: September 17, 2021 08:15	Personnel: Vince Shickora
Well ID: RE105D1	Well Location: 205,072.87 1,126,664.43
Well Status: Other	Screen Interval: 530-550
WELL INVENTORY CONDITION	
Concrete pad in acceptable condition i.e. no cracks?	YES
Manhole cover present and in working condition?	YES
All bolts on manhole present and not stripped?	YES
Well plug present, locked and in good working condition?	YES
OVERALL CONDITION:	GOOD
Notes (Explain if answered No to any of the above)

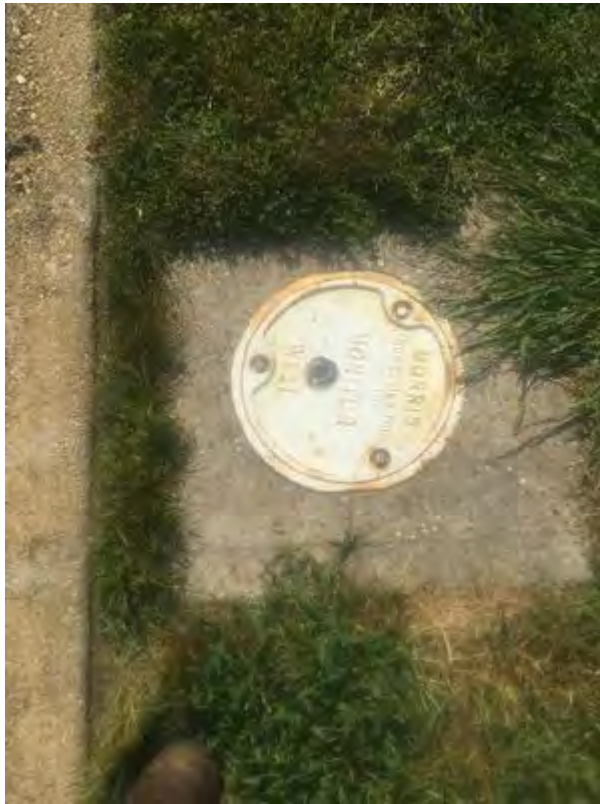
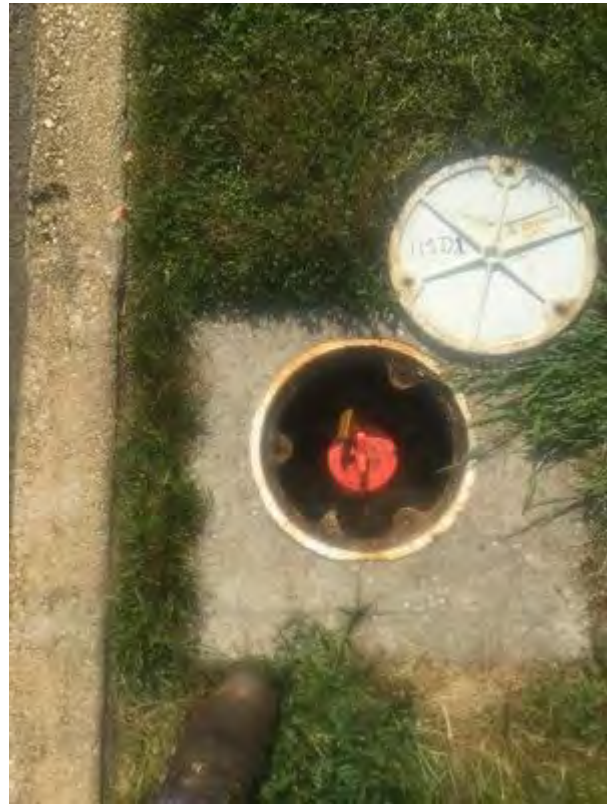
Client: Navy CLEAN	Facility: NWIRP Bethpage
Project Number: 112G08005-WE13	Location: Bethpage, New York
Date: September 15, 2021 15:03	Personnel:
Well ID: RE115D1	Well Location: 201004.250202 1125721.2869
Well Status: Other	Screen Interval: 640-655
WELL INVENTORY CONDITION	
Concrete pad in acceptable condition i.e. no cracks?	YES
Manhole cover present and in working condition?	YES
All bolts on manhole present and not stripped?	YES
Well plug present, locked and in good working condition?	YES
OVERALL CONDITION:	GOOD
Notes (Explain if answered No to any of the above)

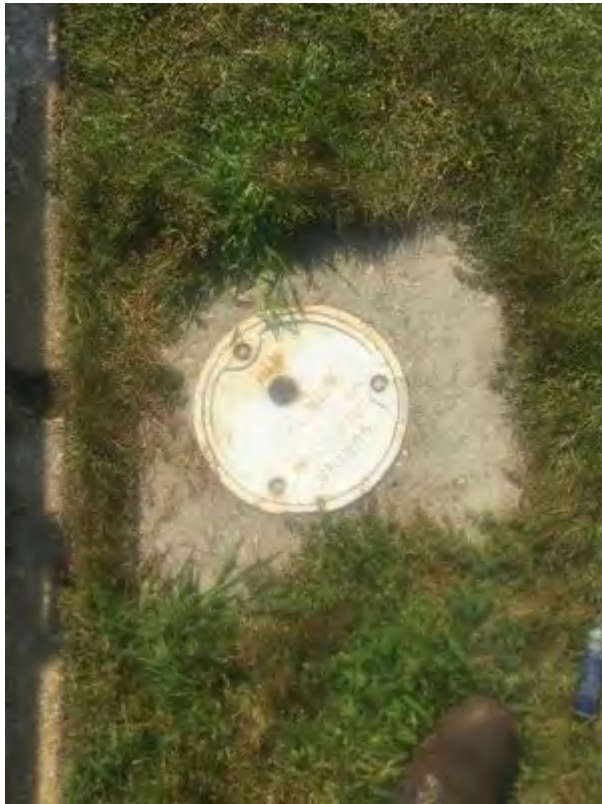
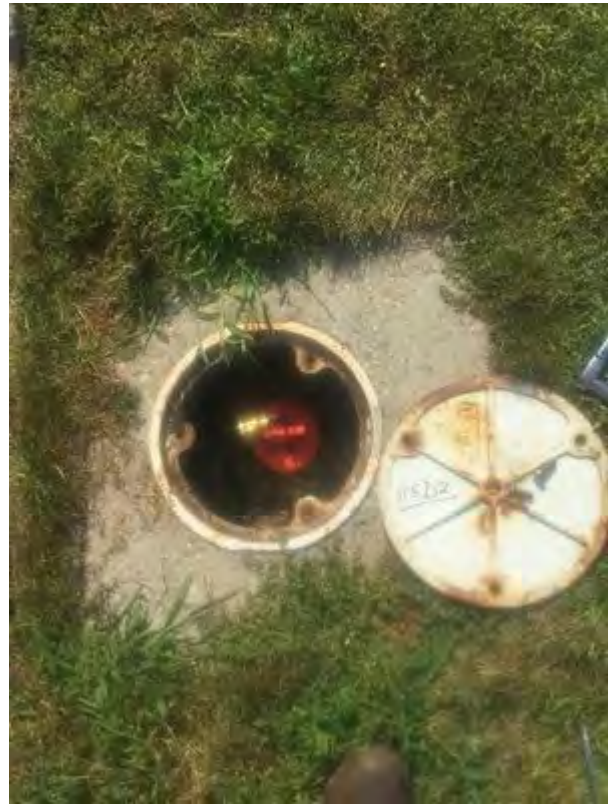
Client: Navy CLEAN	Facility: NWIRP Bethpage
Project Number: 112G08005-WE13	Location: Bethpage, New York
Date: September 15, 2021 15:00	Personnel:
Well ID: RE115D2	Well Location: 201012.40385 1125747.40209
Well Status: Other	Screen Interval: 730-750
WELL INVENTORY CONDITION	
Concrete pad in acceptable condition i.e. no cracks?	YES
Manhole cover present and in working condition?	YES
All bolts on manhole present and not stripped?	YES
Well plug present, locked and in good working condition?	YES
OVERALL CONDITION:	GOOD
Notes (Explain if answered No to any of the above)
