Memorandum

To: Scot Sokolowski, NAVFAC MIDLANT
From: David Brayack, Tetra Tech
Date: December 30, 2021
Re: Annual LUC Inspection and Operation Summary Report: Sites 1, 2, 3, and 4 – NWIRP Bethpage
Revision 1
Contract/CTO Number: N6247016D9008/WE13

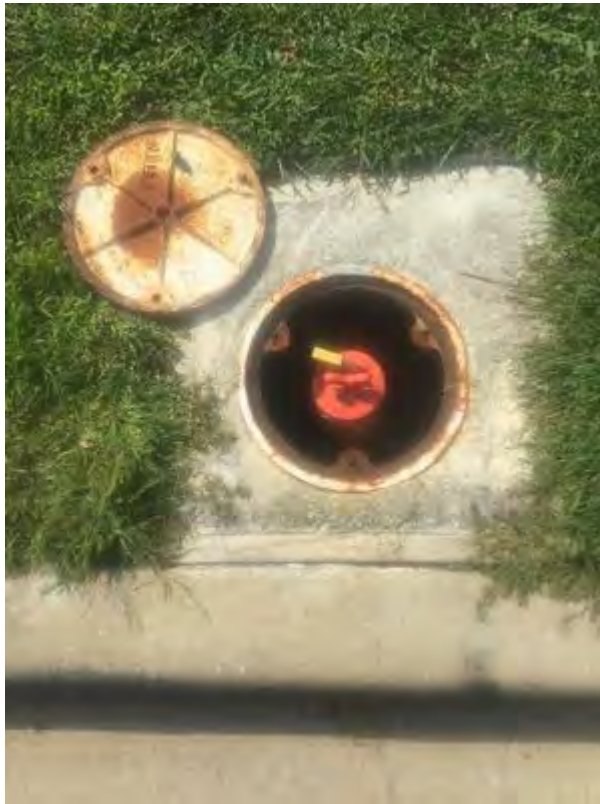
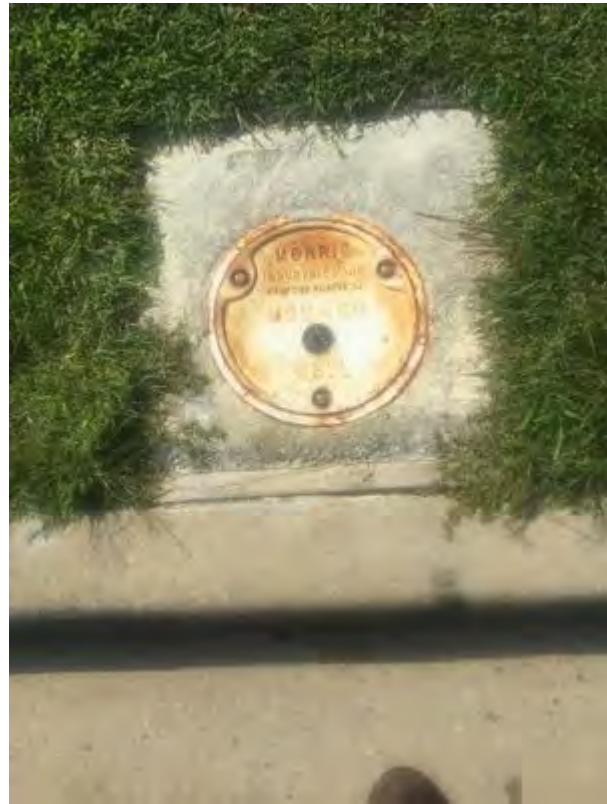
Client: Navy CLEAN	Facility: NWIRP Bethpage
Project Number: 112G08005-WE13	Location: Bethpage, New York
Date: September 15, 2021 14:47	Personnel: Vince Shickora
Well ID: BP-TT-MW180D1	Well Location:
Well Status: Other	Screen Interval: 580-600
WELL INVENTORY CONDITION	
Concrete pad in acceptable condition i.e. no cracks?	YES
Manhole cover present and in working condition?	YES
All bolts on manhole present and not stripped?	YES
Well plug present, locked and in good working condition?	YES
OVERALL CONDITION:	GOOD
Notes (Explain if answered No to any of the above)

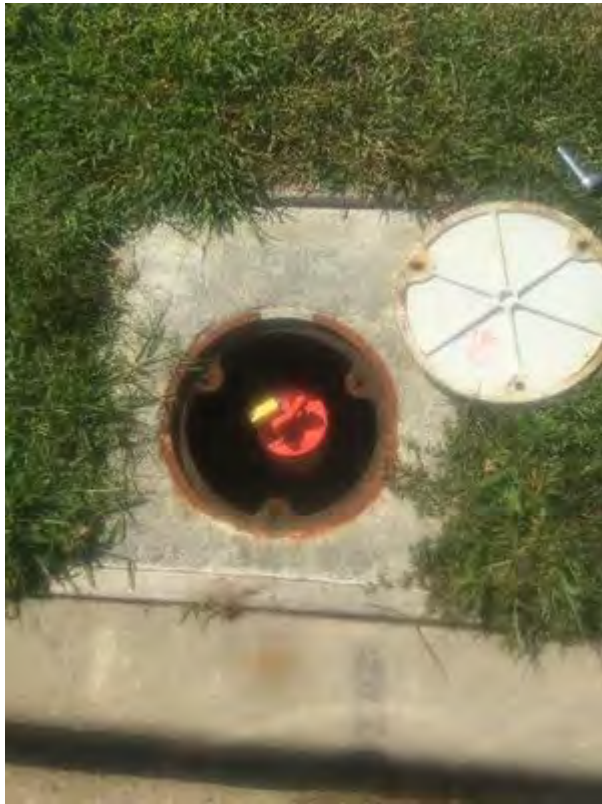
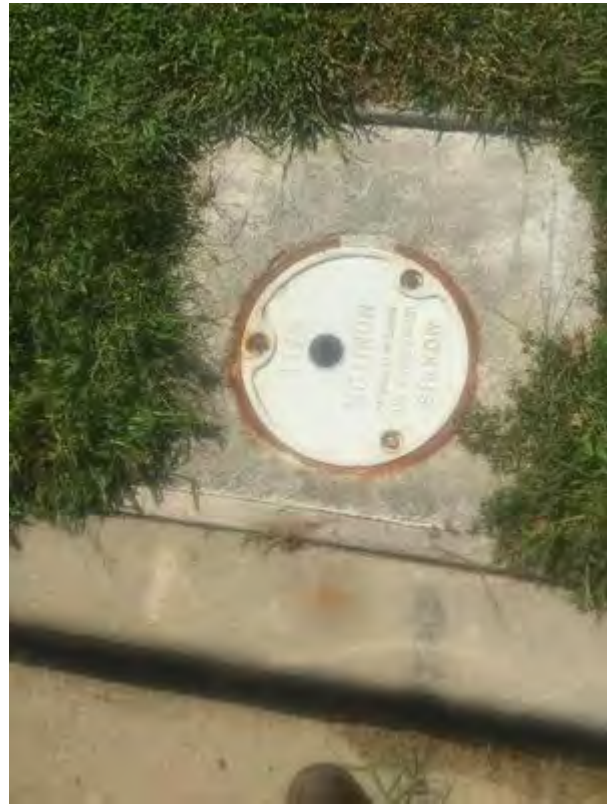
Client: Navy CLEAN	Facility: NWIRP Bethpage
Project Number: 112G08005-WE13	Location: Bethpage, New York
Date: September 15, 2021 14:15	Personnel: Vince Shickora
Well ID: BP-TT-MW180D	Well Location:
Well Status: Other	Screen Interval: 220-240
WELL INVENTORY CONDITION	
Concrete pad in acceptable condition i.e. no cracks?	YES
Manhole cover present and in working condition?	YES
All bolts on manhole present and not stripped?	YES
Well plug present, locked and in good working condition?	YES
OVERALL CONDITION:	GOOD
Notes (Explain if answered No to any of the above)

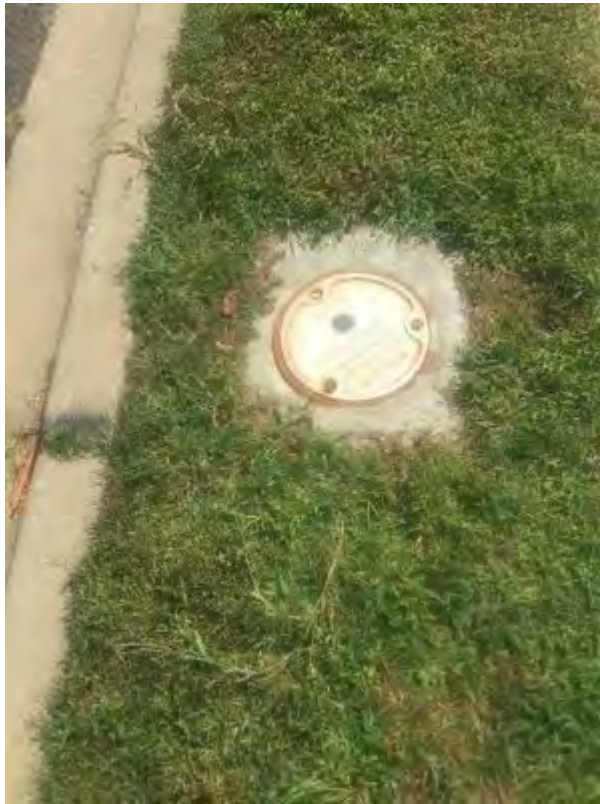
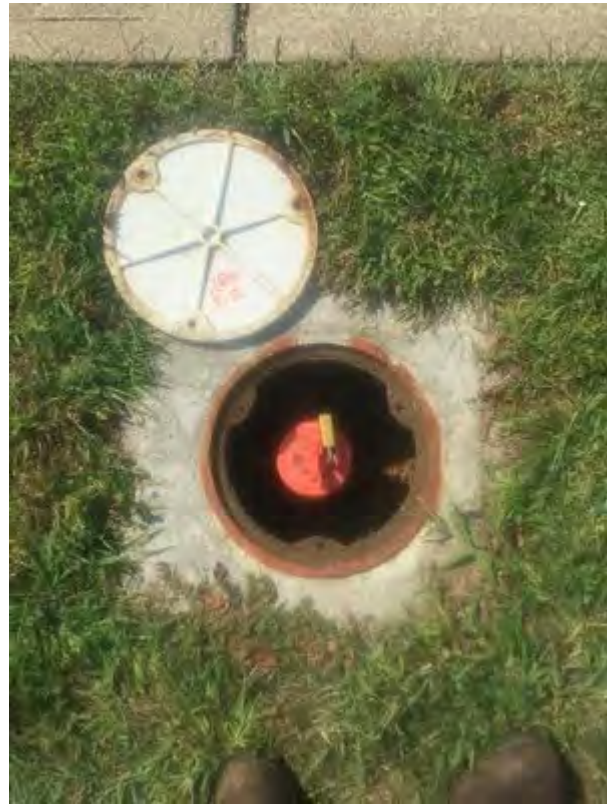
Client: Navy CLEAN	Facility: NWIRP Bethpage
Project Number: 112G08005-WE13	Location: Bethpage, New York
Date: September 15, 2021 14:11	Personnel: Vince Shickora
Well ID: BP-TT-MW180D2	Well Location:
Well Status: Other	Screen Interval: 710-730
WELL INVENTORY CONDITION	
Concrete pad in acceptable condition i.e. no cracks?	YES
Manhole cover present and in working condition?	YES
All bolts on manhole present and not stripped?	YES
Well plug present, locked and in good working condition?	YES
OVERALL CONDITION:	GOOD
Notes (Explain if answered No to any of the above)

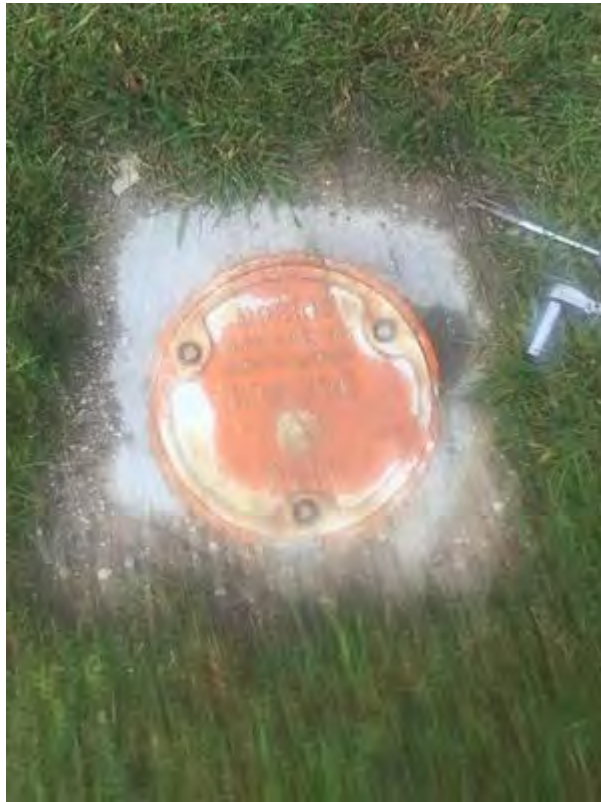
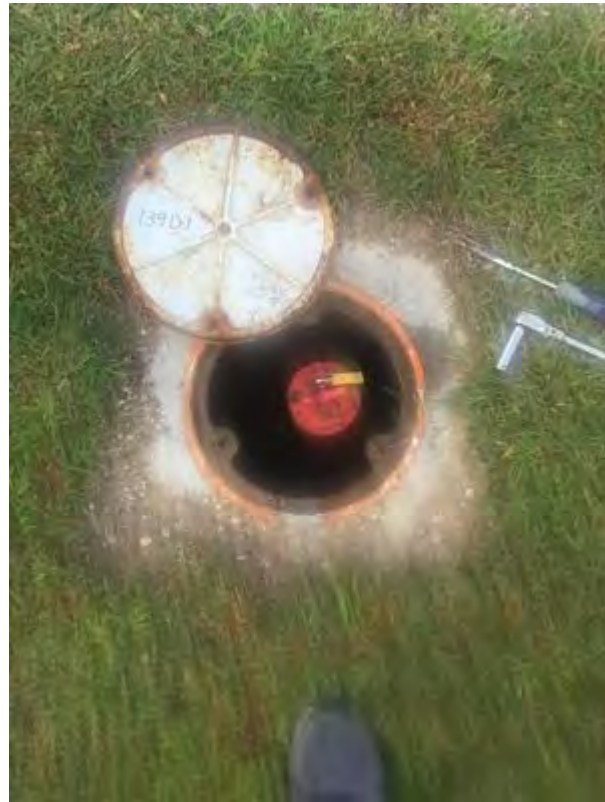
Client: Navy CLEAN	Facility: NWIRP Bethpage
Project Number: 112G08005-WE13	Location: Bethpage, New York
Date: September 15, 2021 08:28	Personnel: Vince Shickora
Well ID: RE139D1	Well Location: 198615.87 1124858.07
Well Status: Other	Screen Interval: 650-670
WELL INVENTORY CONDITION	
Concrete pad in acceptable condition i.e. no cracks?	YES
Manhole cover present and in working condition?	YES
All bolts on manhole present and not stripped?	YES
Well plug present, locked and in good working condition?	YES
OVERALL CONDITION:	GOOD
Notes (Explain if answered No to any of the above)

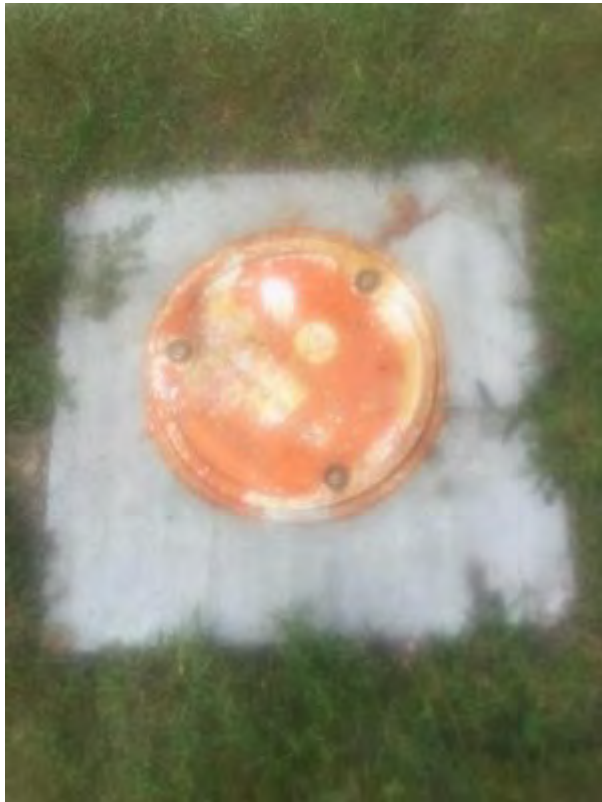
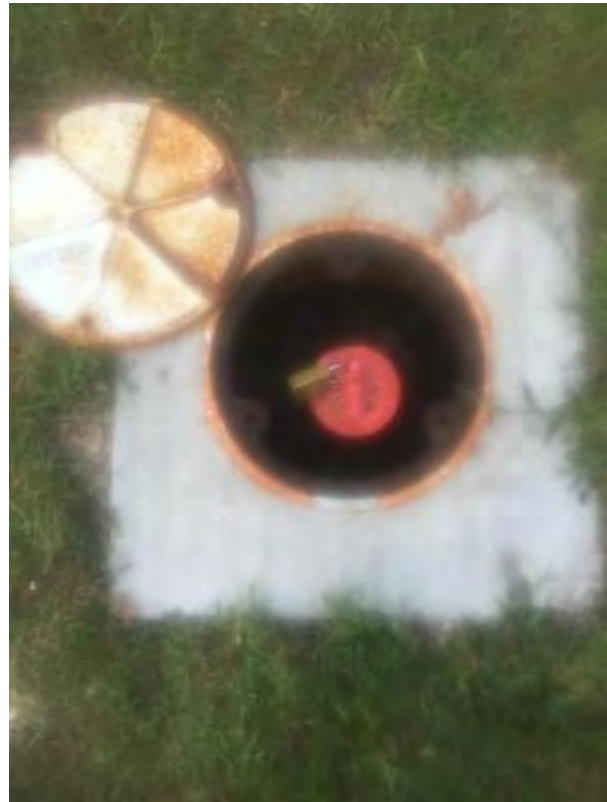
Client: Navy CLEAN	Facility: NWIRP Bethpage
Project Number: 112G08005-WE13	Location: Bethpage, New York
Date: September 15, 2021 08:24	Personnel: Vince Shickora
Well ID: RE139D2	Well Location: 198600.08 1124864.9
Well Status: Other	Screen Interval: 740-760
WELL INVENTORY CONDITION	
Concrete pad in acceptable condition i.e. no cracks?	YES
Manhole cover present and in working condition?	YES
All bolts on manhole present and not stripped?	YES
Well plug present, locked and in good working condition?	YES
OVERALL CONDITION:	GOOD
Notes (Explain if answered No to any of the above)

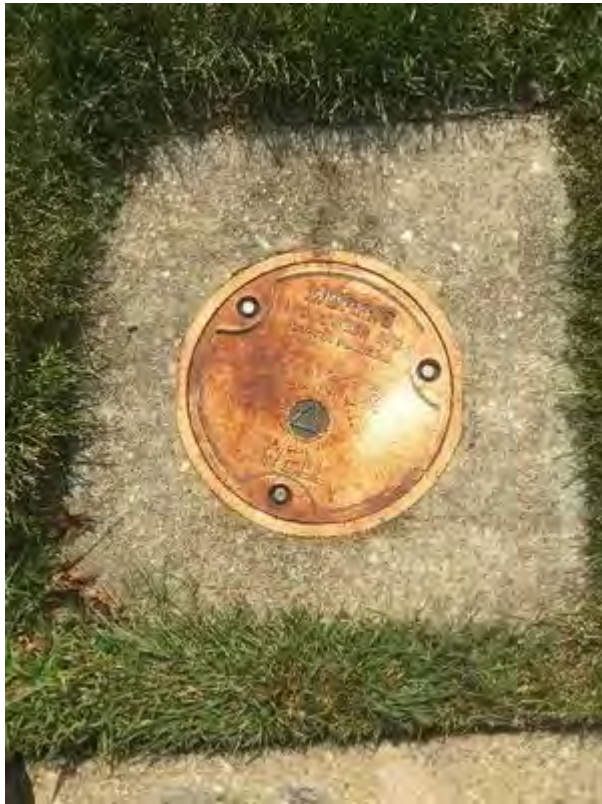
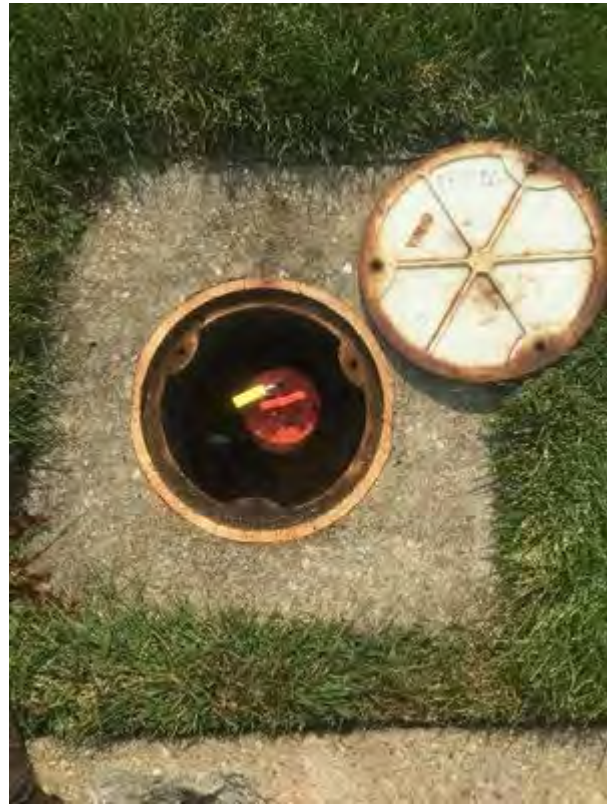
Client: Navy CLEAN	Facility: NWIRP Bethpage
Project Number: 112G08005-WE13	Location: Bethpage, New York
Date: September 14, 2021 13:55	Personnel: Vince Shickora
Well ID: RE117D2	Well Location: 196455.23 1125332.7
Well Status: Other	Screen Interval: 780-805
WELL INVENTORY CONDITION	
Concrete pad in acceptable condition i.e. no cracks?	YES
Manhole cover present and in working condition?	YES
All bolts on manhole present and not stripped?	YES
Well plug present, locked and in good working condition?	YES
OVERALL CONDITION:	GOOD
Notes (Explain if answered No to any of the above)

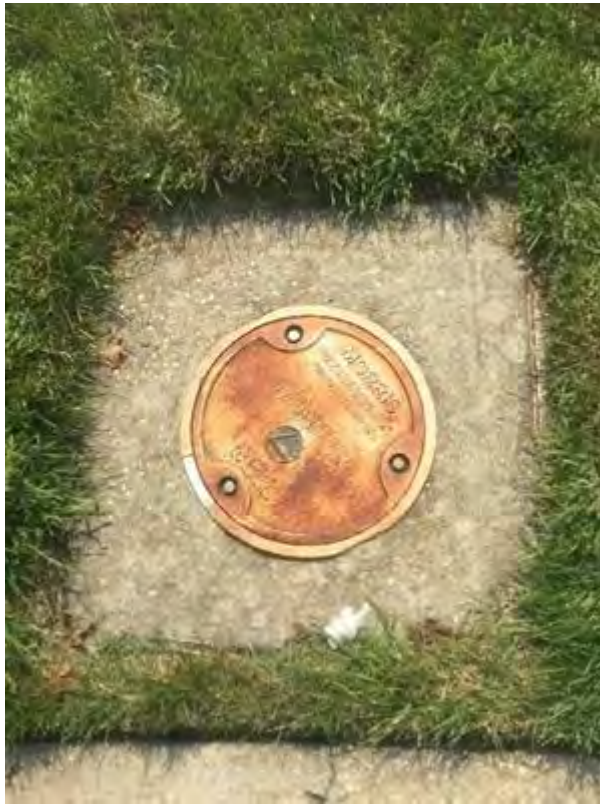
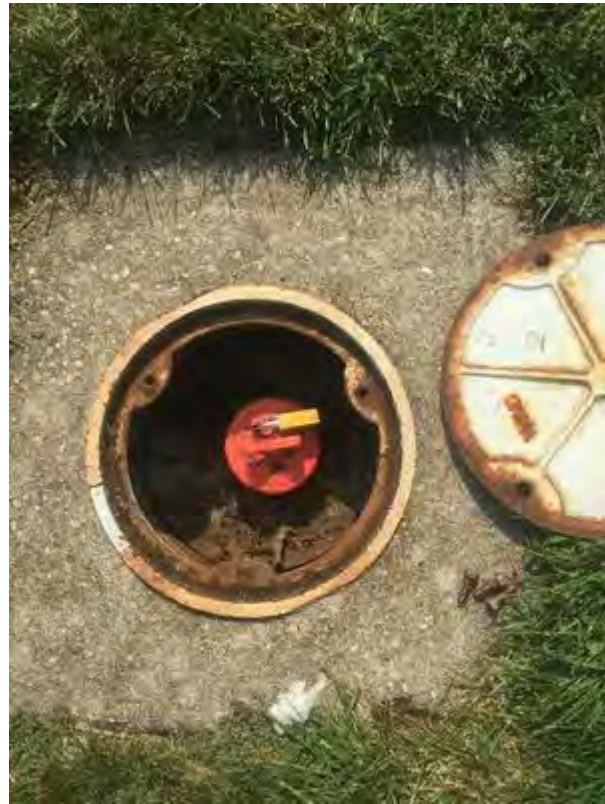
Client: Navy CLEAN	Facility: NWIRP Bethpage
Project Number: 112G08005-WE13	Location: Bethpage, New York
Date: September 14, 2021 13:52	Personnel: Vince Shickora
Well ID: RE117D1	Well Location: 196462.44 1125318.92
Well Status: Other	Screen Interval: 730-755
WELL INVENTORY CONDITION	
Concrete pad in acceptable condition i.e. no cracks?	YES
Manhole cover present and in working condition?	YES
All bolts on manhole present and not stripped?	YES
Well plug present, locked and in good working condition?	YES
OVERALL CONDITION:	GOOD
Notes (Explain if answered No to any of the above)

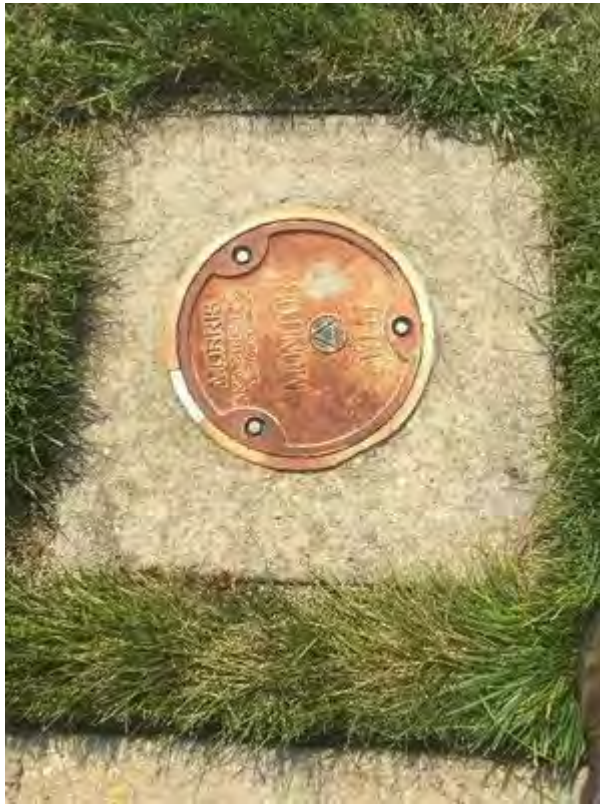
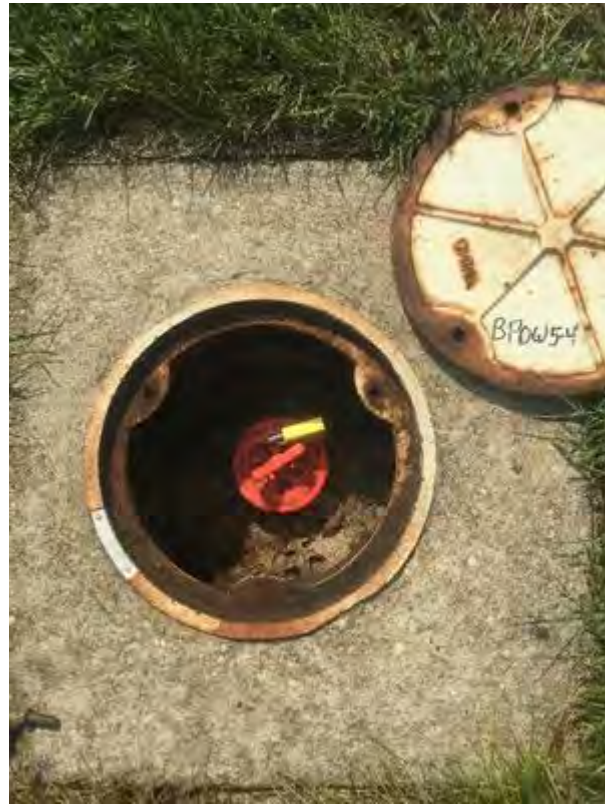
Client: Navy CLEAN	Facility: NWIRP Bethpage
Project Number: 112G08005-WE13	Location: Bethpage, New York
Date: September 14, 2021 13:46	Personnel: Vince Shickora
Well ID: BPOW 5-4	Well Location: 196471.55 1125307.44
Well Status: Other	Screen Interval: 545-570
WELL INVENTORY CONDITION	
Concrete pad in acceptable condition i.e. no cracks?	YES
Manhole cover present and in working condition?	YES
All bolts on manhole present and not stripped?	YES
Well plug present, locked and in good working condition?	YES
OVERALL CONDITION:	GOOD
Notes (Explain if answered No to any of the above)

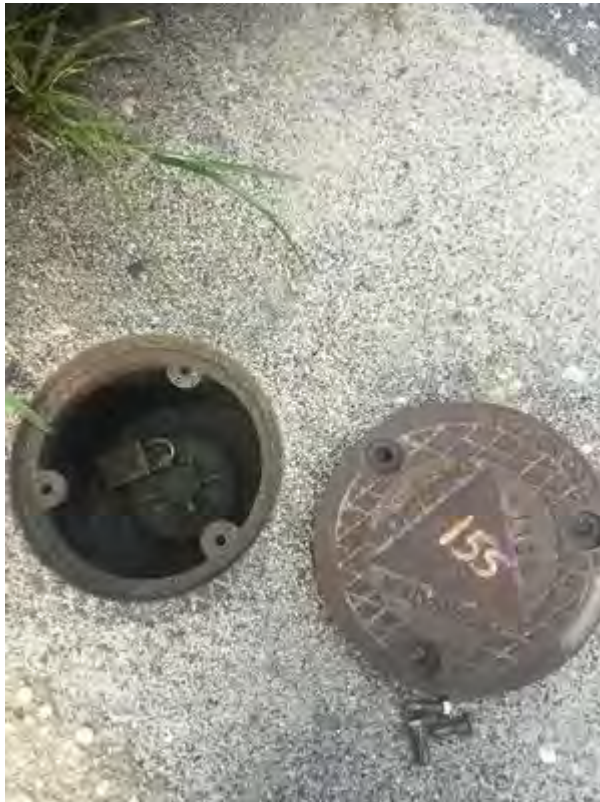
Client: Navy CLEAN	Facility: NWIRP Bethpage
Project Number: 112G08005-WE13	Location: Bethpage, New York
Date: September 13, 2021 16:03	Personnel: Vince Shickora
Well ID: BPGMMW15S	Well Location: 210594.128 1127057.049
Well Status: Other	Screen Interval: 63-67
WELL INVENTORY CONDITION	
Concrete pad in acceptable condition i.e. no cracks?	YES
Manhole cover present and in working condition?	YES
All bolts on manhole present and not stripped?	YES
Well plug present, locked and in good working condition?	YES
OVERALL CONDITION:	GOOD
Notes (Explain if answered No to any of the above)

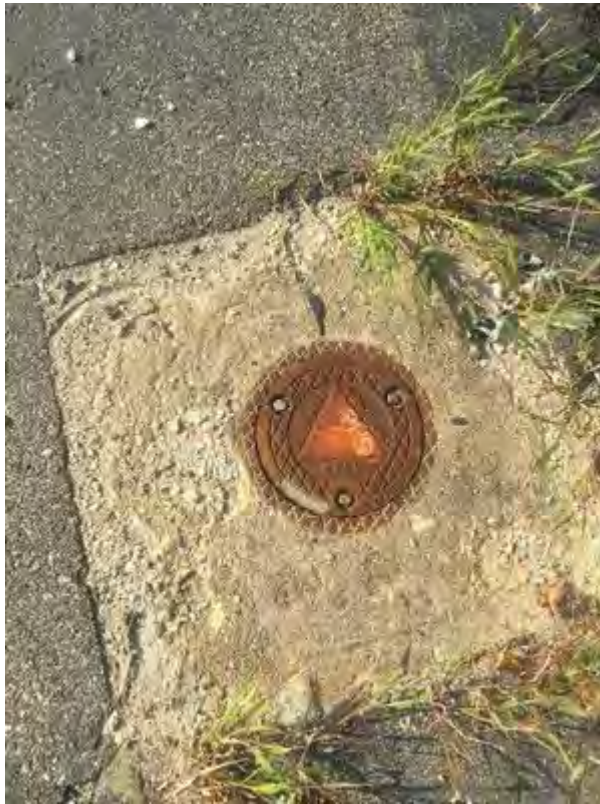
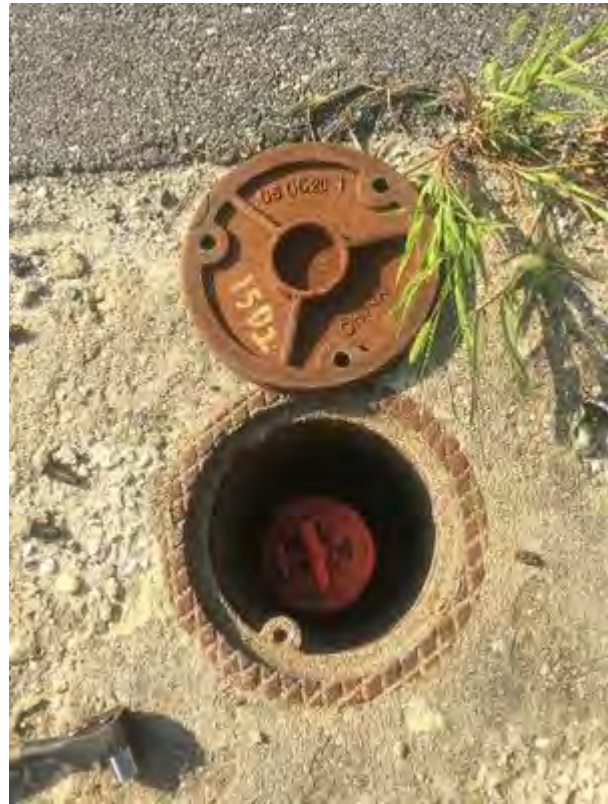
Client: Navy CLEAN	Facility: NWIRP Bethpage
Project Number: 112G08005-WE13	Location: Bethpage, New York
Date: September 13, 2021 16:08	Personnel: Vince Shickora
Well ID: BPGMMW15D2	Well Location: 210611.89 1127076.9
Well Status: Other	Screen Interval: 536-556
WELL INVENTORY CONDITION	
Concrete pad in acceptable condition i.e. no cracks?	YES
Manhole cover present and in working condition?	YES
All bolts on manhole present and not stripped?	YES
Well plug present, locked and in good working condition?	YES
OVERALL CONDITION:	GOOD
Notes (Explain if answered No to any of the above)

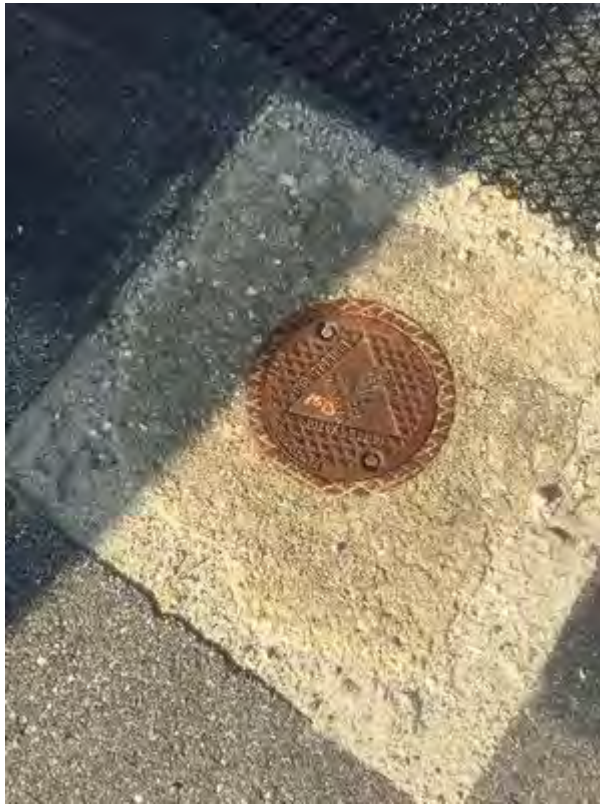
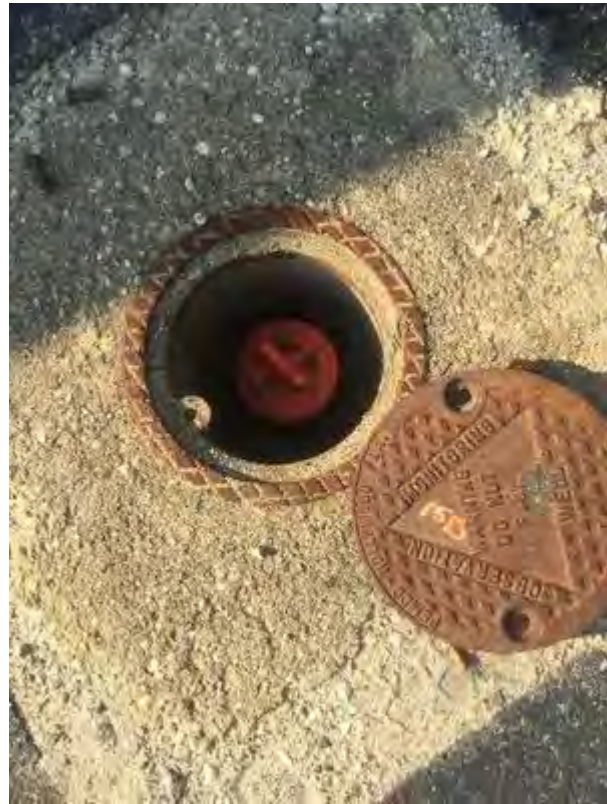
Client: Navy CLEAN	Facility: NWIRP Bethpage
Project Number: 112G08005-WE13	Location: Bethpage, New York
Date: September 13, 2021 16:11	Personnel: Vince Shickora
Well ID: BPGMMW15D	Well Location: 210625.108 1127034.199
Well Status: Other	Screen Interval: 332-342
WELL INVENTORY CONDITION	
Concrete pad in acceptable condition i.e. no cracks?	YES
Manhole cover present and in working condition?	YES
All bolts on manhole present and not stripped?	YES
Well plug present, locked and in good working condition?	YES
OVERALL CONDITION:	GOOD
Notes (Explain if answered No to any of the above)

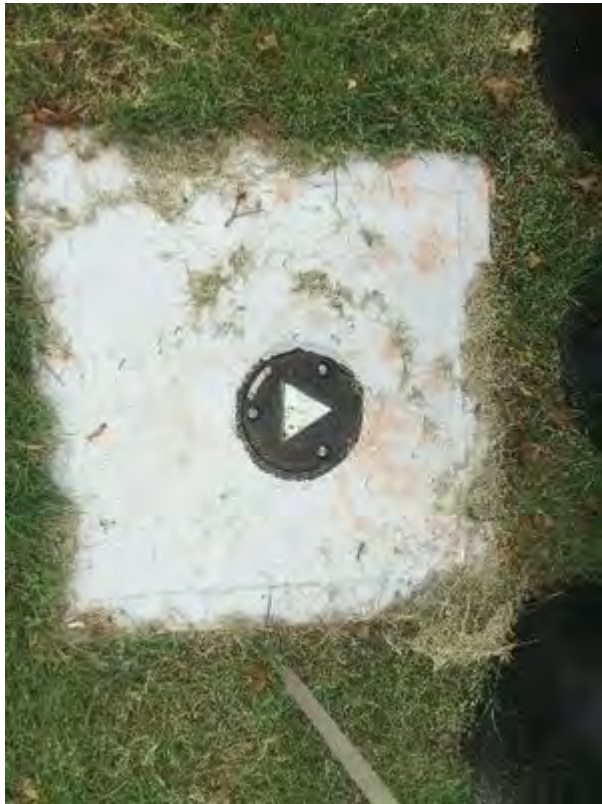
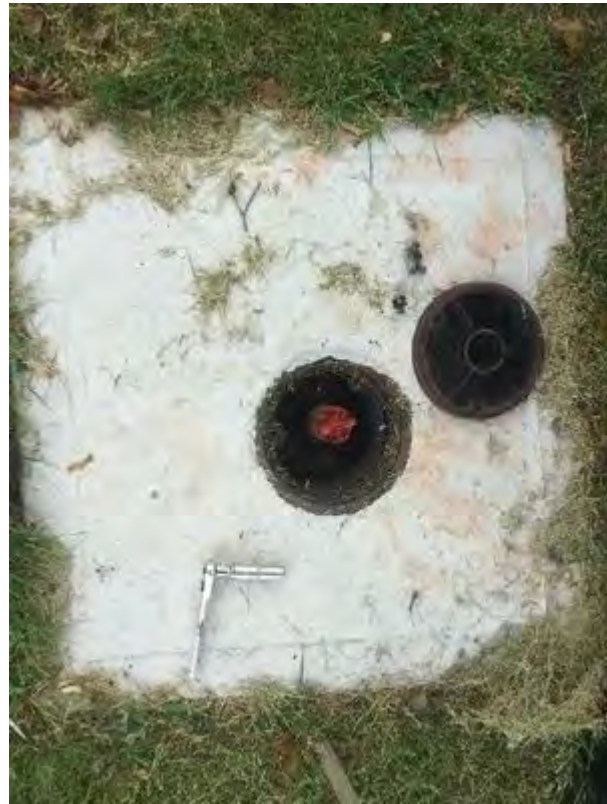
Client: Navy CLEAN	Facility: NWIRP Bethpage
Project Number: 112G08005-WE13	Location: Bethpage, New York
Date: September 22, 2021 12:48	Personnel: Wyatt Bostick
Well ID: EAUA-MW-04S	Well Location:
Well Status: Other	Screen Interval:
WELL INVENTORY CONDITION	
Concrete pad in acceptable condition i.e. no cracks?	YES
Manhole cover present and in working condition?	YES
All bolts on manhole present and not stripped?	YES
Well plug present, locked and in good working condition?	YES
OVERALL CONDITION:	GOOD
Notes (Explain if answered No to any of the above)

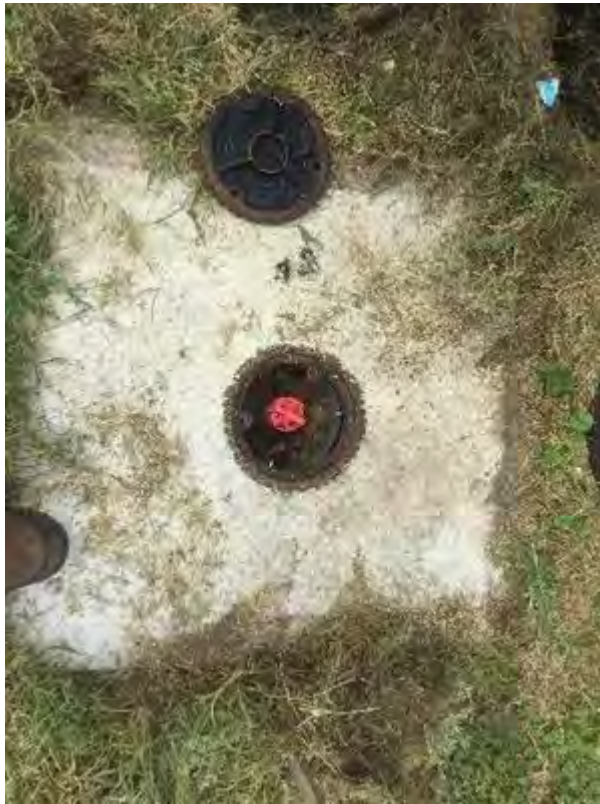
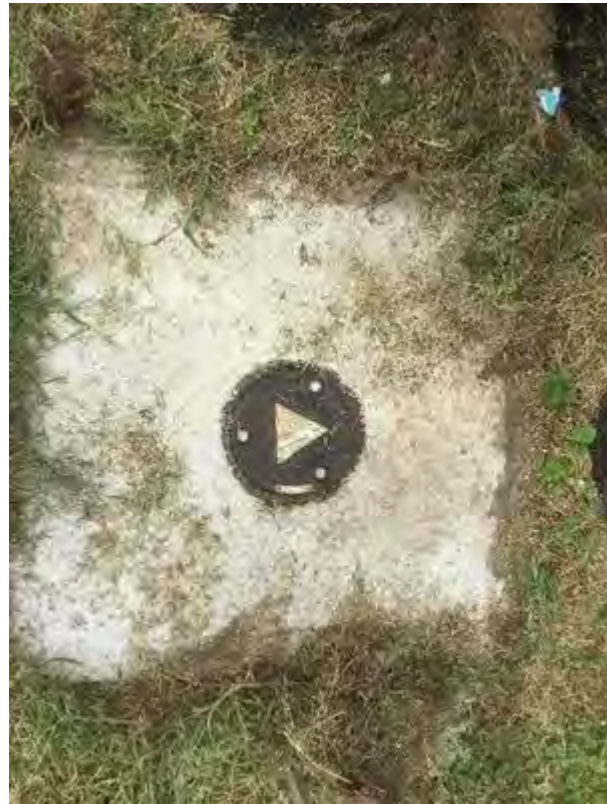
Client: Navy CLEAN	Facility: NWIRP Bethpage
Project Number: 112G08005-WE13	Location: Bethpage, New York
Date: September 22, 2021 12:55	Personnel: Wyatt Bostick
Well ID: EAUA-MW-03S	Well Location:
Well Status: Other	Screen Interval:
WELL INVENTORY CONDITION	
Concrete pad in acceptable condition i.e. no cracks?	YES
Manhole cover present and in working condition?	YES
All bolts on manhole present and not stripped?	YES
Well plug present, locked and in good working condition?	YES
OVERALL CONDITION:	GOOD
Notes (Explain if answered No to any of the above)

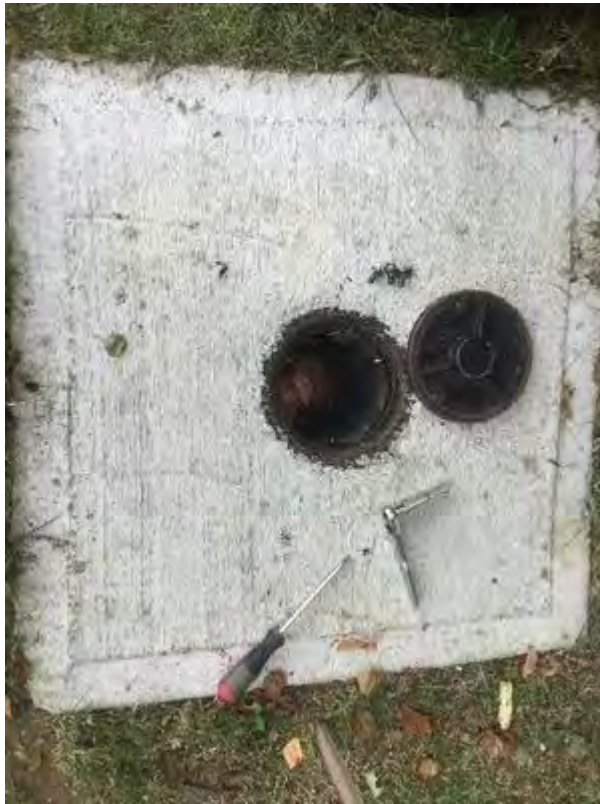
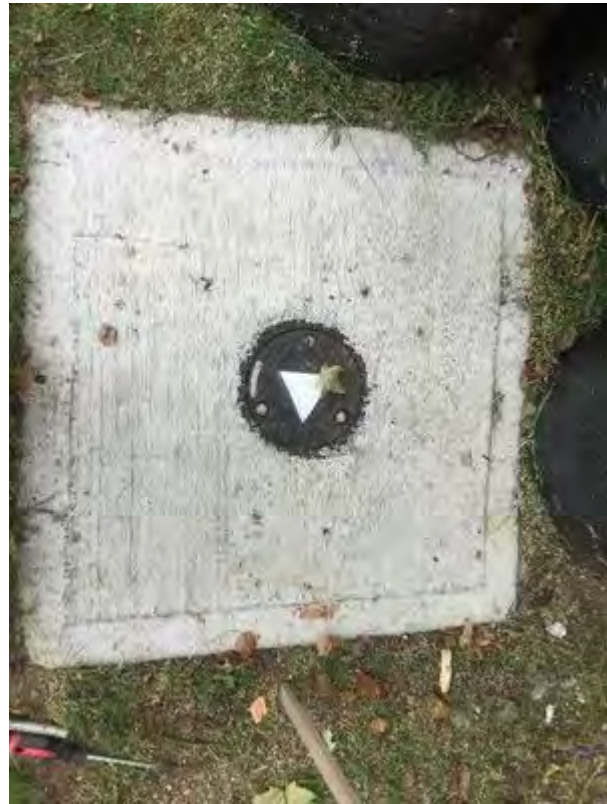
Client: Navy CLEAN	Facility: NWIRP Bethpage
Project Number: 112G08005-WE13	Location: Bethpage, New York
Date: September 22, 2021 12:59	Personnel: Wyatt Bostick
Well ID: EAUA-MW-02S	Well Location:
Well Status: Other	Screen Interval:
WELL INVENTORY CONDITION	
Concrete pad in acceptable condition i.e. no cracks?	YES
Manhole cover present and in working condition?	YES
All bolts on manhole present and not stripped?	YES
Well plug present, locked and in good working condition?	YES
OVERALL CONDITION:	GOOD
Notes (Explain if answered No to any of the above)

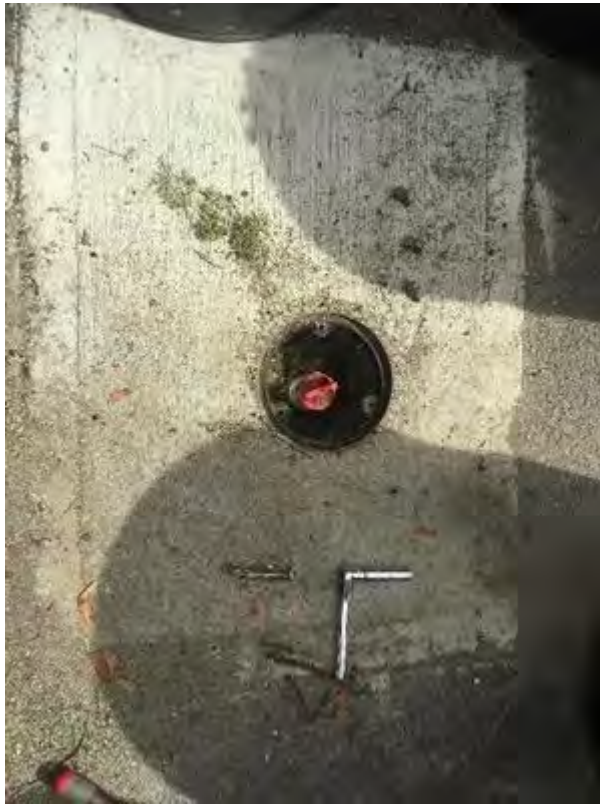
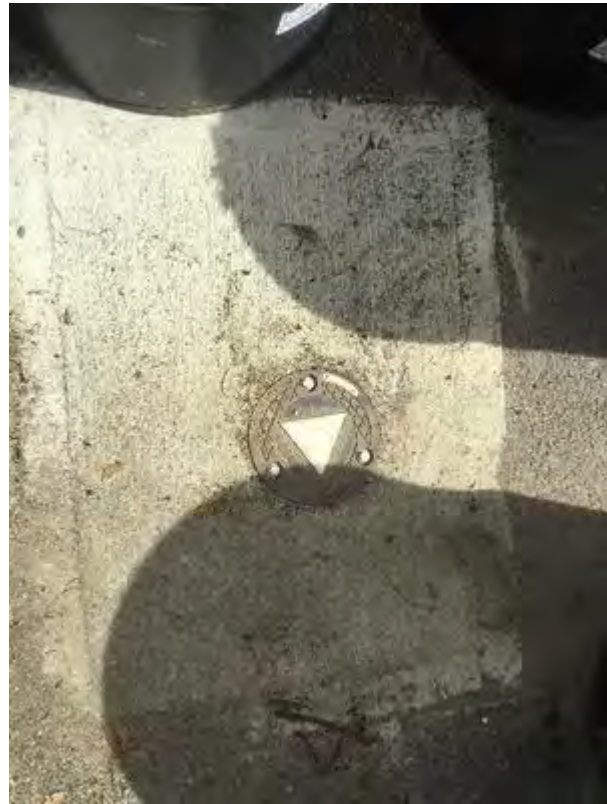
Client: Navy CLEAN	Facility: NWIRP Bethpage
Project Number: 112G08005-WE13	Location: Bethpage, New York
Date: September 22, 2021 13:03	Personnel: Wyatt Bostick
Well ID: EAUA-MW-01S	Well Location:
Well Status: Other	Screen Interval:
WELL INVENTORY CONDITION	
Concrete pad in acceptable condition i.e. no cracks?	YES
Manhole cover present and in working condition?	YES
All bolts on manhole present and not stripped?	YES
Well plug present, locked and in good working condition?	YES
OVERALL CONDITION:	GOOD
Notes (Explain if answered No to any of the above)
