Memorandum

To: Scot Sokolowski, NAVFAC MIDLANT
From: David Brayack, Tetra Tech
Date: November 17, 2022
Re: Annual LUC Inspection and Operation Summary Report: Sites 1, 2, 3, and 4 –
NWIRP Bethpage
Contract/CTO Number: N6247016D9008/WE16

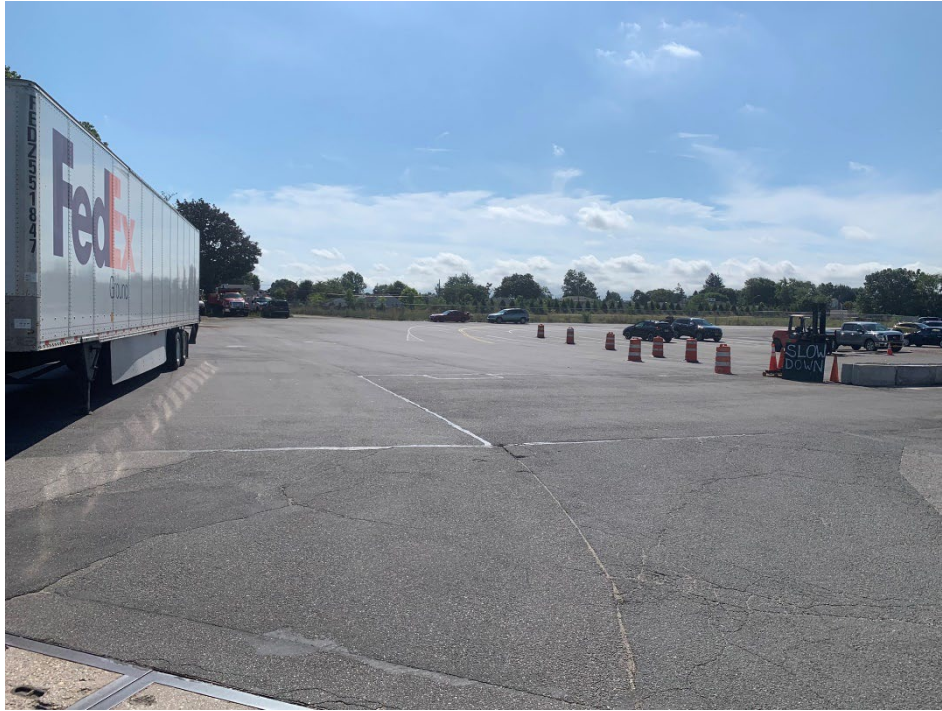
Photo 1A – Northwest corner of Site 1 looking east-southeast

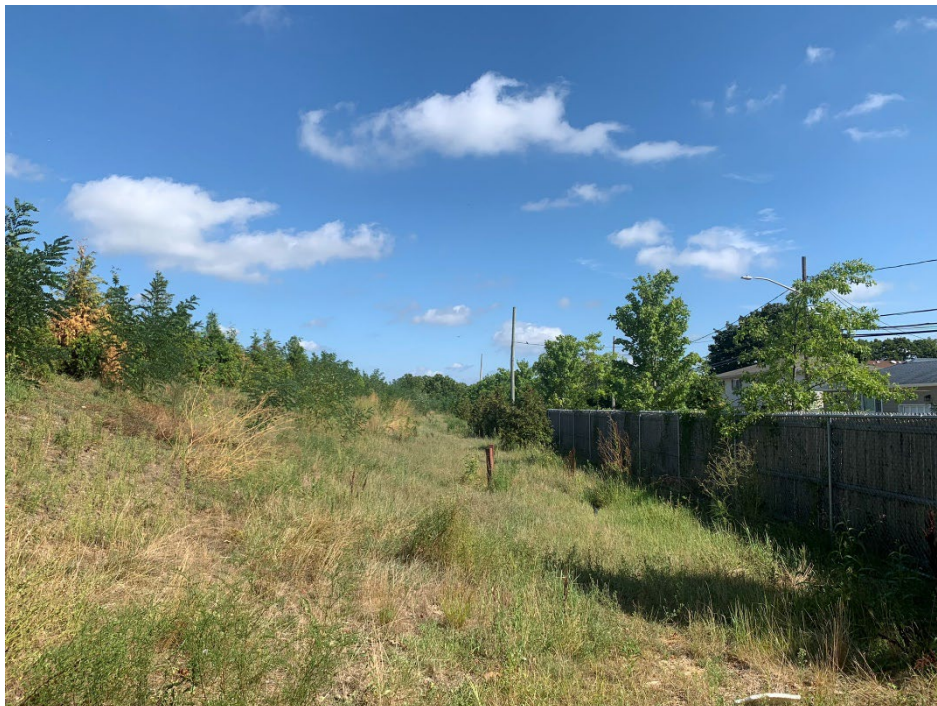
Photo 1B – Site 1 eastern boundary looking north towards SVE wells and additional tree plantings

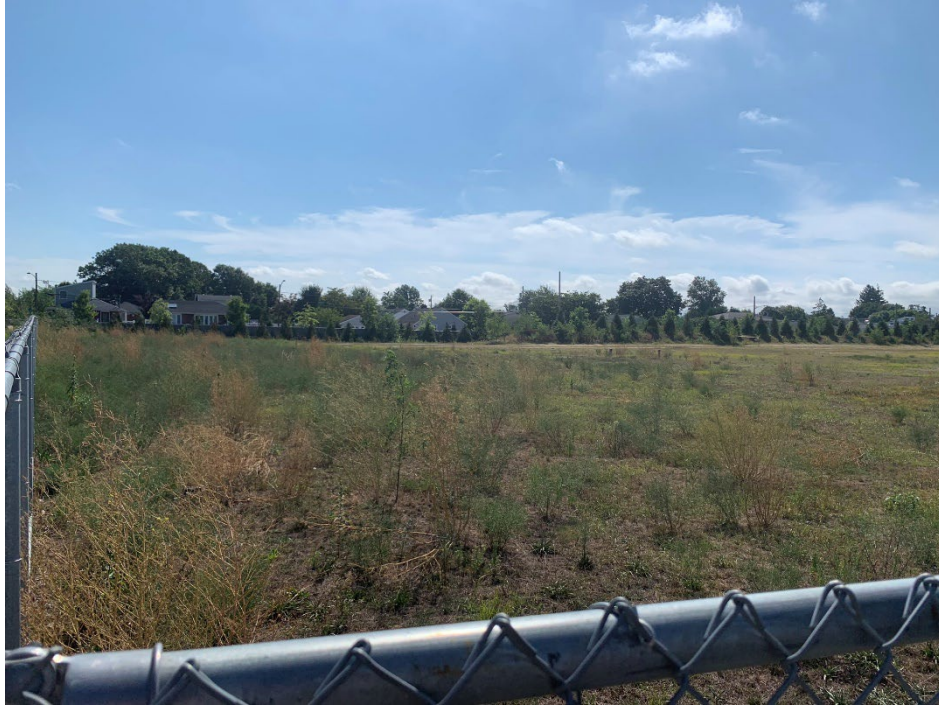
Photo 1C – Northwest corner of Site 1 looking east-southeast within fenced in area of Site 1

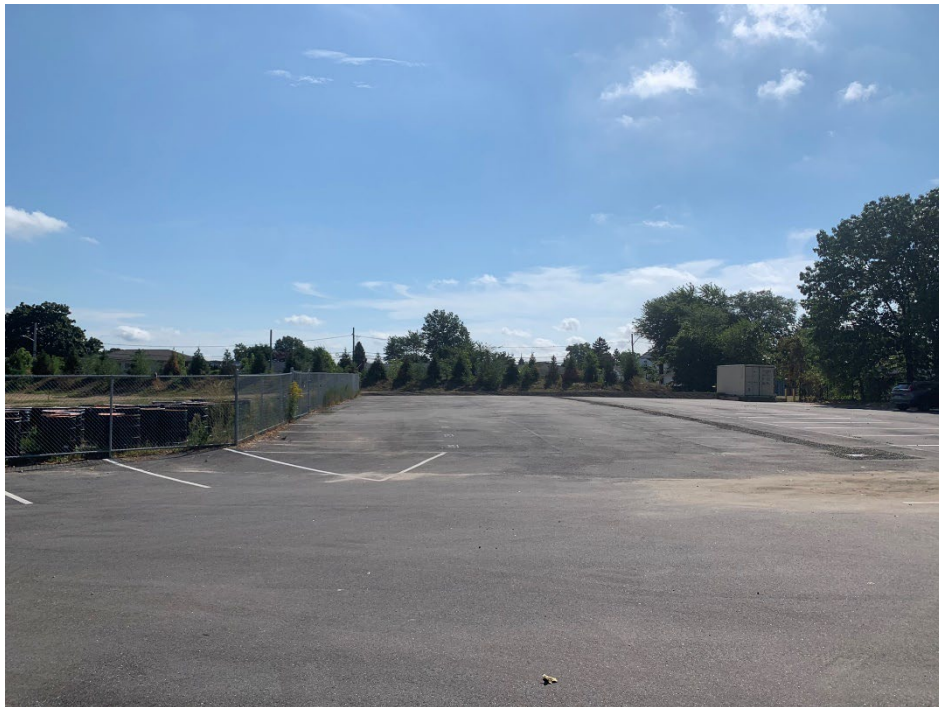
Photo 1D – Site 1 southern boundary looking east at IDW drums and new SVE manifold conex box

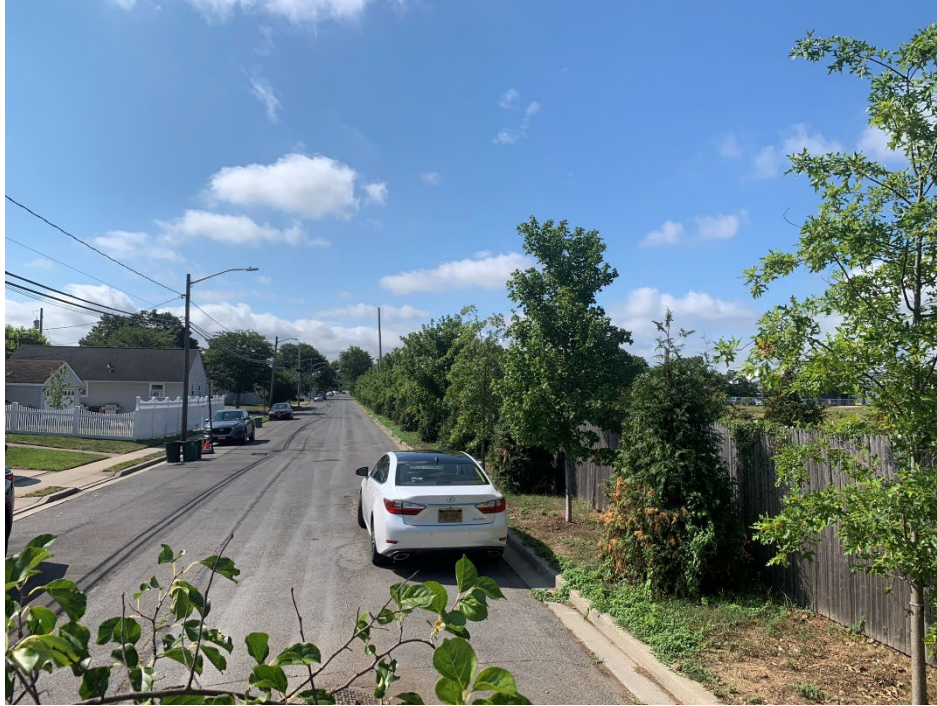
Photo 1E – Site 1 eastern boundary on 11th St looking south at stockade fence and additional tree plantings

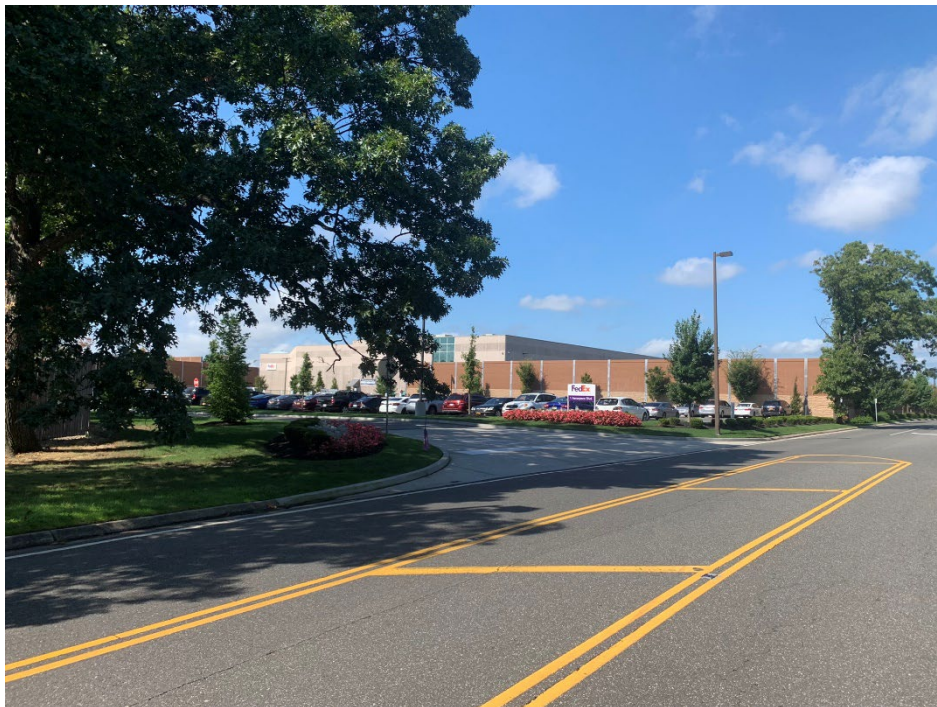
Photo 2A – Northwest portion of Site 2 looking southwest from Aerospace Blvd at FEDEX facility entrance

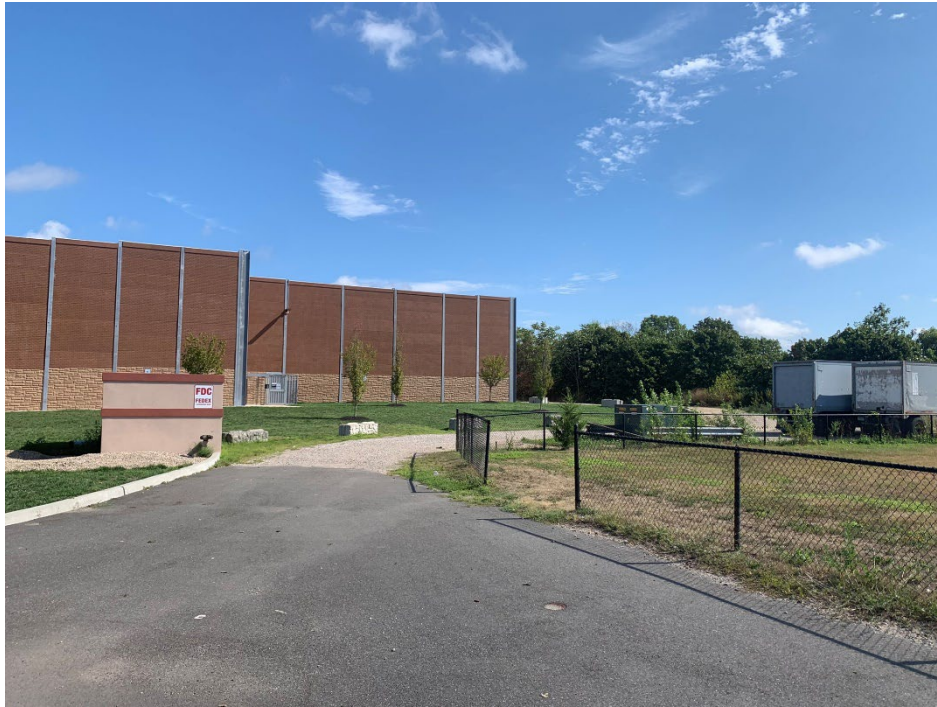
Photo 2B –Southwest corner of Site 2 looking northeast at FEDEX facility sound walls

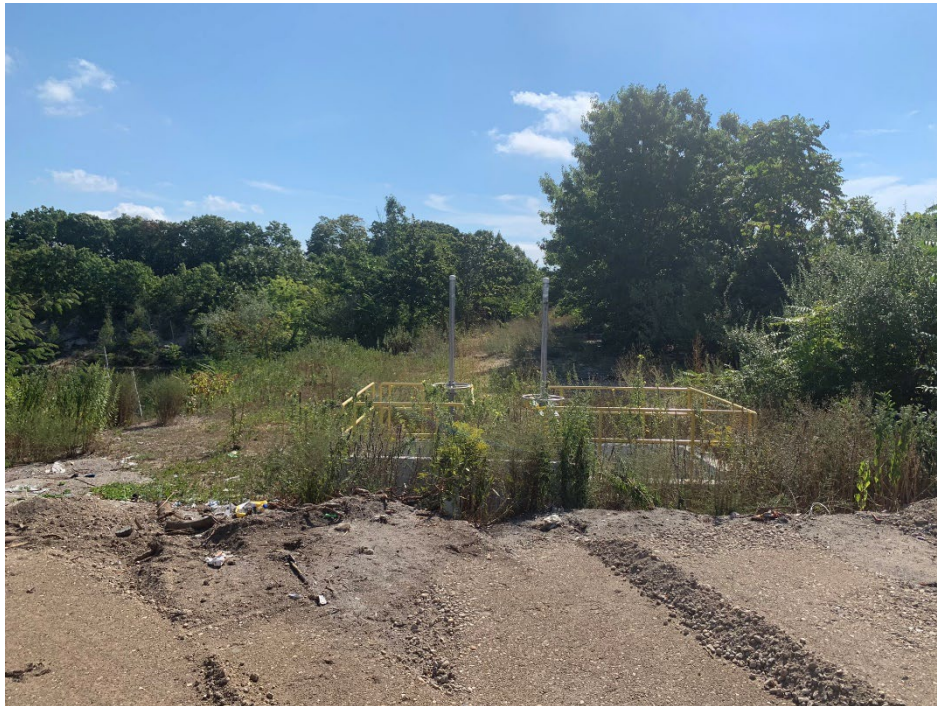
Photo 2C –Center of Site 2 looking east between the north and south basins at sluice gate

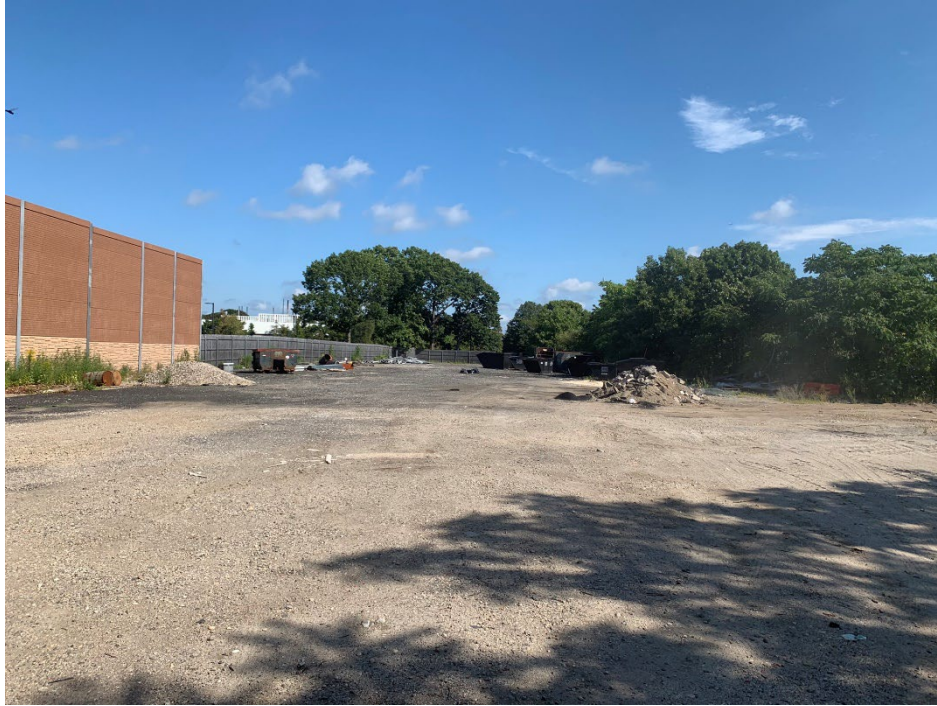
Photo 2D –Center of Site 2 looking north at Steel Equities laydown/storage area between the FEDEX hub terminal and north basin

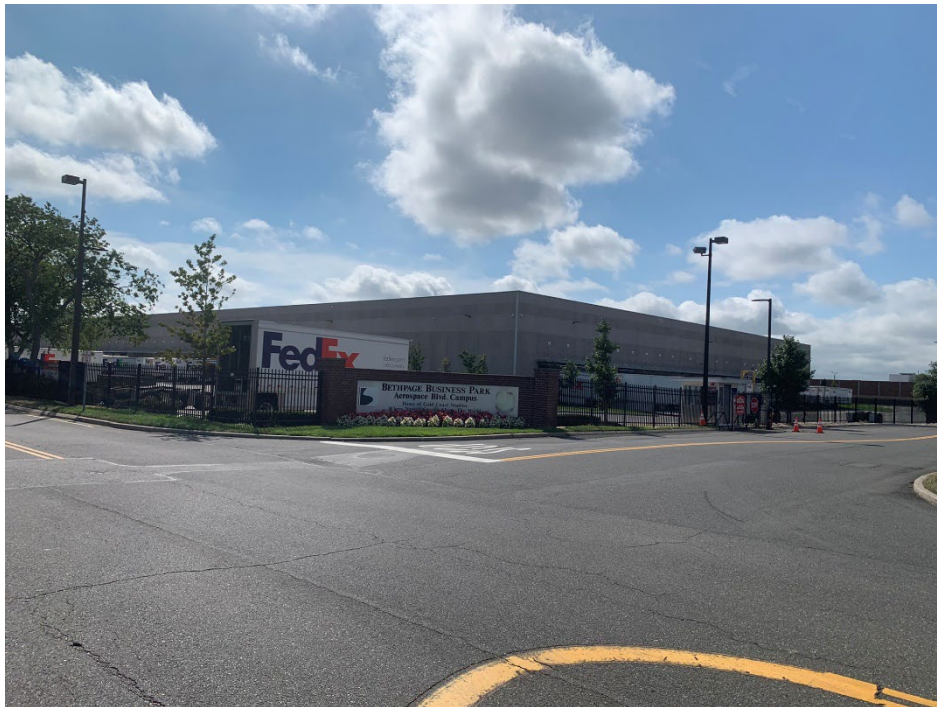
Photo 3A – Northwest corner of Site 3 looking southeast at FEDEX hub terminal

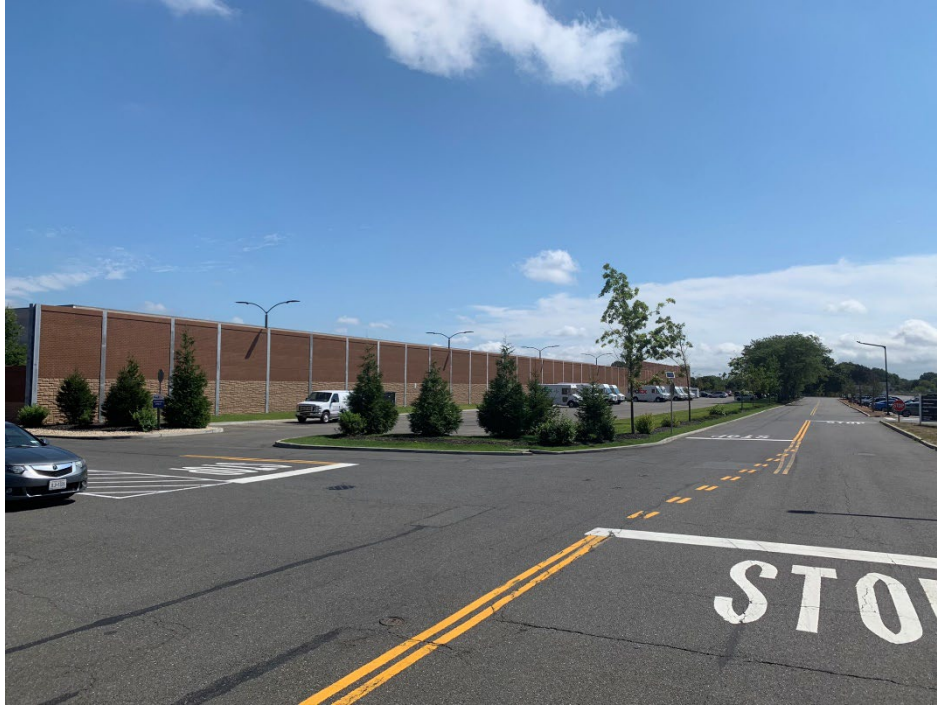
Photo 3B – Southwest corner of Site 3 looking east-northeast at FEDEX hub terminal sound walls and southern parking area

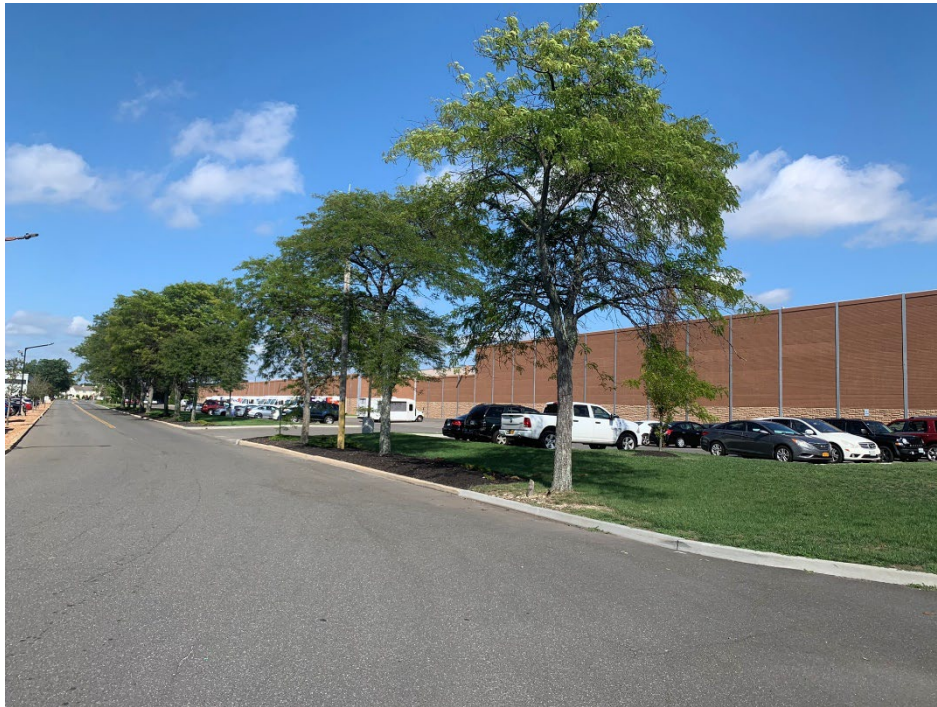
Photo 3C – Southeast corner of Site 3 facing northwest showing the FEDEX hub terminal sound walls and southern parking area

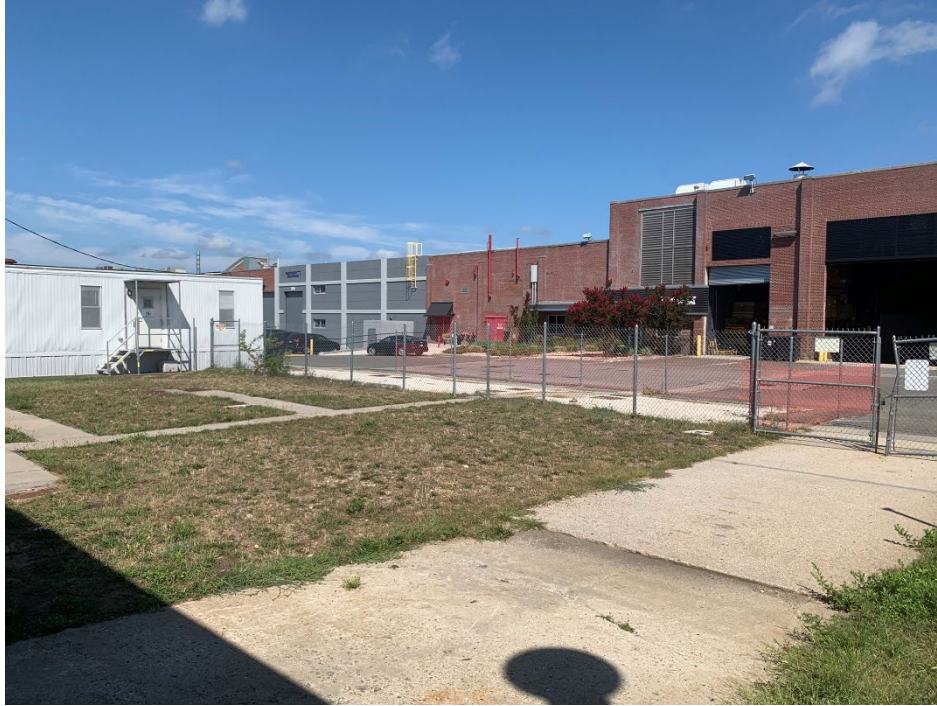
Photo 4A – Southeast corner of Site 4 facing northwest

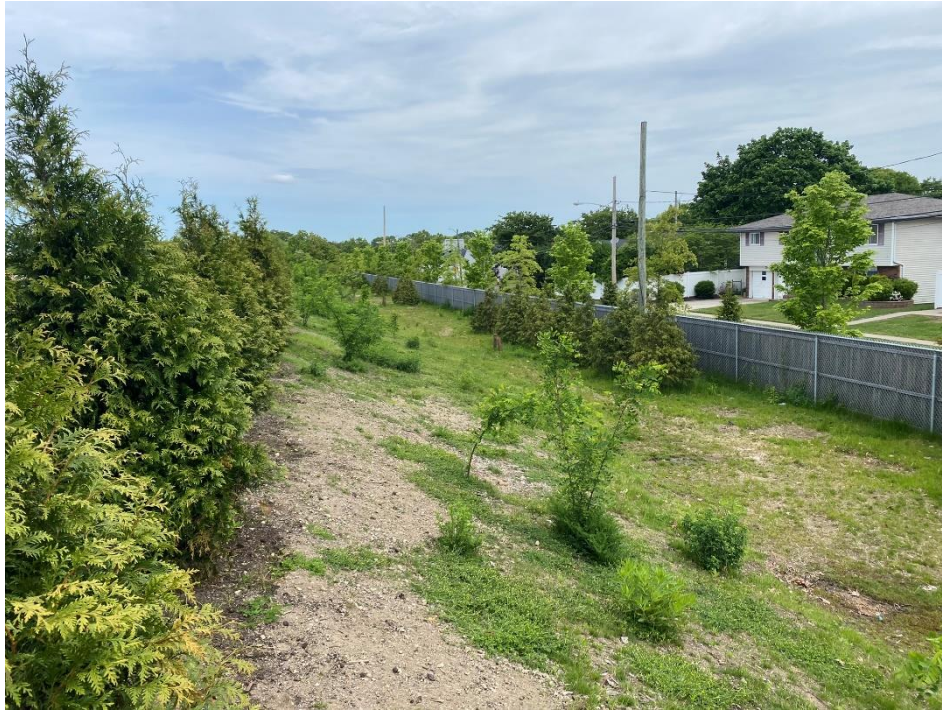
The trees along the eastern fence line were noted during the site walk, see attached photos.

NYSDEC noted that he had received calls from a nearby resident indicating that some of the newly planted trees were dying. (Note that while these trees provide a visual barrier between the community and they are not a requirement of the LUC).

Eastern boundary of Site 1 looking southeast at berm and trees

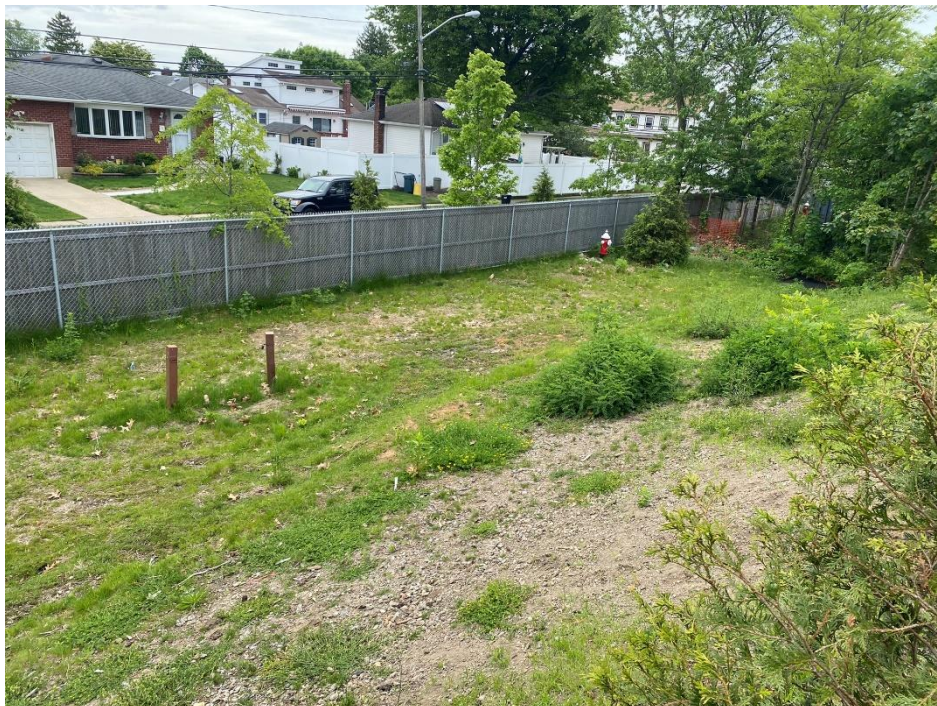
Eastern boundary of Site 1 looking southeast at trees and SVE wells

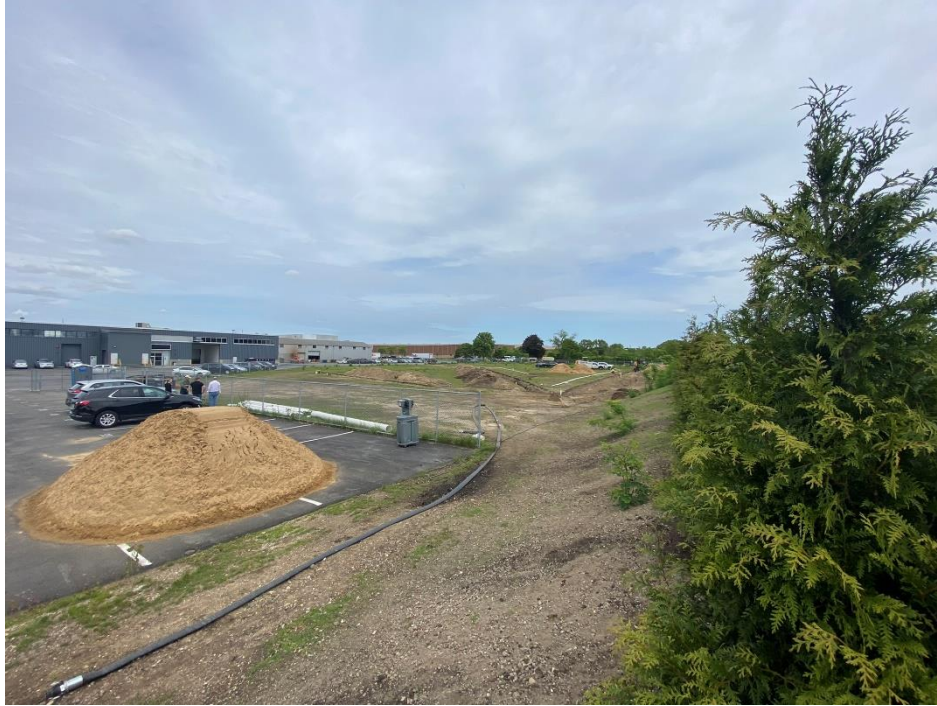
Southeast corner of Site 1 looking northwest at trenching for new SVE piping

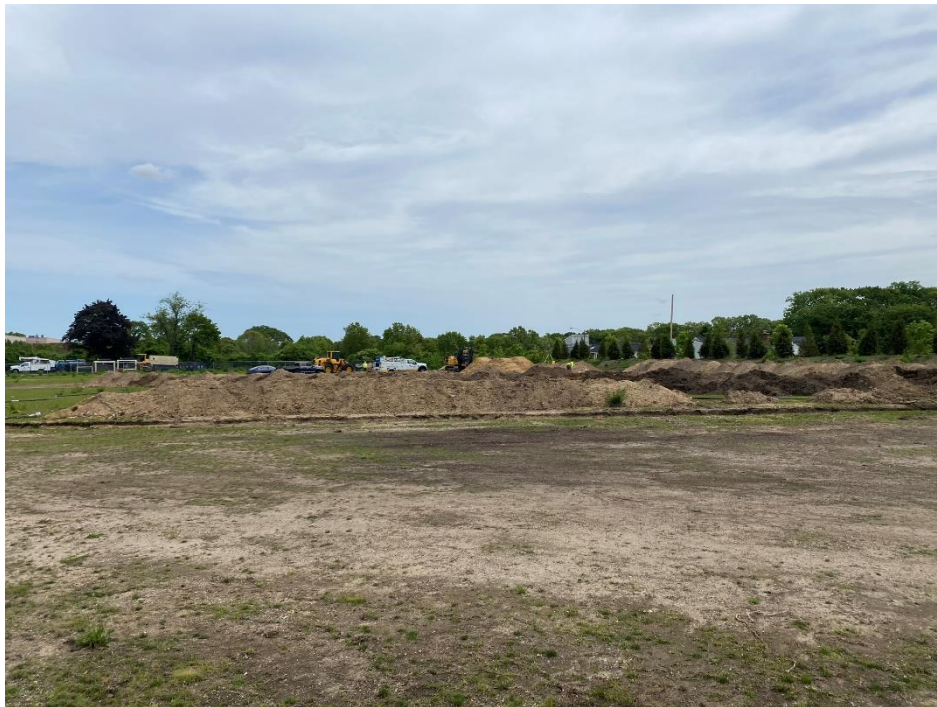
Southwest corner of Site 1 looking northeast at center of site, trenching in place for new SVE piping

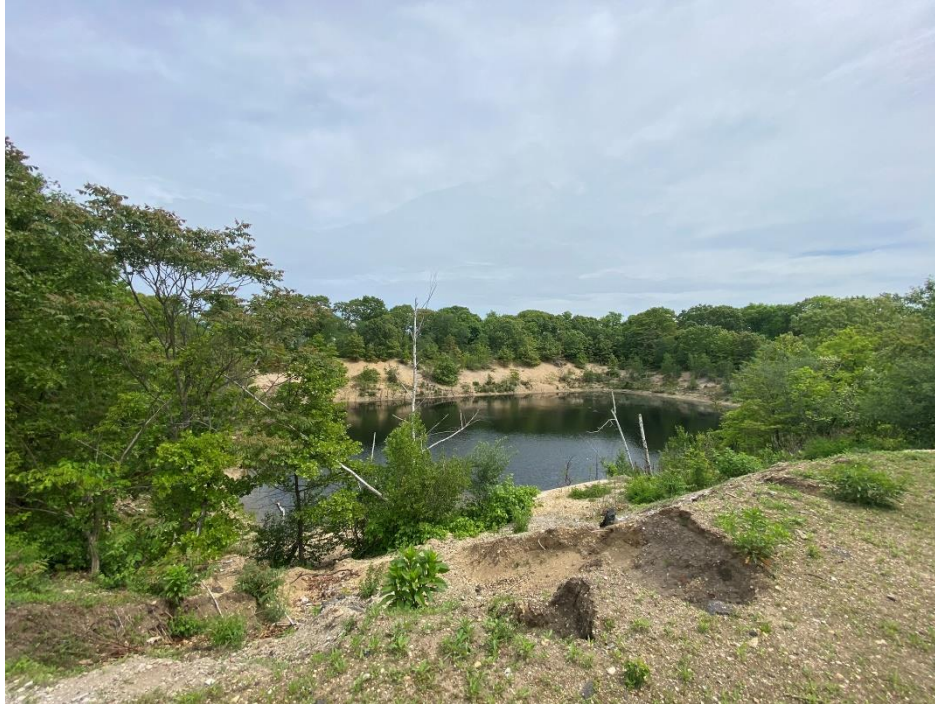
There were no notable issues at this site during the last year. During the site visit, some erosion was noted on the southwest corner of the northeastern basin.

View looking north at area of erosion on the northeast recharge basin

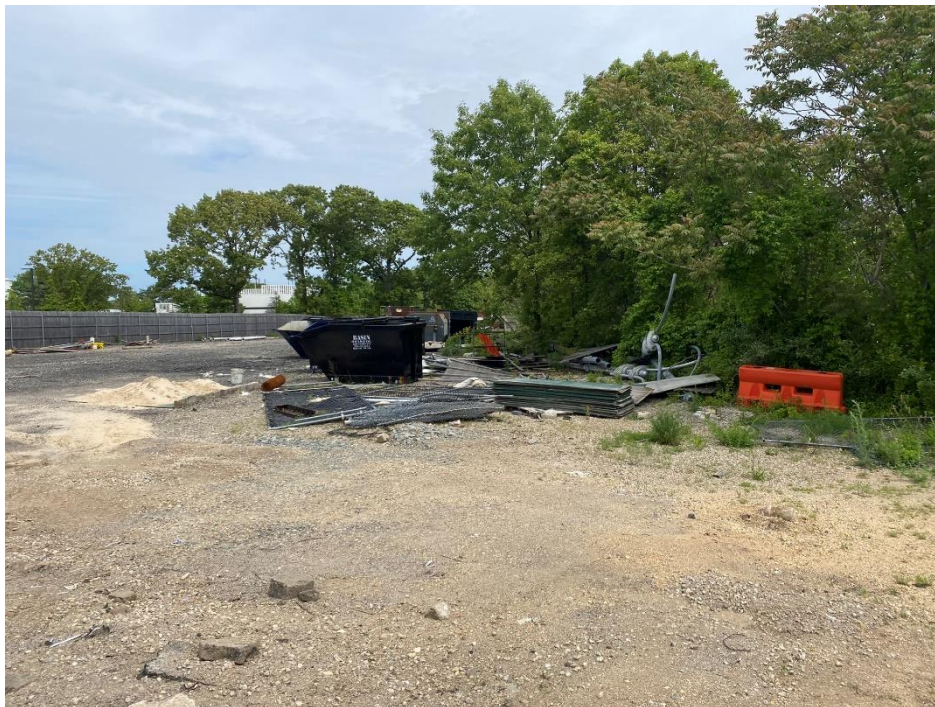
View looking north at Steel Equities laydown area

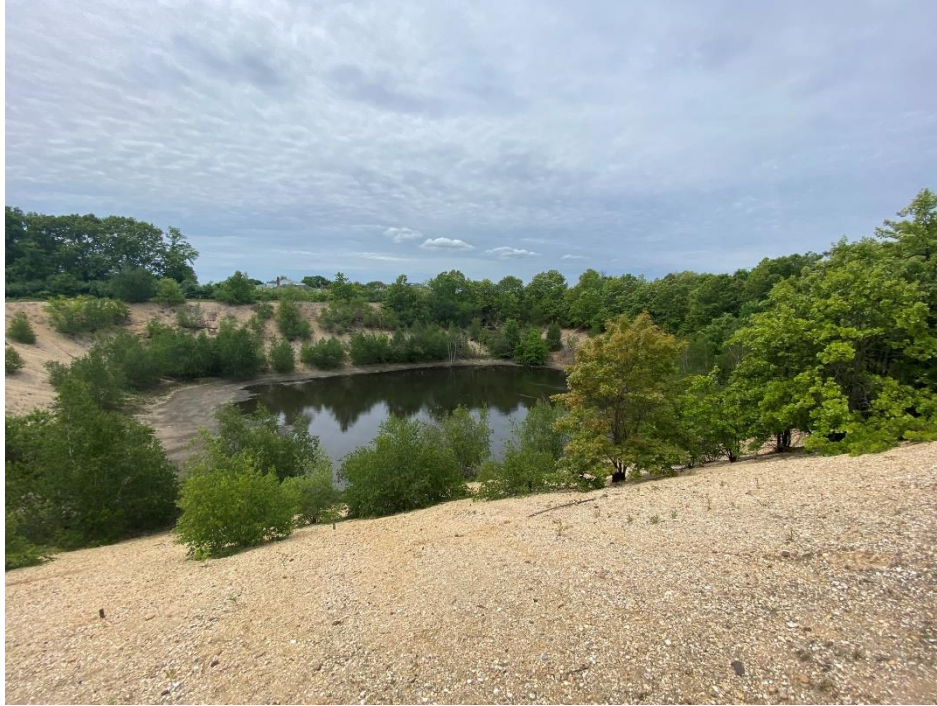
View looking south at southeastern recharge basin

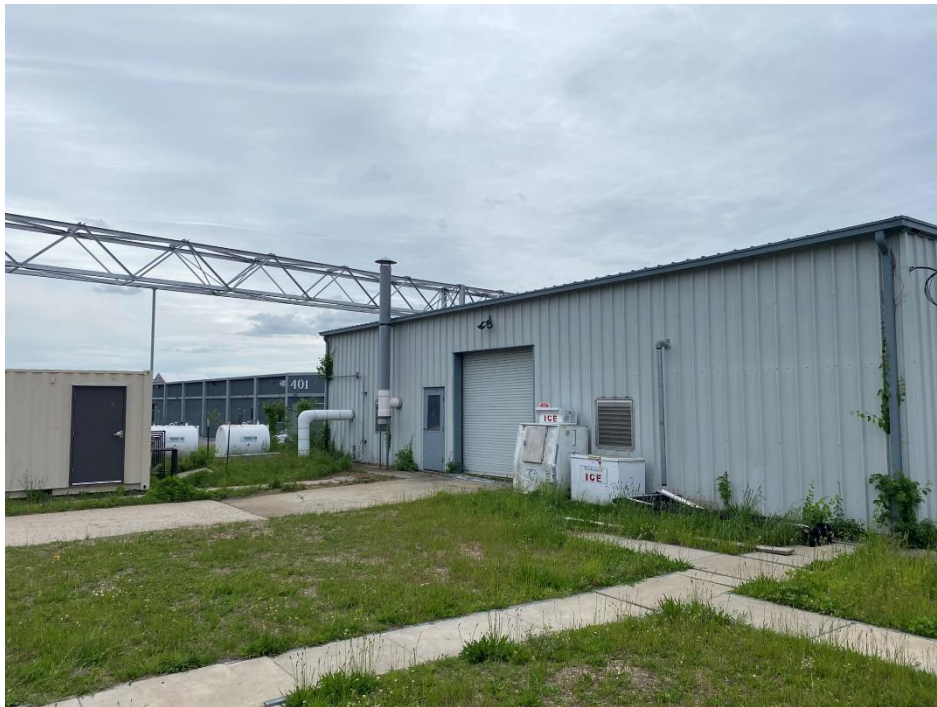
Northwest corner of Site 4 facing southeast looking at blower building (right) and biosparge system (left)

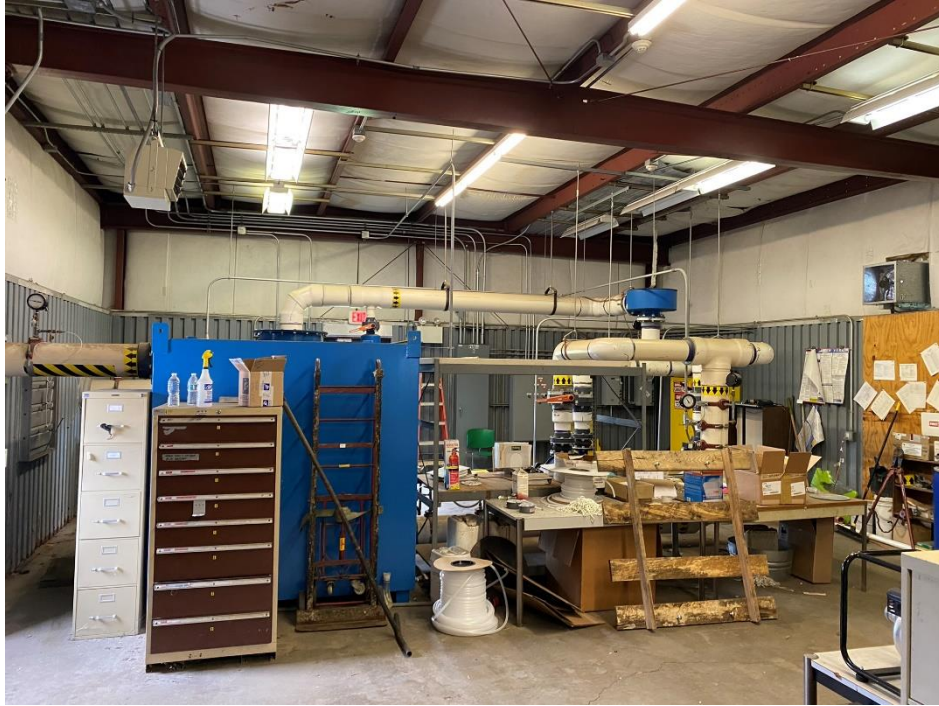
View of Site 1 SVE system blowers and GAC unit

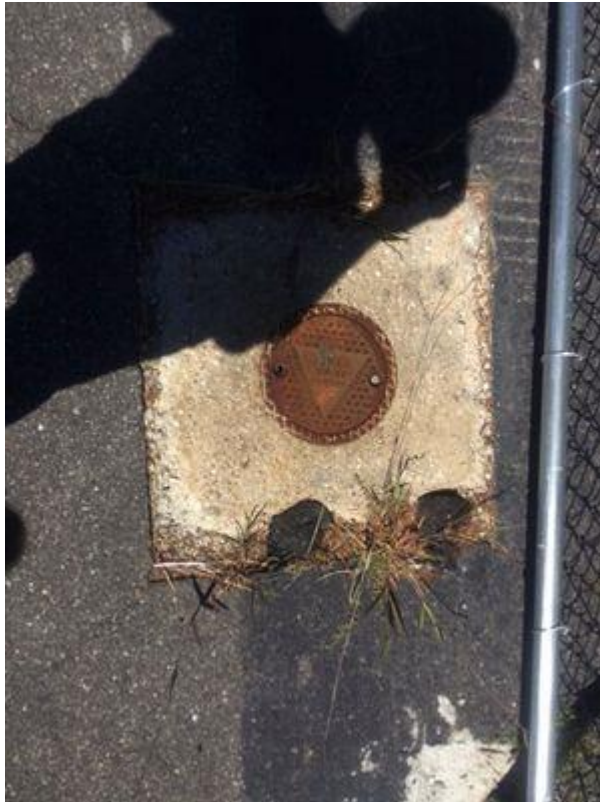
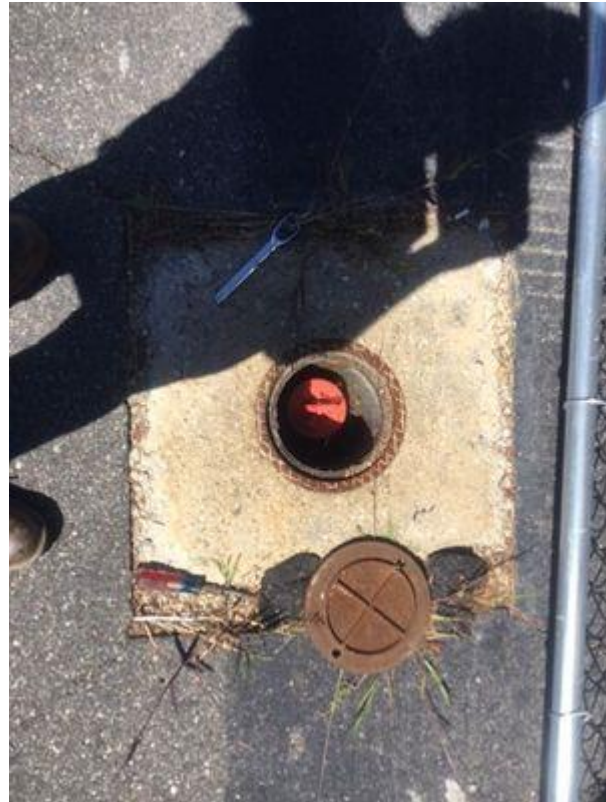
Client: Navy CLEAN	Facility: NWIRP Bethpage
Project Number: 112G08005-WE13	Location: Bethpage, New York
Date: September 2, 2022 12:39	Personnel: Jake Marlow
Well ID: BPGMMW15D	Well Location: 210625.108 1127034.199
Well Status: In Use (Confirmed)	Screen Interval: 332-342
WELL INVENTORY CONDITION	
Concrete pad in acceptable condition i.e. no cracks?	YES
Manhole cover present and in working condition?	NO
All bolts on manhole present and not stripped?	NO
Well plug present, locked and in good working condition?	YES
OVERALL CONDITION:	FAIR
Notes (Explain if answered No to any of the above) Place where bolts attach to manhole is broken, missing one screw

*All wells in Fair/Poor condition will be repaired and/or addressed prior to the next Annual Well Inventory to the extent practicable

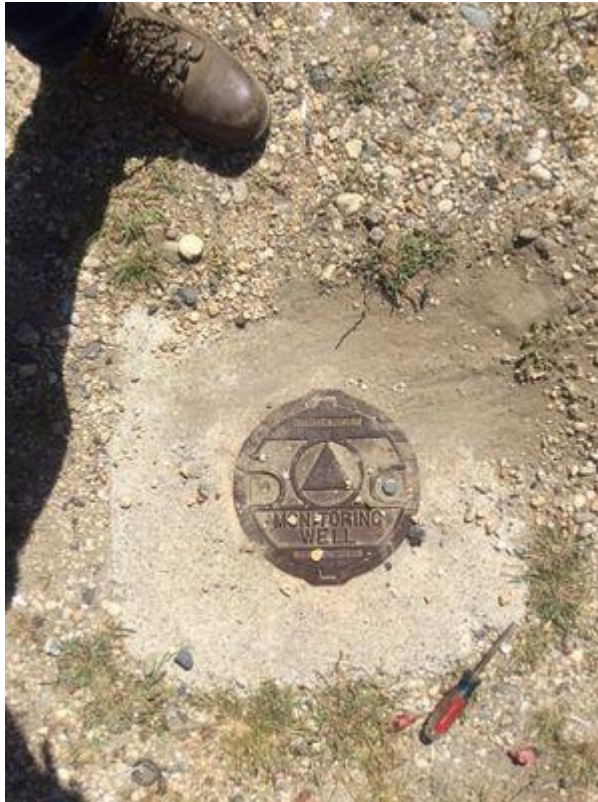
Client: Navy CLEAN	Facility: NWIRP Bethpage
Project Number: 112G08005-WE13	Location: Bethpage, New York
Date: September 2, 2022 11:59	Personnel: Jake Marlow
Well ID: BPGMMW17D	Well Location: 211382.161 1122827.429
Well Status: In Use (Confirmed)	Screen Interval: 278-298
WELL INVENTORY CONDITION	
Concrete pad in acceptable condition i.e. no cracks?	YES
Manhole cover present and in working condition?	YES
All bolts on manhole present and not stripped?	NO
Well plug present, locked and in good working condition?	YES
OVERALL CONDITION:	GOOD
Notes (Explain if answered No to any of the above) Missing bolt

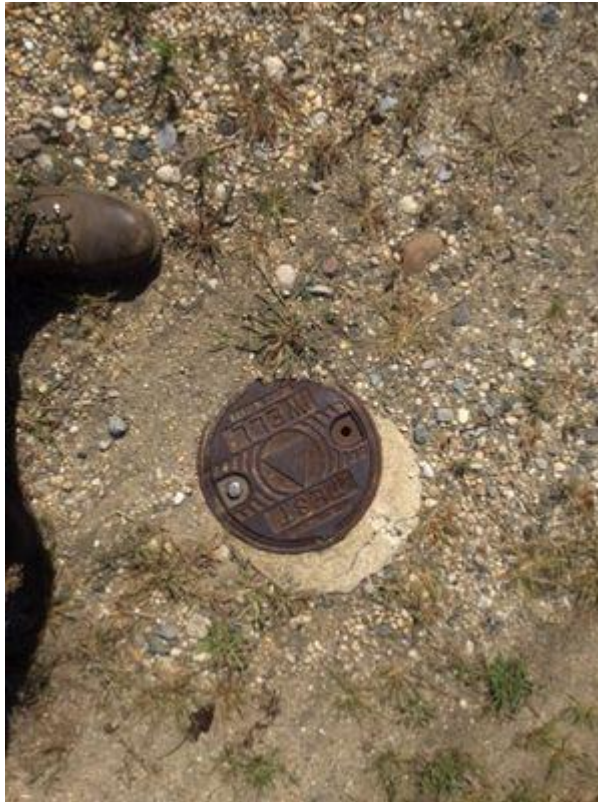
Client: Navy CLEAN	Facility: NWIRP Bethpage
Project Number: 112G08005-WE13	Location: Bethpage, New York
Date: September 2, 2022 11:56	Personnel: Jake Marlow
Well ID: BPGMMW17I	Well Location: 211391.428 1122830.969
Well Status: In Use (Confirmed)	Screen Interval: 100-120
WELL INVENTORY CONDITION	
Concrete pad in acceptable condition i.e. no cracks?	NO
Manhole cover present and in working condition?	YES
All bolts on manhole present and not stripped?	NO
Well plug present, locked and in good working condition?	YES
OVERALL CONDITION:	GOOD
Notes (Explain if answered No to any of the above) Cracked pad, missing bolt

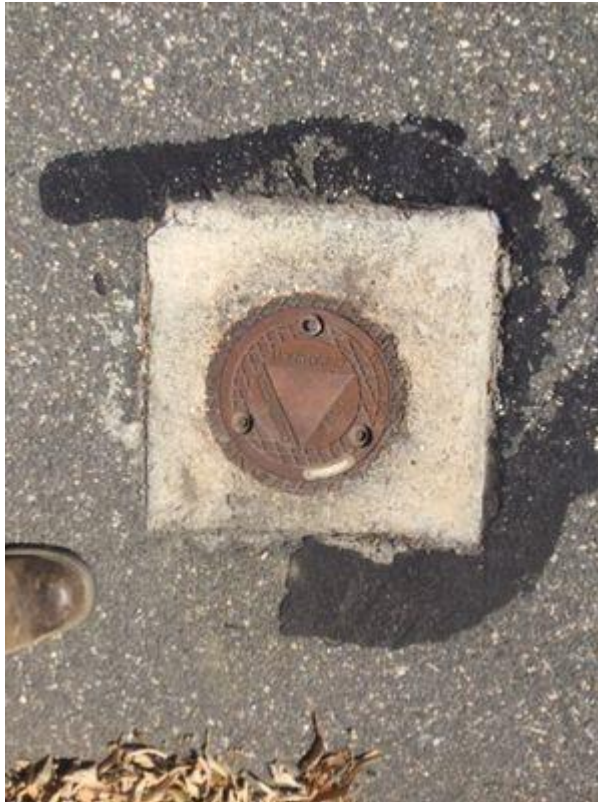
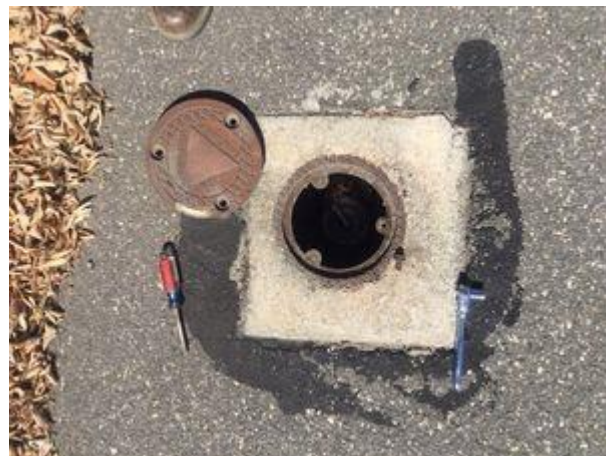
Client: Navy CLEAN	Facility: NWIRP Bethpage
Project Number: 112G08005-WE13	Location: Bethpage, New York
Date: September 2, 2022 11:46	Personnel: Jake Marlow
Well ID: BPGMMW18D	Well Location: 210403 1123701
Well Status: In Use (Confirmed)	Screen Interval: 290-300
WELL INVENTORY CONDITION	
Concrete pad in acceptable condition i.e. no cracks?	YES
Manhole cover present and in working condition?	YES
All bolts on manhole present and not stripped?	NO
Well plug present, locked and in good working condition?	YES
OVERALL CONDITION:	FAIR
Notes (Explain if answered No to any of the above) Two bolts sheared off in manhole

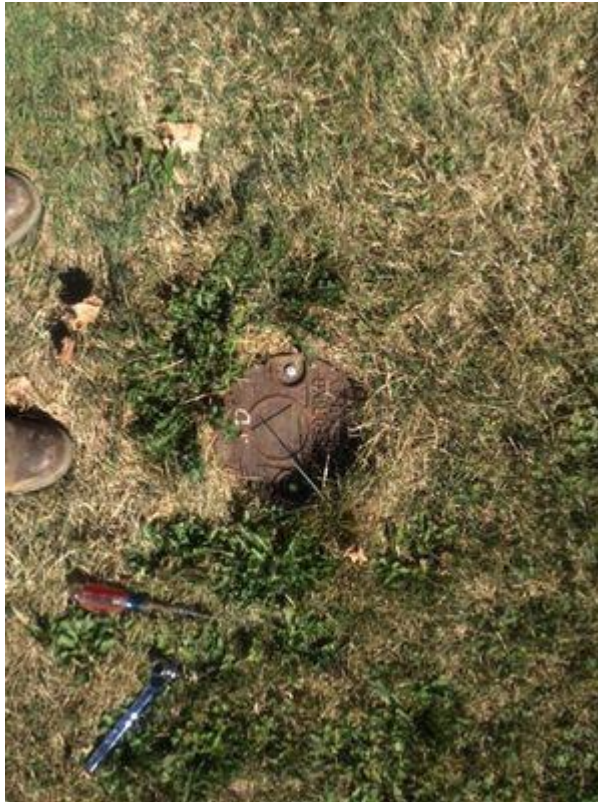
Client: Navy CLEAN	Facility: NWIRP Bethpage
Project Number: 112G08005-WE13	Location: Bethpage, New York
Date: September 2, 2022 11:11	Personnel: Jake Marlow
Well ID: BPGMMW21D	Well Location: 209428 1125462
Well Status: In Use (Confirmed)	Screen Interval: 278-288
WELL INVENTORY CONDITION	
Concrete pad in acceptable condition i.e. no cracks?	YES
Manhole cover present and in working condition?	YES
All bolts on manhole present and not stripped?	NO
Well plug present, locked and in good working condition?	YES
OVERALL CONDITION:	GOOD
Notes (Explain if answered No to any of the above) Replaced two missing bolts

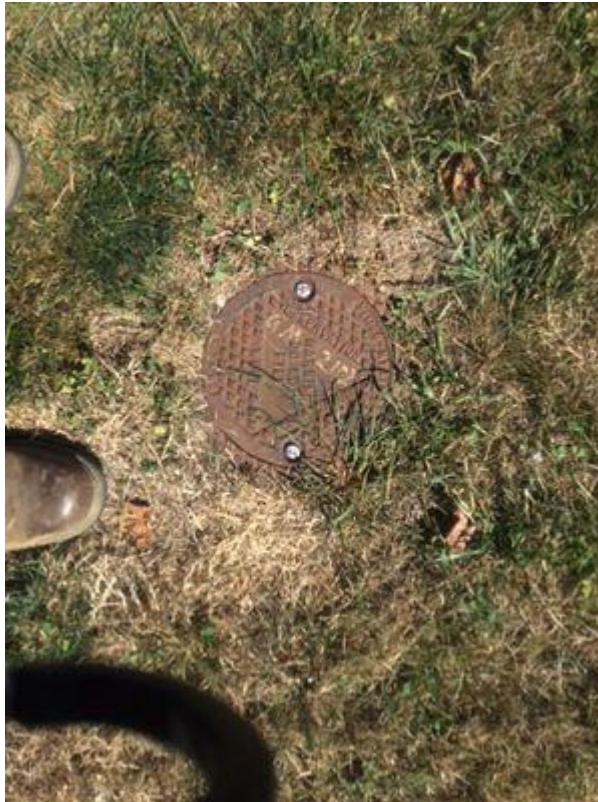
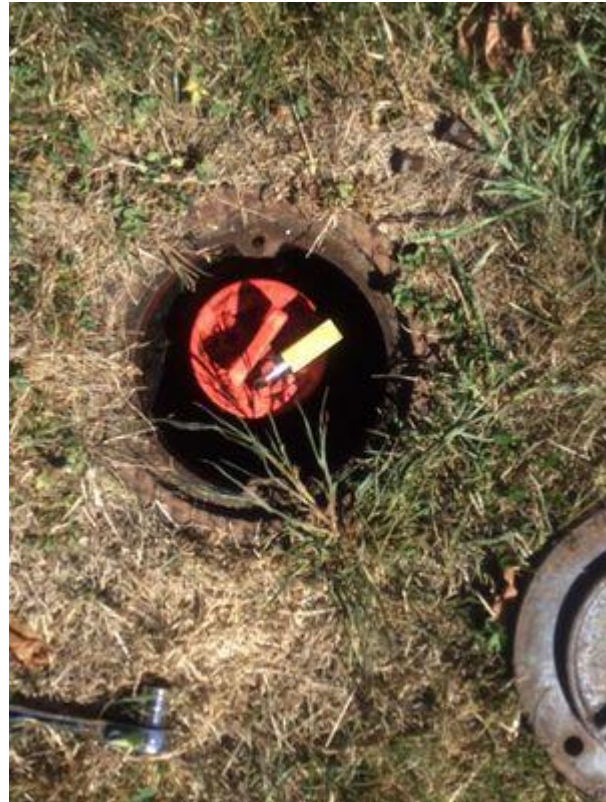
Client: Navy CLEAN	Facility: NWIRP Bethpage
Project Number: 112G08005-WE13	Location: Bethpage, New York
Date: September 2, 2022 11:14	Personnel: Jake Marlow
Well ID: BPGMMW21D2	Well Location: 209438 1125464
Well Status: In Use (Confirmed)	Screen Interval:
WELL INVENTORY CONDITION	
Concrete pad in acceptable condition i.e. no cracks?	YES
Manhole cover present and in working condition?	YES
All bolts on manhole present and not stripped?	NO
Well plug present, locked and in good working condition?	YES
OVERALL CONDITION:	GOOD
Notes (Explain if answered No to any of the above) Replaced two stripped bolts

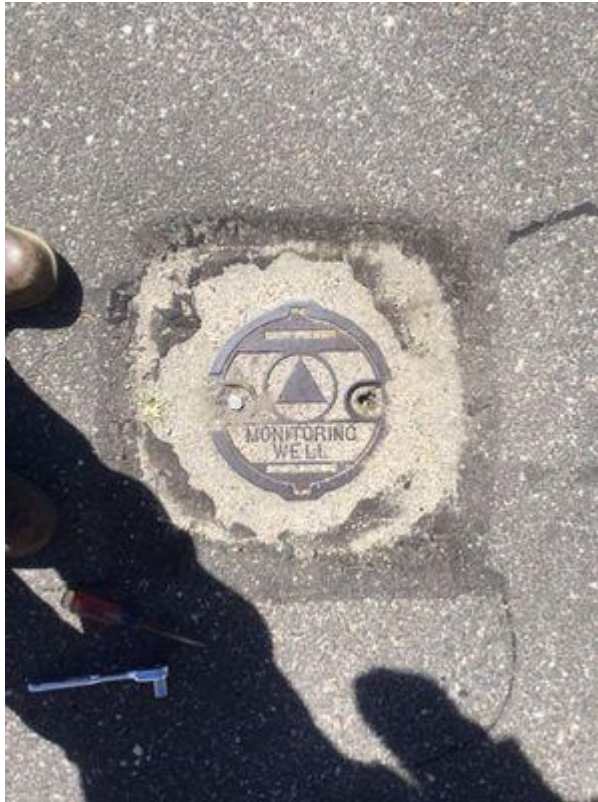
Client: Navy CLEAN	Facility: NWIRP Bethpage
Project Number: 112G08005-WE13	Location: Bethpage, New York
Date: September 2, 2022 11:31	Personnel: Jake Marlow
Well ID: BPGMMW39D	Well Location: 209882 1124170
Well Status: In Use (Confirmed)	Screen Interval: 262-282
WELL INVENTORY CONDITION	
Concrete pad in acceptable condition i.e. no cracks?	YES
Manhole cover present and in working condition?	NO
All bolts on manhole present and not stripped?	NO
Well plug present, locked and in good working condition?	YES
OVERALL CONDITION:	POOR
Notes (Explain if answered No to any of the above) Missing bolt, manhole cover cracked where bolt goes in

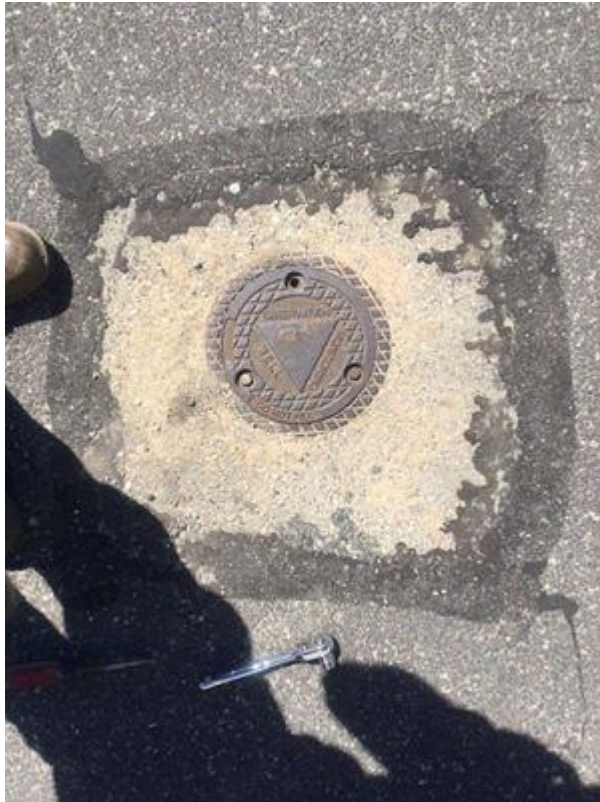
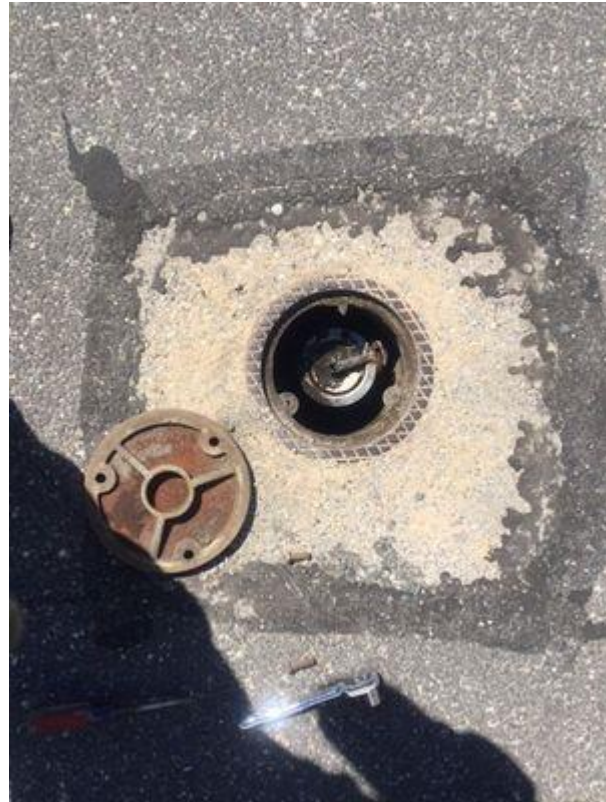
Client: Navy CLEAN	Facility: NWIRP Bethpage
Project Number: 112G08005-WE13	Location: Bethpage, New York
Date: September 2, 2022 11:28	Personnel: Jake Marlow
Well ID: BPGMMW39D2	Well Location: 209884 1124173
Well Status: In Use (Confirmed)	Screen Interval: 410-420
WELL INVENTORY CONDITION	
Concrete pad in acceptable condition i.e. no cracks?	YES
Manhole cover present and in working condition?	YES
All bolts on manhole present and not stripped?	NO
Well plug present, locked and in good working condition?	YES
OVERALL CONDITION:	FAIR
Notes (Explain if answered No to any of the above) Manhole cracked where bolts screw in
