Memorandum

To: Scot Sokolowski, NAVFAC MIDLANT
From: David Brayack, Tetra Tech
Date: November 17, 2022
Re: Annual LUC Inspection and Operation Summary Report: Sites 1, 2, 3, and 4 –
NWIRP Bethpage
Contract/CTO Number: N6247016D9008/WE16

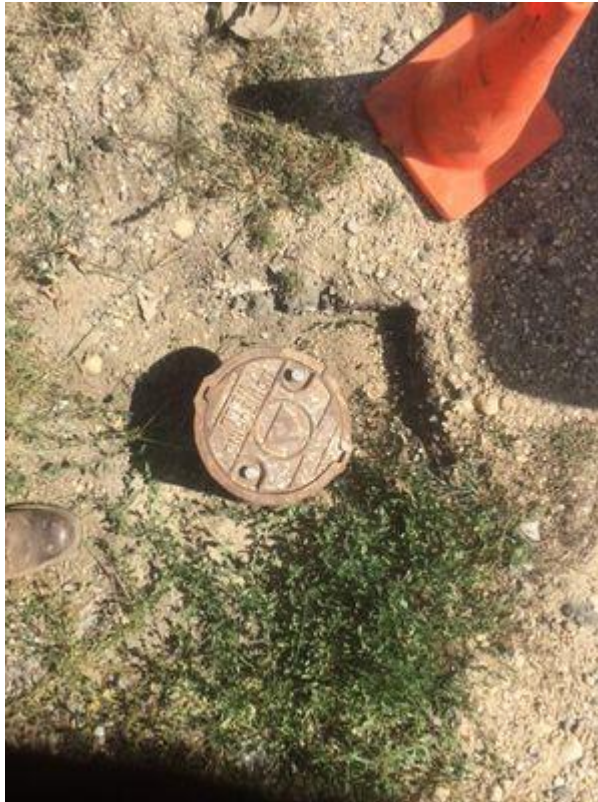
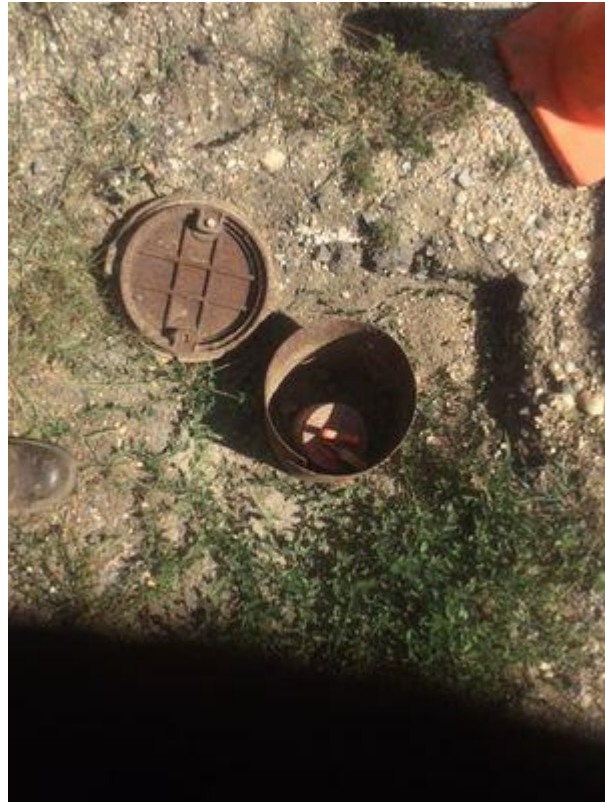
Client: Navy CLEAN	Facility: NWIRP Bethpage
Project Number: 112G08005-WE13	Location: Bethpage, New York
Date: September 2, 2022 13:32	Personnel: Jake Marlow
Well ID: BPGMMW73D2	Well Location: 209851.283 1124674.455
Well Status: In Use (Confirmed)	Screen Interval: 532-552
WELL INVENTORY CONDITION	
Concrete pad in acceptable condition i.e. no cracks?	NO
Manhole cover present and in working condition?	NO
All bolts on manhole present and not stripped?	YES
Well plug present, locked and in good working condition?	YES
OVERALL CONDITION:	FAIR
Notes (Explain if answered No to any of the above) Manhole cover does not attach to manhole, pad no longer there

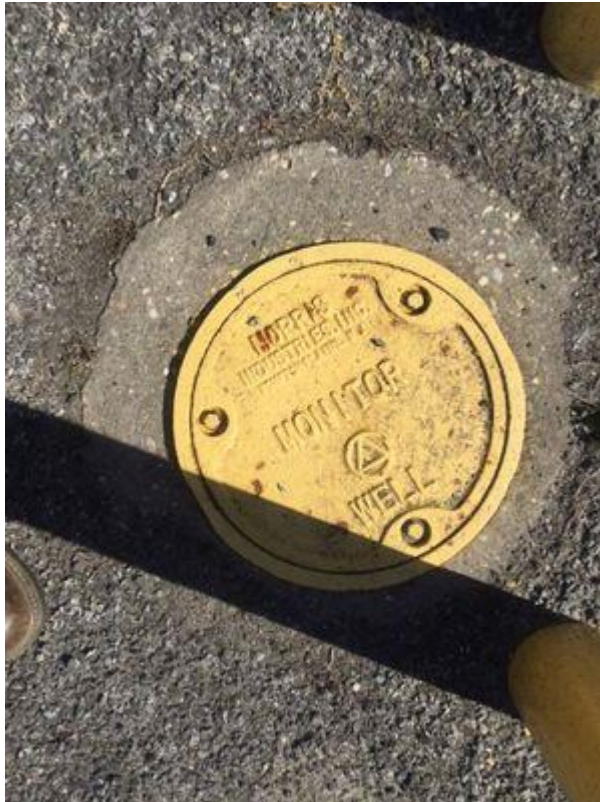
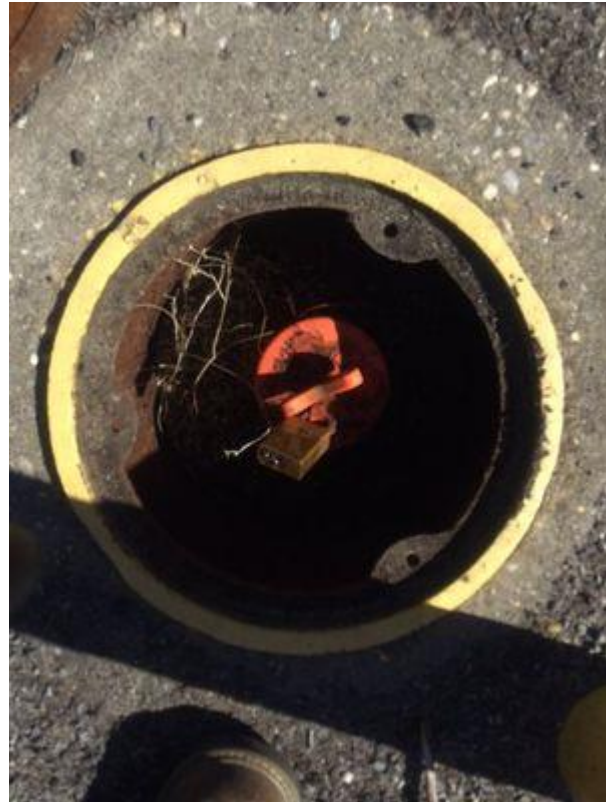
Client: Navy CLEAN	Facility: NWIRP Bethpage
Project Number: 112G08005-WE13	Location: Bethpage, New York
Date: September 1, 2022 15:28	Personnel: Jake Marlow
Well ID: BPHNMW24IR	Well Location: 214063.741045 1123251.03332
Well Status: In Use (Confirmed)	Screen Interval: 148-158
WELL INVENTORY CONDITION	
Concrete pad in acceptable condition i.e. no cracks?	YES
Manhole cover present and in working condition?	YES
All bolts on manhole present and not stripped?	NO
Well plug present, locked and in good working condition?	YES
OVERALL CONDITION:	FAIR
Notes (Explain if answered No to any of the above) Manhole stripped where bolts go in

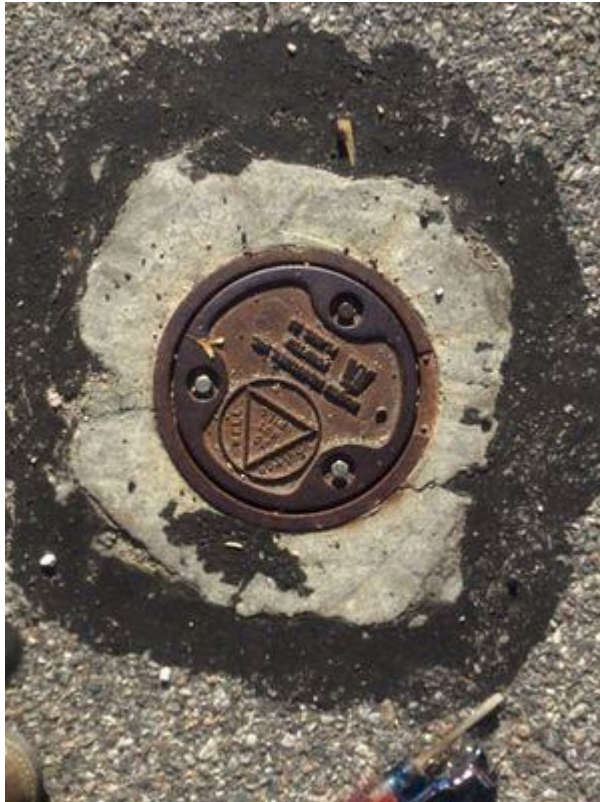
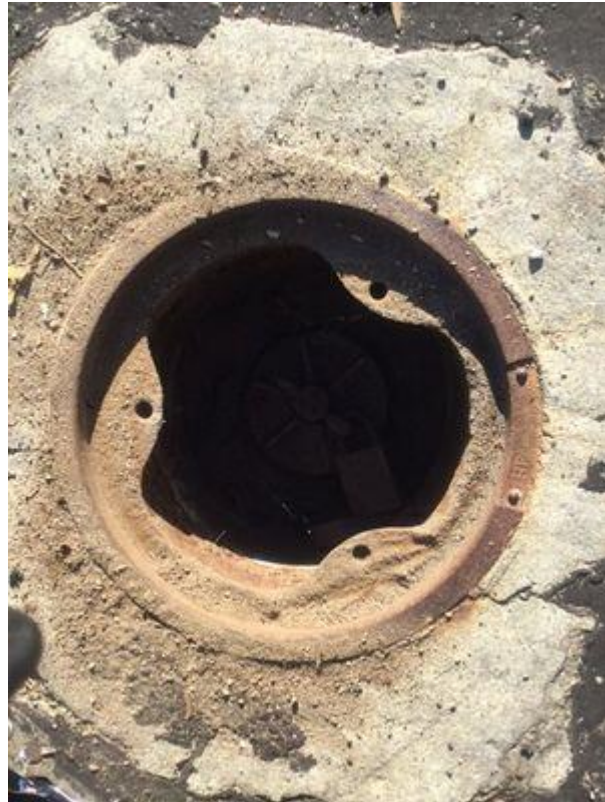
Client: Navy CLEAN	Facility: NWIRP Bethpage
Project Number: 112G08005-WE13	Location: Bethpage, New York
Date: September 1, 2022 17:11	Personnel: Jake Marlow
Well ID: BPHNMW29D	Well Location: 213933.694 1124704.902
Well Status: In Use (Confirmed)	Screen Interval: 210-220
WELL INVENTORY CONDITION	
Concrete pad in acceptable condition i.e. no cracks?	NO
Manhole cover present and in working condition?	NO
All bolts on manhole present and not stripped?	NO
Well plug present, locked and in good working condition?	YES
OVERALL CONDITION:	FAIR
Notes (Explain if answered No to any of the above) Manhole wear bolts go in is stripped, cracks in pad

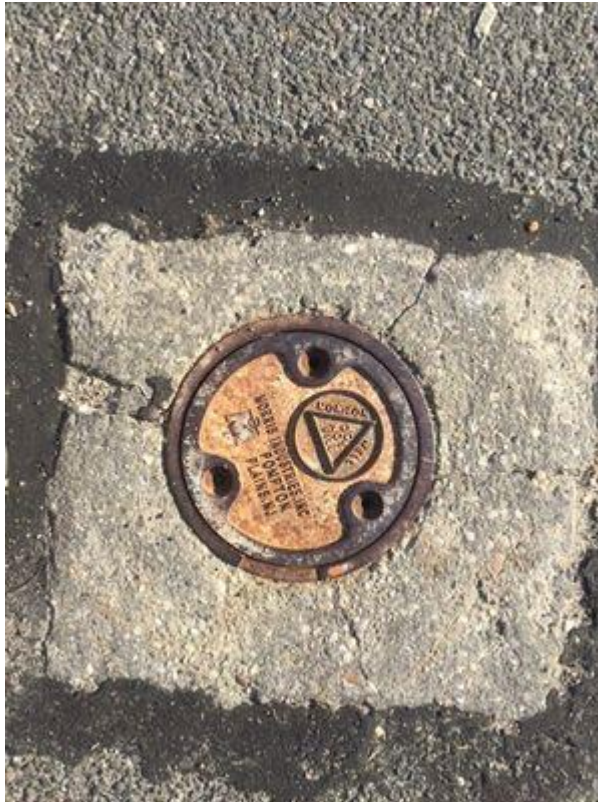
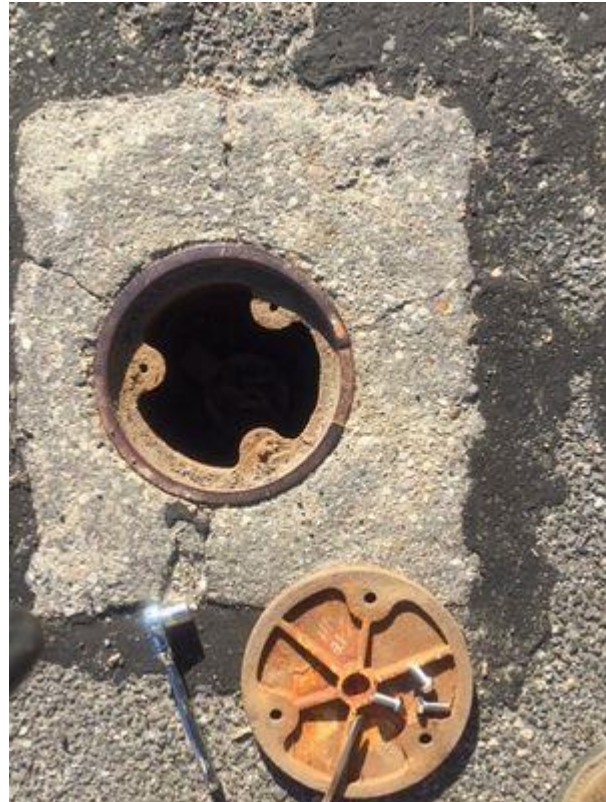
Client: Navy CLEAN,	Facility: NWIRP Bethpage
Project Number: 112G08005-WE13	Location: Bethpage, New York
Date: September 1, 2022 17:17	Personnel: Jake Marlow
Well ID: BPHNMW29IR	Well Location: 213928.573 1124685.862
Well Status: In Use (Confirmed)	Screen Interval: 120-130
WELL INVENTORY CONDITION	
Concrete pad in acceptable condition i.e. no cracks?	NO
Manhole cover present and in working condition?	NO
All bolts on manhole present and not stripped?	NO
Well plug present, locked and in good working condition?	YES
OVERALL CONDITION:	FAIR
Notes (Explain if answered No to any of the above) Two bolts are missing could not replace because manhole is stripped. Another bolt is broken off in the manhole cracks in pad

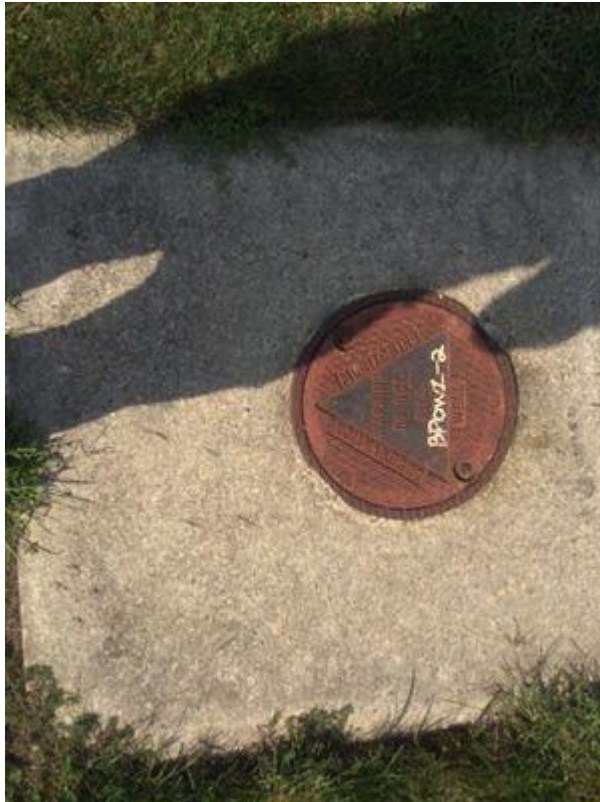
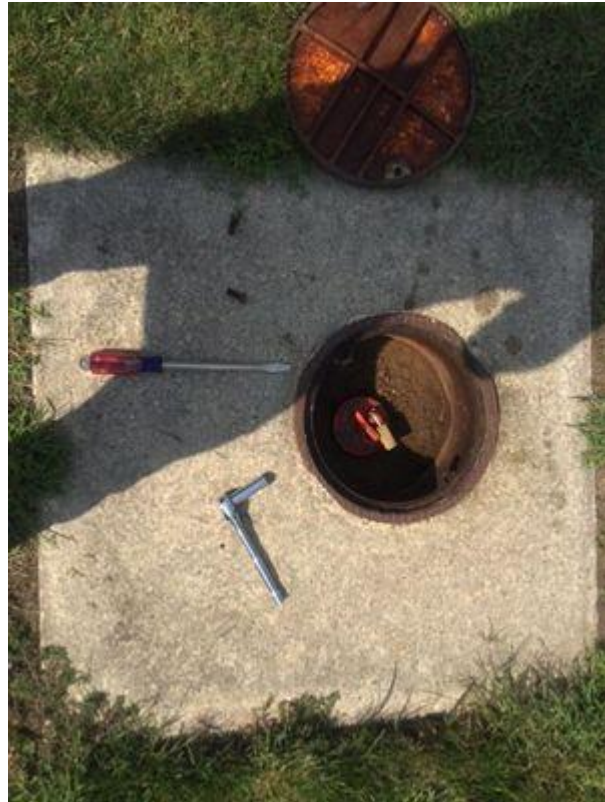
Client: Navy CLEAN	Facility: NWIRP Bethpage
Project Number: 112G08005-WE13	Location: Bethpage, New York
Date: September 16, 2022 11:46	Personnel: Jake Marlow
Well ID: BPOW 1-2	Well Location: 202009.697 1132173.169
Well Status: In Use (Confirmed)	Screen Interval: 310-335
WELL INVENTORY CONDITION	
Concrete pad in acceptable condition i.e. no cracks?	YES
Manhole cover present and in working condition?	YES
All bolts on manhole present and not stripped?	NO
Well plug present, locked and in good working condition?	YES
OVERALL CONDITION:	FAIR
Notes (Explain if answered No to any of the above) Bolts stripped on manhole

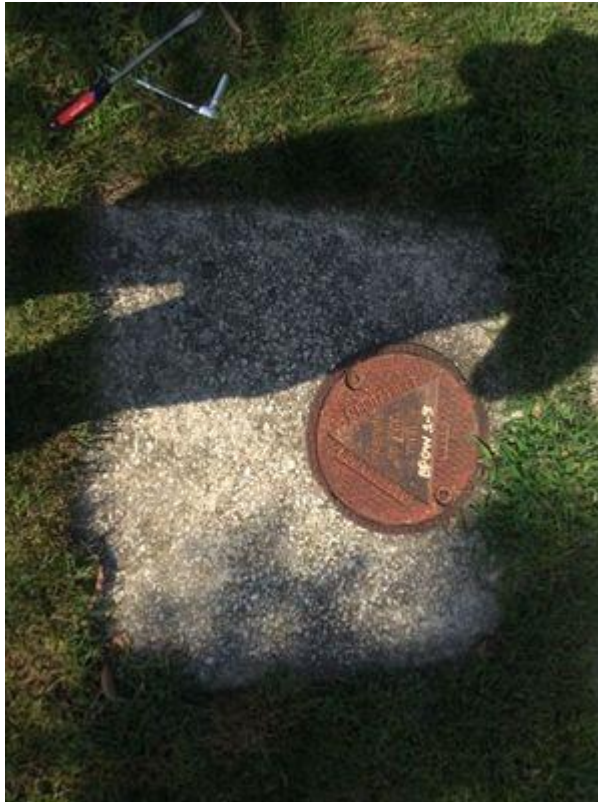
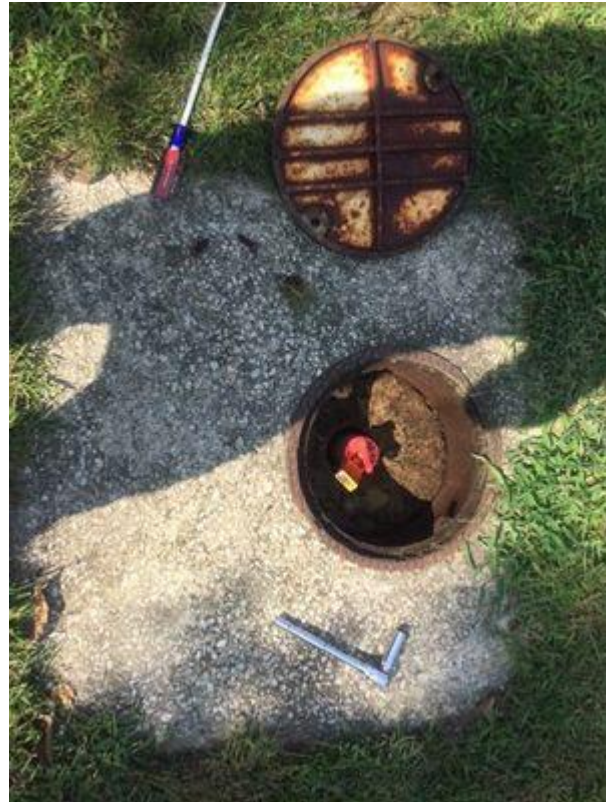
Client: Navy CLEAN	Facility: NWIRP Bethpage
Project Number: 112G08005-WE13	Location: Bethpage, New York
Date: September 16, 2022 11:49	Personnel: Jake Marlow
Well ID: BPOW 1-3	Well Location: 202010.024 1132189.152
Well Status: In Use (Confirmed)	Screen Interval: 374-419
WELL INVENTORY CONDITION	
Concrete pad in acceptable condition i.e. no cracks?	YES
Manhole cover present and in working condition?	YES
All bolts on manhole present and not stripped?	NO
Well plug present, locked and in good working condition?	YES
OVERALL CONDITION:	FAIR
Notes (Explain if answered No to any of the above) Bolts stripped in manhole

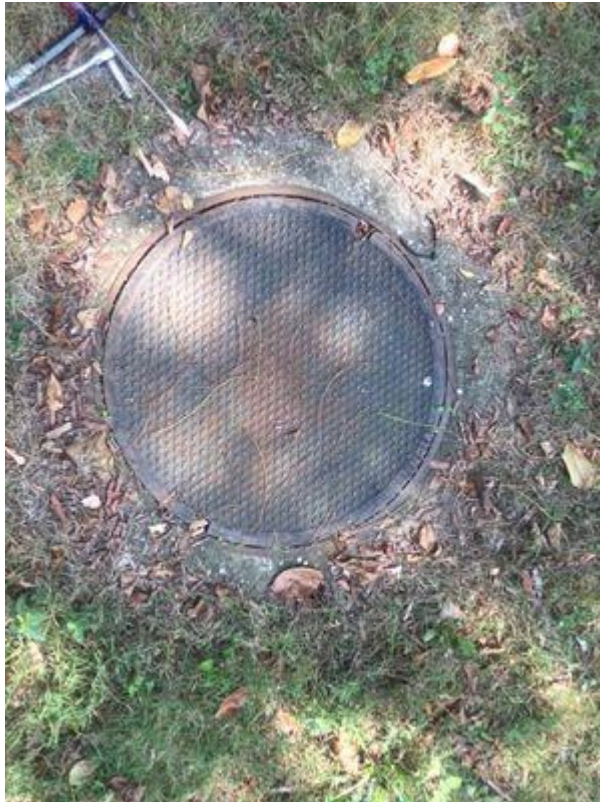
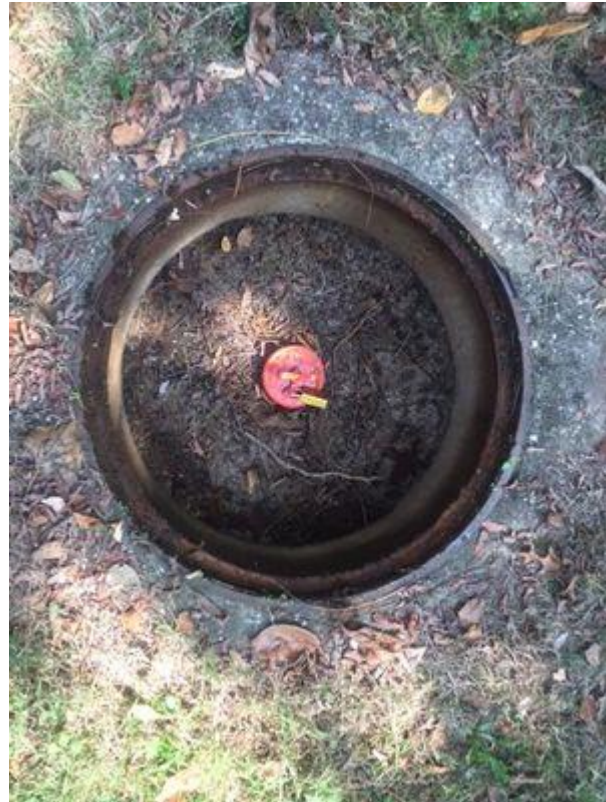
Client: Navy CLEAN	Facility: NWIRP Bethpage
Project Number: 112G08005-WE13	Location: Bethpage, New York
Date: September 16, 2022 13:20	Personnel: Jake Marlow
Well ID: BPOW 1-5	Well Location: 203315.538 1132141.261
Well Status: In Use (Confirmed)	Screen Interval: 600-650
WELL INVENTORY CONDITION	
Concrete pad in acceptable condition i.e. no cracks?	YES
Manhole cover present and in working condition?	YES
All bolts on manhole present and not stripped?	NO
Well plug present, locked and in good working condition?	YES
OVERALL CONDITION:	GOOD
Notes (Explain if answered No to any of the above) No bolts for manhole cover

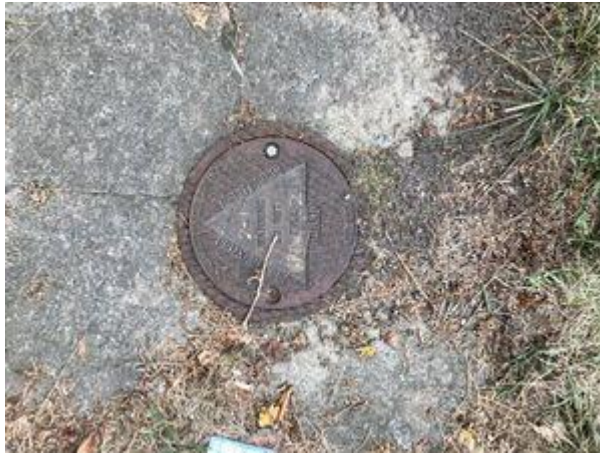
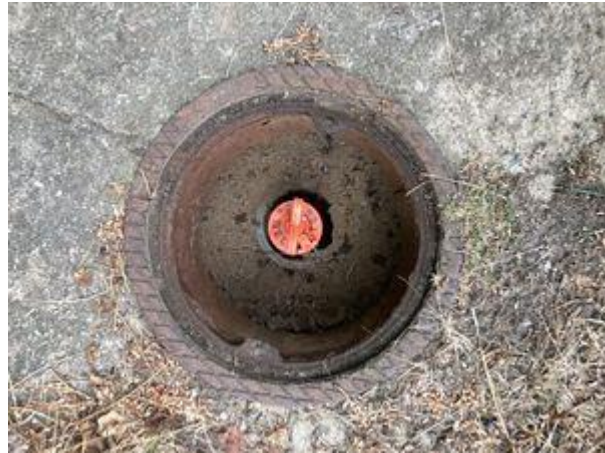
Client: Navy CLEAN	Facility: NWIRP Bethpage
Project Number: 112G08005-WE13	Location: Bethpage, New York
Date: August 17, 2022 08:52	Personnel: Beau Benfield
Well ID: BPOW 2-1	Well Location: 199726.122 1127424.086
Well Status: In Use (Confirmed)	Screen Interval: 356-396
WELL INVENTORY CONDITION	
Concrete pad in acceptable condition i.e. no cracks?	YES
Manhole cover present and in working condition?	YES
All bolts on manhole present and not stripped?	NO
Well plug present, locked and in good working condition?	YES
OVERALL CONDITION:	GOOD
Notes (Explain if answered No to any of the above) One bolt broken off inside well collar

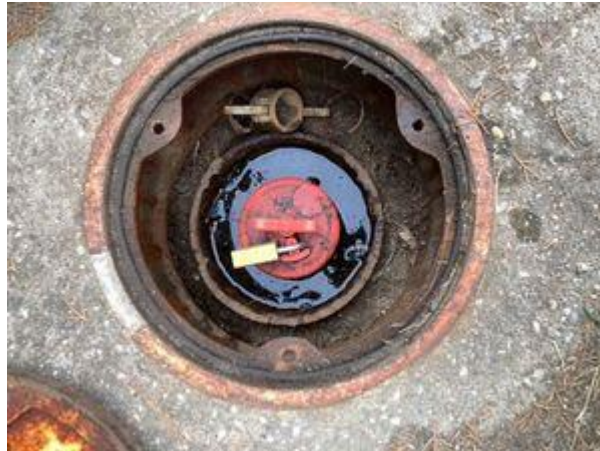
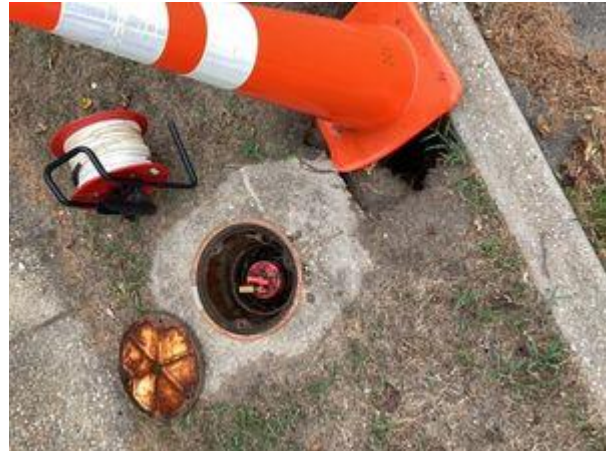
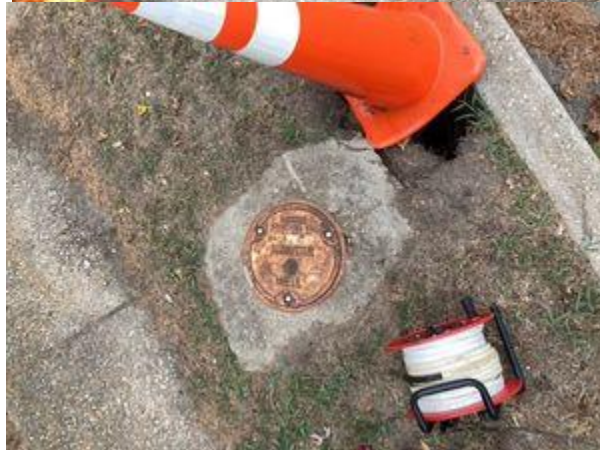
Client: Navy CLEAN	Facility: NWIRP Bethpage
Project Number: 112G08005-WE13	Location: Bethpage, New York
Date: August 17, 2022 09:07	Personnel: Beau Benfield
Well ID: BPOW 2-3	Well Location: 199725.231 1127377.781
Well Status: In Use (Confirmed)	Screen Interval: 564-594
WELL INVENTORY CONDITION	
Concrete pad in acceptable condition i.e. no cracks?	NO
Manhole cover present and in working condition?	YES
All bolts on manhole present and not stripped?	NO
Well plug present, locked and in good working condition?	YES
OVERALL CONDITION:	POOR
Notes (Explain if answered No to any of the above) Ground between curb and well pad has caved in. All bolts are stripped; needs new well collar.

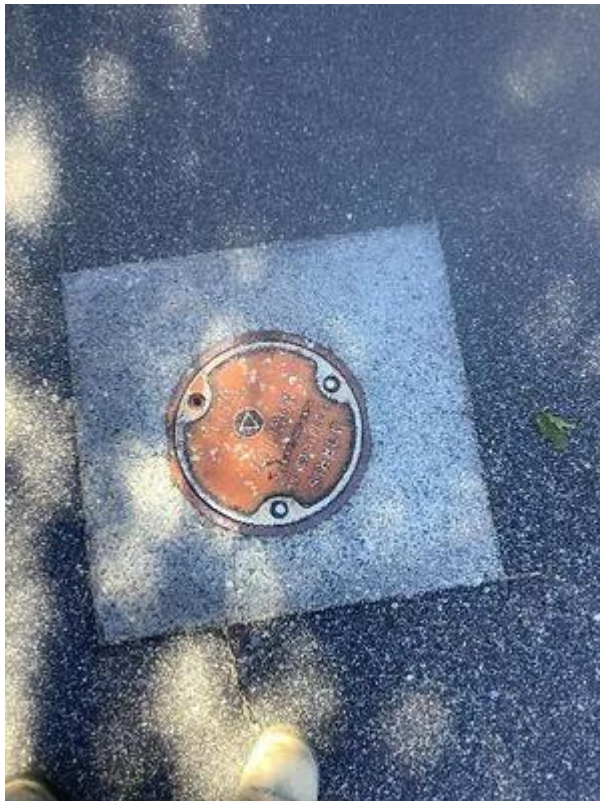
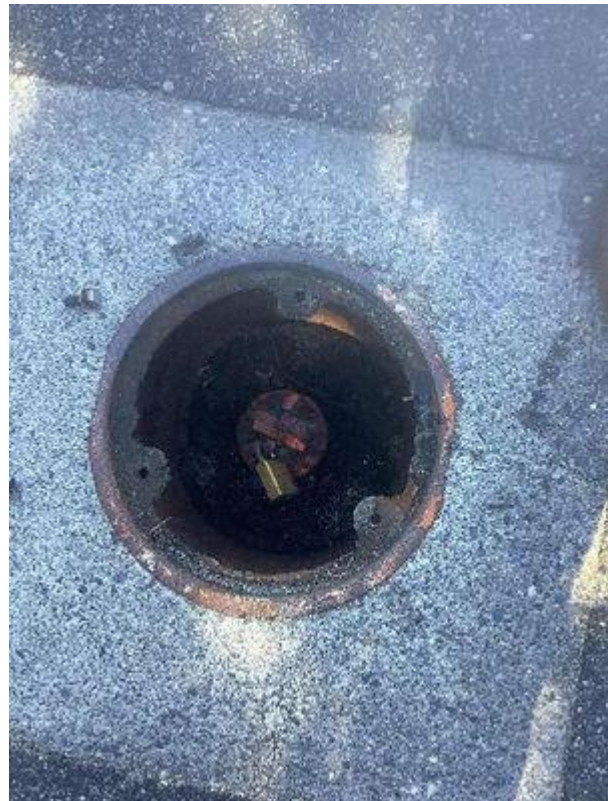
Client: Navy CLEAN	Facility: NWIRP Bethpage
Project Number: 112G08005-WE13	Location: Bethpage, New York
Date: September 2, 2022 10:25	Personnel: Will Yeung
Well ID: BPOW 5-1	Well Location: 198399.79 1127145.842
Well Status: In Use (Confirmed)	Screen Interval: 480-510
WELL INVENTORY CONDITION	
Concrete pad in acceptable condition i.e. no cracks?	YES
Manhole cover present and in working condition?	YES
All bolts on manhole present and not stripped?	NO
Well plug present, locked and in good working condition?	YES
OVERALL CONDITION:	FAIR
Notes (Explain if answered No to any of the above)

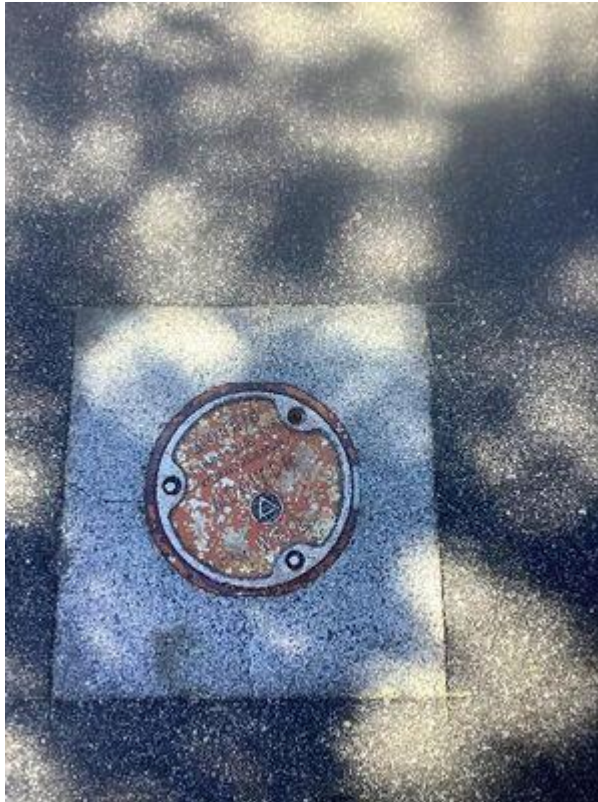
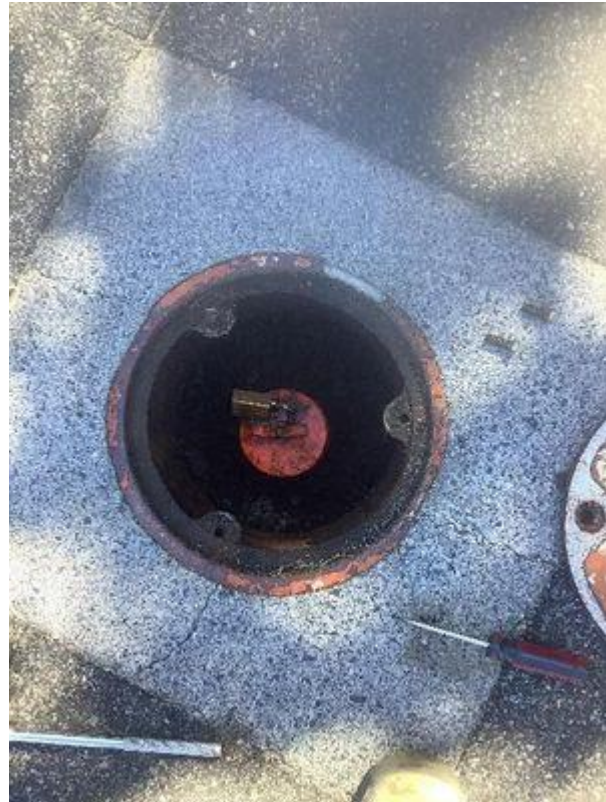
Client: Navy CLEAN	Facility: NWIRP Bethpage
Project Number: 112G08005-WE13	Location: Bethpage, New York
Date: September 2, 2022 10:21	Personnel: Will Yeung
Well ID: BPOW 5-2	Well Location: 198410.857 1127152.768
Well Status: In Use (Confirmed)	Screen Interval: 540-580
WELL INVENTORY CONDITION	
Concrete pad in acceptable condition i.e. no cracks?	YES
Manhole cover present and in working condition?	YES
All bolts on manhole present and not stripped?	NO
Well plug present, locked and in good working condition?	YES
OVERALL CONDITION:	FAIR
Notes (Explain if answered No to any of the above)

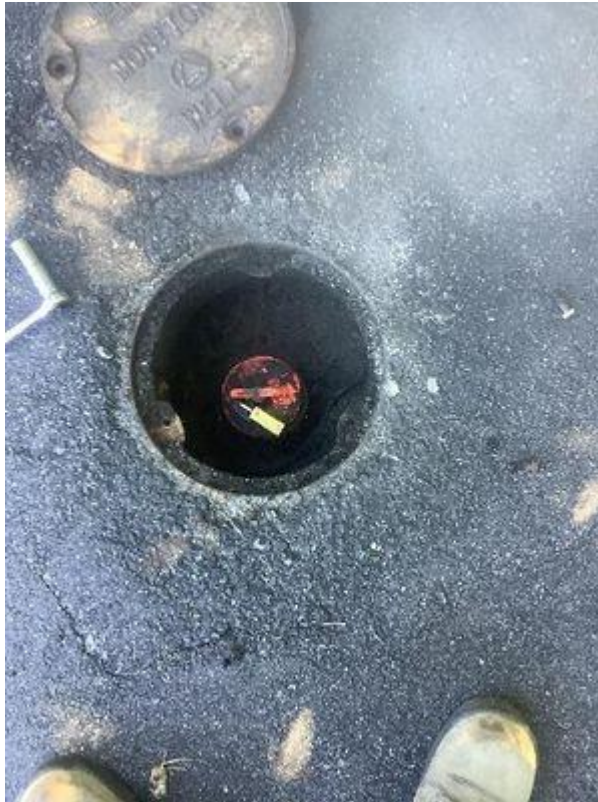
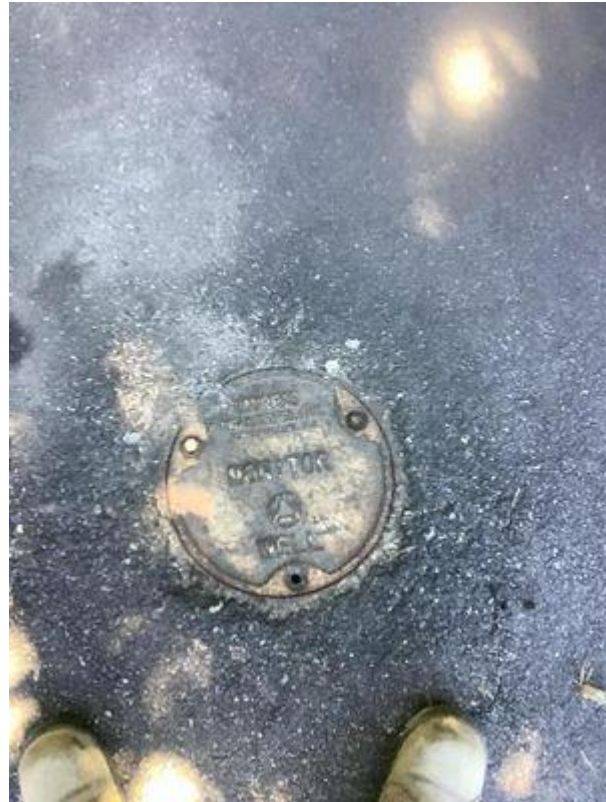
Client: Navy CLEAN	Facility: NWIRP Bethpage
Project Number: 112G08005-WE13	Location: Bethpage, New York
Date: September 2, 2022 10:35	Personnel: Will Yeung
Well ID: BPOW 5-3	Well Location: 198389.891 1127156.801
Well Status: In Use (Confirmed)	Screen Interval: 620-660
WELL INVENTORY CONDITION	
Concrete pad in acceptable condition i.e. no cracks?	YES
Manhole cover present and in working condition?	YES
All bolts on manhole present and not stripped?	NO
Well plug present, locked and in good working condition?	YES
OVERALL CONDITION:	FAIR
Notes (Explain if answered No to any of the above)

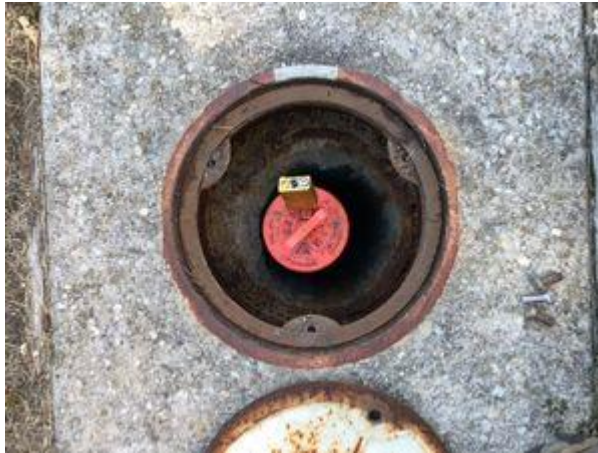
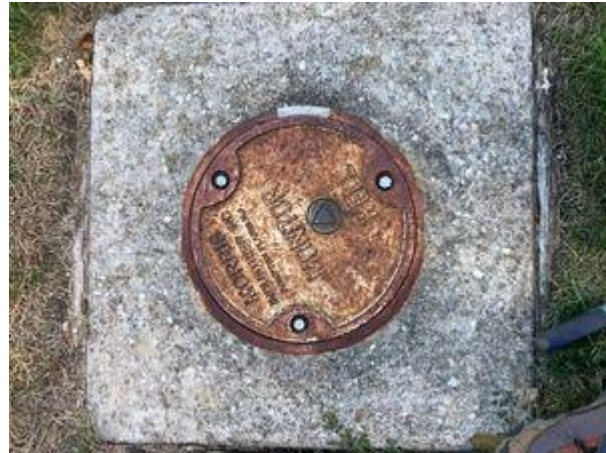
Client: Navy CLEAN	Facility: NWIRP Bethpage
Project Number: 112G08005-WE13	Location: Bethpage, New York
Date: September 2, 2022 15:33	Personnel: Beau Benfield
Well ID: BPOW 5-7	Well Location: 197274.15 1128702.39
Well Status: In Use (Confirmed)	Screen Interval: 525-550
WELL INVENTORY CONDITION	
Concrete pad in acceptable condition i.e. no cracks?	YES
Manhole cover present and in working condition?	YES
All bolts on manhole present and not stripped?	YES
Well plug present, locked and in good working condition?	YES
OVERALL CONDITION:	GOOD
Notes (Explain if answered No to any of the above) Needs backfill around riser

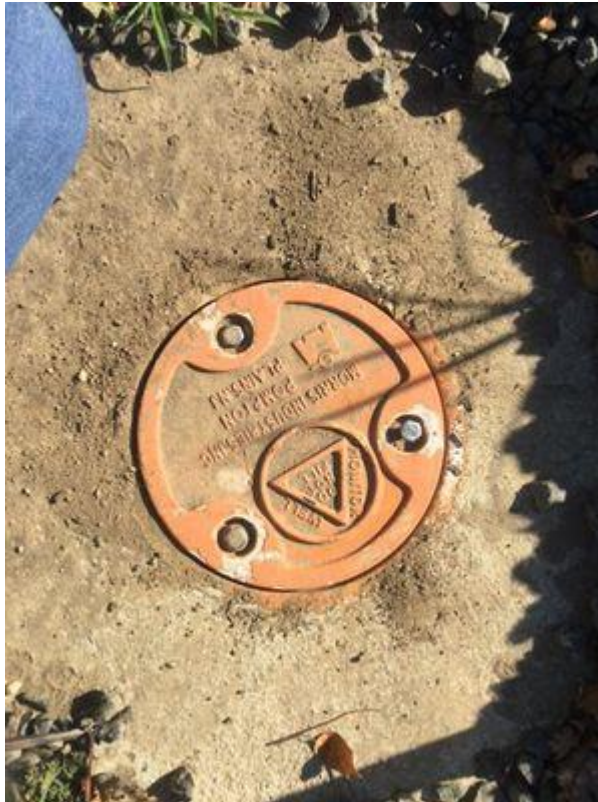
Client: Navy CLEAN	Facility: NWIRP Bethpage
Project Number: 112G08005-WE13	Location: Bethpage, New York
Date: September 1, 2022 16:40	Personnel: Jake Marlow
Well ID: BPS1-FW-MW0111	Well Location: 213996.4054 1124984.536
Well Status: In Use (Confirmed)	Screen Interval: 94-104
WELL INVENTORY CONDITION	
Concrete pad in acceptable condition i.e. no cracks?	YES
Manhole cover present and in working condition?	YES
All bolts on manhole present and not stripped?	NO
Well plug present, locked and in good working condition?	YES
OVERALL CONDITION:	GOOD
Notes (Explain if answered No to any of the above) Replaced one missing bolt

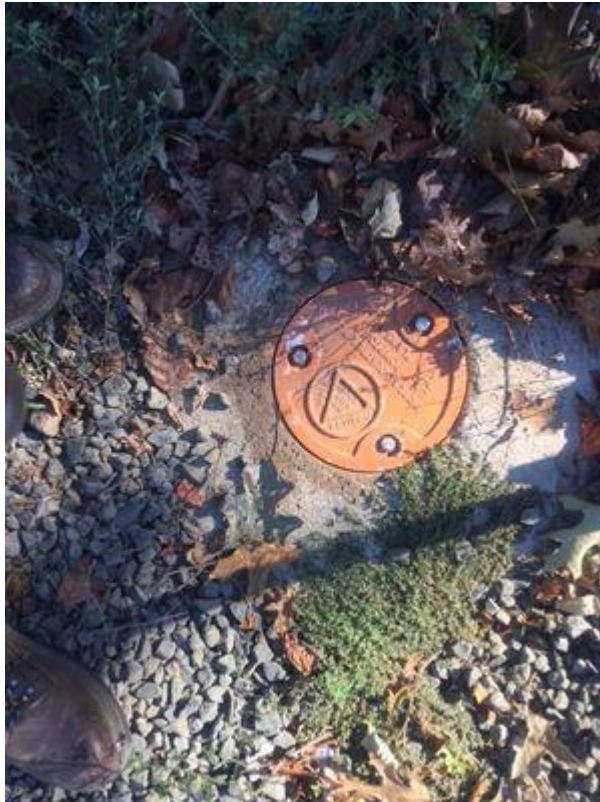
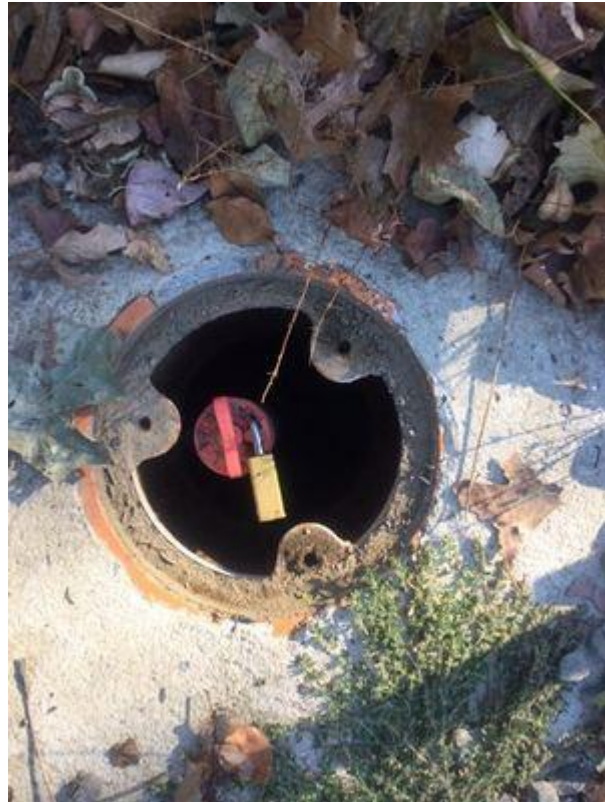
Client: Navy CLEAN	Facility: NWIRP Bethpage
Project Number: 112G08005-WE13	Location: Bethpage, New York
Date: September 1, 2022 16:35	Personnel: Jake Marlow
Well ID: BPS1-FW-MW01I2	Well Location: 213986.0153 1124981.7444
Well Status: In Use (Confirmed)	Screen Interval: 115-125
WELL INVENTORY CONDITION	
Concrete pad in acceptable condition i.e. no cracks?	YES
Manhole cover present and in working condition?	YES
All bolts on manhole present and not stripped?	NO
Well plug present, locked and in good working condition?	YES
OVERALL CONDITION:	GOOD
Notes (Explain if answered No to any of the above) Replaced one missing bolt

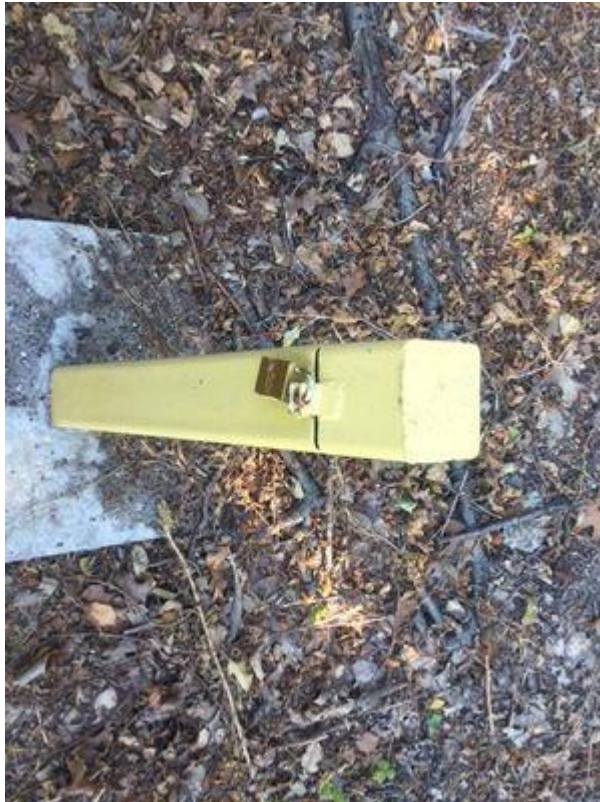
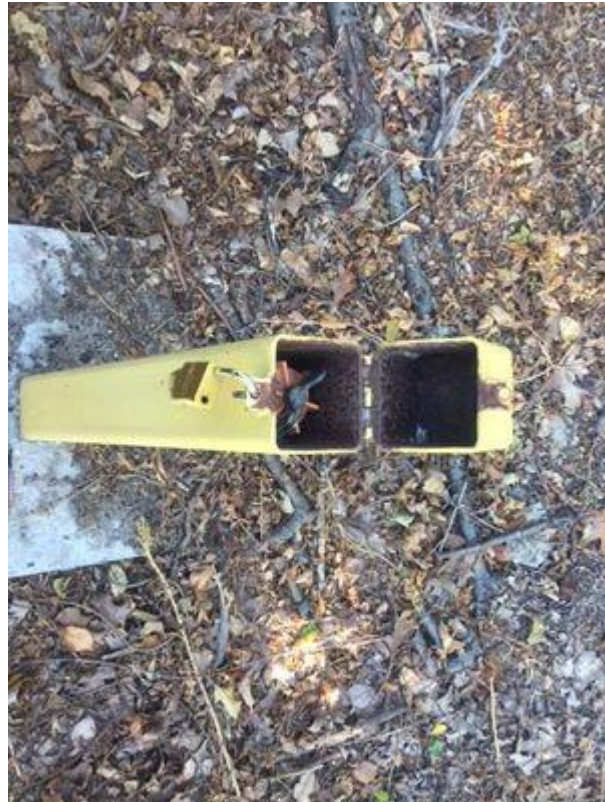
Client: Navy CLEAN	Facility: NWIRP Bethpage
Project Number: 112G08005-WE13	Location: Bethpage, New York
Date: September 1, 2022 17:07	Personnel: Jake Marlow
Well ID: BPS1FWMW03	Well Location: 213978.519 1124733.417
Well Status: In Use (Confirmed)	Screen Interval: 52-67
WELL INVENTORY CONDITION	
Concrete pad in acceptable condition i.e. no cracks?	YES
Manhole cover present and in working condition?	NO
All bolts on manhole present and not stripped?	NO
Well plug present, locked and in good working condition?	YES
OVERALL CONDITION:	GOOD
Notes (Explain if answered No to any of the above) Stickup

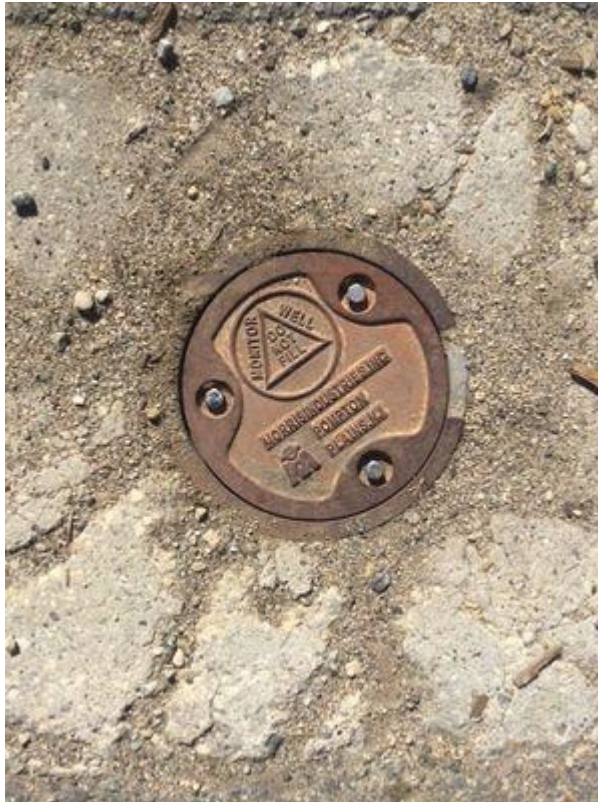
Client: Navy CLEAN	Facility: NWIRP Bethpage
Project Number: 112G08005-WE13	Location: Bethpage, New York
Date: September 1, 2022 15:50	Personnel: Jake Marlow
Well ID: BPS1-TT-MW301D	Well Location: 214562.648 1124880.908
Well Status: In Use (Confirmed)	Screen Interval: 210-220
WELL INVENTORY CONDITION	
Concrete pad in acceptable condition i.e. no cracks?	NO
Manhole cover present and in working condition?	YES
All bolts on manhole present and not stripped?	NO
Well plug present, locked and in good working condition?	YES
OVERALL CONDITION:	FAIR
Notes (Explain if answered No to any of the above) Replaced one missing bolt, cracks in pad

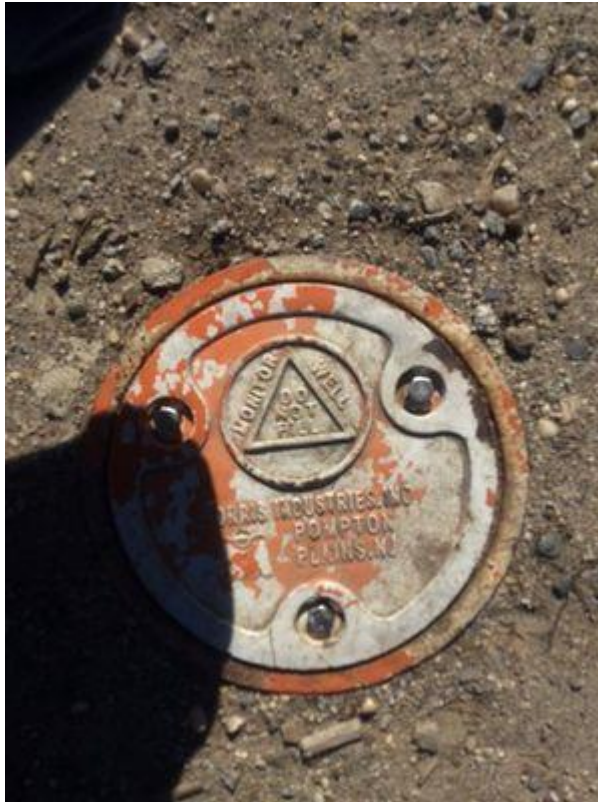
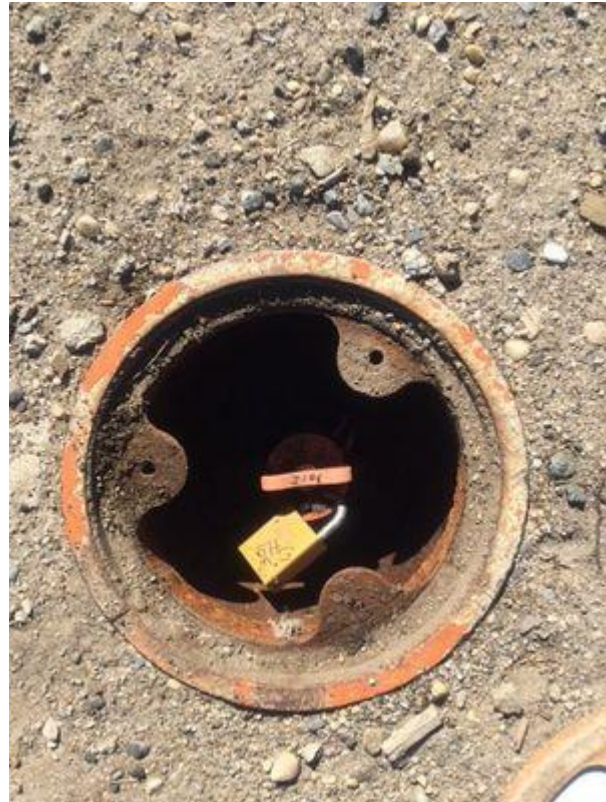
Client: Navy CLEAN	Facility: NWIRP Bethpage
Project Number: 112G08005-WE13	Location: Bethpage, New York
Date: September 1, 2022 15:45	Personnel: Jake Marlow
Well ID: BPS1-TT-MW301I	Well Location: 214566.279 1124906.201
Well Status: In Use (Confirmed)	Screen Interval: 130-140
WELL INVENTORY CONDITION	
Concrete pad in acceptable condition i.e. no cracks?	YES
Manhole cover present and in working condition?	YES
All bolts on manhole present and not stripped?	NO
Well plug present, locked and in good working condition?	YES
OVERALL CONDITION:	GOOD
Notes (Explain if answered No to any of the above) Replaced two bolts

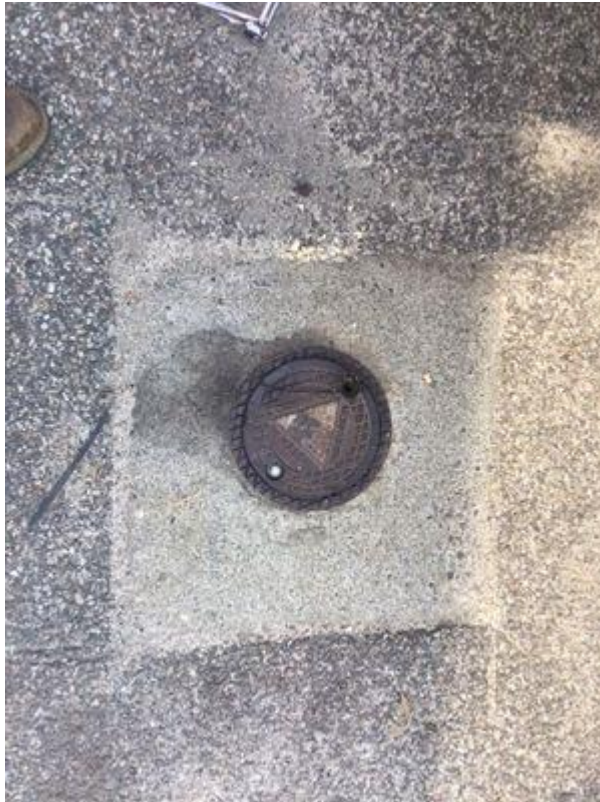
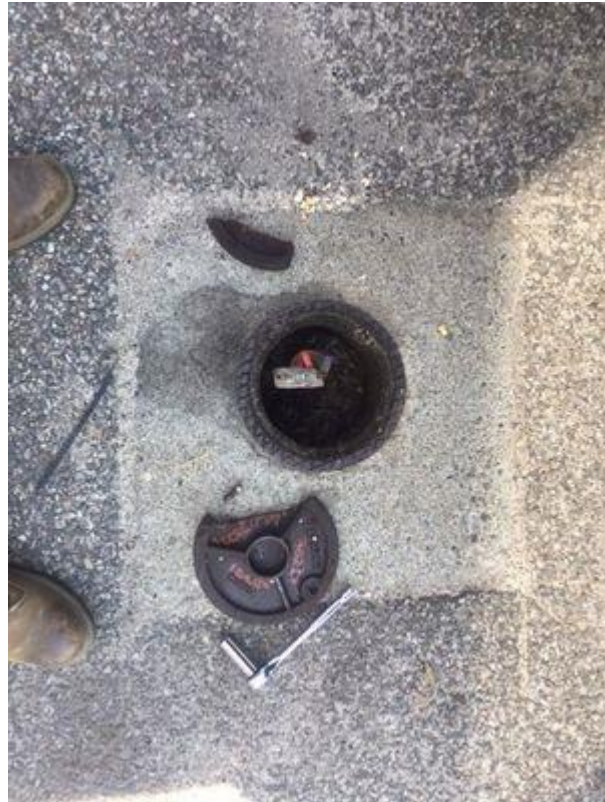
Client: Navy CLEAN	Facility: NWIRP Bethpage
Project Number: 112G08005-WE13	Location: Bethpage, New York
Date: September 16, 2022 14:41	Personnel: Jake Marlow
Well ID: BPS1-TT-MW30211	Well Location: 213812.87 1124251.046
Well Status: In Use (Confirmed)	Screen Interval: 110-120
WELL INVENTORY CONDITION	
Concrete pad in acceptable condition i.e. no cracks?	YES
Manhole cover present and in working condition?	NO
All bolts on manhole present and not stripped?	NO
Well plug present, locked and in good working condition?	YES
OVERALL CONDITION:	FAIR
Notes (Explain if answered No to any of the above) Manhole cover cracked and missing bolt

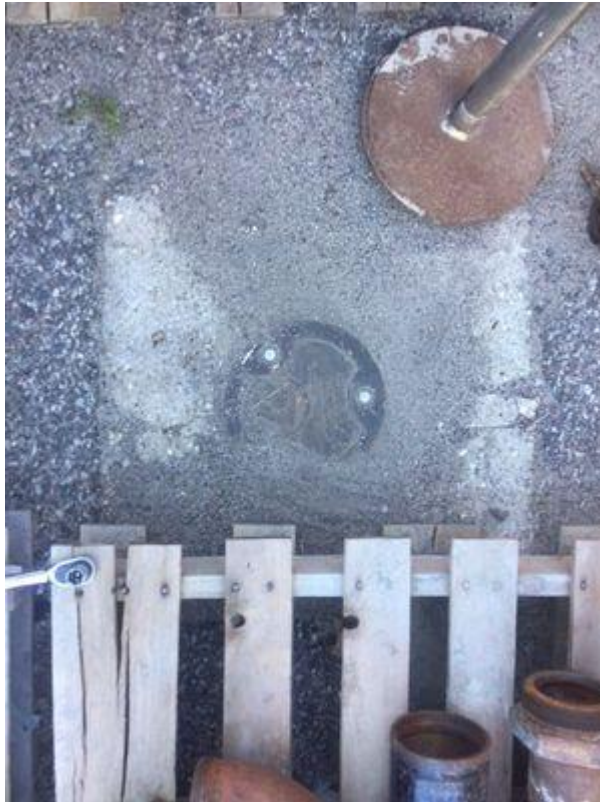
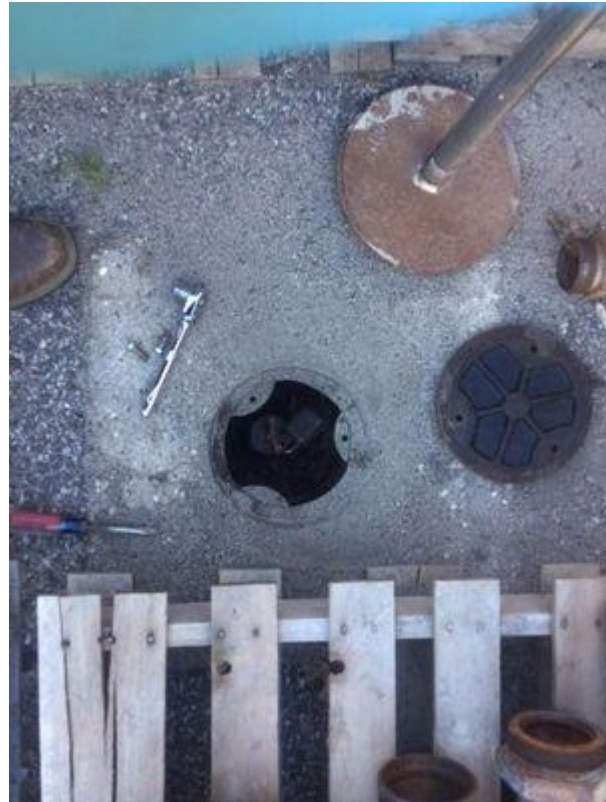
Client: Navy CLEAN	Facility: NWIRP Bethpage
Project Number: 112G08005-WE13	Location: Bethpage, New York
Date: September 2, 2022 08:28	Personnel: Jake Marlow
Well ID: BPS1-TT-MW30212	Well Location: 213813.43 1124241.215
Well Status: In Use (Confirmed)	Screen Interval: 140-150
WELL INVENTORY CONDITION	
Concrete pad in acceptable condition i.e. no cracks?	YES
Manhole cover present and in working condition?	YES
All bolts on manhole present and not stripped?	NO
Well plug present, locked and in good working condition?	YES
OVERALL CONDITION:	GOOD
Notes (Explain if answered No to any of the above) Replaced one missing bolt

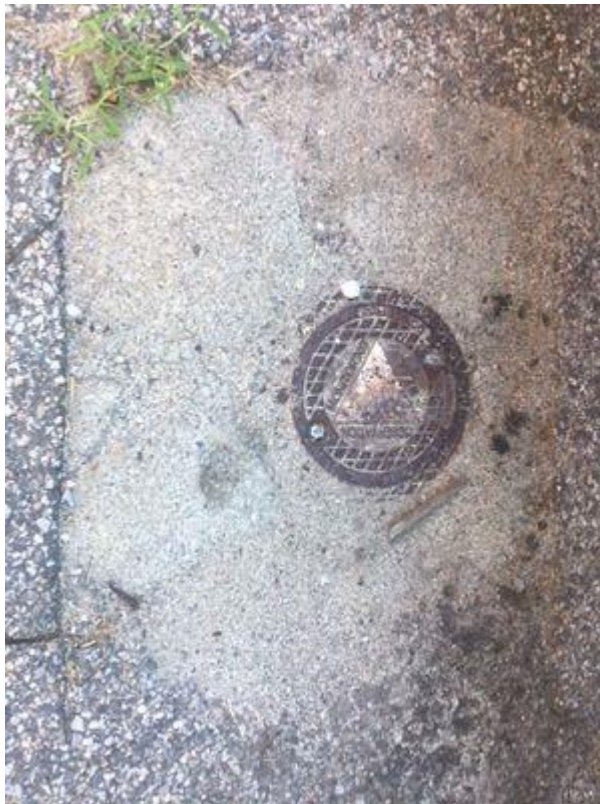
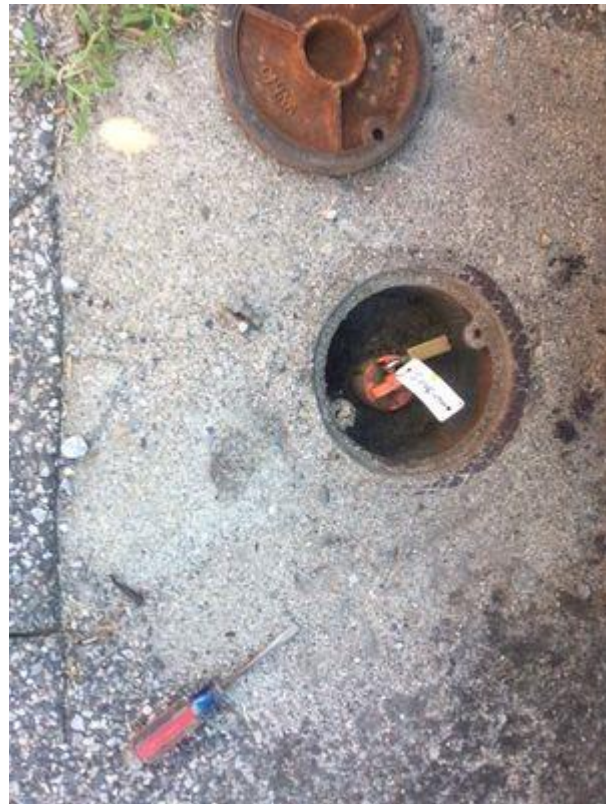
Client: Navy CLEAN	Facility: NWIRP Bethpage
Project Number: 112G08005-WE13	Location: Bethpage, New York
Date: September 2, 2022 08:23	Personnel: Jake Marlow
Well ID: BPS1-TT-MW302S	Well Location: 213812.671 1124261.772
Well Status: In Use (Confirmed)	Screen Interval: 41-51
WELL INVENTORY CONDITION	
Concrete pad in acceptable condition i.e. no cracks?	NO
Manhole cover present and in working condition?	YES
All bolts on manhole present and not stripped?	YES
Well plug present, locked and in good working condition?	YES
OVERALL CONDITION:	FAIR
Notes (Explain if answered No to any of the above) Cracked pad

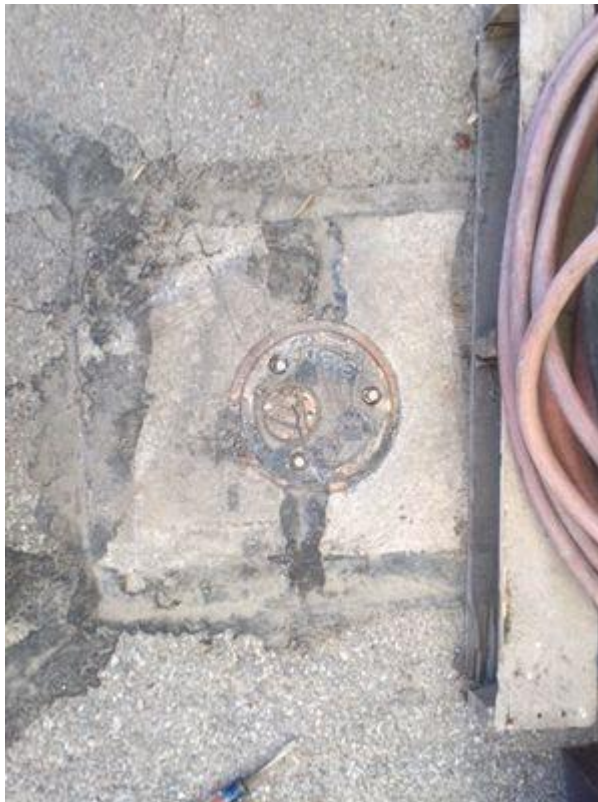
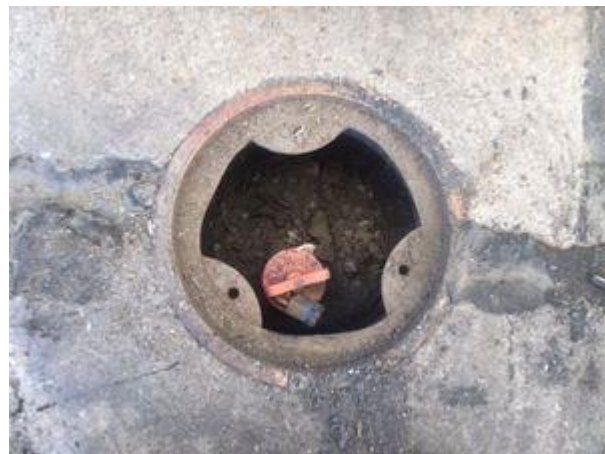
Client: Navy CLEAN	Facility: NWIRP Bethpage
Project Number: 112G08005-WE13	Location: Bethpage, New York
Date: September 2, 2022 08:05	Personnel: Jake Marlow
Well ID: BPS1-TT-MW303D	Well Location: 213779.29 1124550.691
Well Status: In Use (Confirmed)	Screen Interval: 208-218
WELL INVENTORY CONDITION	
Concrete pad in acceptable condition i.e. no cracks?	NO
Manhole cover present and in working condition?	YES
All bolts on manhole present and not stripped?	YES
Well plug present, locked and in good working condition?	YES
OVERALL CONDITION:	FAIR
Notes (Explain if answered No to any of the above) Cracked pad
