Memorandum

To: Scot Sokolowski, NAVFAC MIDLANT
From: David Brayack, Tetra Tech
Date: November 17, 2022
Re: Annual LUC Inspection and Operation Summary Report: Sites 1, 2, 3, and 4 –
NWIRP Bethpage
Contract/CTO Number: N6247016D9008/WE16

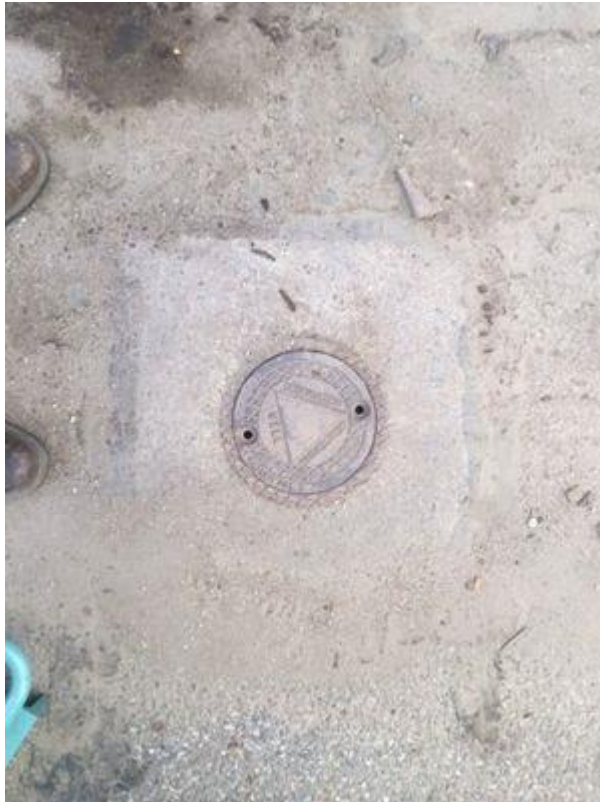
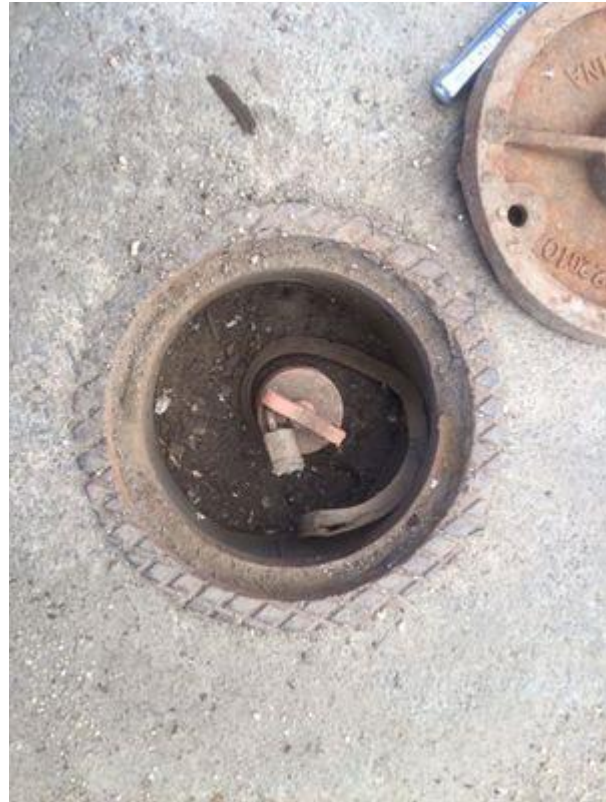
Client: Navy CLEAN	Facility: NWIRP Bethpage
Project Number: 112G08005-WE13	Location: Bethpage, New York
Date: September 2, 2022 08:09	Personnel: Jake Marlow
Well ID: BPS1-TT-MW303I2	Well Location: 213779.054 1124562.054
Well Status: In Use (Confirmed)	Screen Interval: 146-156
WELL INVENTORY CONDITION	
Concrete pad in acceptable condition i.e. no cracks?	YES
Manhole cover present and in working condition?	NO
All bolts on manhole present and not stripped?	NO
Well plug present, locked and in good working condition?	YES
OVERALL CONDITION:	FAIR
Notes (Explain if answered No to any of the above) Missing bolts, manhole is broken where bolts screw into it

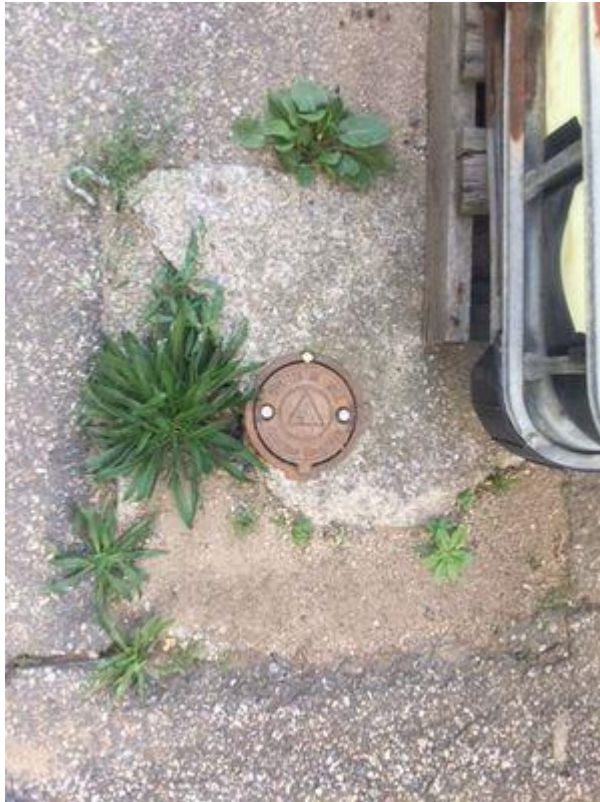
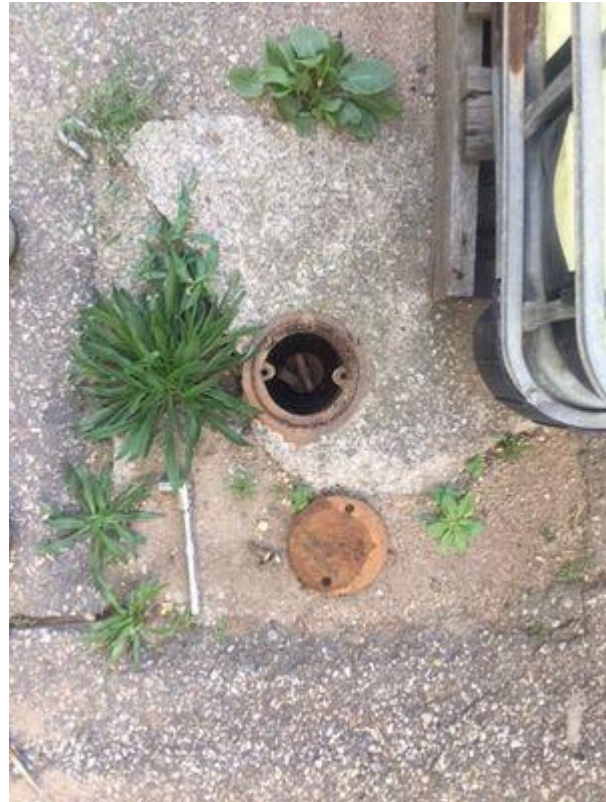
Client: Navy CLEAN	Facility: NWIRP Bethpage
Project Number: 112G08005-WE13	Location: Bethpage, New York
Date: September 2, 2022 08:18	Personnel: Jake Marlow
Well ID: BPS1-TT-MW303S	Well Location: 213778.188 1124583.496
Well Status: In Use (Confirmed)	Screen Interval: 46-56
WELL INVENTORY CONDITION	
Concrete pad in acceptable condition i.e. no cracks?	NO
Manhole cover present and in working condition?	YES
All bolts on manhole present and not stripped?	YES
Well plug present, locked and in good working condition?	YES
OVERALL CONDITION:	FAIR
Notes (Explain if answered No to any of the above) Cracked pad

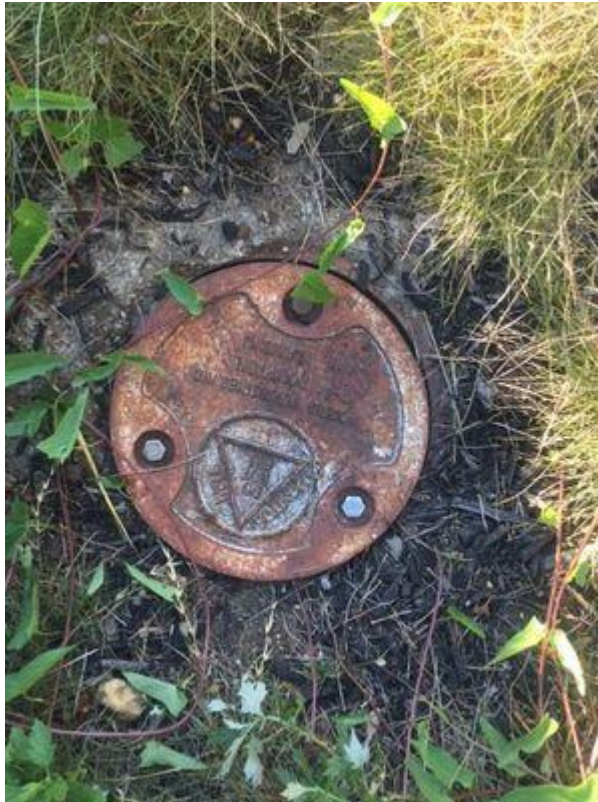
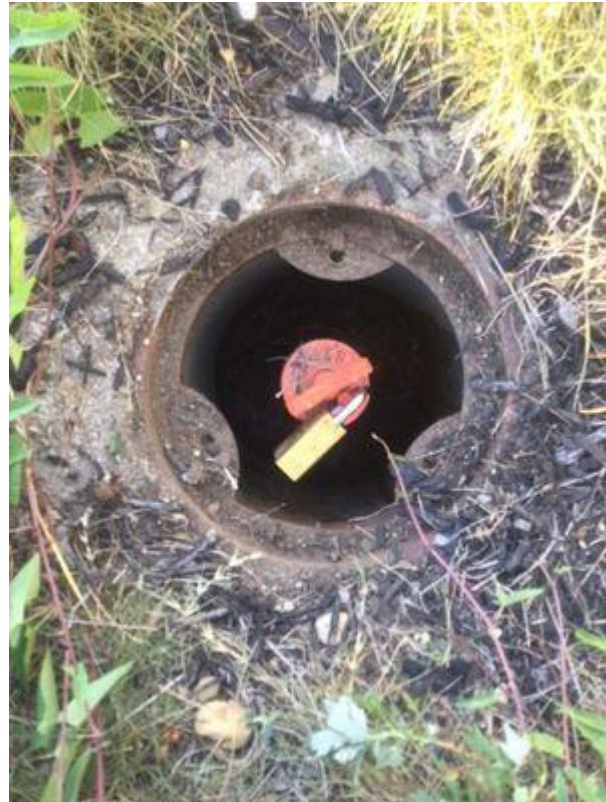
Client: Navy CLEAN	Facility: NWIRP Bethpage
Project Number: 112G08005-WE13	Location: Bethpage, New York
Date: September 1, 2022 18:26	Personnel: Jake Marlow
Well ID: BPS1-TT-MW304D	Well Location: 213692.271 1124994.753
Well Status: In Use (Confirmed)	Screen Interval: 180-190
WELL INVENTORY CONDITION	
Concrete pad in acceptable condition i.e. no cracks?	YES
Manhole cover present and in working condition?	YES
All bolts on manhole present and not stripped?	NO
Well plug present, locked and in good working condition?	YES
OVERALL CONDITION:	GOOD
Notes (Explain if answered No to any of the above) Replaced one missing bolt

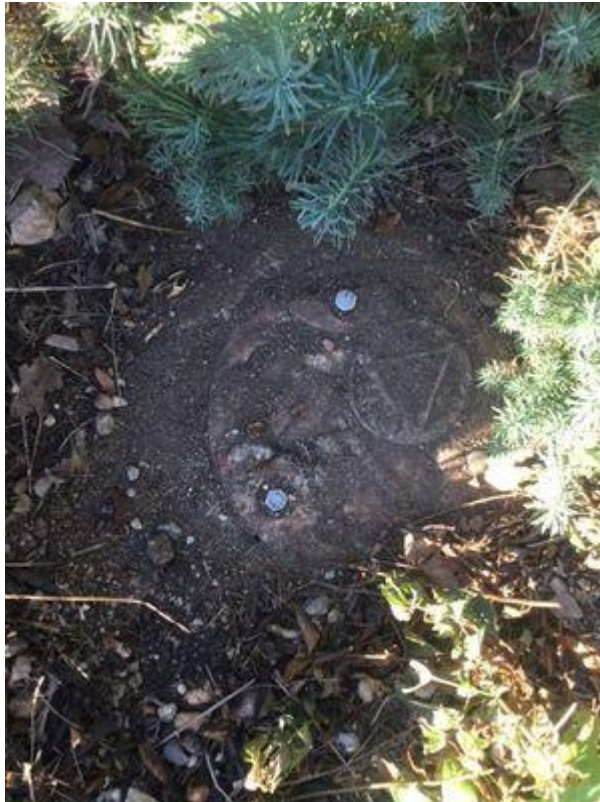
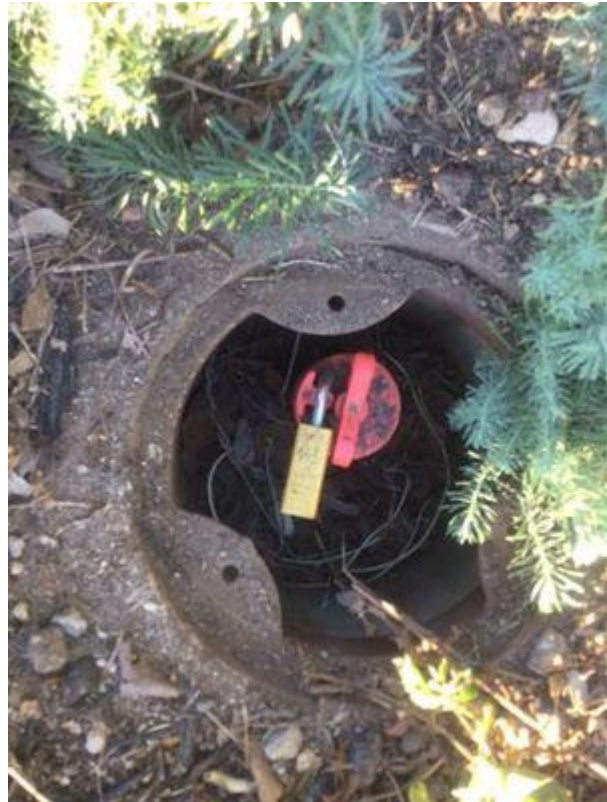
Client: Navy CLEAN	Facility: NWIRP Bethpage
Project Number: 112G08005-WE13	Location: Bethpage, New York
Date: September 1, 2022 18:18	Personnel: Jake Marlow
Well ID: BPS1-TT-MW30411	Well Location: 213717.1 1124995.715
Well Status: In Use (Confirmed)	Screen Interval: 102-112
WELL INVENTORY CONDITION	
Concrete pad in acceptable condition i.e. no cracks?	YES
Manhole cover present and in working condition?	YES
All bolts on manhole present and not stripped?	YES
Well plug present, locked and in good working condition?	YES
OVERALL CONDITION:	GOOD
Notes (Explain if answered No to any of the above)

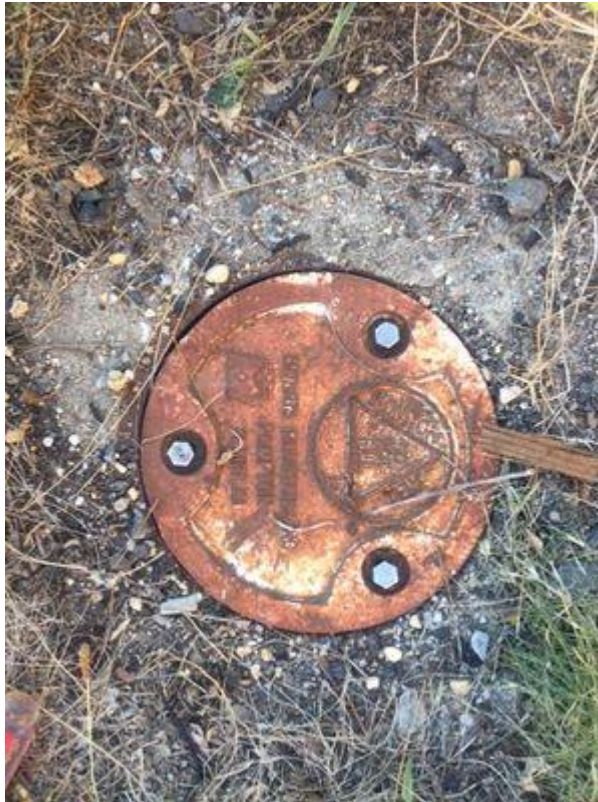
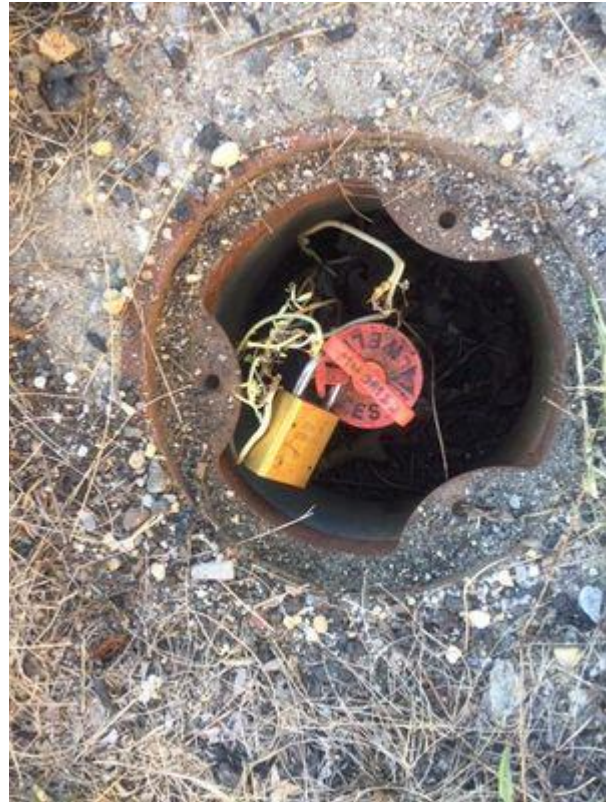
Client: Navy CLEAN	Facility: NWIRP Bethpage
Project Number: 112G08005-WE13	Location: Bethpage, New York
Date: September 1, 2022 18:22	Personnel: Jake Marlow
Well ID: BPS1-TT-MW30412	Well Location: 213705.436 1124989.868
Well Status: In Use (Confirmed)	Screen Interval: 140-150
WELL INVENTORY CONDITION	
Concrete pad in acceptable condition i.e. no cracks?	YES
Manhole cover present and in working condition?	YES
All bolts on manhole present and not stripped?	NO
Well plug present, locked and in good working condition?	YES
OVERALL CONDITION:	GOOD
Notes (Explain if answered No to any of the above) Replaced two missing bolts

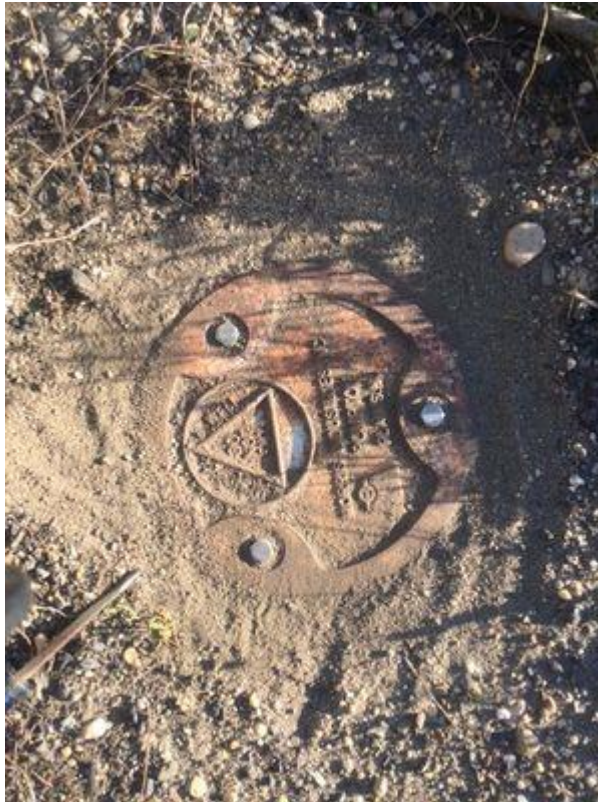
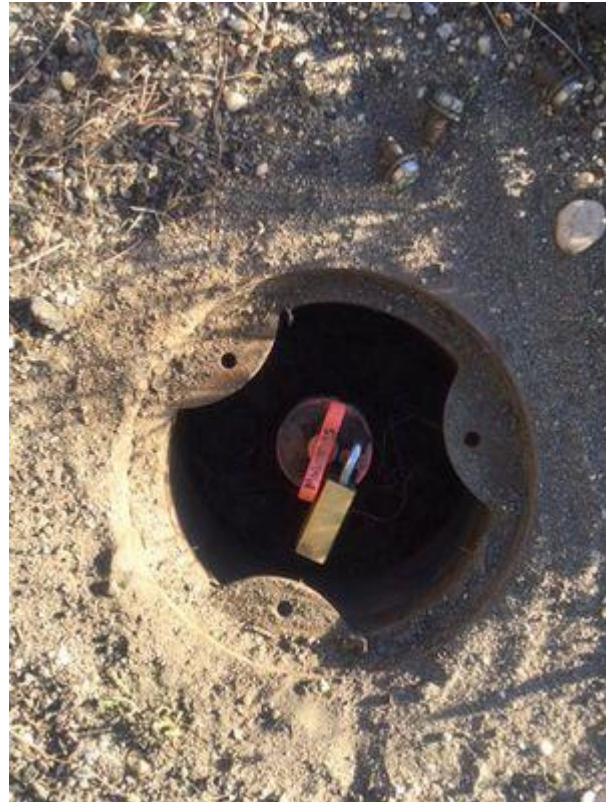
Client: Navy CLEAN	Facility: NWIRP Bethpage
Project Number: 112G08005-WE13	Location: Bethpage, New York
Date: September 1, 2022 18:13	Personnel: Jake Marlow
Well ID: BPS1-TT-MW304S	Well Location: 213728.252 1124991.233
Well Status: In Use (Confirmed)	Screen Interval: 43-53
WELL INVENTORY CONDITION	
Concrete pad in acceptable condition i.e. no cracks?	YES
Manhole cover present and in working condition?	YES
All bolts on manhole present and not stripped?	YES
Well plug present, locked and in good working condition?	YES
OVERALL CONDITION:	GOOD
Notes (Explain if answered No to any of the above)

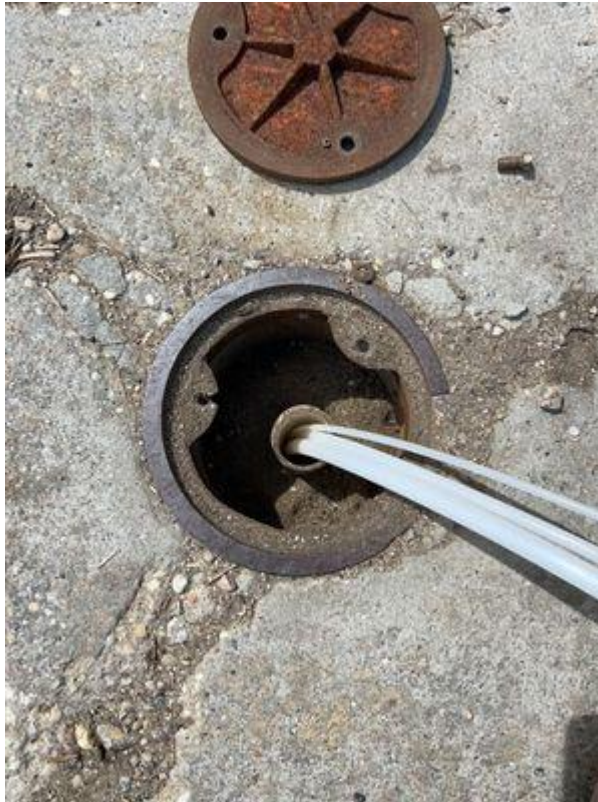
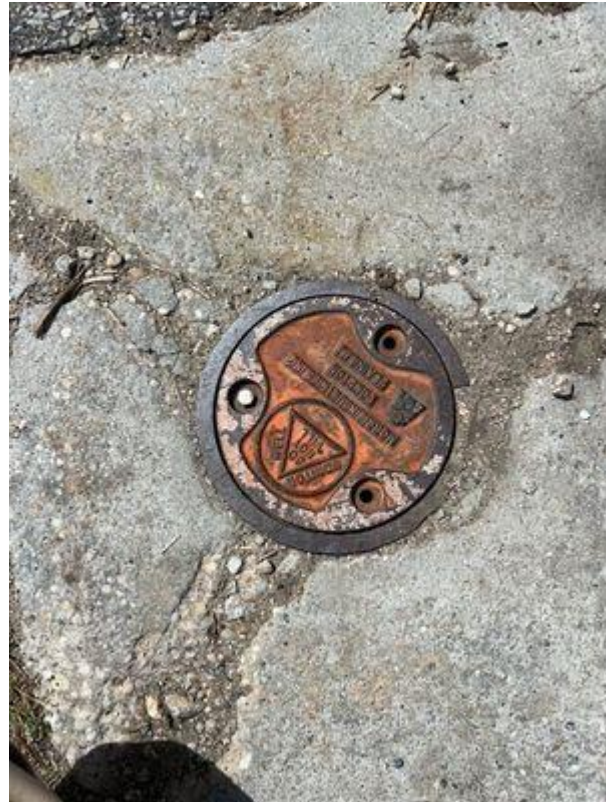
Client: Navy CLEAN	Facility: NWIRP Bethpage
Project Number: 112G08005-WE13	Location: Bethpage, New York
Date: August 15, 2022 11:30	Personnel: RJ Brydon
Well ID: BPS1-TT-MW305D	Well Location: 213405.975 1123949.183
Well Status: In Use (Confirmed)	Screen Interval: 286-296
WELL INVENTORY CONDITION	
Concrete pad in acceptable condition i.e. no cracks?	YES
Manhole cover present and in working condition?	YES
All bolts on manhole present and not stripped?	NO
Well plug present, locked and in good working condition?	YES
OVERALL CONDITION:	GOOD
Notes (Explain if answered No to any of the above) 2 bolts missing

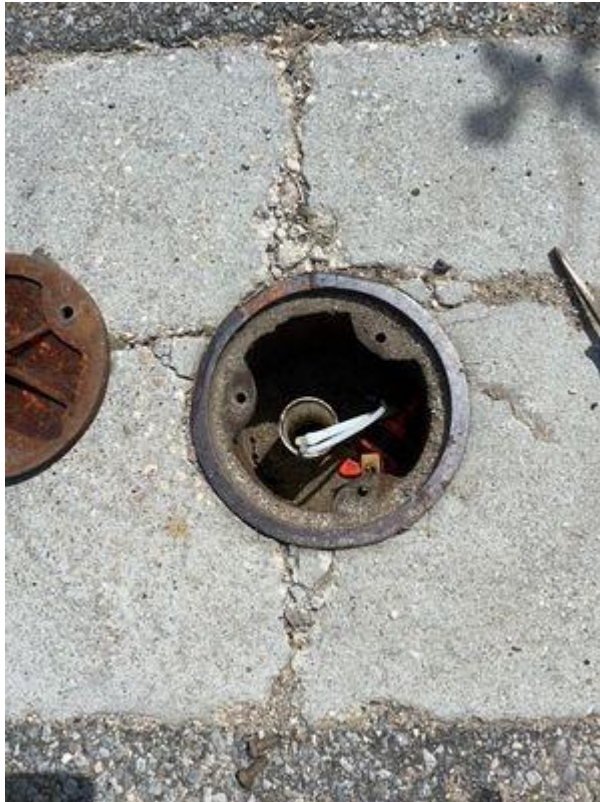
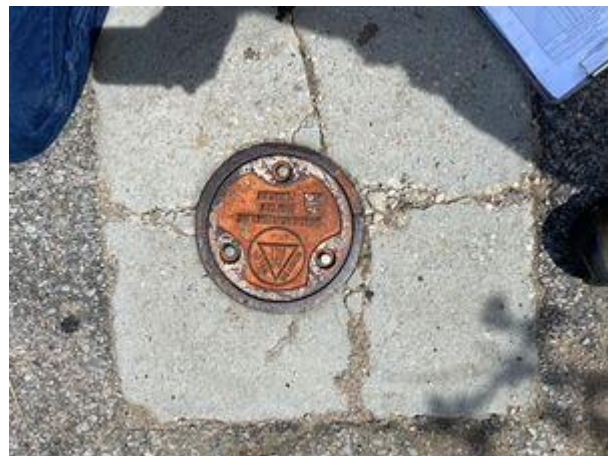
Client: Navy CLEAN	Facility: NWIRP Bethpage
Project Number: 112G08005-WE13	Location: Bethpage, New York
Date: August 15, 2022 11:27	Personnel: RJ Brydon
Well ID: BPS1-TT-MW305I	Well Location: 213408.557 1123939.487
Well Status: In Use (Confirmed)	Screen Interval: 190-200
WELL INVENTORY CONDITION	
Concrete pad in acceptable condition i.e. no cracks?	YES
Manhole cover present and in working condition?	YES
All bolts on manhole present and not stripped?	YES
Well plug present, locked and in good working condition?	YES
OVERALL CONDITION:	GOOD
Notes (Explain if answered No to any of the above)

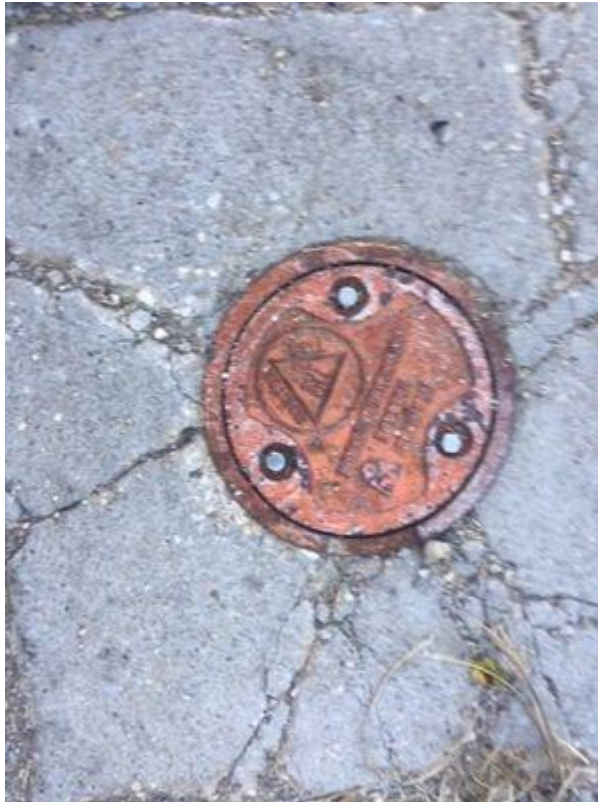
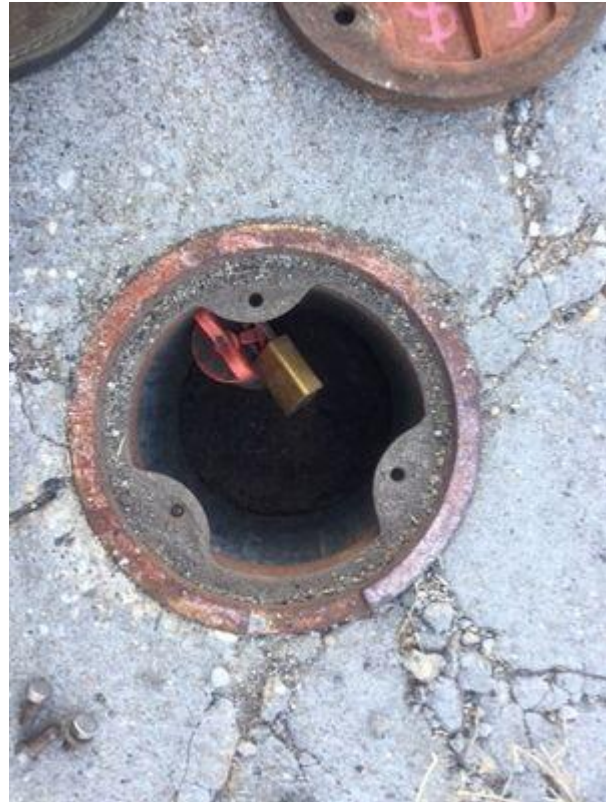
Client: Navy CLEAN	Facility: NWIRP Bethpage
Project Number: 112G08005-WE13	Location: Bethpage, New York
Date: September 1, 2022 18:51	Personnel: Jake Marlow
Well ID: BPS1-TT-MW305S	Well Location: 213411.021 1123930.127
Well Status: In Use (Confirmed)	Screen Interval: 40-50
WELL INVENTORY CONDITION	
Concrete pad in acceptable condition i.e. no cracks?	NO
Manhole cover present and in working condition?	YES
All bolts on manhole present and not stripped?	YES
Well plug present, locked and in good working condition?	YES
OVERALL CONDITION:	FAIR
Notes (Explain if answered No to any of the above) Cracks on pad

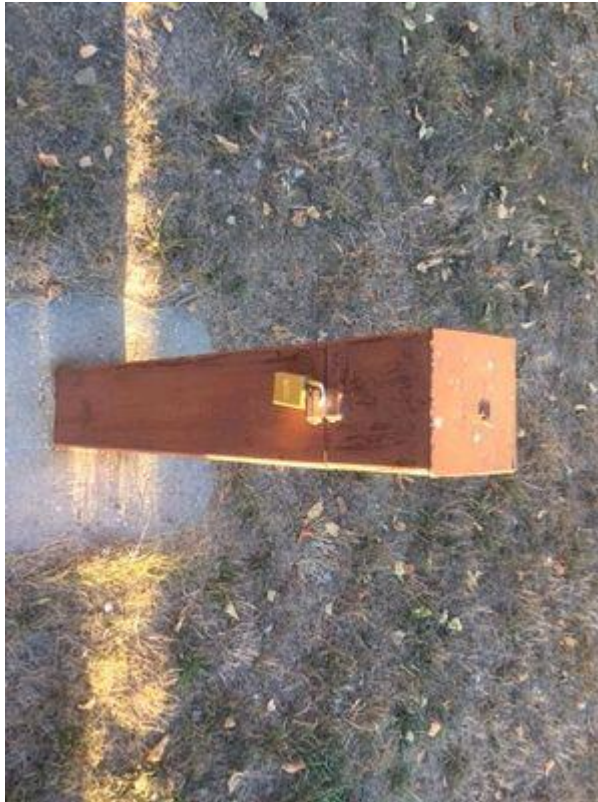
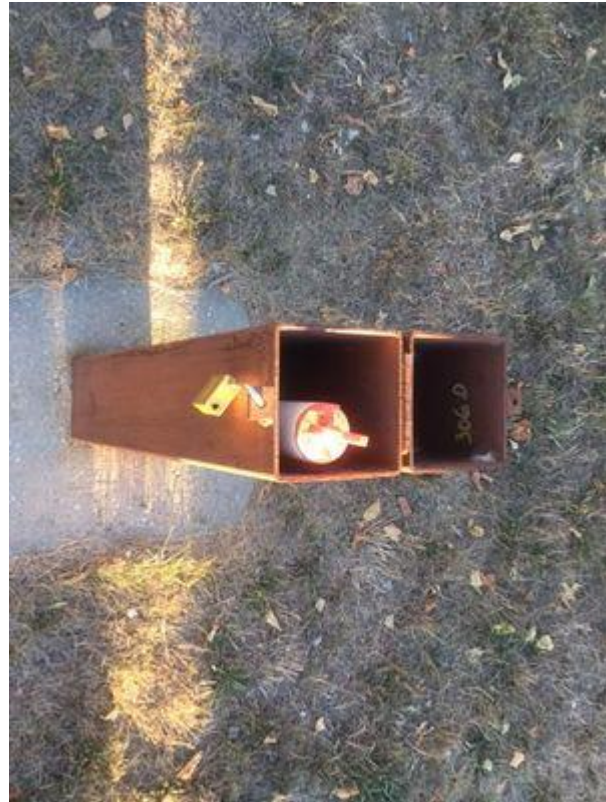
Client: Navy CLEAN	Facility: NWIRP Bethpage
Project Number: 112G08005-WE13	Location: Bethpage, New York
Date: September 1, 2022 18:42	Personnel: Jake Marlow
Well ID: BPS1-TT-MW306D	Well Location: 213380.799 1124409.899
Well Status: In Use (Confirmed)	Screen Interval: 284-294
WELL INVENTORY CONDITION	
Concrete pad in acceptable condition i.e. no cracks?	YES
Manhole cover present and in working condition?	NO
All bolts on manhole present and not stripped?	NO
Well plug present, locked and in good working condition?	YES
OVERALL CONDITION:	GOOD
Notes (Explain if answered No to any of the above) Stickup

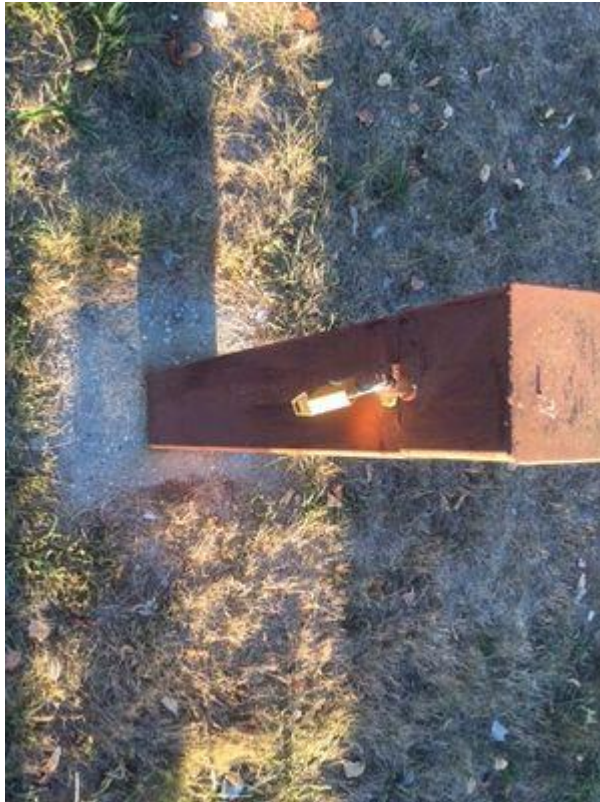
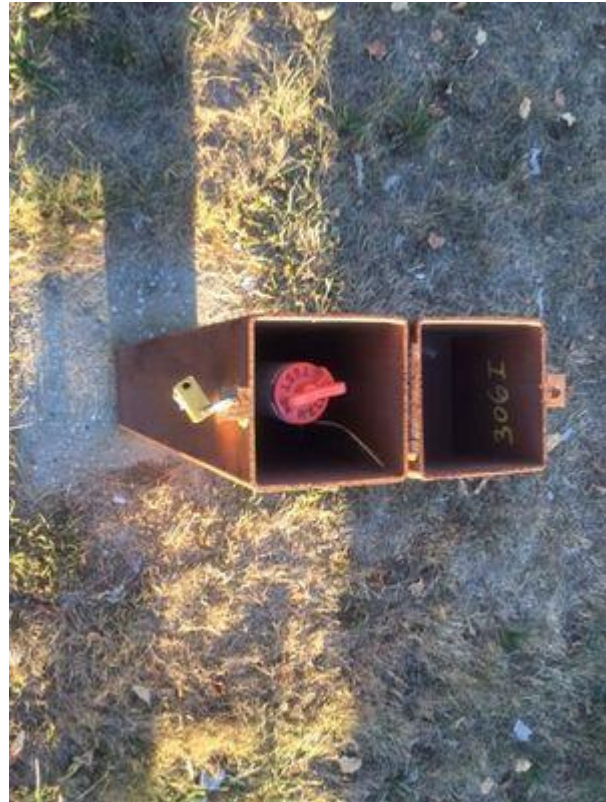
Client: Navy CLEAN	Facility: NWIRP Bethpage
Project Number: 112G08005-WE13	Location: Bethpage, New York
Date: September 1, 2022 18:45	Personnel: Jake Marlow
Well ID: BPS1-TT-MW306I	Well Location: 213382.124 1124399.458
Well Status: In Use (Confirmed)	Screen Interval: 189-199
WELL INVENTORY CONDITION	
Concrete pad in acceptable condition i.e. no cracks?	YES
Manhole cover present and in working condition?	NO
All bolts on manhole present and not stripped?	NO
Well plug present, locked and in good working condition?	YES
OVERALL CONDITION:	GOOD
Notes (Explain if answered No to any of the above) Stickup

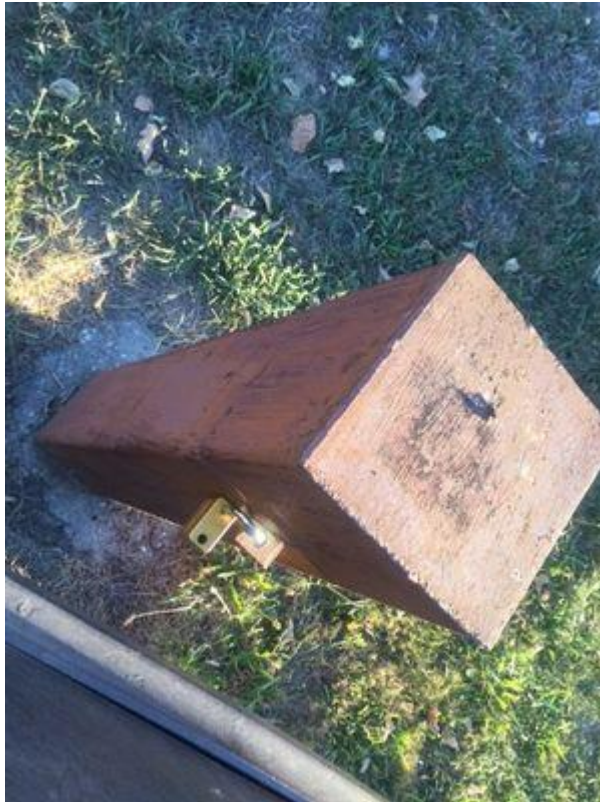
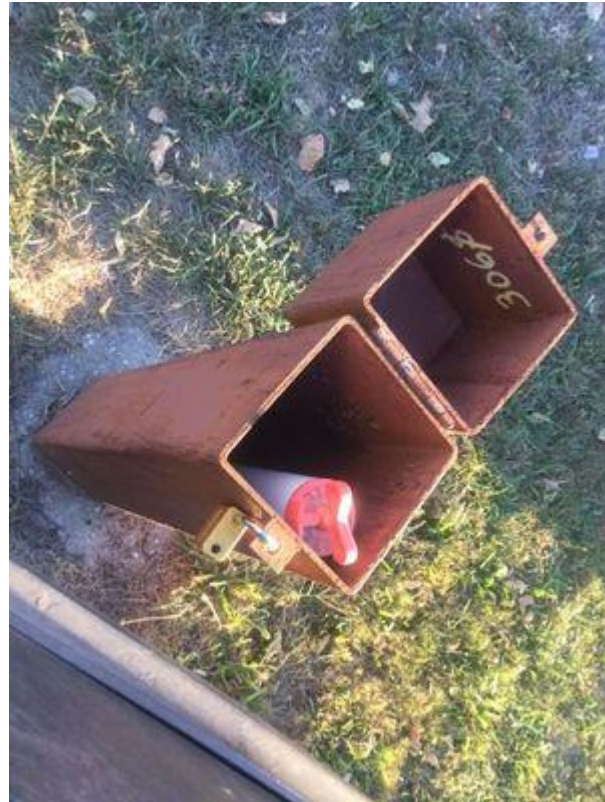
Client: Navy CLEAN	Facility: NWIRP Bethpage
Project Number: 112G08005-WE13	Location: Bethpage, New York
Date: September 1, 2022 18:47	Personnel: Jake Marlow
Well ID: BPS1-TT-MW306S	Well Location: 213383.55 1124387.814
Well Status: In Use (Confirmed)	Screen Interval: 50-60
WELL INVENTORY CONDITION	
Concrete pad in acceptable condition i.e. no cracks?	YES
Manhole cover present and in working condition?	NO
All bolts on manhole present and not stripped?	NO
Well plug present, locked and in good working condition?	YES
OVERALL CONDITION:	GOOD
Notes (Explain if answered No to any of the above) Stickup

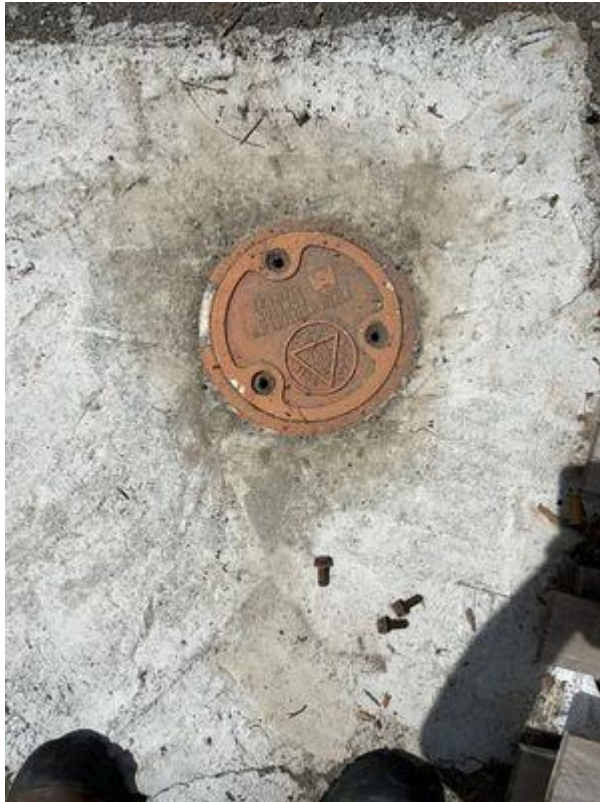
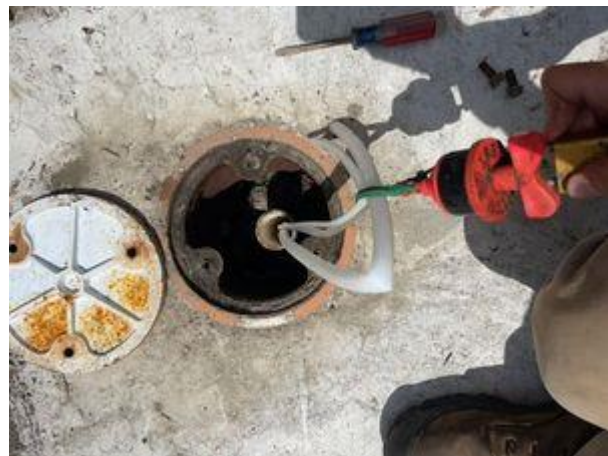
Client: Navy CLEAN	Facility: NWIRP Bethpage
Project Number: 112G08005-WE13	Location: Bethpage, New York
Date: August 15, 2022 12:29	Personnel: RJ Brydon
Well ID: BPS1-TT-MW307D	Well Location: 213357.307 1124926.918
Well Status: In Use (Confirmed)	Screen Interval: 276-286
WELL INVENTORY CONDITION	
Concrete pad in acceptable condition i.e. no cracks?	YES
Manhole cover present and in working condition?	YES
All bolts on manhole present and not stripped?	YES
Well plug present, locked and in good working condition?	YES
OVERALL CONDITION:	GOOD
Notes (Explain if answered No to any of the above)

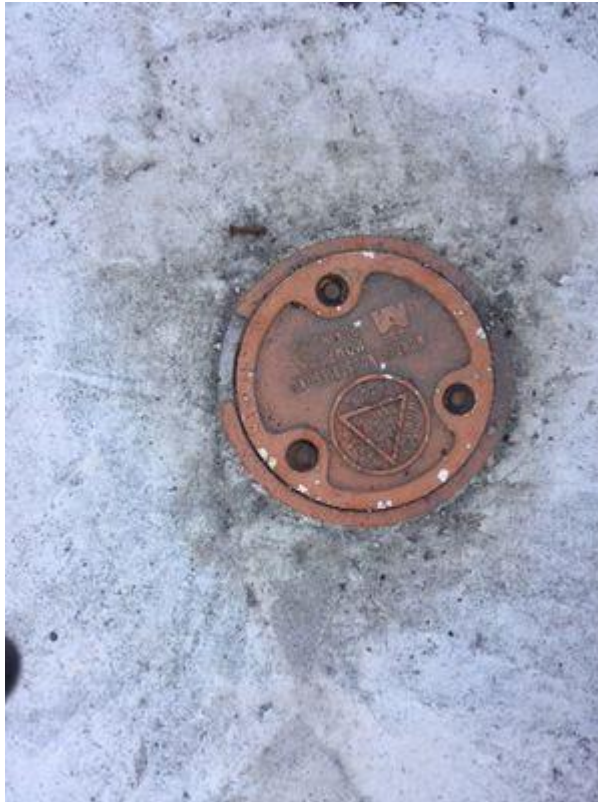
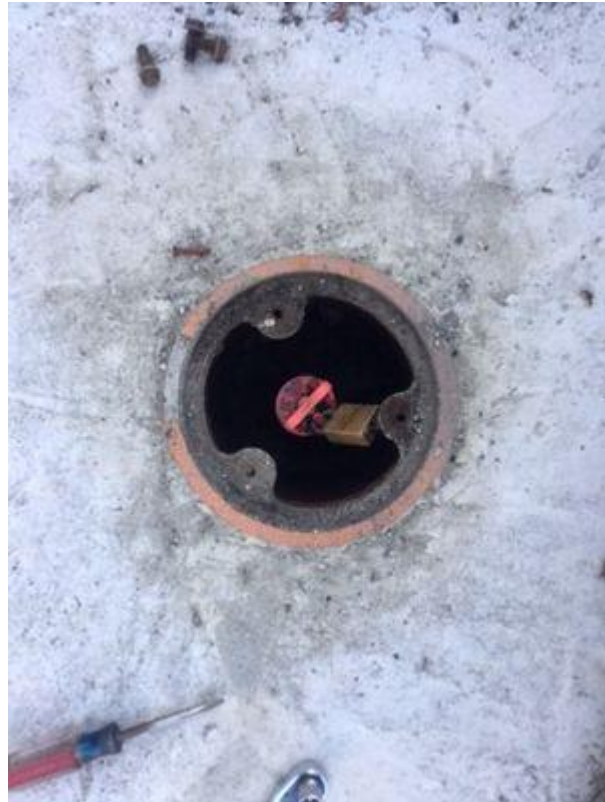
Client: Navy CLEAN	Facility: NWIRP Bethpage
Project Number: 112G08005-WE13	Location: Bethpage, New York
Date: September 1, 2022 18:32	Personnel: Jake Marlow
Well ID: BPS1-TT-MW307D	Well Location: 213357.307 1124926.918
Well Status: In Use (Confirmed)	Screen Interval: 276-286
WELL INVENTORY CONDITION	
Concrete pad in acceptable condition i.e. no cracks?	YES
Manhole cover present and in working condition?	YES
All bolts on manhole present and not stripped?	YES
Well plug present, locked and in good working condition?	YES
OVERALL CONDITION:	FAIR
Notes (Explain if answered No to any of the above)

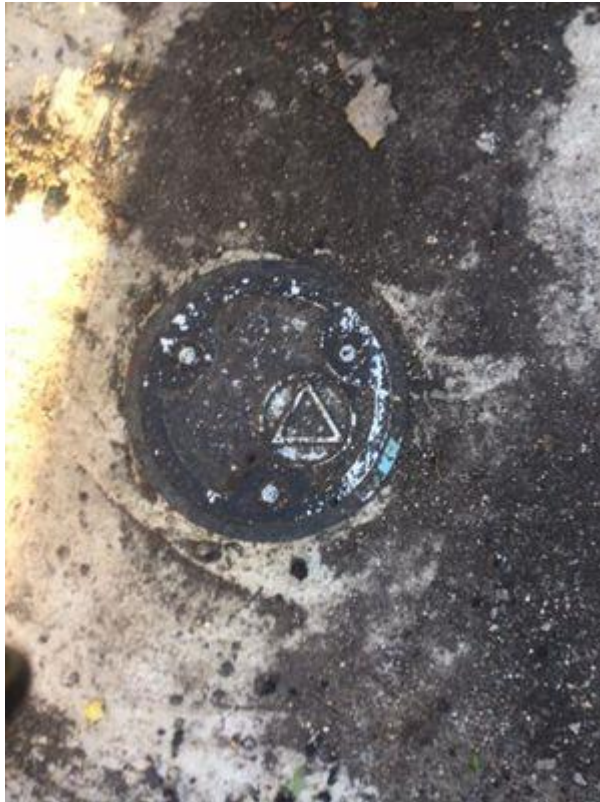
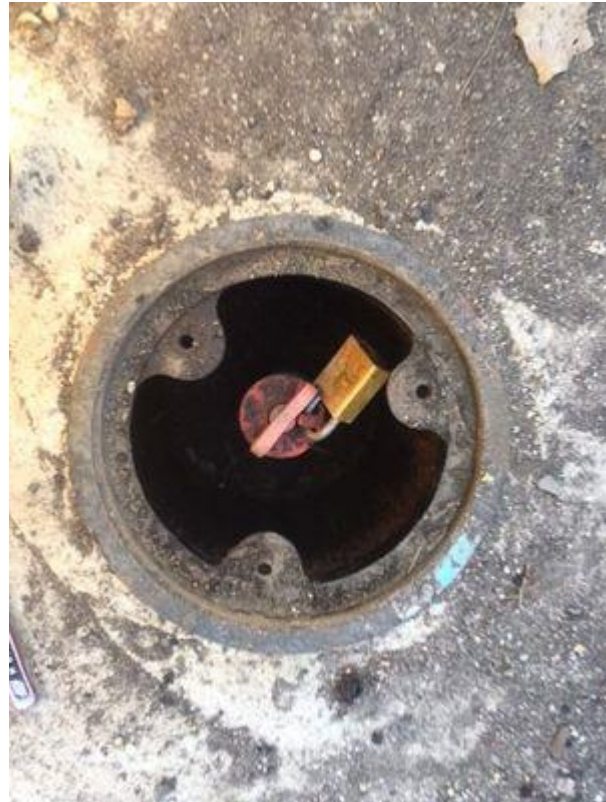
Client: Navy CLEAN	Facility: NWIRP Bethpage
Project Number: 112G08005-WE13	Location: Bethpage, New York
Date: September 1, 2022 18:35	Personnel: Jake Marlow
Well ID: BPS1-TT-MW3071	Well Location: 213353.775 1124914.838
Well Status: In Use (Confirmed)	Screen Interval: 188-198
WELL INVENTORY CONDITION	
Concrete pad in acceptable condition i.e. no cracks?	YES
Manhole cover present and in working condition?	YES
All bolts on manhole present and not stripped?	YES
Well plug present, locked and in good working condition?	YES
OVERALL CONDITION:	GOOD
Notes (Explain if answered No to any of the above)

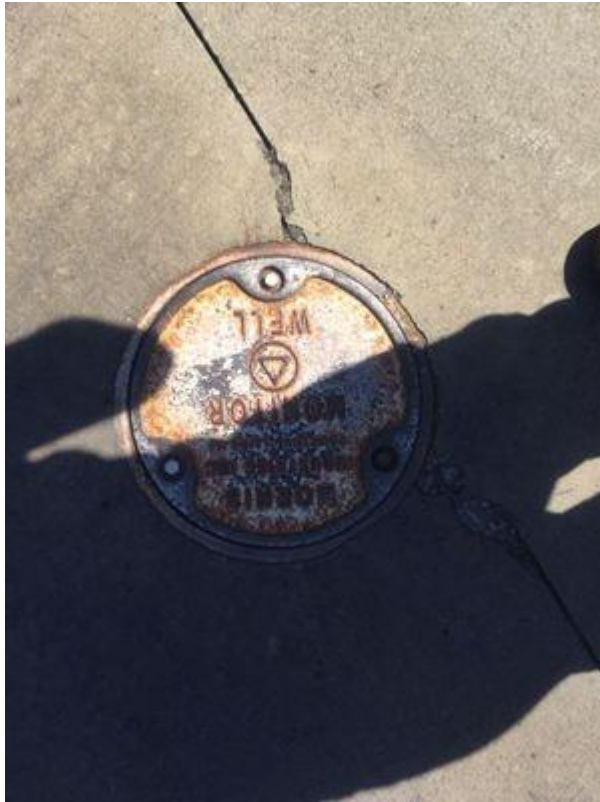
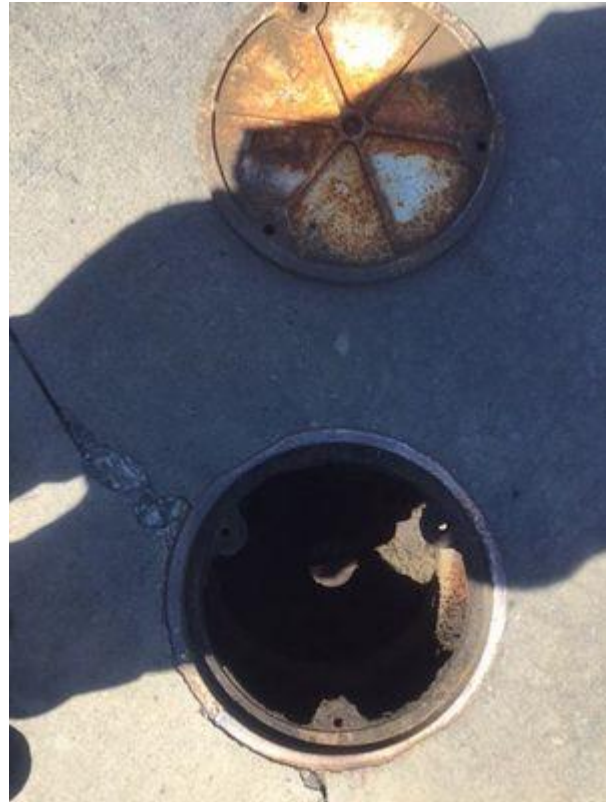
Client: Navy CLEAN	Facility: NWIRP Bethpage
Project Number: 112G08005-WE13	Location: Bethpage, New York
Date: September 1, 2022 13:27	Personnel: Jake Marlow
Well ID: BPS1-TT-MW308D	Well Location: 214965.9 1124935.6
Well Status: In Use (Confirmed)	Screen Interval: 250-260
WELL INVENTORY CONDITION	
Concrete pad in acceptable condition i.e. no cracks?	NO
Manhole cover present and in working condition?	YES
All bolts on manhole present and not stripped?	YES
Well plug present, locked and in good working condition?	YES
OVERALL CONDITION:	FAIR
Notes (Explain if answered No to any of the above) Crack in pad

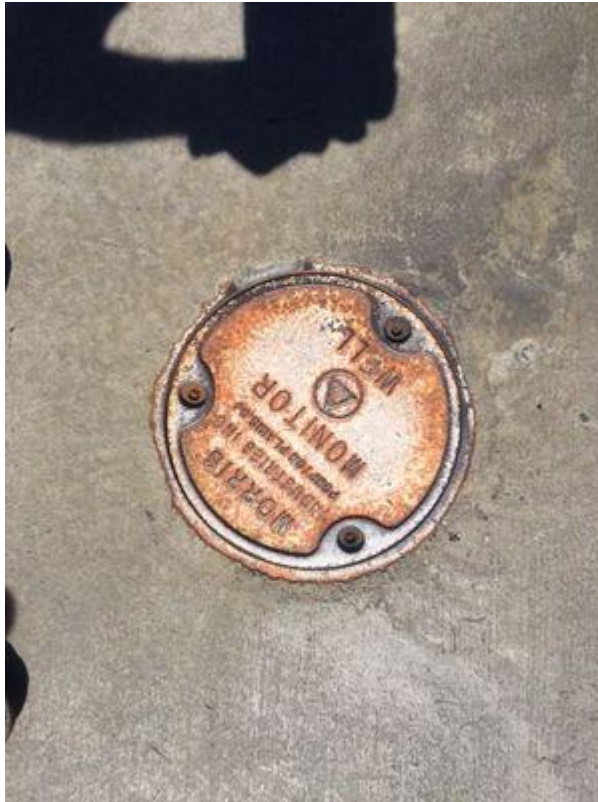
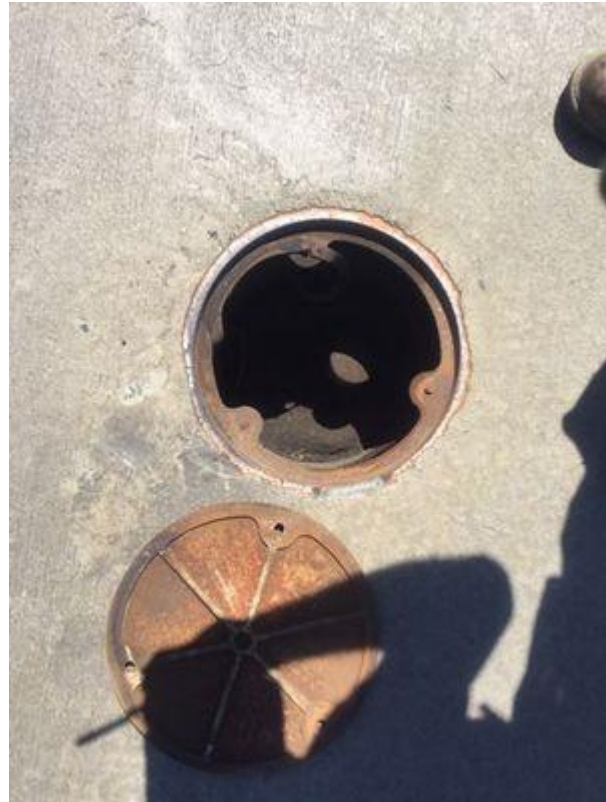
Client: Navy CLEAN	Facility: NWIRP Bethpage
Project Number: 112G08005-WE13	Location: Bethpage, New York
Date: September 1, 2022 13:23	Personnel: Jake Marlow
Well ID: BPS1-TT-MW308I	Well Location: 214972.2 1124923.7
Well Status: In Use (Confirmed)	Screen Interval: 156-166
WELL INVENTORY CONDITION	
Concrete pad in acceptable condition i.e. no cracks?	YES
Manhole cover present and in working condition?	YES
All bolts on manhole present and not stripped?	NO
Well plug present, locked and in good working condition?	YES
OVERALL CONDITION:	FAIR
Notes (Explain if answered No to any of the above) Bolts sheared

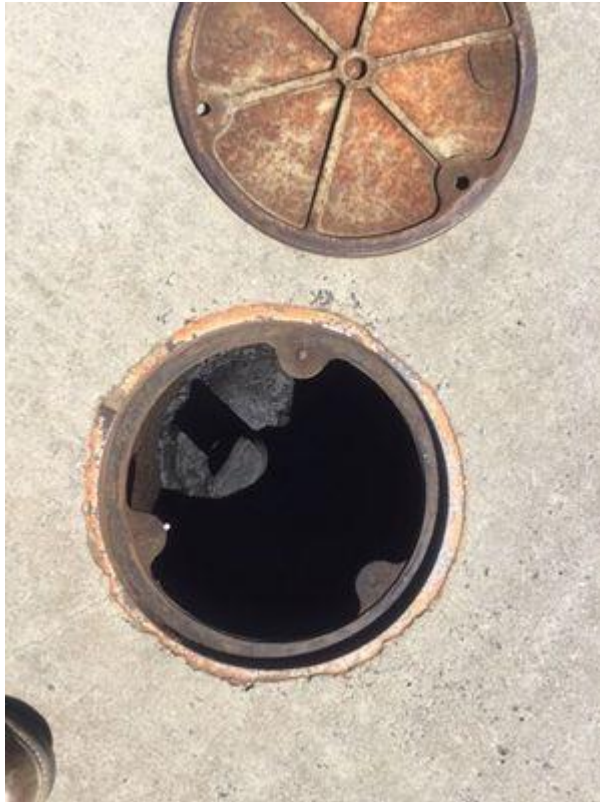
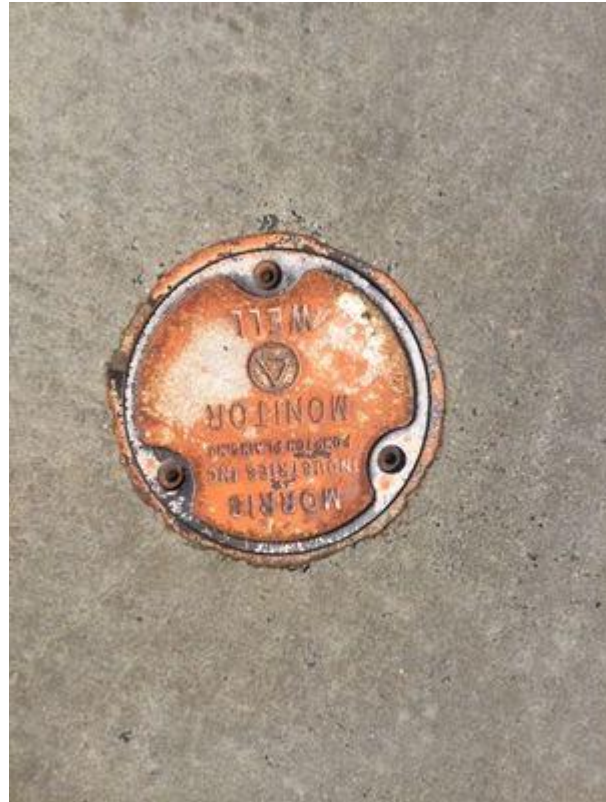
Client: Navy CLEAN	Facility: NWIRP Bethpage
Project Number: 112G08005-WE13	Location: Bethpage, New York
Date: September 1, 2022 13:18	Personnel: RJ Brydon
Well ID: BPS1-TT-MW308S	Well Location: 214977.9 1124910.2
Well Status: In Use (Confirmed)	Screen Interval: 54-64
WELL INVENTORY CONDITION	
Concrete pad in acceptable condition i.e. no cracks?	YES
Manhole cover present and in working condition?	YES
All bolts on manhole present and not stripped?	NO
Well plug present, locked and in good working condition?	YES
OVERALL CONDITION:	FAIR
Notes (Explain if answered No to any of the above) Bolts sheared

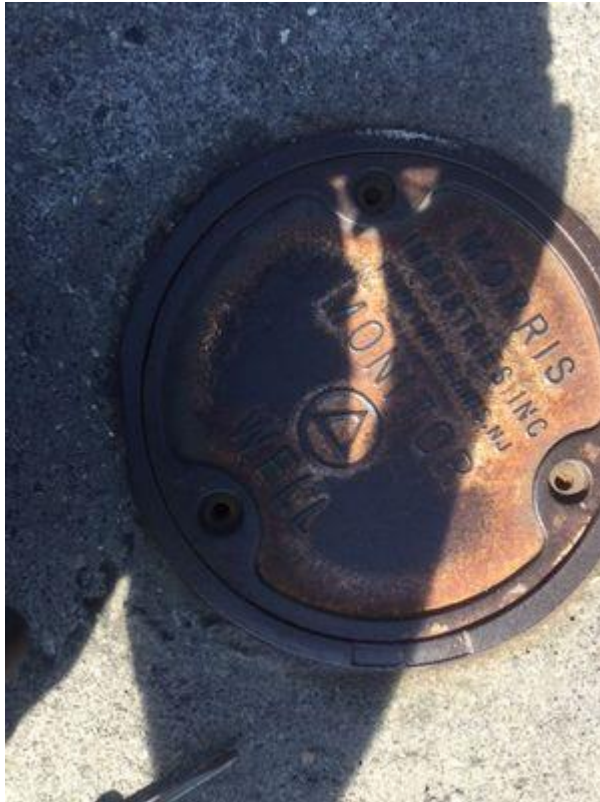
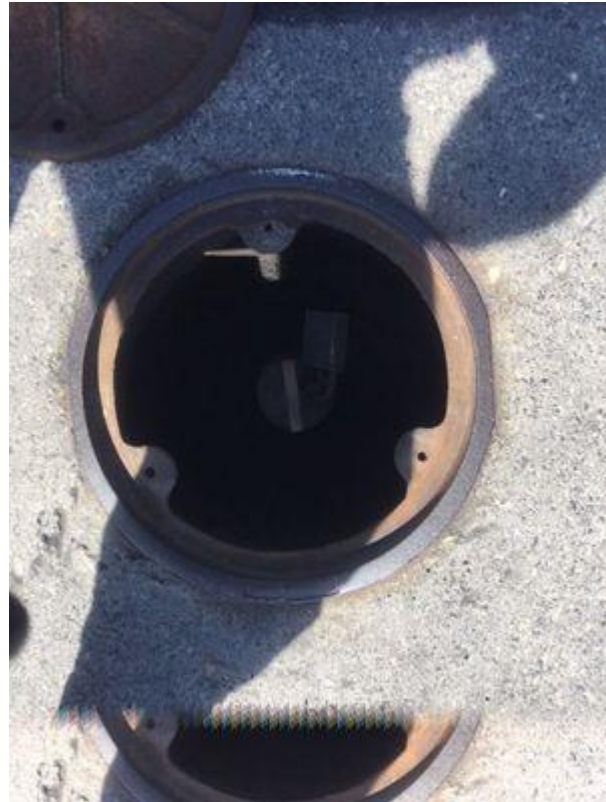
Client: Navy CLEAN	Facility: NWIRP Bethpage
Project Number: 112G08005-WE13	Location: Bethpage, New York
Date: September 1, 2022 14:25	Personnel: Jake Marlow
Well ID: BPS1-TT-MW309D	Well Location: 215208.441 1125028.421
Well Status: In Use (Confirmed)	Screen Interval: 252-262
WELL INVENTORY CONDITION	
Concrete pad in acceptable condition i.e. no cracks?	YES
Manhole cover present and in working condition?	NO
All bolts on manhole present and not stripped?	NO
Well plug present, locked and in good working condition?	YES
OVERALL CONDITION:	FAIR
Notes (Explain if answered No to any of the above) No Bolts; manhole cover does not align w/ manhole to place bolts in

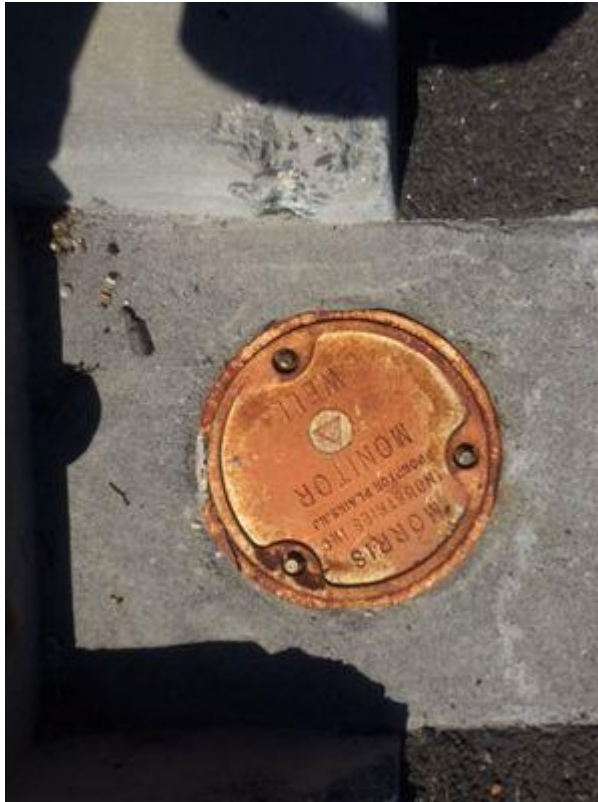
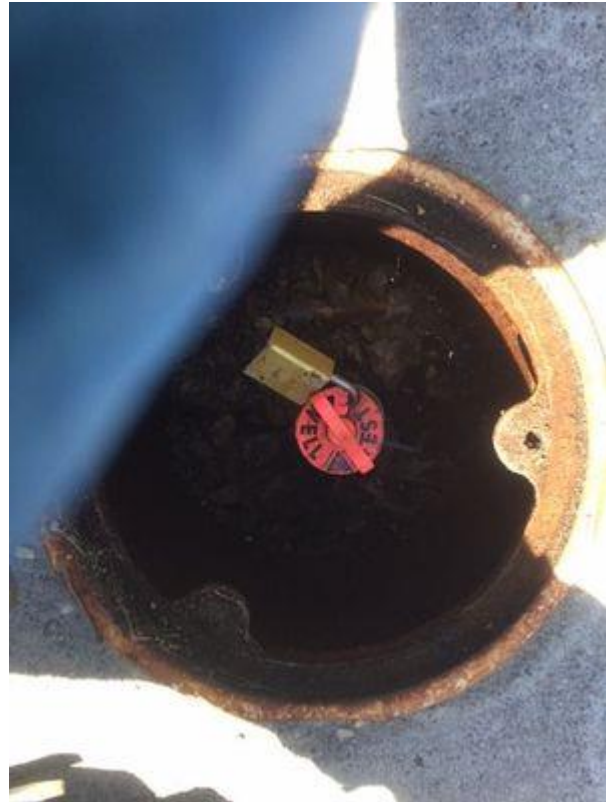
Client: Navy CLEAN	Facility: NWIRP Bethpage
Project Number: 112G08005-WE13	Location: Bethpage, New York
Date: September 1, 2022 14:19	Personnel: Jake Marlow
Well ID: BPS1-TT-MW309I	Well Location: 215209.932 1125016.144
Well Status: In Use (Confirmed)	Screen Interval: 160-170
WELL INVENTORY CONDITION	
Concrete pad in acceptable condition i.e. no cracks?	YES
Manhole cover present and in working condition?	YES
All bolts on manhole present and not stripped?	YES
Well plug present, locked and in good working condition?	YES
OVERALL CONDITION:	GOOD
Notes (Explain if answered No to any of the above)
