Memorandum

To: Scot Sokolowski, NAVFAC MIDLANT
From: David Brayack, Tetra Tech
Date: November 17, 2022
Re: Annual LUC Inspection and Operation Summary Report: Sites 1, 2, 3, and 4 –
NWIRP Bethpage
Contract/CTO Number: N6247016D9008/WE16

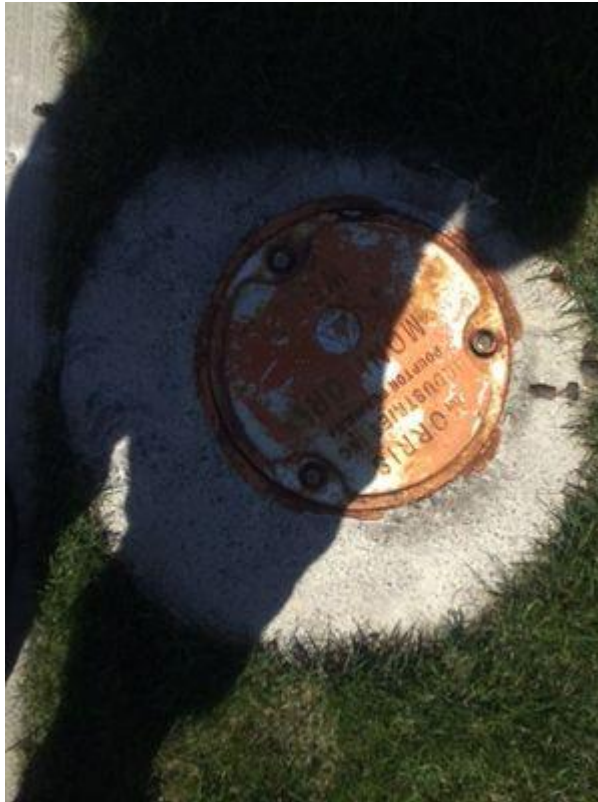
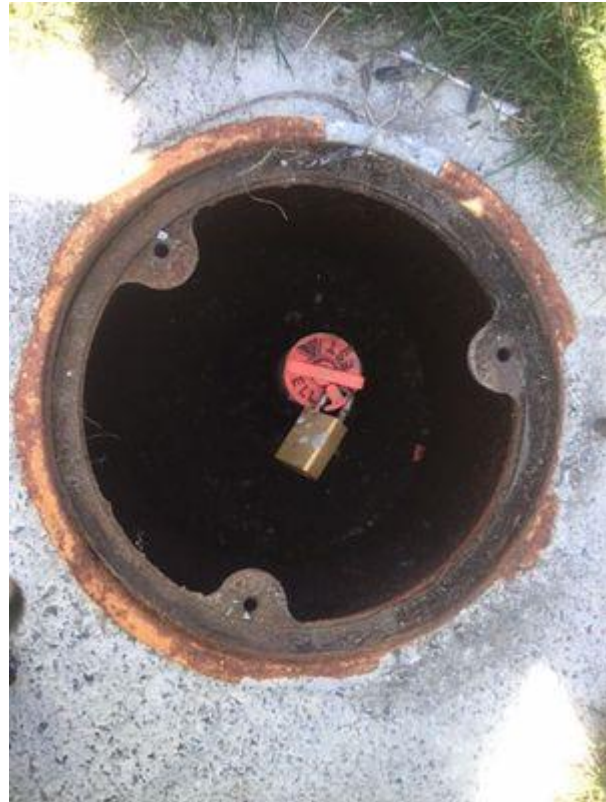
Client: Navy CLEAN	Facility: NWIRP Bethpage
Project Number: 112G08005-WE13	Location: Bethpage, New York
Date: September 1, 2022 14:14	Personnel: Jake Marlow
Well ID: BPS1-TT-MW309S	Well Location: 215212.06 1124997.916
Well Status: In Use (Confirmed)	Screen Interval: 53-63
WELL INVENTORY CONDITION	
Concrete pad in acceptable condition i.e. no cracks?	YES
Manhole cover present and in working condition?	YES
All bolts on manhole present and not stripped?	YES
Well plug present, locked and in good working condition?	YES
OVERALL CONDITION:	GOOD
Notes (Explain if answered No to any of the above)

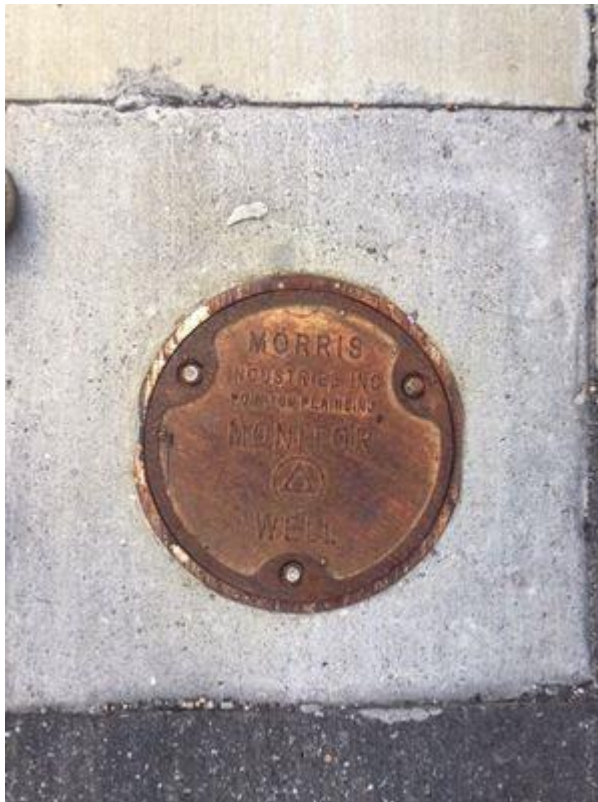
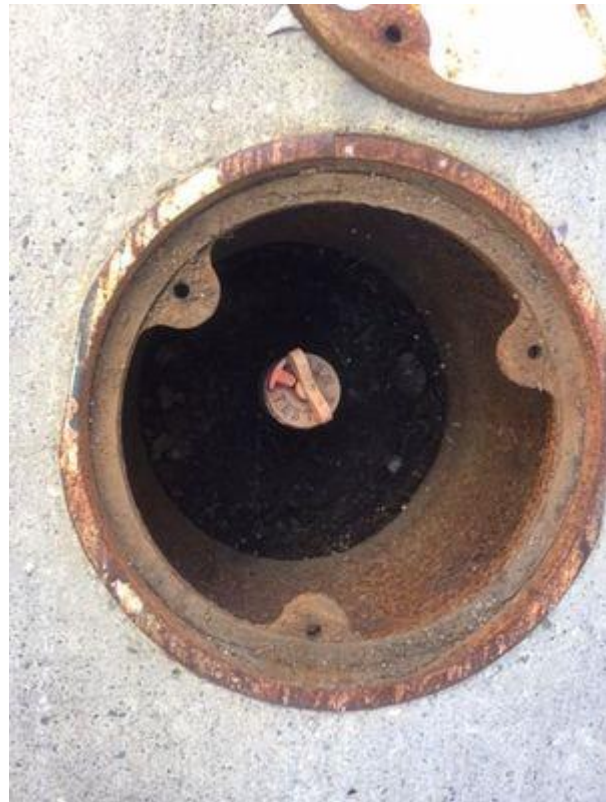
Client: Navy CLEAN	Facility: NWIRP Bethpage
Project Number: 112G08005-WE13	Location: Bethpage, New York
Date: September 1, 2022 14:00	Personnel: Jake Marlow
Well ID: BPS1-TT-MW310S	Well Location: 215489.753 1124093.163
Well Status: In Use (Confirmed)	Screen Interval: 57.5-67.5
WELL INVENTORY CONDITION	
Concrete pad in acceptable condition i.e. no cracks?	YES
Manhole cover present and in working condition?	YES
All bolts on manhole present and not stripped?	YES
Well plug present, locked and in good working condition?	YES
OVERALL CONDITION:	GOOD
Notes (Explain if answered No to any of the above)

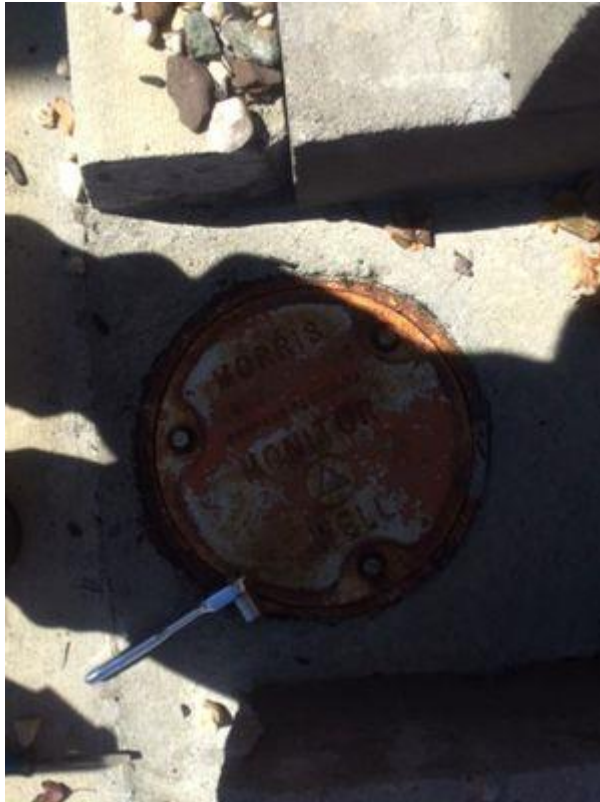
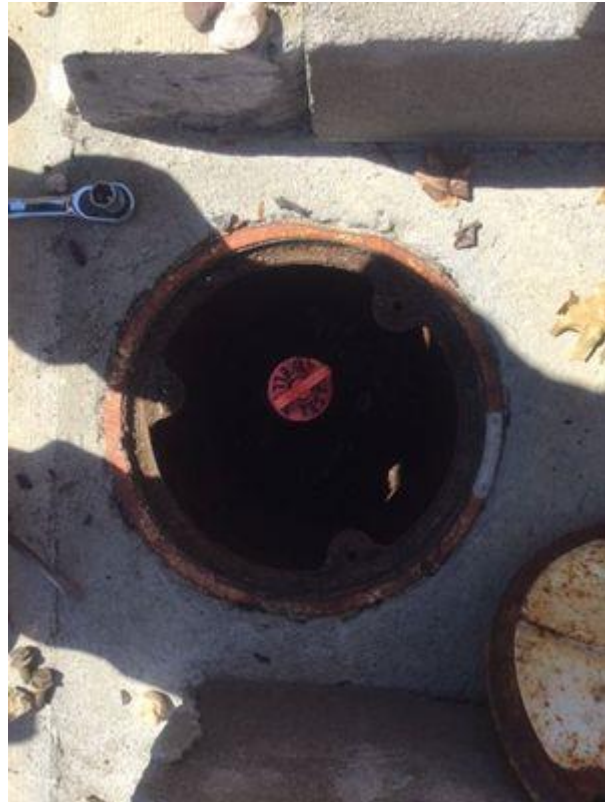
Client: Navy CLEAN	Facility: NWIRP Bethpage
Project Number: 112G08005-WE13	Location: Bethpage, New York
Date: September 1, 2022 13:53	Personnel: Jake Marlow
Well ID: BPS1-TT-MW311I	Well Location: 215422.011 1124599.099
Well Status: In Use (Confirmed)	Screen Interval: 160-170
WELL INVENTORY CONDITION	
Concrete pad in acceptable condition i.e. no cracks?	YES
Manhole cover present and in working condition?	YES
All bolts on manhole present and not stripped?	YES
Well plug present, locked and in good working condition?	YES
OVERALL CONDITION:	GOOD
Notes (Explain if answered No to any of the above)

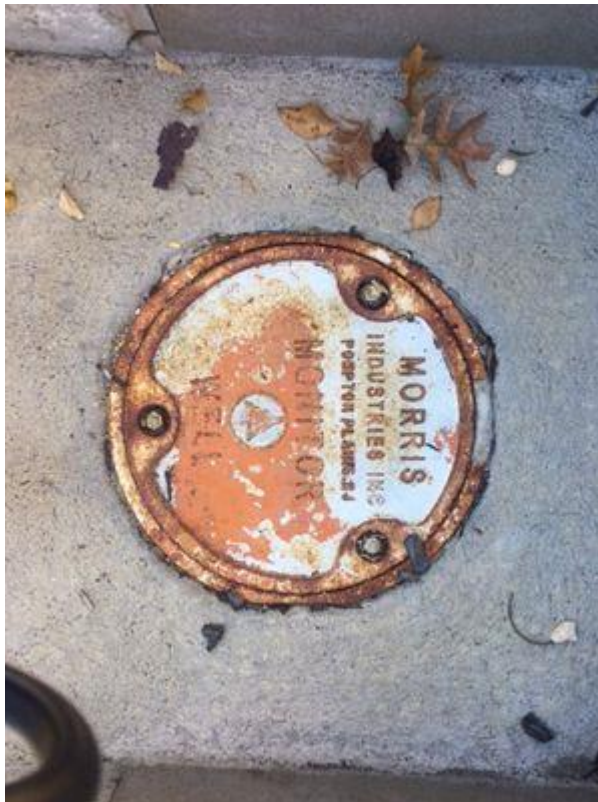
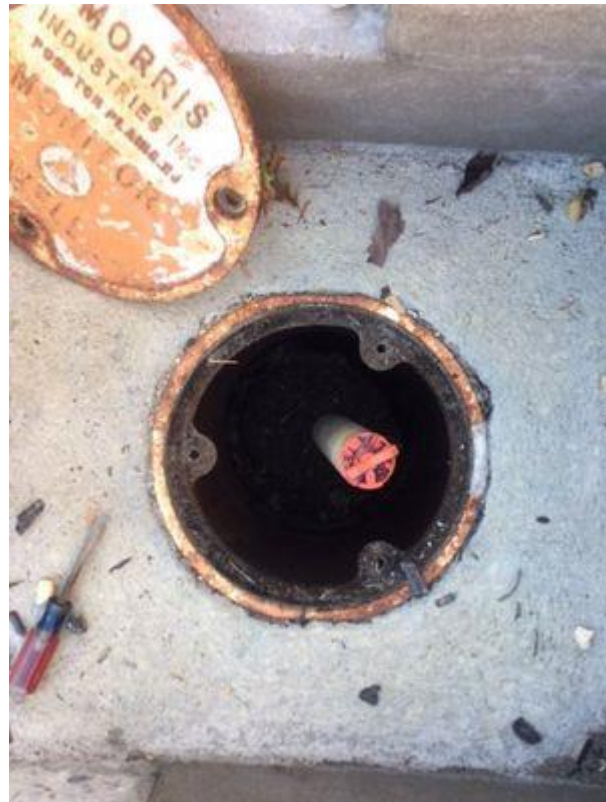
Client: Navy CLEAN	Facility: NWIRP Bethpage
Project Number: 112G08005-WE13	Location: Bethpage, New York
Date: September 1, 2022 13:41	Personnel: Jake Marlow
Well ID: BPS1-TT-MW311S	Well Location: 215423.402 1124594.444
Well Status: In Use (Confirmed)	Screen Interval: 55-65
WELL INVENTORY CONDITION	
Concrete pad in acceptable condition i.e. no cracks?	YES
Manhole cover present and in working condition?	YES
All bolts on manhole present and not stripped?	YES
Well plug present, locked and in good working condition?	YES
OVERALL CONDITION:	GOOD
Notes (Explain if answered No to any of the above)

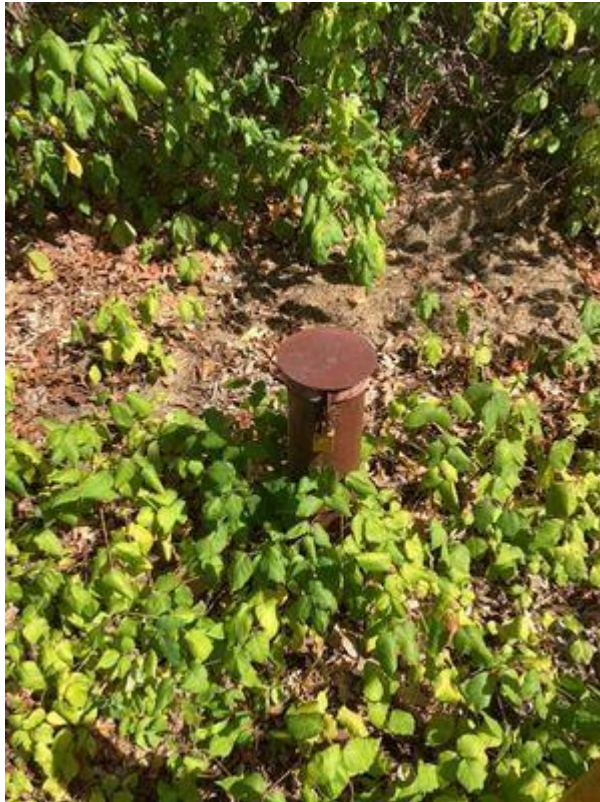
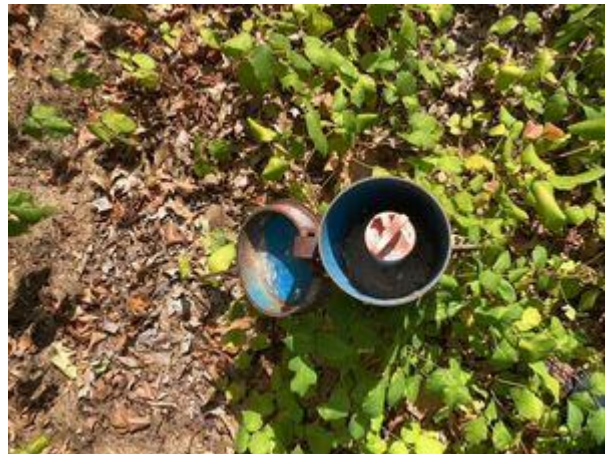
Client: Navy CLEAN	Facility: NWIRP Bethpage
Project Number: 112G08005-WE13	Location: Bethpage, New York
Date: September 2, 2022 14:20	Personnel: Beau Benfield
Well ID: BPS1-TT-MW312I	Well Location: 215327.647 1125165.865
Well Status: In Use (Confirmed)	Screen Interval: 160-170
WELL INVENTORY CONDITION	
Concrete pad in acceptable condition i.e. no cracks?	YES
Manhole cover present and in working condition?	NO
All bolts on manhole present and not stripped?	NO
Well plug present, locked and in good working condition?	YES
OVERALL CONDITION:	GOOD
Notes (Explain if answered No to any of the above) Stick up well

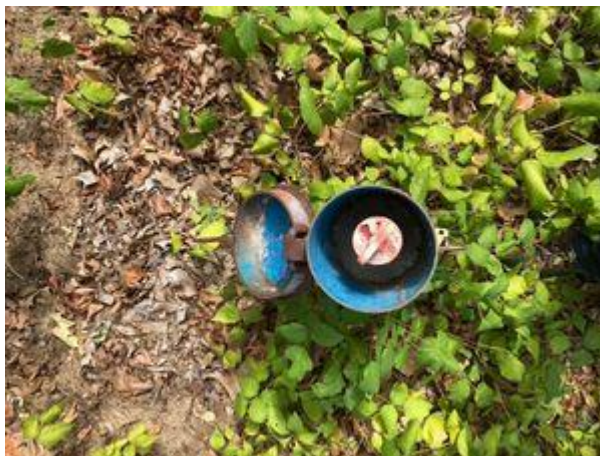
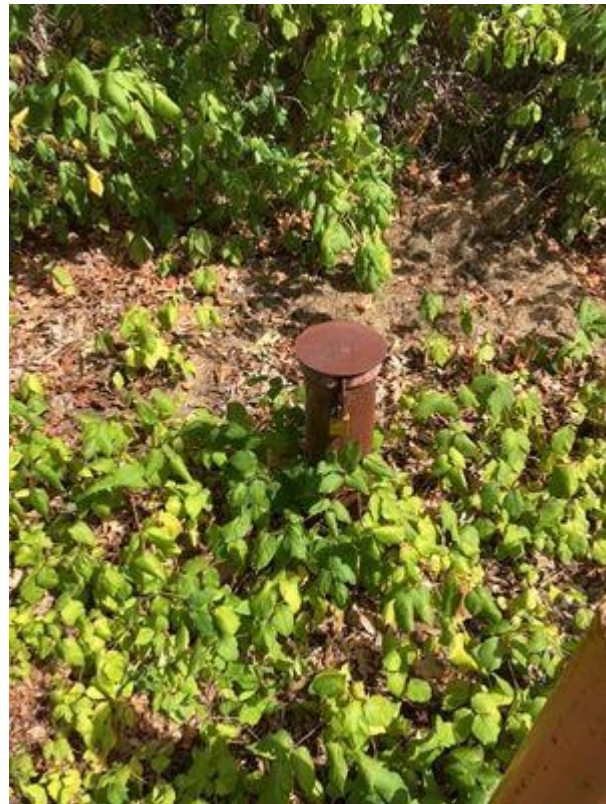
Client: Navy CLEAN	Facility: NWIRP Bethpage
Project Number: 112G08005-WE13	Location: Bethpage, New York
Date: September 2, 2022 14:17	Personnel: Beau Benfield
Well ID: BPS1-TT-MW312S	Well Location: 215322.312 1125165.285
Well Status: In Use (Confirmed)	Screen Interval: 53-63
WELL INVENTORY CONDITION	
Concrete pad in acceptable condition i.e. no cracks?	YES
Manhole cover present and in working condition?	NO
All bolts on manhole present and not stripped?	NO
Well plug present, locked and in good working condition?	YES
OVERALL CONDITION:	GOOD
Notes (Explain if answered No to any of the above) Stick up well

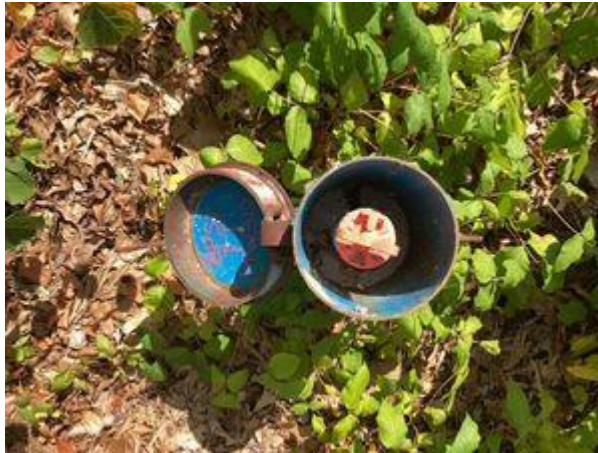
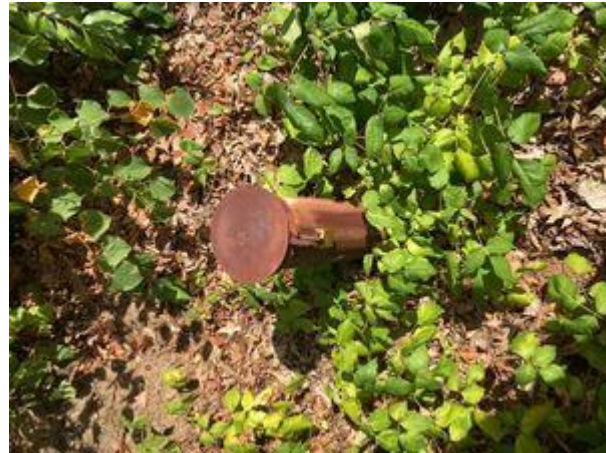
Client: Navy CLEAN	Facility: NWIRP Bethpage
Project Number: 112G08005-WE13	Location: Bethpage, New York
Date: September 2, 2022 14:22	Personnel: Beau Benfield
Well ID: BPS1-TT-MW312S	Well Location: 215322.312 1125165.285
Well Status: In Use (Confirmed)	Screen Interval: 53-63
WELL INVENTORY CONDITION	
Concrete pad in acceptable condition i.e. no cracks?	YES
Manhole cover present and in working condition?	NO
All bolts on manhole present and not stripped?	NO
Well plug present, locked and in good working condition?	YES
OVERALL CONDITION:	GOOD
Notes (Explain if answered No to any of the above) Stick up well

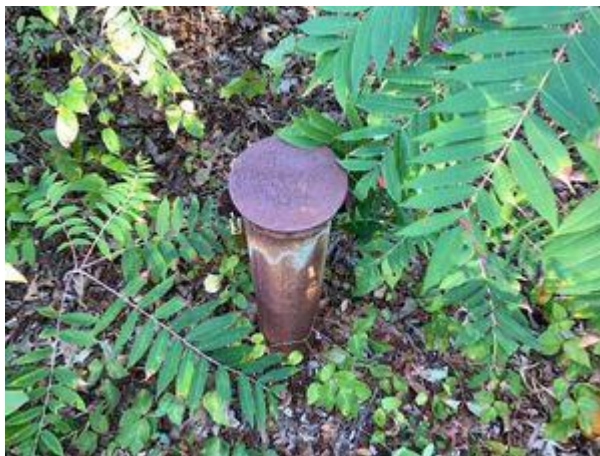
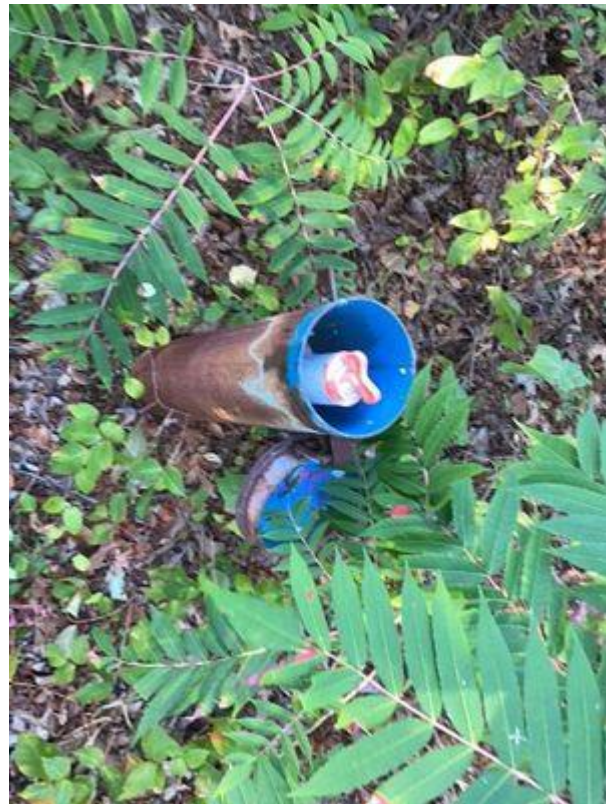
Client: Navy CLEAN	Facility: NWIRP Bethpage
Project Number: 112G08005-WE13	Location: Bethpage, New York
Date: September 29, 2022 08:21	Personnel: Jake Marlow
Well ID: BPS1-TT-MW313S	Well Location: 215126.39961 1125591.27256
Well Status: In Use (Confirmed)	Screen Interval: 53-63
WELL INVENTORY CONDITION	
Concrete pad in acceptable condition i.e. no cracks?	YES
Manhole cover present and in working condition?	YES
All bolts on manhole present and not stripped?	YES
Well plug present, locked and in good working condition?	YES
OVERALL CONDITION:	GOOD
Notes (Explain if answered No to any of the above)

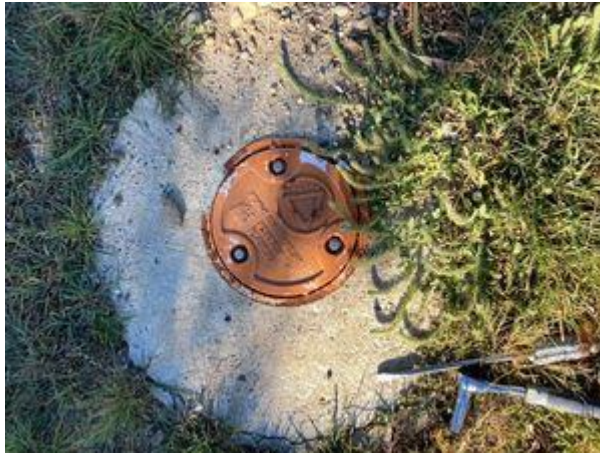
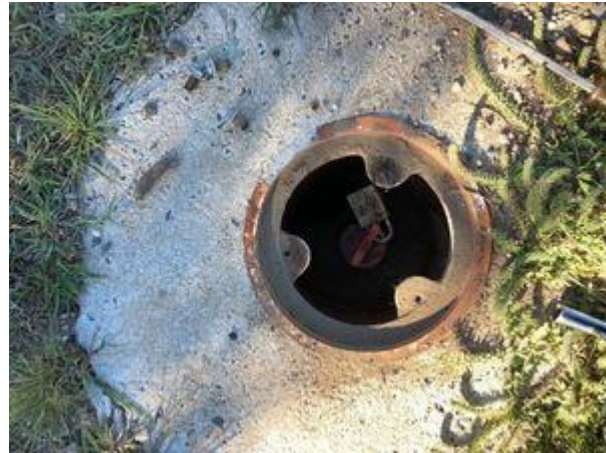
Client: Navy CLEAN	Facility: NWIRP Bethpage
Project Number: 112G08005-WE13	Location: Bethpage, New York
Date: September 2, 2022 08:38	Personnel: Beau Benfield
Well ID: BPS1-TT-MW500I	Well Location: 214300.4537 1124998.7117
Well Status: In Use (Confirmed)	Screen Interval: 130-140
WELL INVENTORY CONDITION	
Concrete pad in acceptable condition i.e. no cracks?	YES
Manhole cover present and in working condition?	YES
All bolts on manhole present and not stripped?	YES
Well plug present, locked and in good working condition?	YES
OVERALL CONDITION:	GOOD
Notes (Explain if answered No to any of the above)

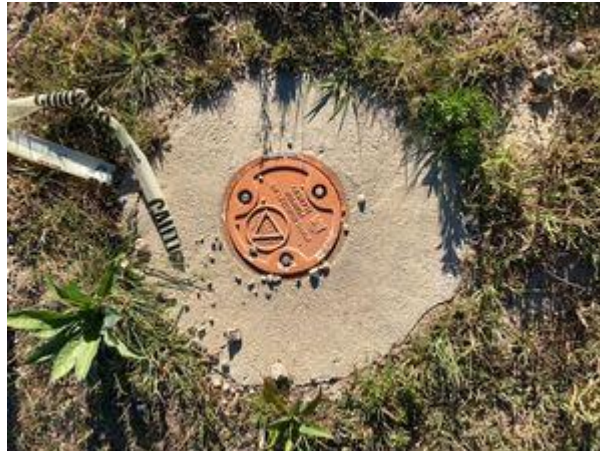
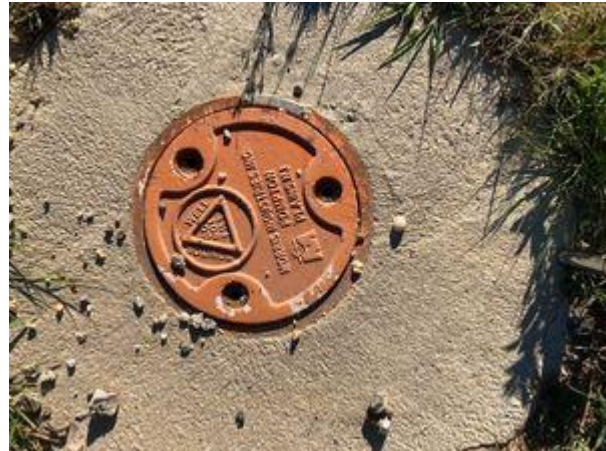
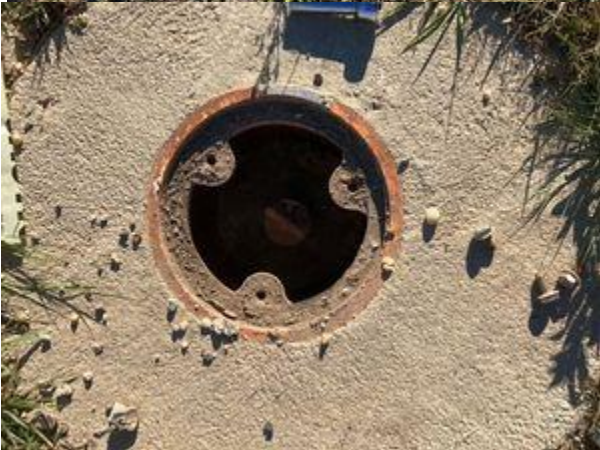
Client: Navy CLEAN	Facility: NWIRP Bethpage
Project Number: 112G08005-WE13	Location: Bethpage, New York
Date: September 2, 2022 08:32	Personnel: Beau Benfield
Well ID: BPS1-TT-MW500S	Well Location: 214309.346 1124999.8605
Well Status: In Use (Confirmed)	Screen Interval: 51-61
WELL INVENTORY CONDITION	
Concrete pad in acceptable condition i.e. no cracks?	YES
Manhole cover present and in working condition?	YES
All bolts on manhole present and not stripped?	YES
Well plug present, locked and in good working condition?	YES
OVERALL CONDITION:	GOOD
Notes (Explain if answered No to any of the above)

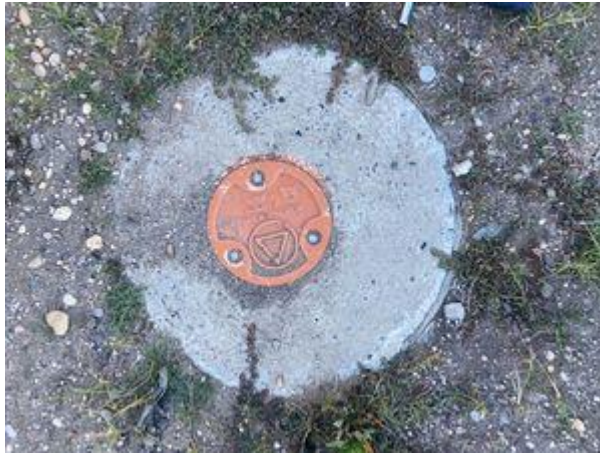
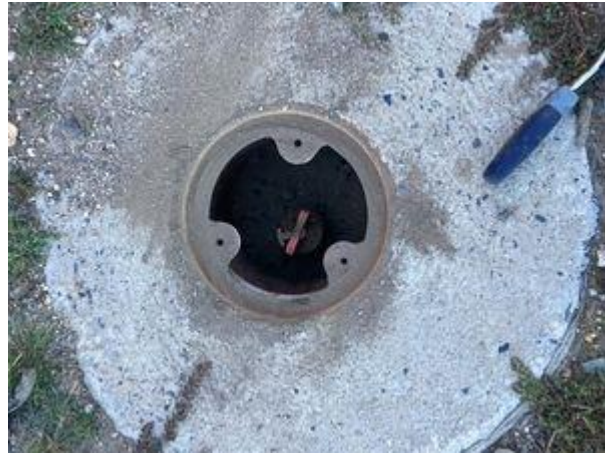
Client: Navy CLEAN	Facility: NWIRP Bethpage
Project Number: 112G08005-WE13	Location: Bethpage, New York
Date: September 2, 2022 08:22	Personnel: Beau Benfield
Well ID: BPS1-TT-MW50111	Well Location: 214111.9645 1124983.0019
Well Status: In Use (Confirmed)	Screen Interval: 88-98
WELL INVENTORY CONDITION	
Concrete pad in acceptable condition i.e. no cracks?	YES
Manhole cover present and in working condition?	YES
All bolts on manhole present and not stripped?	YES
Well plug present, locked and in good working condition?	YES
OVERALL CONDITION:	GOOD
Notes (Explain if answered No to any of the above)

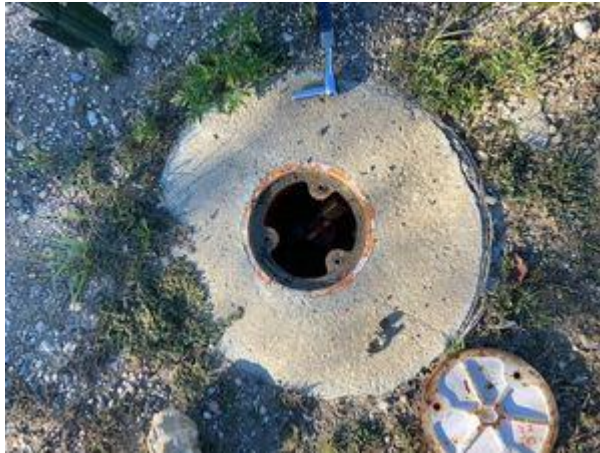
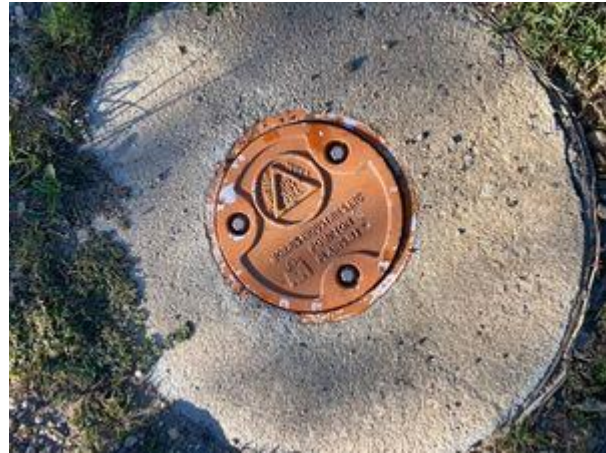
Client: Navy CLEAN	Facility: NWIRP Bethpage
Project Number: 112G08005-WE13	Location: Bethpage, New York
Date: September 2, 2022 08:20	Personnel: Beau Benfield
Well ID: BPS1-TT-MW50112	Well Location: 214094.7225 1124982.2535
Well Status: In Use (Confirmed)	Screen Interval: 120-130
WELL INVENTORY CONDITION	
Concrete pad in acceptable condition i.e. no cracks?	YES
Manhole cover present and in working condition?	YES
All bolts on manhole present and not stripped?	YES
Well plug present, locked and in good working condition?	YES
OVERALL CONDITION:	GOOD
Notes (Explain if answered No to any of the above)

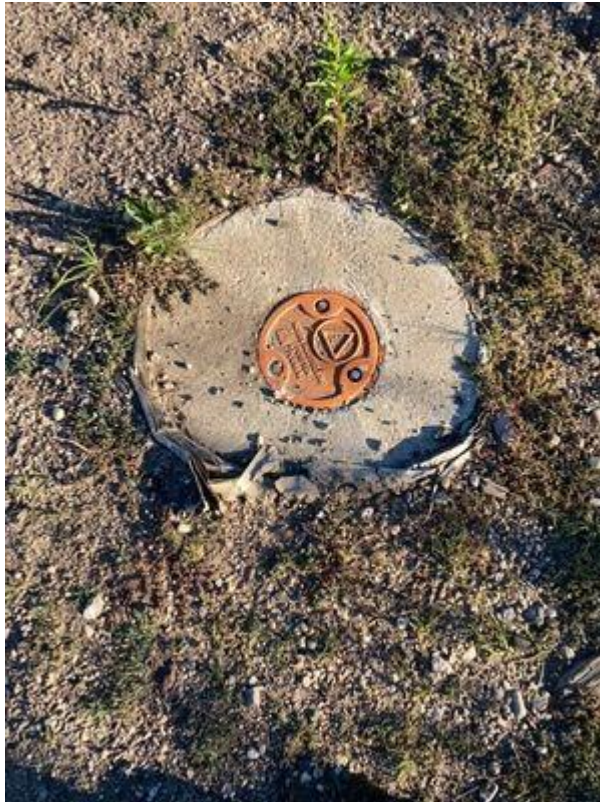
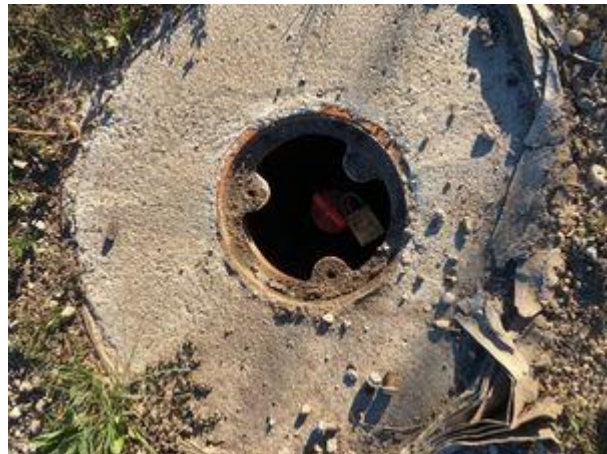
Client: Navy CLEAN	Facility: NWIRP Bethpage
Project Number: 112G08005-WE13	Location: Bethpage, New York
Date: September 2, 2022 07:57	Personnel: Beau Benfield
Well ID: BPS1-TT-MW501S	Well Location: 214103.3038 1124982.0052
Well Status: In Use (Confirmed)	Screen Interval: 51-61
WELL INVENTORY CONDITION	
Concrete pad in acceptable condition i.e. no cracks?	YES
Manhole cover present and in working condition?	YES
All bolts on manhole present and not stripped?	YES
Well plug present, locked and in good working condition?	YES
OVERALL CONDITION:	GOOD
Notes (Explain if answered No to any of the above)

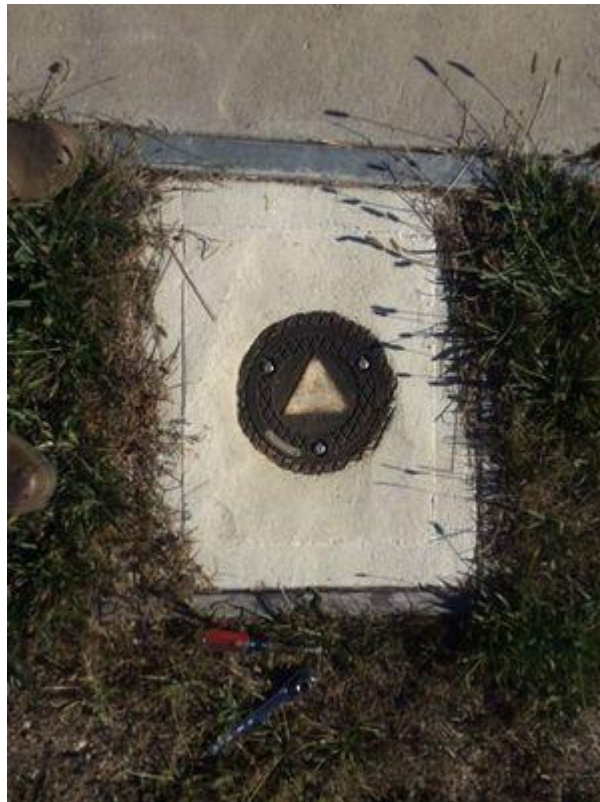
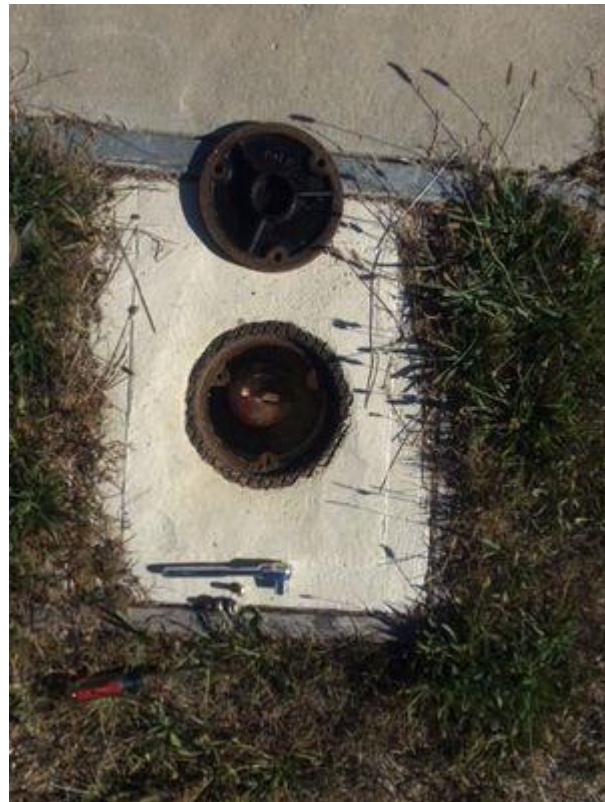
Client: Navy CLEAN	Facility: NWIRP Bethpage
Project Number: 112G08005-WE13	Location: Bethpage, New York
Date: September 2, 2022 09:10	Personnel: Jake Marlow
Well ID: BPTTAOC22MW01	Well Location: 214058.401042 1123682.91667
Well Status: In Use (Confirmed)	Screen Interval: 48-68
WELL INVENTORY CONDITION	
Concrete pad in acceptable condition i.e. no cracks?	YES
Manhole cover present and in working condition?	YES
All bolts on manhole present and not stripped?	YES
Well plug present, locked and in good working condition?	YES
OVERALL CONDITION:	GOOD
Notes (Explain if answered No to any of the above)

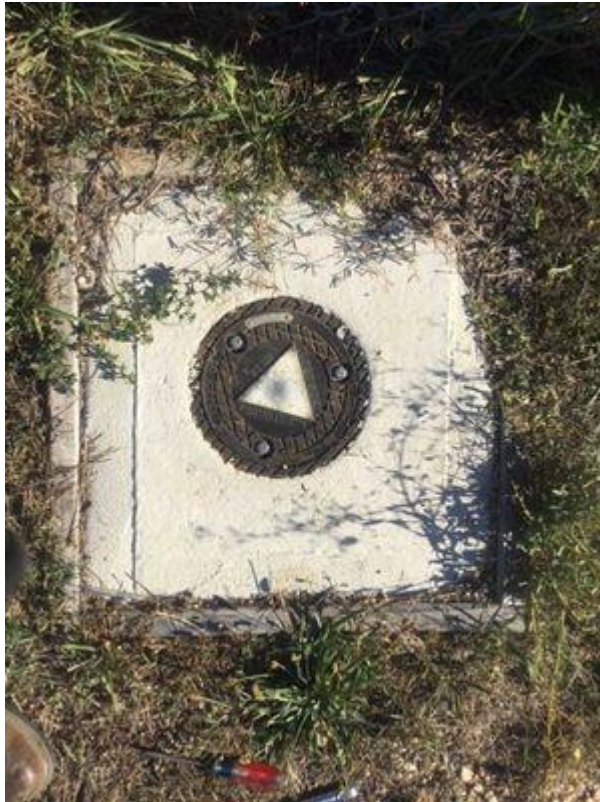
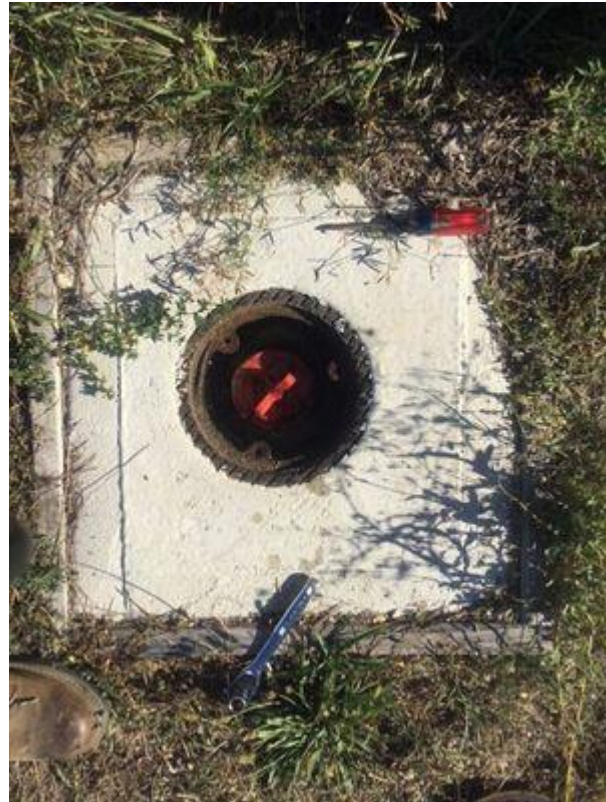
Client: Navy CLEAN	Facility: NWIRP Bethpage
Project Number: 112G08005-WE13	Location: Bethpage, New York
Date: September 2, 2022 09:06	Personnel: Jake Marlow
Well ID: BPTTAOC22MW02	Well Location: 214069.527778 1123712.08333
Well Status: In Use (Confirmed)	Screen Interval: 46-66
WELL INVENTORY CONDITION	
Concrete pad in acceptable condition i.e. no cracks?	YES
Manhole cover present and in working condition?	YES
All bolts on manhole present and not stripped?	YES
Well plug present, locked and in good working condition?	YES
OVERALL CONDITION:	GOOD
Notes (Explain if answered No to any of the above)

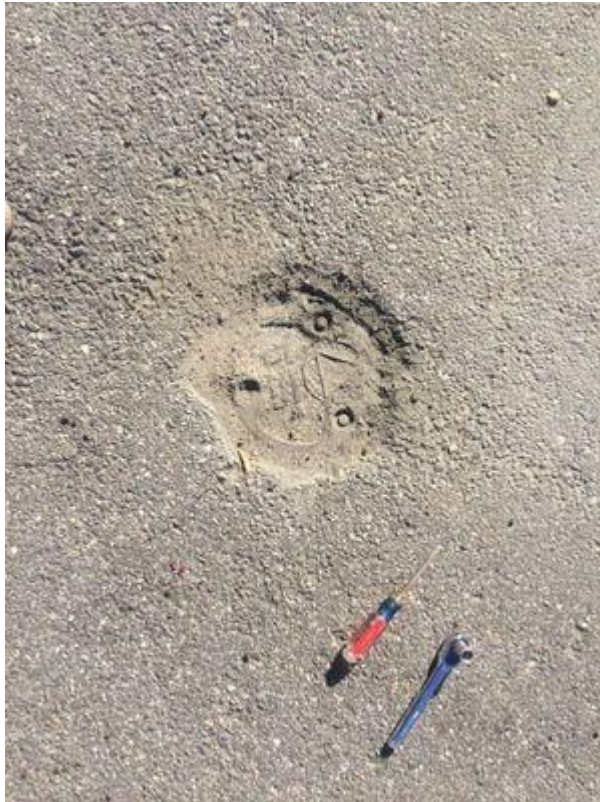
Client: Navy CLEAN	Facility: NWIRP Bethpage
Project Number: 112G08005-WE13	Location: Bethpage, New York
Date: September 2, 2022 08:58	Personnel: Jake Marlow
Well ID: BPTTAOC22MW03	Well Location: 214146.208333 1123683.95833
Well Status: In Use (Confirmed)	Screen Interval: 45.5-65.5
WELL INVENTORY CONDITION	
Concrete pad in acceptable condition i.e. no cracks?	YES
Manhole cover present and in working condition?	NO
All bolts on manhole present and not stripped?	YES
Well plug present, locked and in good working condition?	YES
OVERALL CONDITION:	FAIR
Notes (Explain if answered No to any of the above) Missing bolt, two bolts stripped

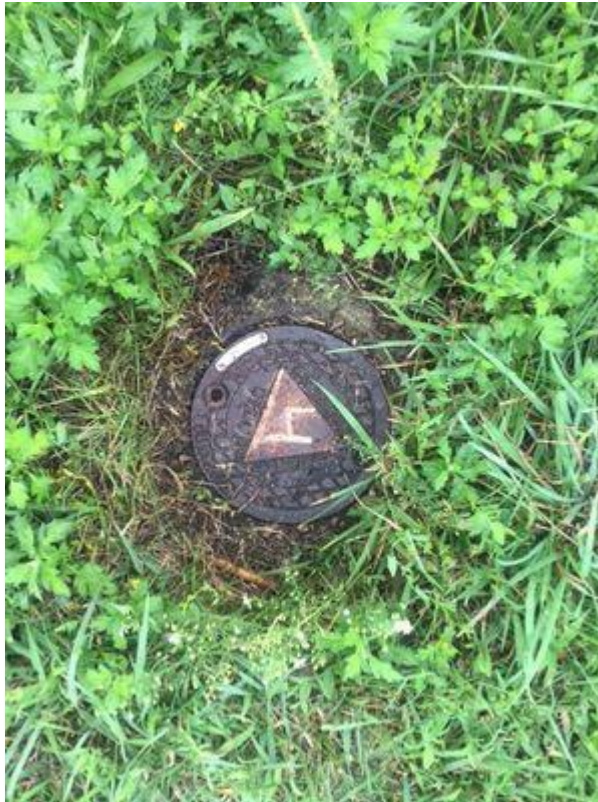
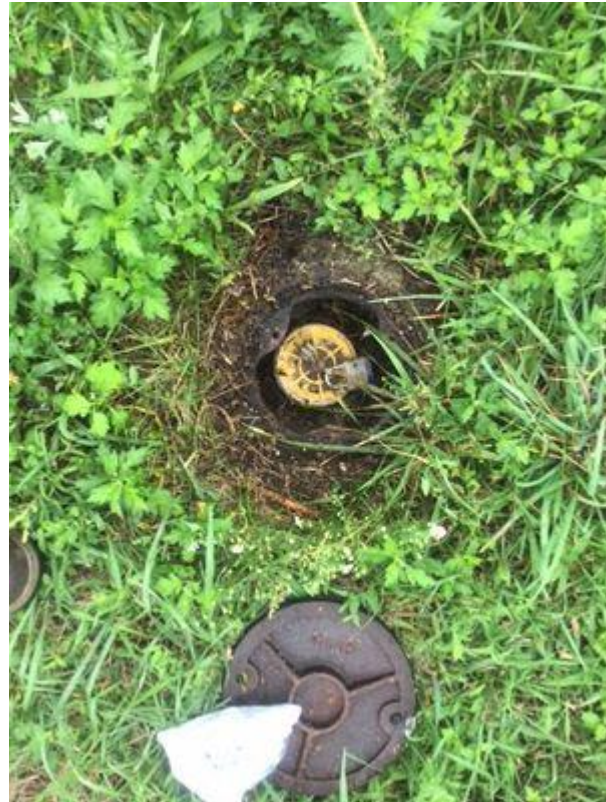
Client: Navy CLEAN	Facility: NWIRP Bethpage
Project Number: 112G08005-WE13	Location: Bethpage, New York
Date: September 22, 2022 15:57	Personnel: Jake Marlow
Well ID: BPTTAOC22MW04	Well Location: 214026.062685 1123644.93391
Well Status: In Use (Confirmed)	Screen Interval: 46-66
WELL INVENTORY CONDITION	
Concrete pad in acceptable condition i.e. no cracks?	YES
Manhole cover present and in working condition?	YES
All bolts on manhole present and not stripped?	NO
Well plug present, locked and in good working condition?	YES
OVERALL CONDITION:	FAIR
Notes (Explain if answered No to any of the above) Needs lid with 3 bolt holes not 2

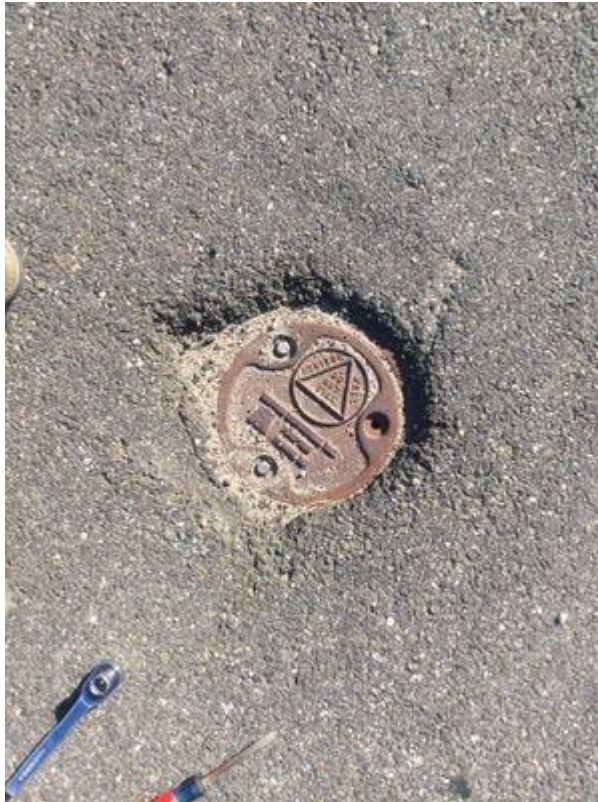
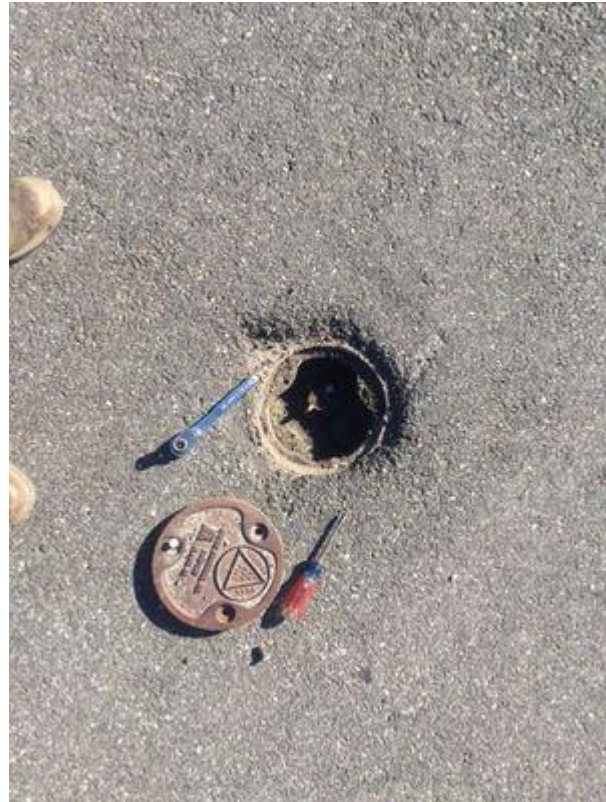
Client: Navy CLEAN	Facility: NWIRP Bethpage
Project Number: 112G08005-WE13	Location: Bethpage, New York
Date: September 2, 2022 09:15	Personnel: Jake Marlow
Well ID: BPTTAOC22MW06	Well Location: 213898.349824 1123746.01449
Well Status: In Use (Confirmed)	Screen Interval: 52-62
WELL INVENTORY CONDITION	
Concrete pad in acceptable condition i.e. no cracks?	YES
Manhole cover present and in working condition?	NO
All bolts on manhole present and not stripped?	NO
Well plug present, locked and in good working condition?	YES
OVERALL CONDITION:	FAIR
Notes (Explain if answered No to any of the above) Sand heave, missing bolt, manhole cracked where bolts screw in

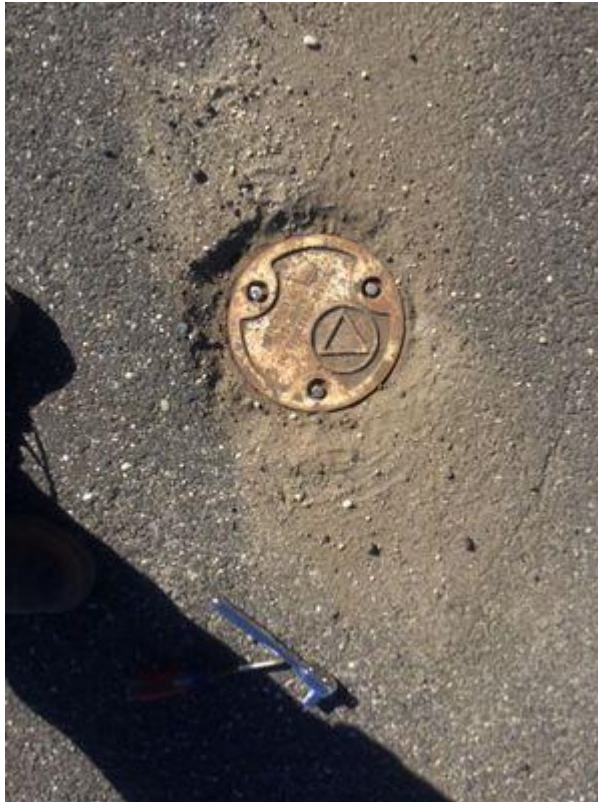
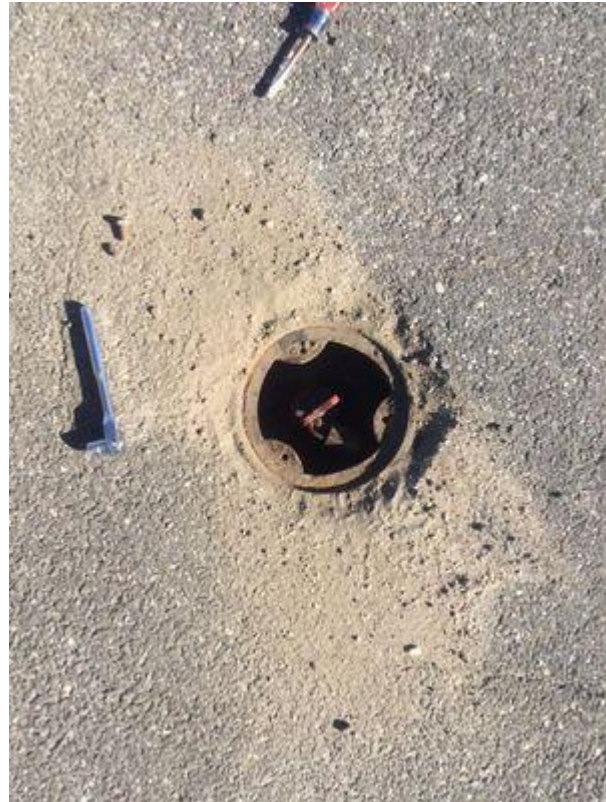
Client: Navy CLEAN	Facility: NWIRP Bethpage
Project Number: 112G08005-WE11	Location: Bethpage, New York
Date: September 2, 2022 09:20	Personnel: Jake Marlow
Well ID: BPTTAOC22MW07	Well Location: 213883.666163 1123660.8565
Well Status: In Use (Confirmed)	Screen Interval: 52-62
WELL INVENTORY CONDITION	
Concrete pad in acceptable condition i.e. no cracks?	YES
Manhole cover present and in working condition?	YES
All bolts on manhole present and not stripped?	NO
Well plug present, locked and in good working condition?	YES
OVERALL CONDITION:	FAIR
Notes (Explain if answered No to any of the above) Replaced missing bolt, manhole is stripped where bolts screw in

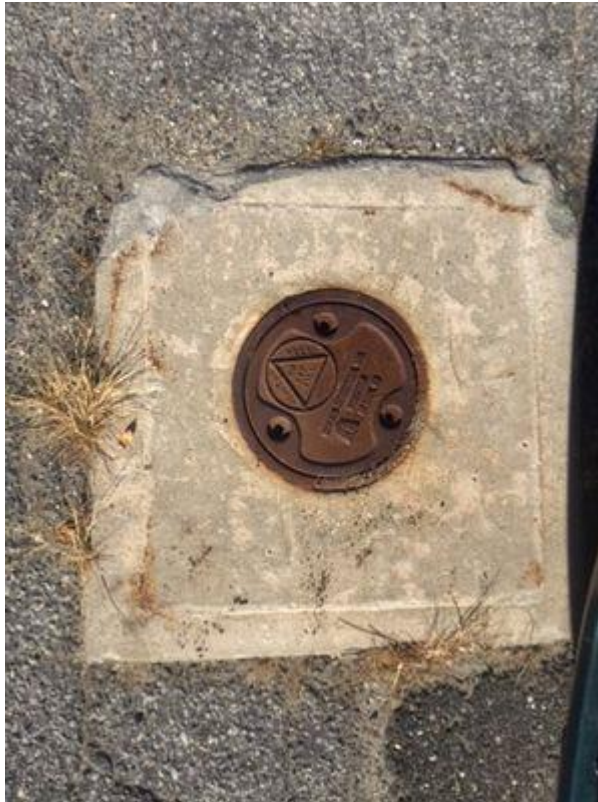
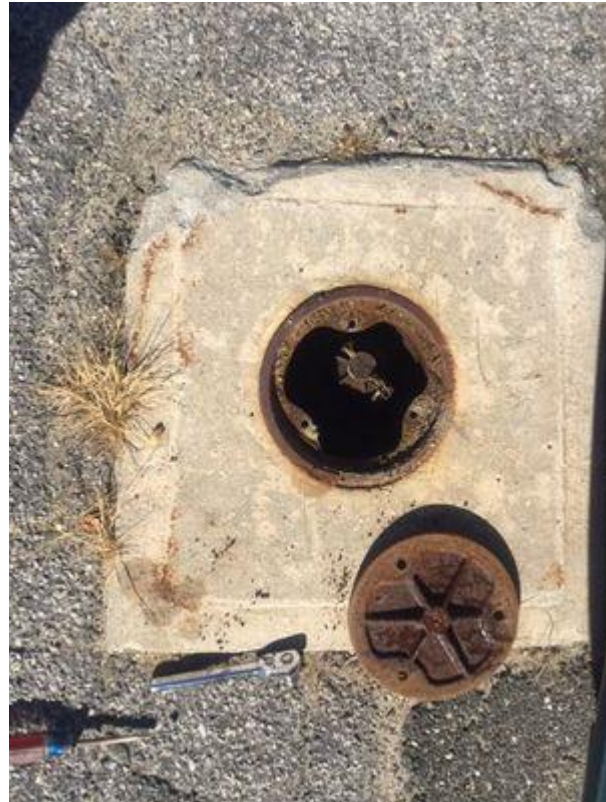
Client: Navy CLEAN	Facility: NWIRP Bethpage
Project Number: 112G08005-WE13	Location: Bethpage, New York
Date: September 2, 2022 09:25	Personnel: Jake Marlow
Well ID: BPTTAOC22MW08	Well Location: 213932.291179 1123576.0651
Well Status: In Use (Confirmed)	Screen Interval: 52-62
WELL INVENTORY CONDITION	
Concrete pad in acceptable condition i.e. no cracks?	YES
Manhole cover present and in working condition?	YES
All bolts on manhole present and not stripped?	NO
Well plug present, locked and in good working condition?	YES
OVERALL CONDITION:	FAIR
Notes (Explain if answered No to any of the above) Three missing bolts, manhole stripped where bolts screw in

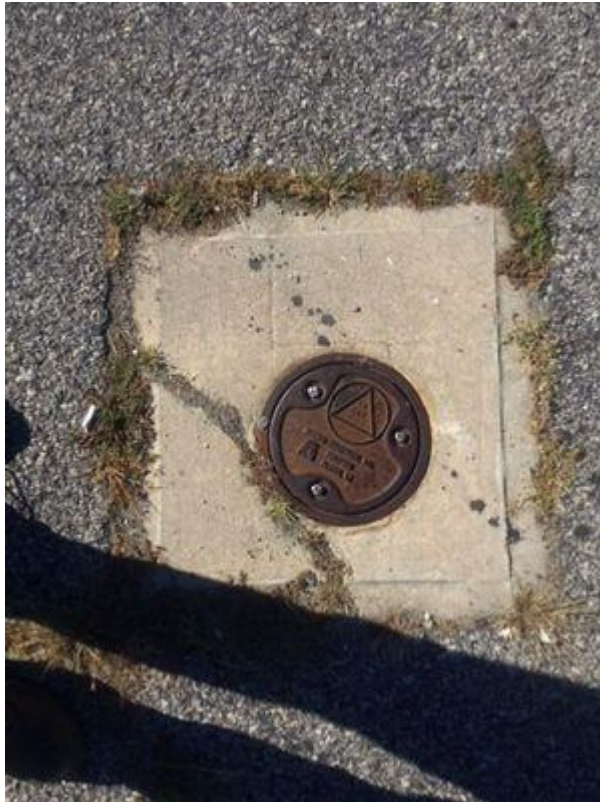
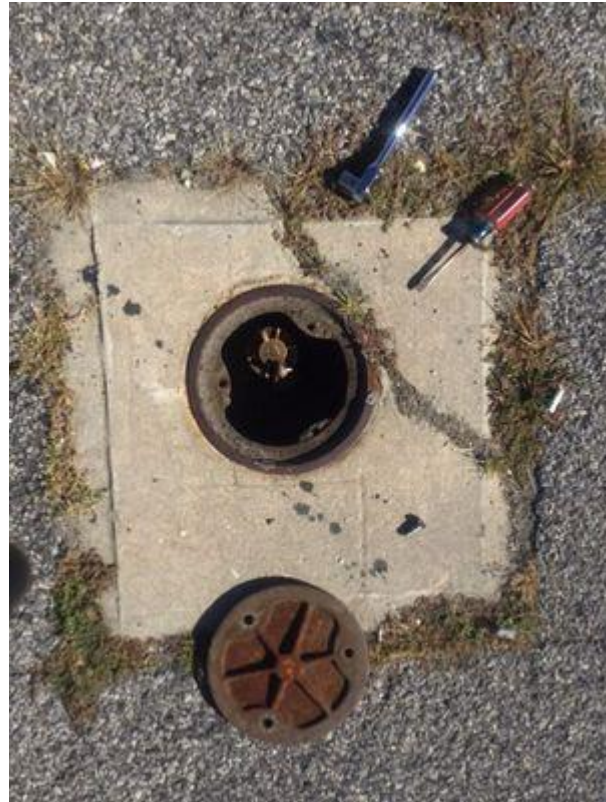
Client: Navy CLEAN	Facility: NWIRP Bethpage
Project Number: 112G08005-WE13	Location: Bethpage, New York
Date: September 2, 2022 09:29	Personnel: Jake Marlow
Well ID: BPTTAOC22MW09	Well Location: 214007.819715 1123539.30462
Well Status: In Use (Confirmed)	Screen Interval: 52-62
WELL INVENTORY CONDITION	
Concrete pad in acceptable condition i.e. no cracks?	NO
Manhole cover present and in working condition?	YES
All bolts on manhole present and not stripped?	NO
Well plug present, locked and in good working condition?	YES
OVERALL CONDITION:	FAIR
Notes (Explain if answered No to any of the above) Cracked pad, replaced two missing bolts

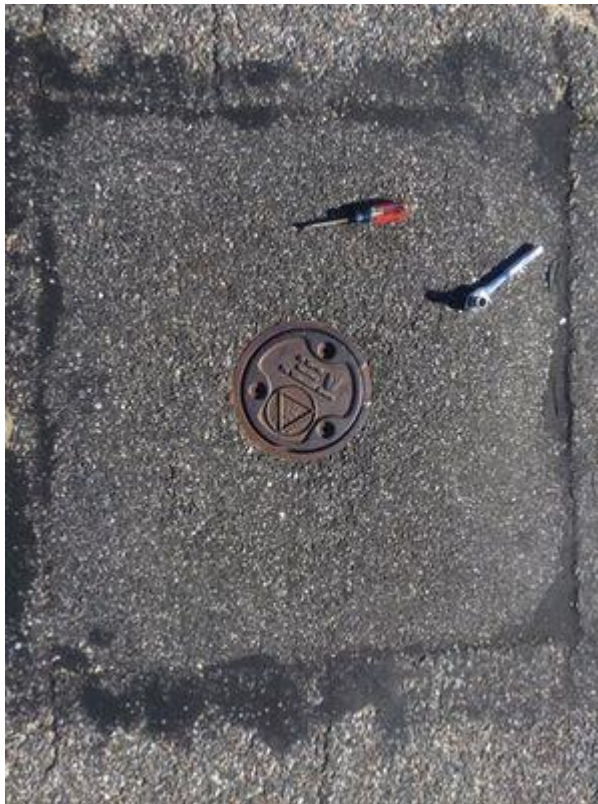
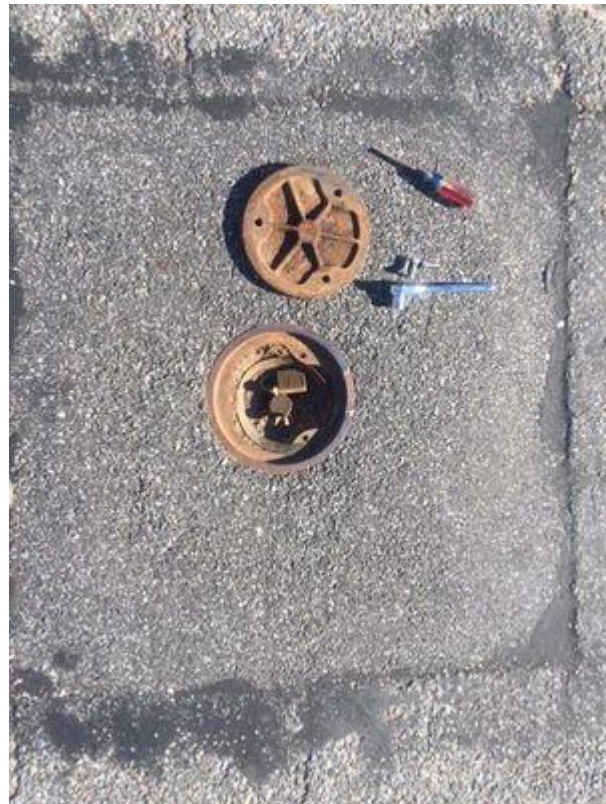
Client: Navy CLEAN	Facility: NWIRP Bethpage
Project Number: 112G08005-WE13	Location: Bethpage, New York
Date: September 2, 2022 08:43	Personnel: Jake Marlow
Well ID: BPTTAOC22MW10	Well Location: 213950.533507 1123833.5788
Well Status: In Use (Confirmed)	Screen Interval: 49-59
WELL INVENTORY CONDITION	
Concrete pad in acceptable condition i.e. no cracks?	YES
Manhole cover present and in working condition?	NO
All bolts on manhole present and not stripped?	NO
Well plug present, locked and in good working condition?	YES
OVERALL CONDITION:	FAIR
Notes (Explain if answered No to any of the above) Three missing bolts, could not replace because stripped in manhole, sand heave in well
