Memorandum

To: Scot Sokolowski, NAVFAC MIDLANT
From: David Brayack, Tetra Tech
Date: November 17, 2022
Re: Annual LUC Inspection and Operation Summary Report: Sites 1, 2, 3, and 4 –
NWIRP Bethpage
Contract/CTO Number: N6247016D9008/WE16

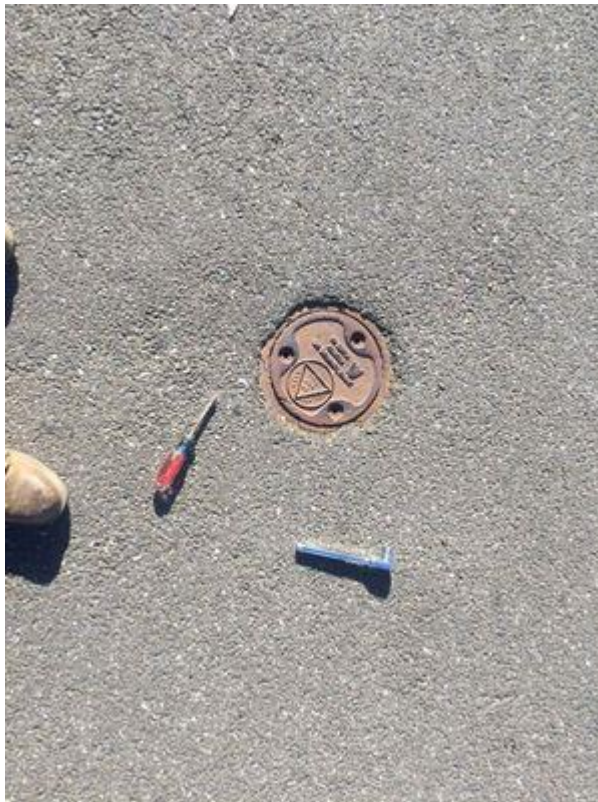
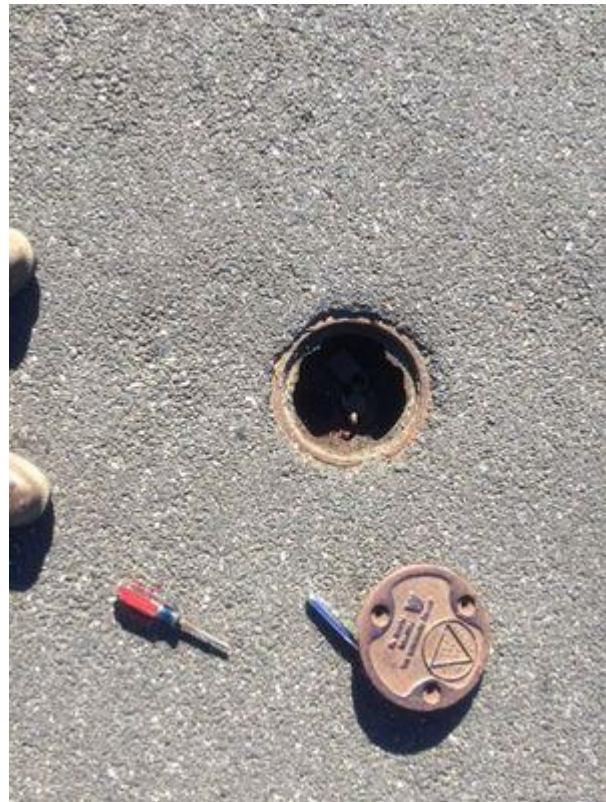
Client: Navy CLEAN	Facility: NWIRP Bethpage
Project Number: 112G08005-WE13	Location: Bethpage, New York
Date: September 2, 2022 08:54	Personnel: Jake Marlow
Well ID: BPTTAOC22MW11	Well Location: 214145.28085 1123547.94787
Well Status: In Use (Confirmed)	Screen Interval: 53-63
WELL INVENTORY CONDITION	
Concrete pad in acceptable condition i.e. no cracks?	YES
Manhole cover present and in working condition?	NO
All bolts on manhole present and not stripped?	NO
Well plug present, locked and in good working condition?	NO
OVERALL CONDITION:	FAIR
Notes (Explain if answered No to any of the above) Bolts missing, manhole cracked where bolts screw in, sand heave, jpug cracked

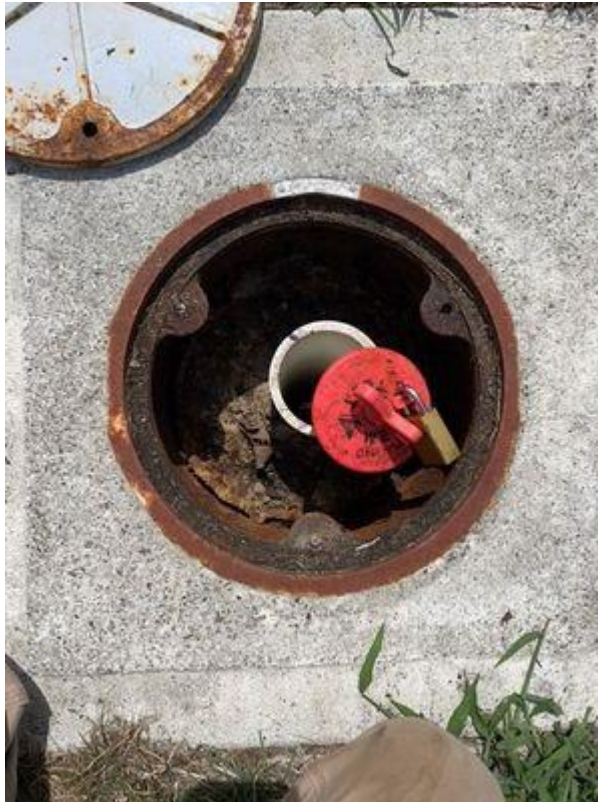
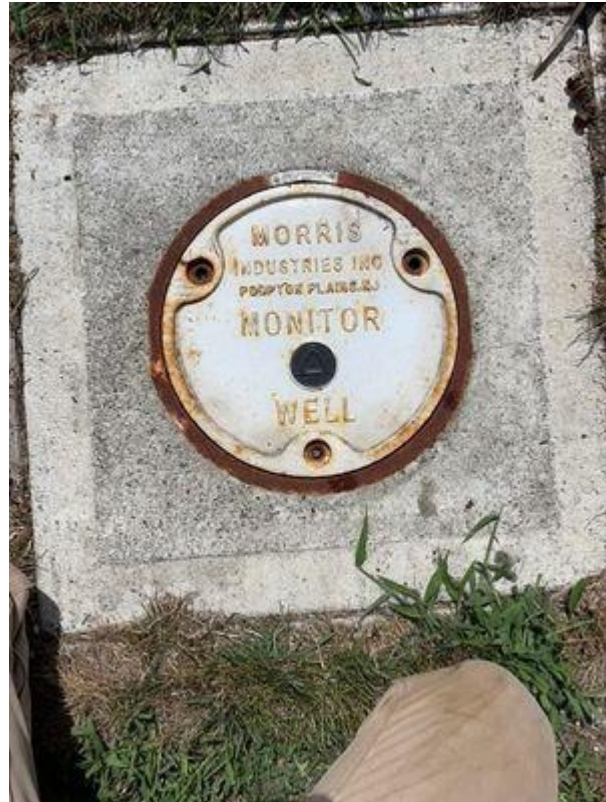
Client: Navy CLEAN	Facility: NWIRP Bethpage
Project Number: 112G08005-WE13	Location: Bethpage, New York
Date: August 15, 2022 11:54	Personnel: RJ Brydon
Well ID: BP-TT-MW179D	Well Location: 213555.0078 1120940.8274
Well Status: In Use (Confirmed)	Screen Interval: 212-232
WELL INVENTORY CONDITION	
Concrete pad in acceptable condition i.e. no cracks?	YES
Manhole cover present and in working condition?	YES
All bolts on manhole present and not stripped?	NO
Well plug present, locked and in good working condition?	YES
OVERALL CONDITION:	GOOD
Notes (Explain if answered No to any of the above) 2 broken bolts

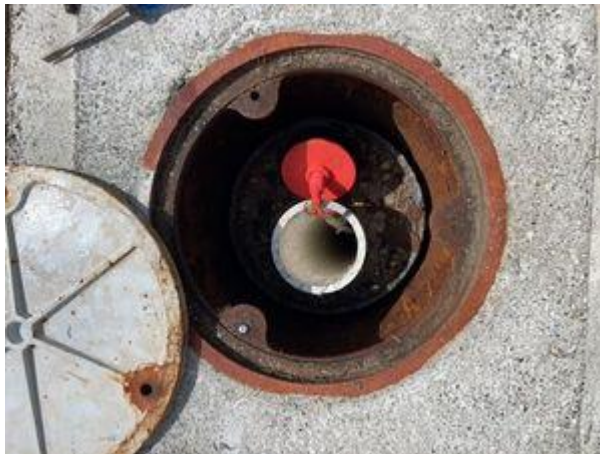
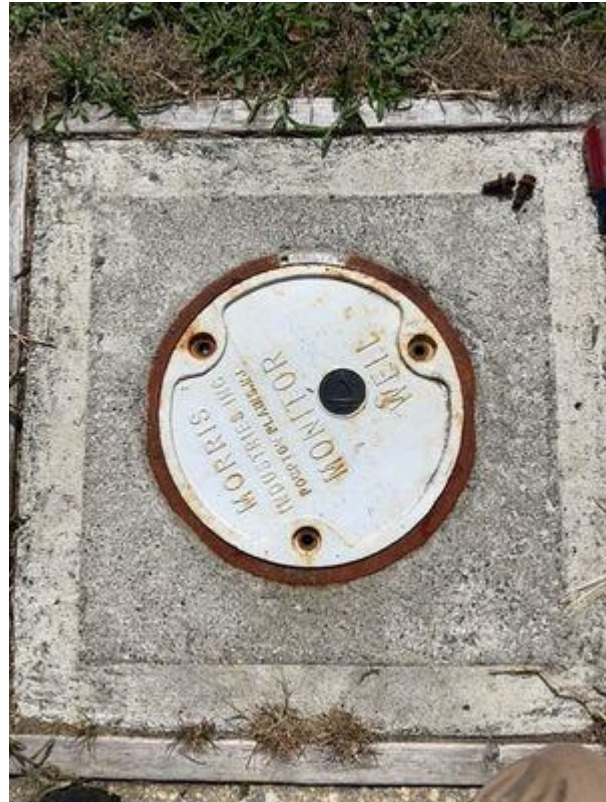
Client: Navy CLEAN	Facility: NWIRP Bethpage
Project Number: 112G08005-WE13	Location: Bethpage, New York
Date: August 15, 2022 11:50	Personnel: RJ Brydon
Well ID: BP-TT-MW179D2	Well Location: 213537.6175 1120915.7882
Well Status: In Use (Confirmed)	Screen Interval: 400-420
WELL INVENTORY CONDITION	
Concrete pad in acceptable condition i.e. no cracks?	YES
Manhole cover present and in working condition?	YES
All bolts on manhole present and not stripped?	NO
Well plug present, locked and in good working condition?	YES
OVERALL CONDITION:	GOOD
Notes (Explain if answered No to any of the above) 1 broken bolt

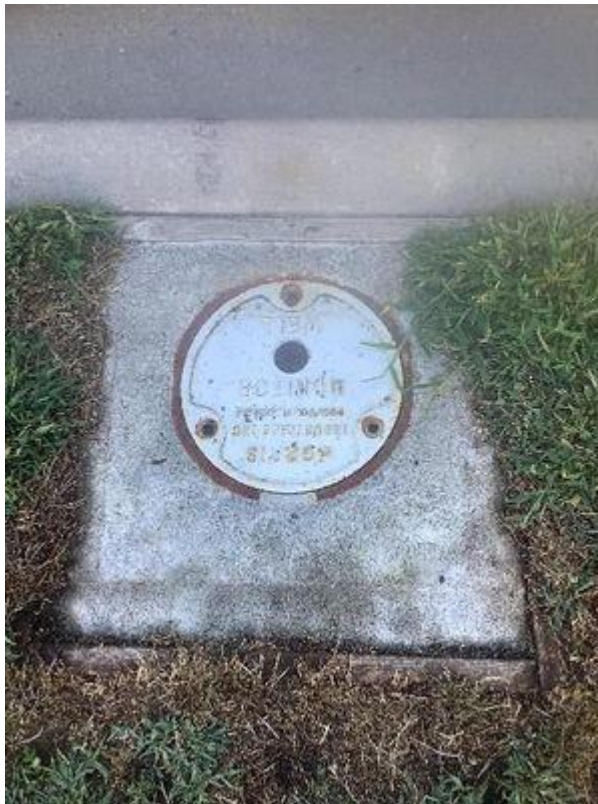
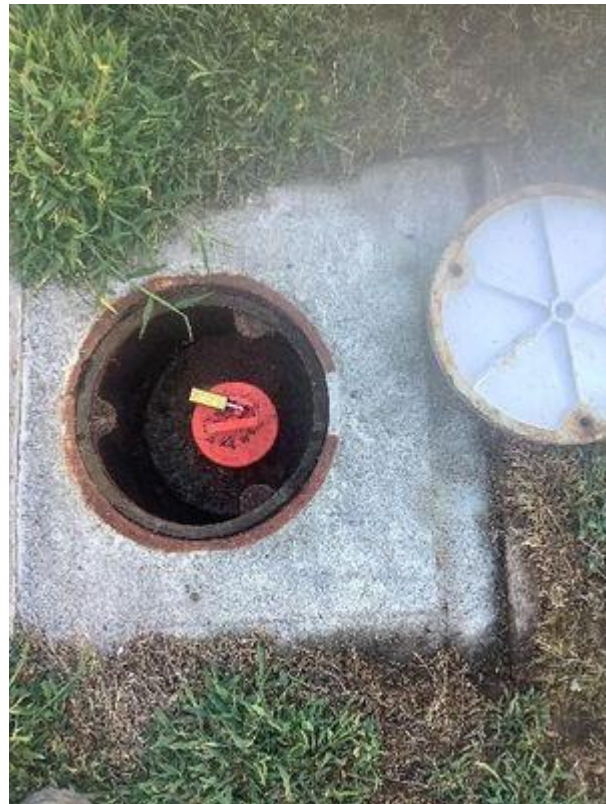
Client: Navy CLEAN	Facility: NWIRP Bethpage
Project Number: 112G08005-WE13	Location: Bethpage, New York
Date: September 2, 2022 09:05	Personnel:
Well ID: BP-TT-MW180D	Well Location: 200999.2932 1124946.3877
Well Status: In Use (Confirmed)	Screen Interval: 220-240
WELL INVENTORY CONDITION	
Concrete pad in acceptable condition i.e. no cracks?	YES
Manhole cover present and in working condition?	YES
All bolts on manhole present and not stripped?	NO
Well plug present, locked and in good working condition?	YES
OVERALL CONDITION:	FAIR
Notes (Explain if answered No to any of the above)

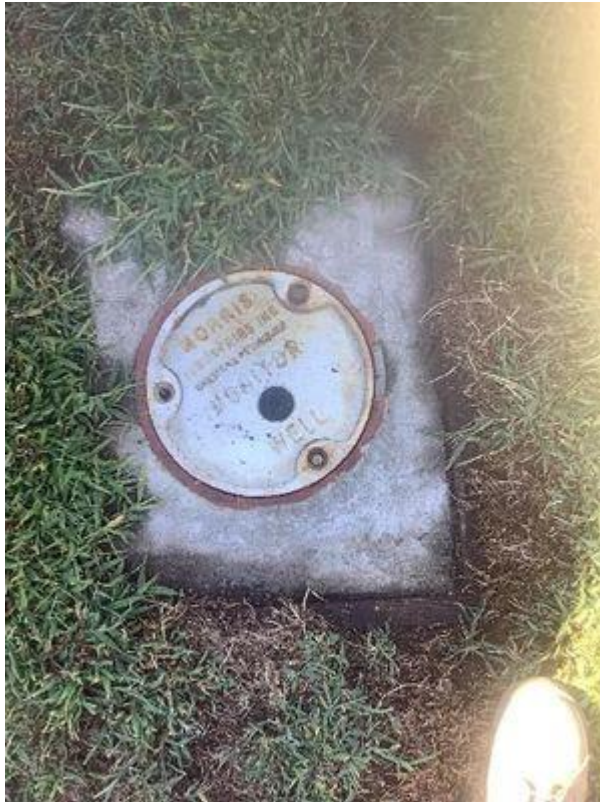
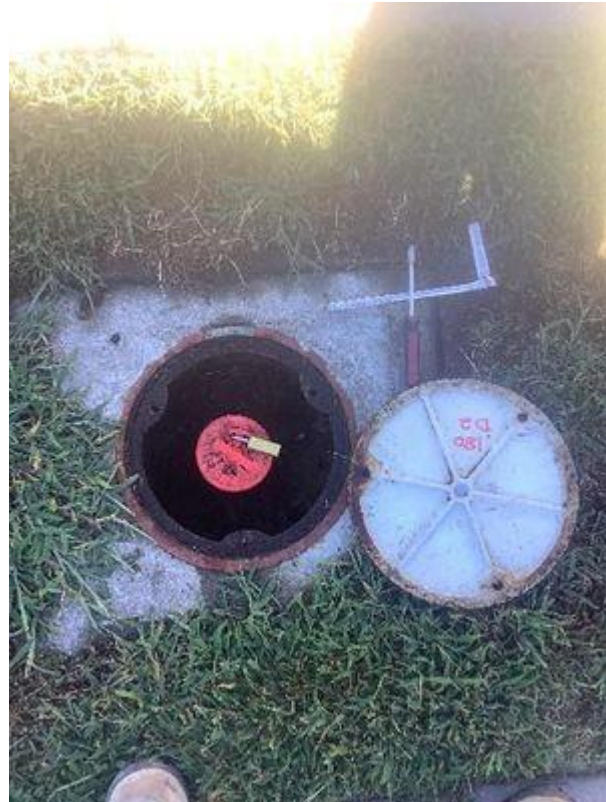
Client: Navy CLEAN	Facility: NWIRP Bethpage
Project Number: 112G08005-WE13	Location: Bethpage, New York
Date: September 2, 2022 09:13	Personnel:
Well ID: BP-TT-MW180D2	Well Location: 200969.016 1124947.2396
Well Status: In Use (Confirmed)	Screen Interval: 710-730
WELL INVENTORY CONDITION	
Concrete pad in acceptable condition i.e. no cracks?	YES
Manhole cover present and in working condition?	YES
All bolts on manhole present and not stripped?	NO
Well plug present, locked and in good working condition?	YES
OVERALL CONDITION:	FAIR
Notes (Explain if answered No to any of the above)

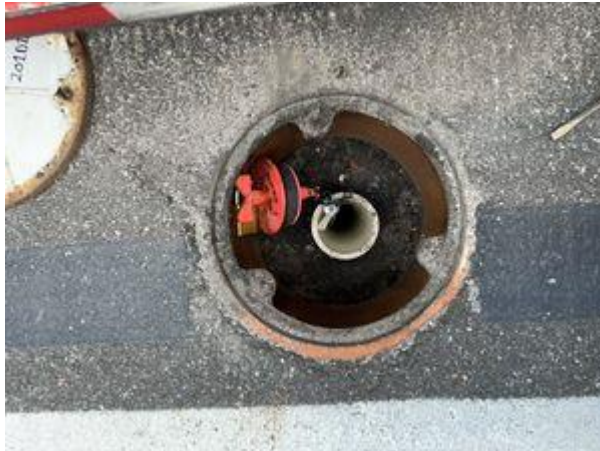
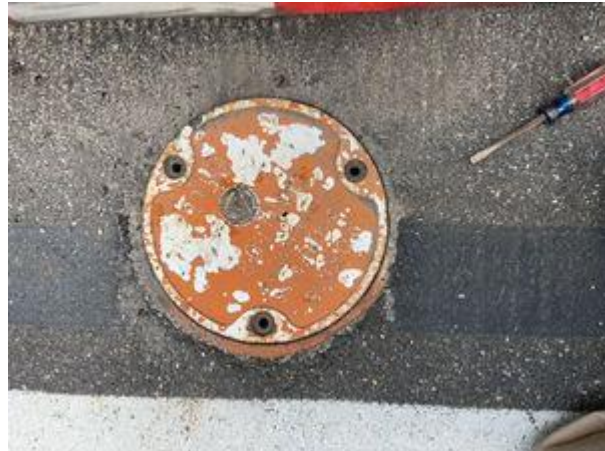
Client: Navy CLEAN	Facility: NWIRP Bethpage
Project Number: 112G08005-WE13	Location: Bethpage, New York
Date: August 15, 2022 11:07	Personnel: RJ Brydon
Well ID: BP-TT-MW201D1	Well Location: 214055.8 1123155.3
Well Status: In Use (Confirmed)	Screen Interval: 480-500
WELL INVENTORY CONDITION	
Concrete pad in acceptable condition i.e. no cracks?	YES
Manhole cover present and in working condition?	YES
All bolts on manhole present and not stripped?	NO
Well plug present, locked and in good working condition?	YES
OVERALL CONDITION:	GOOD
Notes (Explain if answered No to any of the above) All 3 bolts broken

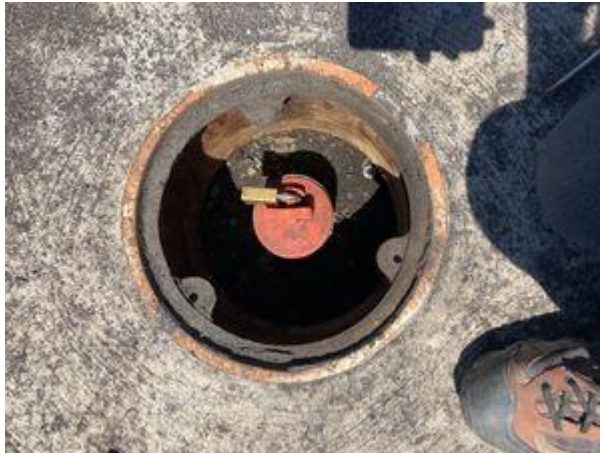
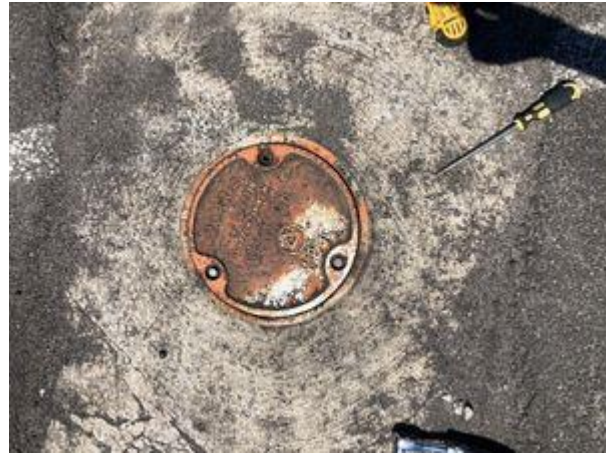
Client: Navy CLEAN	Facility: NWIRP Bethpage
Project Number: 112G08005-WE13	Location: Bethpage, New York
Date: August 12, 2022 13:30	Personnel: Beau Benfield
Well ID: BP-TT-MW202D	Well Location: 215062 1122983.6
Well Status: In Use (Confirmed)	Screen Interval: 335-350
WELL INVENTORY CONDITION	
Concrete pad in acceptable condition i.e. no cracks?	YES
Manhole cover present and in working condition?	YES
All bolts on manhole present and not stripped?	NO
Well plug present, locked and in good working condition?	YES
OVERALL CONDITION:	GOOD
Notes (Explain if answered No to any of the above) One bolt boken off inside well collar

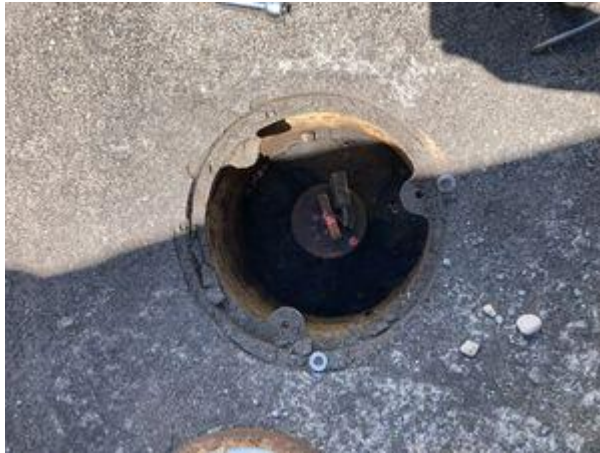
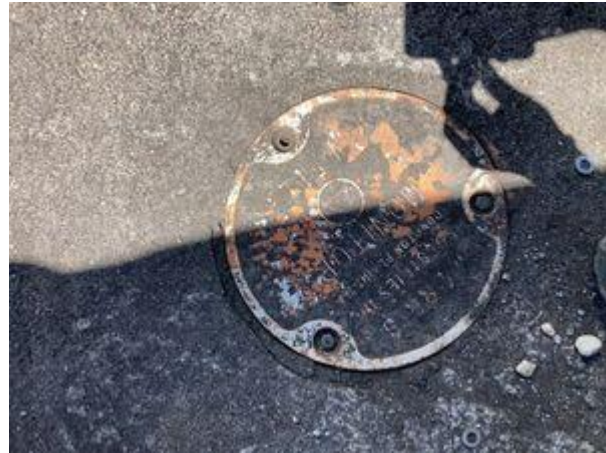
Client: Navy CLEAN	Facility: NWIRP Bethpage
Project Number: 112G08005-WE13	Location: Bethpage, New York
Date: August 12, 2022 13:33	Personnel: Beau Benfield
Well ID: BP-TT-MW202D1	Well Location: 215078.6 1122982.4
Well Status: In Use (Confirmed)	Screen Interval: 425-440
WELL INVENTORY CONDITION	
Concrete pad in acceptable condition i.e. no cracks?	YES
Manhole cover present and in working condition?	YES
All bolts on manhole present and not stripped?	NO
Well plug present, locked and in good working condition?	YES
OVERALL CONDITION:	GOOD
Notes (Explain if answered No to any of the above) One bolt stripped off inside well collar

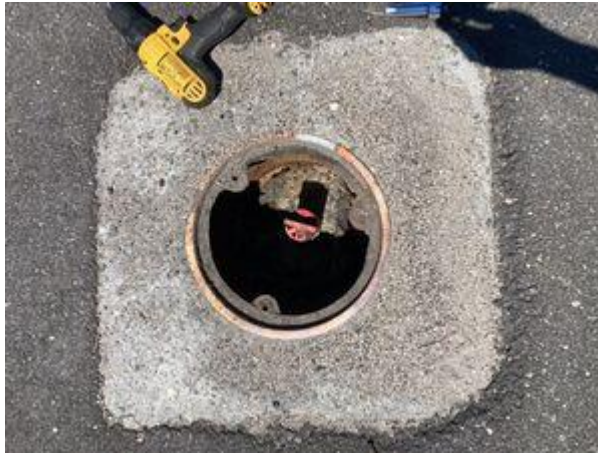
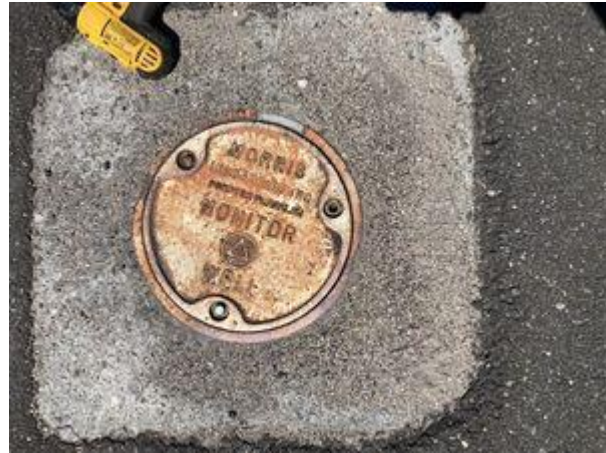
Client: Navy CLEAN	Facility: NWIRP Bethpage
Project Number: 112G08005-WE13	Location: Bethpage, New York
Date: August 12, 2022 13:40	Personnel: Beau Benfield
Well ID: BP-TT-MW202S	Well Location: 215099.9 1122993.3
Well Status: In Use (Confirmed)	Screen Interval: 54-64
WELL INVENTORY CONDITION	
Concrete pad in acceptable condition i.e. no cracks?	YES
Manhole cover present and in working condition?	YES
All bolts on manhole present and not stripped?	NO
Well plug present, locked and in good working condition?	YES
OVERALL CONDITION:	GOOD
Notes (Explain if answered No to any of the above) One bolt broken off in well collar

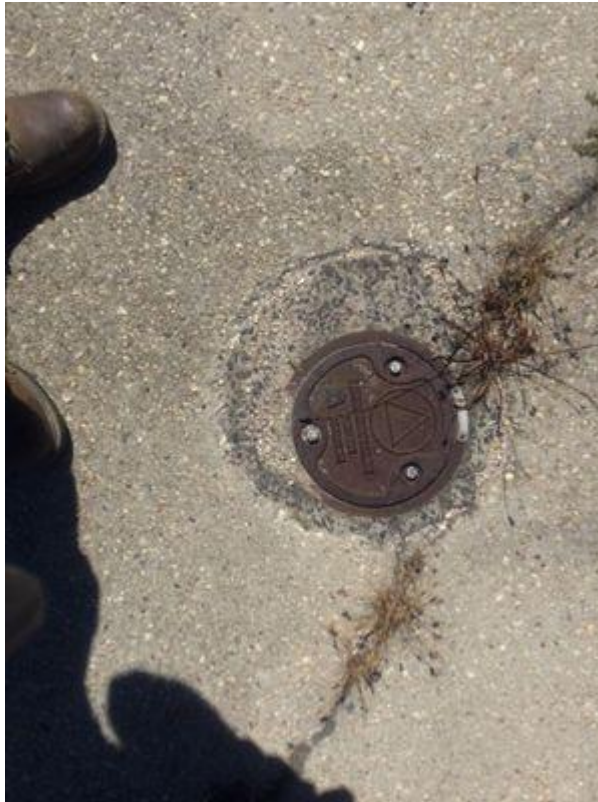
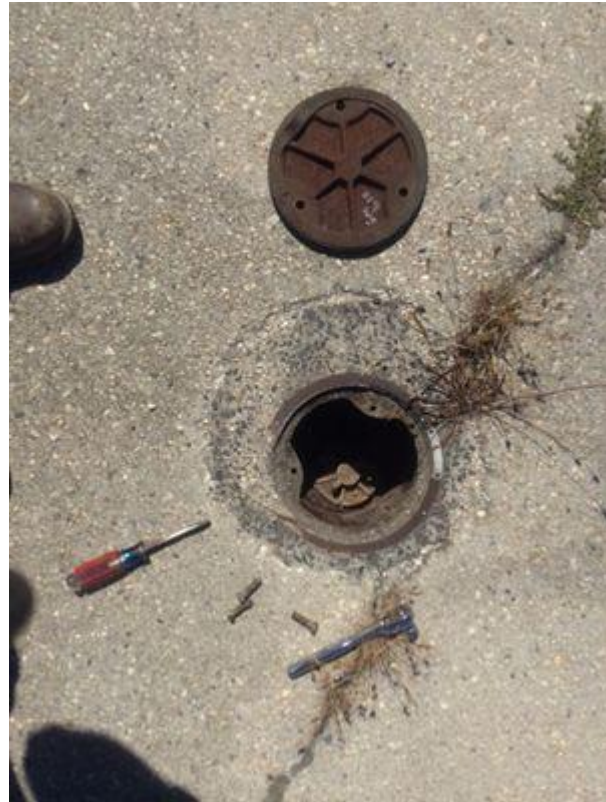
Client: Navy CLEAN	Facility: NWIRP Bethpage
Project Number: 112G08005-WE13	Location: Bethpage, New York
Date: September 2, 2022 12:21	Personnel: Jake Marlow
Well ID: GM-16SR	Well Location: 212308 1123645
Well Status: In Use (Confirmed)	Screen Interval:
WELL INVENTORY CONDITION	
Concrete pad in acceptable condition i.e. no cracks?	NO
Manhole cover present and in working condition?	YES
All bolts on manhole present and not stripped?	YES
Well plug present, locked and in good working condition?	YES
OVERALL CONDITION:	FAIR
Notes (Explain if answered No to any of the above)

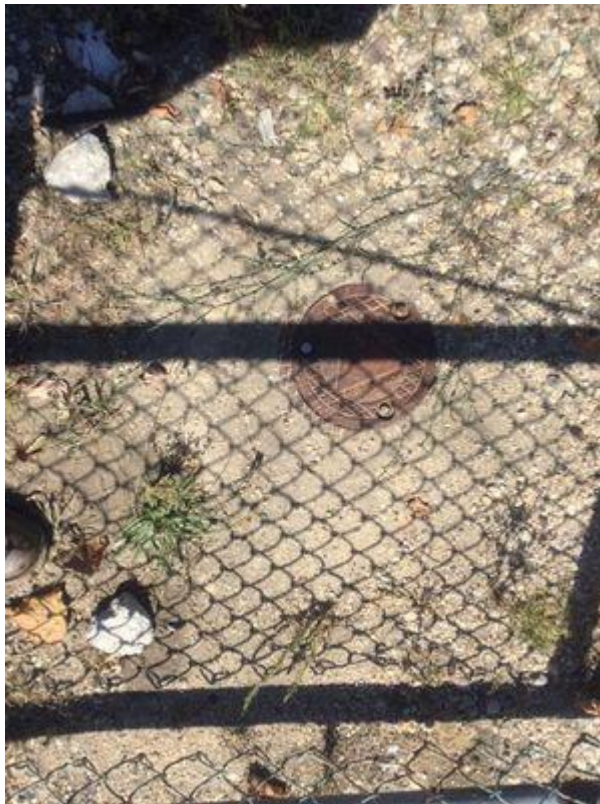
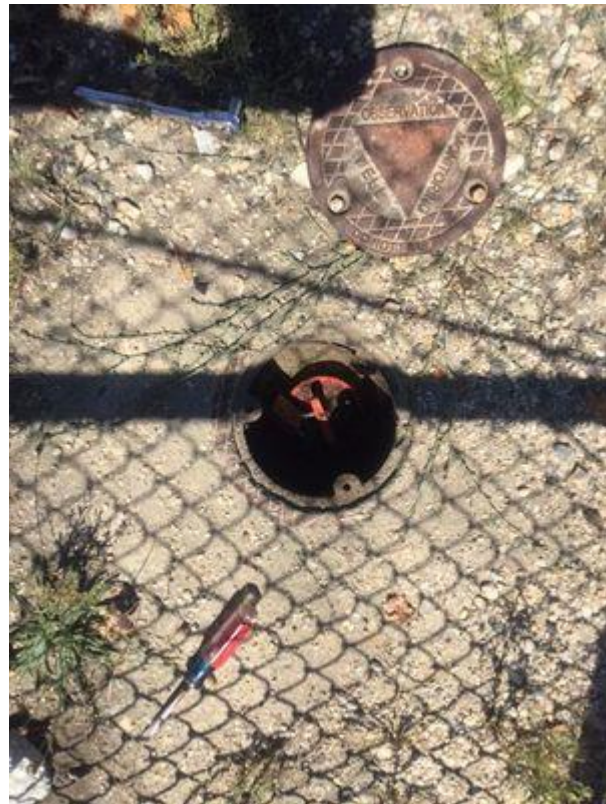
Client: Navy CLEAN	Facility: NWIRP Bethpage
Project Number: 112G08005-WE13	Location: Bethpage, New York
Date: September 2, 2022 12:05	Personnel: Jake Marlow
Well ID: GM-17SR	Well Location: 211377.743056 1122835.51042
Well Status: In Use (Confirmed)	Screen Interval:
WELL INVENTORY CONDITION	
Concrete pad in acceptable condition i.e. no cracks?	YES
Manhole cover present and in working condition?	YES
All bolts on manhole present and not stripped?	NO
Well plug present, locked and in good working condition?	YES
OVERALL CONDITION:	GOOD
Notes (Explain if answered No to any of the above) Replaced one missing bolt

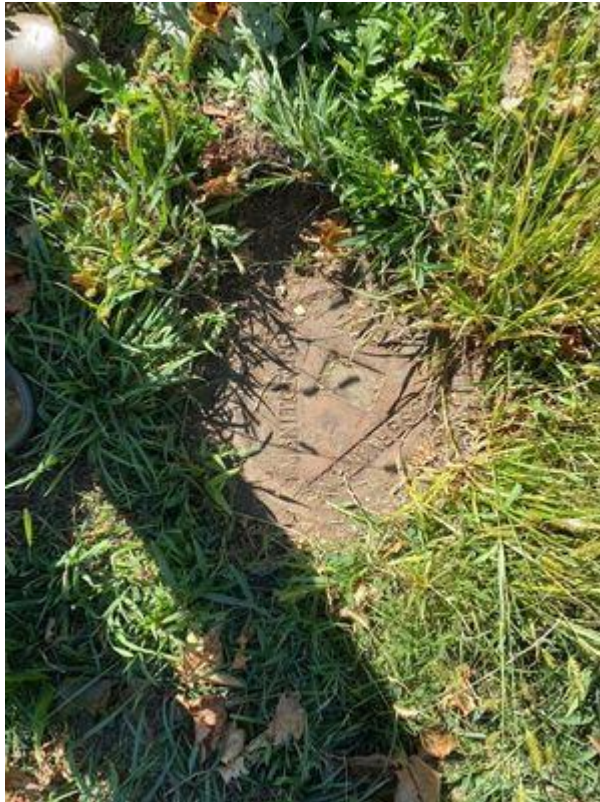
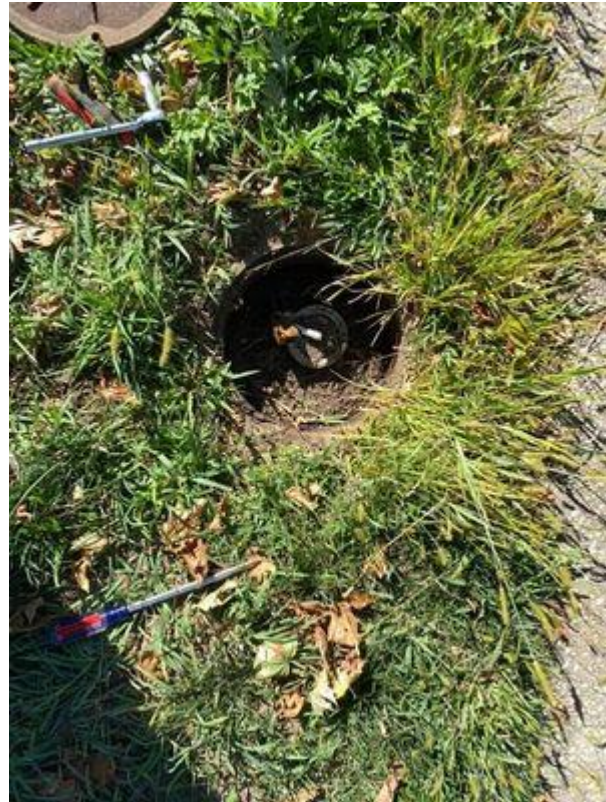
Client: Navy CLEAN	Facility: NWIRP Bethpage
Project Number: 112G08005-WE13	Location: Bethpage, New York
Date: September 29, 2022 10:41	Personnel: Jake Marlow
Well ID: GM38D	Well Location: 206354 1128945
Well Status: In Use (Confirmed)	Screen Interval: 320-340
WELL INVENTORY CONDITION	
Concrete pad in acceptable condition i.e. no cracks?	YES
Manhole cover present and in working condition?	YES
All bolts on manhole present and not stripped?	NO
Well plug present, locked and in good working condition?	YES
OVERALL CONDITION:	GOOD
Notes (Explain if answered No to any of the above) Manhole stripped where bolts screw in

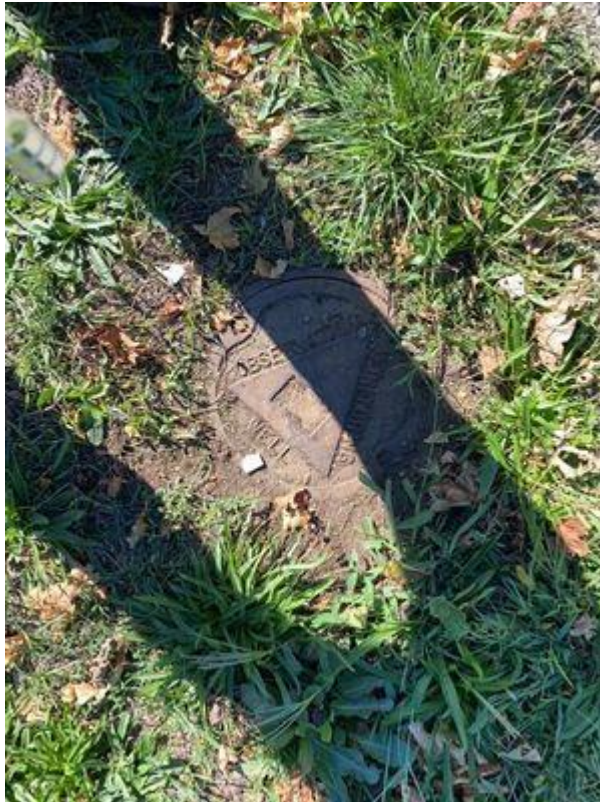
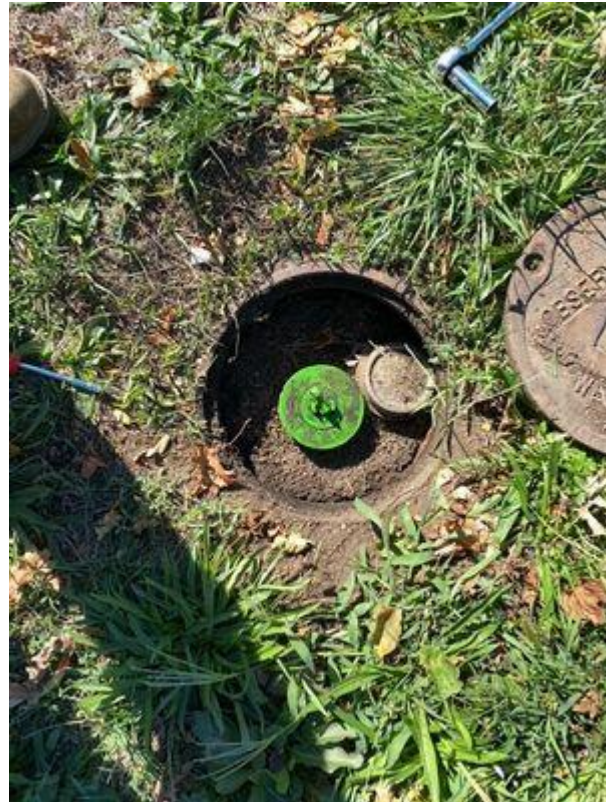
Client: Navy CLEAN	Facility: NWIRP Bethpage
Project Number: 112G08005-WE13	Location: Bethpage, New York
Date: September 29, 2022 10:37	Personnel: Jake Marlow
Well ID: GM38D2	Well Location: 206338 1128953
Well Status: In Use (Confirmed)	Screen Interval: 475-495
WELL INVENTORY CONDITION	
Concrete pad in acceptable condition i.e. no cracks?	YES
Manhole cover present and in working condition?	YES
All bolts on manhole present and not stripped?	NO
Well plug present, locked and in good working condition?	YES
OVERALL CONDITION:	FAIR
Notes (Explain if answered No to any of the above) Manhole stripped where bolts screw in

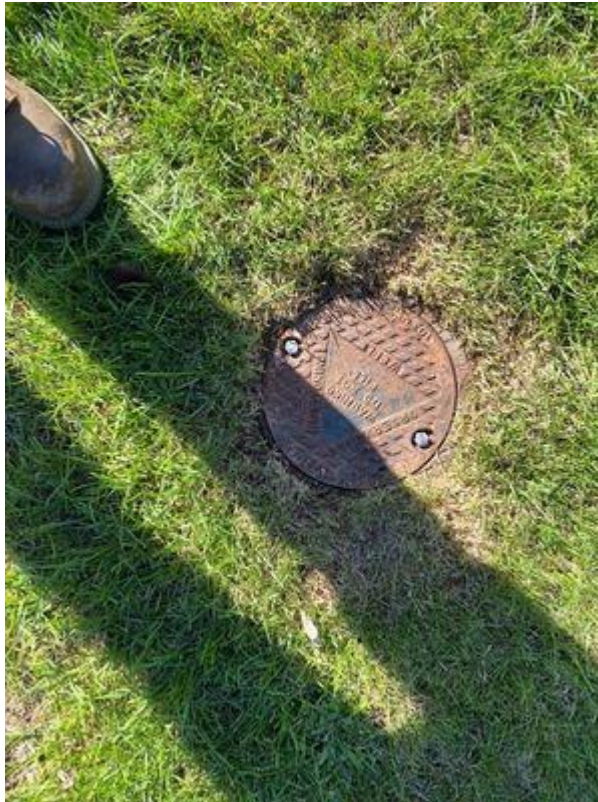
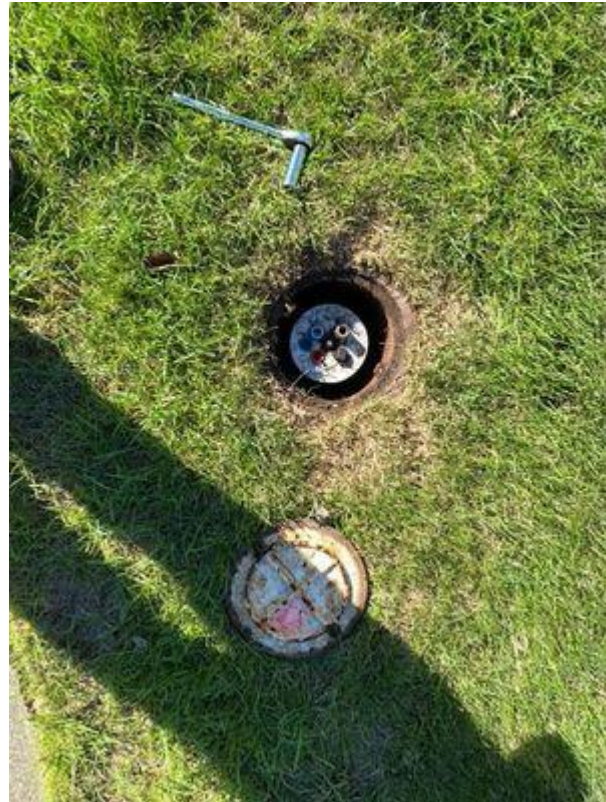
Client: Navy CLEAN	Facility: NWIRP Bethpage
Project Number: 112G08005-WE13	Location: Bethpage, New York
Date: September 29, 2022 10:28	Personnel: Jake Marlow
Well ID: GM38-RW1-MW1	Well Location: 206068.116 1129607.668
Well Status: In Use (Confirmed)	Screen Interval: 395-435
WELL INVENTORY CONDITION	
Concrete pad in acceptable condition i.e. no cracks?	YES
Manhole cover present and in working condition?	YES
All bolts on manhole present and not stripped?	NO
Well plug present, locked and in good working condition?	YES
OVERALL CONDITION:	FAIR
Notes (Explain if answered No to any of the above) Replaced 2 missing bolts

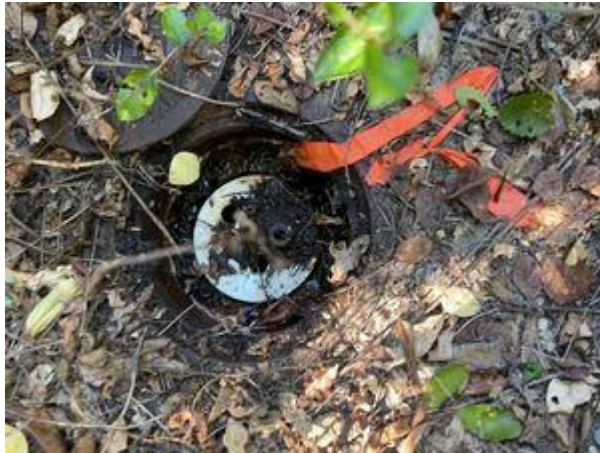
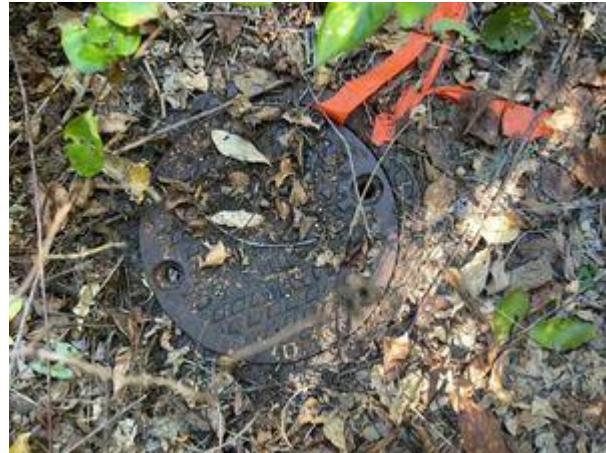
Client: Navy CLEAN	Facility: NWIRP Bethpage
Project Number: 112G08005-WE13	Location: Bethpage, New York
Date: August 15, 2022 16:03	Personnel: RJ Brydon
Well ID: GM38-RW1-MW2	Well Location: 206077.6 1129746.4
Well Status: Not In Use	Screen Interval: 395-435
WELL INVENTORY CONDITION	
Concrete pad in acceptable condition i.e. no cracks?	YES
Manhole cover present and in working condition?	YES
All bolts on manhole present and not stripped?	NO
Well plug present, locked and in good working condition?	YES
OVERALL CONDITION:	GOOD
Notes (Explain if answered No to any of the above) No bolts

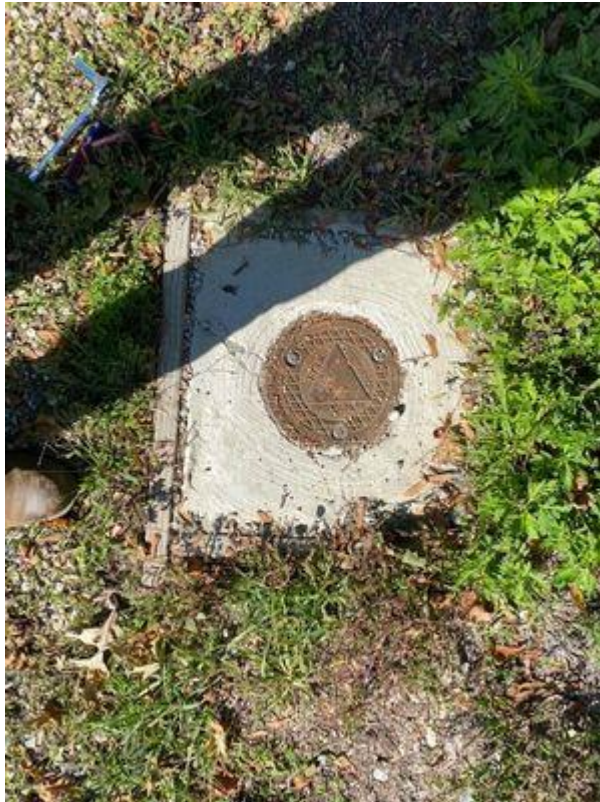
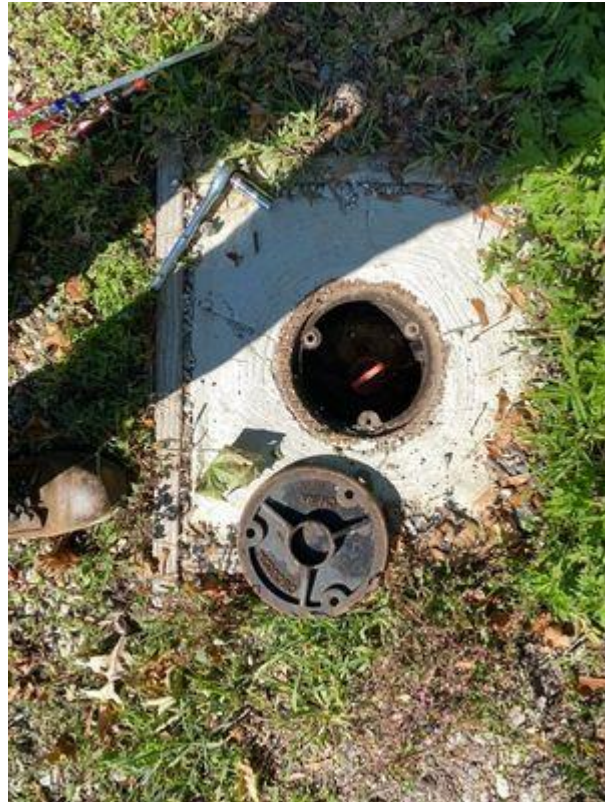
Client: Navy CLEAN	Facility: NWIRP Bethpage
Project Number: 112G08005-WE13	Location: Bethpage, New York
Date: September 29, 2022 10:52	Personnel: Jake Marlow
Well ID: GM38-RW2-MW3	Well Location: 206388.3 1129262.3
Well Status: In Use (Confirmed)	Screen Interval: 470-510
WELL INVENTORY CONDITION	
Concrete pad in acceptable condition i.e. no cracks?	NO
Manhole cover present and in working condition?	YES
All bolts on manhole present and not stripped?	YES
Well plug present, locked and in good working condition?	YES
OVERALL CONDITION:	FAIR
Notes (Explain if answered No to any of the above) Cracked pad

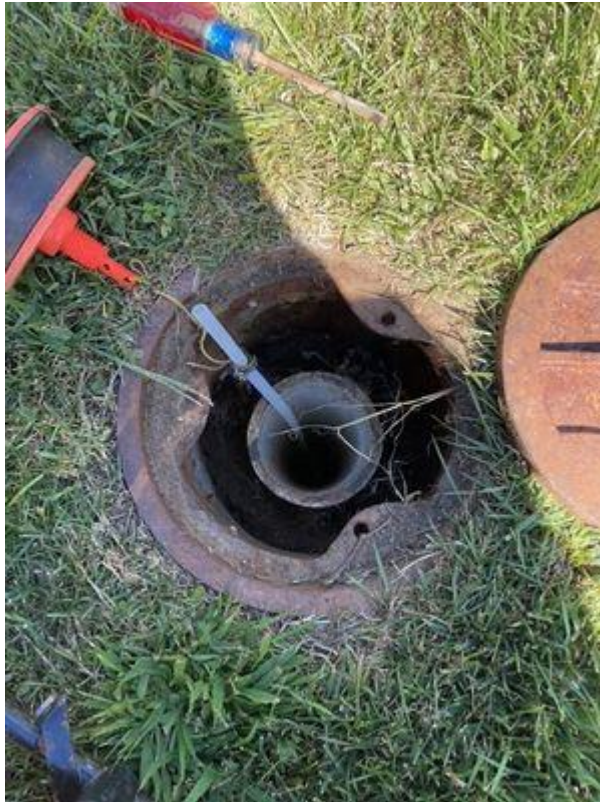
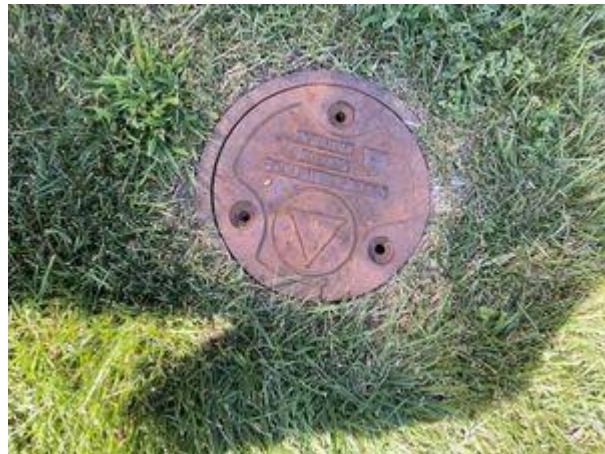
Client: Navy CLEAN	Facility: NWIRP Bethpage
Project Number: 112G08005-WE13	Location: Bethpage, New York
Date: August 15, 2022 15:29	Personnel: RJ Brydon
Well ID: GM38-RW3-MW3	Well Location: 206763.9 1128986.6
Well Status: In Use (Confirmed)	Screen Interval: 320-340
WELL INVENTORY CONDITION	
Concrete pad in acceptable condition i.e. no cracks?	YES
Manhole cover present and in working condition?	
All bolts on manhole present and not stripped?	NO
Well plug present, locked and in good working condition?	YES
OVERALL CONDITION:	GOOD
Notes (Explain if answered No to any of the above) No bolts

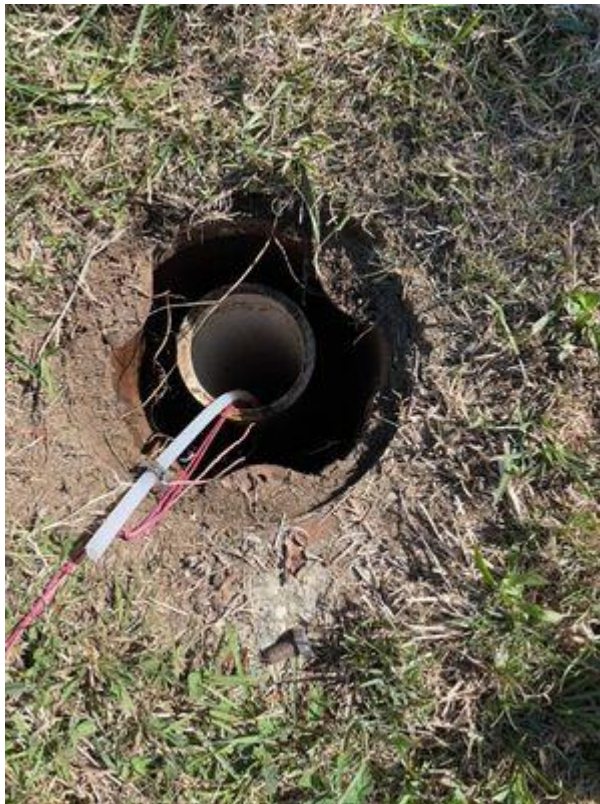
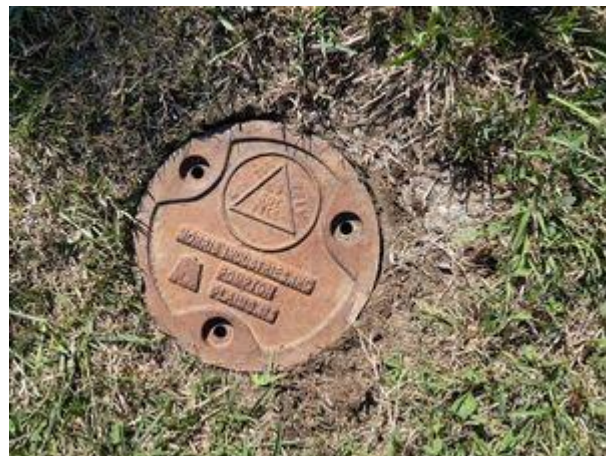
Client: Navy CLEAN	Facility: NWIRP Bethpage
Project Number: 112G08005-WE13	Location: Bethpage, New York
Date: August 15, 2022 15:32	Personnel: RJ Brydon
Well ID: GM38-RW3-MW4	Well Location: 206759.7 1128970.5
Well Status: In Use (Confirmed)	Screen Interval: 475-495
WELL INVENTORY CONDITION	
Concrete pad in acceptable condition i.e. no cracks?	YES
Manhole cover present and in working condition?	YES
All bolts on manhole present and not stripped?	YES
Well plug present, locked and in good working condition?	YES
OVERALL CONDITION:	GOOD
Notes (Explain if answered No to any of the above) Missing 2 bolts

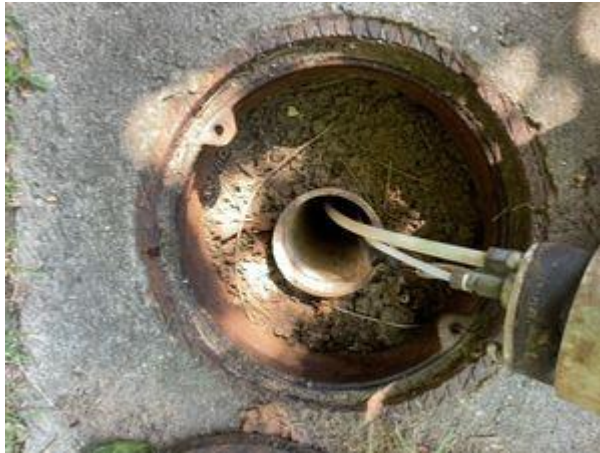
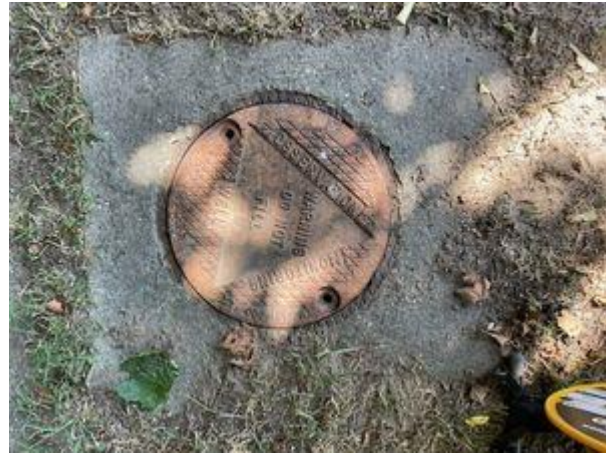
Client: Navy CLEAN	Facility: NWIRP Bethpage
Project Number: 112G08005-WE13	Location: Bethpage, New York
Date: August 15, 2022 15:00	Personnel: RJ Brydon
Well ID: RE104D1	Well Location: 207037.186215 1127745.67815
Well Status: In Use (Confirmed)	Screen Interval: 350-370
WELL INVENTORY CONDITION	
Concrete pad in acceptable condition i.e. no cracks?	YES
Manhole cover present and in working condition?	YES
All bolts on manhole present and not stripped?	NO
Well plug present, locked and in good working condition?	YES
OVERALL CONDITION:	GOOD
Notes (Explain if answered No to any of the above) No bolts

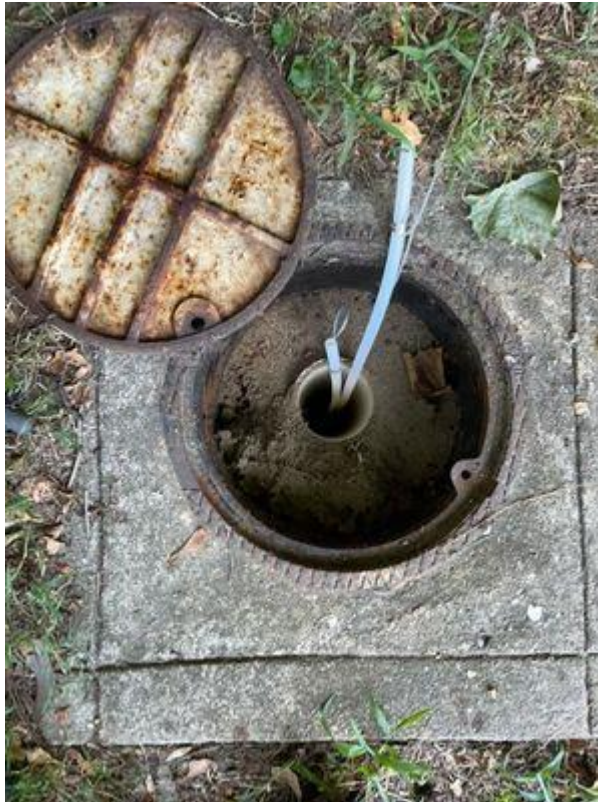
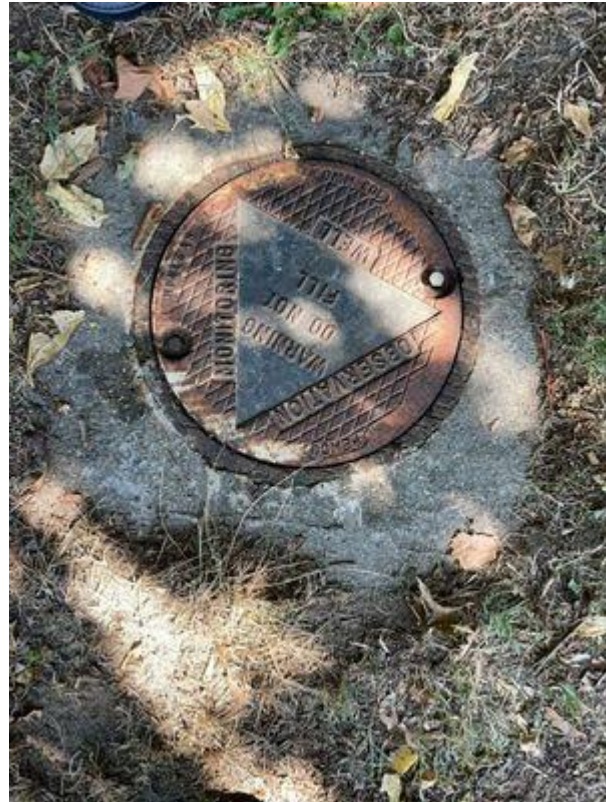
Client: Navy CLEAN	Facility: NWIRP Bethpage
Project Number: 112G08005-WE13	Location: Bethpage, New York
Date: August 15, 2022 15:04	Personnel: RJ Brydon
Well ID: RE104D2	Well Location: 207000.03614 1127708.99093
Well Status: In Use (Confirmed)	Screen Interval: 710-730
WELL INVENTORY CONDITION	
Concrete pad in acceptable condition i.e. no cracks?	YES
Manhole cover present and in working condition?	YES
All bolts on manhole present and not stripped?	NO
Well plug present, locked and in good working condition?	
OVERALL CONDITION:	GOOD
Notes (Explain if answered No to any of the above) No bolts

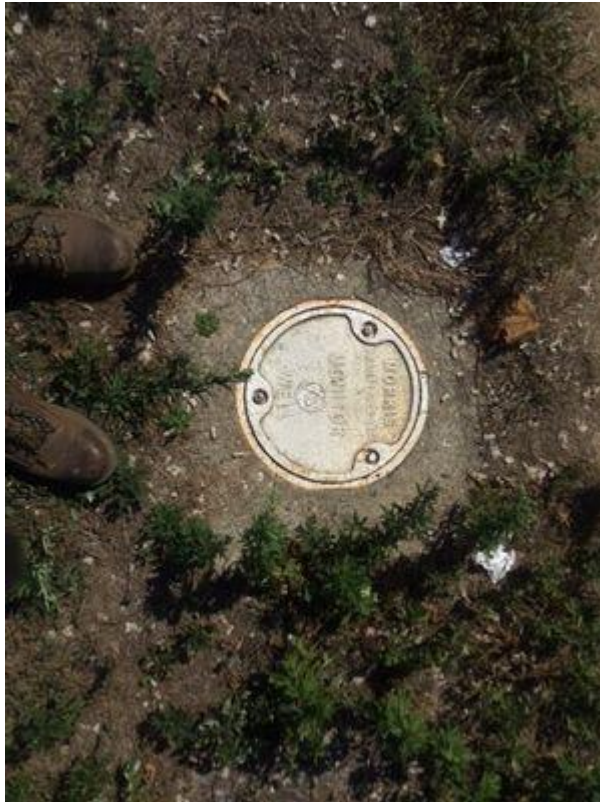
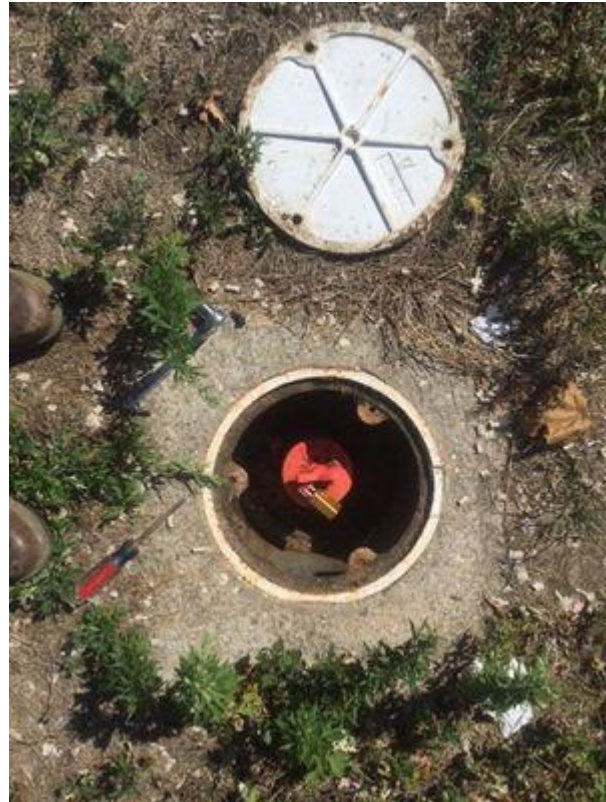
Client: Navy CLEAN	Facility: NWIRP Bethpage
Project Number: 112G08005-WE13	Location: Bethpage, New York
Date: September 2, 2022 14:42	Personnel: Jake Marlow
Well ID: RE106D2	Well Location: 209390.528269 1122872.74612
Well Status: In Use (Confirmed)	Screen Interval: 480-490
WELL INVENTORY CONDITION	
Concrete pad in acceptable condition i.e. no cracks?	YES
Manhole cover present and in working condition?	YES
All bolts on manhole present and not stripped?	NO
Well plug present, locked and in good working condition?	YES
OVERALL CONDITION:	GOOD
Notes (Explain if answered No to any of the above) Replaced two bolts

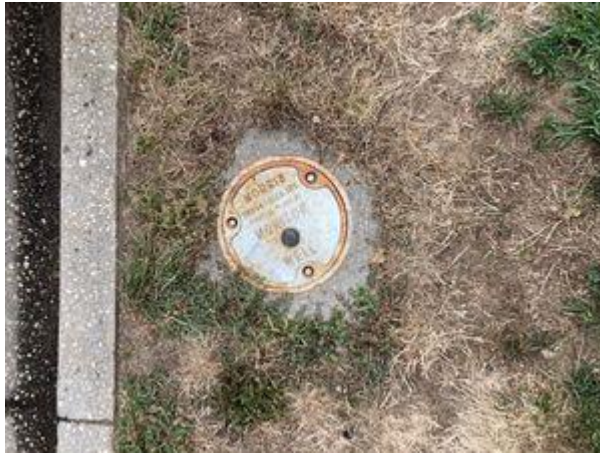
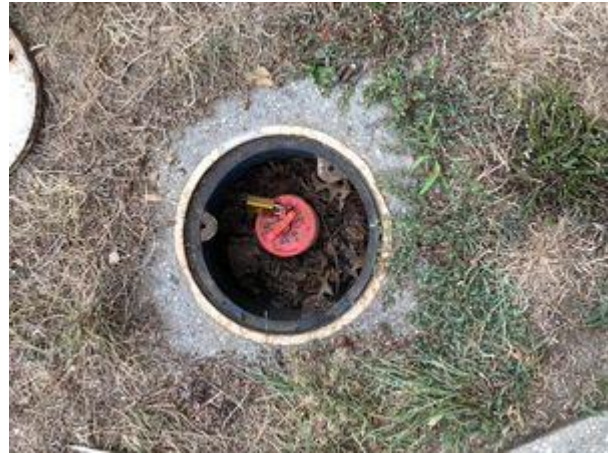
Client: Navy CLEAN	Facility: NWIRP Bethpage
Project Number: 112G08005-WE13	Location: Bethpage, New York
Date: August 17, 2022 09:53	Personnel: Beau Benfield
Well ID: RE114D1	Well Location: 201728.64 1124289.94
Well Status: In Use (Confirmed)	Screen Interval: 535-550
WELL INVENTORY CONDITION	
Concrete pad in acceptable condition i.e. no cracks?	YES
Manhole cover present and in working condition?	YES
All bolts on manhole present and not stripped?	YES
Well plug present, locked and in good working condition?	YES
OVERALL CONDITION:	GOOD
Notes (Explain if answered No to any of the above)

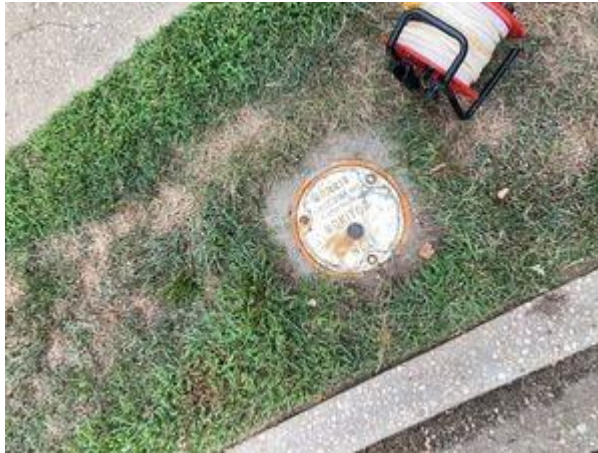
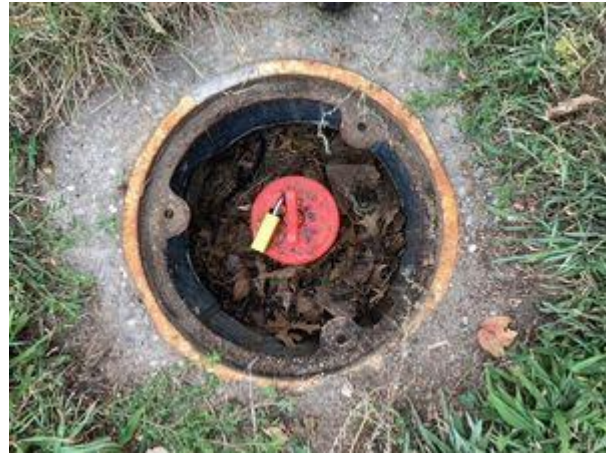
Client: Navy CLEAN	Facility: NWIRP Bethpage
Project Number: 112G08005-WE13	Location: Bethpage, New York
Date: August 17, 2022 10:06	Personnel: Beau Benfield
Well ID: RE114D2	Well Location: 201710.25 1124365.4
Well Status: In Use (Confirmed)	Screen Interval: 610-630
WELL INVENTORY CONDITION	
Concrete pad in acceptable condition i.e. no cracks?	YES
Manhole cover present and in working condition?	YES
All bolts on manhole present and not stripped?	YES
Well plug present, locked and in good working condition?	YES
OVERALL CONDITION:	GOOD
Notes (Explain if answered No to any of the above)

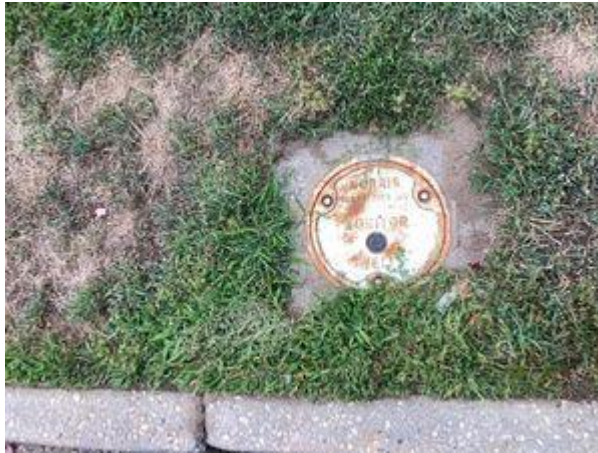
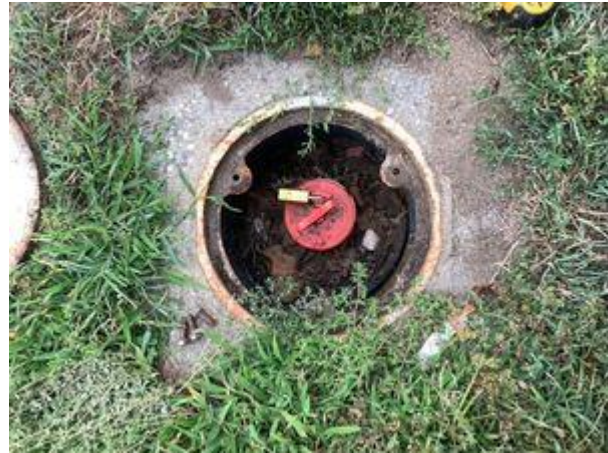
Client: Navy CLEAN	Facility: NWIRP Bethpage
Project Number: 112G08005-WE13	Location: Bethpage, New York
Date: August 17, 2022 09:57	Personnel: Beau Benfield
Well ID: RE114D3	Well Location: 201719.48 1124277.84
Well Status: In Use (Confirmed)	Screen Interval: 700-720
WELL INVENTORY CONDITION	
Concrete pad in acceptable condition i.e. no cracks?	YES
Manhole cover present and in working condition?	YES
All bolts on manhole present and not stripped?	YES
Well plug present, locked and in good working condition?	YES
OVERALL CONDITION:	GOOD
Notes (Explain if answered No to any of the above)
