Memorandum

To: Scot Sokolowski, NAVFAC MIDLANT
From: David Brayack, Tetra Tech
Date: November 17, 2022
Re: Annual LUC Inspection and Operation Summary Report: Sites 1, 2, 3, and 4 –
NWIRP Bethpage
Contract/CTO Number: N6247016D9008/WE16

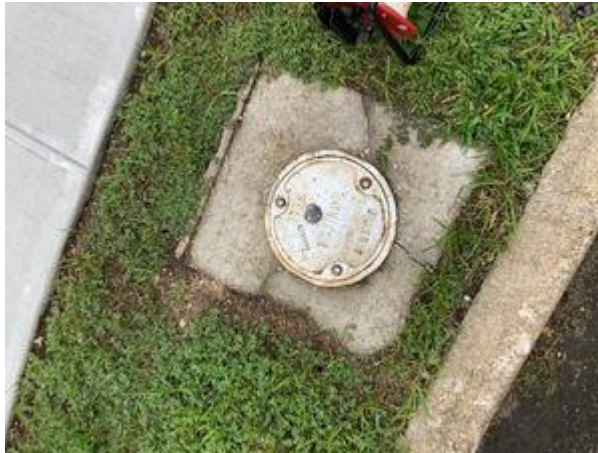
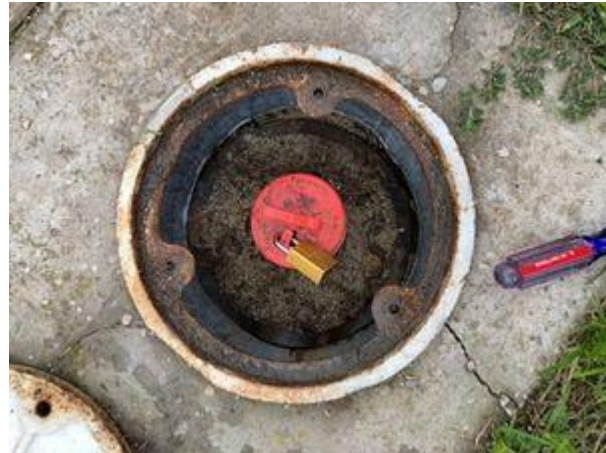
Client: Navy CLEAN	Facility: NWIRP Bethpage
Project Number: 112G08005-WE13	Location: Bethpage, New York
Date: August 17, 2022 10:17	Personnel: Beau Benfield
Well ID: RE115D1	Well Location: 201004.250202 1125721.2869
Well Status: In Use (Confirmed)	Screen Interval: 640-655
WELL INVENTORY CONDITION	
Concrete pad in acceptable condition i.e. no cracks?	YES
Manhole cover present and in working condition?	YES
All bolts on manhole present and not stripped?	YES
Well plug present, locked and in good working condition?	YES
OVERALL CONDITION:	GOOD
Notes (Explain if answered No to any of the above)

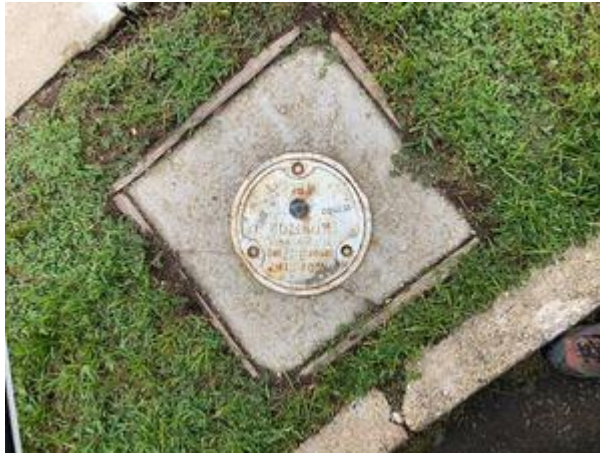
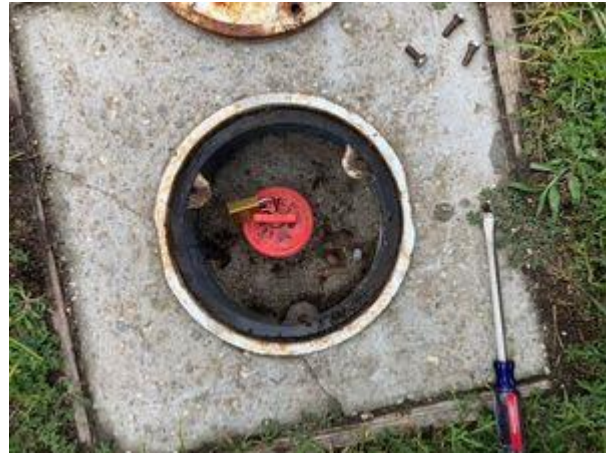
Client: Navy CLEAN	Facility: NWIRP Bethpage
Project Number: 112G08005-WE13	Location: Bethpage, New York
Date: August 17, 2022 10:21	Personnel: Beau Benfield
Well ID: RE115D2	Well Location: 201012.40385 1125747.40209
Well Status: In Use (Confirmed)	Screen Interval: 730-750
WELL INVENTORY CONDITION	
Concrete pad in acceptable condition i.e. no cracks?	YES
Manhole cover present and in working condition?	YES
All bolts on manhole present and not stripped?	YES
Well plug present, locked and in good working condition?	YES
OVERALL CONDITION:	GOOD
Notes (Explain if answered No to any of the above)

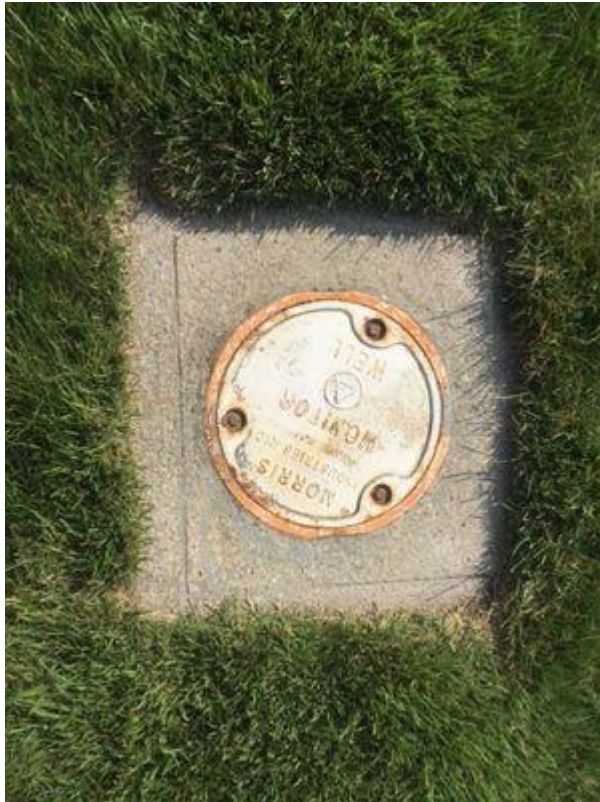
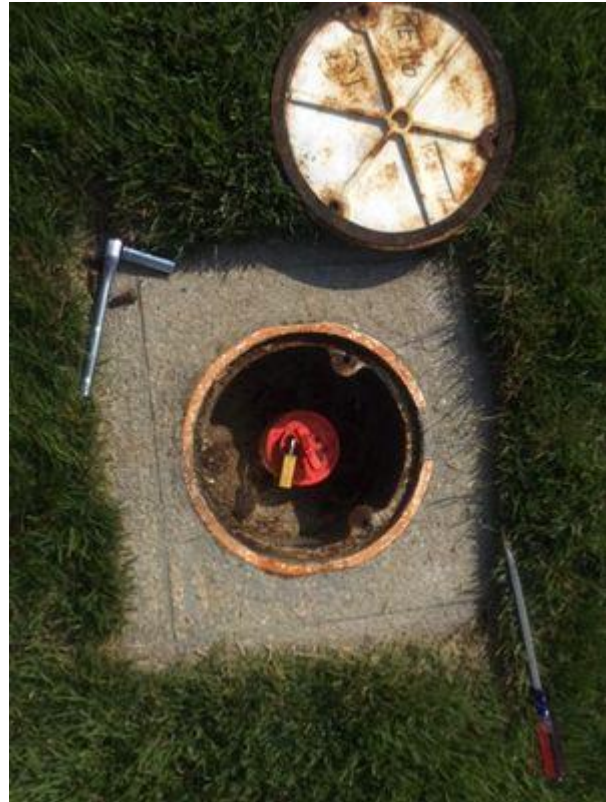
Client: Navy CLEAN	Facility: NWIRP Bethpage
Project Number: 112G08005-WE13	Location: Bethpage, New York
Date: September 16, 2022 11:10	Personnel: Jake Marlow
Well ID: RE116D1	Well Location: 202312.88 1128388.54
Well Status: In Use (Confirmed)	Screen Interval: 570-590
WELL INVENTORY CONDITION	
Concrete pad in acceptable condition i.e. no cracks?	YES
Manhole cover present and in working condition?	YES
All bolts on manhole present and not stripped?	YES
Well plug present, locked and in good working condition?	YES
OVERALL CONDITION:	GOOD
Notes (Explain if answered No to any of the above)

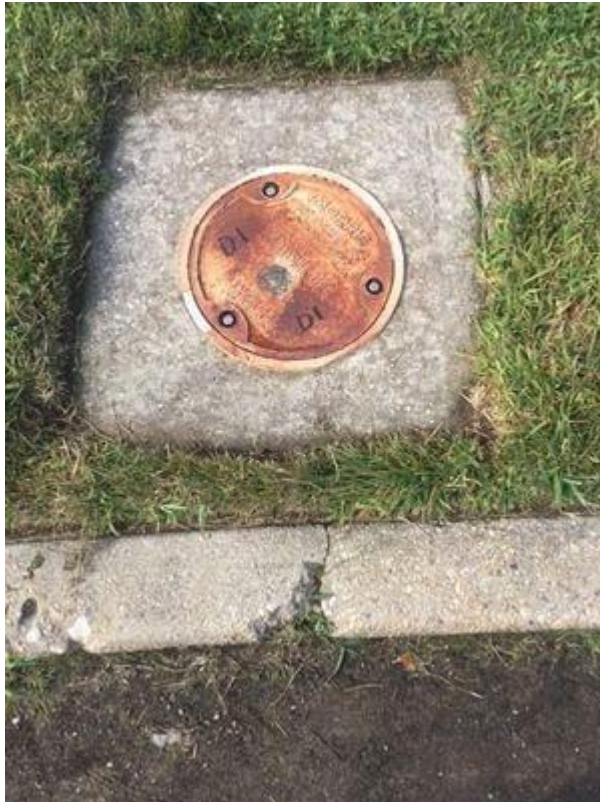
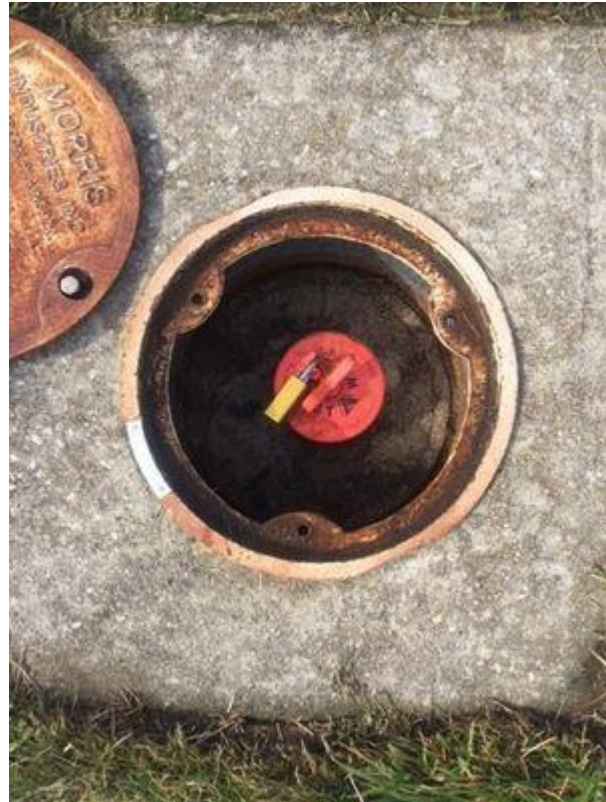
Client: Navy CLEAN	Facility: NWIRP Bethpage
Project Number: 112G08005-WE13	Location: Bethpage, New York
Date: August 15, 2022 09:15	Personnel:
Well ID: RE117D1	Well Location: 196462.44 1125318.92
Well Status: In Use (Confirmed)	Screen Interval: 730-755
WELL INVENTORY CONDITION	
Concrete pad in acceptable condition i.e. no cracks?	YES
Manhole cover present and in working condition?	YES
All bolts on manhole present and not stripped?	YES
Well plug present, locked and in good working condition?	YES
OVERALL CONDITION:	GOOD
Notes (Explain if answered No to any of the above)

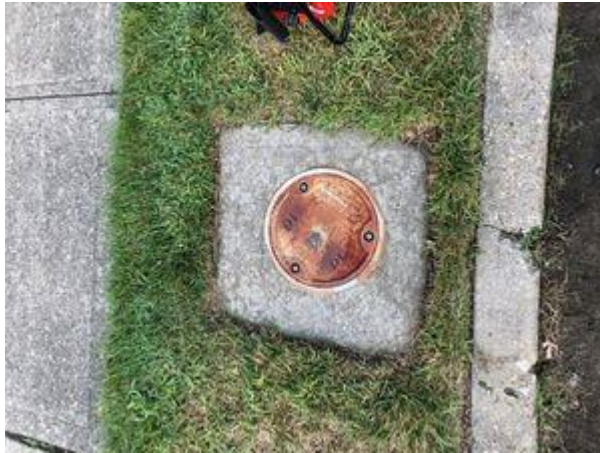
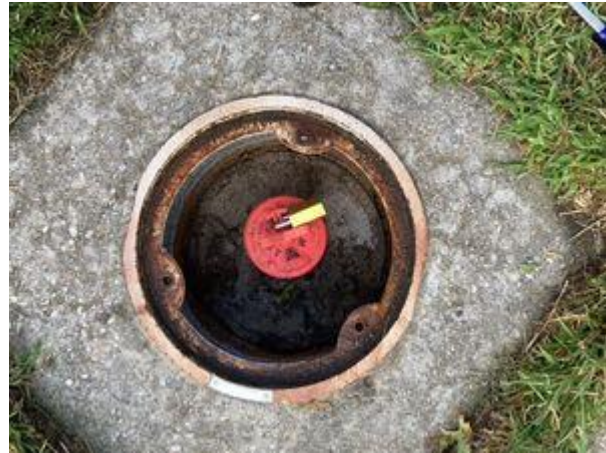
Client: Navy CLEAN	Facility: NWIRP Bethpage
Project Number: 112G08005-WE13	Location: Bethpage, New York
Date: August 17, 2022 08:12	Personnel: Beau Benfield
Well ID: RE117D1	Well Location: 196462.44 1125318.92
Well Status: In Use (Confirmed)	Screen Interval: 730-755
WELL INVENTORY CONDITION	
Concrete pad in acceptable condition i.e. no cracks?	YES
Manhole cover present and in working condition?	YES
All bolts on manhole present and not stripped?	YES
Well plug present, locked and in good working condition?	YES
OVERALL CONDITION:	GOOD
Notes (Explain if answered No to any of the above)

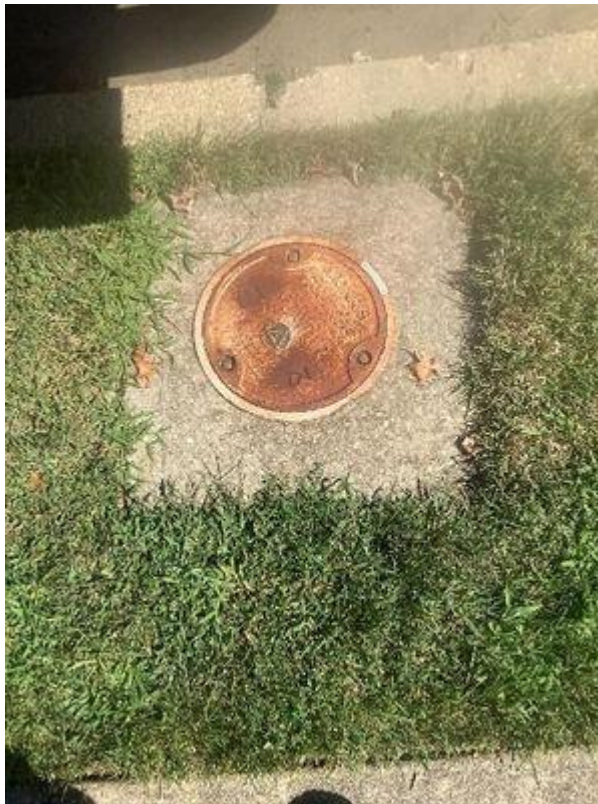
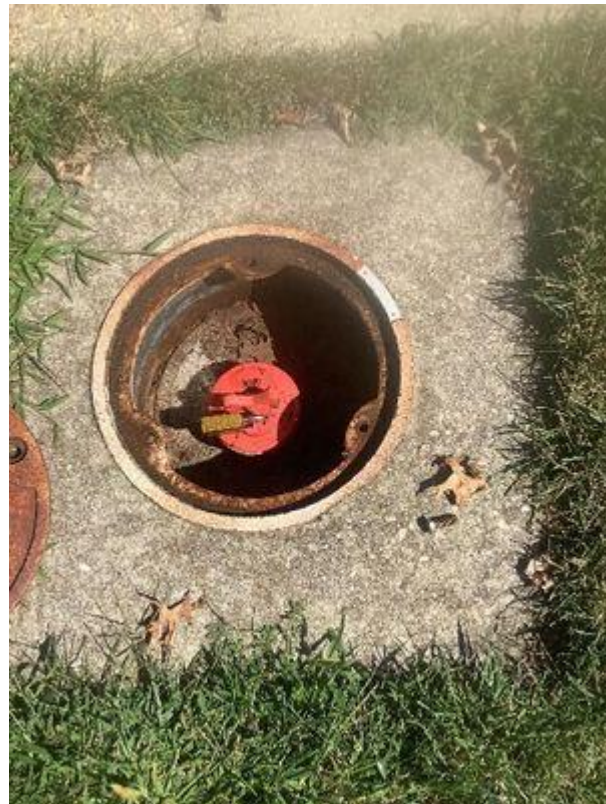
Client: Navy CLEAN	Facility: NWIRP Bethpage
Project Number: 112G08005-WE13	Location: Bethpage, New York
Date: September 2, 2022 11:30	Personnel: Will Yeung
Well ID: RE117D1	Well Location: 196462.44 1125318.92
Well Status: In Use (Confirmed)	Screen Interval: 730-755
WELL INVENTORY CONDITION	
Concrete pad in acceptable condition i.e. no cracks?	YES
Manhole cover present and in working condition?	YES
All bolts on manhole present and not stripped?	YES
Well plug present, locked and in good working condition?	YES
OVERALL CONDITION:	GOOD
Notes (Explain if answered No to any of the above)

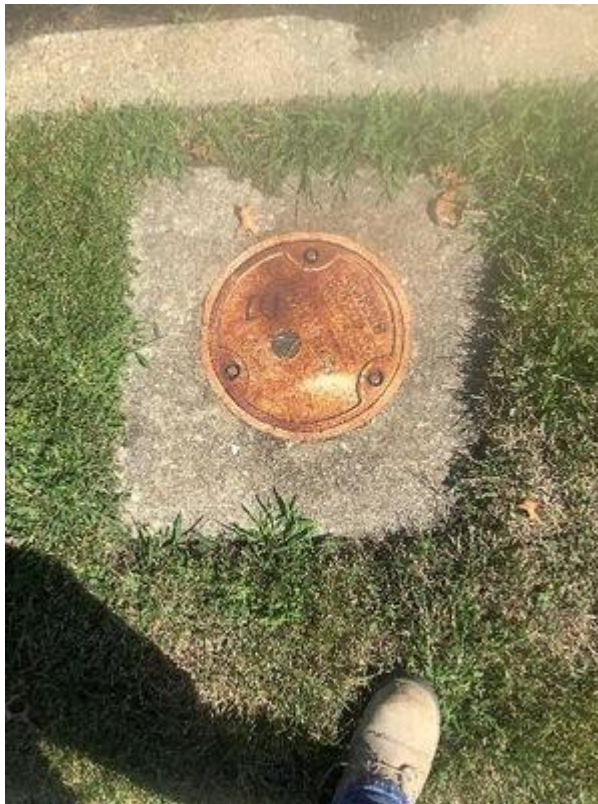
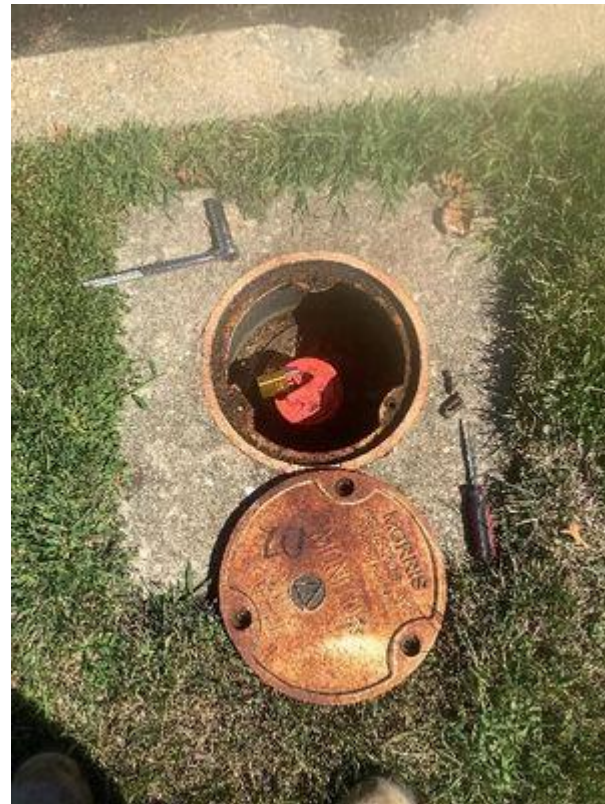
Client: Navy CLEAN	Facility: NWIRP Bethpage
Project Number: 112G08005-WE13	Location: Bethpage, New York
Date: September 2, 2022 11:25	Personnel: Will Yeung
Well ID: RE117D2	Well Location: 196455.23 1125332.7
Well Status: In Use (Confirmed)	Screen Interval: 780-805
WELL INVENTORY CONDITION	
Concrete pad in acceptable condition i.e. no cracks?	YES
Manhole cover present and in working condition?	YES
All bolts on manhole present and not stripped?	YES
Well plug present, locked and in good working condition?	YES
OVERALL CONDITION:	GOOD
Notes (Explain if answered No to any of the above)

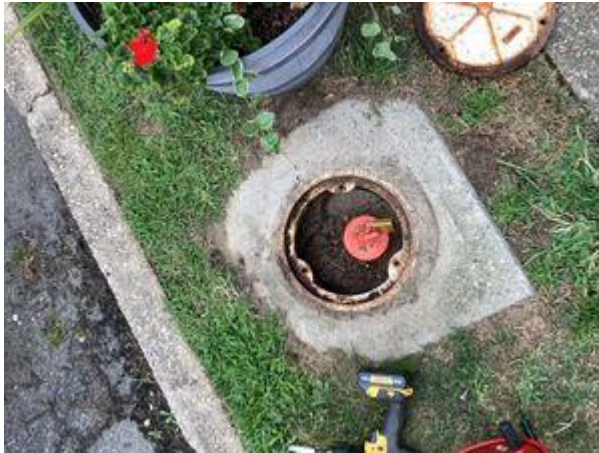
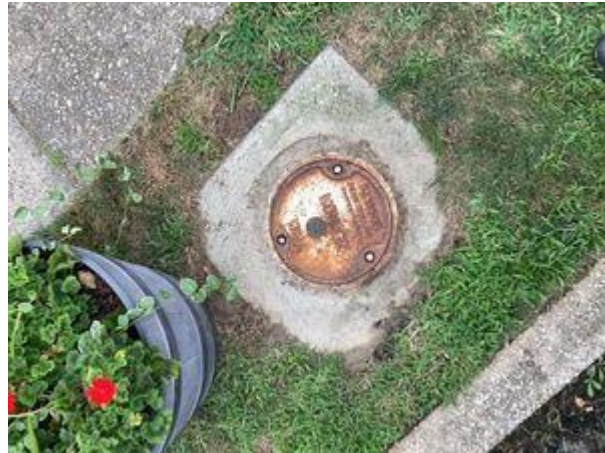
Client: Navy CLEAN	Facility: NWIRP Bethpage
Project Number: 112G08005-WE13	Location: Bethpage, New York
Date: August 17, 2022 09:21	Personnel: Beau Benfield
Well ID: RE118D1	Well Location: 197298.81 1126290.8
Well Status: In Use (Confirmed)	Screen Interval: 765-790
WELL INVENTORY CONDITION	
Concrete pad in acceptable condition i.e. no cracks?	YES
Manhole cover present and in working condition?	YES
All bolts on manhole present and not stripped?	YES
Well plug present, locked and in good working condition?	YES
OVERALL CONDITION:	GOOD
Notes (Explain if answered No to any of the above)

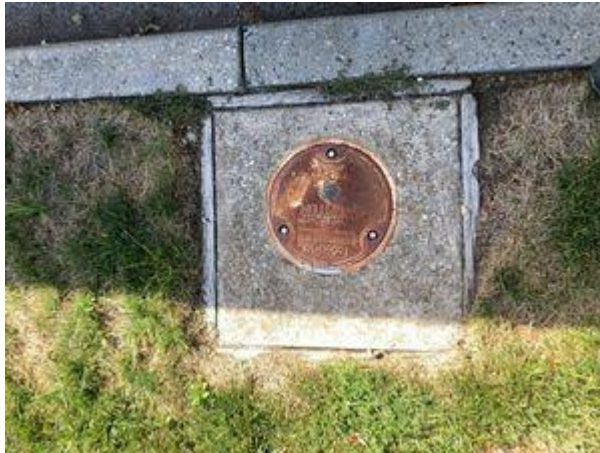
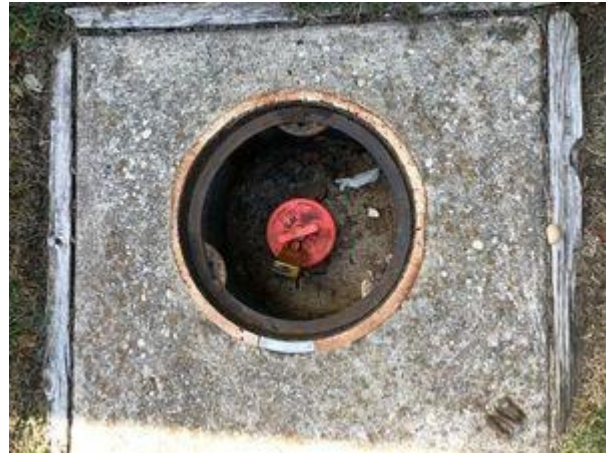
Client: Navy CLEAN	Facility: NWIRP Bethpage
Project Number: 112G08005-WE13	Location: Bethpage, New York
Date: September 2, 2022 15:30	Personnel: Beau Benfield
Well ID: RE119D1	Well Location: 197245.89 1128694.84
Well Status: In Use (Confirmed)	Screen Interval: 715-740
WELL INVENTORY CONDITION	
Concrete pad in acceptable condition i.e. no cracks?	YES
Manhole cover present and in working condition?	YES
All bolts on manhole present and not stripped?	YES
Well plug present, locked and in good working condition?	YES
OVERALL CONDITION:	GOOD
Notes (Explain if answered No to any of the above)

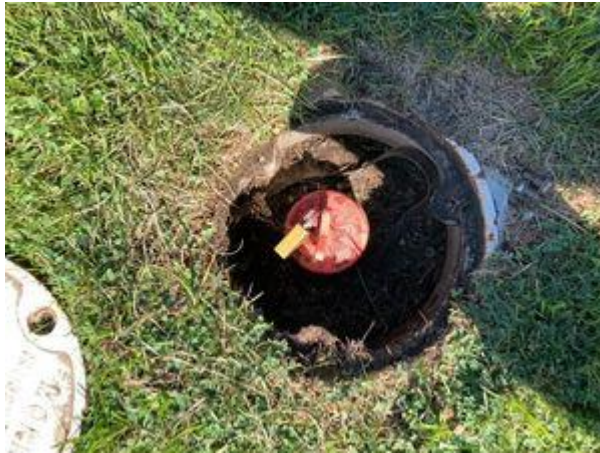
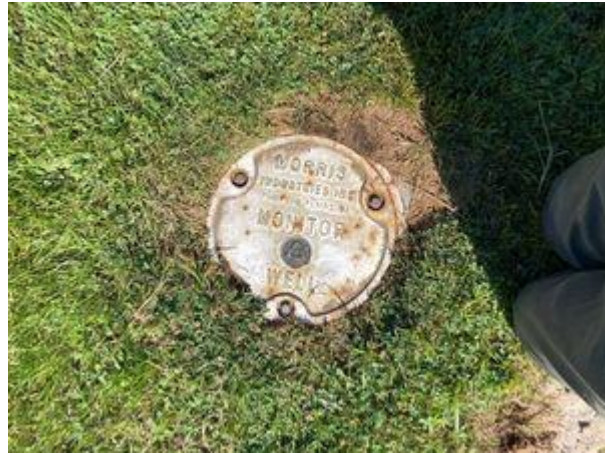
Client: Navy CLEAN	Facility: NWIRP Bethpage
Project Number: 112G08005-WE13	Location: Bethpage, New York
Date: August 18, 2022 10:10	Personnel: Beau Benfield
Well ID: RE120D1	Well Location: 204590.37 1125060.7
Well Status: In Use (Confirmed)	Screen Interval: 630-650
WELL INVENTORY CONDITION	
Concrete pad in acceptable condition i.e. no cracks?	YES
Manhole cover present and in working condition?	YES
All bolts on manhole present and not stripped?	YES
Well plug present, locked and in good working condition?	YES
OVERALL CONDITION:	GOOD
Notes (Explain if answered No to any of the above)

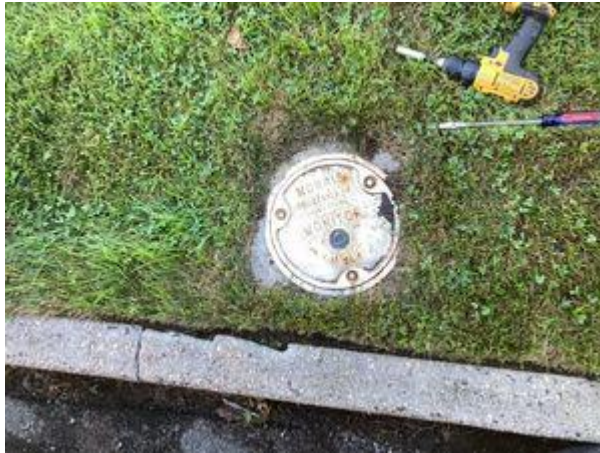
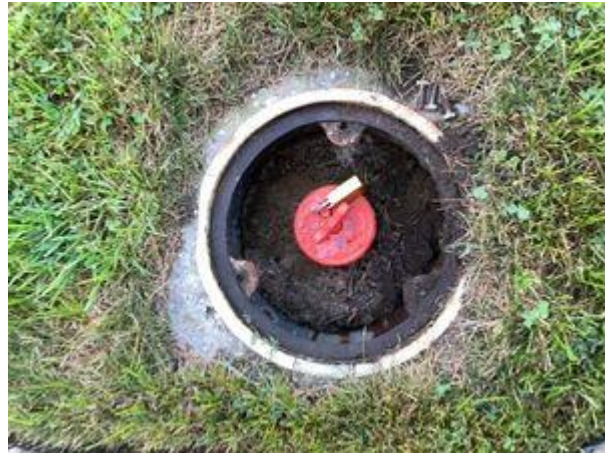
Client: Navy CLEAN	Facility: NWIRP Bethpage
Project Number: 112G08005-WE13	Location: Bethpage, New York
Date: August 18, 2022 09:56	Personnel: Beau Benfield
Well ID: RE120D2	Well Location: 204576.78 1125060.08
Well Status: In Use (Confirmed)	Screen Interval: 690-710
WELL INVENTORY CONDITION	
Concrete pad in acceptable condition i.e. no cracks?	YES
Manhole cover present and in working condition?	YES
All bolts on manhole present and not stripped?	YES
Well plug present, locked and in good working condition?	YES
OVERALL CONDITION:	GOOD
Notes (Explain if answered No to any of the above)

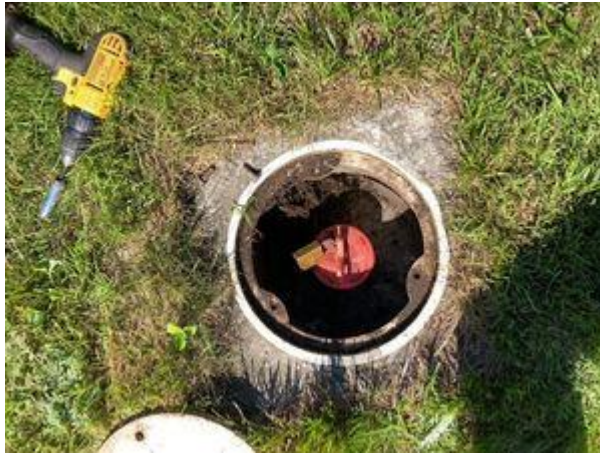
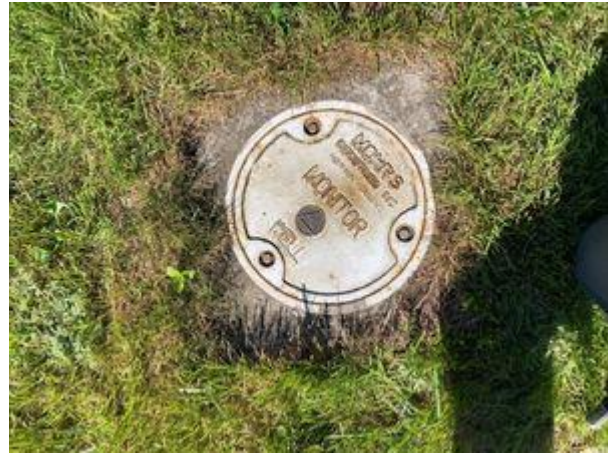
Client: Navy CLEAN	Facility: NWIRP Bethpage
Project Number: 112G08005-WE13	Location: Bethpage, New York
Date: August 18, 2022 10:19	Personnel: Beau Benfield
Well ID: RE120D3	Well Location: 204618.12 1125061.88
Well Status: In Use (Confirmed)	Screen Interval: 740-760
WELL INVENTORY CONDITION	
Concrete pad in acceptable condition i.e. no cracks?	YES
Manhole cover present and in working condition?	YES
All bolts on manhole present and not stripped?	YES
Well plug present, locked and in good working condition?	YES
OVERALL CONDITION:	GOOD
Notes (Explain if answered No to any of the above)

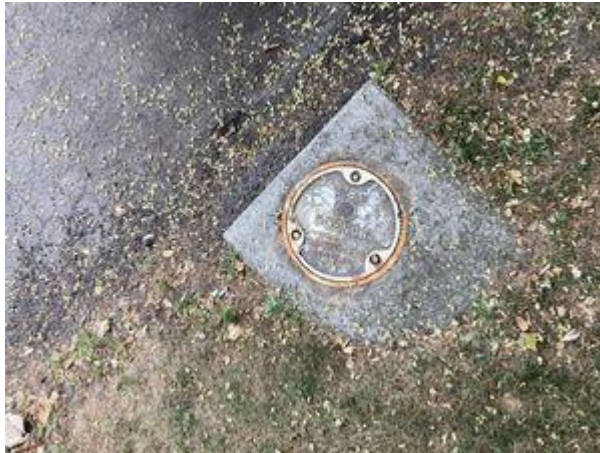
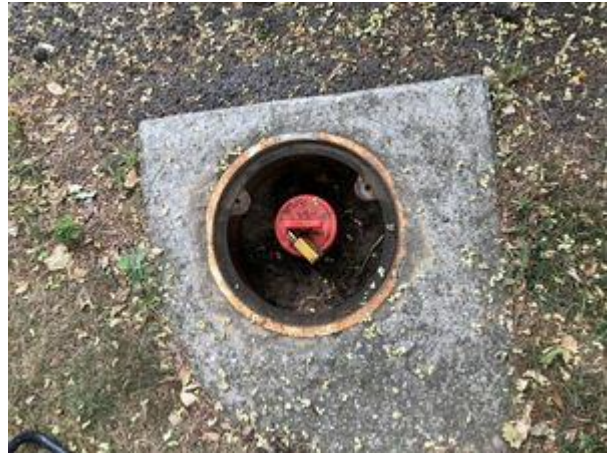
Client: Navy CLEAN	Facility: NWIRP Bethpage
Project Number: 112G08005-WE13	Location: Bethpage, New York
Date: August 17, 2022 11:57	Personnel: Beau Benfield
Well ID: RE121D2	Well Location: 203003.36 1126663.5
Well Status: In Use (Confirmed)	Screen Interval: 730-750
WELL INVENTORY CONDITION	
Concrete pad in acceptable condition i.e. no cracks?	YES
Manhole cover present and in working condition?	YES
All bolts on manhole present and not stripped?	YES
Well plug present, locked and in good working condition?	YES
OVERALL CONDITION:	GOOD
Notes (Explain if answered No to any of the above)

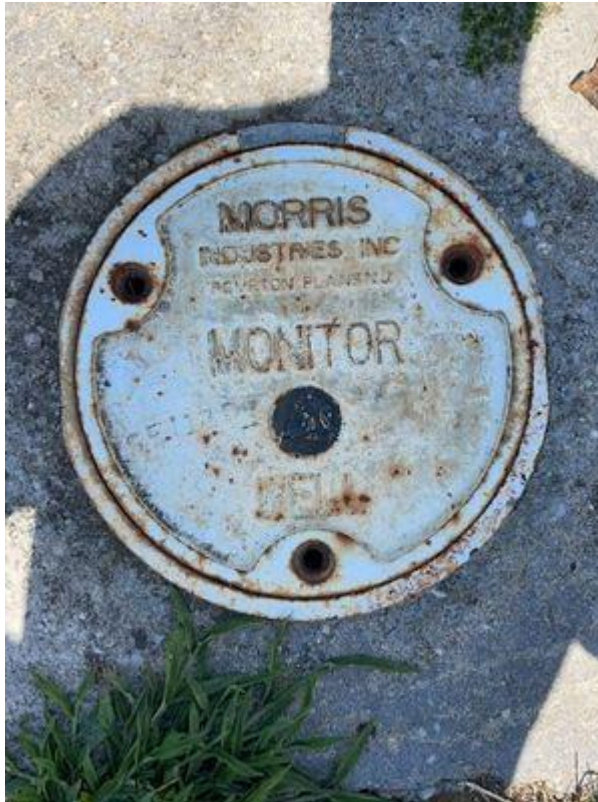
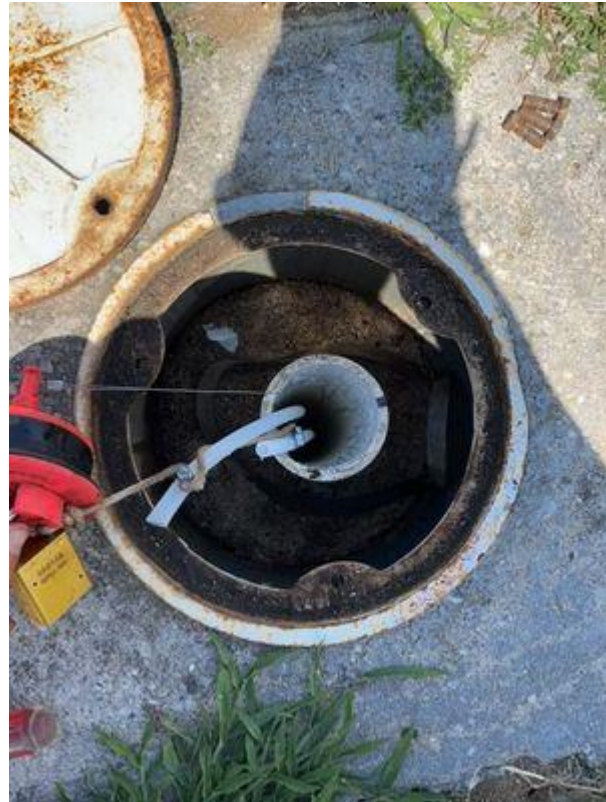
Client: Navy CLEAN	Facility: NWIRP Bethpage
Project Number: 112G08005-WE13	Location: Bethpage, New York
Date: August 15, 2022 14:33	Personnel: RJ Brydon
Well ID: Re122D1	Well Location: 207818.19 1124982.01
Well Status: In Use (Confirmed)	Screen Interval: 520-540
WELL INVENTORY CONDITION	
Concrete pad in acceptable condition i.e. no cracks?	YES
Manhole cover present and in working condition?	YES
All bolts on manhole present and not stripped?	YES
Well plug present, locked and in good working condition?	YES
OVERALL CONDITION:	GOOD
Notes (Explain if answered No to any of the above)

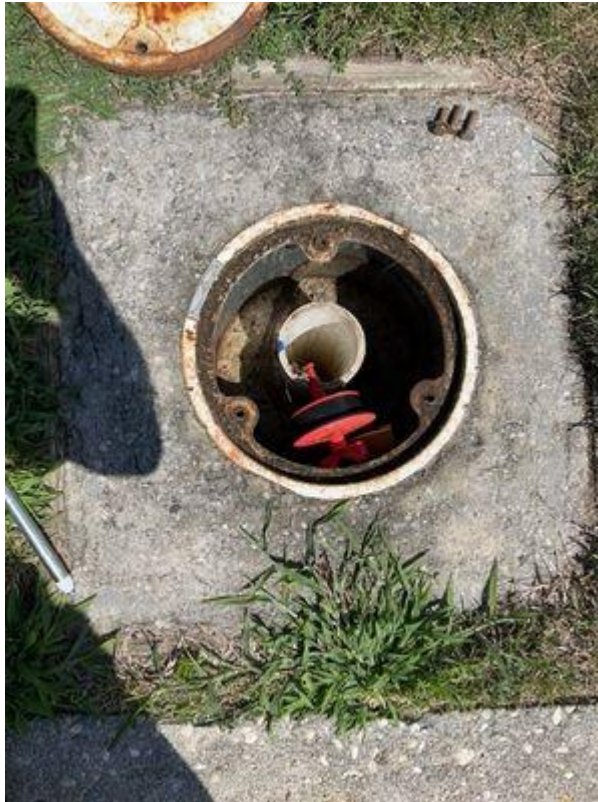
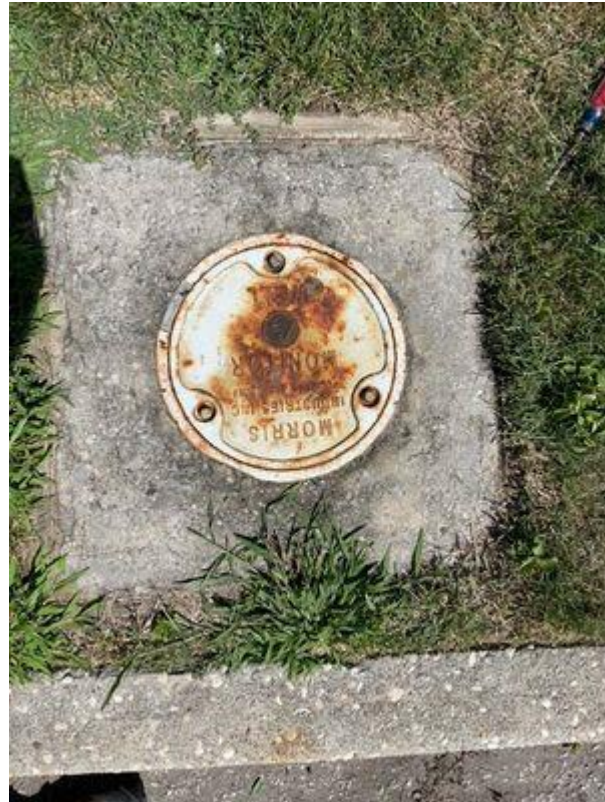
Client: Navy CLEAN	Facility: NWIRP Bethpage
Project Number: 112G08005-WE13	Location: Bethpage, New York
Date: August 15, 2022 14:40	Personnel: RJ Brydon
Well ID: Re122D1	Well Location: 207818.19 1124982.01
Well Status: In Use (Confirmed)	Screen Interval: 520-540
WELL INVENTORY CONDITION	
Concrete pad in acceptable condition i.e. no cracks?	YES
Manhole cover present and in working condition?	YES
All bolts on manhole present and not stripped?	YES
Well plug present, locked and in good working condition?	YES
OVERALL CONDITION:	GOOD
Notes (Explain if answered No to any of the above)

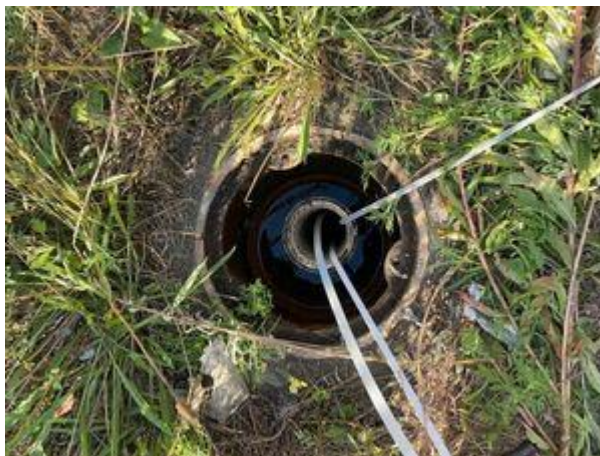
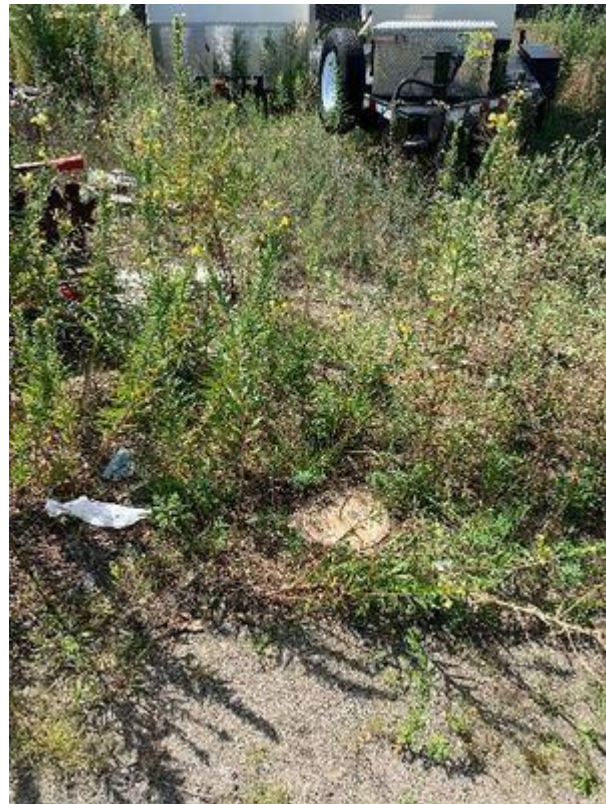
Client: Navy CLEAN	Facility: NWIRP Bethpage
Project Number: 112G08005-WE13	Location: Bethpage, New York
Date: August 19, 2022 08:35	Personnel: RJ Brydon
Well ID: RE123D1	Well Location: 209894.44 1124871.2
Well Status: In Use (Confirmed)	Screen Interval: 480-500
WELL INVENTORY CONDITION	
Concrete pad in acceptable condition i.e. no cracks?	YES
Manhole cover present and in working condition?	YES
All bolts on manhole present and not stripped?	YES
Well plug present, locked and in good working condition?	YES
OVERALL CONDITION:	GOOD
Notes (Explain if answered No to any of the above)

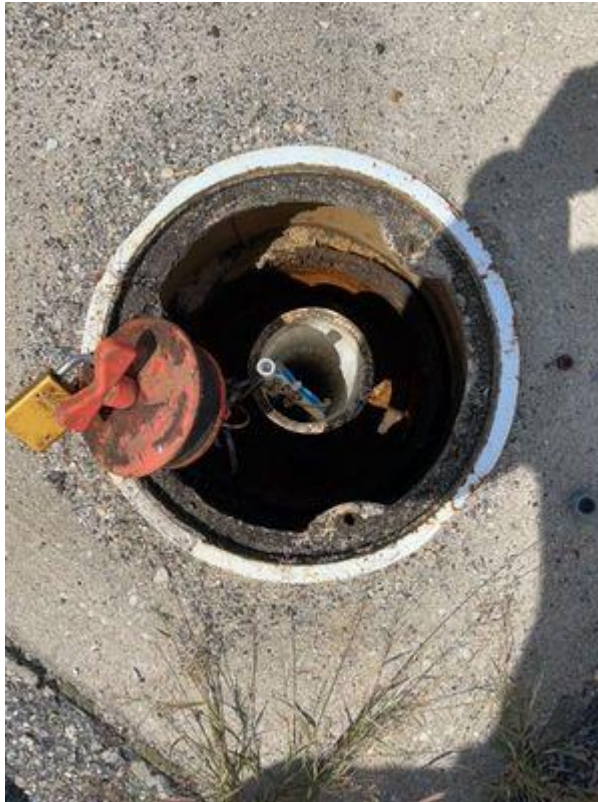
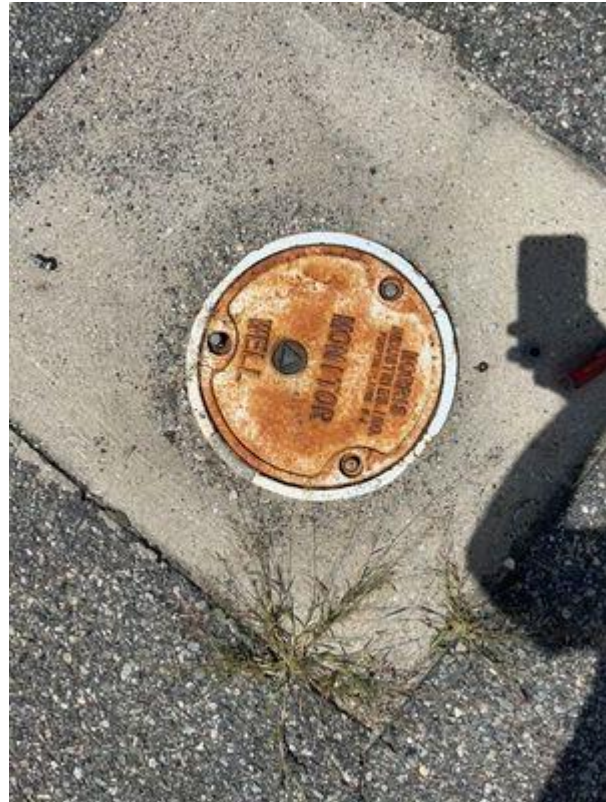
Client: Navy CLEAN	Facility: NWIRP Bethpage
Project Number: 112G08005-WE13	Location: Bethpage, New York
Date: August 15, 2022 13:27	Personnel: RJ Brydon
Well ID: RE123D2	Well Location: 209887.34 1124886.22
Well Status: In Use (Confirmed)	Screen Interval: 635-655
WELL INVENTORY CONDITION	
Concrete pad in acceptable condition i.e. no cracks?	YES
Manhole cover present and in working condition?	YES
All bolts on manhole present and not stripped?	YES
Well plug present, locked and in good working condition?	YES
OVERALL CONDITION:	GOOD
Notes (Explain if answered No to any of the above)

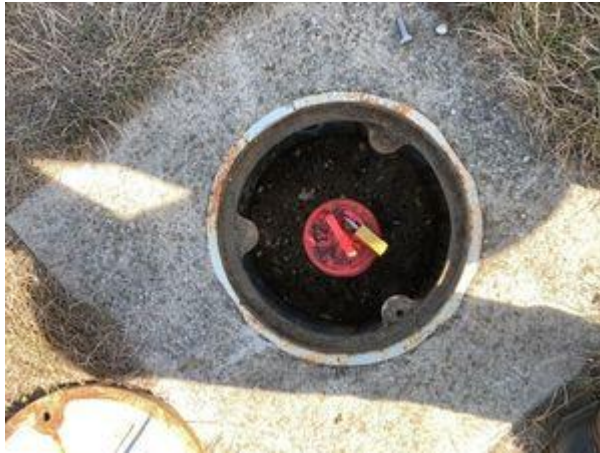
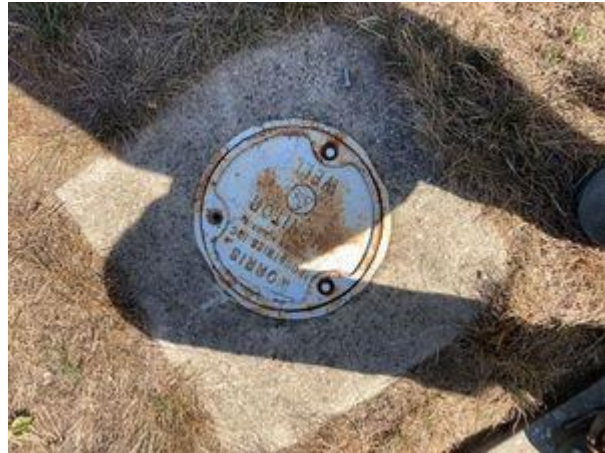
Client: Navy CLEAN	Facility: NWIRP Bethpage
Project Number: 112G08005-WE13	Location: Bethpage, New York
Date: September 2, 2022 15:43	Personnel: Beau Benfield
Well ID: RE127D1	Well Location: 199120.06 1131245.1
Well Status: In Use (Confirmed)	Screen Interval: 660-680
WELL INVENTORY CONDITION	
Concrete pad in acceptable condition i.e. no cracks?	YES
Manhole cover present and in working condition?	YES
All bolts on manhole present and not stripped?	NO
Well plug present, locked and in good working condition?	YES
OVERALL CONDITION:	GOOD
Notes (Explain if answered No to any of the above) One bolt broken off inside well collar ear

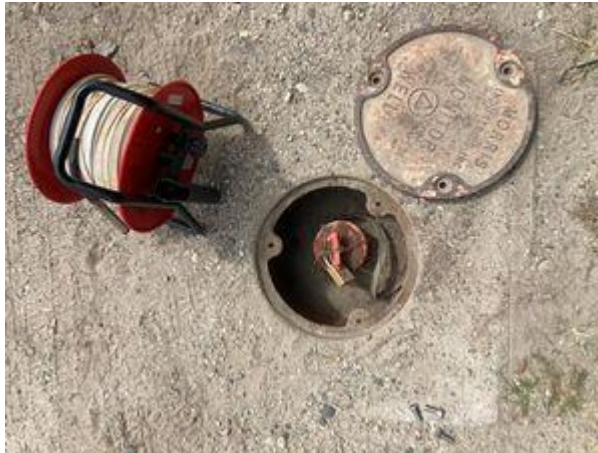
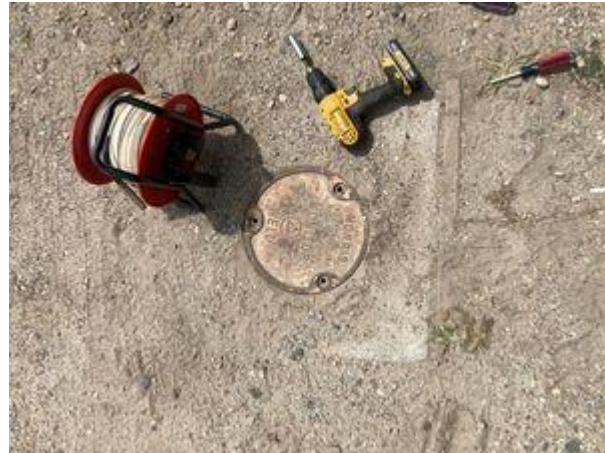
Client: Navy CLEAN	Facility: NWIRP Bethpage
Project Number: 112G08005-WE13	Location: Bethpage, New York
Date: August 17, 2022 12:19	Personnel: Beau Benfield
Well ID: RE128D1	Well Location: 200556.421231 1129214.87395
Well Status: In Use (Confirmed)	Screen Interval: 660-680
WELL INVENTORY CONDITION	
Concrete pad in acceptable condition i.e. no cracks?	YES
Manhole cover present and in working condition?	YES
All bolts on manhole present and not stripped?	NO
Well plug present, locked and in good working condition?	YES
OVERALL CONDITION:	GOOD
Notes (Explain if answered No to any of the above) Well collar threads corroded

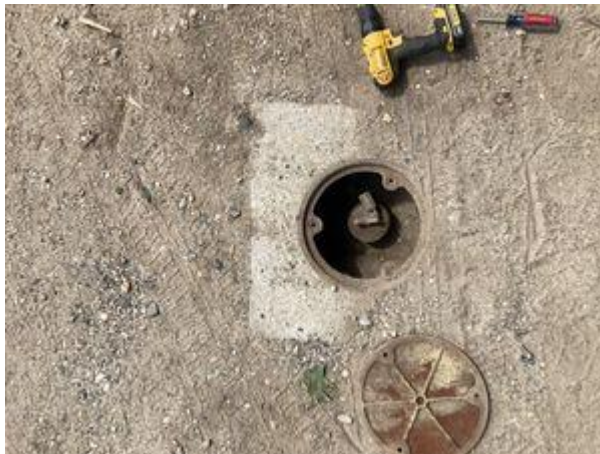
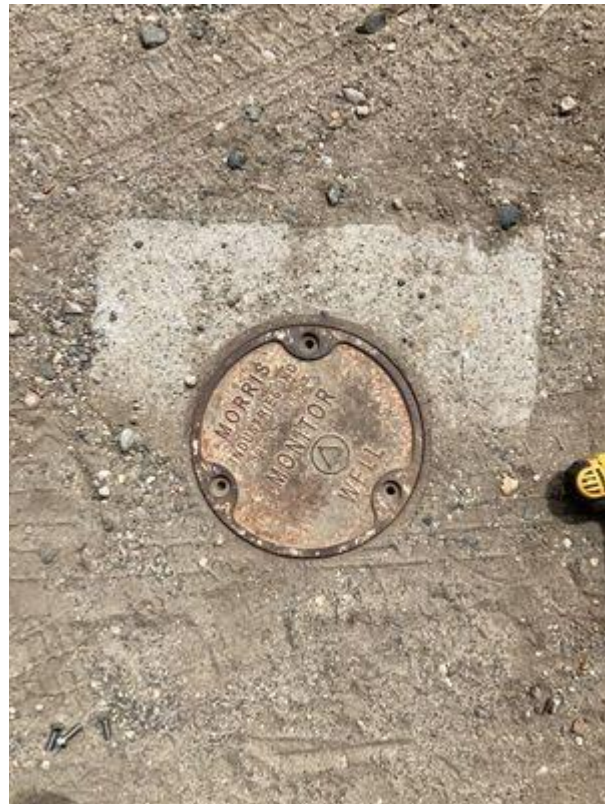
Client: Navy CLEAN	Facility: NWIRP Bethpage
Project Number: 112G08005-WE13	Location: Bethpage, New York
Date: August 17, 2022 12:28	Personnel: Beau Benfield
Well ID: RE128D2	Well Location: 200537.7 1129203.48
Well Status: In Use (Confirmed)	Screen Interval: 735-755
WELL INVENTORY CONDITION	
Concrete pad in acceptable condition i.e. no cracks?	YES
Manhole cover present and in working condition?	YES
All bolts on manhole present and not stripped?	NO
Well plug present, locked and in good working condition?	YES
OVERALL CONDITION:	GOOD
Notes (Explain if answered No to any of the above) Well collar threads corroded

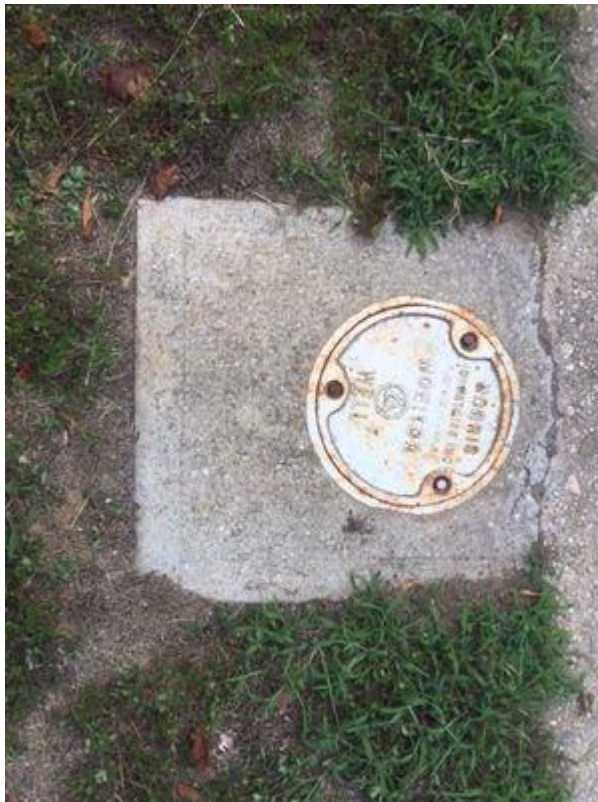
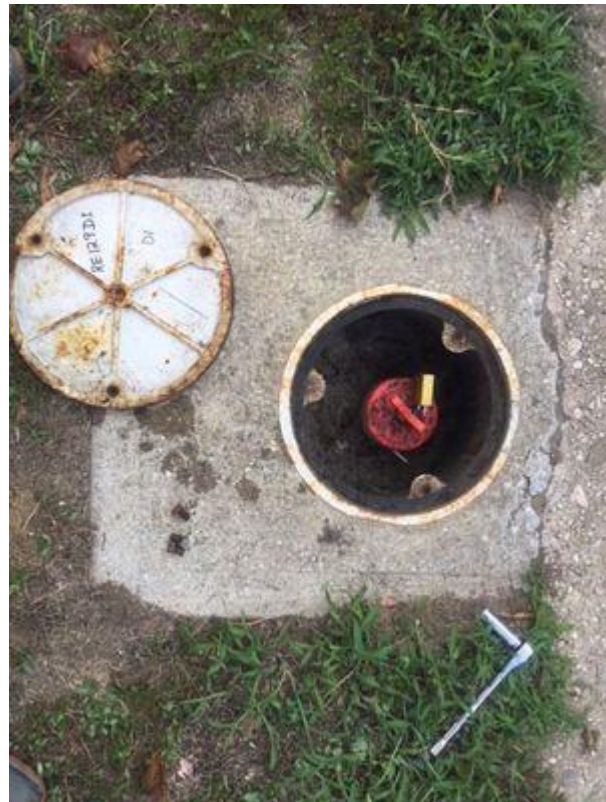
Client: Navy CLEAN	Facility: NWIRP Bethpage
Project Number: 112G08005-WE13	Location: Bethpage, New York
Date: September 16, 2022 08:55	Personnel: Jake Marlow
Well ID: RE129D1	Well Location: 196086.63 1124099.54
Well Status: In Use (Confirmed)	Screen Interval: 690-710
WELL INVENTORY CONDITION	
Concrete pad in acceptable condition i.e. no cracks?	YES
Manhole cover present and in working condition?	YES
All bolts on manhole present and not stripped?	NO
Well plug present, locked and in good working condition?	YES
OVERALL CONDITION:	FAIR
Notes (Explain if answered No to any of the above) Two bolts broken in manhole

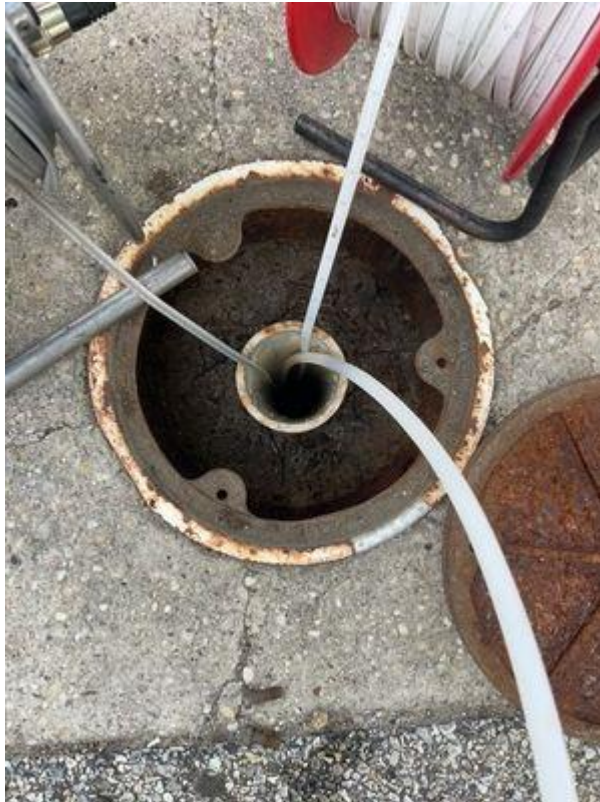
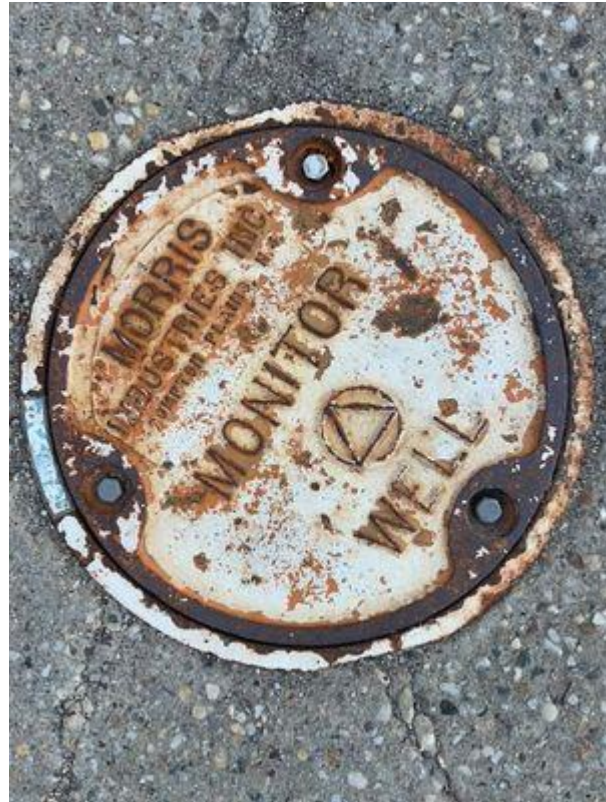
Client: Navy CLEAN	Facility: NWIRP Bethpage
Project Number: 112G08005-WE13	Location: Bethpage, New York
Date: August 21, 2022 08:30	Personnel: RJ Brydon
Well ID: RE131D1	Well Location: 204367.45 1123114.27
Well Status: In Use (Confirmed)	Screen Interval: 430-450
WELL INVENTORY CONDITION	
Concrete pad in acceptable condition i.e. no cracks?	YES
Manhole cover present and in working condition?	YES
All bolts on manhole present and not stripped?	NO
Well plug present, locked and in good working condition?	YES
OVERALL CONDITION:	GOOD
Notes (Explain if answered No to any of the above) Bolts stripped

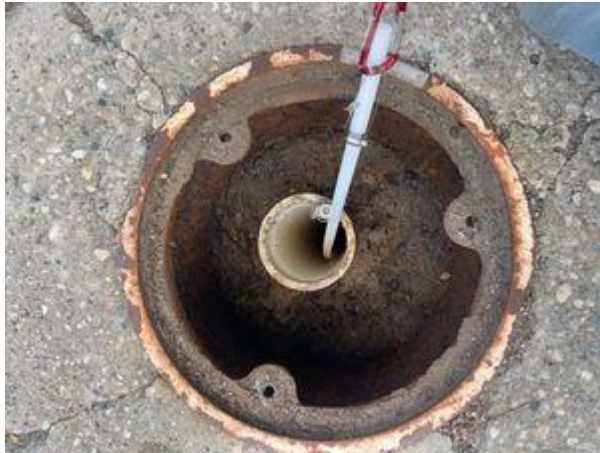
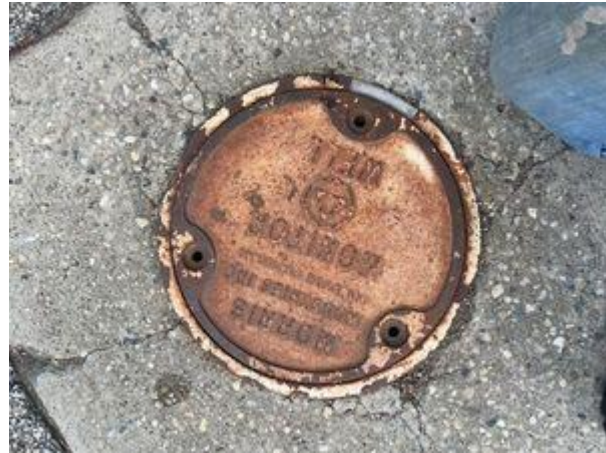
Client: Navy CLEAN	Facility: NWIRP Bethpage
Project Number: 112G08005-WE13	Location: Bethpage, New York
Date: August 21, 2022 08:16	Personnel: RJ Brydon
Well ID: RE131D2	Well Location: 204359.42 1123099.42
Well Status: In Use (Confirmed)	Screen Interval: 565-590
WELL INVENTORY CONDITION	
Concrete pad in acceptable condition i.e. no cracks?	YES
Manhole cover present and in working condition?	YES
All bolts on manhole present and not stripped?	NO
Well plug present, locked and in good working condition?	YES
OVERALL CONDITION:	GOOD
Notes (Explain if answered No to any of the above) 1 bolt missing, other 2 stripped.

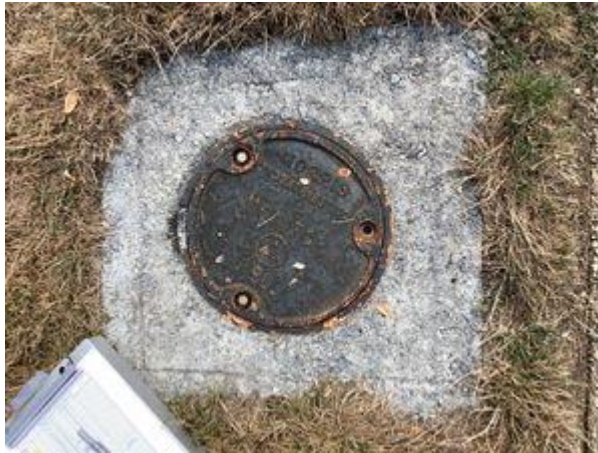
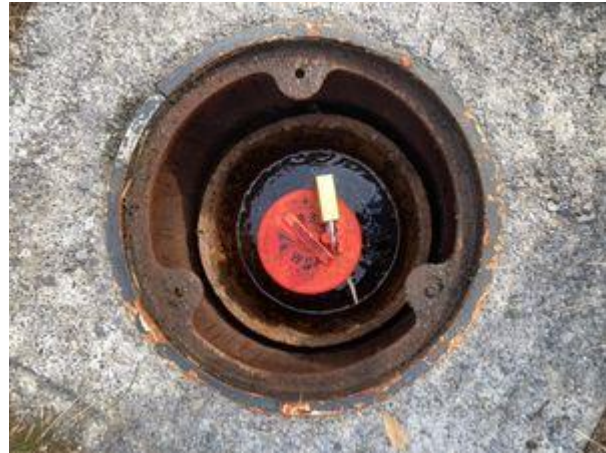
Client: Navy CLEAN	Facility: NWIRP Bethpage
Project Number: 112G08005-WE13	Location: Bethpage, New York
Date: August 15, 2022 10:01	Personnel: Beau Benfield
Well ID: RE132D2	Well Location: 203115.870081 1125692.65057
Well Status: In Use (Confirmed)	Screen Interval: 330-350
WELL INVENTORY CONDITION	
Concrete pad in acceptable condition i.e. no cracks?	YES
Manhole cover present and in working condition?	YES
All bolts on manhole present and not stripped?	NO
Well plug present, locked and in good working condition?	YES
OVERALL CONDITION:	GOOD
Notes (Explain if answered No to any of the above) One bolt broken off inside well collar

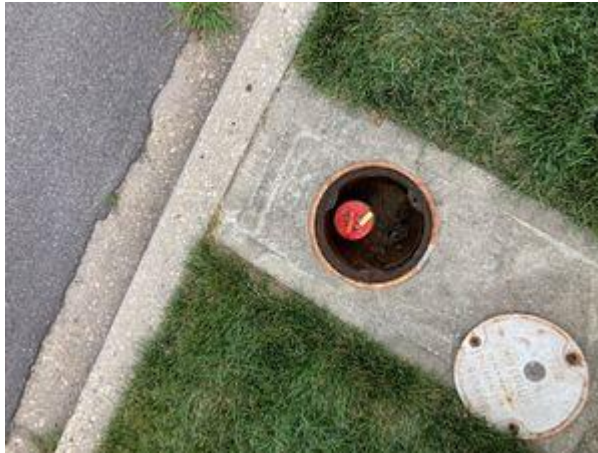
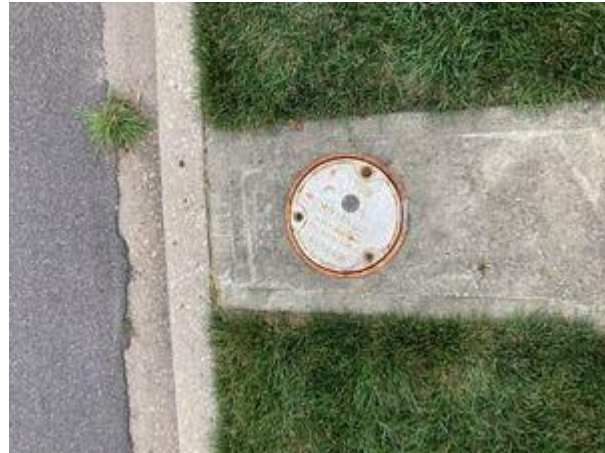
Client: Navy CLEAN	Facility: NWIRP Bethpage
Project Number: 112G08005-WE13	Location: Bethpage, New York
Date: August 17, 2022 14:27	Personnel: Beau Benfield
Well ID: RE134D1	Well Location: 206193.848977 1123302.32141
Well Status: In Use (Confirmed)	Screen Interval: 325-345
WELL INVENTORY CONDITION	
Concrete pad in acceptable condition i.e. no cracks?	YES
Manhole cover present and in working condition?	YES
All bolts on manhole present and not stripped?	NO
Well plug present, locked and in good working condition?	YES
OVERALL CONDITION:	GOOD
Notes (Explain if answered No to any of the above) One bolt broken off inside well collar

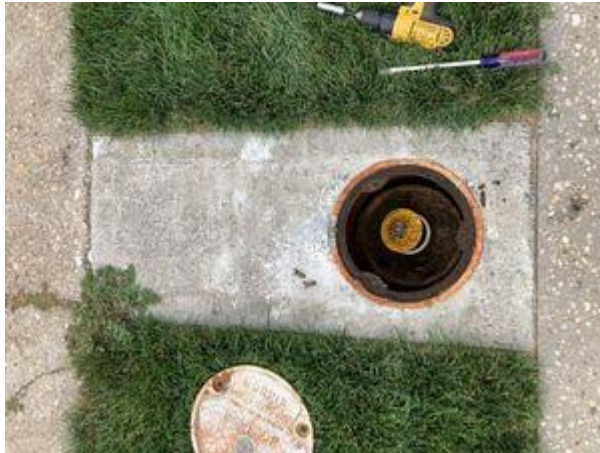
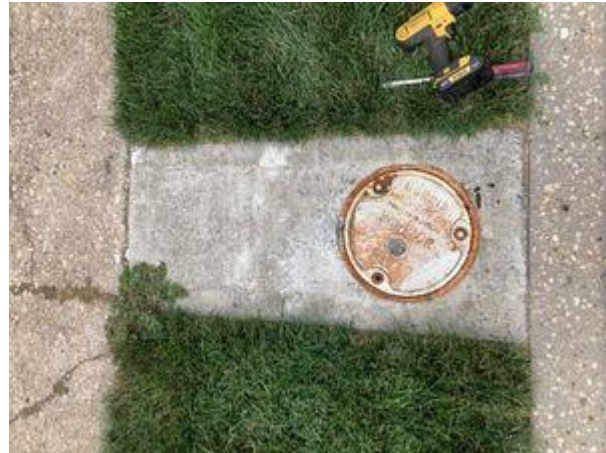
Client: Navy CLEAN	Facility: NWIRP Bethpage
Project Number: 112G08005-WE13	Location: Bethpage, New York
Date: August 17, 2022 14:43	Personnel: Beau Benfield
Well ID: RE134D4	Well Location: 206154.828879 1123280.64358
Well Status: In Use (Confirmed)	Screen Interval: 665-685
WELL INVENTORY CONDITION	
Concrete pad in acceptable condition i.e. no cracks?	YES
Manhole cover present and in working condition?	YES
All bolts on manhole present and not stripped?	NO
Well plug present, locked and in good working condition?	YES
OVERALL CONDITION:	GOOD
Notes (Explain if answered No to any of the above) One bolt broken off inside well collar
