Memorandum

To: Scot Sokolowski, NAVFAC MIDLANT
From: David Brayack, Tetra Tech
Date: November 17, 2022
Re: Annual LUC Inspection and Operation Summary Report: Sites 1, 2, 3, and 4 –
NWIRP Bethpage
Contract/CTO Number: N6247016D9008/WE16

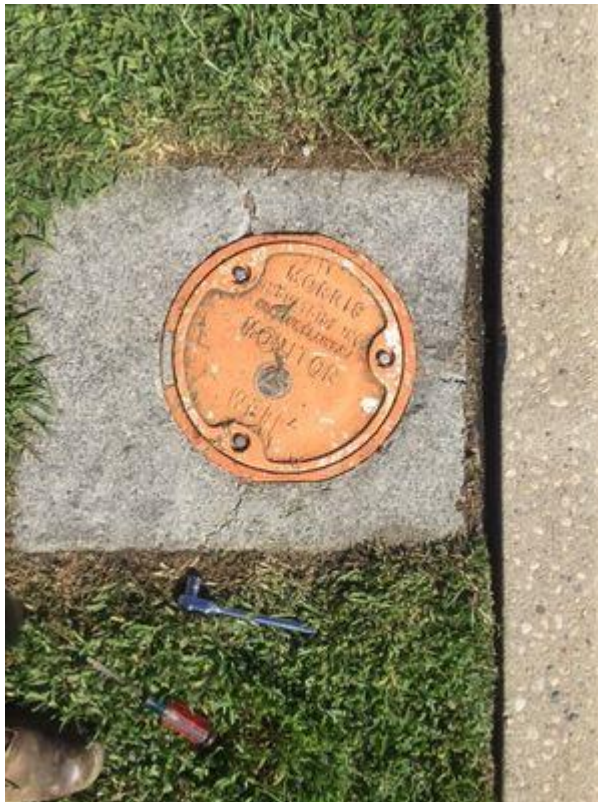
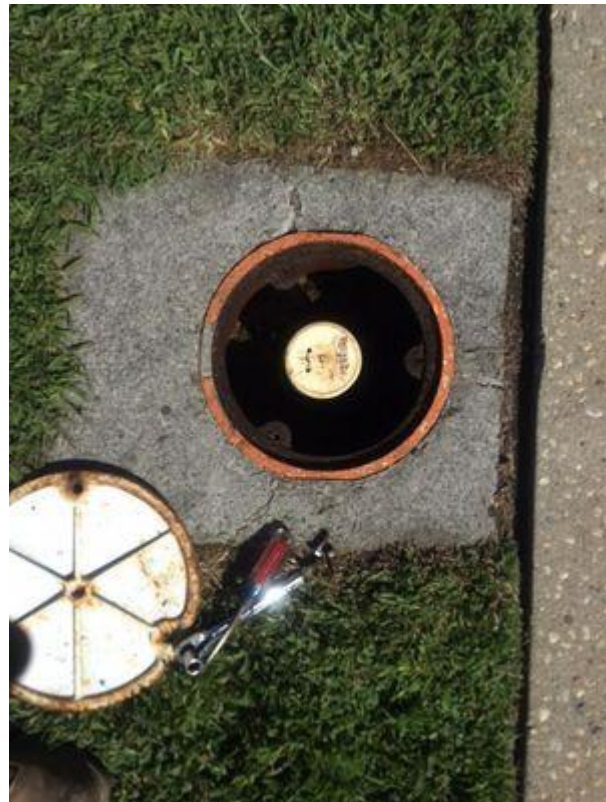
Client: Navy CLEAN	Facility: NWIRP Bethpage
Project Number: 112G08005-WE13	Location: Bethpage, New York
Date: September 2, 2022 15:18	Personnel: Jake Marlow
Well ID: RE135D1	Well Location: 204601.68 1120806.68
Well Status: In Use (Confirmed)	Screen Interval: 410-430
WELL INVENTORY CONDITION	
Concrete pad in acceptable condition i.e. no cracks?	NO
Manhole cover present and in working condition?	YES
All bolts on manhole present and not stripped?	YES
Well plug present, locked and in good working condition?	YES
OVERALL CONDITION:	GOOD
Notes (Explain if answered No to any of the above) Cracked pad

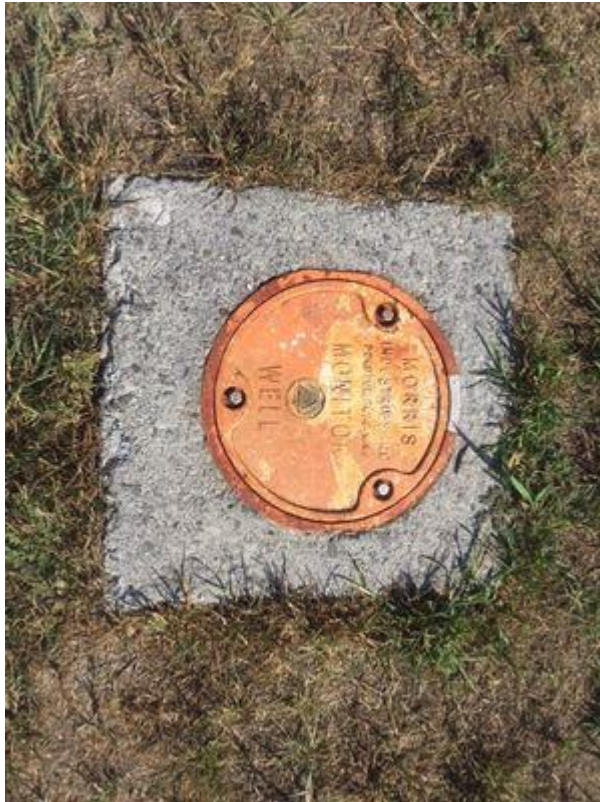
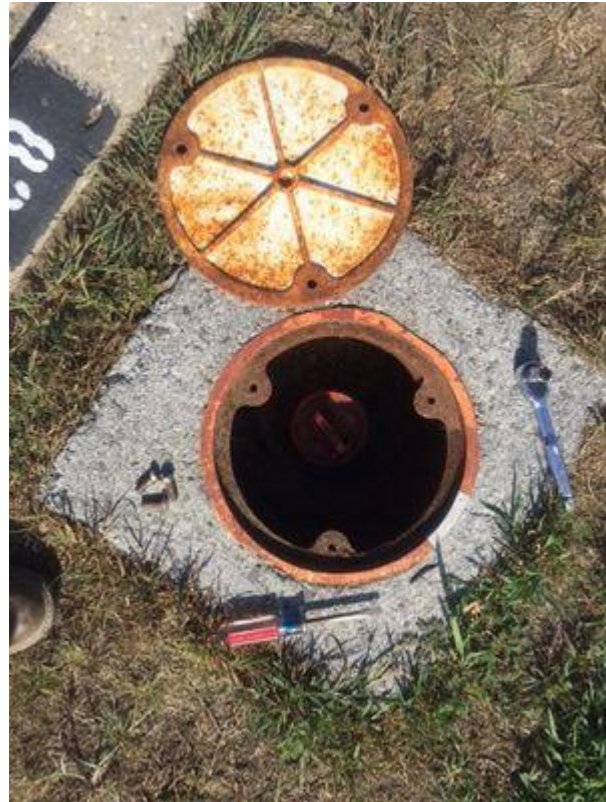
Client: Navy CLEAN	Facility: NWIRP Bethpage
Project Number: 112G08005-WE13	Location: Bethpage, New York
Date: September 2, 2022 15:30	Personnel: Jake Marlow
Well ID: RE135D2	Well Location: 204569.37 1120786.64
Well Status: In Use (Confirmed)	Screen Interval: 545-565
WELL INVENTORY CONDITION	
Concrete pad in acceptable condition i.e. no cracks?	NO
Manhole cover present and in working condition?	YES
All bolts on manhole present and not stripped?	YES
Well plug present, locked and in good working condition?	YES
OVERALL CONDITION:	FAIR
Notes (Explain if answered No to any of the above) Cracked pad

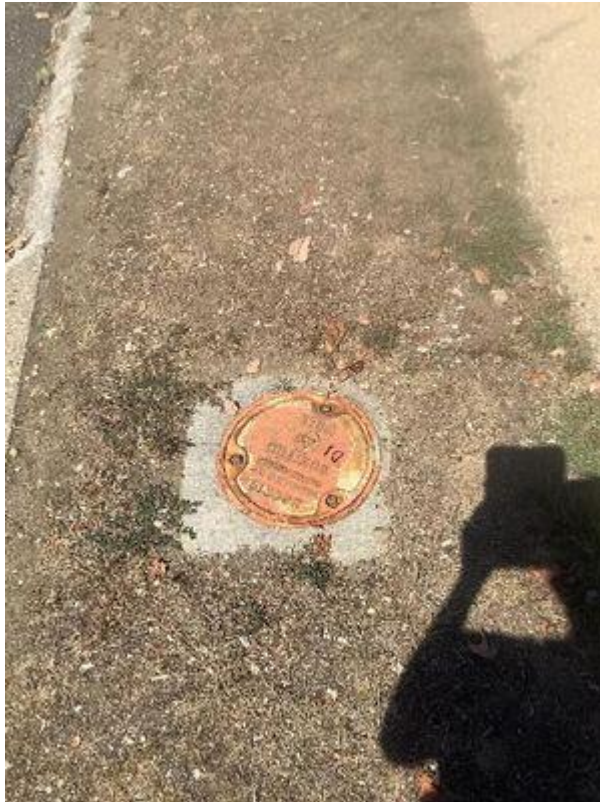
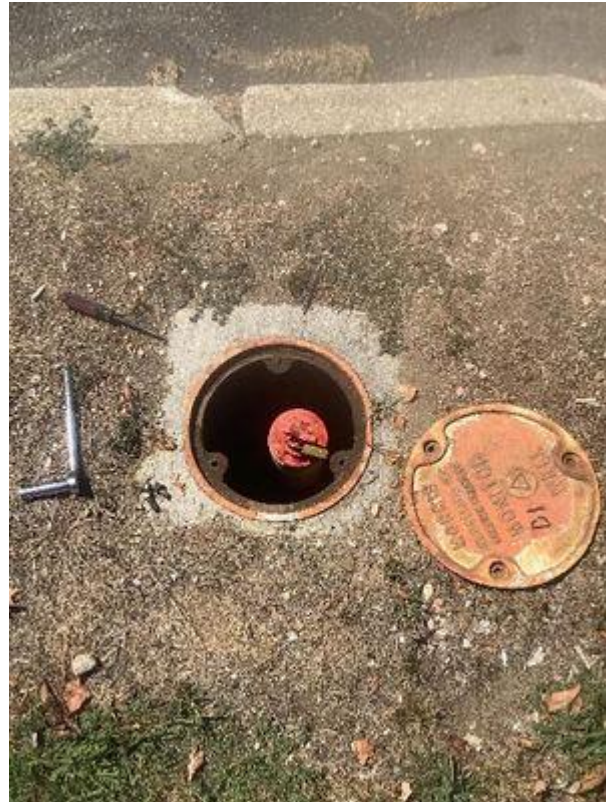
Client: Navy CLEAN	Facility: NWIRP Bethpage
Project Number: 112G08005-WE13	Location: Bethpage, New York
Date: September 2, 2022 13:00	Personnel: Will Yeung
Well ID: RE139D1	Well Location: 198615.87 1124858.07
Well Status: In Use (Confirmed)	Screen Interval: 650-670
WELL INVENTORY CONDITION	
Concrete pad in acceptable condition i.e. no cracks?	YES
Manhole cover present and in working condition?	YES
All bolts on manhole present and not stripped?	YES
Well plug present, locked and in good working condition?	YES
OVERALL CONDITION:	GOOD
Notes (Explain if answered No to any of the above)

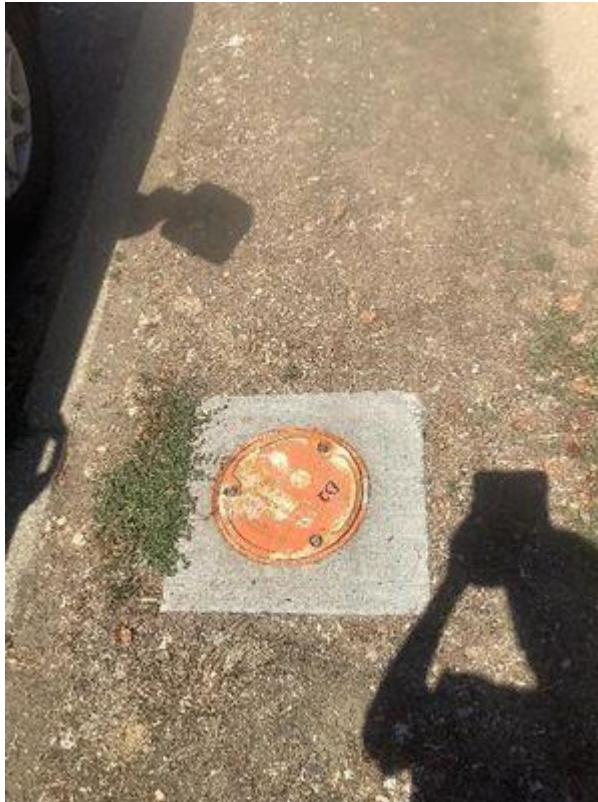
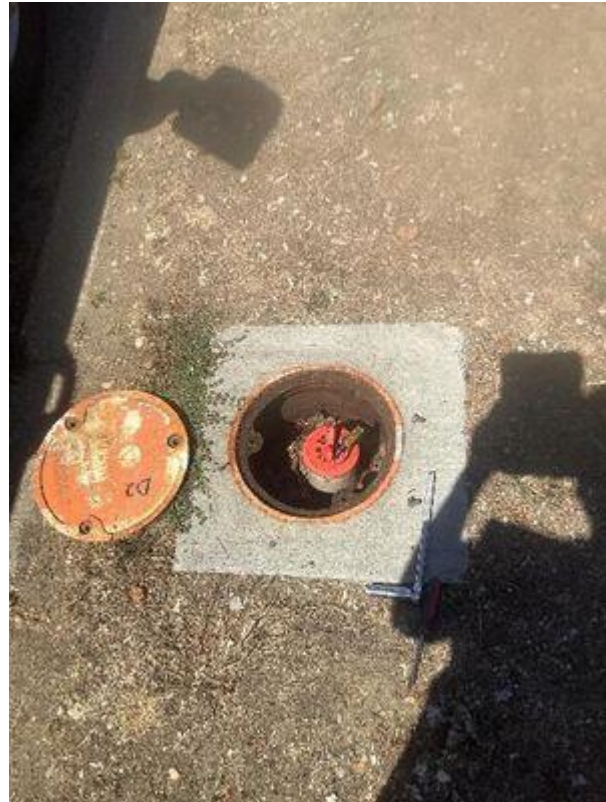
Client: Navy CLEAN	Facility: NWIRP Bethpage
Project Number: 112G08005-WE13	Location: Bethpage, New York
Date: September 2, 2022 12:56	Personnel: Will Yeung
Well ID: RE139D2	Well Location: 198600.08 1124864.9
Well Status: In Use (Confirmed)	Screen Interval: 740-760
WELL INVENTORY CONDITION	
Concrete pad in acceptable condition i.e. no cracks?	YES
Manhole cover present and in working condition?	YES
All bolts on manhole present and not stripped?	YES
Well plug present, locked and in good working condition?	YES
OVERALL CONDITION:	GOOD
Notes (Explain if answered No to any of the above)

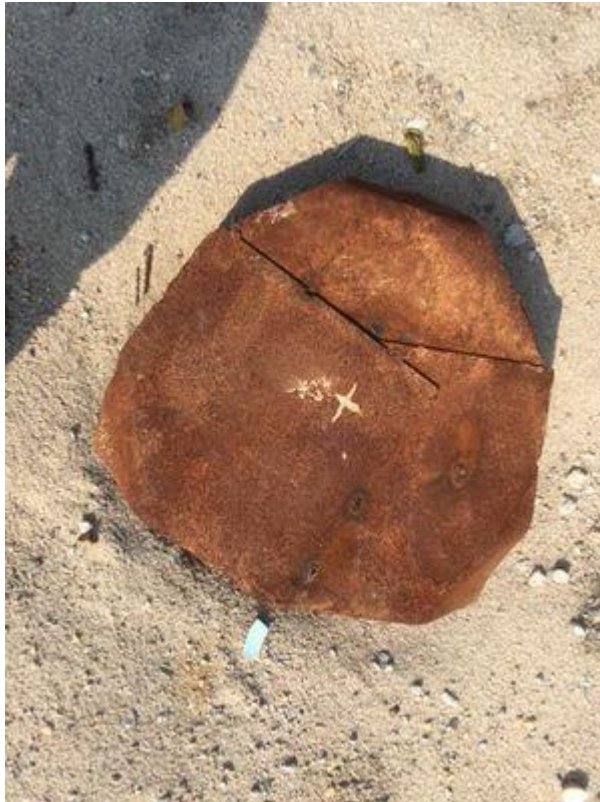
Client: Navy CLEAN	Facility: NWIRP Bethpage
Project Number: 112G08005-WE13	Location: Bethpage, New York
Date: September 16, 2022 10:11	Personnel: Jake Marlow
Well ID: RW7A	Well Location: 199747.367615417 1125393.81317234
Well Status: Unknown	Screen Interval:
WELL INVENTORY CONDITION	
Concrete pad in acceptable condition i.e. no cracks?	NO
Manhole cover present and in working condition?	NO
All bolts on manhole present and not stripped?	NO
Well plug present, locked and in good working condition?	YES
OVERALL CONDITION:	FAIR
Notes (Explain if answered No to any of the above) No concrete pad or manhole

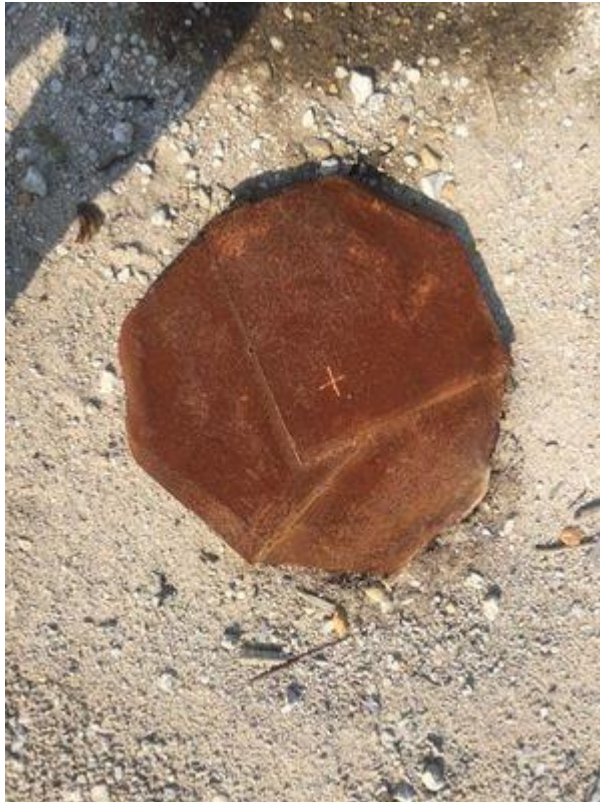
Client: Navy CLEAN	Facility: NWIRP Bethpage
Project Number: 112G08005-WE13	Location: Bethpage, New York
Date: September 16, 2022 10:13	Personnel: Jake Marlow
Well ID: RW7B	Well Location: 199737.385023832 1125488.64828451
Well Status: Unknown	Screen Interval:
WELL INVENTORY CONDITION	
Concrete pad in acceptable condition i.e. no cracks?	NO
Manhole cover present and in working condition?	NO
All bolts on manhole present and not stripped?	NO
Well plug present, locked and in good working condition?	YES
OVERALL CONDITION:	FAIR
Notes (Explain if answered No to any of the above) No concrete pad or manhole

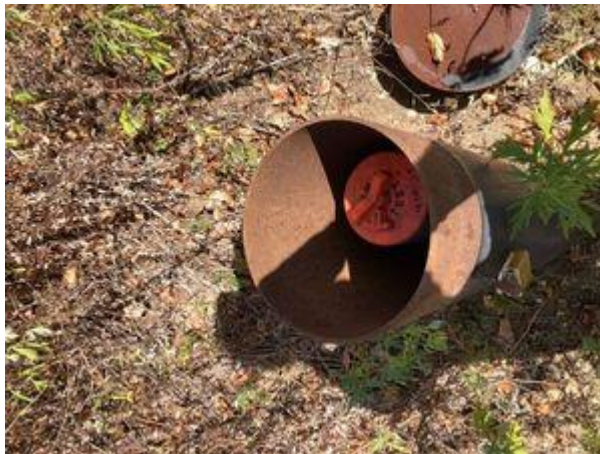
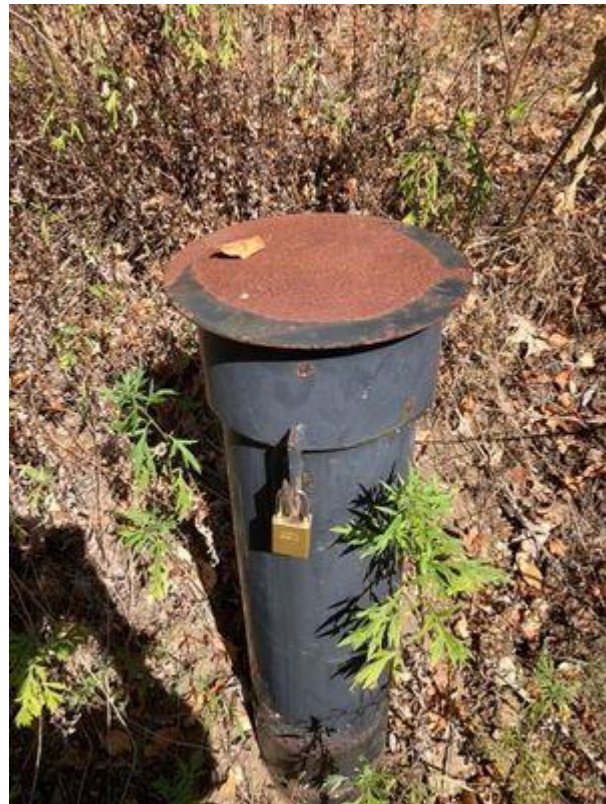
Client: Navy CLEAN	Facility: NWIRP Bethpage
Project Number: 112G08005-WE13	Location: Bethpage, New York
Date: September 2, 2022 15:11	Personnel: Beau Benfield
Well ID: TT102D1	Well Location: 195341.937 1127148.911
Well Status: In Use (Confirmed)	Screen Interval: 560-600
WELL INVENTORY CONDITION	
Concrete pad in acceptable condition i.e. no cracks?	YES
Manhole cover present and in working condition?	NO
All bolts on manhole present and not stripped?	NO
Well plug present, locked and in good working condition?	YES
OVERALL CONDITION:	GOOD
Notes (Explain if answered No to any of the above) Stick up well

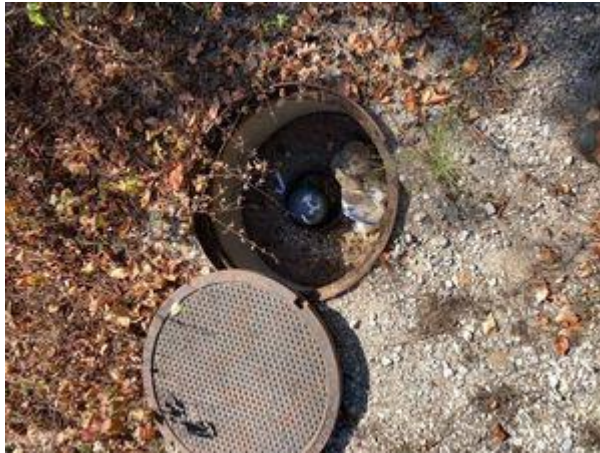
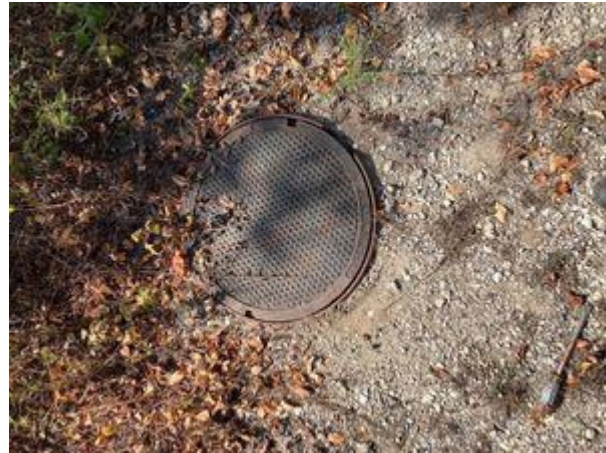
Client: Navy CLEAN	Facility: NWIRP Bethpage
Project Number: 112G08005-WE13	Location: Bethpage, New York
Date: September 2, 2022 15:16	Personnel: Beau Benfield
Well ID: TT102D2	Well Location: 195346.266 1127132.843
Well Status: In Use (Confirmed)	Screen Interval: 740-770
WELL INVENTORY CONDITION	
Concrete pad in acceptable condition i.e. no cracks?	YES
Manhole cover present and in working condition?	YES
All bolts on manhole present and not stripped?	NO
Well plug present, locked and in good working condition?	YES
OVERALL CONDITION:	GOOD
Notes (Explain if answered No to any of the above) No bolts (manhole cover)

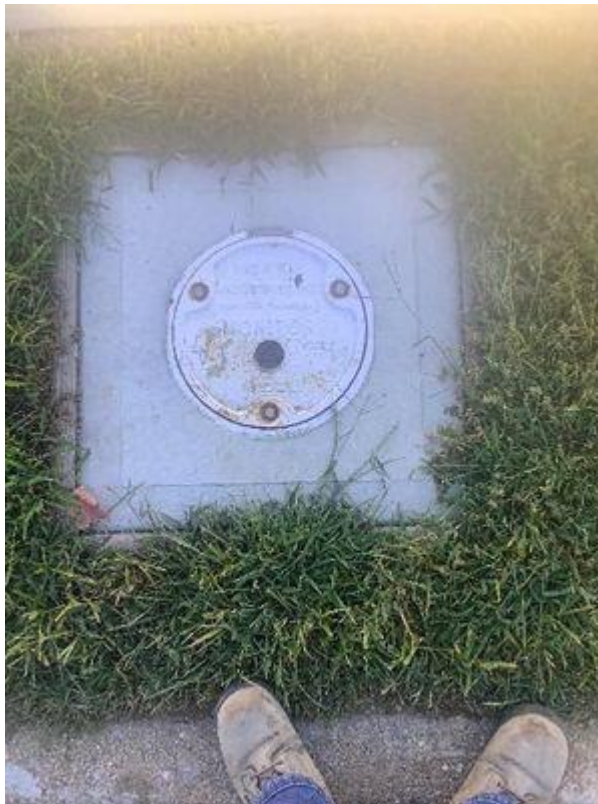
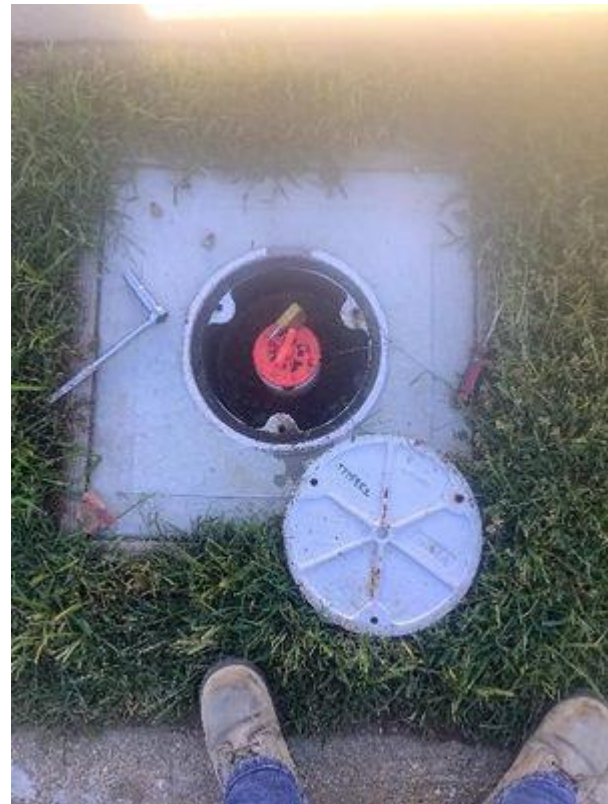
Client: Navy CLEAN	Facility: NWIRP Bethpage
Project Number: 112G08005-WE13	Location: Bethpage, New York
Date: September 2, 2022 09:39	Personnel: Will Yeung
Well ID: TT-MW14911	Well Location: 201015.84375301 1125757.42596218
Well Status: In Use (Confirmed)	Screen Interval:
WELL INVENTORY CONDITION	
Concrete pad in acceptable condition i.e. no cracks?	YES
Manhole cover present and in working condition?	YES
All bolts on manhole present and not stripped?	YES
Well plug present, locked and in good working condition?	YES
OVERALL CONDITION:	GOOD
Notes (Explain if answered No to any of the above)

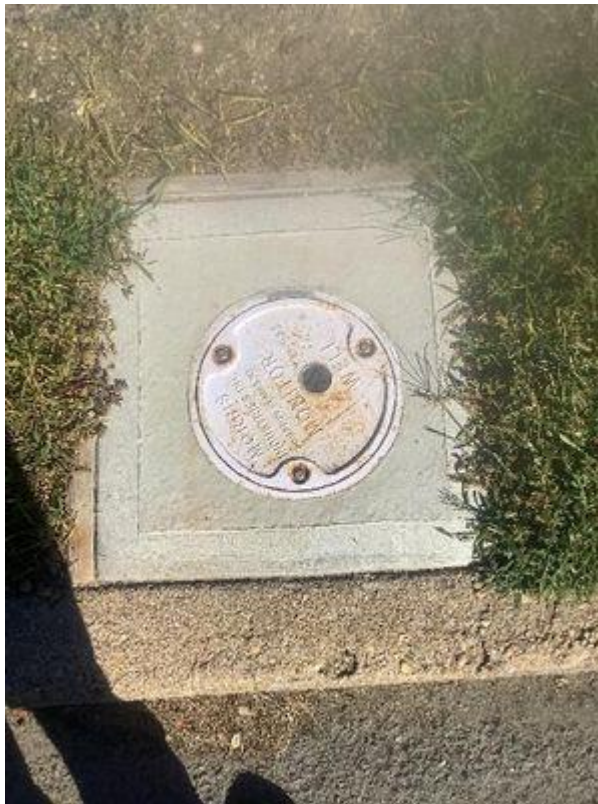
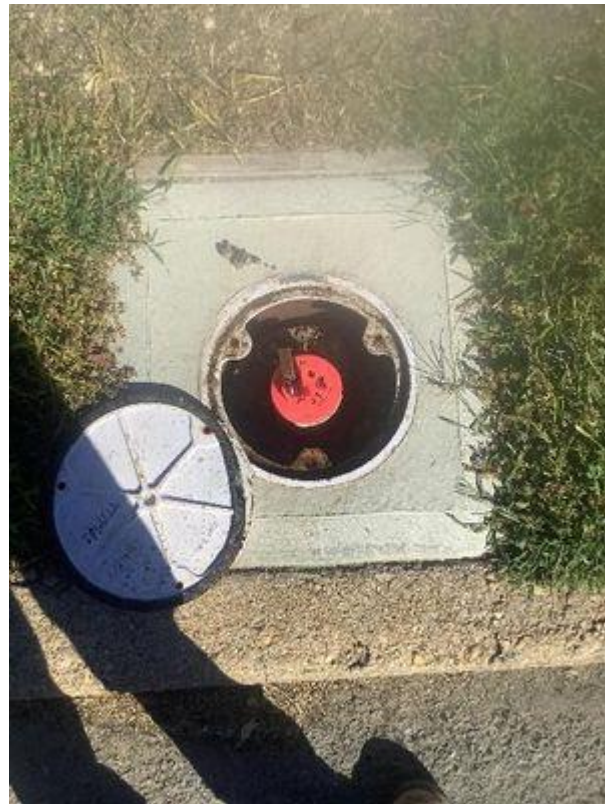
Client: Navy CLEAN	Facility: NWIRP Bethpage
Project Number: 112G08005-WE13	Location: Bethpage, New York
Date: September 2, 2022 09:34	Personnel: Will Yeung
Well ID: TT-MW149S1	Well Location: 201000.529479176 1125735.45323709
Well Status: In Use (Confirmed)	Screen Interval:
WELL INVENTORY CONDITION	
Concrete pad in acceptable condition i.e. no cracks?	YES
Manhole cover present and in working condition?	YES
All bolts on manhole present and not stripped?	YES
Well plug present, locked and in good working condition?	YES
OVERALL CONDITION:	GOOD
Notes (Explain if answered No to any of the above)

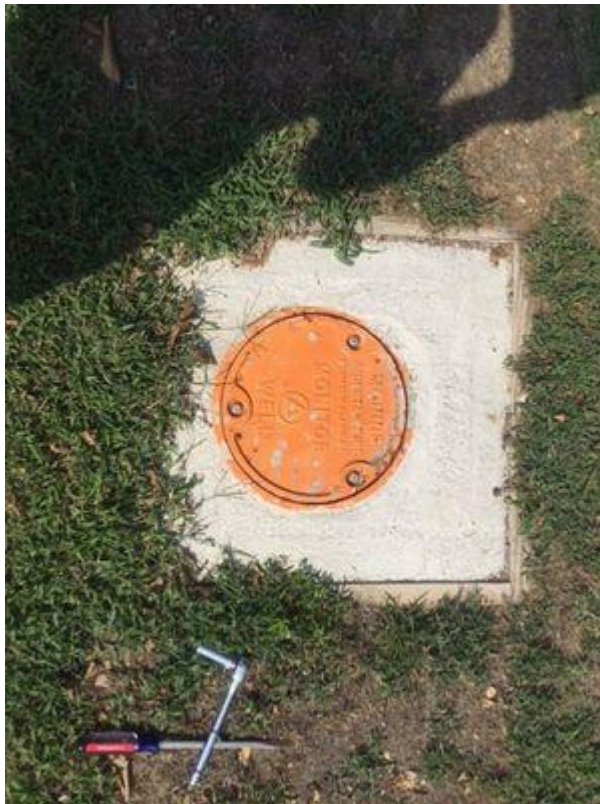
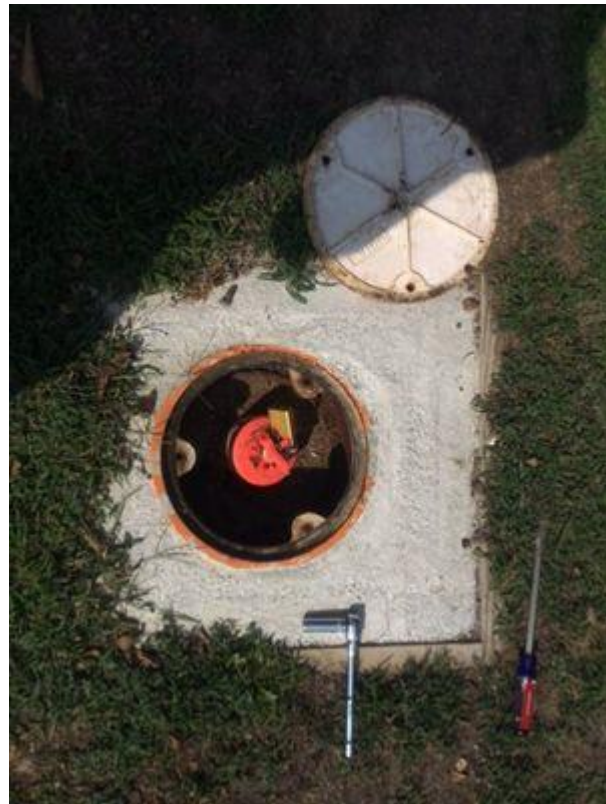
Client: Navy CLEAN	Facility: NWIRP Bethpage
Project Number: 112G08005-WE13	Location: Bethpage, New York
Date: September 16, 2022 11:05	Personnel: Jake Marlow
Well ID: TT-MW150S1	Well Location: 202103.378651425 1128286.72995867
Well Status: In Use (Confirmed)	Screen Interval:
WELL INVENTORY CONDITION	
Concrete pad in acceptable condition i.e. no cracks?	YES
Manhole cover present and in working condition?	YES
All bolts on manhole present and not stripped?	YES
Well plug present, locked and in good working condition?	YES
OVERALL CONDITION:	GOOD
Notes (Explain if answered No to any of the above)

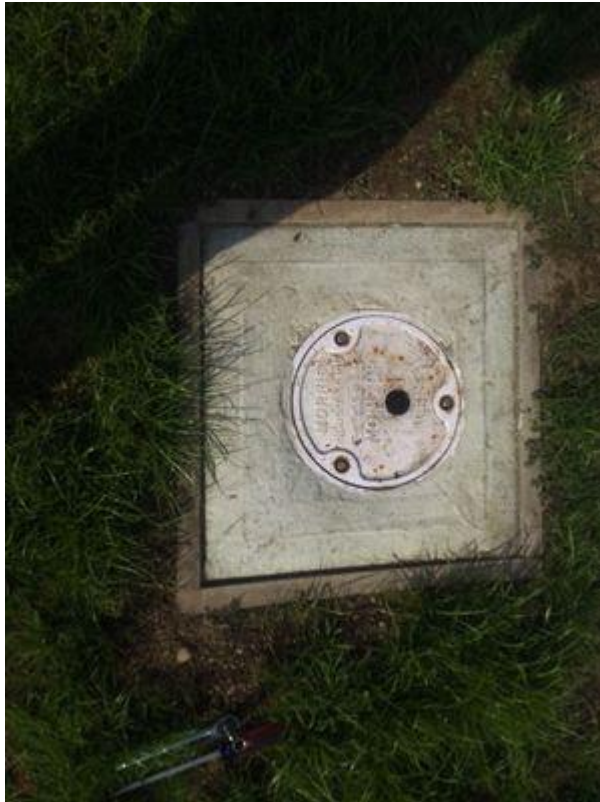
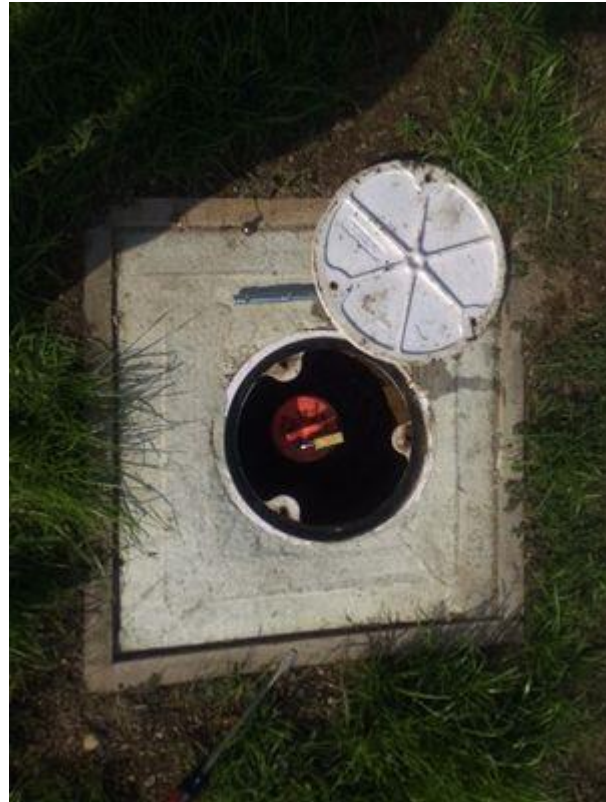
Client: Navy CLEAN	Facility: NWIRP Bethpage
Project Number: 112G08005-WE13	Location: Bethpage, New York
Date: September 16, 2022 10:29	Personnel: Jake Marlow
Well ID: TT-MW15811	Well Location: 202262.429186344 1122193.69752534
Well Status: In Use (Confirmed)	Screen Interval:
WELL INVENTORY CONDITION	
Concrete pad in acceptable condition i.e. no cracks?	YES
Manhole cover present and in working condition?	YES
All bolts on manhole present and not stripped?	YES
Well plug present, locked and in good working condition?	YES
OVERALL CONDITION:	GOOD
Notes (Explain if answered No to any of the above)

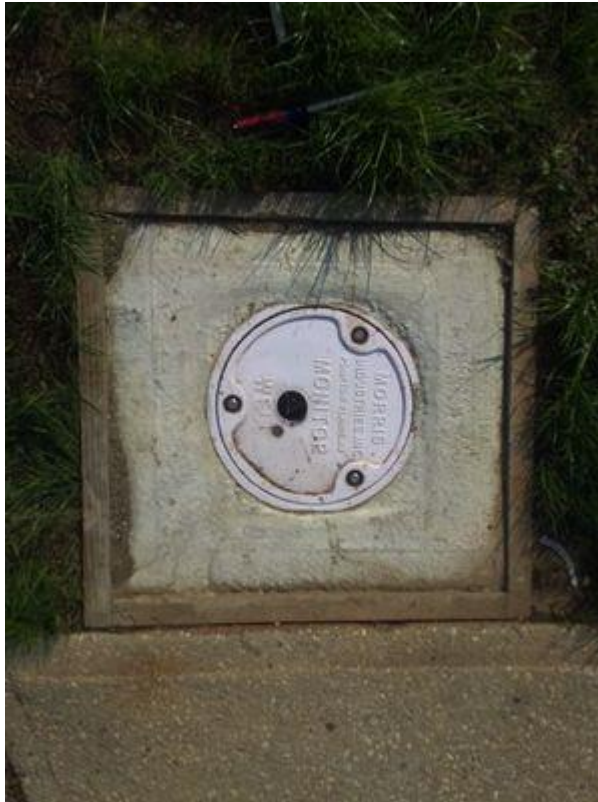
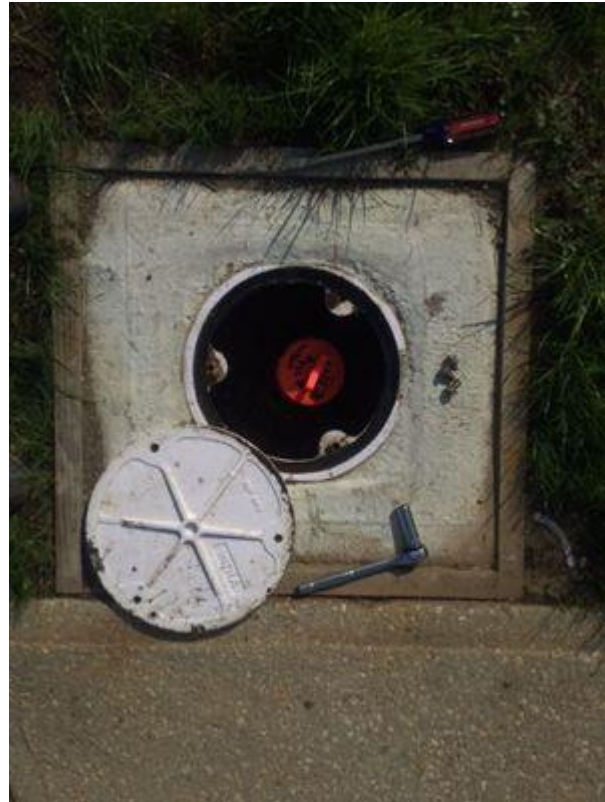
Client: Navy CLEAN	Facility: NWIRP Bethpage
Project Number: 112G08005-WE13	Location: Bethpage, New York
Date: September 16, 2022 10:24	Personnel: Jake Marlow
Well ID: TT-MW158S1	Well Location: 202267.089938179 1122236.31128526
Well Status: In Use (Confirmed)	Screen Interval:
WELL INVENTORY CONDITION	
Concrete pad in acceptable condition i.e. no cracks?	YES
Manhole cover present and in working condition?	YES
All bolts on manhole present and not stripped?	YES
Well plug present, locked and in good working condition?	YES
OVERALL CONDITION:	GOOD
Notes (Explain if answered No to any of the above)

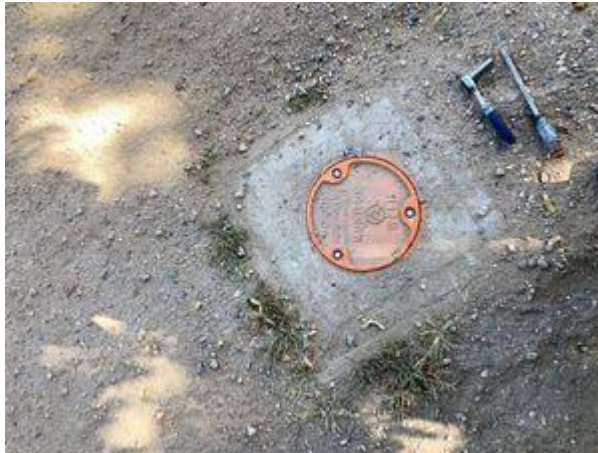
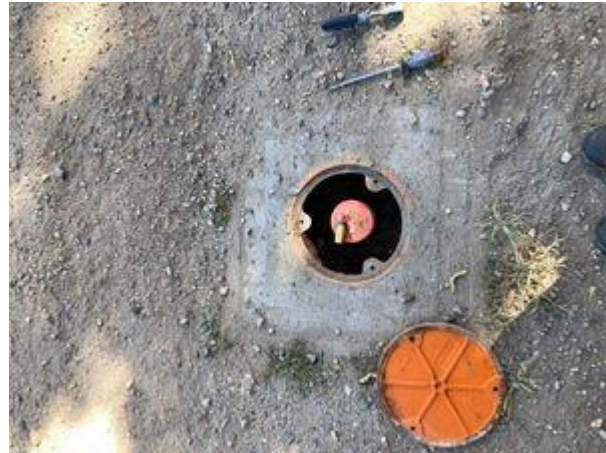
Client: Navy CLEAN	Facility: NWIRP Bethpage
Project Number: 112G08005-WE13	Location: Bethpage, New York
Date: September 2, 2022 15:50	Personnel: Beau Benfield
Well ID: TT-MW162S1	Well Location: 200520.461213589 1129191.11135201
Well Status: In Use (Confirmed)	Screen Interval:
WELL INVENTORY CONDITION	
Concrete pad in acceptable condition i.e. no cracks?	YES
Manhole cover present and in working condition?	YES
All bolts on manhole present and not stripped?	YES
Well plug present, locked and in good working condition?	YES
OVERALL CONDITION:	GOOD
Notes (Explain if answered No to any of the above)

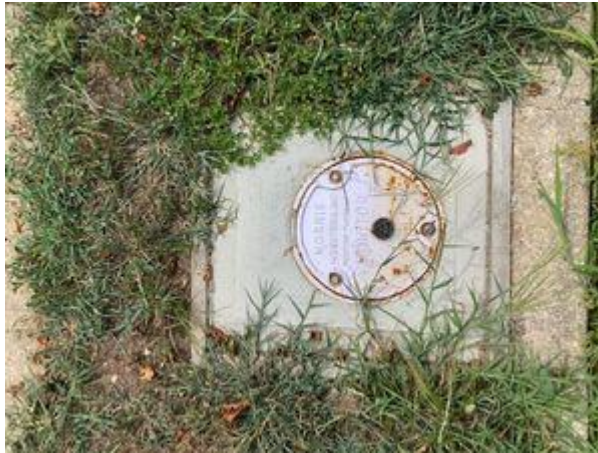
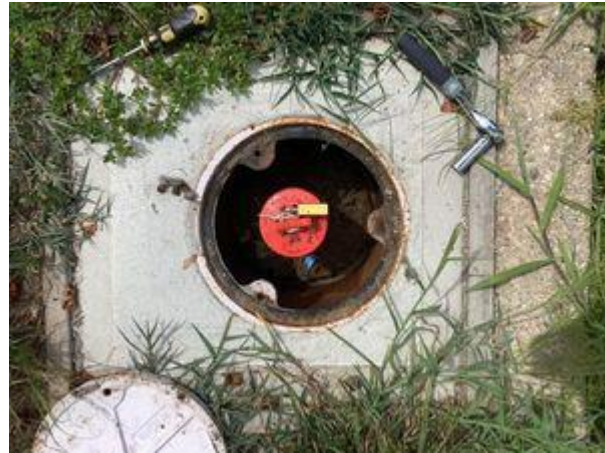
Client: Navy CLEAN	Facility: NWIRP Bethpage
Project Number: 112G08005-WE13	Location: Bethpage, New York
Date: August 15, 2022 12:52	Personnel: Beau Benfield
Well ID: TT-MW163S1	Well Location: 196117.924415007 1124134.82946984
Well Status: In Use (Confirmed)	Screen Interval:
WELL INVENTORY CONDITION	
Concrete pad in acceptable condition i.e. no cracks?	YES
Manhole cover present and in working condition?	YES
All bolts on manhole present and not stripped?	YES
Well plug present, locked and in good working condition?	YES
OVERALL CONDITION:	GOOD
Notes (Explain if answered No to any of the above)

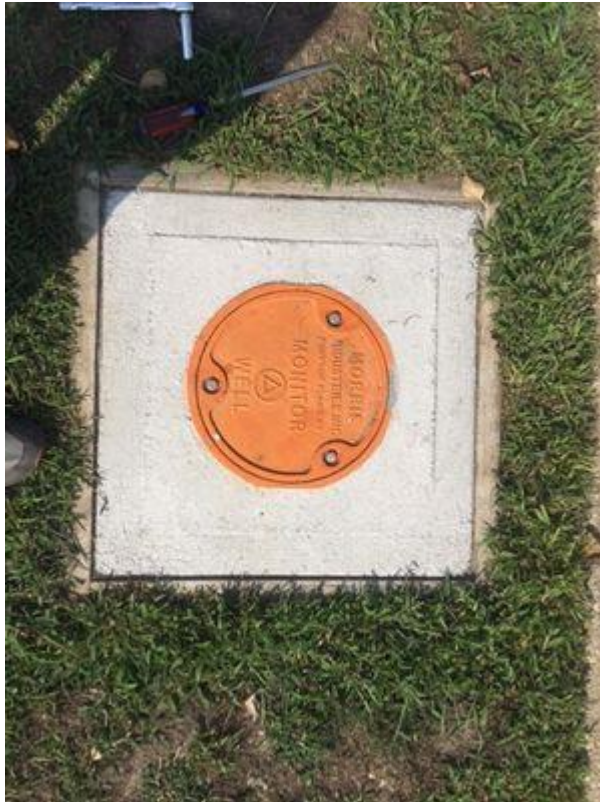
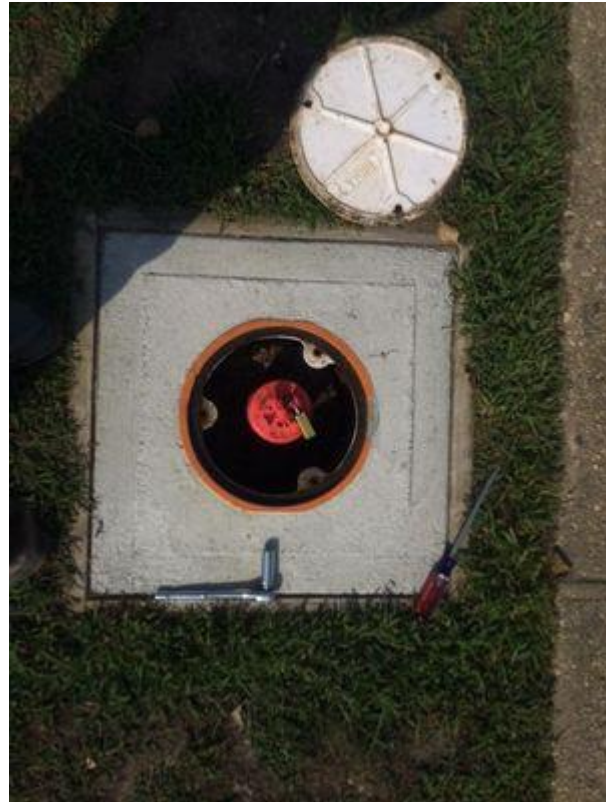
Client: Navy CLEAN	Facility: NWIRP Bethpage
Project Number: 112G08005-WE13	Location: Bethpage, New York
Date: September 16, 2022 10:51	Personnel: Jake Marlow
Well ID: TT-MW172S1	Well Location: 201426.242538512 1127013.04910709
Well Status: In Use (Confirmed)	Screen Interval:
WELL INVENTORY CONDITION	
Concrete pad in acceptable condition i.e. no cracks?	YES
Manhole cover present and in working condition?	YES
All bolts on manhole present and not stripped?	YES
Well plug present, locked and in good working condition?	YES
OVERALL CONDITION:	GOOD
Notes (Explain if answered No to any of the above)

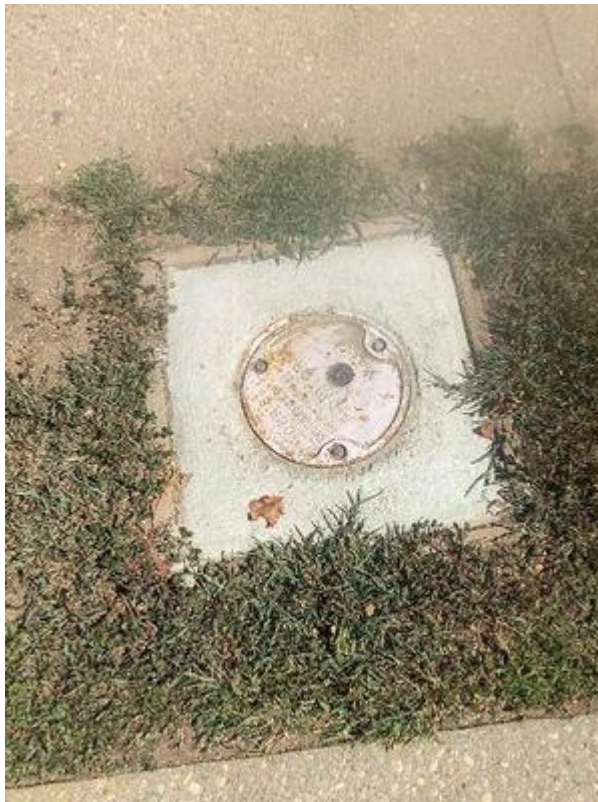
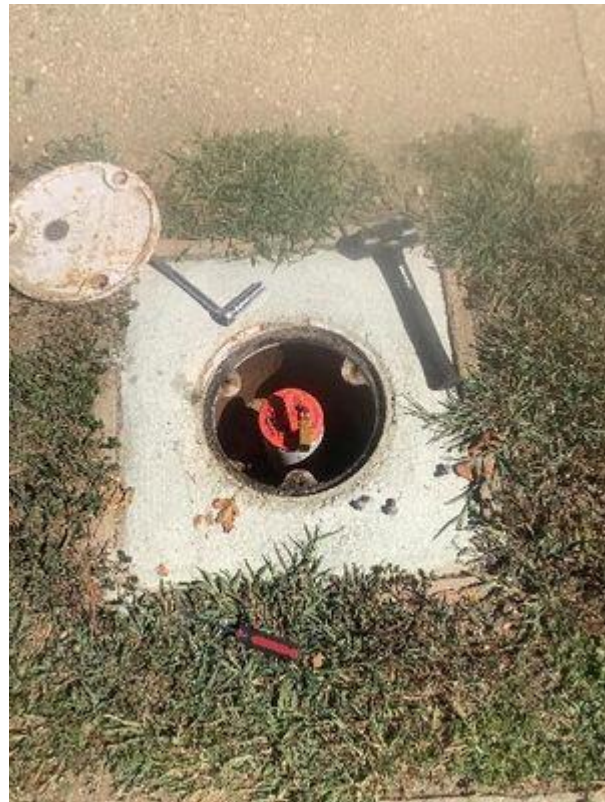
Client: Navy CLEAN	Facility: NWIRP Bethpage
Project Number: 112G08005-WE13	Location: Bethpage, New York
Date: September 2, 2022 14:37	Personnel: Will Yeung
Well ID: TT-MW17411	Well Location: 200711.885043338 1123206.03244293
Well Status: In Use (Confirmed)	Screen Interval:
WELL INVENTORY CONDITION	
Concrete pad in acceptable condition i.e. no cracks?	YES
Manhole cover present and in working condition?	YES
All bolts on manhole present and not stripped?	YES
Well plug present, locked and in good working condition?	YES
OVERALL CONDITION:	GOOD
Notes (Explain if answered No to any of the above)

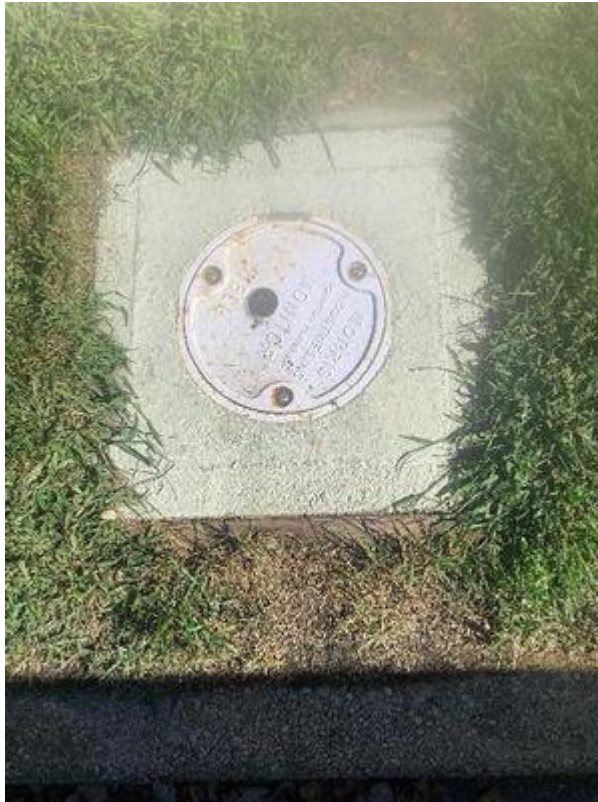
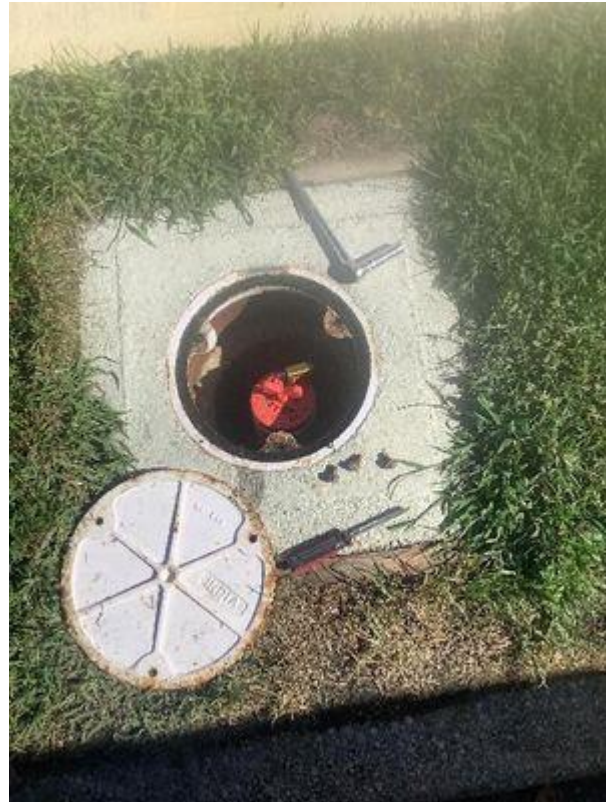
Client: Navy CLEAN	Facility: NWIRP Bethpage
Project Number: 112G08005-WE13	Location: Bethpage, New York
Date: September 2, 2022 10:02	Personnel: Will Yeung
Well ID: TT-MW205S1	Well Location: 199861.653476089 1126298.18636359
Well Status: In Use (Confirmed)	Screen Interval:
WELL INVENTORY CONDITION	
Concrete pad in acceptable condition i.e. no cracks?	YES
Manhole cover present and in working condition?	YES
All bolts on manhole present and not stripped?	YES
Well plug present, locked and in good working condition?	YES
OVERALL CONDITION:	GOOD
Notes (Explain if answered No to any of the above)
