Contractor Fatality

Tipped Elevated Manlift

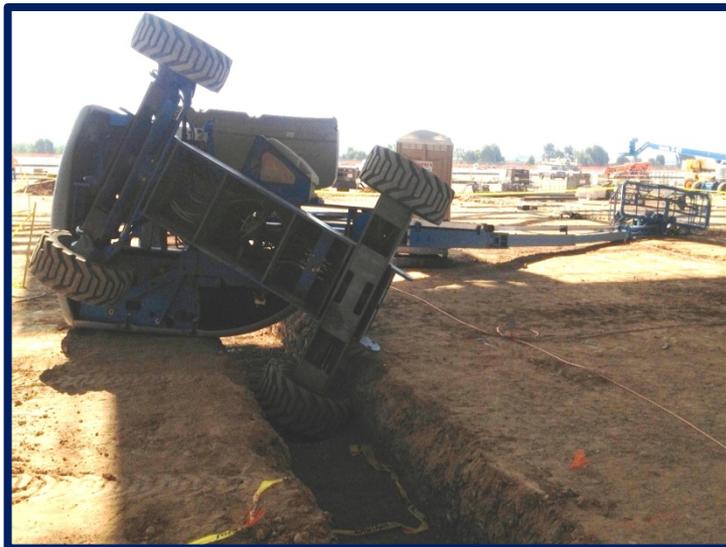
Activity: Two third-tier subcontractor employees performing overhead steel erection work in support of an aircraft hangar Military Construction project, were injured, **one fatally (23 yrs. old) and one seriously (40 yrs. old)**, when the articulating boom lift they were operating within the interior of the hangar tipped over. The boom was elevated to approximately 35' (max capacity >60'). When repositioning the lift on the earthen floor of the hangar, a wheel rolled into a 2' deep trench, causing the lift to topple and dropping the men an equivalent of 3 stories.

- Equipment travel over uneven surfaces (trench)
- Articulating boom lift traveling in elevated position
- Failure or bypass of controls limiting elevated lift travel
- Ineffective trench warning system or physical separation by spotter, barricades, demarcation, or trench covers.

- Operators **must** pre-plan all work and walk equipment travel paths to identify and mitigate hazards before starting **any** work
- Operators **must know** equipment operational tolerances and restrictions on uneven surfaces and while elevated
