# Contractor Fatality

## Electrocution

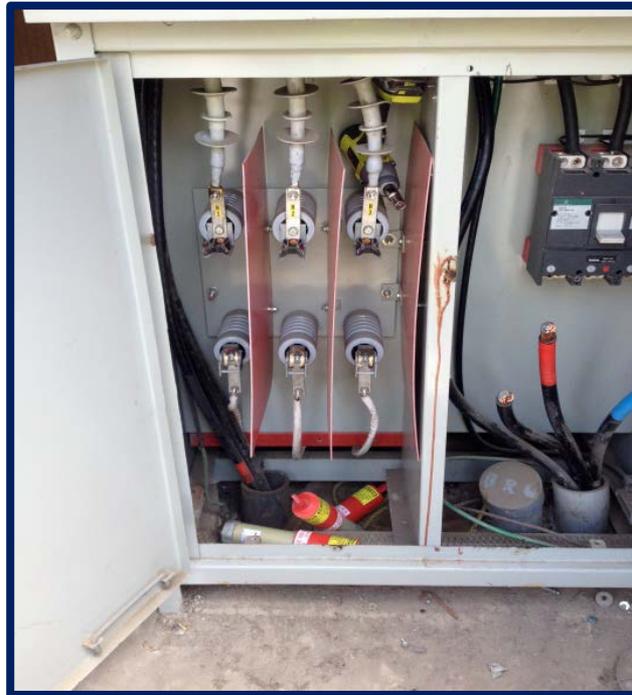
**Activity:** A 37 year old contractor was electrocuted while working on an electrical transformer. Working alone to remove emergency generator cables (pig tails) from the low voltage (right) side of the transformer, the employee removed a bolted panel controlling access to the high voltage side in order to access an area on the low voltage side required to complete the cable disconnect task. The low voltage fuses were previously removed from the primary side rendering the low voltage circuits de-energized, but the high voltage side was energized and should have been considered as such. The initial point of contact with 4160 V power is uncertain, but signs of arc flash were found inside the cabinet and while proper personal protective equipment (PPE) for low voltage work was worn, it was insufficient protection from energized high voltage circuit parts, and exit wounds were found on his shoulder, shins and fingers.

- Inadequate hazard consequence recognition and mitigation
- Insufficient/incomplete work planning and implementation of steps necessary to perform entire evolution in safest possible manner

- Entire electrical work evolutions must be fully planned and incorporate the fundamentals of Operational Risk Management (ORM) – identify and assess hazards, implement controls, and validate controls are effective; stopping and revising if controls are inadequate to mitigate encountered conditions
- Consider all circuit parts energized, and maintain safe separation until verified de-energized, or establish controls to work on/near energized circuit parts
