FINAL RESOURCE CONSERVATION AND RECOVERY ACT PARTIAL CLOSURE REPORT
FOR BUILDING 20 WITH TRANSMITTAL LETTER NAS BRUNSWICK ME
11/5/2010
NAS BRUNSWICK

RCRA PARTIAL CLOSURE REPORT
for
BUILDING 20 – NAVY COLLEGE OFFICE PARCEL
NAVAL AIR STATION BRUNSWICK, MAINE
USEPA IDENTIFICATION NUMBER ME8170022018
OCTOBER 2010

**HWSA INSPECTION REPORT
HAZARDOUS WASTE STORAGE AREAS CLOSURE
NAS BRUNSWICK
BRUNSWICK, MAINE
CTO WE22**

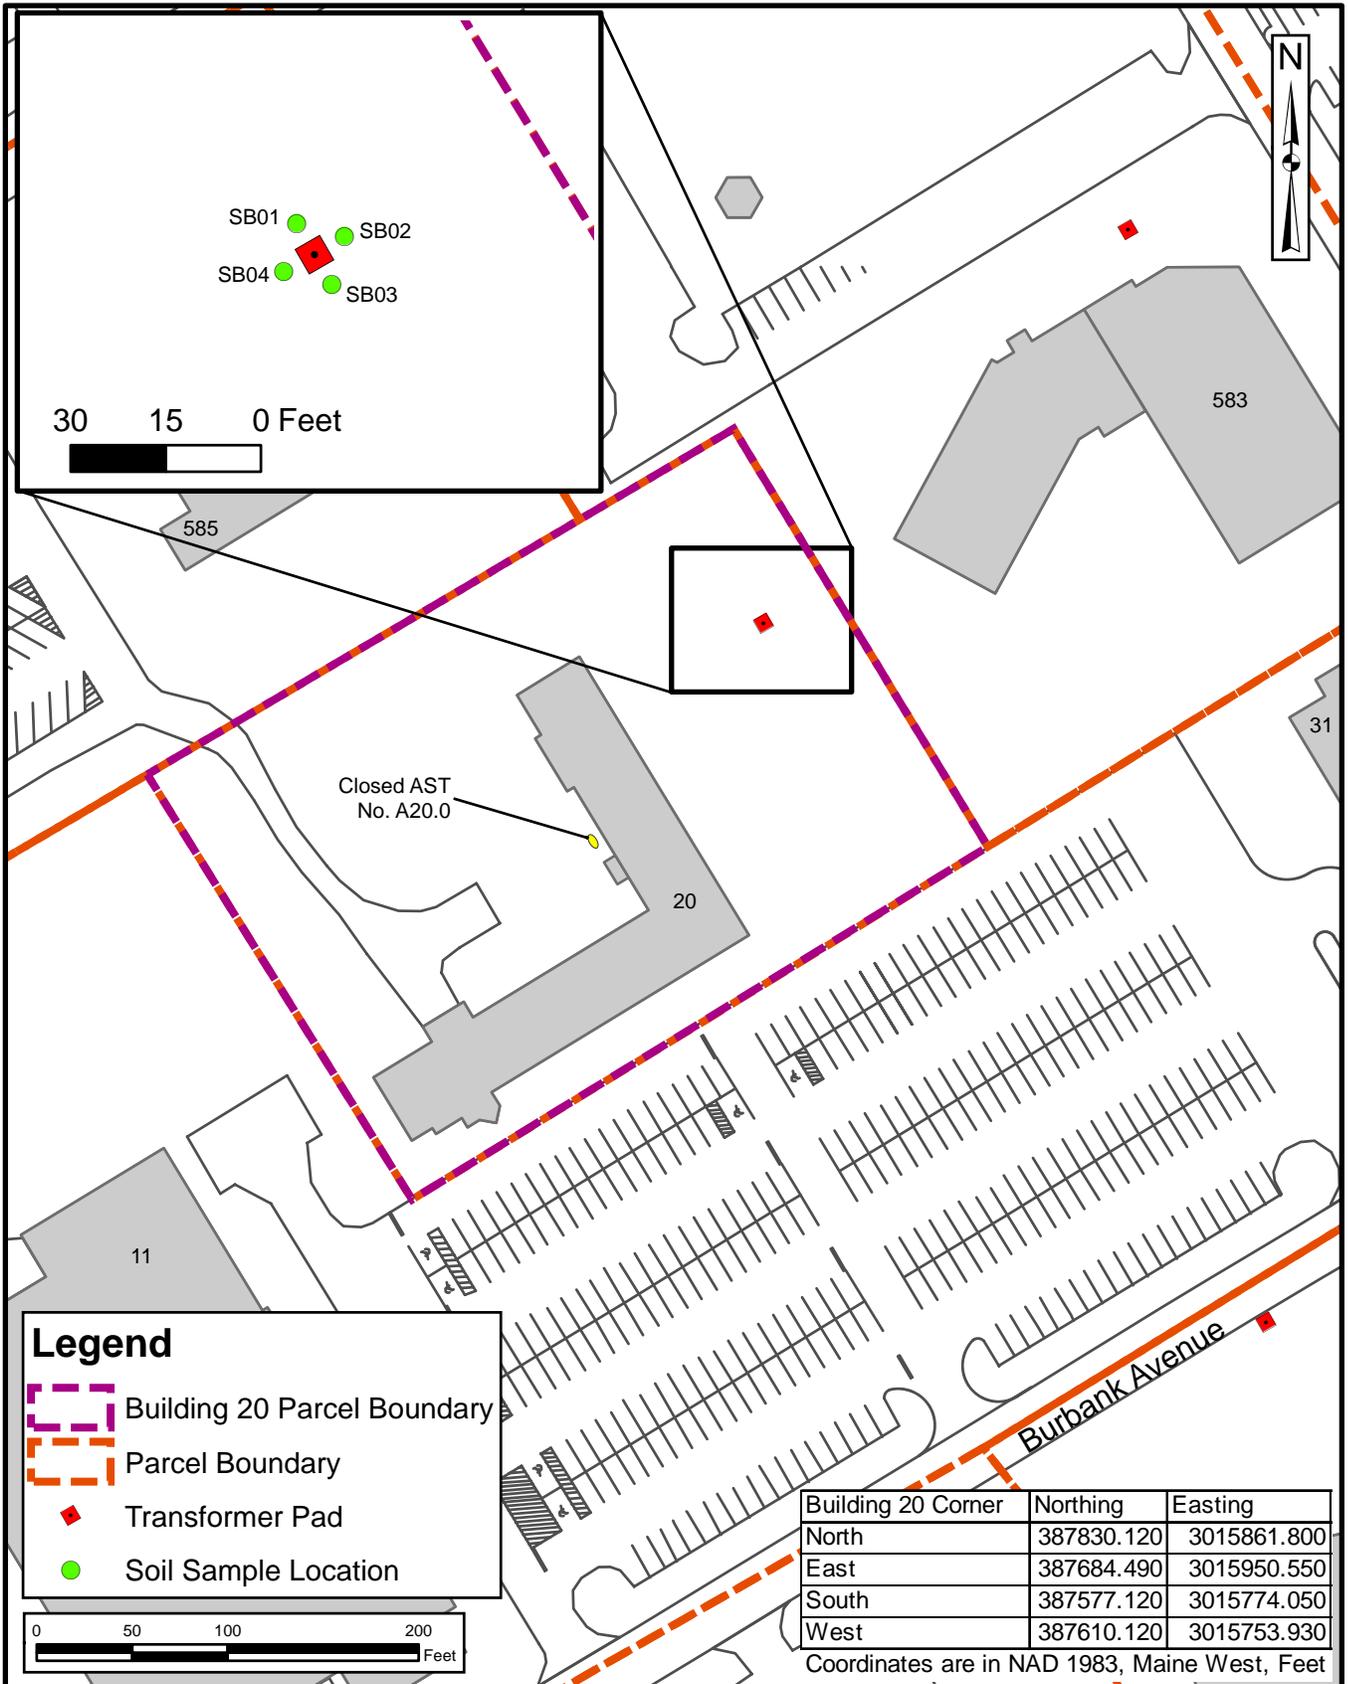
SCALE AS NOTED	
FILE L:\NASB_BLDG_20_SITE_MAP.MXD	
REV 0	DATE 11/01/10
FIGURE NUMBER FIGURE NO. 2

A label on the transformer located on the eastern side of Building 20 indicated it serviced Buildings 20 and 614. Building 614 was the former Swimming Pool Building that was east of Building 20 but razed in 1997 (approximately). According to NAS Brunswick records, the observed 225-kVA transformer was a replacement for a 5 kVA transformer removed in 1991, which reportedly contained PCBs.

Due to the building's age and because a PCB-containing transformer had been located at this pad, soil sampling was conducted to determine if there had been a release from former transformer. On September 16, 2010, soil samples were collected from each side of the transformer pad (Figure 2 using hand-augers). At each sample set location, the samples were collected from 0 to 6 and 6 to 24 inches bgs.
