FINAL RESOURCE CONSERVATION AND RECOVERY ACT PARTIAL CLOSURE REPORT  
FOR BUILDING 86 WITH TRANSMITTAL LETTER NAS BRUNSWICK ME  
12/1/2010  
NAS BRUNSWICK

Subj: Final RCRA Partial Closure Report for Building 86

**RCRA PARTIAL CLOSURE REPORT  
for  
BUILDING 86 – GROUND SUPPORT EQUIPMENT (GSE) MAINTENANCE SHOP PARCEL  
NAVAL AIR STATION BRUNSWICK, MAINE  
USEPA IDENTIFICATION NUMBER ME8170022018  
NOVEMBER 2010**

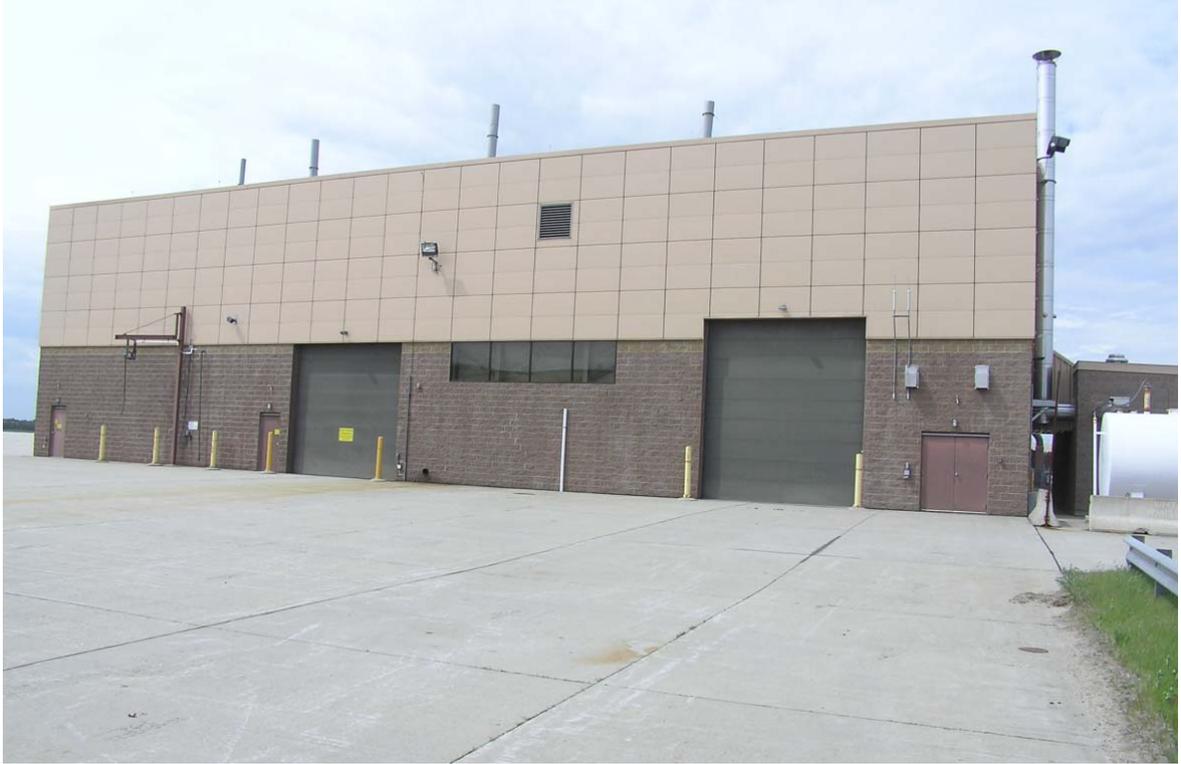
No. 3 Building 86 – NAS Brunswick  
GSE Maintenance Shop south elevation

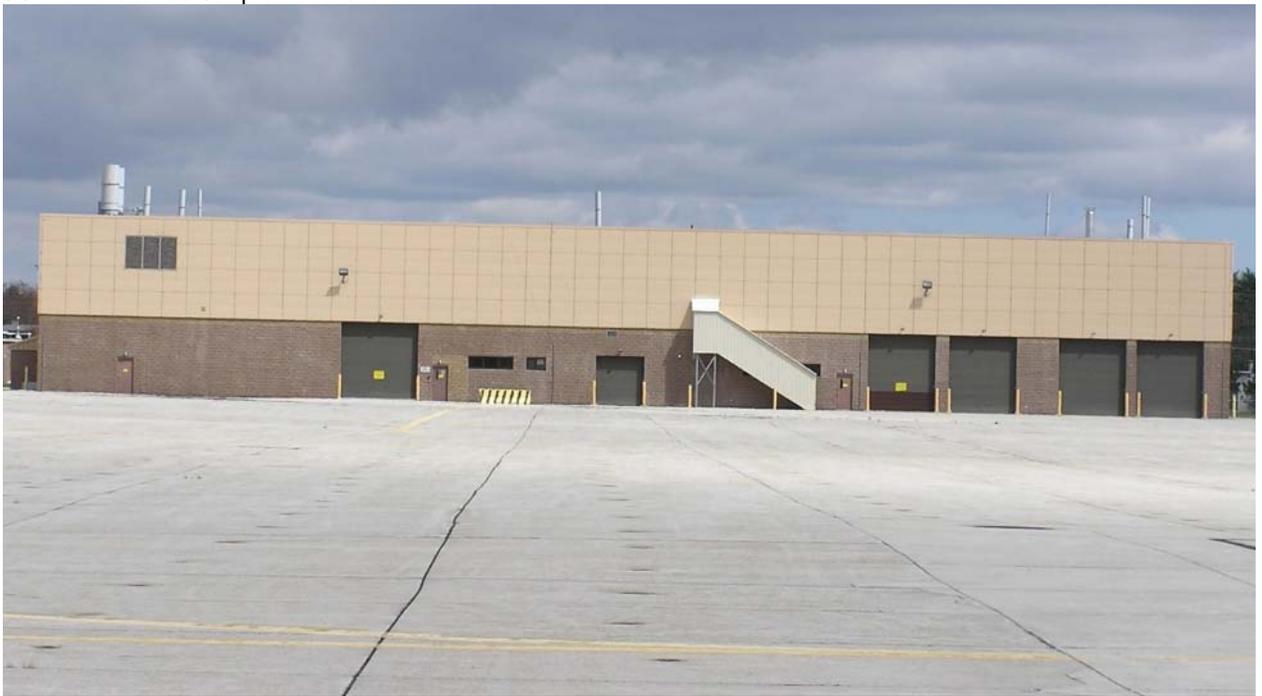
No. 4 Building 86 – NAS Brunswick  
GSE Maintenance Shop west elevation

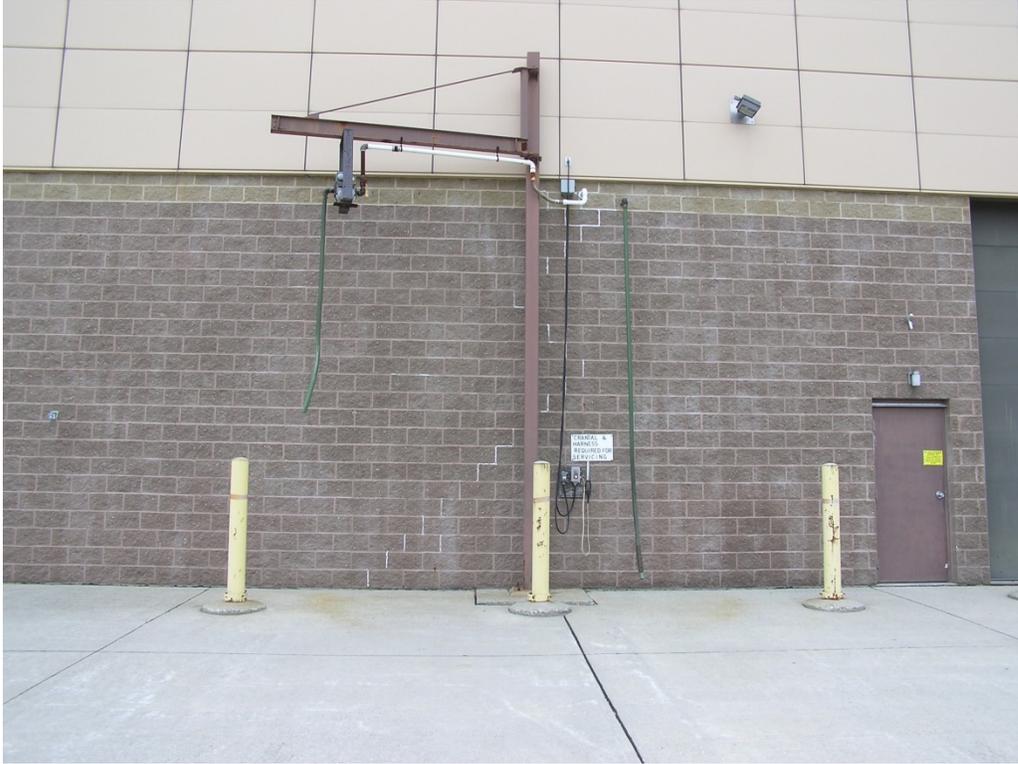
No. 5 Building 86 – NAS Brunswick June 8, 2010  
GSE Maintenance Shop glycol filling station along the south side of building

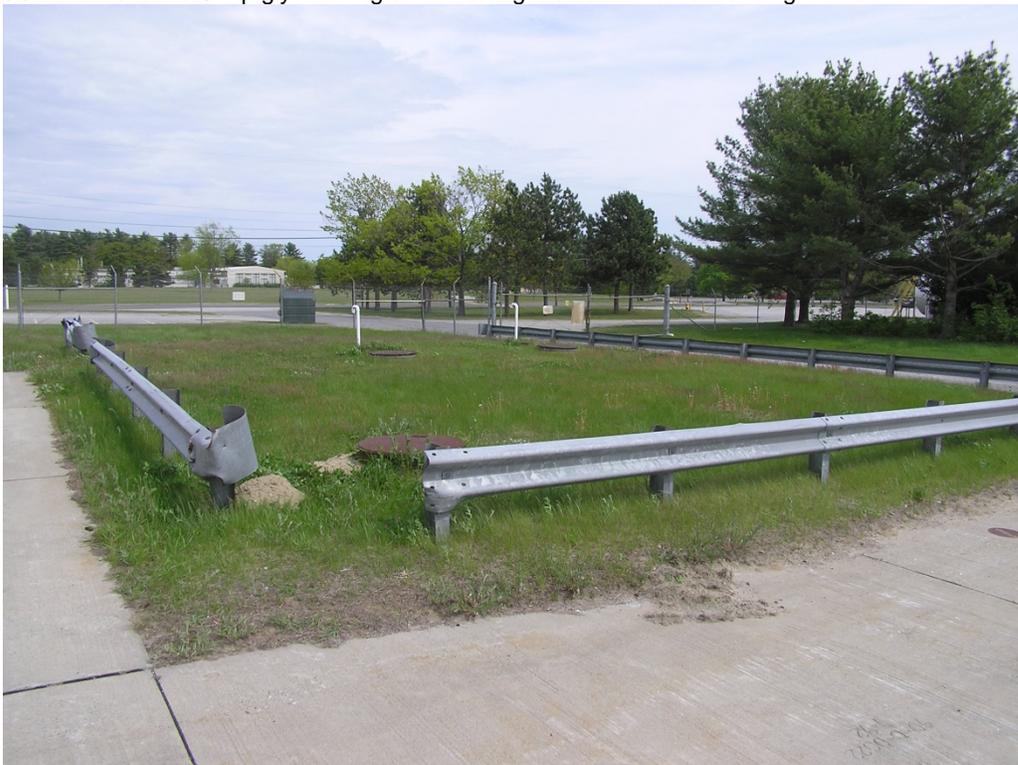
No. 6 Building 86 – NAS Brunswick May 12, 2010  
Propylene glycol underground storage tanks south of GSE Maintenance Shop
