FINAL RESOURCE CONSERVATION AND RECOVERY ACT PARTIAL CLOSURE REPORT
FOR BUILDING 404 WITH TRANSMITTAL LETTER NAS BRUNSWICK ME
3/14/2011
NAS BRUNSWICK

**RCRA PARTIAL CLOSURE REPORT
for
BUILDING 404 – NMCB-27/STORAGE
NAVAL AIR STATION BRUNSWICK, MAINE
USEPA IDENTIFICATION NUMBER ME8170022018
FEBRUARY 2011**

**HWSA INSPECTION REPORT
HAZARDOUS WASTE STORAGE AREAS CLOSURE
NAS BRUNSWICK
BRUNSWICK, MAINE
CTO WE22**

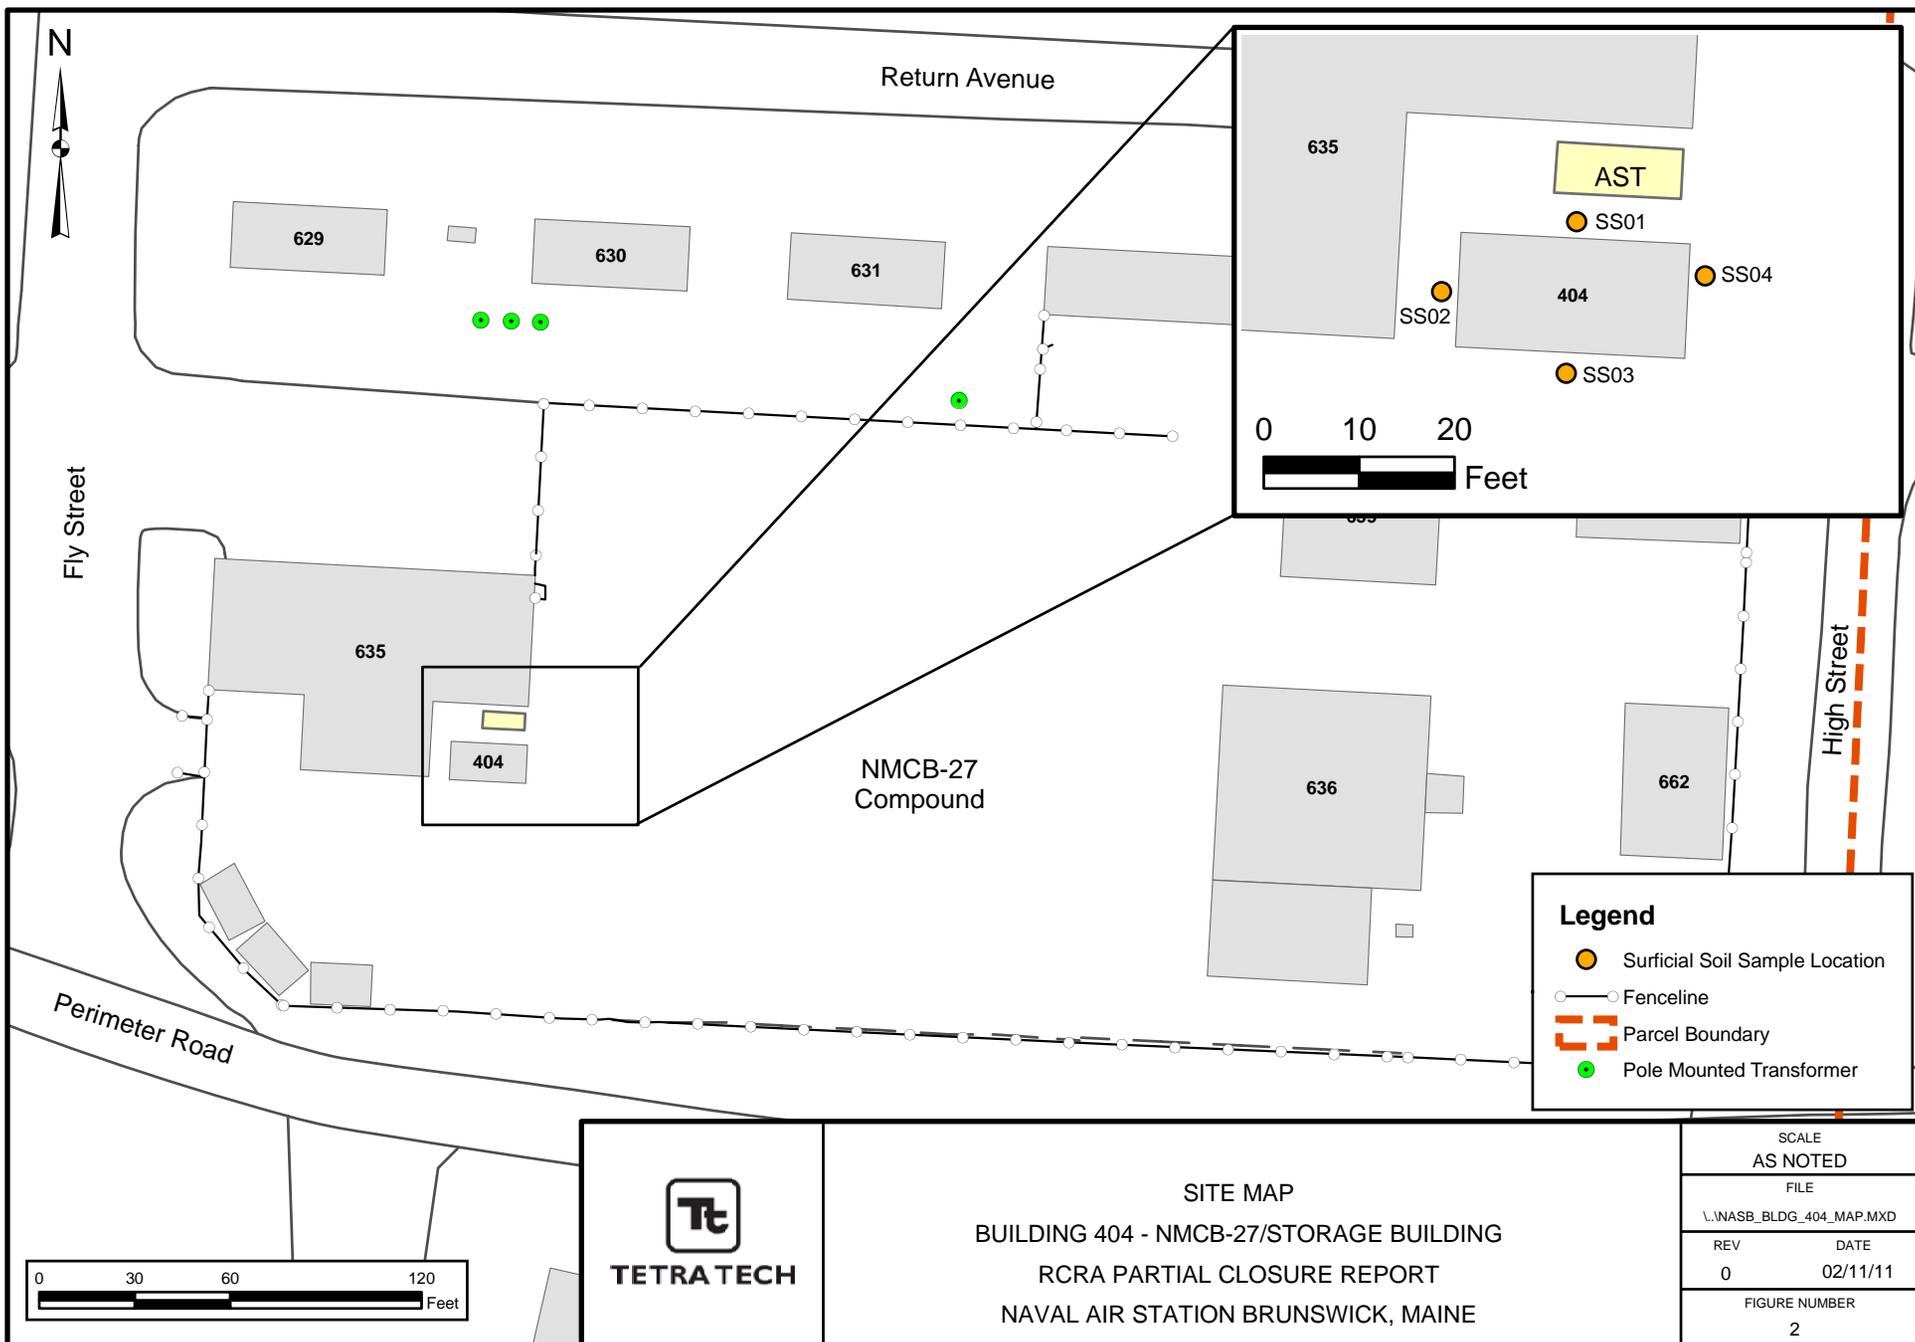
SCALE AS NOTED	
FILE	
\\NASB_BLDG_404_MAP.MXD	
REV	DATE
0	02/11/11
FIGURE NUMBER	
2

This investigation of the hazardous waste closure requirement applies to the building footprint of Building 404 (building footprint as shown on Figure 2). It does not apply to the land surrounding or the groundwater underlying Building 404.

SITE MAP
BUILDING 404 - NMCB-27/STORAGE BUILDING
RCRA PARTIAL CLOSURE REPORT
NAVAL AIR STATION BRUNSWICK, MAINE
