**Department of the Navy  
Installation Restoration Program  
Field Investigation Photograph Album  
Sites 6, 9, 48, and 69**

**SITES 6, 9, 48, AND 69  
MARINE CORPS BASE CAMP LEJEUNE  
NORTH CAROLINA**

**CONTRACT TASK ORDER 0133**

**JANUARY 15, 1993**

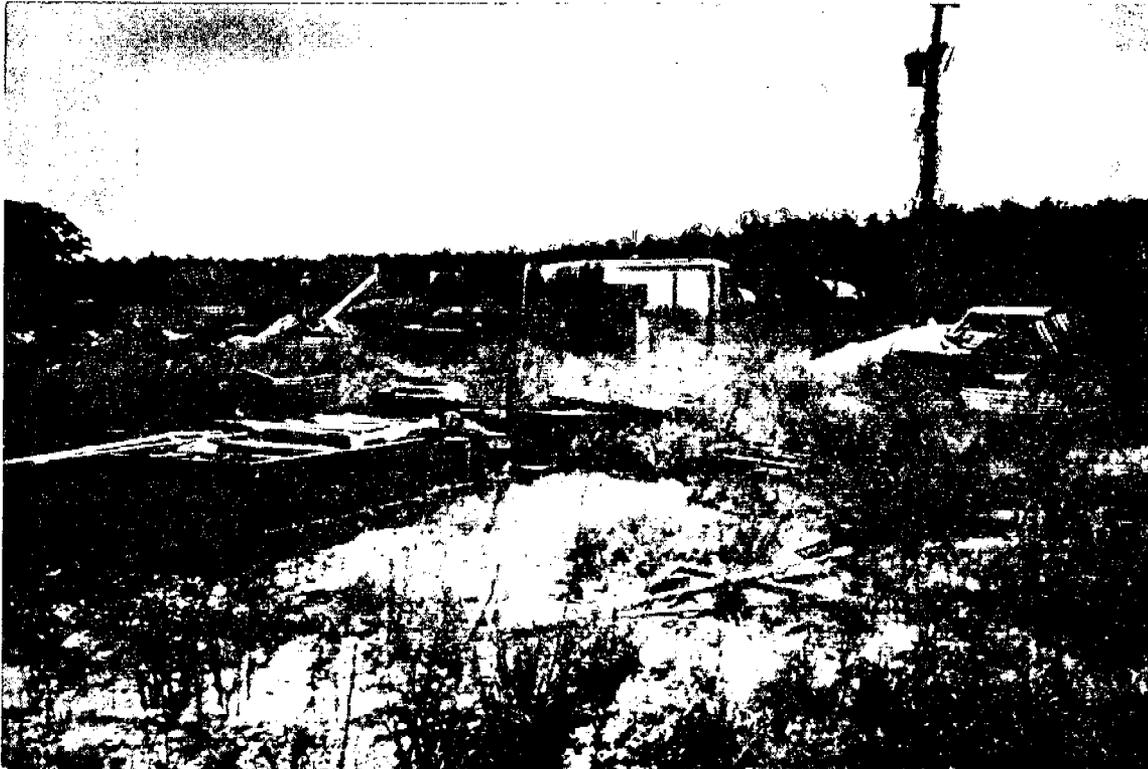
**Photograph 2-2**

View looking southeast across Lot 203 from the western fence line. Building 821 and above ground storage tanks are pictured in the background.

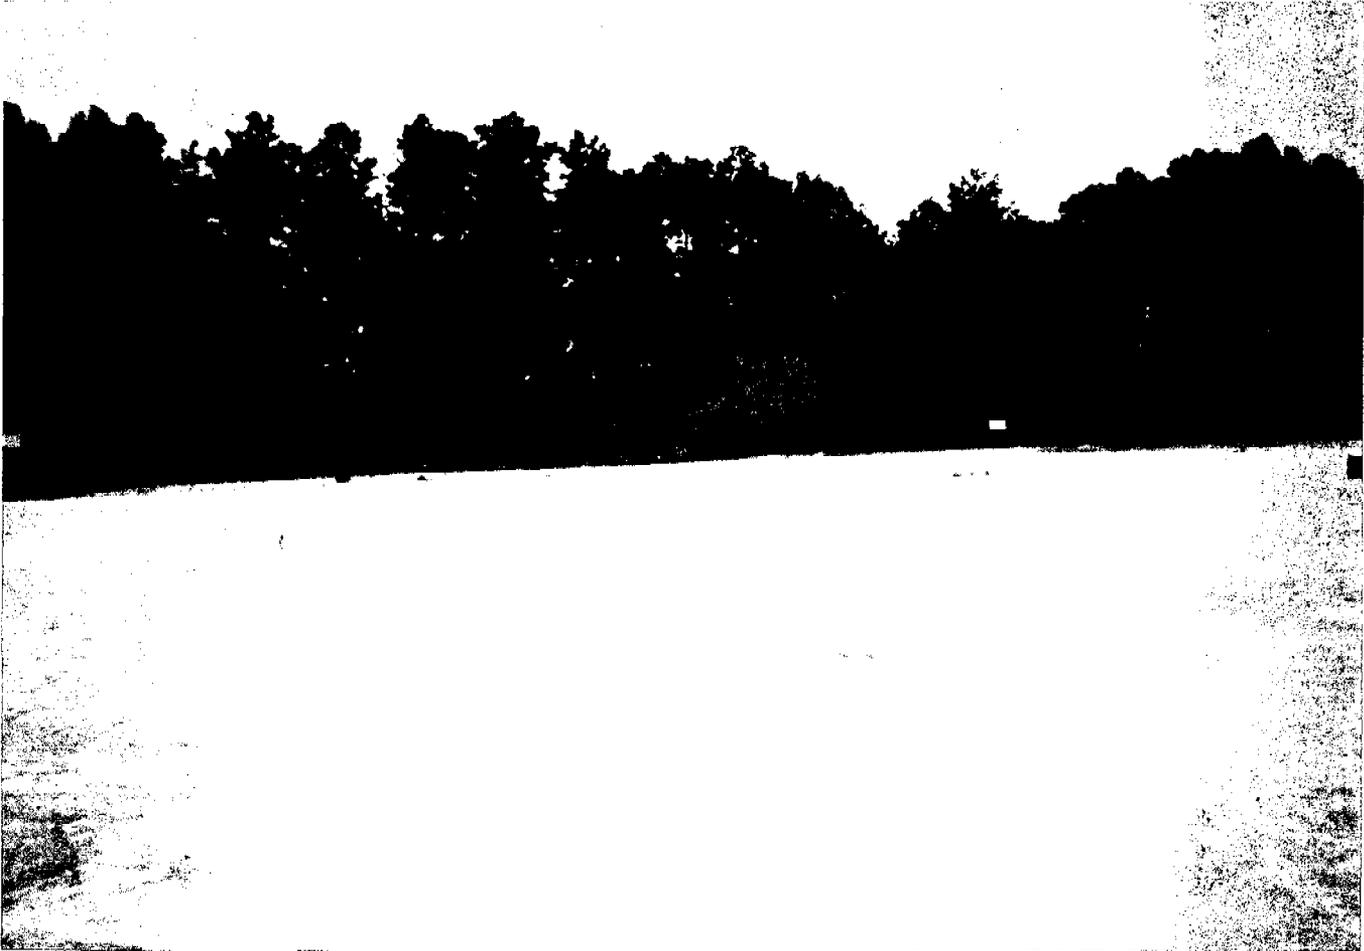
**Photograph 2-5**

View looking north from within the open storage area of Lot 201. Grid A, reported pesticide storage location, and survey markers are pictured.

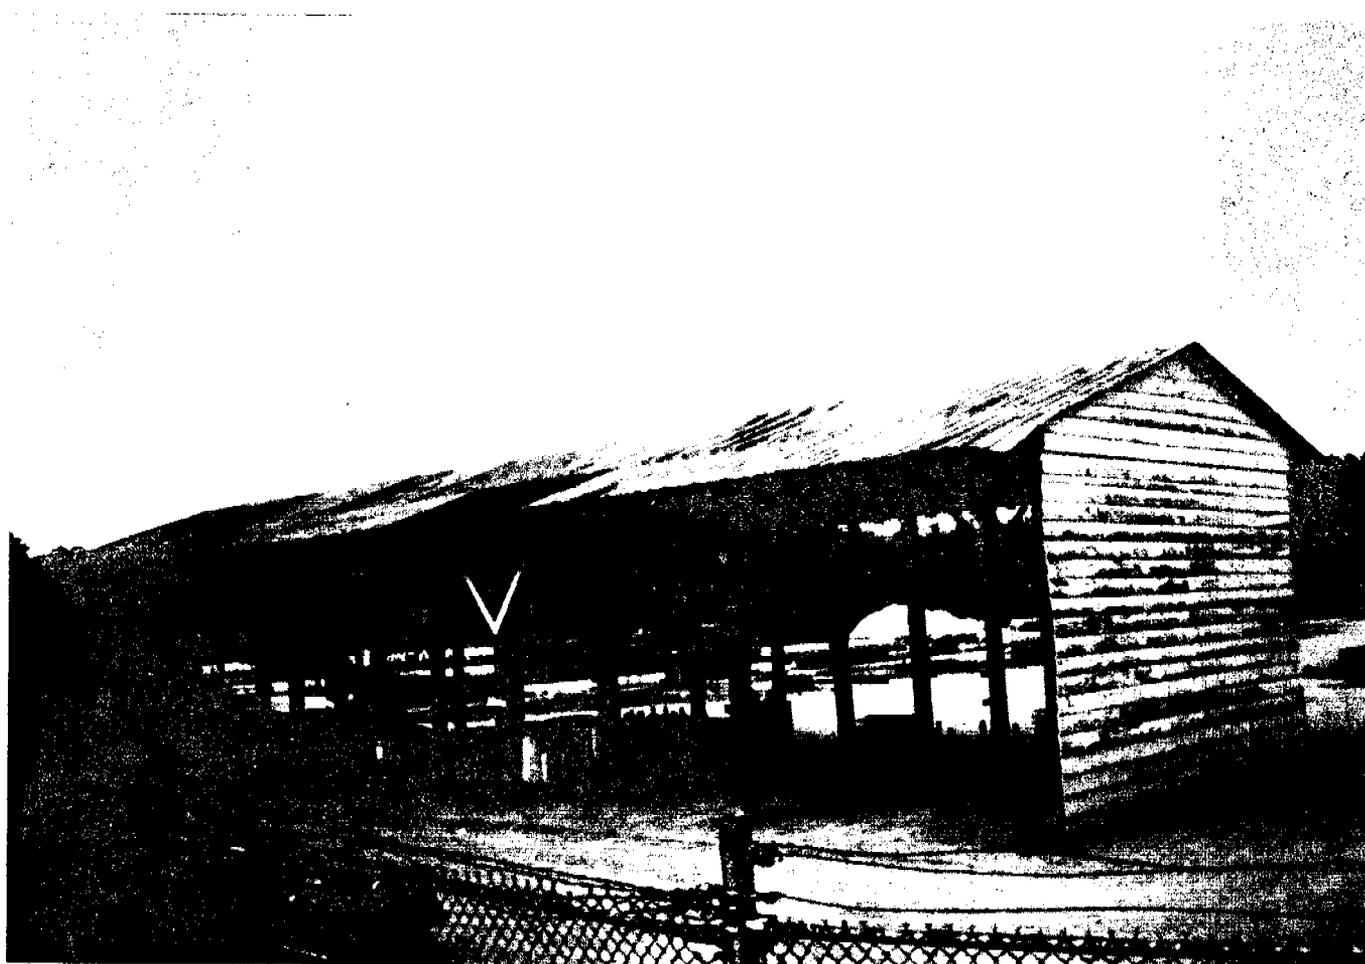
**Photograph 2-6**

Building materials, lumber, and compressed gas cylinders are stockpiled in the covered storage area of Lot 201, pictured here. This lot is currently in use by MCB Camp Lejeune.

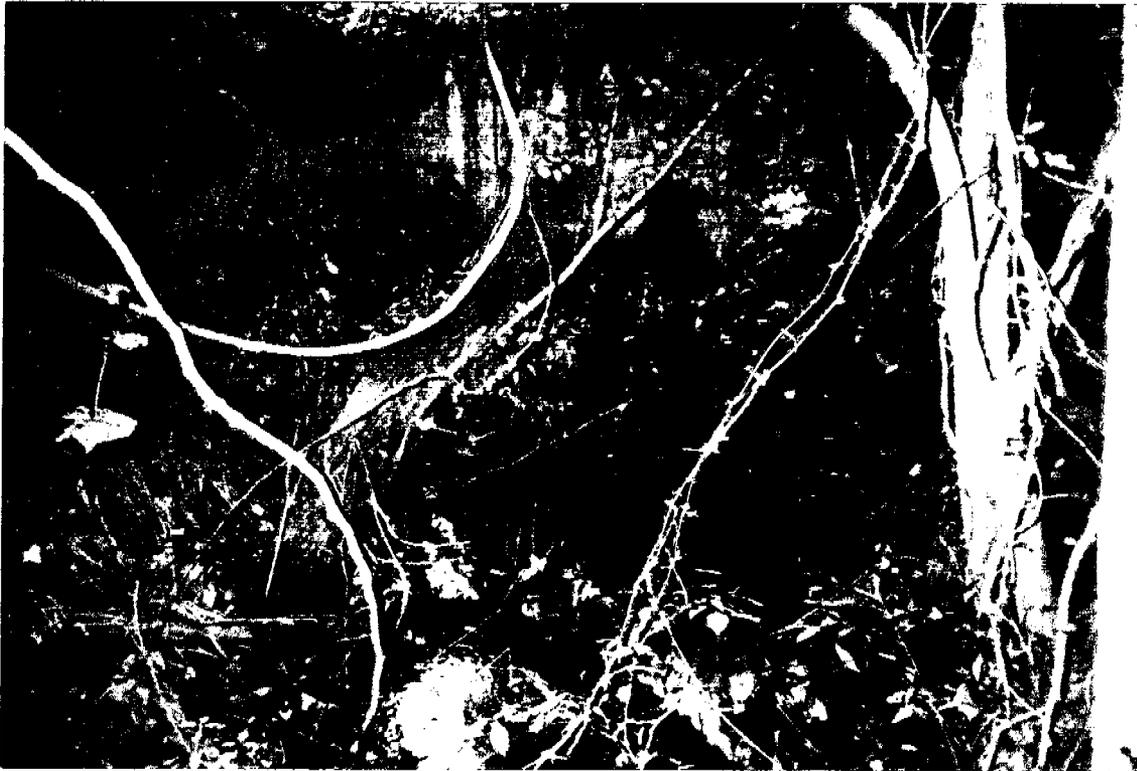
**Photograph 2-7**

Bear Head Creek culvert where railroad line intersects waterway, south of Lot 201.

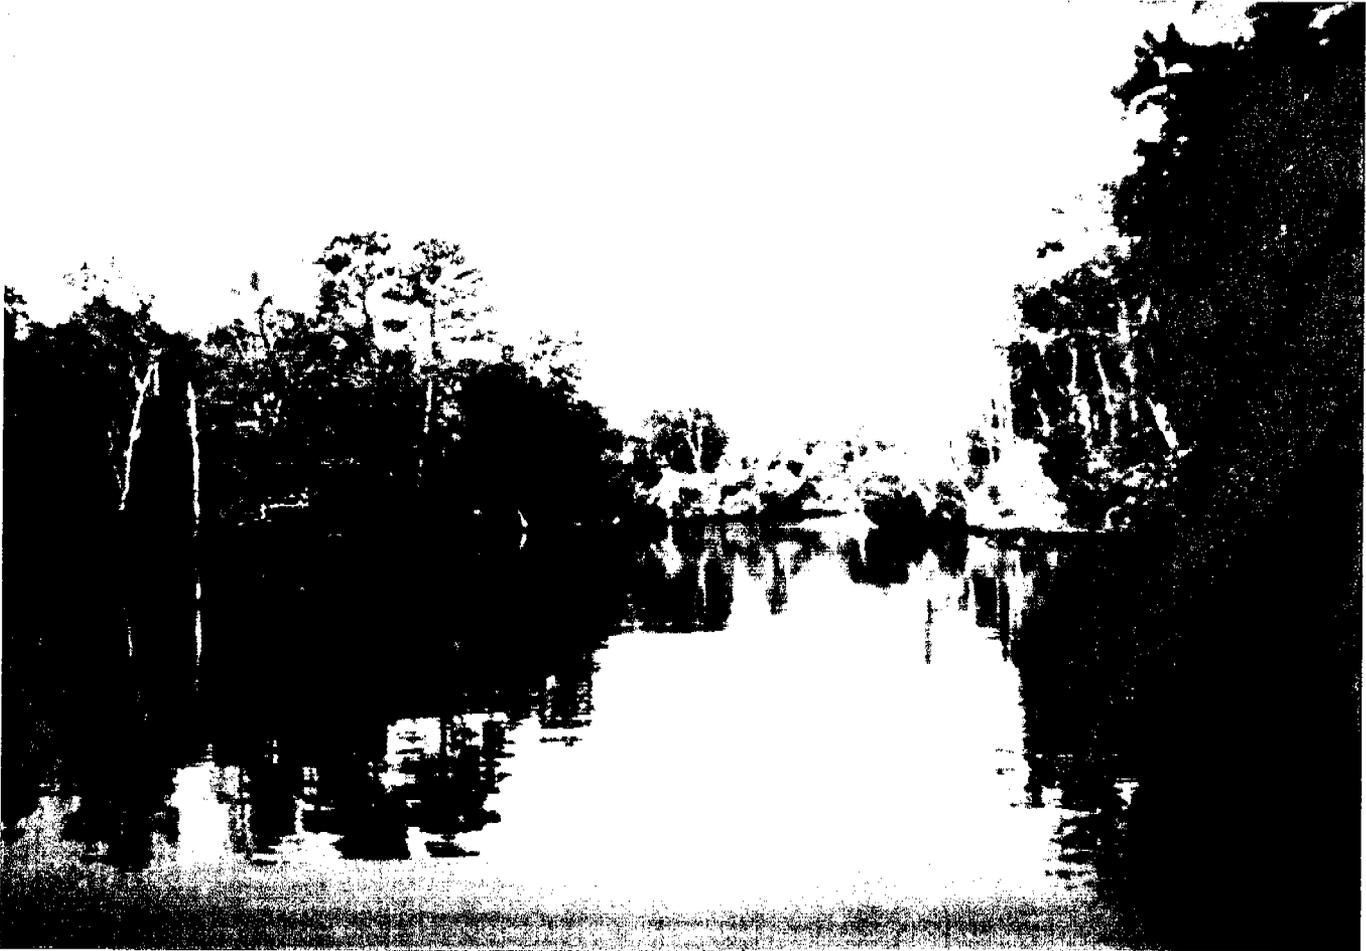
**Photograph 2-9**

View looking east, upstream, on Wallace Creek. Ravine drainage empties into Wallace Creek from the right bank.

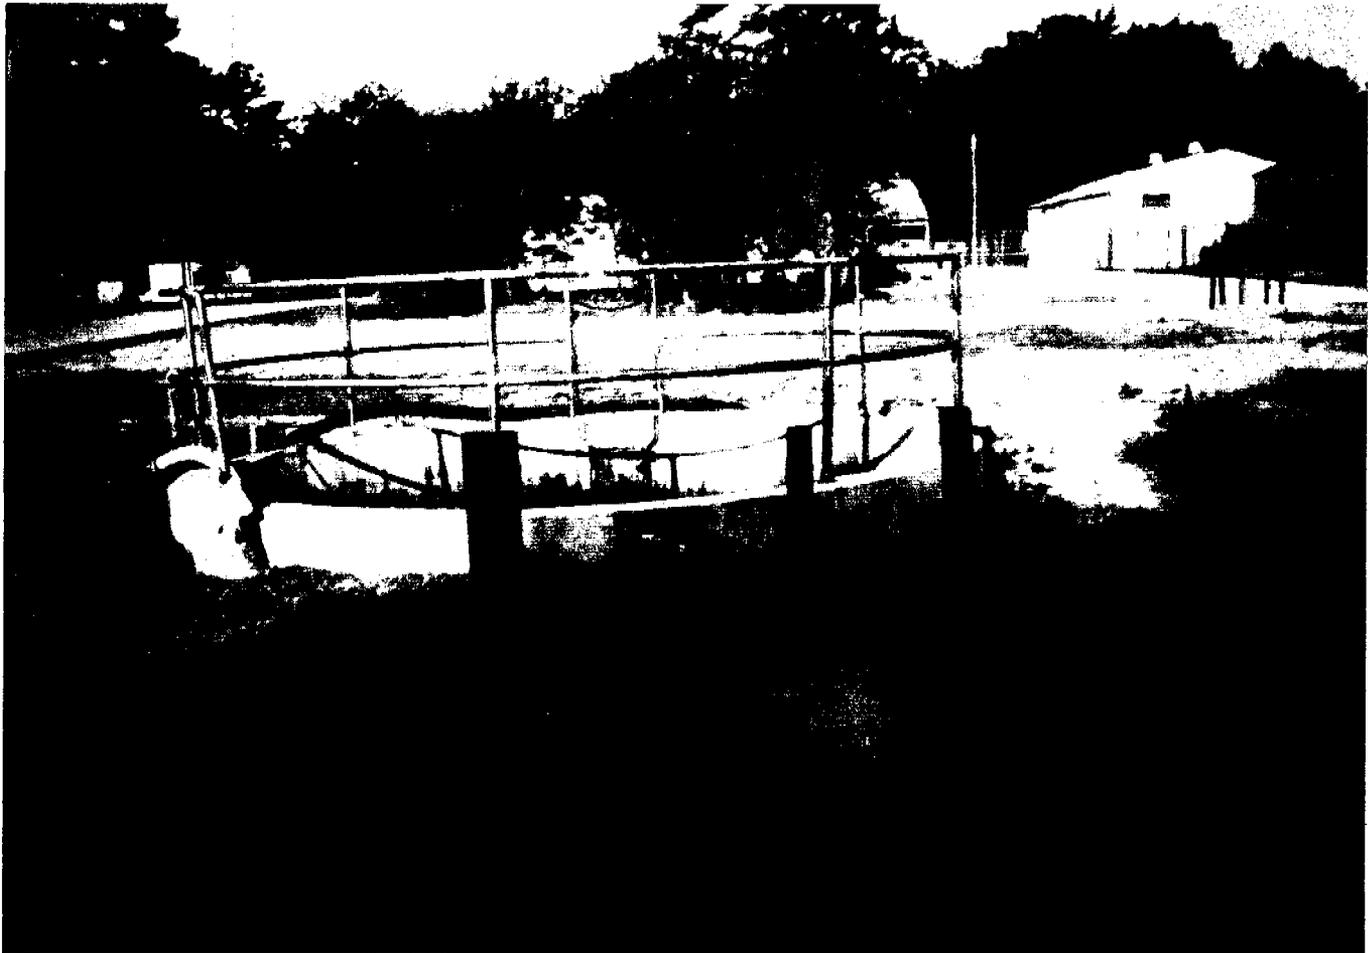
**Photograph 2-12**

Shallow well number 9GW1 is pictured in the foreground with the oil/water separator directly behind.

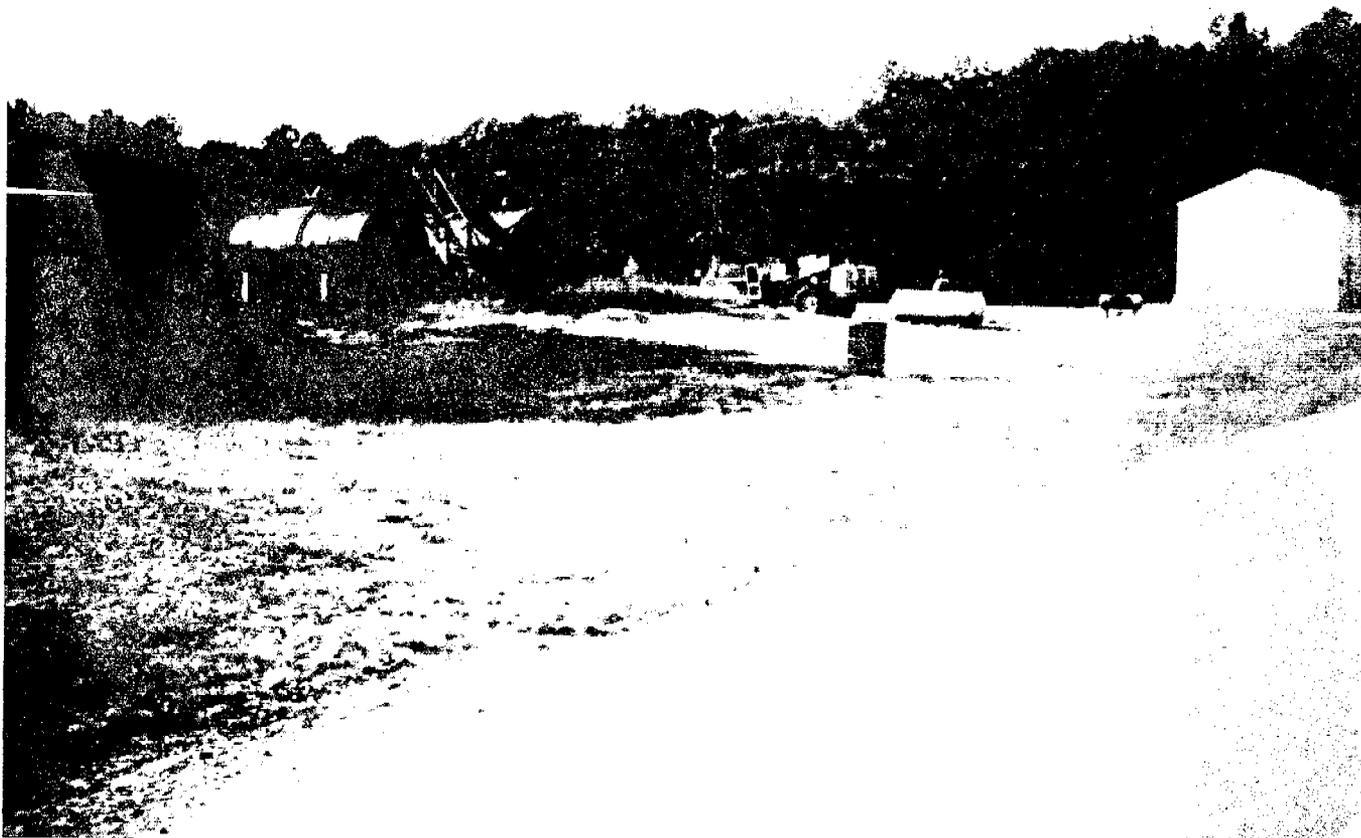
**Photograph 2-13**

View looking northwest across Site 9 toward two above ground storage tanks, two propane tanks, and the fire training tower.

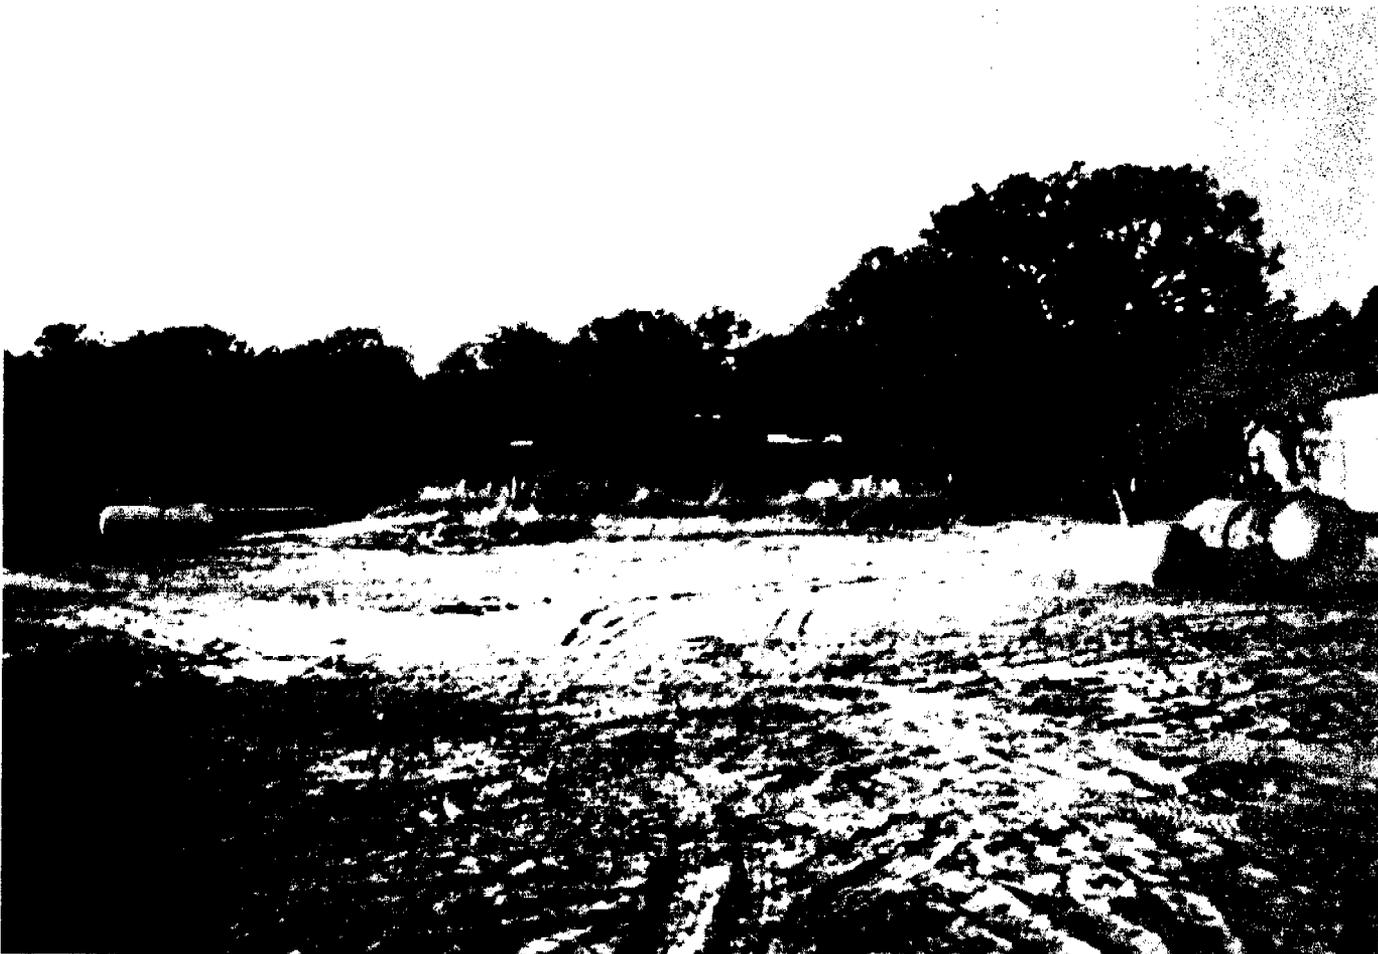
**Photograph 2-14**

Photograph taken from northern end of Site 9, adjacent to fire training tower, looking south toward above ground storage tanks.

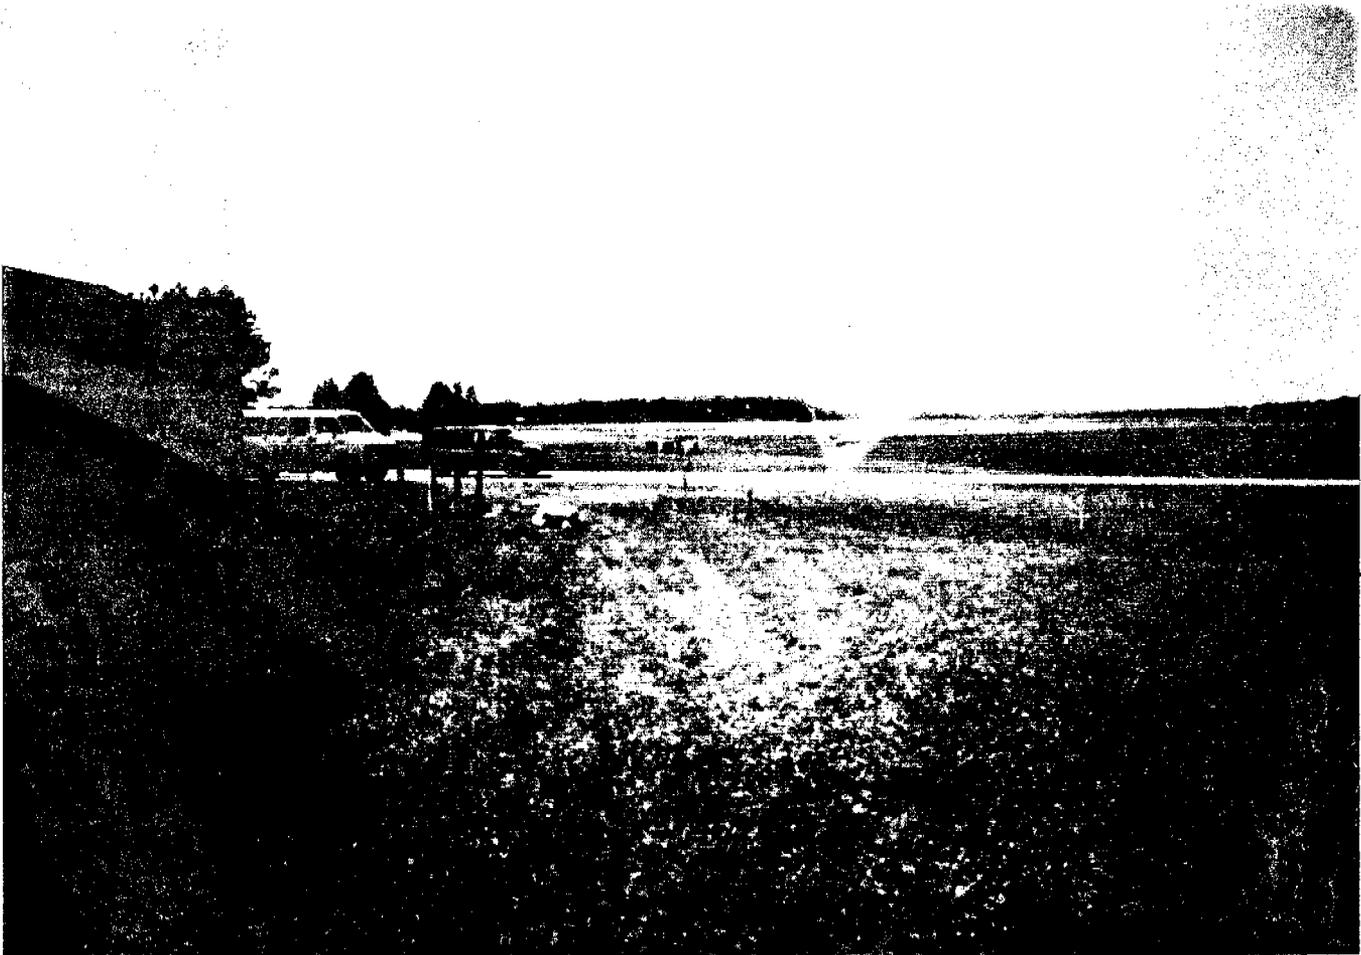
**Photograph 2-15**

Photograph taken facing southwest across Longstaff Road adjacent to Building AS804, former photo lab. Historical photographs depict ground disturbance and revegetation in this area.

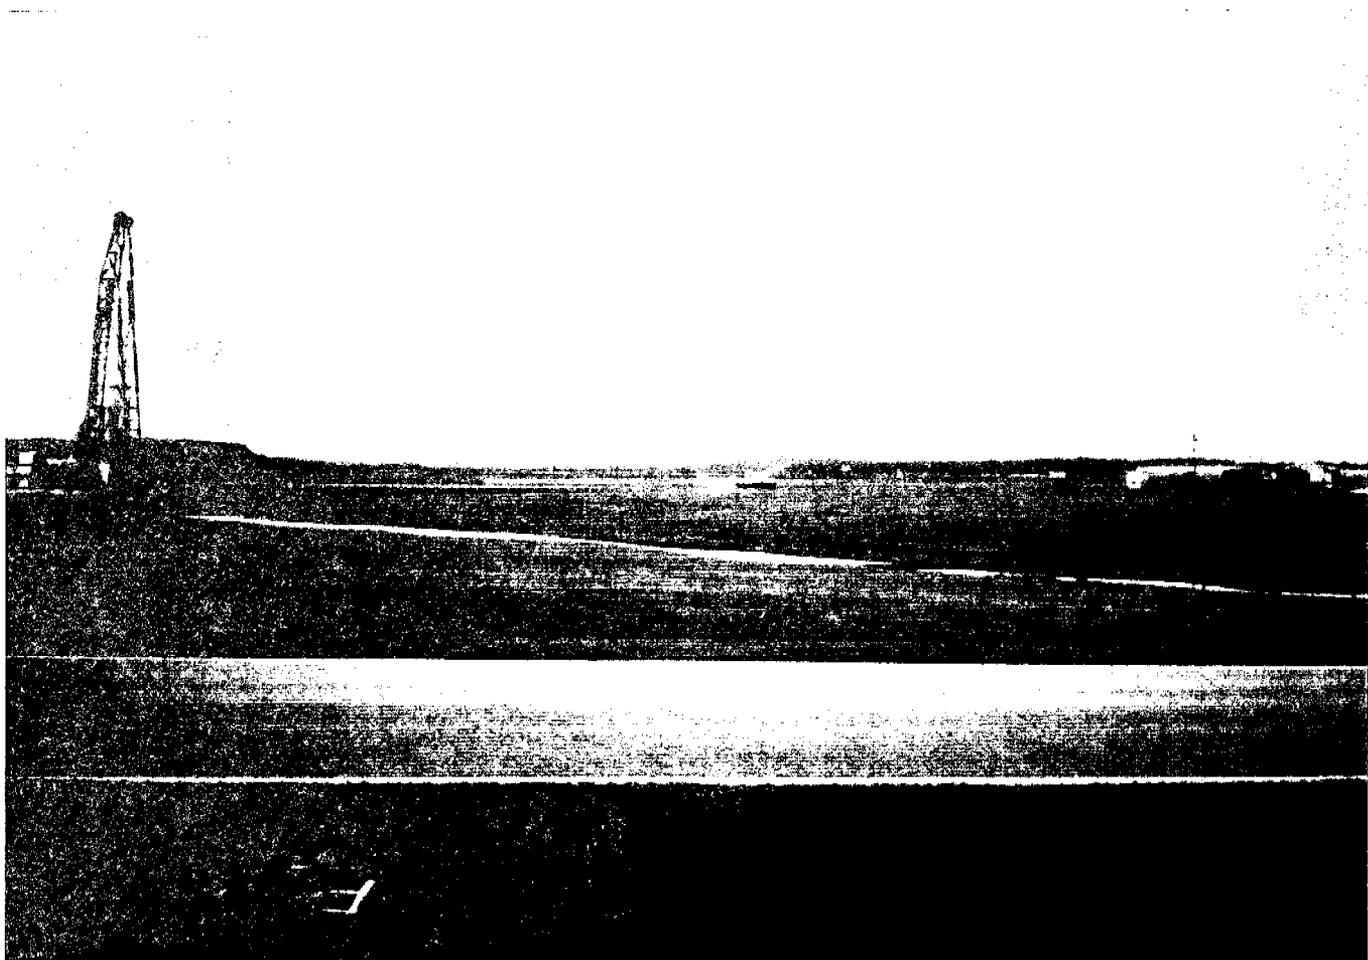
**Photograph 2-17**

Photograph facing southwest across Longstaff Road toward man-made drainage ditch that borders Site 48. Ground scars were identified on historical photographs in this area.

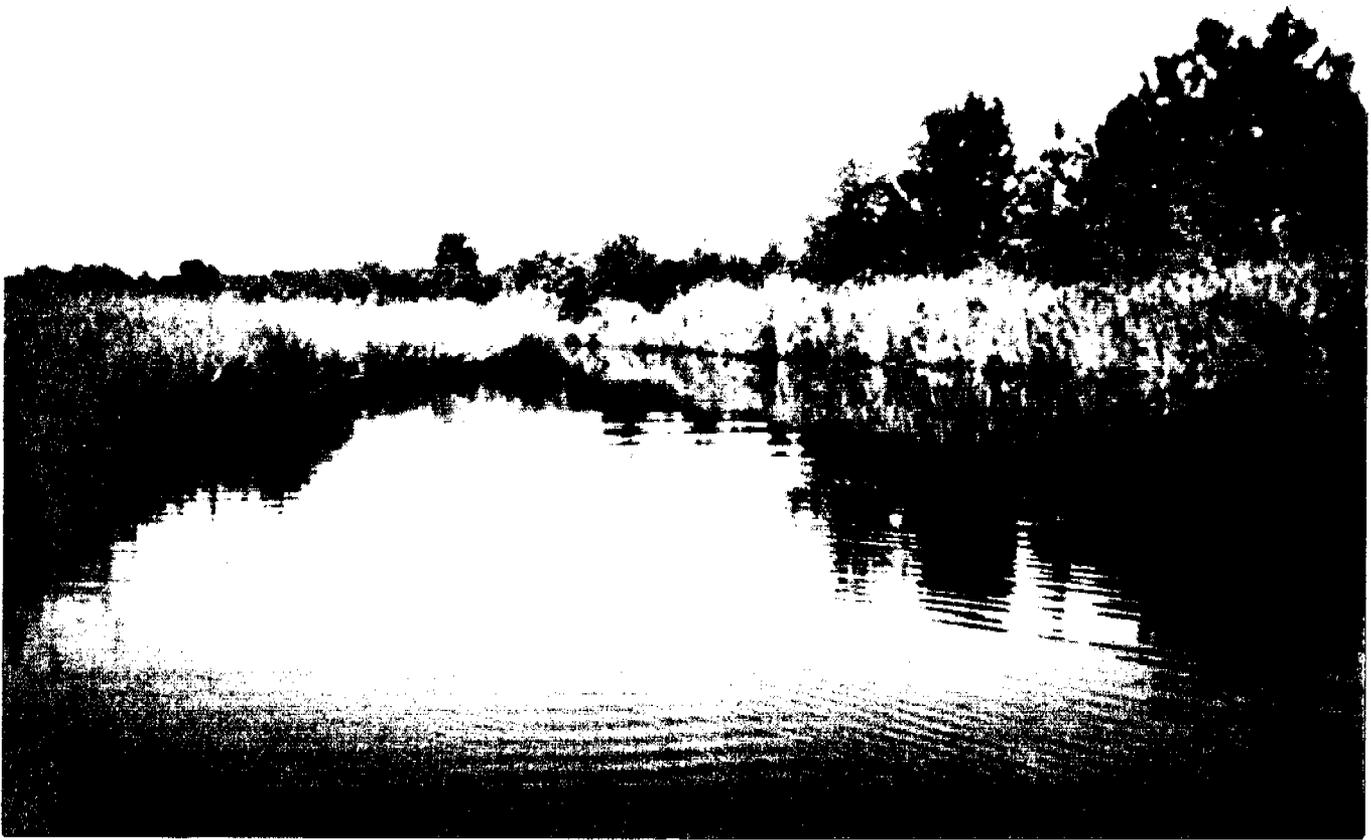
**Photograph 2-19**

Photograph taken from the New River looking northwest toward the unnamed tributary that borders Site 48.

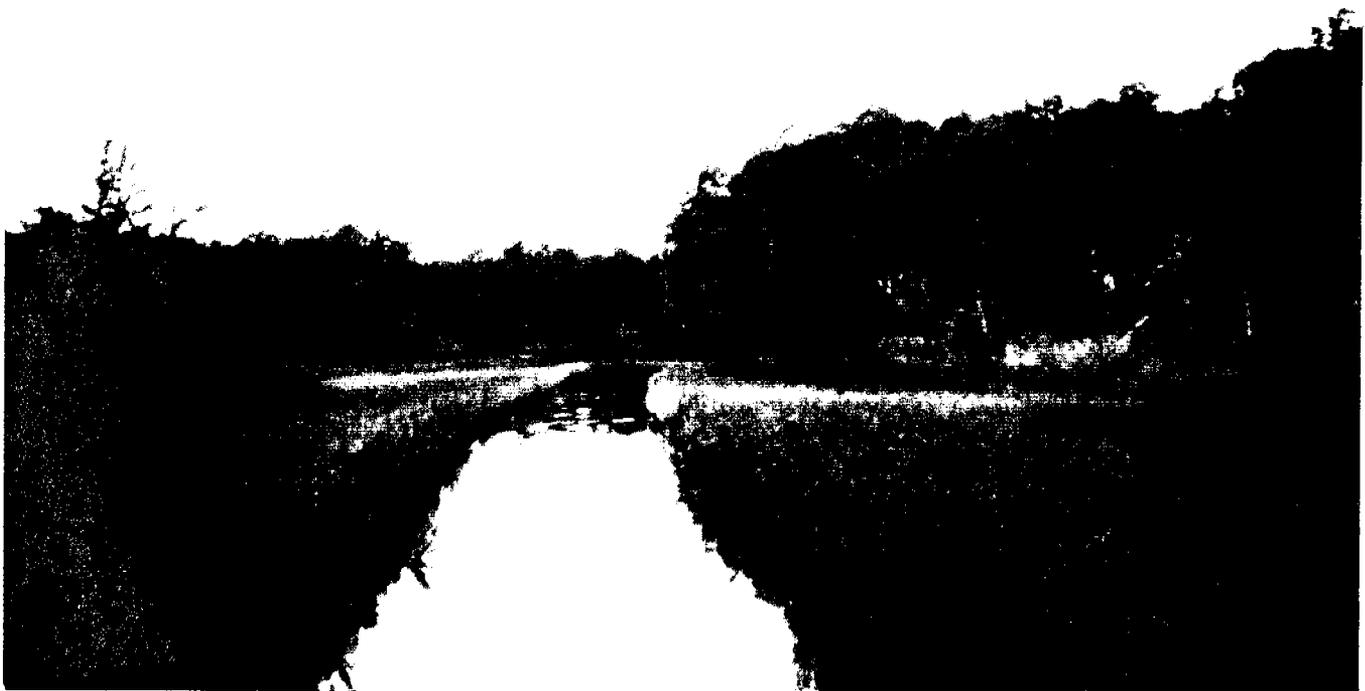
**Photograph 2-22**

Photograph taken facing east toward the New River from an unnamed tributary north of Site 69.

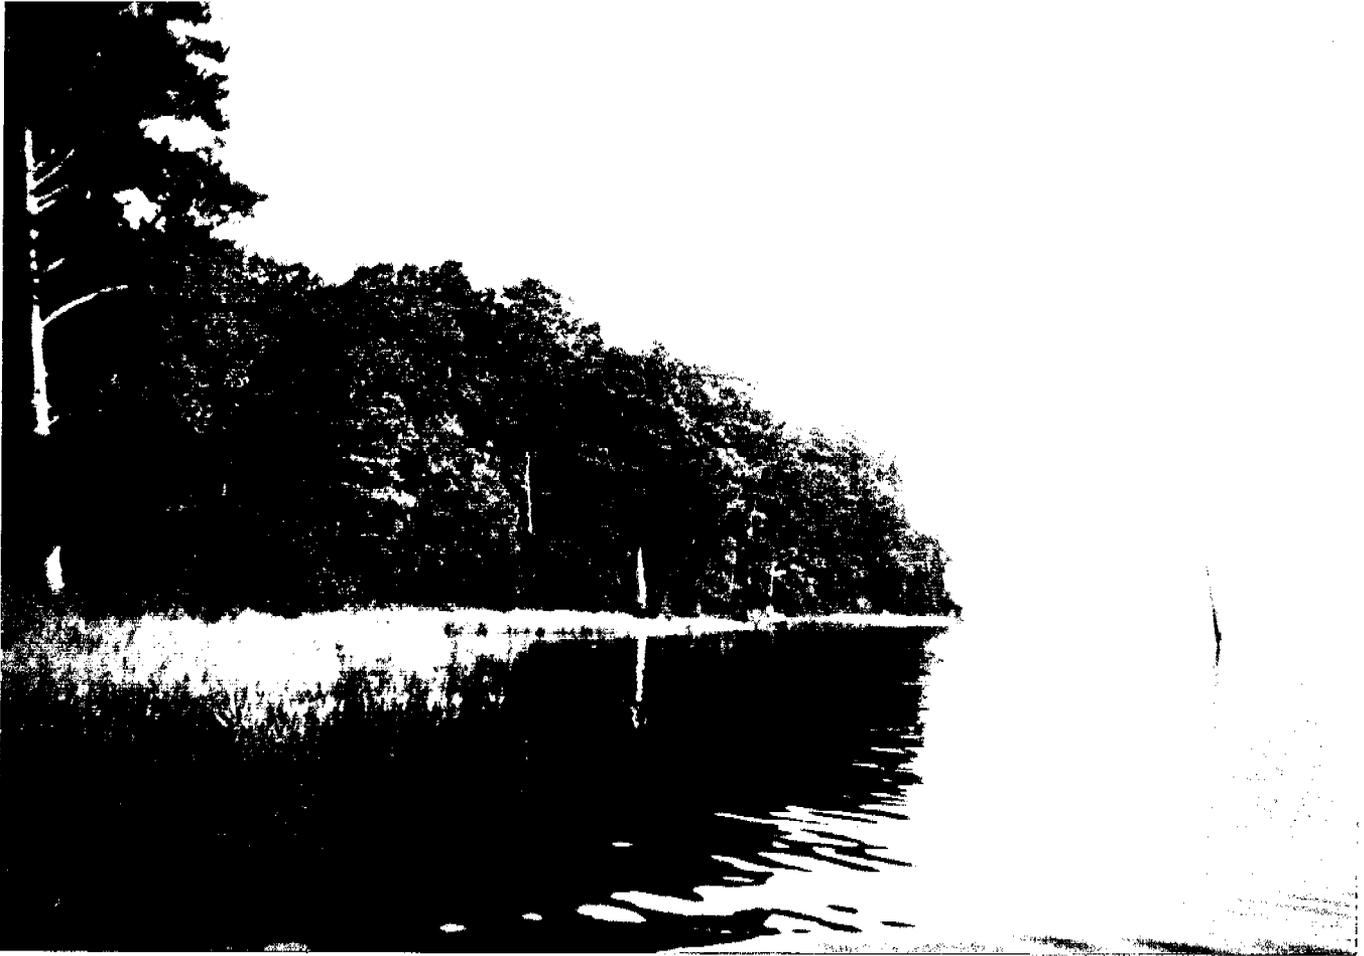
**Photograph 2-23**

View looking northwest from the New River, in the general direction of Site 69.  
Site 69 is approximately 1500-feet from the New River.

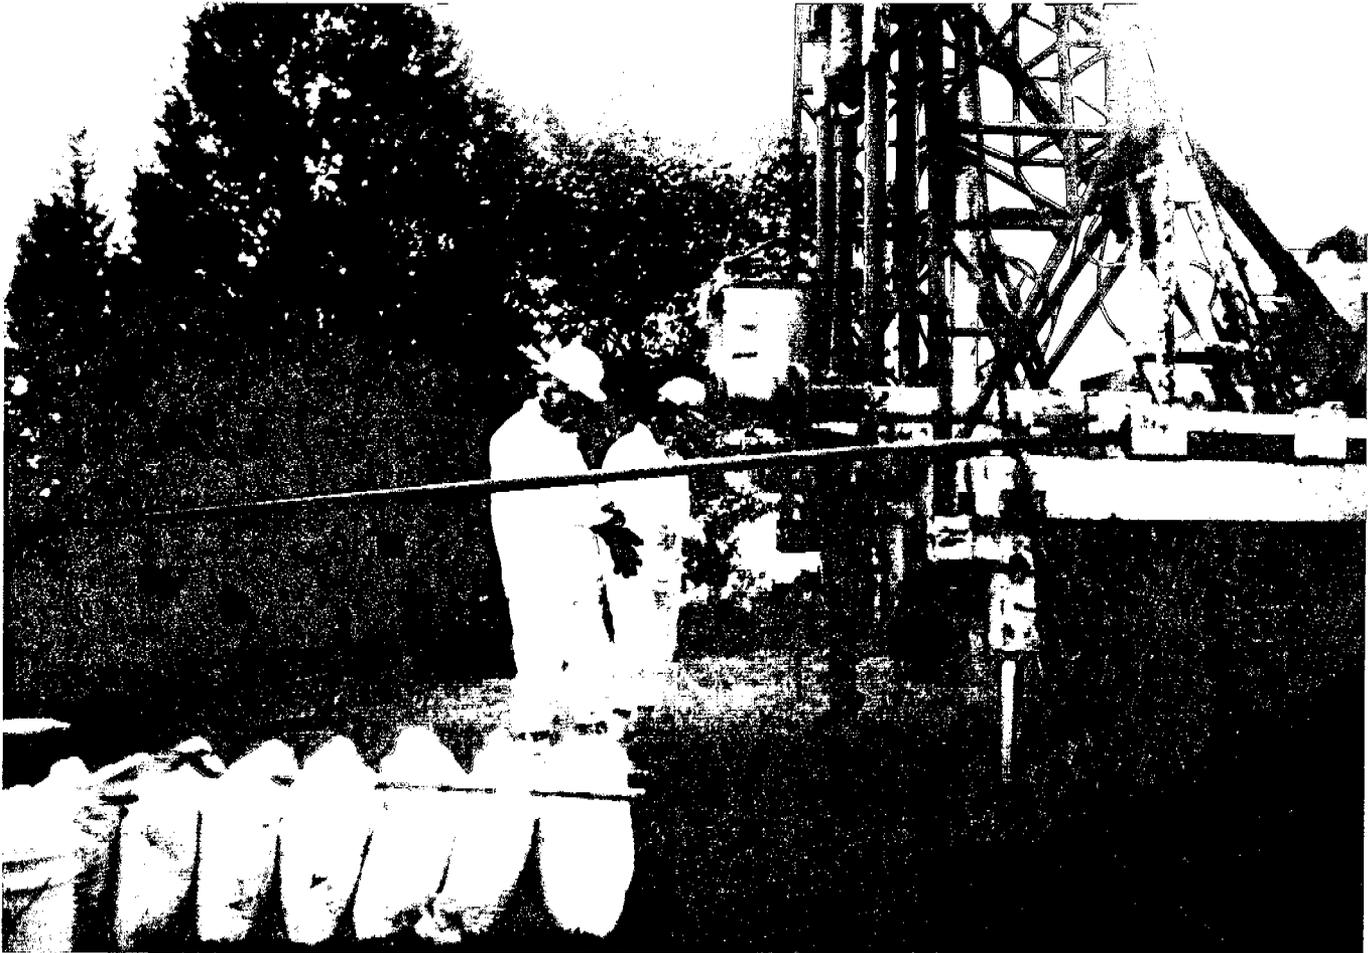
**Photograph 3-1**

Photograph depicts shallow well installation operations at Site 48, east of Building AS804, the suspected mercury dump. Drilling operations were conducted using Level-C health and safety protection.

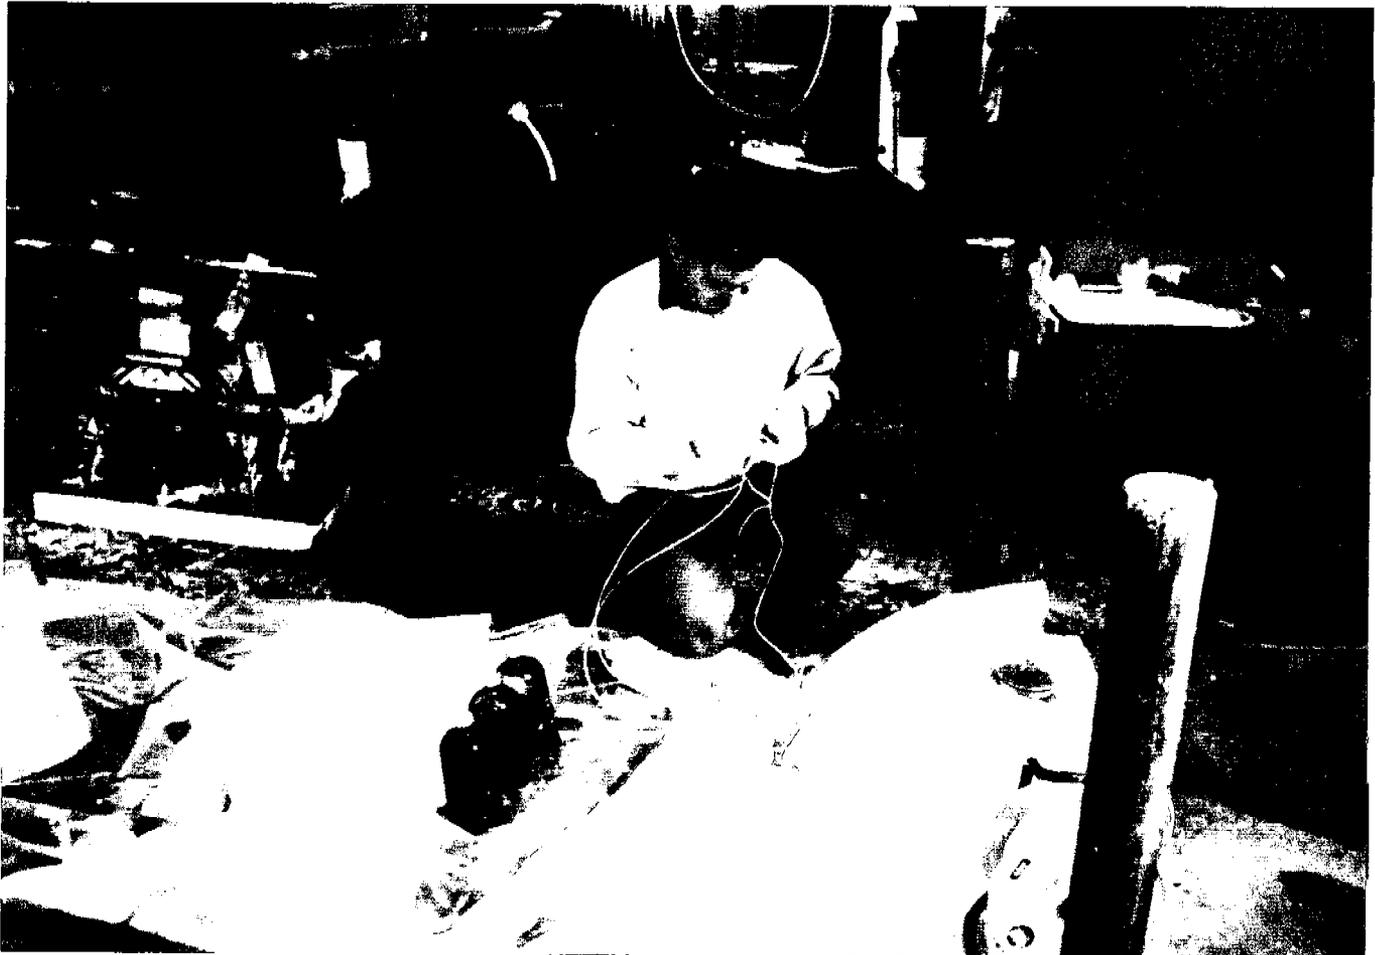
**Photograph 3-5**

Baker personnel preparing to sample groundwater using teflon-coated leader and four-inch teflon bailer.

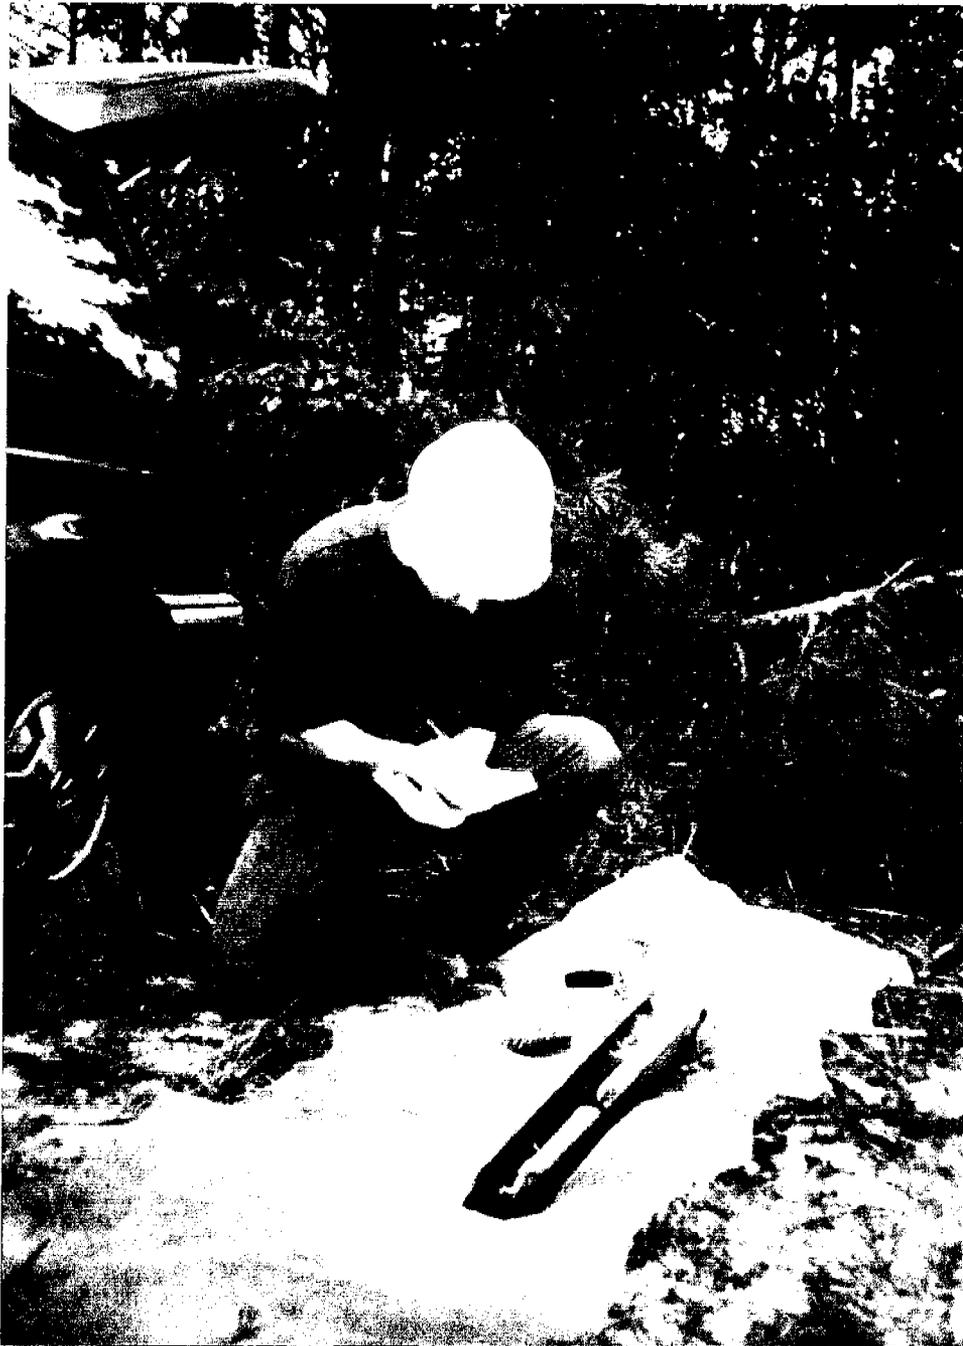
**Photograph 3-8**

Baker personnel logging soil sample description.

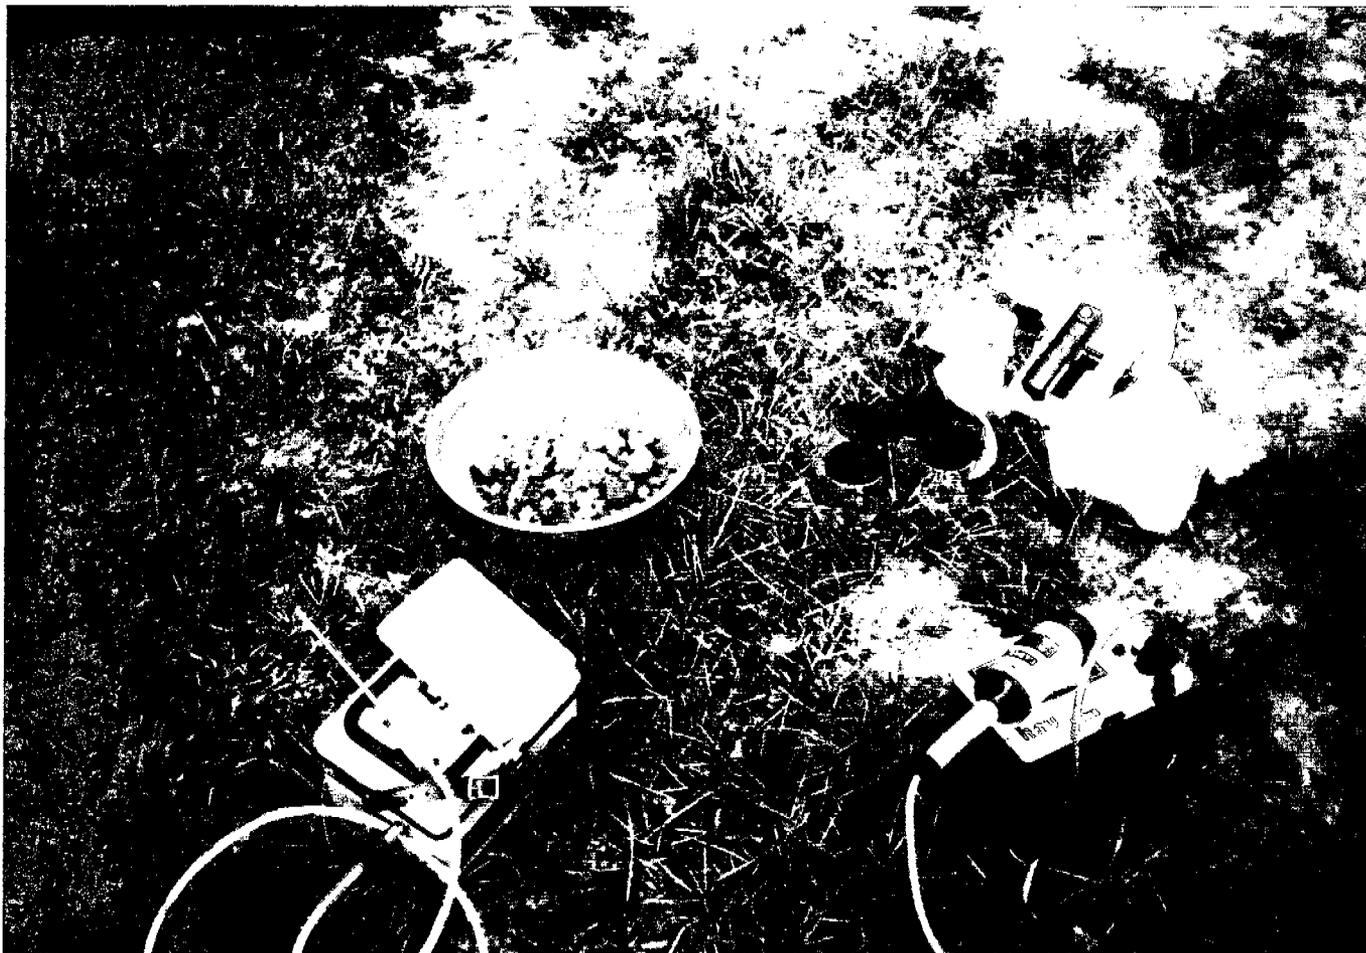
**Photograph 3-9**

Photograph illustrates a composite soil sample within a stainless steel mixing bowl. The sample is surrounded by monitoring equipment used during the soil investigation.

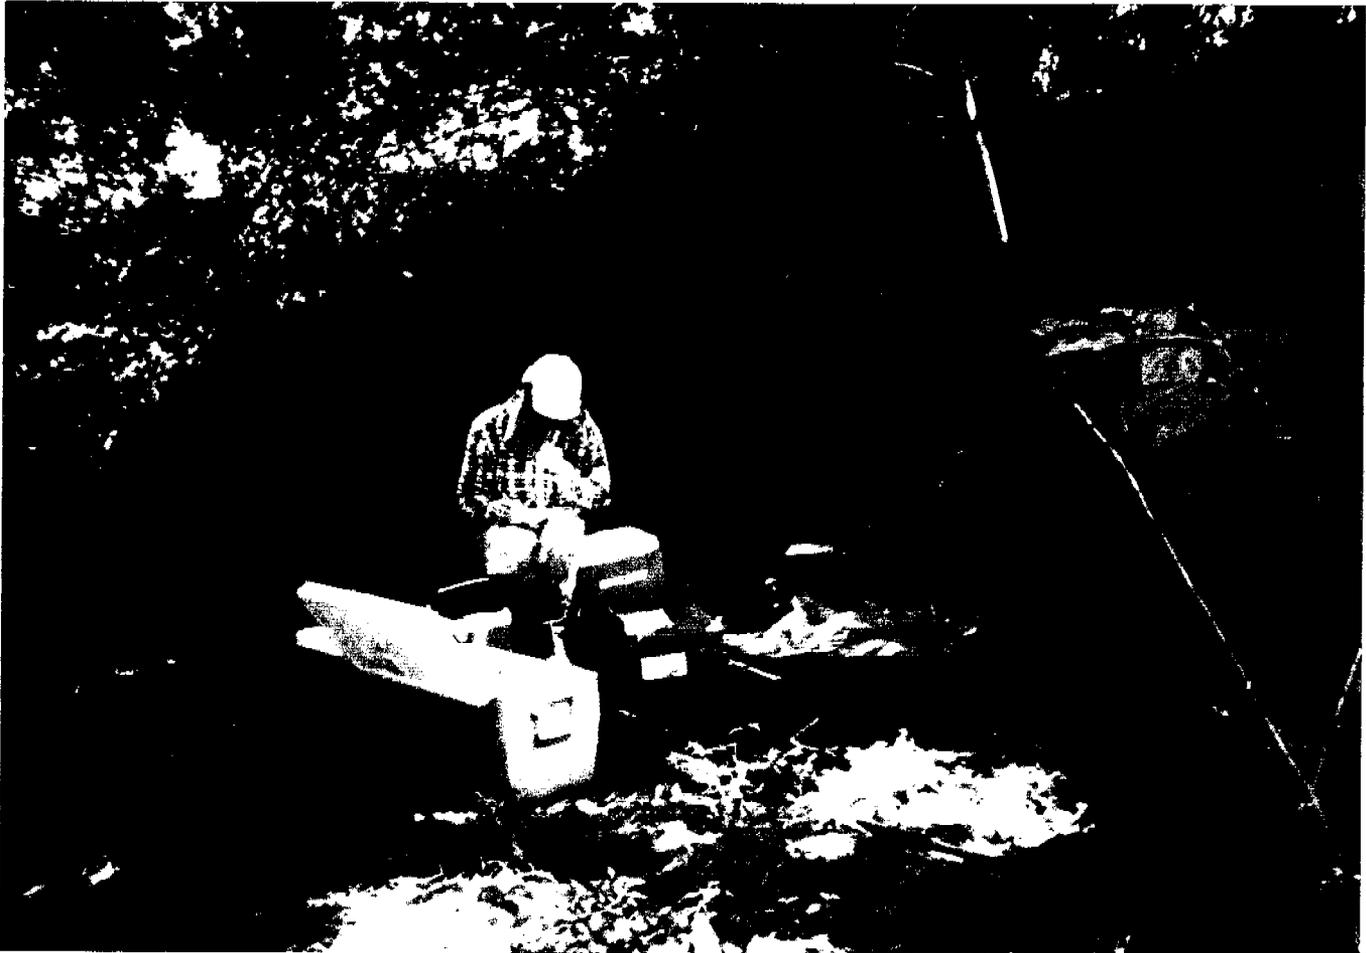
**Photograph 3-10**

Photograph depicts Baker personnel logging a hand-augered soil sample from within the Ravine Area of Site 6.
