**Department of the Navy  
Installation Restoration Program  
Field Investigation Photograph Album  
Sites 6, 9, 48, and 69**

**SITES 6, 9, 48, AND 69  
MARINE CORPS BASE CAMP LEJEUNE  
NORTH CAROLINA**

**CONTRACT TASK ORDER 0133**

**JANUARY 15, 1993**

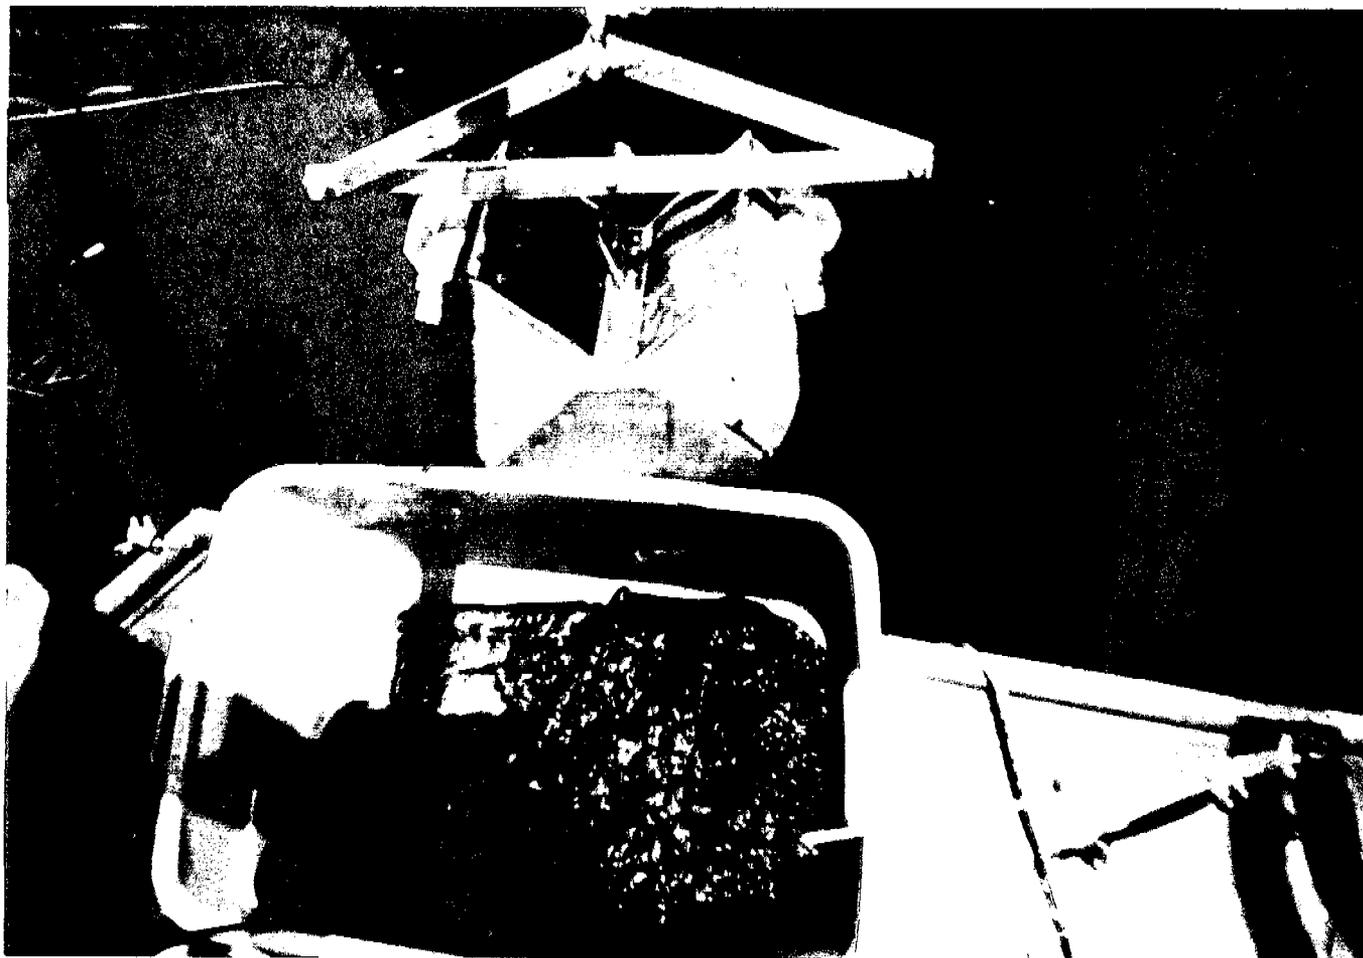
**Photograph 3-13**

The ponar grab, pictured here, was used to collect benthic macroinvertebrates. The sediment was filtered through a 500-micron sieve; the remaining material was then placed in jars containing preservative.

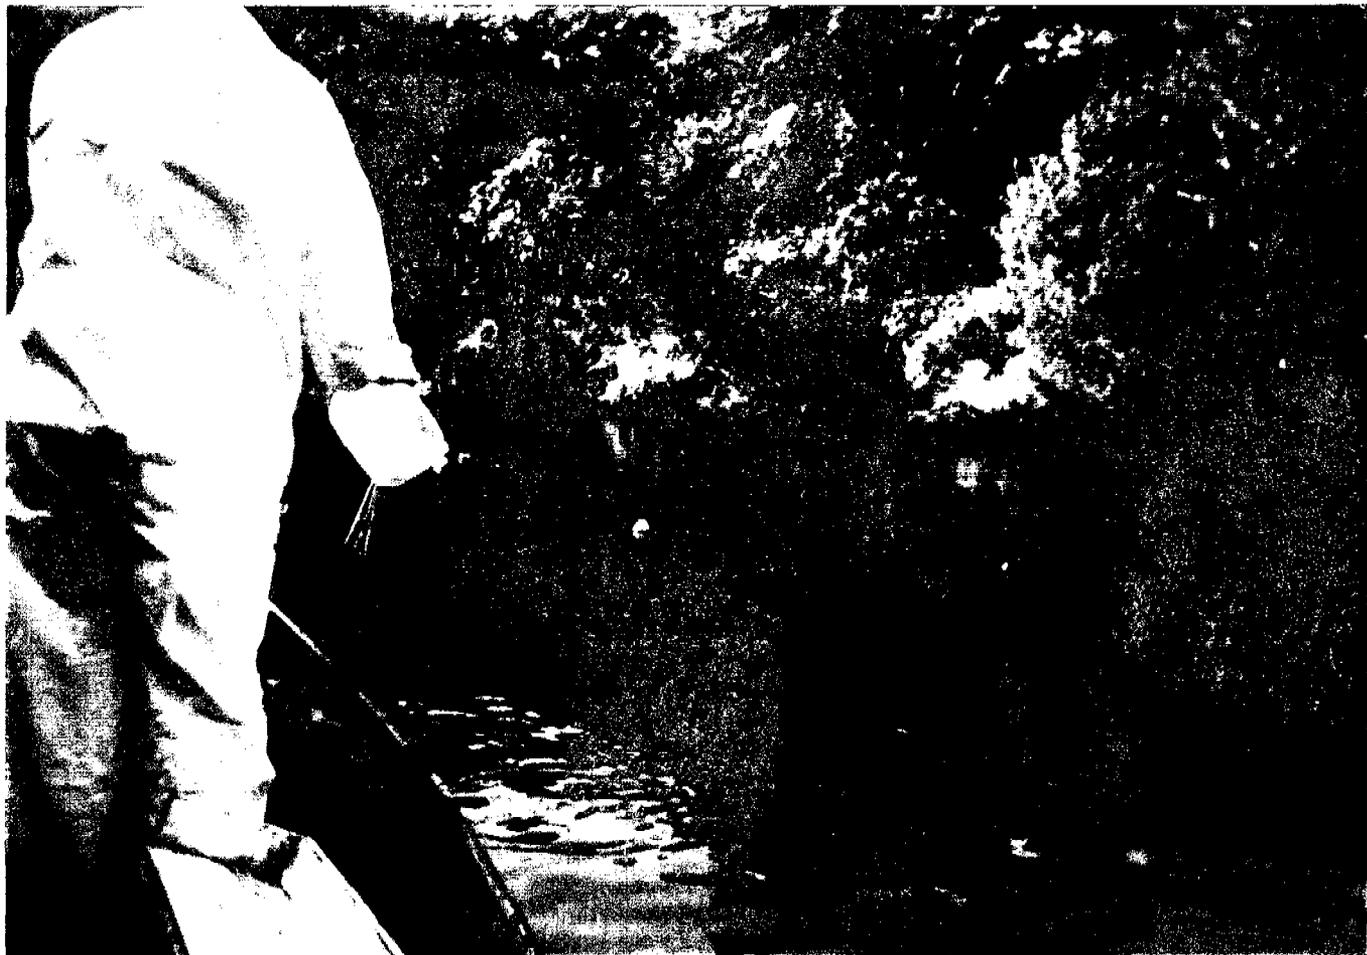
**Photograph 3-15**

This photograph depicts a gill net being deployed. This method was used to catch fish for subsequent evaluation and, in some cases, chemical analysis.

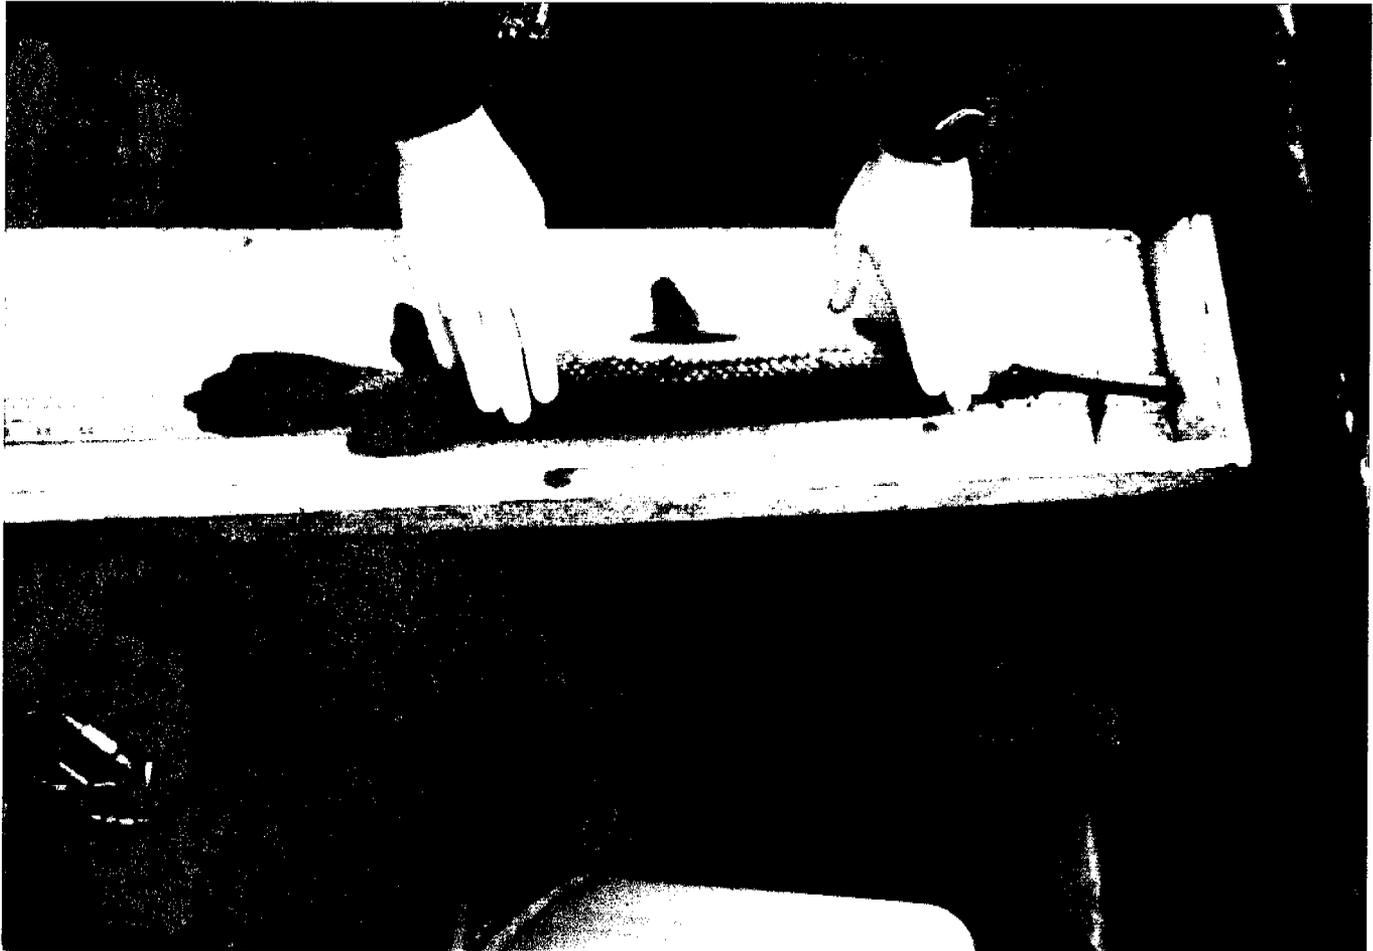
**Photograph 3-16**

The long-nose gar, pictured here, is in the process of being measured, weighed, and logged.

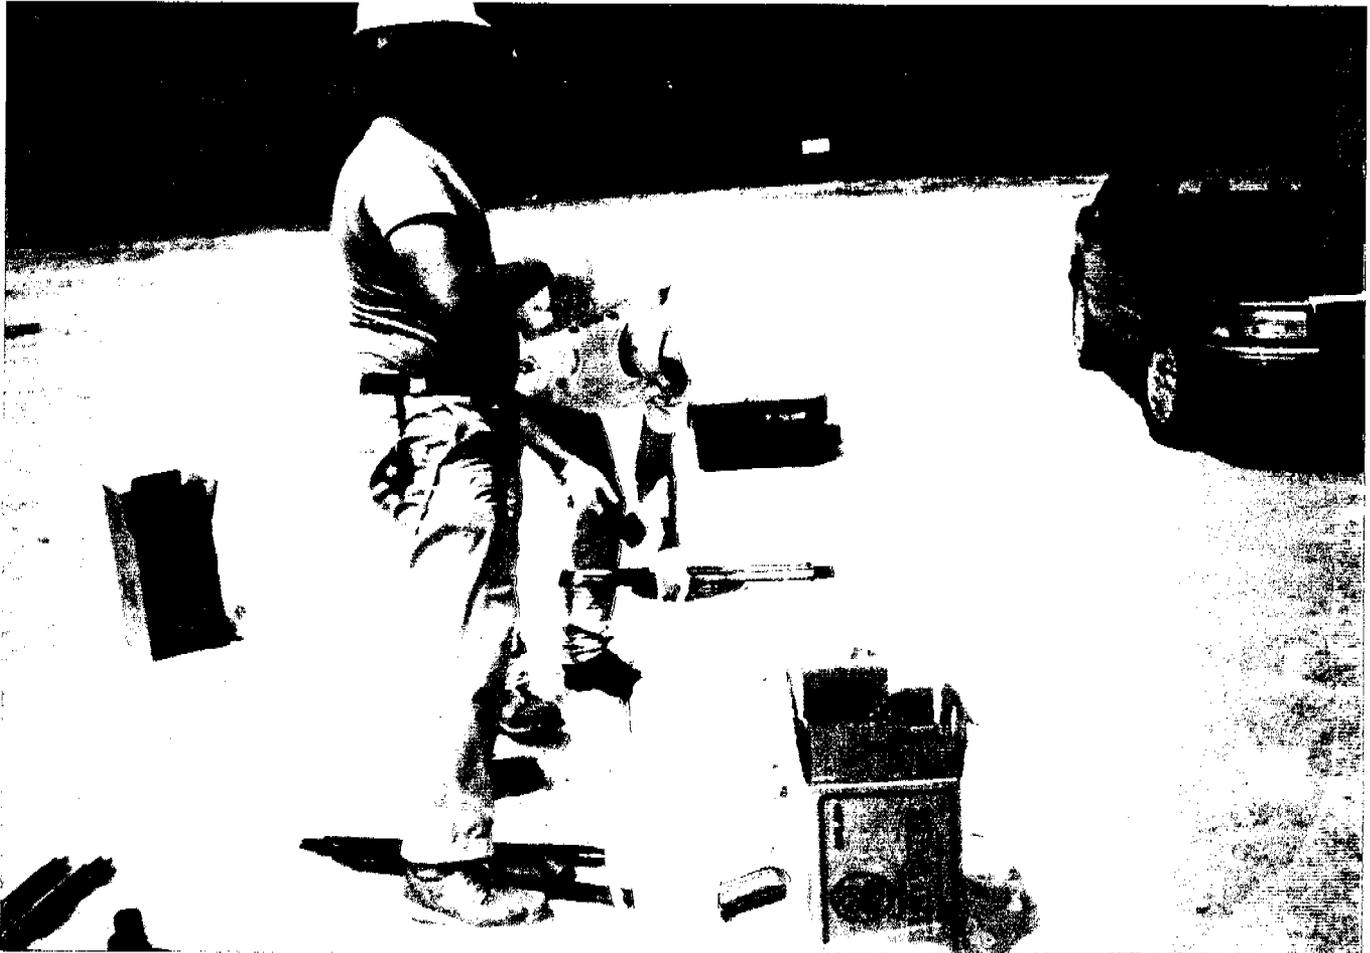
**Photograph 4-1**

This photograph illustrates the split-spoon decontamination procedure used during both the soil and groundwater investigations.

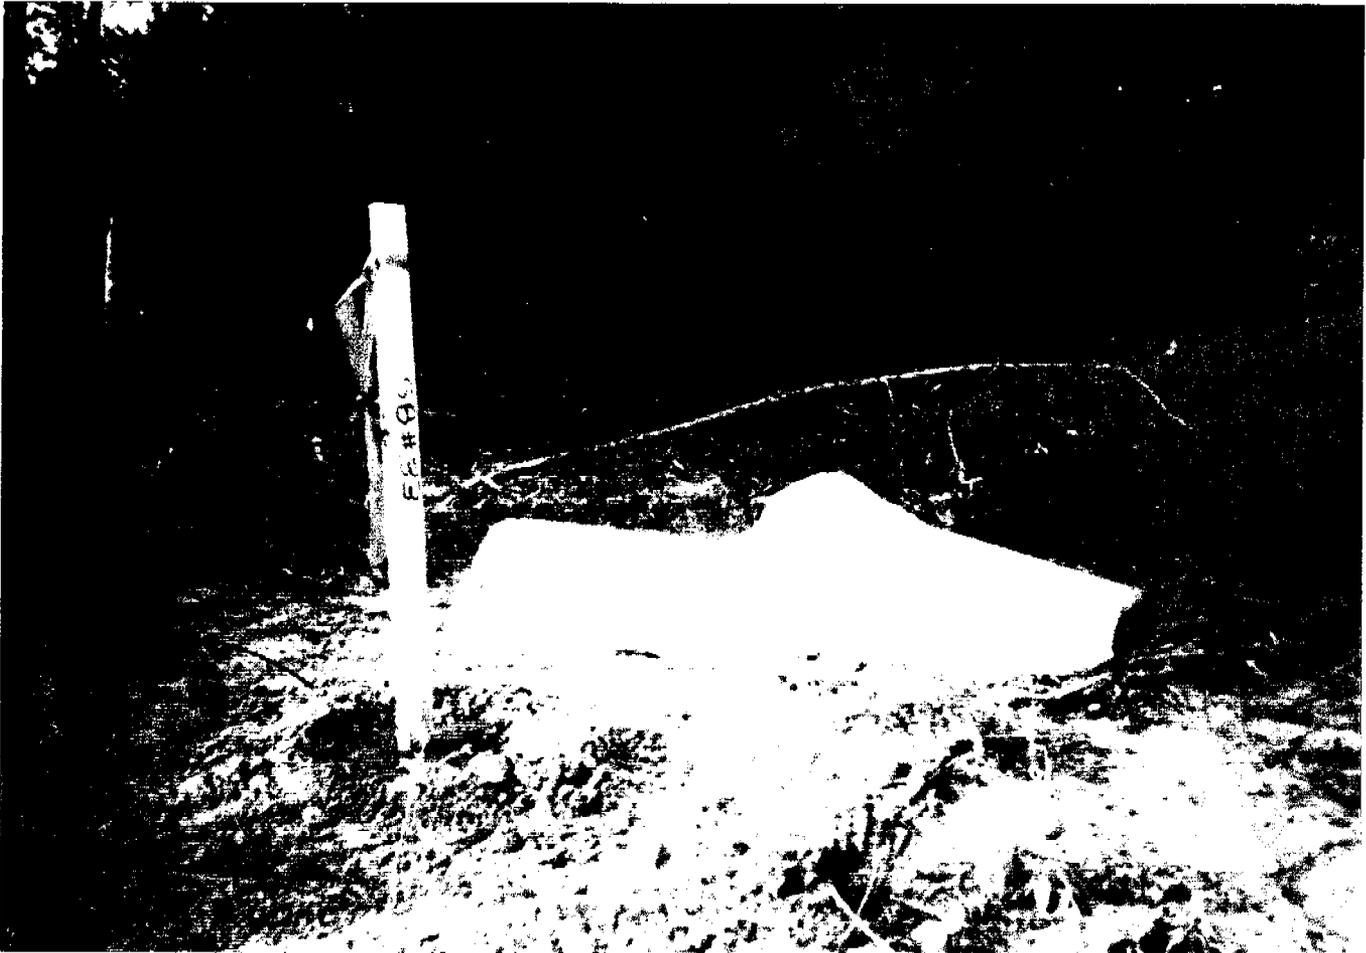
**Photograph 4-3**

The above photograph illustrates the temporary stockpiling of waste soil upon completion of a soil boring. The open borehole is backfilled with a bentonite grout.
