## Initial Investigation Completed

The initial investigation (Site Inspection) of Former Bomb Target 2 (BT-2) has been completed. The Site Inspection Report is being developed now and will be available to the public in early 2010, after it has been reviewed by the North Carolina Department of Environment and Natural Resources (NCDENR).

**This fact sheet provides an update on the investigation of munitions at Former Bomb Target 2 (BT-2) in Bogue Sound, where Marine Corps Air Station Cherry Point conducted training in the 1940s–1950s.**

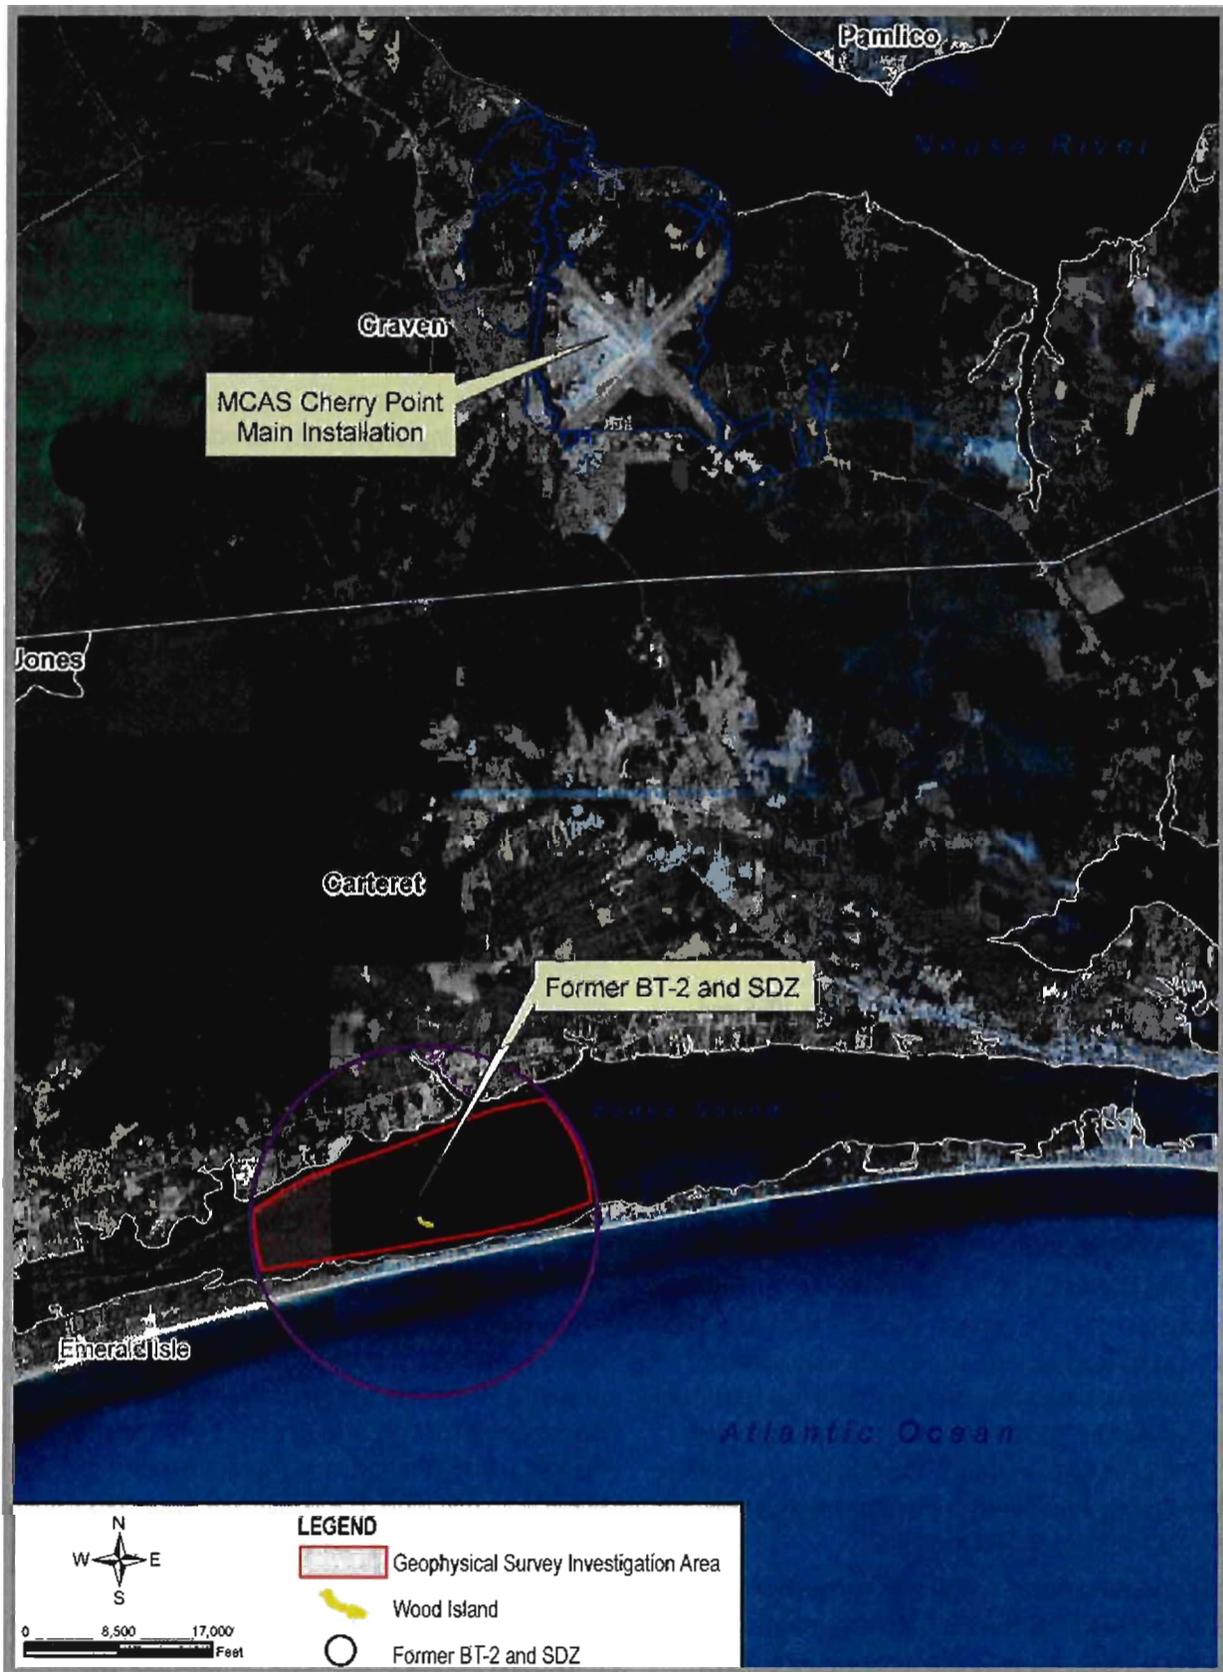
Figure 1 – Investigation Area

In spring 2009, a digital geophysical mapping (DGM) survey was conducted, using a commercial helicopter, over the part of Bogue Sound that surrounds Wood Island (Figure 1). The purpose of the survey was to detect and accurately map metallic items (referred to as magnetic anomalies) within the SDZ around BT-2. The patterns of anomalies identified by the aerial DGM survey will be used to focus future stages of the investigation.
