N61414.AR.001872
NAB LITTLE CREEK
5090.3a

TIER 2 SITE VISIT NAB LITTLE CREEK VA
10/27/1998
NAB LITTLE CREEK

Little Creek Tier II Site Visit

27 October, 1998

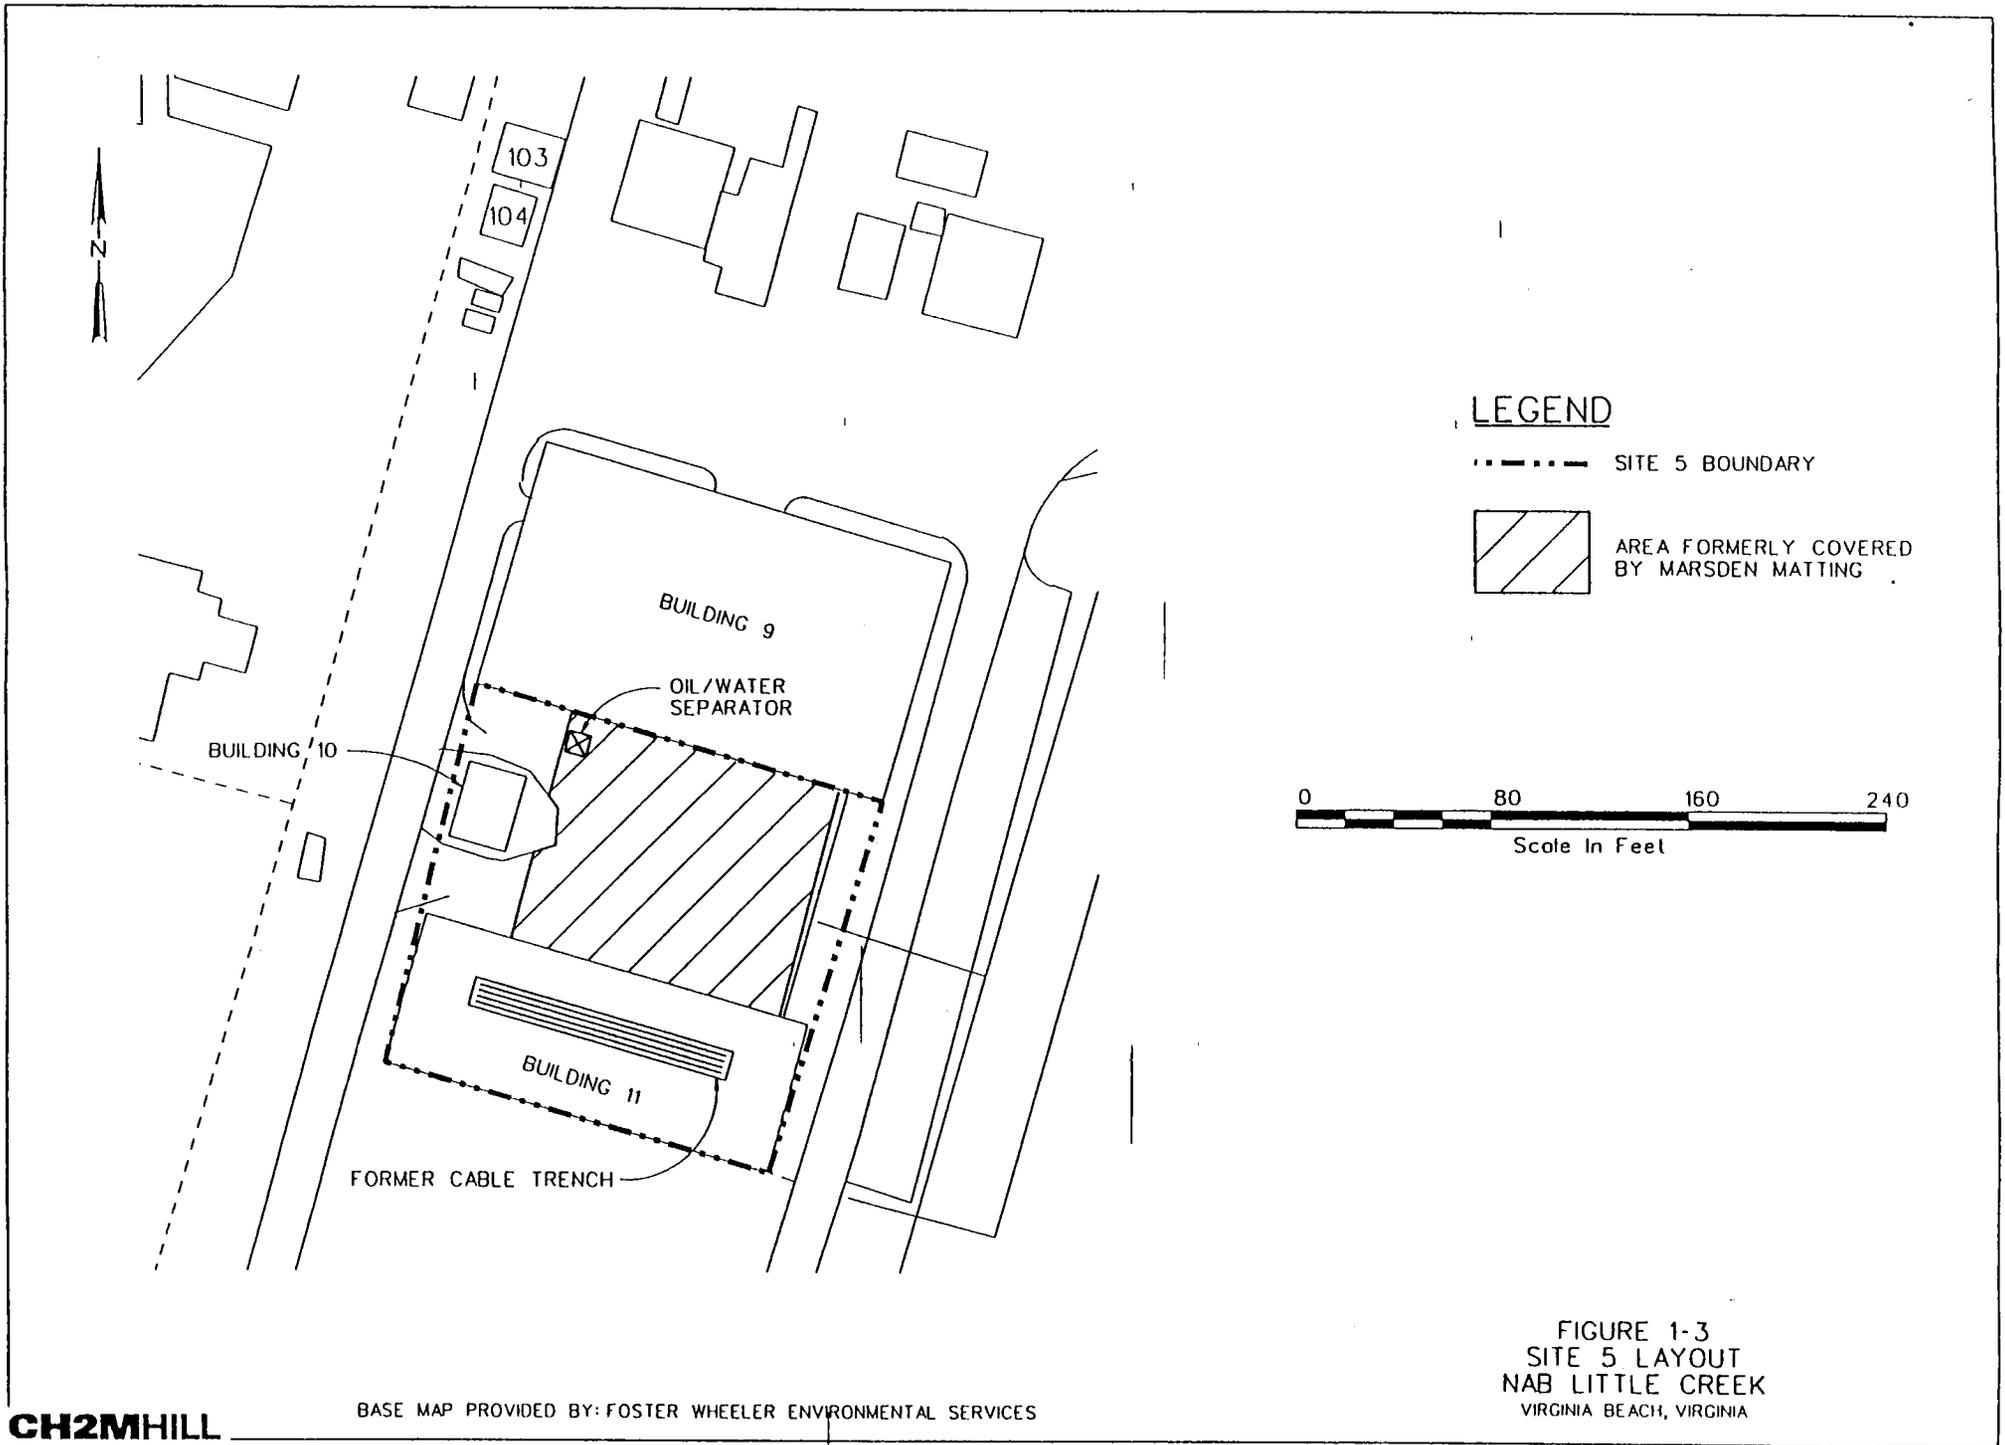
Site 5- Buildings 9-11 Motor Oil Disposal Area

Building T-9 was used for motor pool maintenance and was demolished in 1996. Building 116 was constructed in approximately the same location. Reportedly 50,000 gallons of oil and antifreeze may have been dumped on the ground in between T-9 and T-11. However, in the apparent disposal area, Marsden matting was present. The matting consisted of a solid steel plate under steel braces. The existence of the matting made it highly unlikely that disposal of this magnitude ever occurred. Building T-11 was a cable tank building with 10 tanks to store/perform maintenance on mooring cables for mines. In the 1960s, 7 tanks were filled with concrete. The remaining 3 were covered with steel plates. Reportedly, 43,000 gallons of oil and antifreeze were dumped in the remaining cable tanks. In both cases, improper disposal was assumed due to the lack of disposal records. No physical/visual evidence was ever found to indicate improper disposal.

Soil - low levels of TPH detected – nothing to indicate massive disposal

Groundwater - low levels of lead & 1,1-DCA. Two rounds of GW sampling continued to detect 1,1 DCA & chloroethane below RBCs in one well

Liquid in Cable Tanks - characteristic for lead. The liquid was removed and disposed; the tank was cleaned, filled, and covered with a concrete cap to prevent further disposal

Soil & Groundwater results indicate no risk posed by contamination.

- Prepare Final No Further Response Action Planned Decision Document (NFRAP DD) and public notice. Comments on Draft Final due November 30, 1998. Public Notice announcing availability of Draft Final was published in the Virginian Pilot on October 11, 1998.

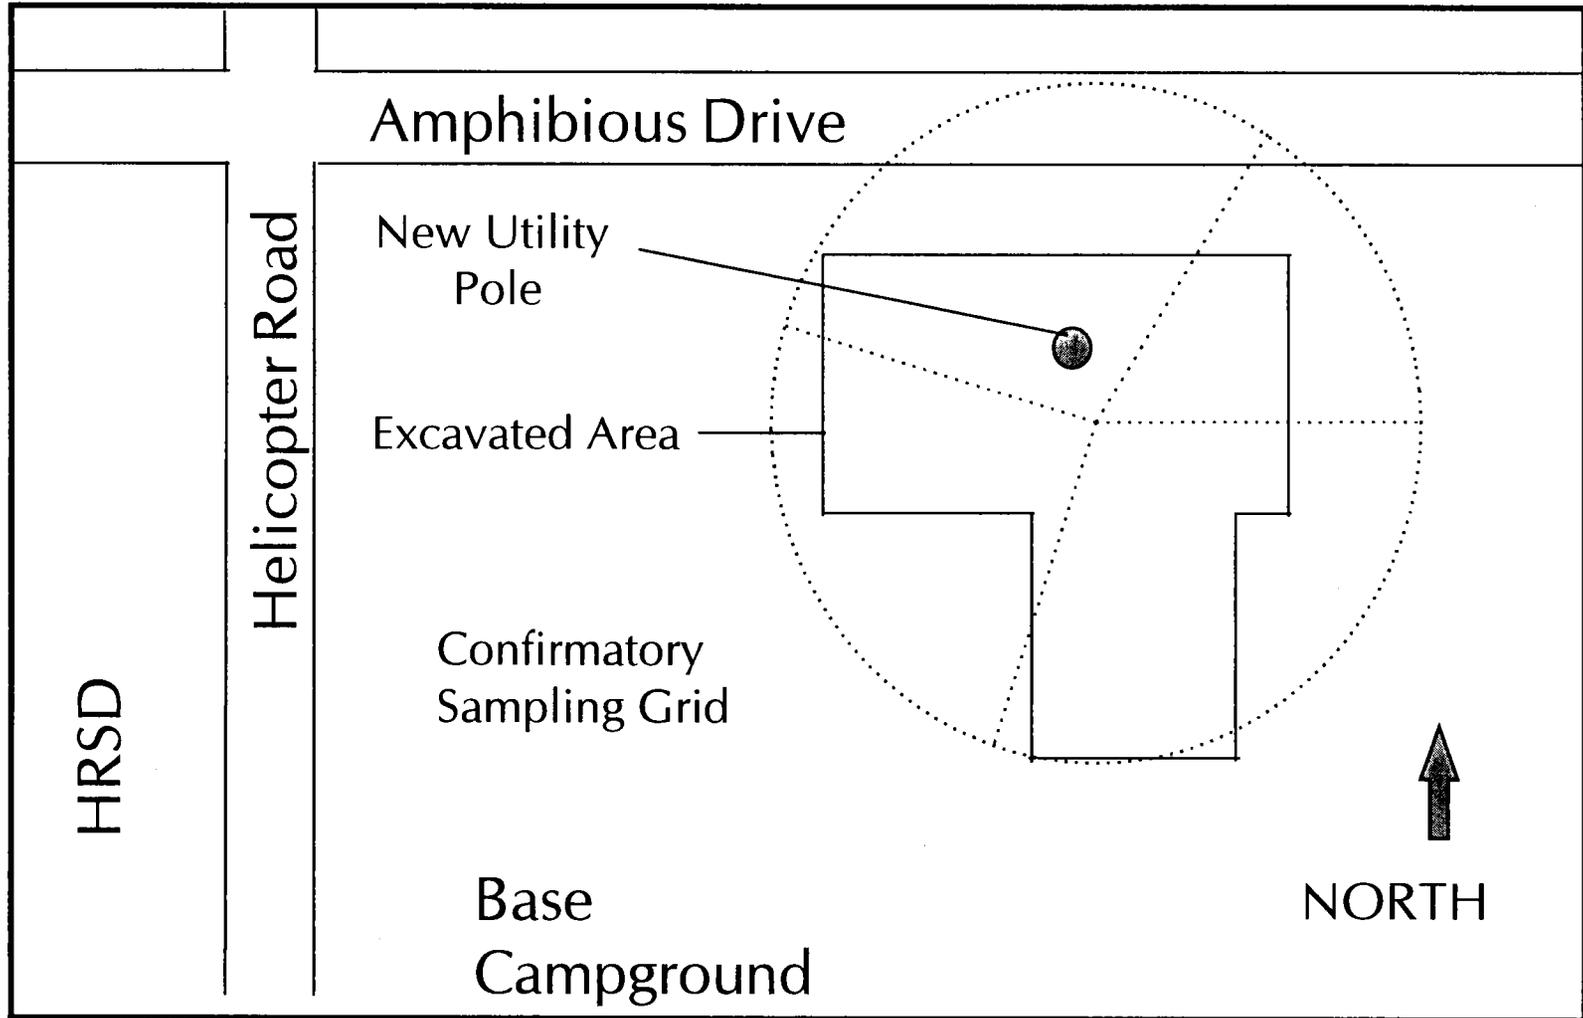
SITE 16

In the early 1980s, a lightning strike caused less than 5 gallons of PCB-containing dielectric fluid to leak from the capacitor on pole #425. Subsequent investigations revealed Aroclor 1260 above action levels in the soil. A removal action in 1995 removed the contaminated soil, the pole, and surrounding vegetation. The Closeout Report documented the implementation of all appropriate and required response actions. It was approved with no comments from the public, state, or EPA. The site is now closed – No Further Response Action Planned (NFRAP).

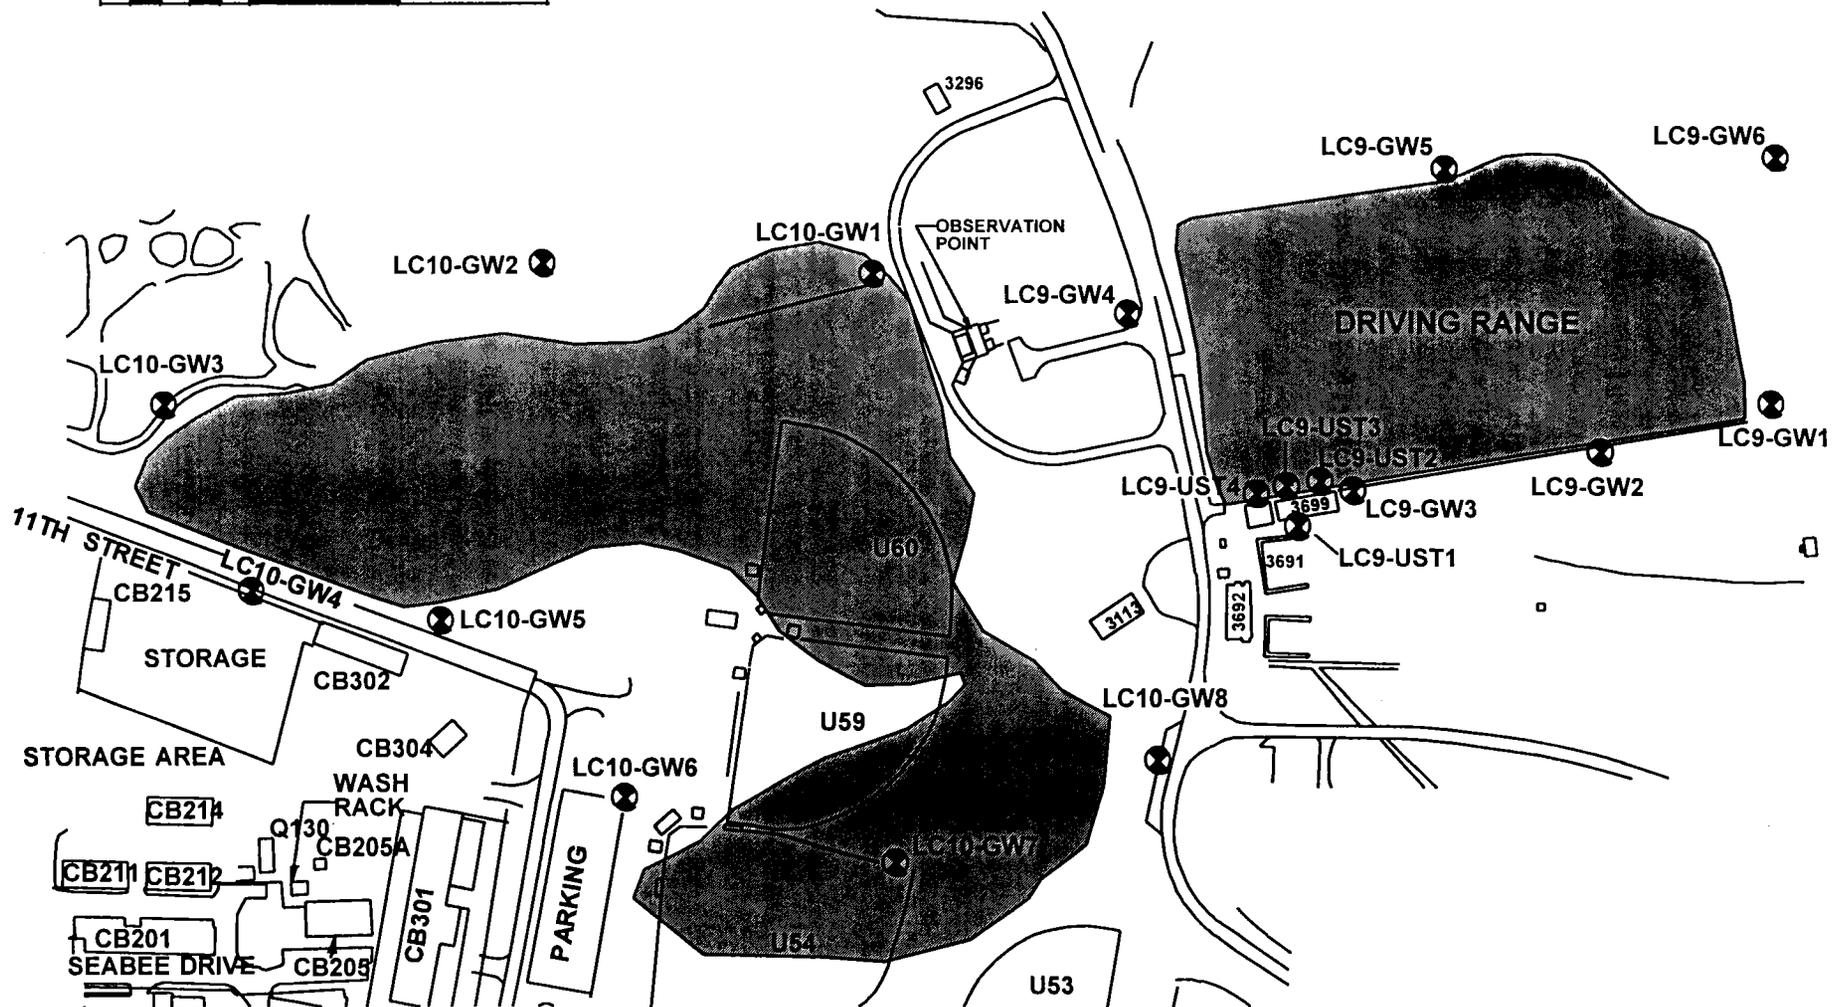
Site 9 – Driving Range Landfill

Site 9 - Operated from 1950 to 1956, contains 40,000 cy and is 6 acres. Contains mostly non-hazardous, solid, household waste.
