LEAD BASE PAINT SURVEY OF 12 DUPLEX FAMILY UNITS SECTION 1 CNC  
CHARLESTON SC  
4/1/2001  
PRECISION ENVIRONMENTAL MANAGEMENT, INC.

**LEAD BASE PAINT SURVEY OF  
12 DUPLEX FAMILY UNITS AT  
CHARLESTON NAVAL COMPLEX  
CHARLESTON, SC**

**April 5, 2001**

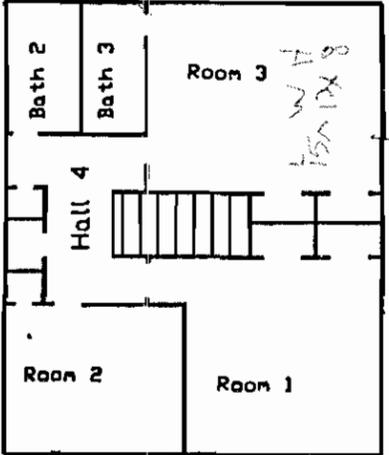
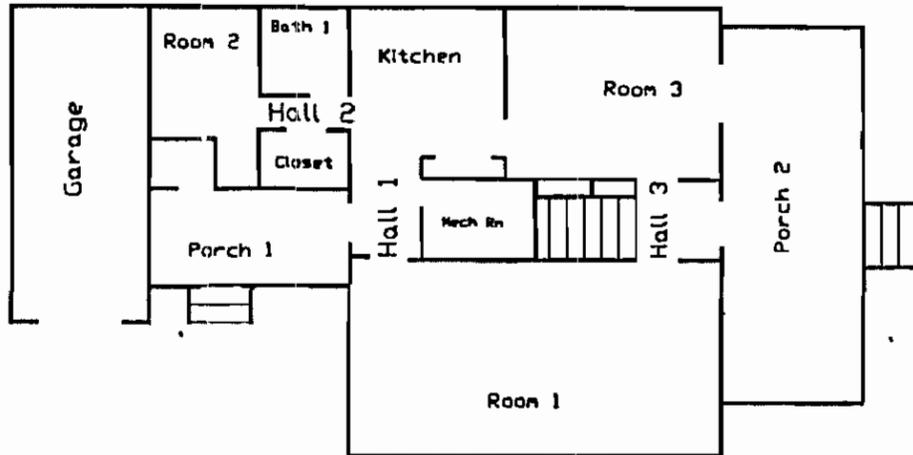
Kitchens wallpaper except doors and ceilings  
 Halls - white paint throughout the house  
 Bathrooms wallpaper except ceiling and doors  
 Overall - Very good condition

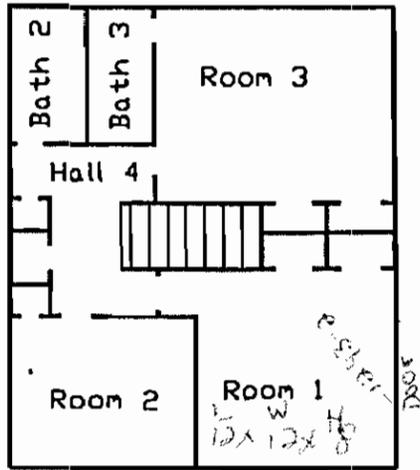
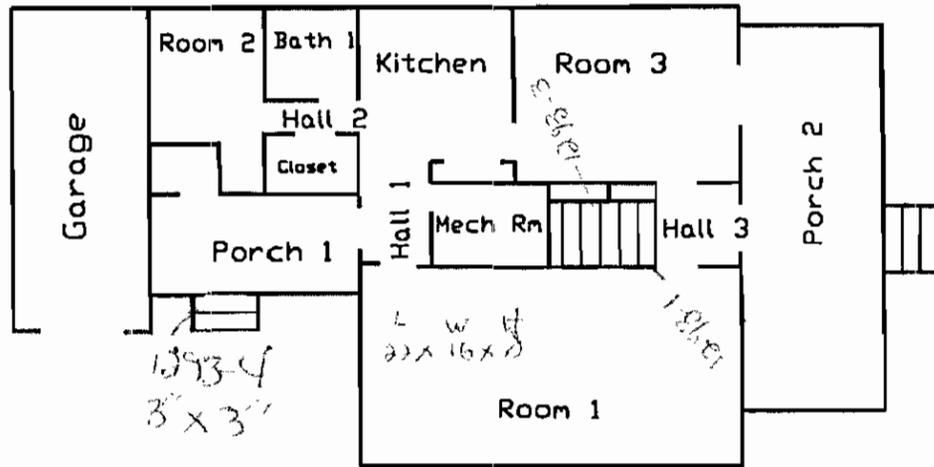
Figure 24-a, Quarters DD, Floorplan  
609

Site in Good Condition

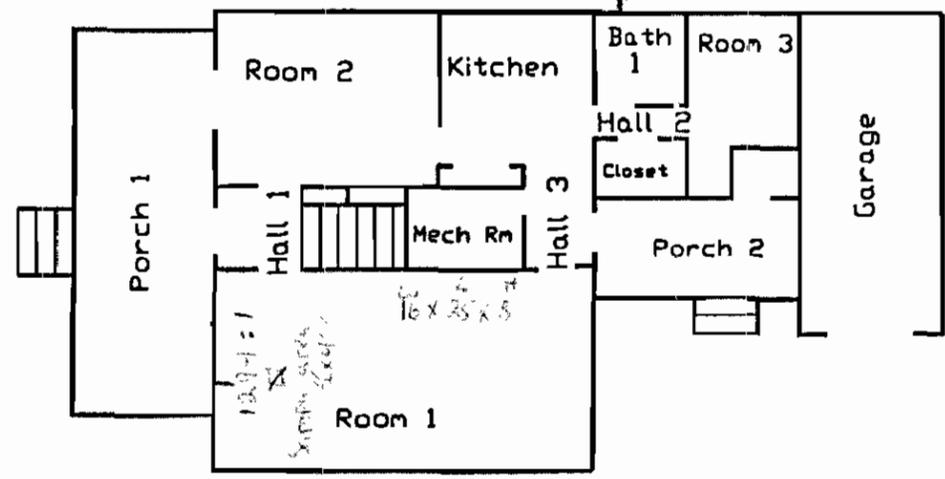
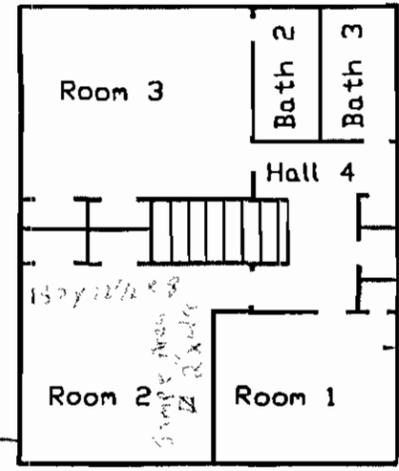
Figure 27-a, Quarters GG, Floorplan  
 658

Substrate - wood Living Room  
 Molding - white paint throughout the house  
 Kitchen wallpaper except on ceiling and doors  
 Bathroom wallpaper except ceiling through out the walls  
 Substrate - Sweetrack Bathroom  
 Substrate - ~~wood~~ Sheetrock Room #2  
 Overall - New Paint Job / Very Good Condition

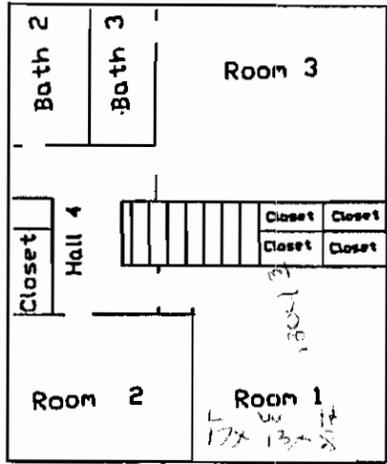
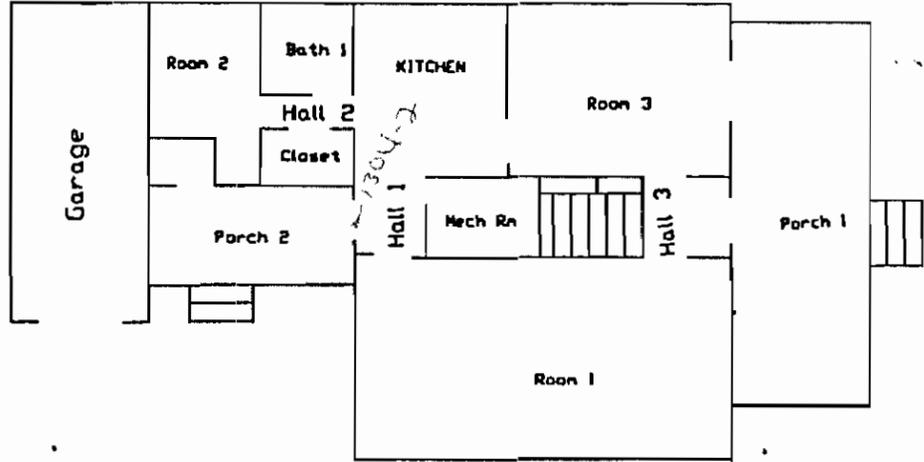
- 1305-1 Mech. Room door / substrate - wood 1 sq ft. damage area
- 1305-2 Bathroom #1 door / substrate - wood 1 sq ft. damage area
- 1305-3 Kitchen Ceiling - water damage - / substrate sheet rock 1 sq ft damage

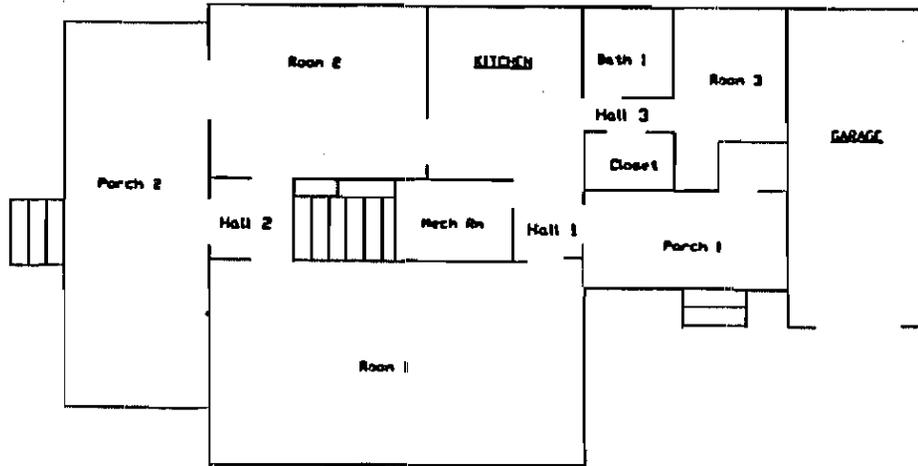
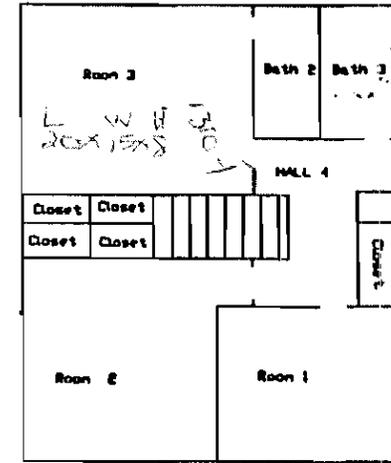
- 1311-1 Kitchen Ceiling - substrate sheetrock - close by water damage 1 sq ft
- 1311-2 Bedroom #3 Baseboard - (B wall) substrate - wood - 1/2 sq ft.
- 1311-3 Kitchen (A wall) Vent substrate - metal - 1/2 sq ft.

Wallpaper in Bathroom and Kitchen except for ceiling & doors, & molding  
 Hermynis white paint throughout the house  
 Overall New paint job and very good condition

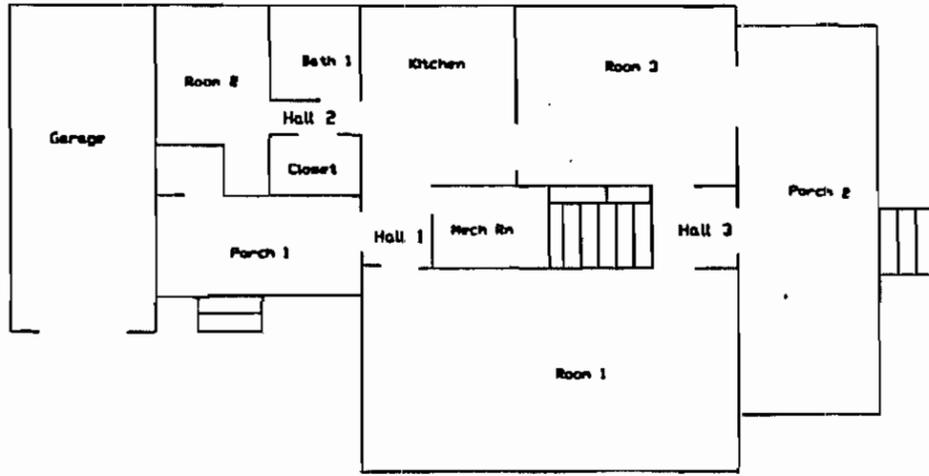
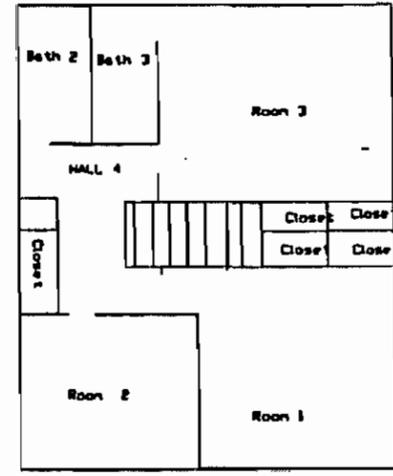
Figure 50-a, Quarters JJ, Floor plan

Horizontal white paint  
 wallpaper in Bathrooms + Kitchen walls not on ceiling  
 New paint job  
 No sign of staining paint, off time of inspection
