LEAD BASE PAINT SURVEY OF 12 DUPLEX FAMILY UNITS SECTION 3 CNC
CHARLESTON SC
4/1/2001
PRECISION ENVIRONMENTAL MANAGEMENT, INC.

**LEAD BASE PAINT SURVEY OF
12 DUPLEX FAMILY UNITS AT
CHARLESTON NAVAL COMPLEX
CHARLESTON, SC**

April 5, 2001

1.0 Executive Summary

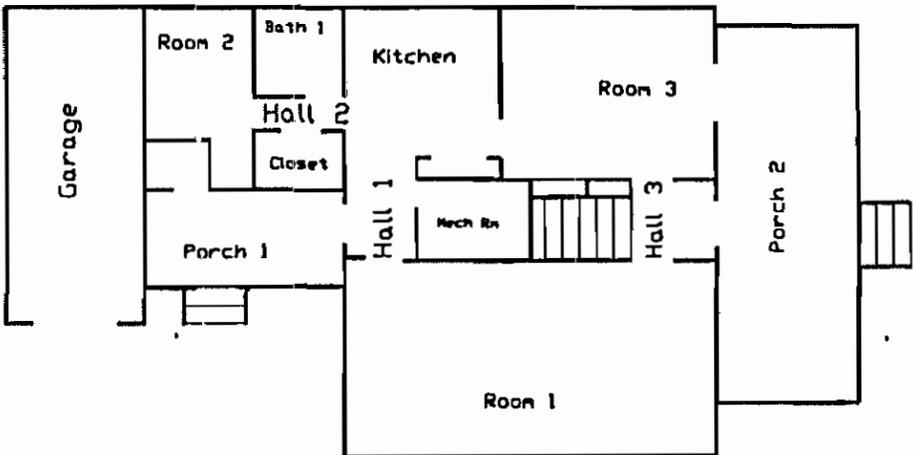
Figure 26-a, Quarters FF, Floorplan

Kitchen - Wallpaper except doors and ceilings
 throughout white paint throughout the house
 Bathrooms - wallpaper except ceiling and
 Overall - very good condition

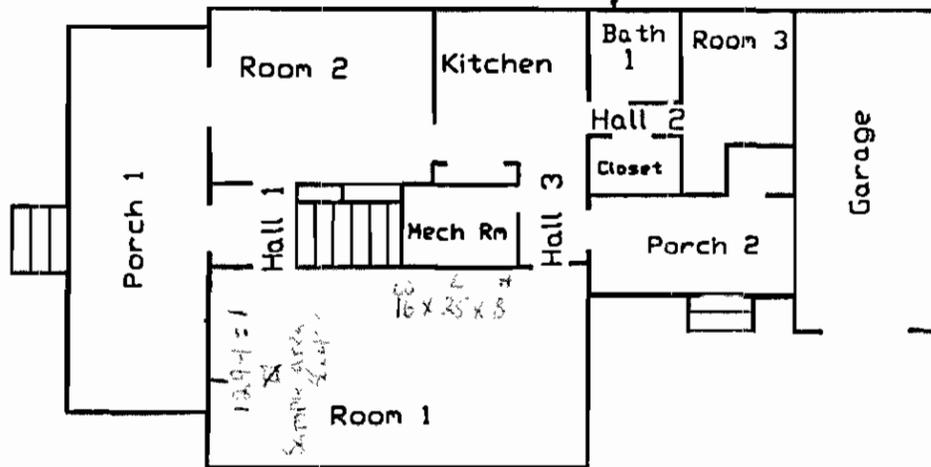
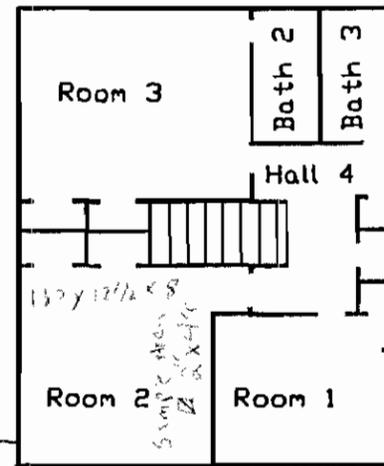
Sample near 2' X 4"
1294-2 ceiling

- Substrate - wood Living Room
- Herajems - white paint throughout the house
- Kitchen wallpaper except on ceiling and doors
- Bathroom wallpaper except ceiling through out the halls
- Substrate - Sheetrock Bathroom
- Substrate - Sheetrock Room #2
- Overall - New Paint Job / Very Good Condition

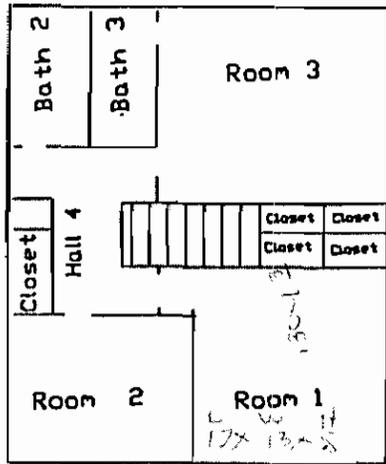
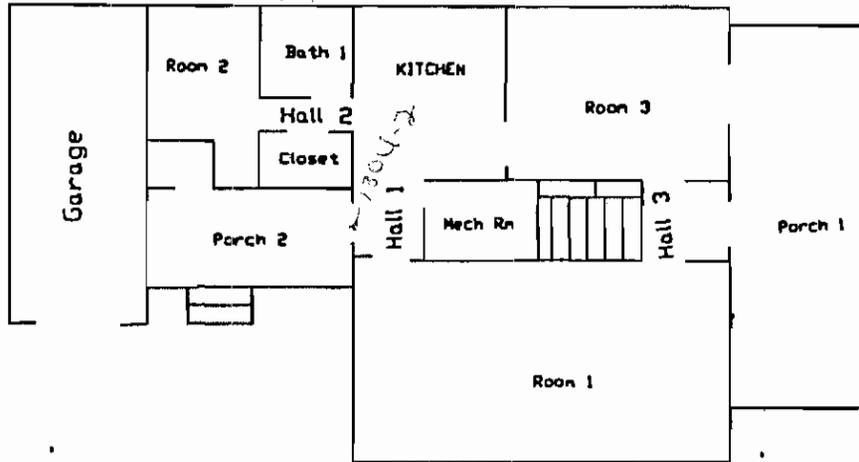
1304-1
1304-2

* Damage area is approx 4" x 11" X

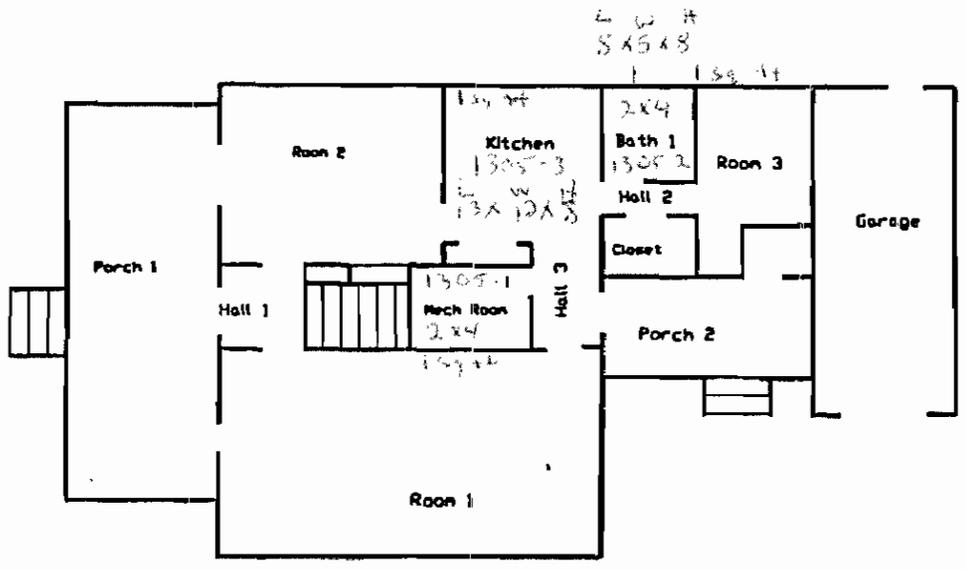
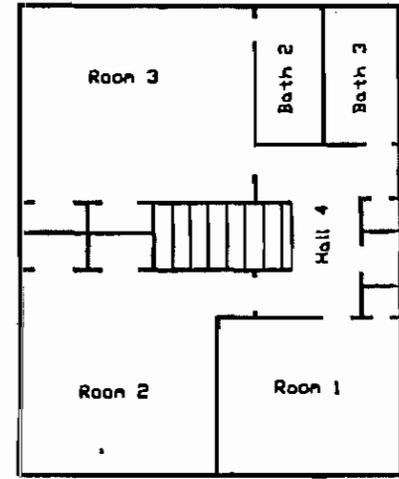
- 1305-1 Mech Room door / substrate - wood 1 sq ft. damage area
- 1305-2 Bathroom #1 door / substrate - wood 1 sq ft. damage area
- 1305-3 Kitchen Ceiling - water damage - / substrate - sheet rock 1 sq ft damage

Homogenous white paint throughout house
 Kitchen and Bathroom wallpaper except for ceiling & doors
 New paint job
 Overall Good condition

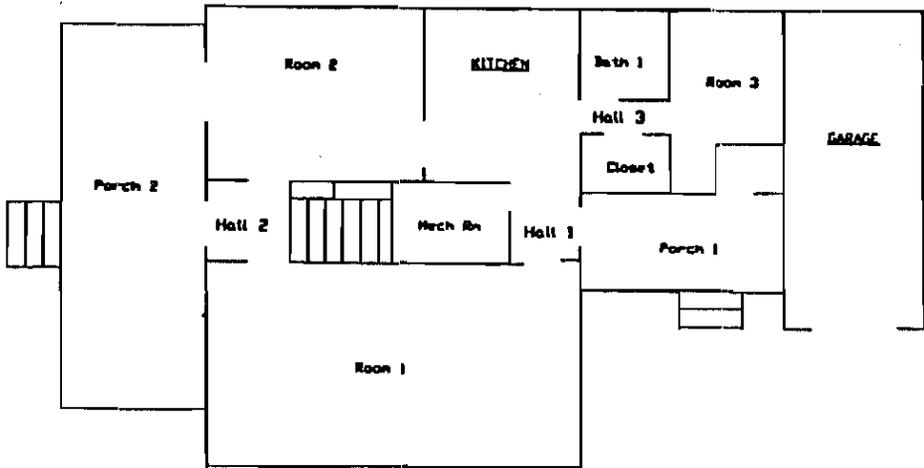
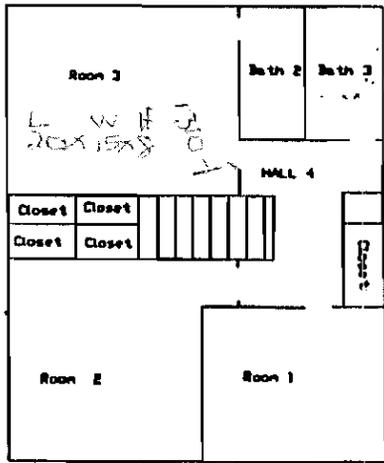
Figure 29-a, Quarters II, Floorplan 689

- 1311-1 Kitchen Ceiling - substrate sheetrock - Change by water damage 1 sq ft
- 1311-2 Bedroom #3 Base board - (B wall) substrate - wood - 1/2 sq ft
- 1311-3 Kitchen (A wall) Vent substrate - Metal - 1/2 sq ft.

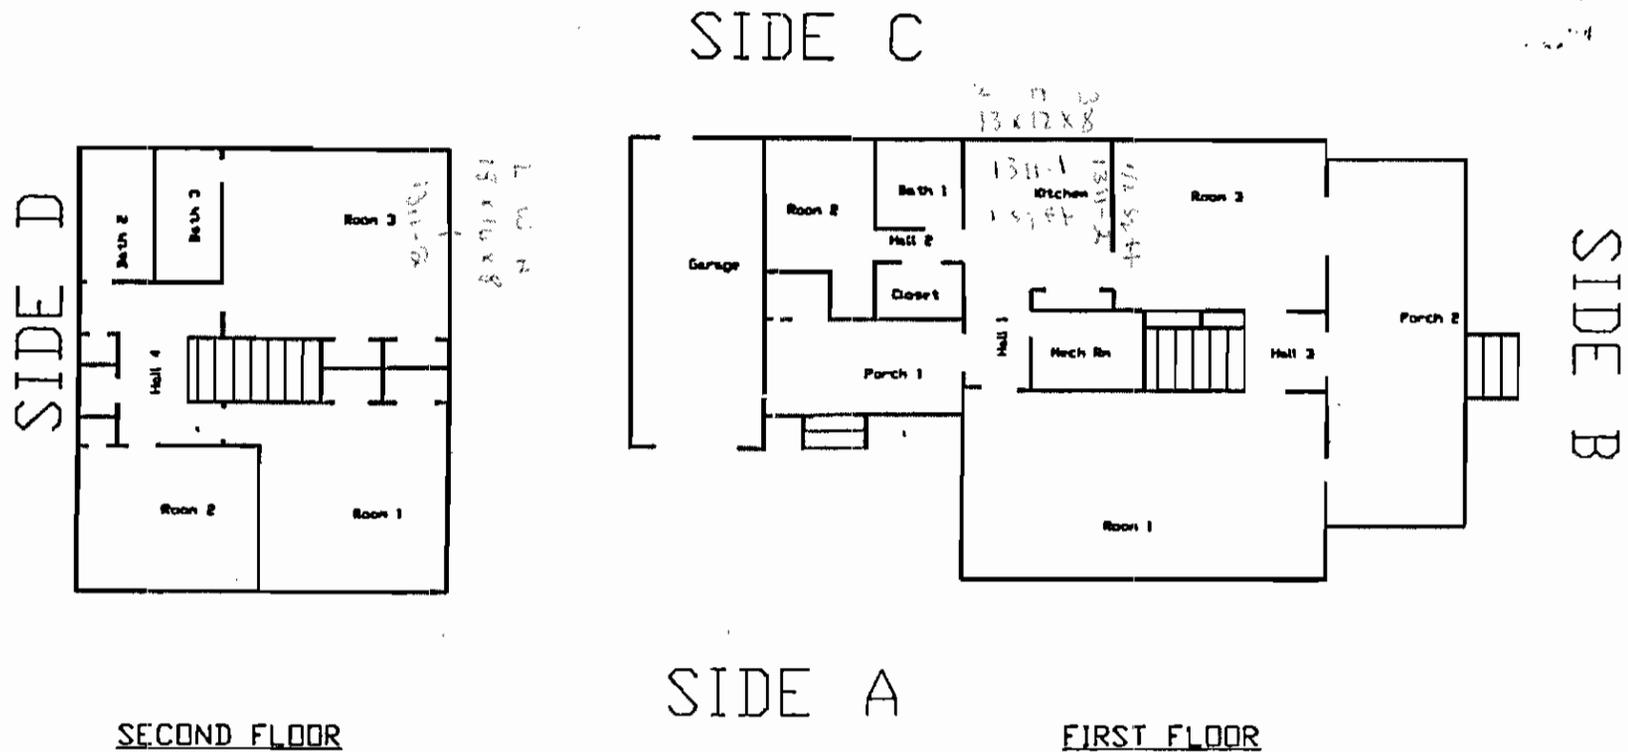
SPORTENVDETSASN 1899 North Hobson Ave. North Charleston, SC 29405-2108 Ph. (803) 743-6777	Floor Plan (Type HD-23) 1311 AVE. "G" QUARTERS (BB) Charleston Naval Complex Charleston, SC
	DWG DATE: 12 MAR 98 DWG NAME: Qtrs-BB

Wallpaper in Bathroom and Kitchen except for ceiling & doors, + Molding
 Hermynis white paint throughout the house
 Overall New paint job and very good condition
