ASBESTOS-CONTAINING MATERIAL RE-INSPECTION FOR BUILDING 234 VOLUME 14
CNC CHARLESTON SC
2/15/2000
BAT ASSOCIATES, INC.

**Asbestos-Containing Material Re-inspection
For Building 234
Charleston Naval Shipyard
Charleston, South Carolina**

Contract No. N2467-96-D-0998
Delivery Order No. 0013

February 15, 2000

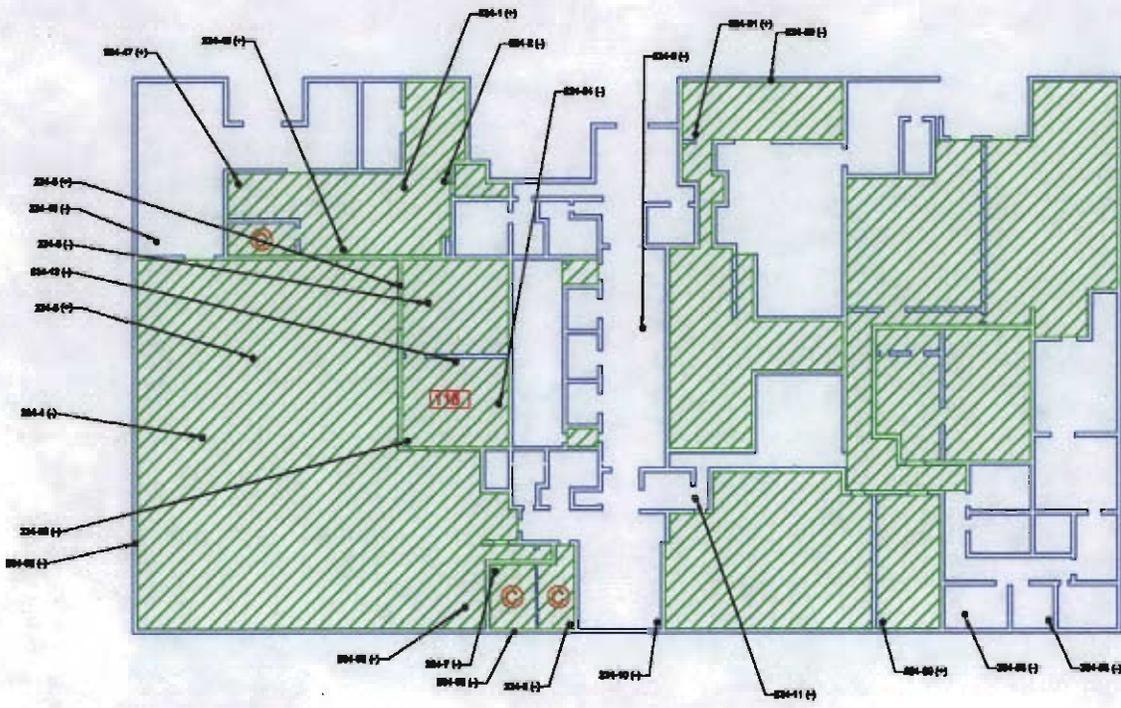
NOTE 1:
All Interior Drywall Wall and Ceiling Systems Contain Asbestos-Containing Joint Compound.

NOTE 2:
All Piping Systems Are Insulated With Non-Suspect Asbestos-Containing Materials.

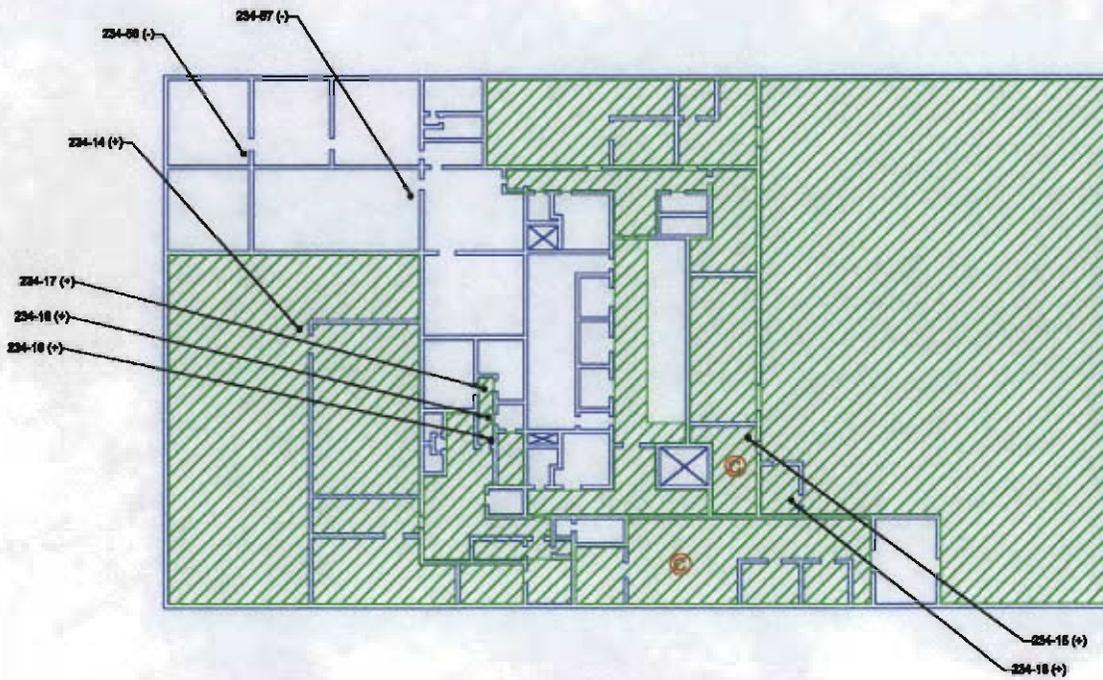
NOTE 1:
All Interior Drywall Wall and Ceiling Systems Contain Asbestos-Containing Joint Compound.

NOTE 2:
Majority Of Floors Have Multiple Layers Of Asbestos-Containing Floor Tile And Mastic

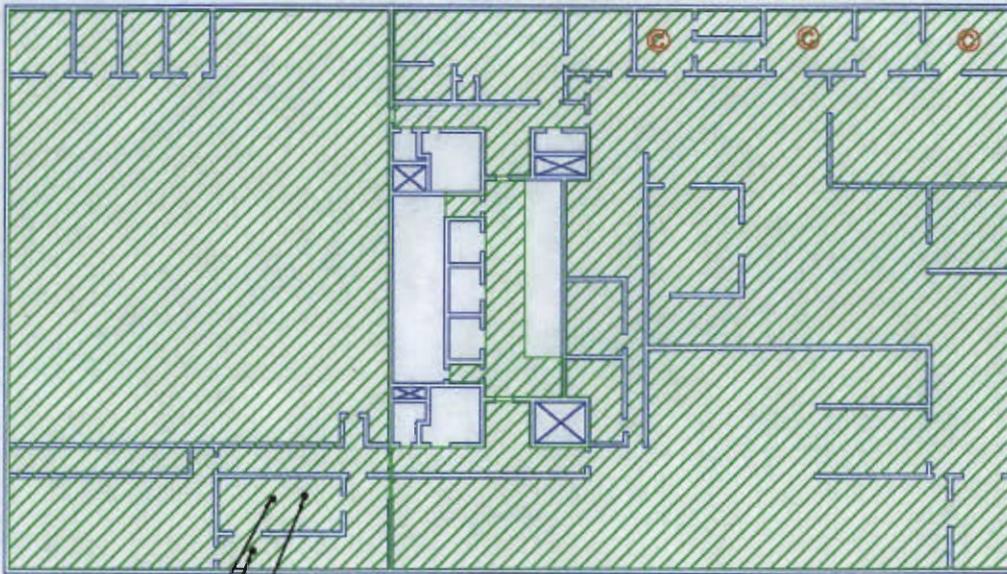
234-21 (+)
234-20 (+)
234-22 (+)

NOTE 1:
All Interior Drywall Wall and Ceiling Systems Contain Asbestos-Containing Joint Compound.

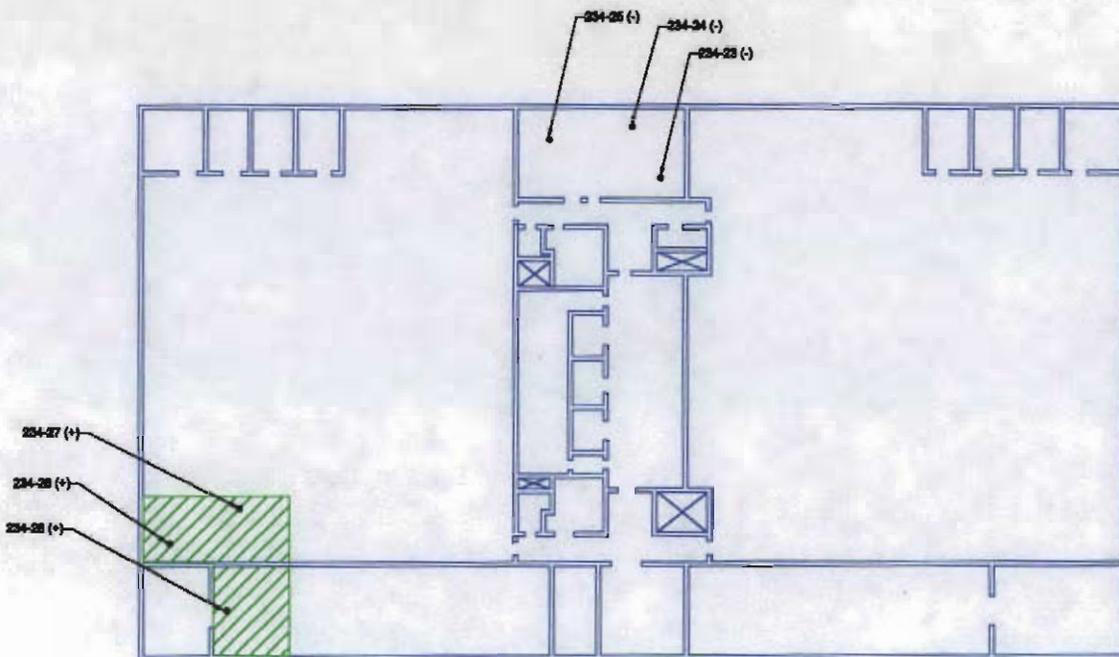
NOTE 1:
All Interior Drywall Wall and Ceiling Systems Contain Asbestos-Containing Joint Compound.

NOTE 2:
All Piping Systems Are Insulated With Non-Suspect Asbestos-Containing Materials.

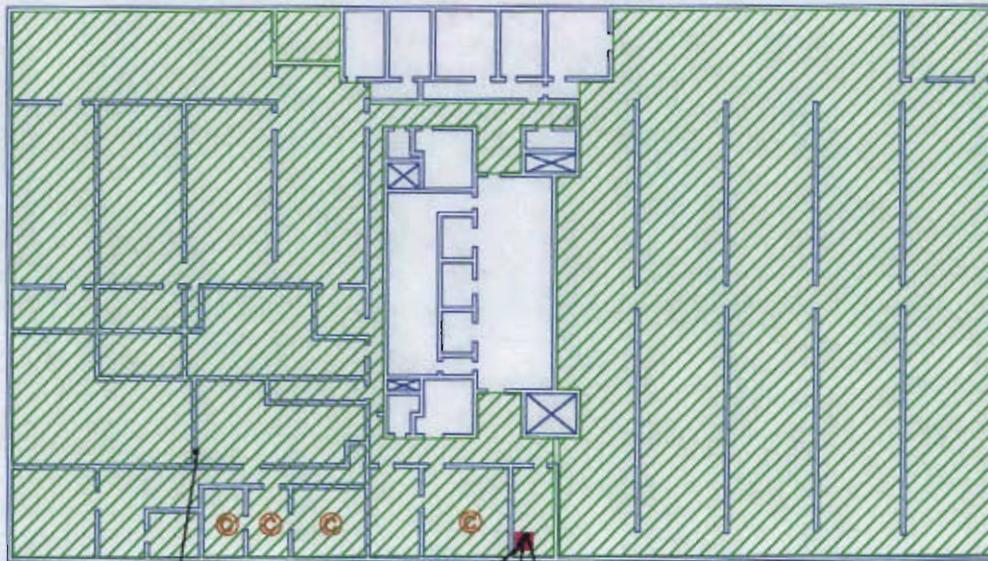
NOTE 1:
All Interior Drywall Wall and Ceiling Systems Contain Asbestos-Containing Joint Compound.

NOTE 2:
All Piping Systems Are Insulated With Non-Suspect Asbestos-Containing Materials.

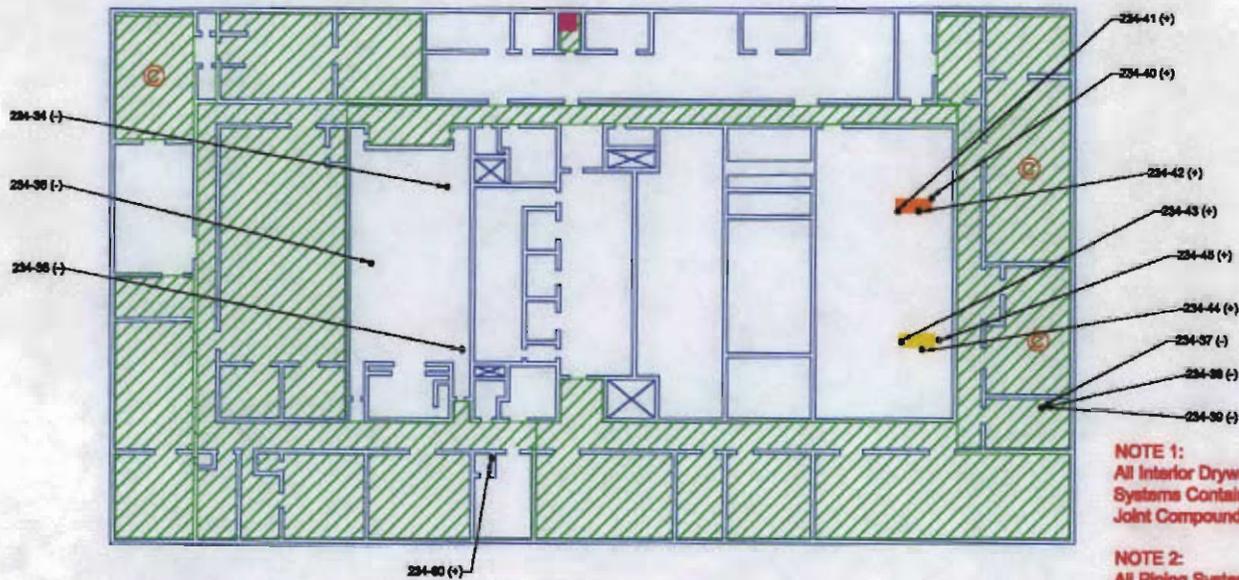
NOTE 1:
All Interior Drywall Wall and Ceiling Systems Contain Asbestos-Containing Joint Compound.

NOTE 2:
All Piping Systems Are Insulated With Non-Suspect Asbestos-Containing Materials.
