COMPLETION REPORT FOR TANK P AND PUMP ROOM AT CHICORA TANK FARM CNC
CHARLESTON SC
04/16/1999
ENVIRONMENTAL DETACHMENT CHARLESTON

**COMPLETION REPORT FOR TANK P
AND PUMP ROOM AT
CHICORA TANK FARM IN
NORTH CHARLESTON, S.C.**

ENVIRONMENTAL DETACHMENT
CHARLESTON
1899 NORTH HOBSON AVE.
NORTH CHARLESTON, S.C. 29405-2106

April 1999

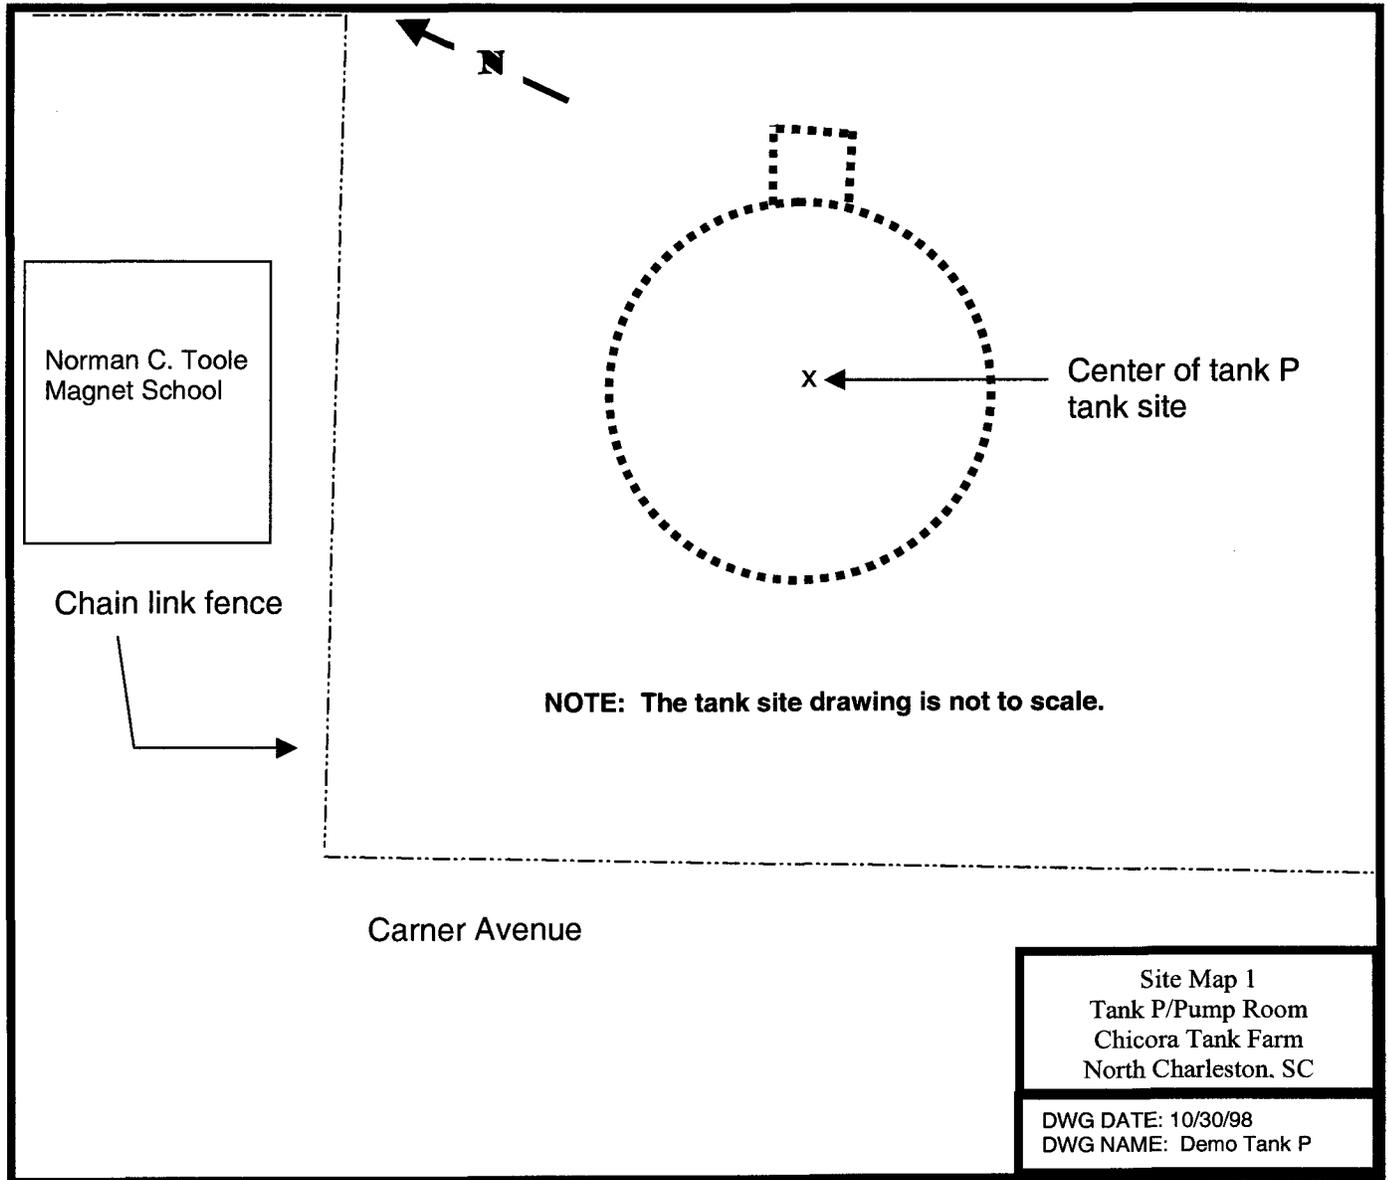
Chicora Tank Farm
Elevations from the Tank "P" Site

Location	Elevation	Date surveyed
1. center of the original tank top	20.1107'	08-07-98
2. center of tank site under the clay cap	7.5071'	09-08-98
3. center of tank site on top of the clay cap	8.6616'	09-29-98
4. center of tank site after backfilled to finished grade	14.7200'	10-13-98

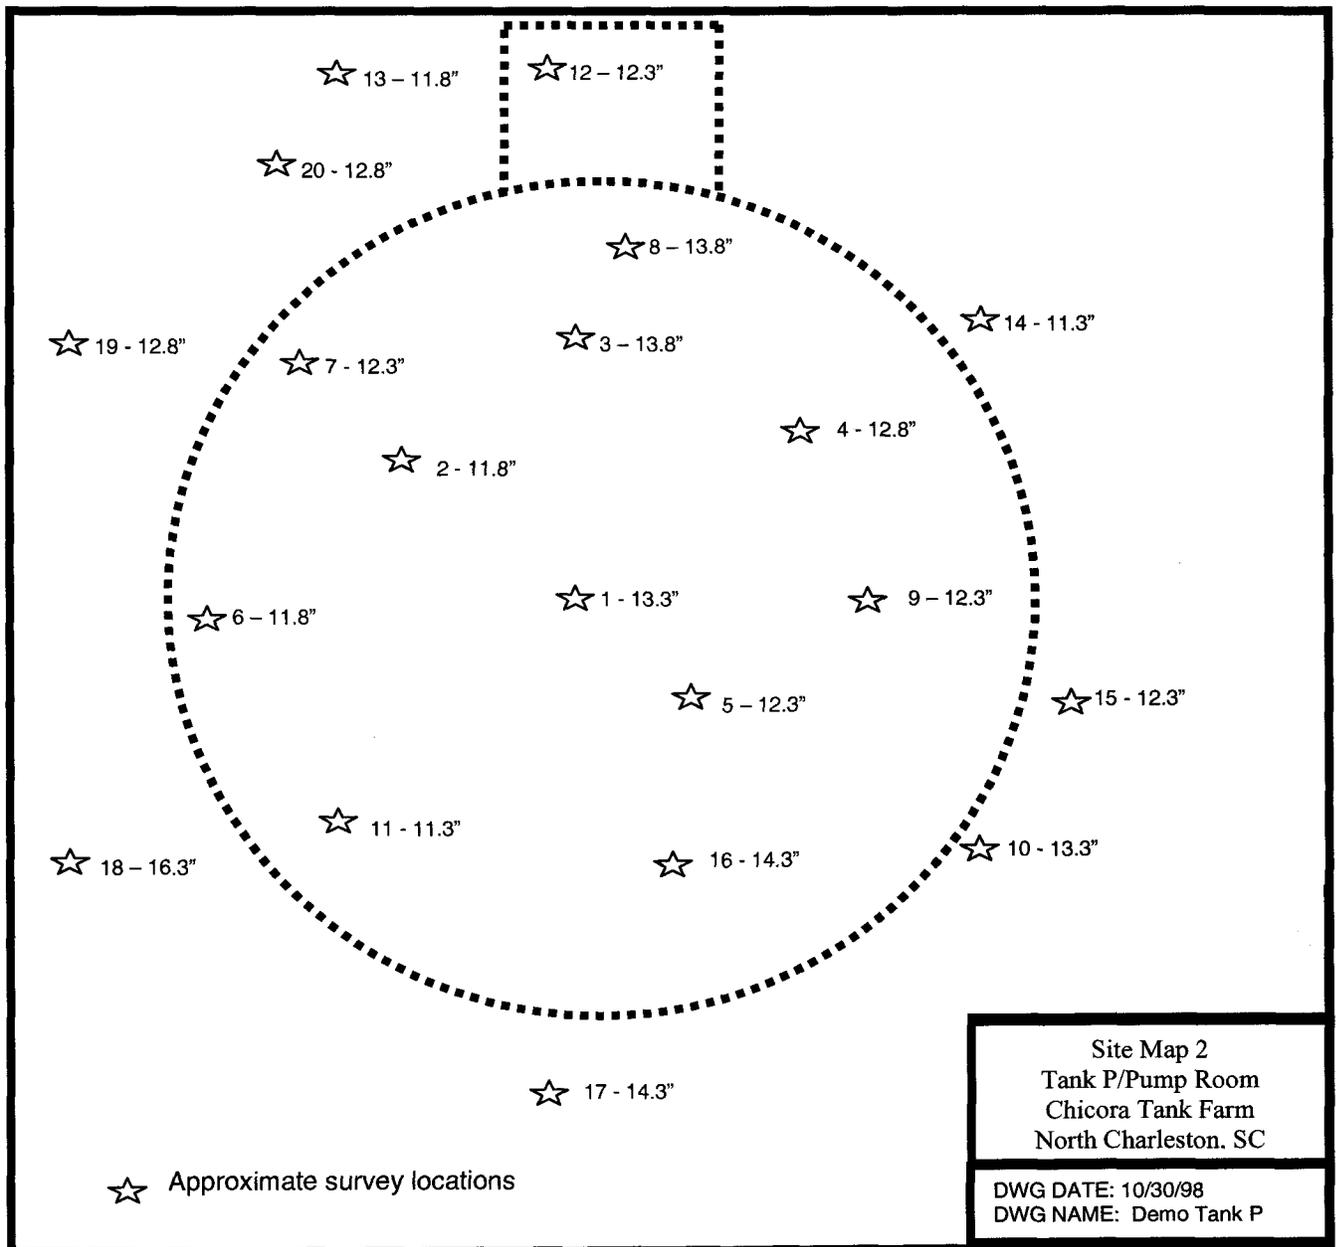
Clay cap material (inches) thickness over the Tank Site

survey point	Thickness (inches)	survey point	Thickness (inches)
1	13.3	11	11.3
2	11.8	12	12.3
3	13.8	13	11.8
4	12.8	14	11.3
5	12.3	15	12.3
6	11.8	16	14.3
7	12.3	17	14.3
8	13.8	18	16.3
9	12.3	19	12.8
10	13.3	20	12.8

NOTE: The clay cap material was applied over the backfilled tank/pump room. The clay cap extended five feet minimum beyond the remaining walls of the tank/pump room.

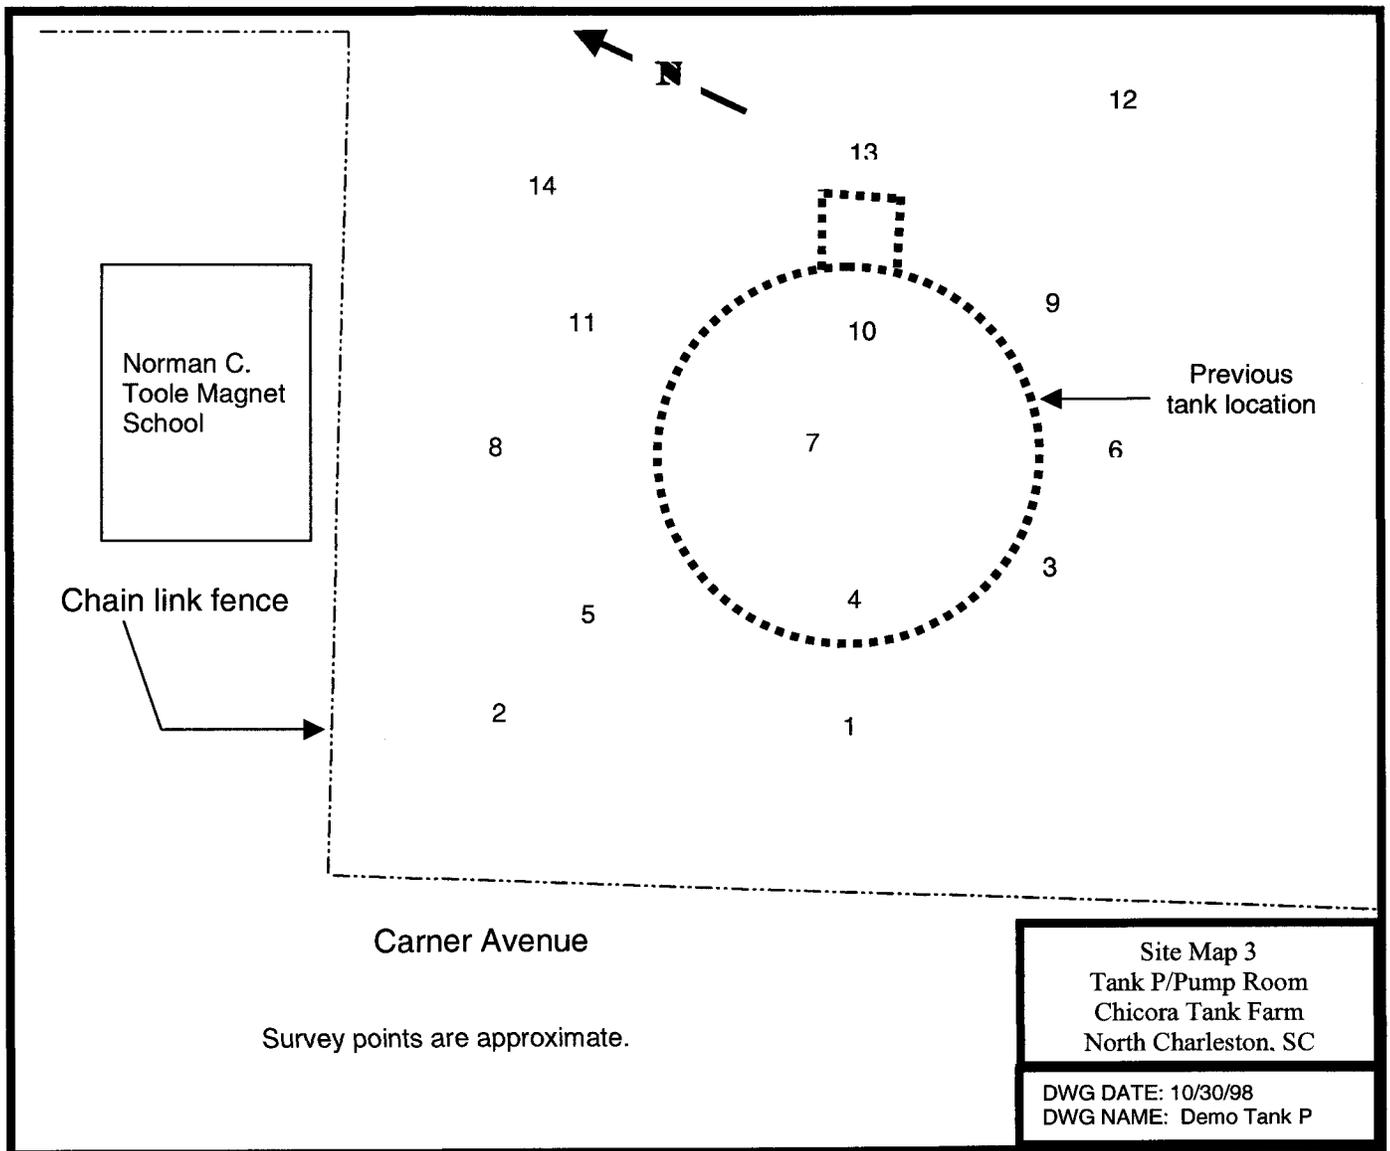
Elevations from Tank Site taken
after backfilling and grading

point	elevation	point	elevation
1	15.1886'	8	14.7313'
2	16.0946'	9	13.1897'
3	14.5718'	10	13.7623'
4	14.9606'	11	14.0250'
5	15.3118'	12	12.4375'
6	14.5036'	13	12.6086'
7	14.7200'	14	12.4393'

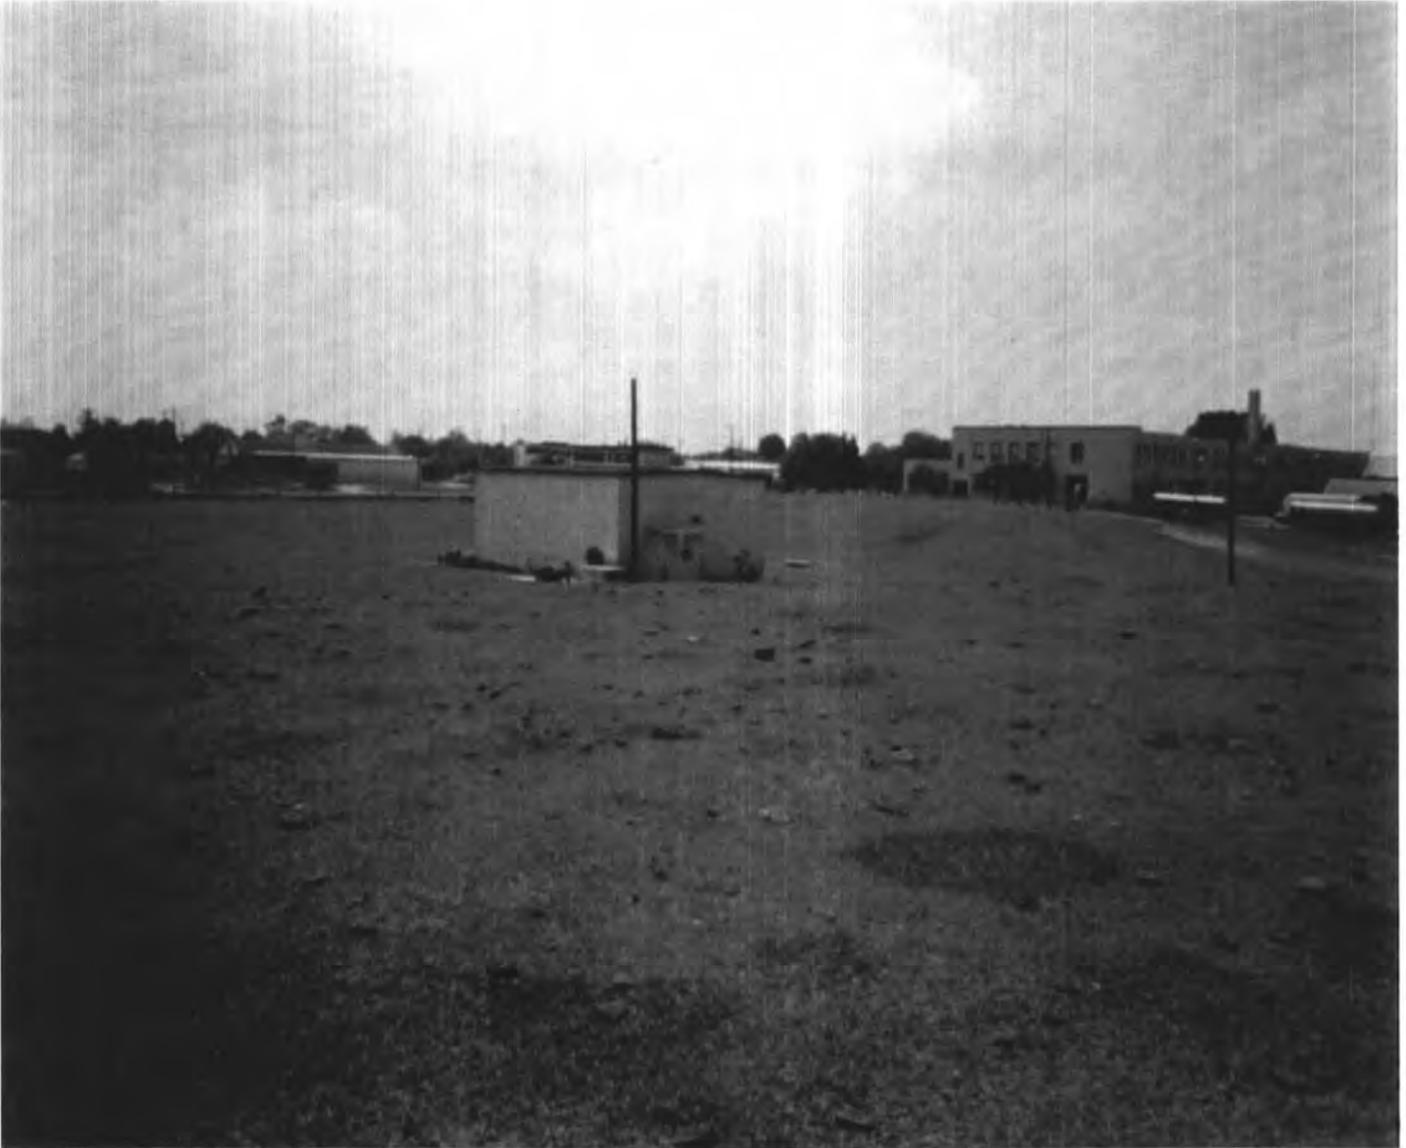
7.1 SITE PRIOR TO UNEARTHING

The tank farm was leased to a farmer who had grazed approximately 30 cows and a couple of horses on the property for many years. There was running water and sewer services as well as electrical power on site. However, the utilities and equipment associated with the tanks and piping on site had not been maintained for several years and were overall in poor condition. Tank "P" site is shown to the right of the steam building and in front of the Norman C. Toole magnet school.
