**Construction Completion Report
French Drain and Groundwater Treatment System Installations
(SWMU's 1, 2, and 4)**

**Naval Air Station
Corpus Christi, Texas**

July 2004

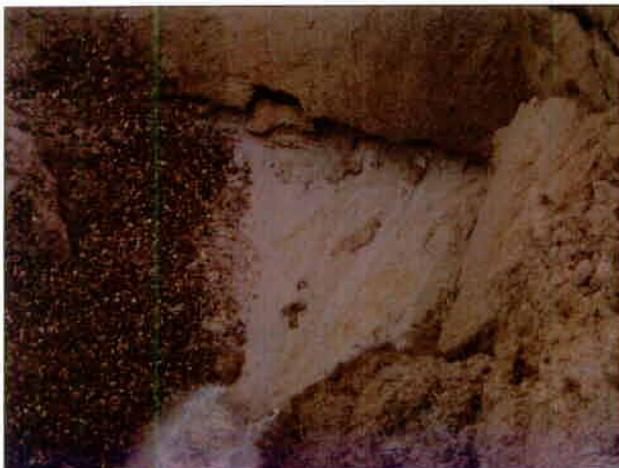
Photo A-7 (General)
Typical flowing sands in excavations

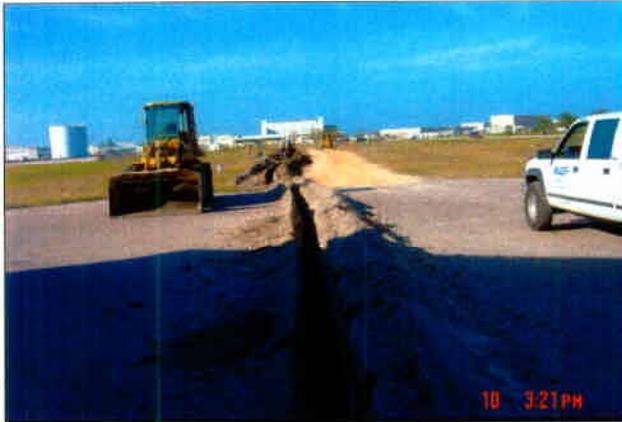
Photo A-33 (Electrical)

Installation of electrical line/conduit trench through paved driveway/parking area at the DRMO scrap yard
