REPORT OF ASBESTOS SURVEY U S DEPARTMENT OF AGRICULTURE ANIMAL AND  
PLANT HEALTH INSPECTION SERVICE FACILITY NAS KEY WEST FL  
6/25/1999  
LAW ENGINEERING AND ENVIRONMENTAL SERVICES

**REPORT OF ASBESTOS SURVEY**

**USDA APHIS FACILITY  
KEY WEST, FLORIDA**

June 25, 1999

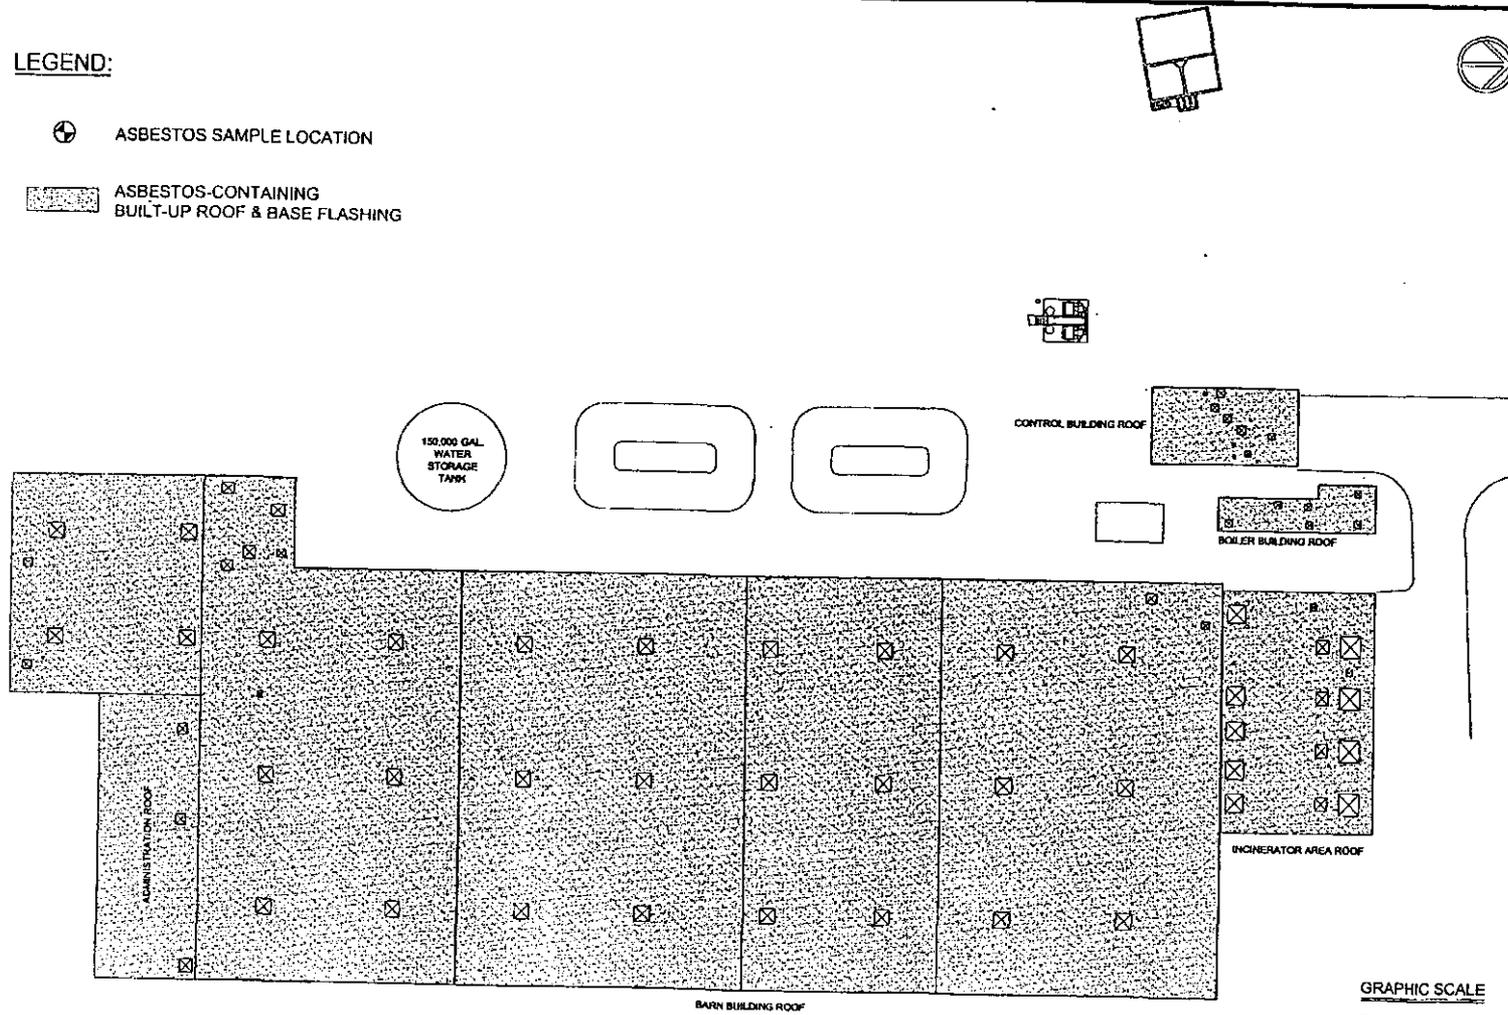
ASBESTOS-CONTAINING BUILT-UP ROOF & BASE FLASHING

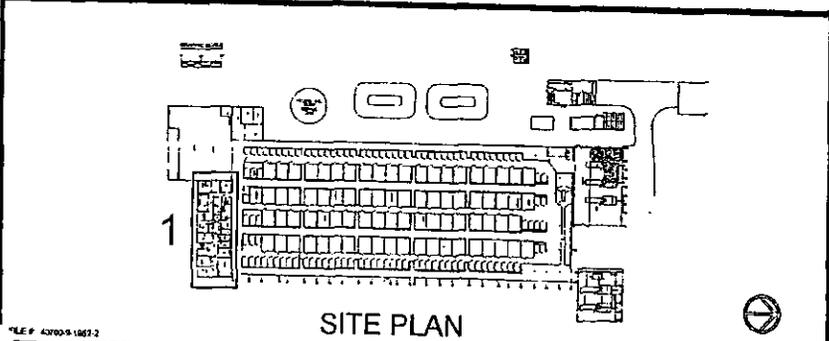
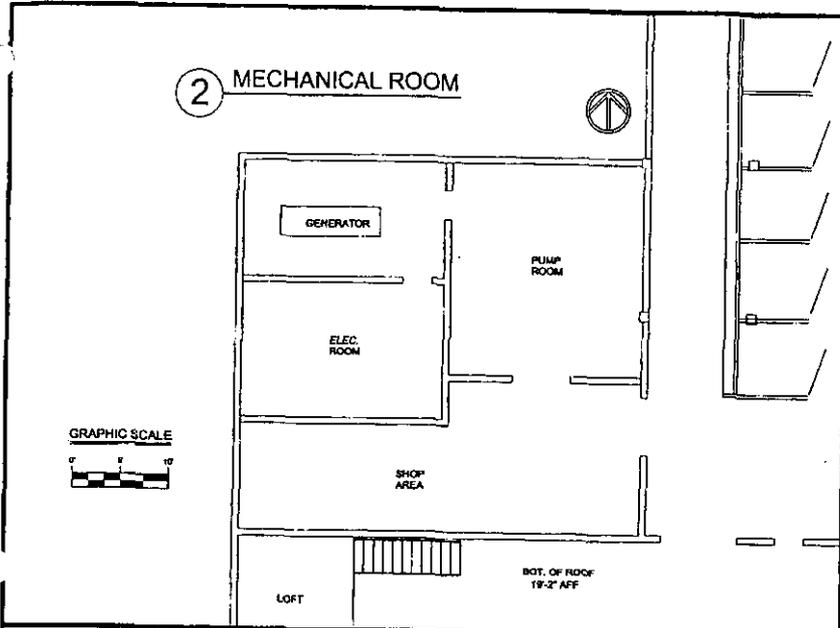
FIGURE 2 DELINERATION MAP OF ASBESTOS-CONTAINING MATERIALS ADMINISTRATION AREA	
DRAWN BY: N.A.B.	DATE: 06/22/99
CHECKED BY: T.R.	SCALE: AS SHOWN

- LEGEND:**
- ASBESTOS-CONTAINING 12" X 12" TAN FLOOR TILE/MASTIC
  - ASBESTOS-CONTAINING 12" X 12" BROWN FLOOR TILE/MASTIC
  - ASBESTOS-CONTAINING 12" X 12" WHITE FLOOR TILE/MASTIC
  - ASBESTOS-CONTAINING 12" X 12" BLUE FLOOR TILE/MASTIC
  - ASBESTOS-CONTAINING 12" X 12" RED FLOOR TILE/MASTIC
  - SHEET FLOOR COVERING

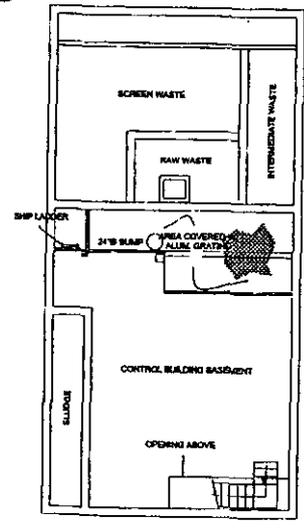
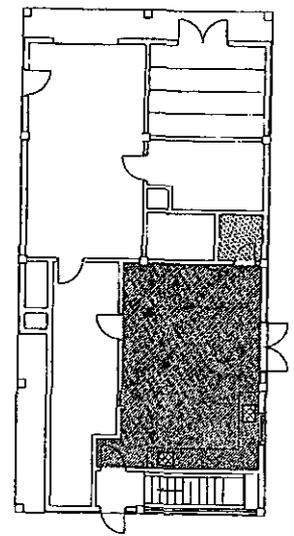
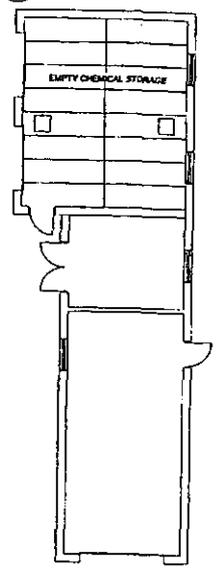
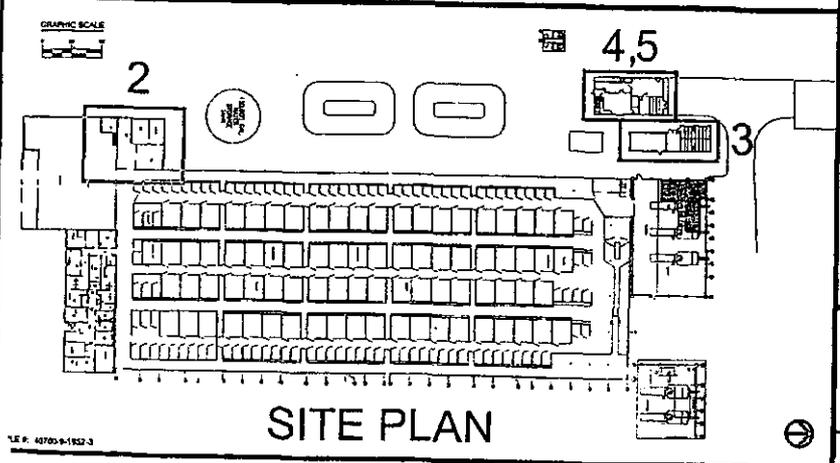
FIGURE 3  
DELINATION MAP OF  
ASBESTOS-CONTAINING MATERIALS  
CONTROL BLDG., BARN & BOILER BLDG.  
DRAWN BY: N.A.B. DATE: 06/22/99  
CHECKED BY: T.R. SCALE: AS SHOWN

- ASBESTOS SAMPLE LOCATION
- ASBESTOS-CONTAINING 12" X 12" TAN FLOOR TILE/MASTIC
- ASBESTOS-CONTAINING 12" X 12" BROWN FLOOR TILE/MASTIC
- ASBESTOS-CONTAINING 12" X 12" WHITE FLOOR TILE/MASTIC
- ASBESTOS-CONTAINING 12" X 12" BLUE FLOOR TILE/MASTIC
- ASBESTOS-CONTAINING 12" X 12" RED FLOOR TILE/MASTIC
- ASBESTOS-CONTAINING SHEET FLOOR COVERING
- ASBESTOS-CONTAINING SINK UNDERCOATING
