June 1983

INITIAL ASSESSMENT STUDY OF NAVAL AIR STATION, PENSACOLA PENSACOLA, FLORIDA

NEESA 13-015

NAVAL ENERGY AND ENVIRONMENTAL
SUPPORT ACTIVITY

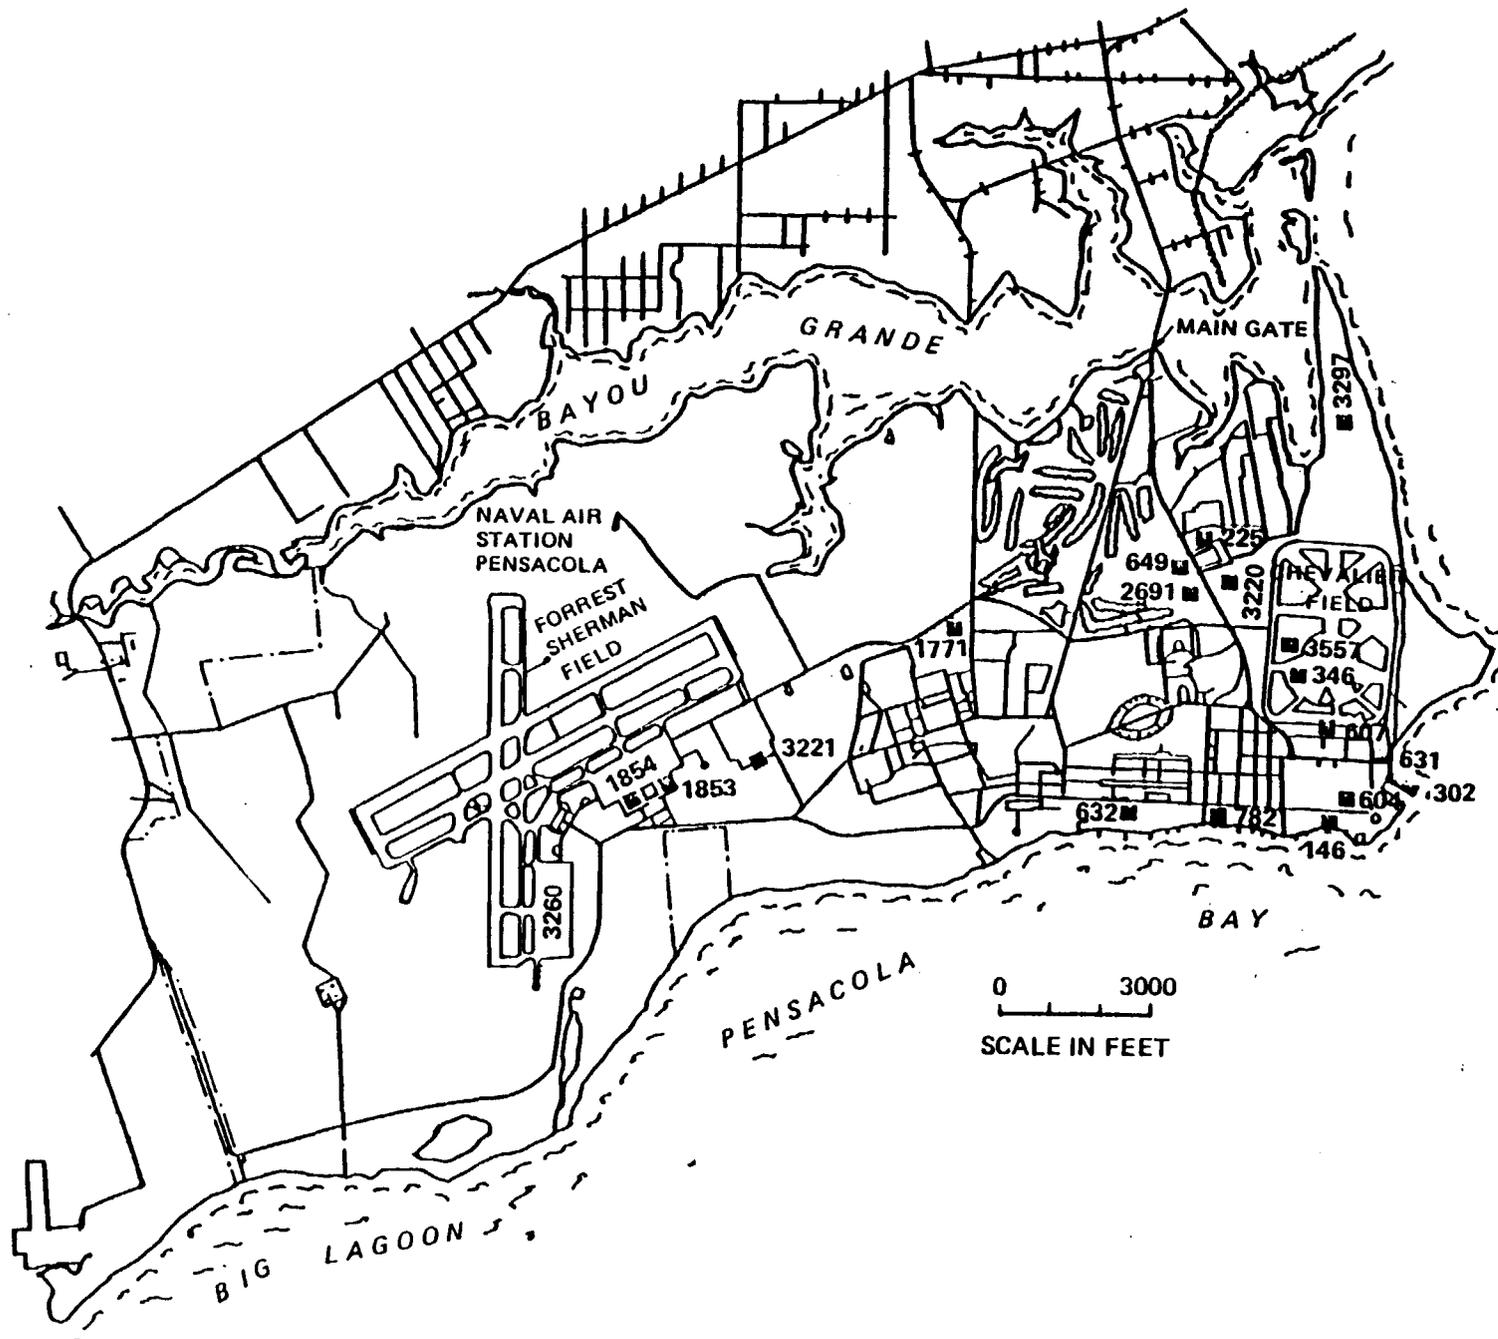
FIGURE 6-5 Location of Waste Oil Collection Points

6.5.2.3 Waste Oil Tanks. Methods for disposal of waste oil included removal by contractor, disposal through the IWTP, and disposal to the crash crew fire training activity. Table 6-18 lists capacities and locations of all waste oil collection tanks. Figure 6-5 shows the locations of all collection tanks. It is not known how long the tanks have been used, but some were reportedly

installed prior to 1946. Approximately 85,000-100,000 gallons per year of waste oil is collected from the tanks by a contractor. Some of the oil is contaminated with hydraulic fluids, acids, and paint strippers, according to installation personnel. The contractor reprocesses the oil for recycling.

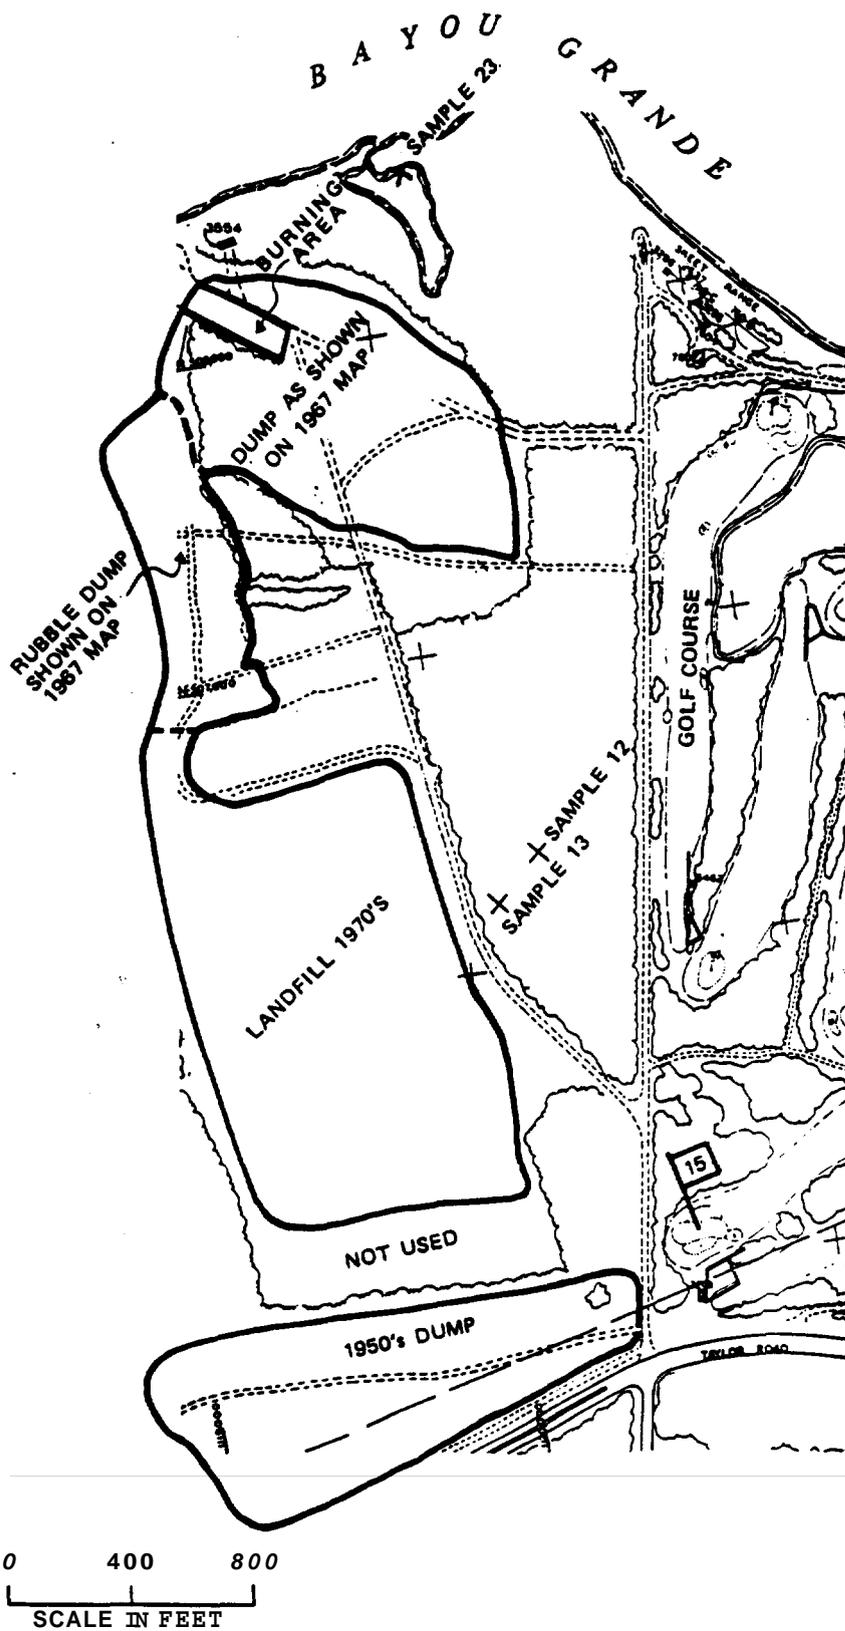
FIGURE 6-6 Historical landfill use. Several discrete areas of the landfill were used at different times.

6.6.1 Sanitary Landfill (Site 1). In the early 1950s, a new station disposal site was started at NAS Pensacola. This disposal site was located northeast of Fort Redoubt, just west of Hole 15 of the golf course. An area approximately 2,000 feet north of this disposal site was used for open disposing of rubbish and rubble from demolition, construction, and grounds maintenance. The station disposal site was moved approximately 3,000 feet north, some time around 1960, to a position adjacent to the rubble disposal site. The rubble disposal site was used throughout this time. In the late 1960s the station disposal site was moved south to the area commonly known at NAS Pensacola as the landfill. The landfill was officially closed on 1 October 1976. Figure 6-6 gives the locations of these disposal sites, which, when combined, comprise Site 1. The first two station disposal sites mentioned above were used for burning refuse and other materials. Paint wastes, solvents, waste oils, and other flammable materials were burned and the resulting ashes were landfilled. In the 1970s, with the advent of citizen's concern over pollution, much less burning of flammable wastes was done in an area that was part of the 1960s section of the disposal site.

The landfill accepted waste from several outlying fields (OLFs) including Corry, Saufley, Ellison, Baron, and Whiting Fields, in addition to wastes generated by NAS Pensacola. A partial listing of wastes disposed of at Site 1 is found in Table 6-19. It should be noted that there is no indication that any radiological material was disposed of in Site 1.

During the on-site survey, the NACIP team obtained samples of leachate from Site 1. Sediment samples from the leachate point of entry into Bayou Grande were also taken. The samples were analyzed for several of the contaminants believed to be in the landfill. The results of chemical analysis are shown in Table 6-20. The approximate locations of the sampling points are shown in Figure 6-6.

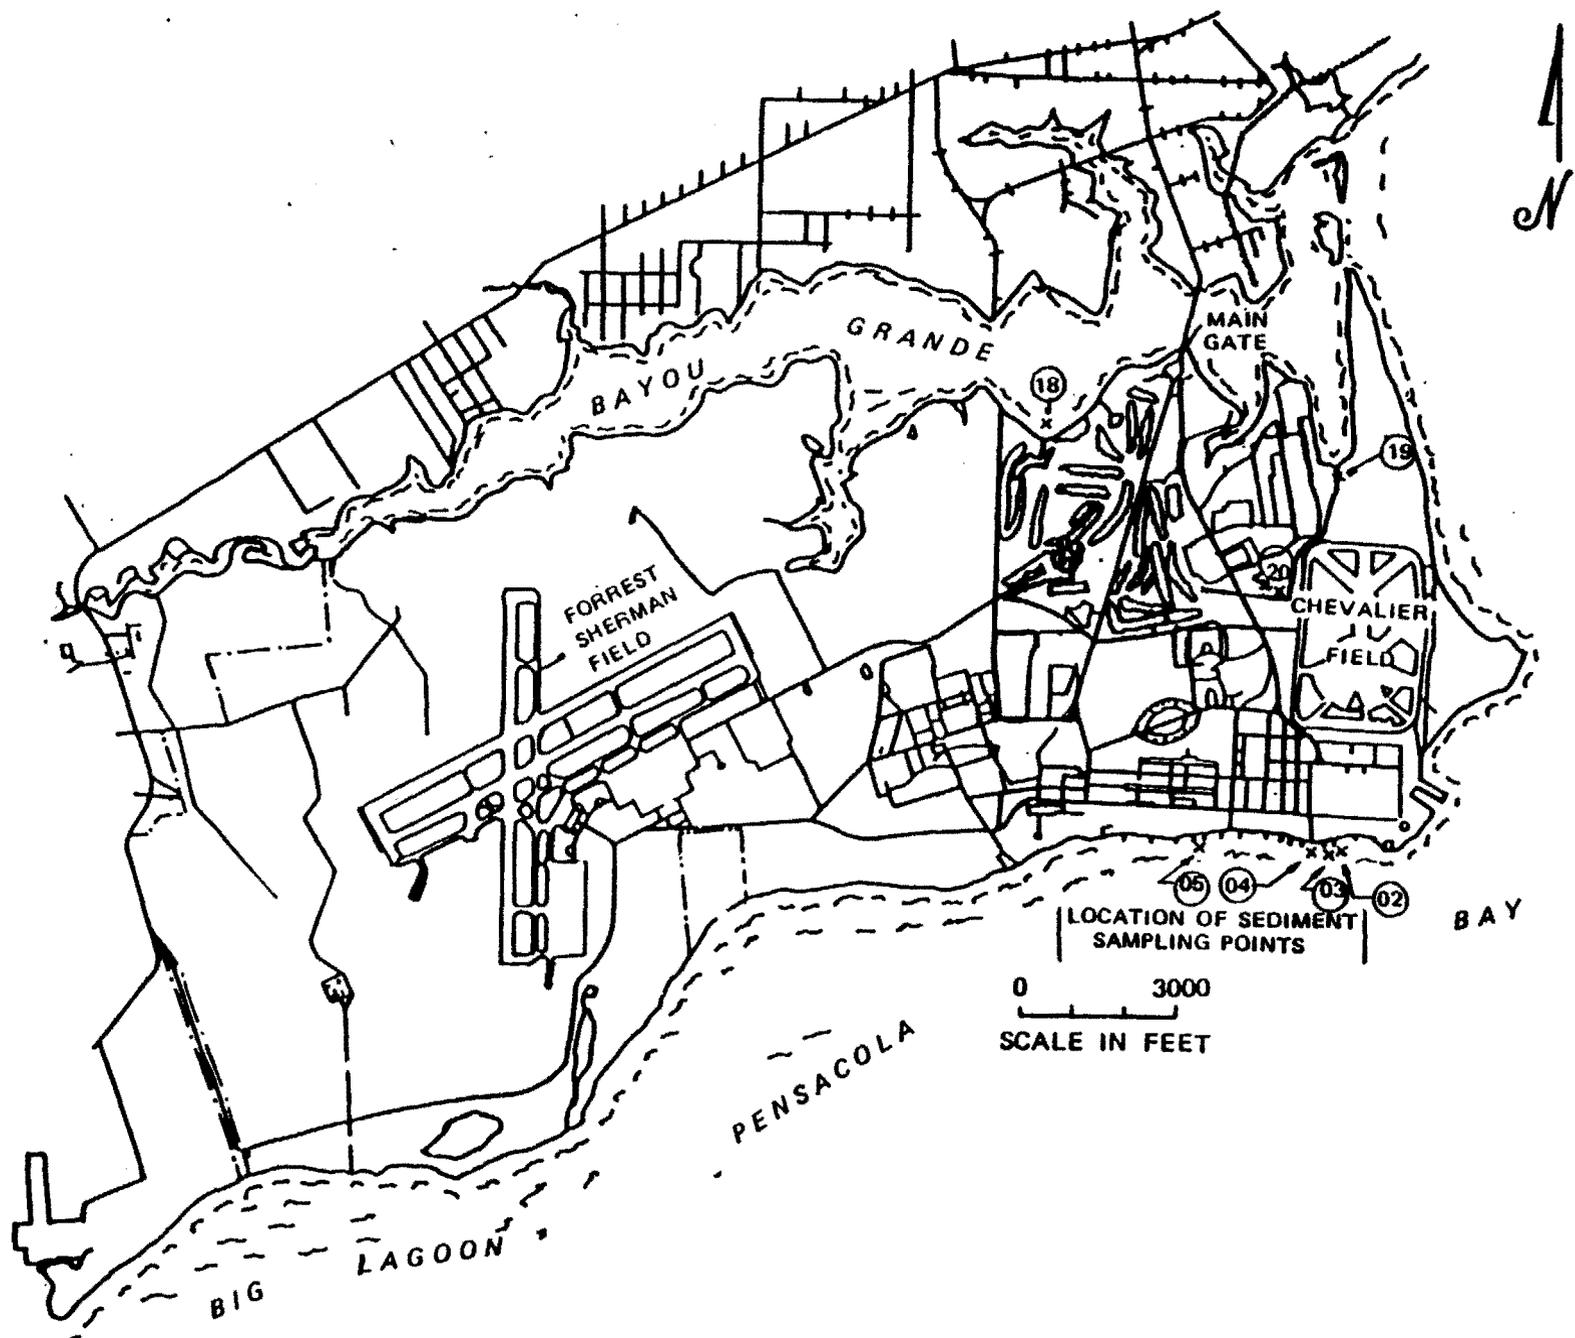
FIGURE 6-7 Locations of Sediment Sampling Points

Many of the chemicals discharged to the bay were biodegradable or would have been flushed out to the Gulf of Mexico from normal tidal fluctuations. Some chemicals, in particular inorganic compounds containing metals such as chromium, lead, mercury, and cadmium, may have been deposited in the sediments of the bay.

During the on-site survey, the NACIP team sampled the sediments of Pensacola Bay adjoining the base. The samples were analyzed for several of the known contaminants discharged by the Navy into Pensacola Bay. The results of the chemical analysis are shown in Table 6-22. The location of the sampling points are shown in Figure 6-7. No standard exists to define safe levels of a contaminant in a sediment. To get an idea of relative toxicity of the materials analyzed for, the EP toxicity limit is shown. The EP toxicity test involves the leaching of a contaminant from a solid sample and the limit shown is the level above which a material is considered hazardous. The results of sample analysis shown in Table 6-22 is the total amount of contaminant in the sample, not the amount that is leachable from the sample. If the EP toxicity test would have been performed on these samples, the results obtained would have been less than or equal to the results shown.

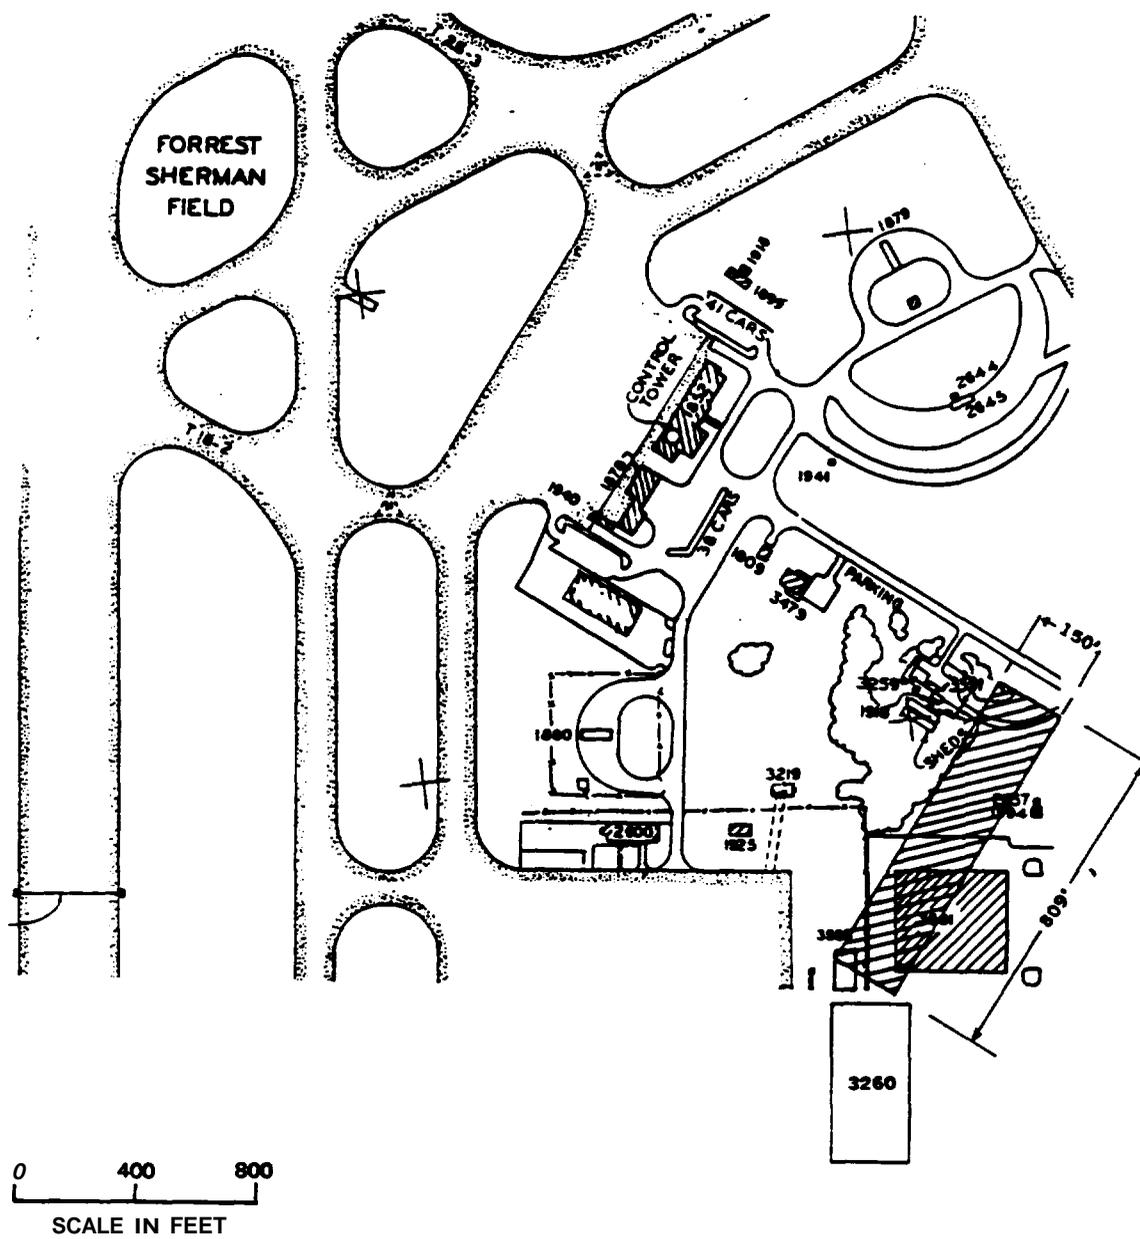
FIGURE 6-9 Approximate boundaries of the Army rubble disposal site, Site 4.

6.6.4 Army Rubble Disposal Site (Site 4). About 1951, the old Army barracks in Fort Barrancas were torn down. The rubble from this demolition was disposed of near what is now Building 3260 at Forrest Sherman Field. The rubble included timber, pipes, mattresses, and other demolition wastes. No burning was conducted at this site, and from all reports, no hazardous materials were disposed of here. The site is located at coordinates L-10 of the NAS Yensacola General Development Map. The site is rectangular shaped, measuring about 150 feet by 900 feet. Figure 6-9 shows the approximate boundaries of Site 4.

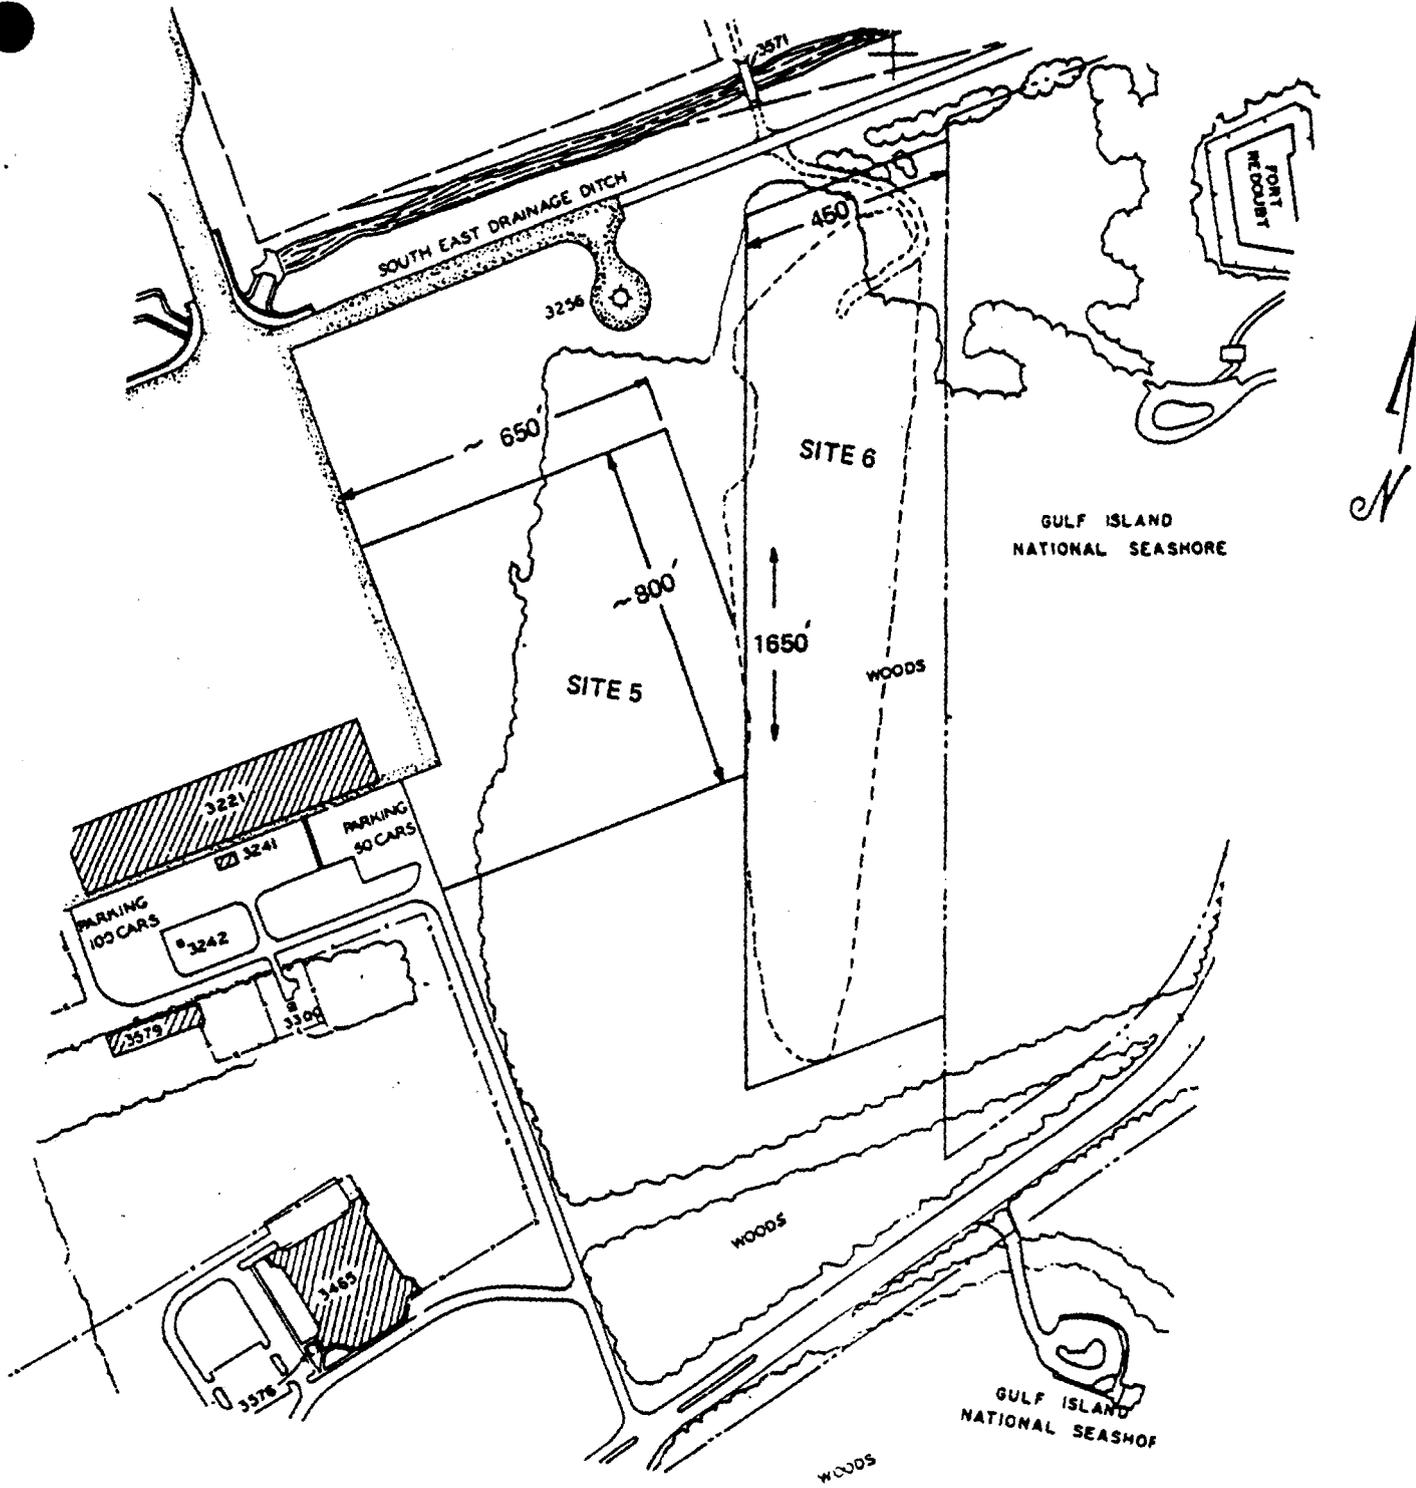
FIGURE

6.6.5 Borrow Pit (Site 5). About 1976, this site was cleared and soil was removed for cover material for the activity's sanitary landfill. The site, located to the east of Building 3221, is currently cleared with little or no vegetation growing on it. No reports of hazardous waste disposal were made during the survey. Visual inspection of the site by the NACIP team confirmed that no hazardous materials were disposed of at the site. The site is basically rectangular shaped, measuring about 650 by 800 feet. Figure 6-10 shows the approximate boundaries of Site 5.

6.6.6 Fort Redoubt Rubble Disposal Site (Site 6). From about 1973 to present, this site has been used for a rubble disposal. The site, adjacent to Site 5, has reportedly received rubble and demolition wastes from the removal of several buildings on base. During the visual inspection of the site by the NACIP team, concrete, wood, metal, and a few plastic items were observed at the site. No evidence of hazardous waste disposal was found relating to this site. The site is basically rectangular shaped, measuring about 450 by 1,650 feet. Figure 6-10 shows the approximate boundaries of Site 6.

6-10 APPROXIMATE BOUNDARIES OF THE BORROW PIT (SITE 5) THE
 FORT REDOUBT RUBBLE DISPOSAL SITE (SITE 6) AND

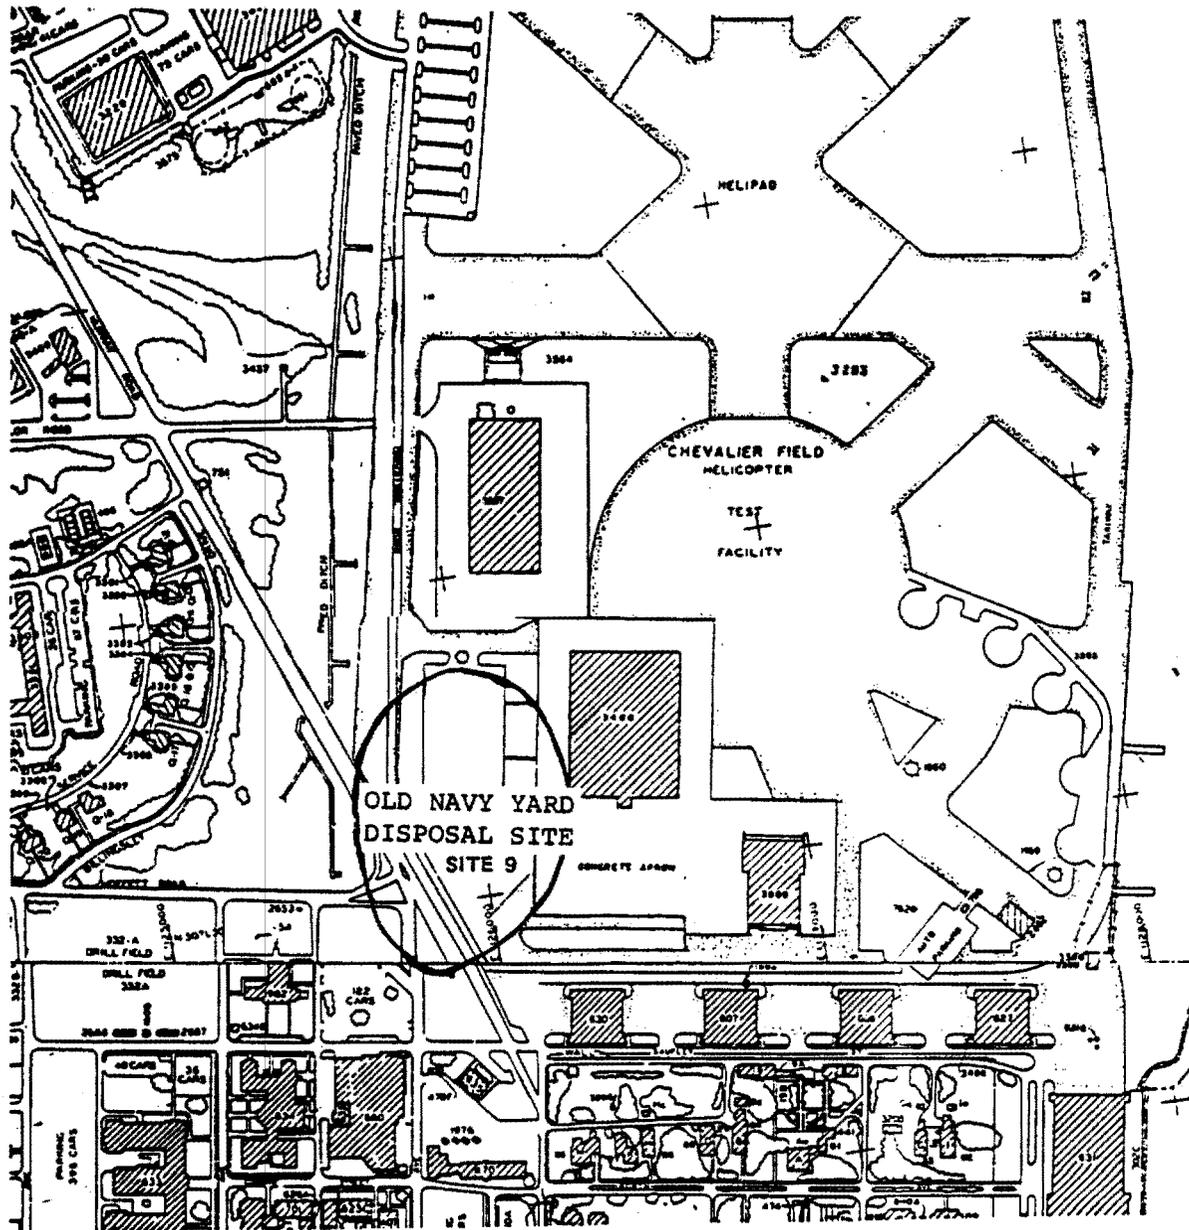
FIGURE 6-11 APPROXIMATE LOCATION OF THE OLD NAVY YARD DISPOSAL SITE. (SITE 9)

6.6.9 Navy Yard Disposal Site (Site 9). From the early 1900s until the early 1930s, a disposal site was located just northwest of the old yard wall. This disposal site is shown on several old maps and was known as the Navy Yard Dump or the Warrington Village Dump. The site is located at coordinates I23-24, H23-24 of the NAS Pensacola General Development Map. In the late 1960s, while trenching for the IWTP system, part of this disposal site was unearthed. Unearthed items included steel vehicle parts, broken glass, scrap metal, and debris. The bottom of this section of the disposal site was below the water table. No unusual odor was associated with the disposal site. Figure 6-11 gives the probable boundaries of the disposal site. Due to the age and accuracy of the maps used as references, Figure 6-11 represents the approximate location and boundaries of the disposal site.

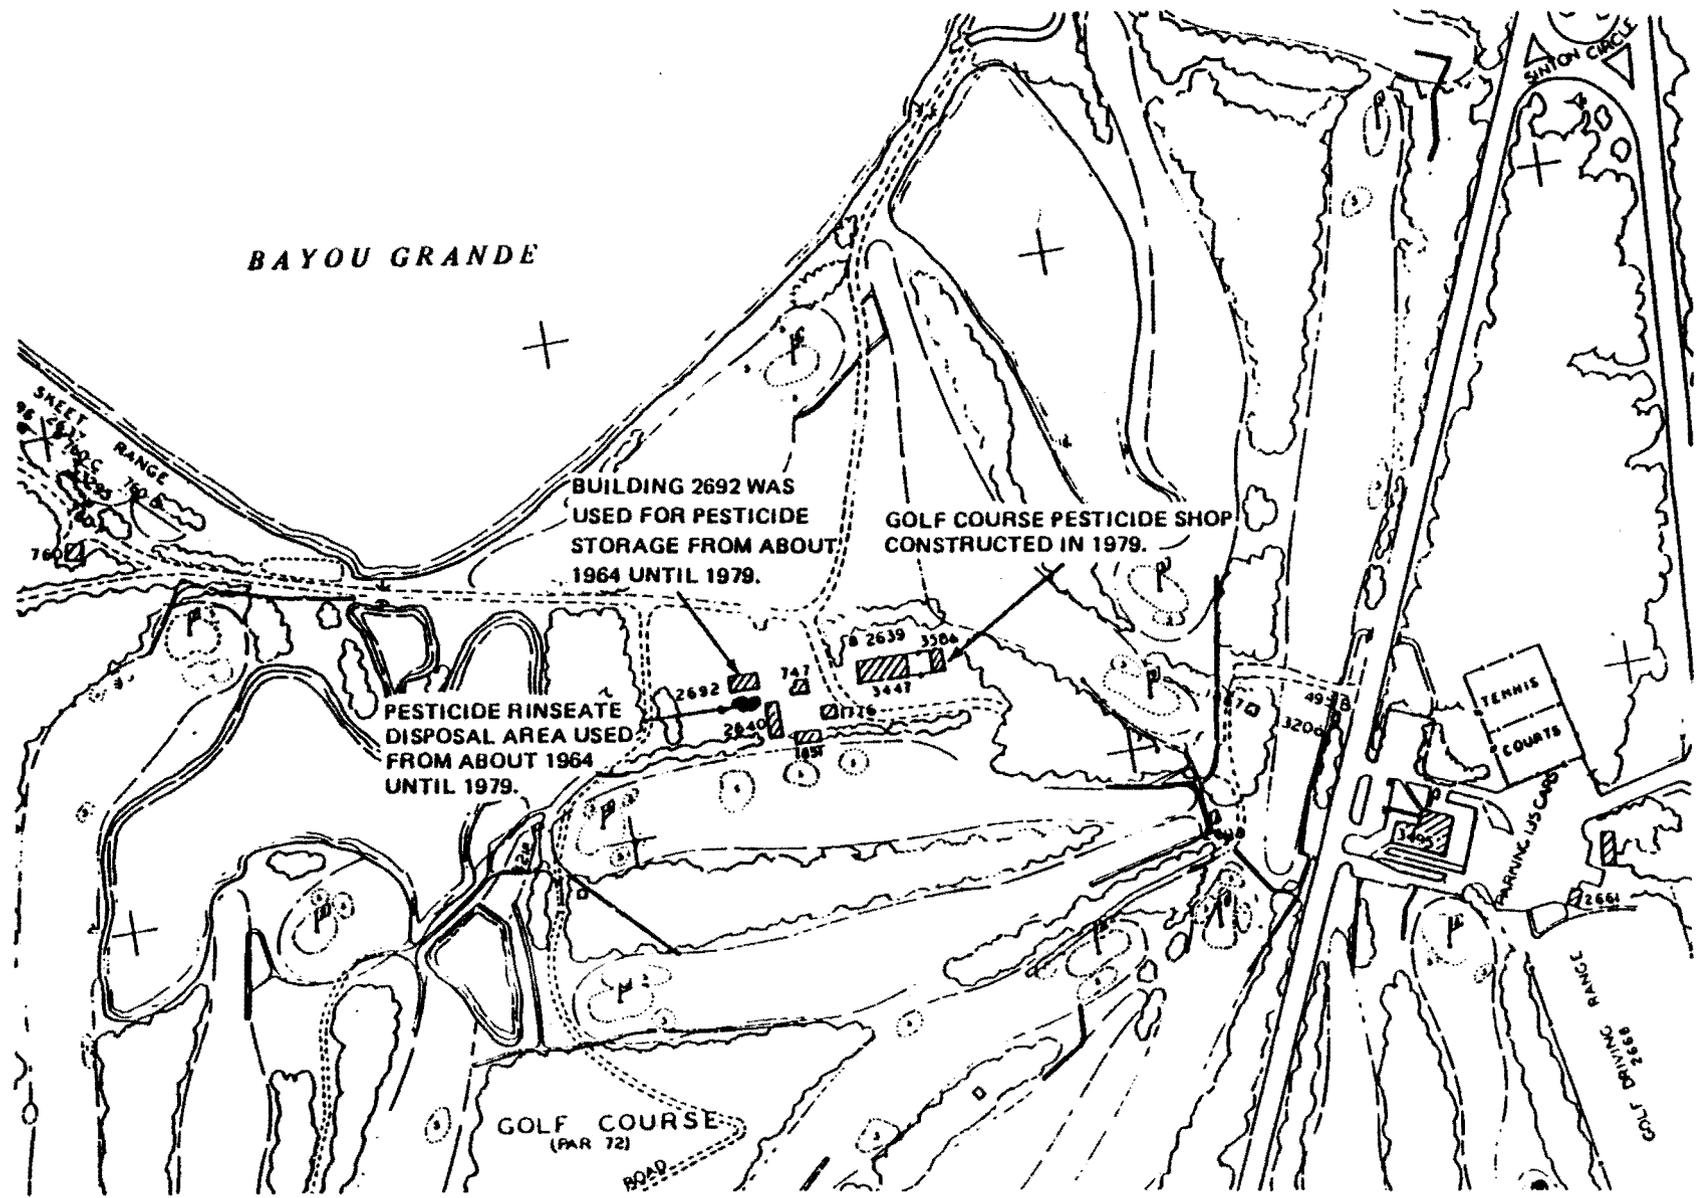
FIGURE 6-13 Approximate location of pesticide rinseate disposal area.

6.6.15 Pesticide Rinseate Disposal Area (Site 15). This site was used between 1963 and 1979 for disposal of pesticide rinseates. The site is located in an area between buildings 2640 and 2692 in the golf course maintenance area. Figure 6-13 illustrates the location of the disposal area. The area is located at coordinate D-19 on the general development map. Materials disposed of at this site consisted of organic phosphate, chlorinated hydrocarbons, Carbaryl, and carbamates.

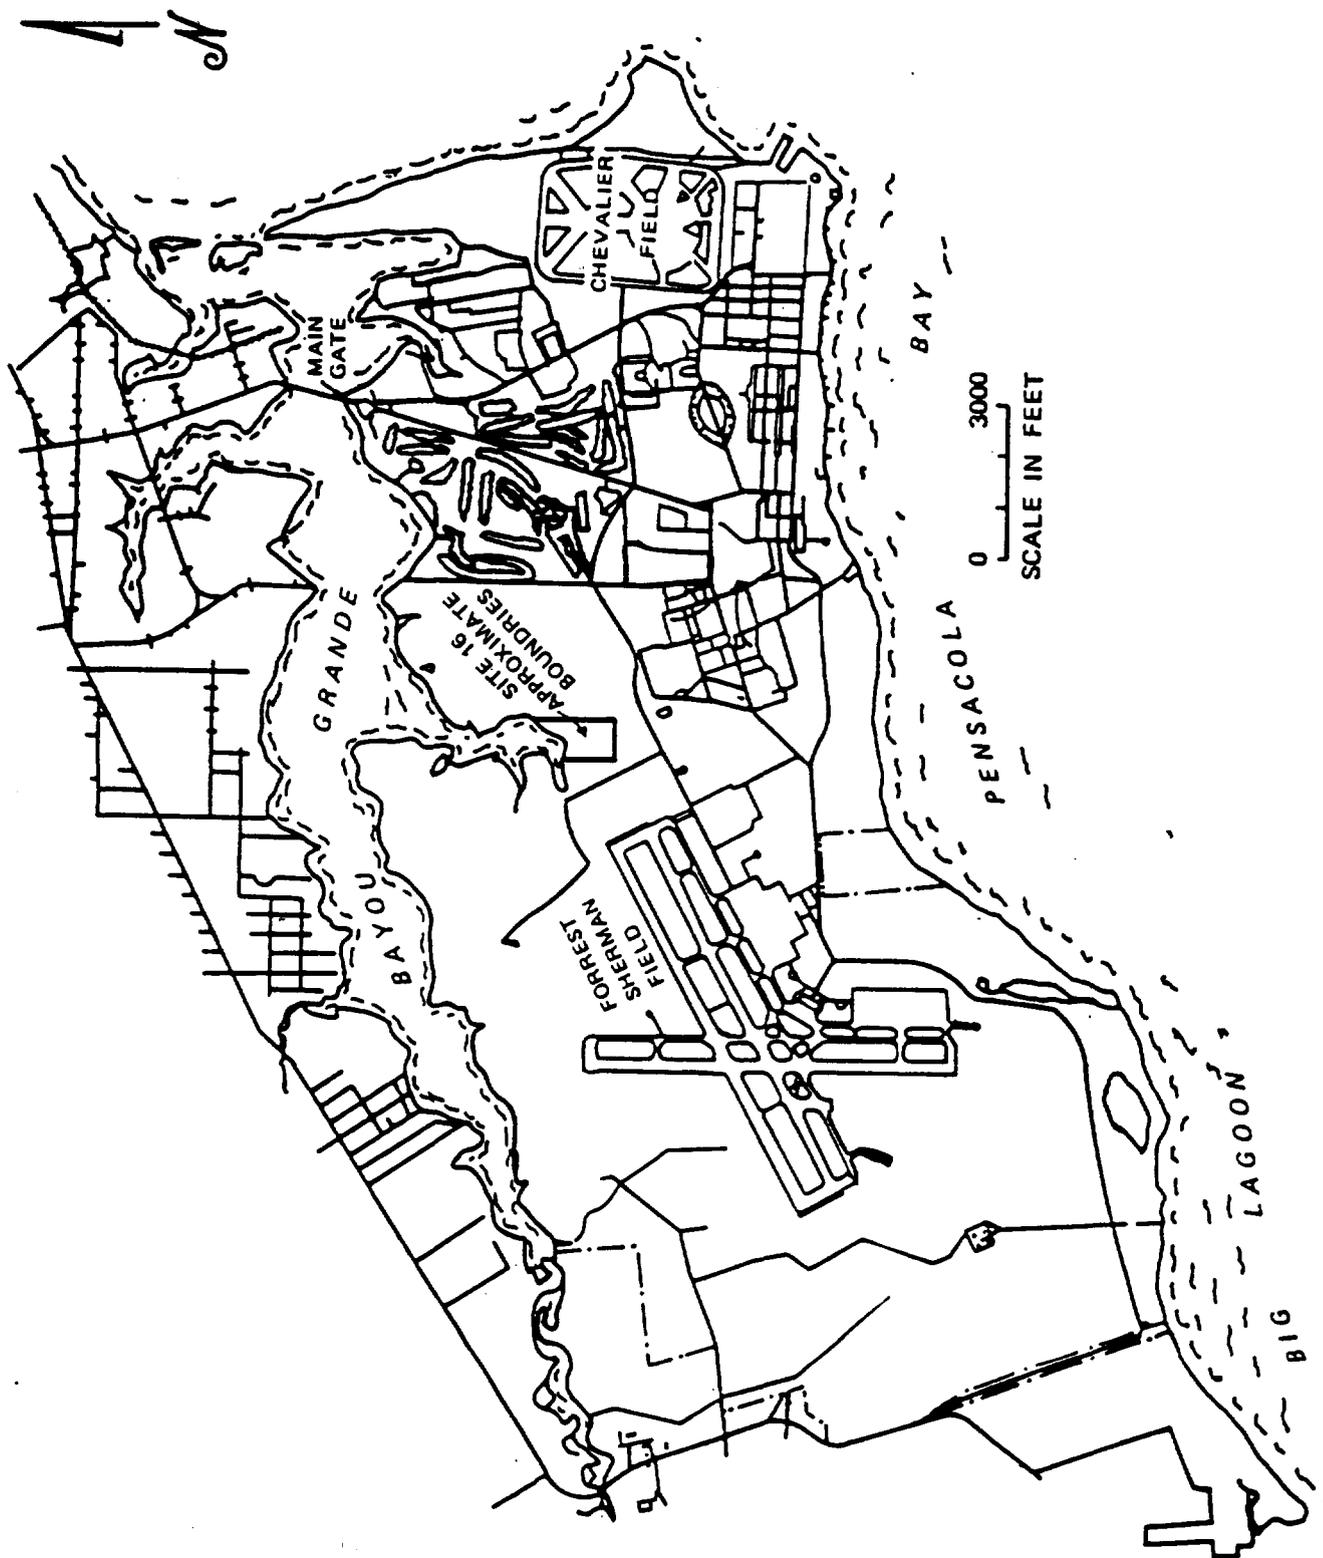
FIGURE 6-14 LOCATION OF SITE 16, THE BRUSH DISPOSAL SITE

6.6.16 Brush Disposal Site (Site 16). Since the late 1960s, this site has been used for the disposal of brush and tree limbs (see Figure 6-14). Aerial photographs indicate that, prior to about 1951, a portion of the brush disposal area may have been used for garbage burning and resultant ash disposal. The area was used by the Army during that time period. There is no evidence of any chemical usage by the Army at that base, and photographs indicate that all the waste was burned. Visual inspection of the site revealed that only brush, tree limbs, and several pieces of metal were present at the site. No evidence of disposal of hazardous waste was present.
