**DRAFT FINAL SUMMARY AND  
TECHNICAL EVALUATION REVIEW  
OF WORK PERFORMED AT 51  
SWMUs AND AOCs  
U.S. NAVAL STATION  
ROOSEVELT ROADS  
CEIBA, PUERTO RICO  
Work Assignment: R02031  
(Ref. No. 1-635-340)**

**Prepared for:  
U.S. Environmental Protection Agency**

DRAFT FINAL SUMMARY AND TECHNICAL EVALUATION REVIEW  
OF WORK PERFORMED AT 51  
SWMUs AND AOCs  
U.S. NAVAL STATION ROOSEVELT ROADS  
CEIBA, PUERTO RICO

Work Assignment No.:	R02031
EPA Region:	II
EPA Site/Facility I.D. No.:	PR2170027203
Contract No.:	68-W9-0003 (TES-6)
TRC Document No.:	NY-R31.RP4
TRC Project No.:	1-635-340-3-2000-0
TRC Project Manager:	Steven E. Panter
Telephone Number:	(908) 563-1100
Subcontract No.:	NA
Subcontractor Project Manager:	NA
Telephone No.:	NA
EPA Work Assignment Manager:	Timothy Gordon
Telephone No.:	(212) 264-9538
Date Prepared:	June 30, 1993

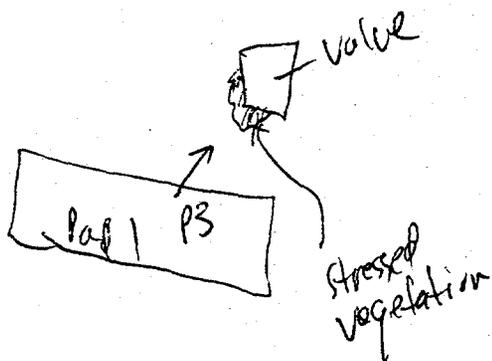
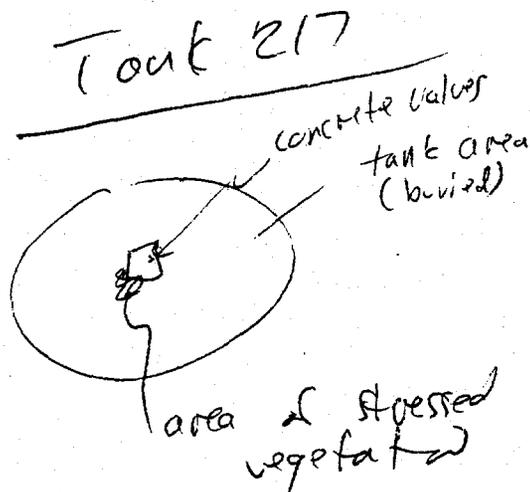
8. Are there any signs of stressed vegetation? If so, describe and sketch.

Yes. (See photos). At the area of vapor filter area:

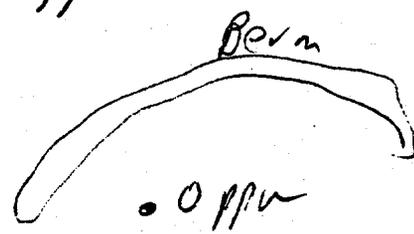
Pit 2

All readings = 0 ppm

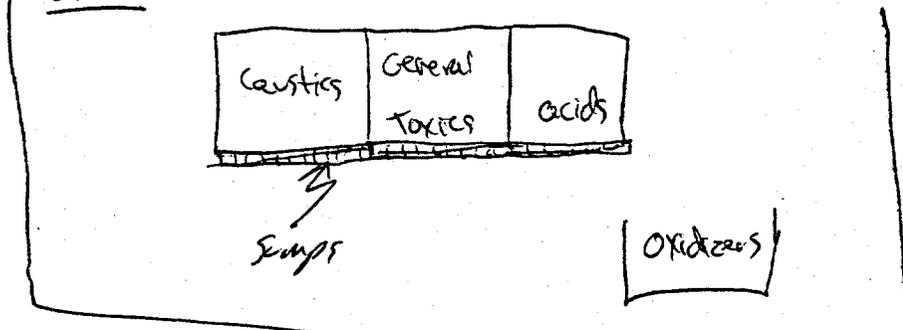
1. Is there any visible staining or evidence of release? If so, describe below in detail. Sketch extent of release.

No. There are 4 bays (caustics, general toxics, acids & oxidizers). Bays are inside DRMO Bldg.

1. This unit is very clean & organized.
2. No signs of staining.
3. Sump for each bay separates materials
4. Concrete is in good condition.
5. Recommend no further action. Keep facility in the shape that it is presently in.

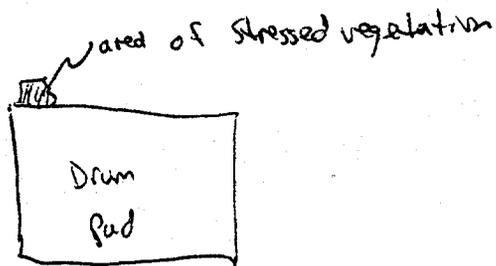
~~No~~ Yes, at NE corner of bermed pad.  
Took HNV reading from dug hole = zero ppm

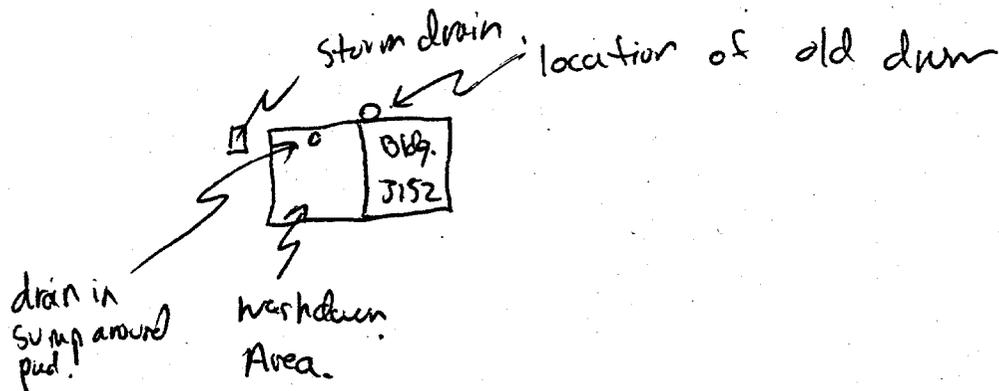
Location of storm drain:

2 Pad is not currently used

3 Old drum's content should be determined & appropriately dealt with

1. May want to collect samples ~~around~~ in storm drain to check for release.
