Final
Asbestos Inspection Report
for

Naval Activity Puerto Rico
Ceiba, Puerto Rico

Volume 6 of 7

Buildings 2342 through 2684

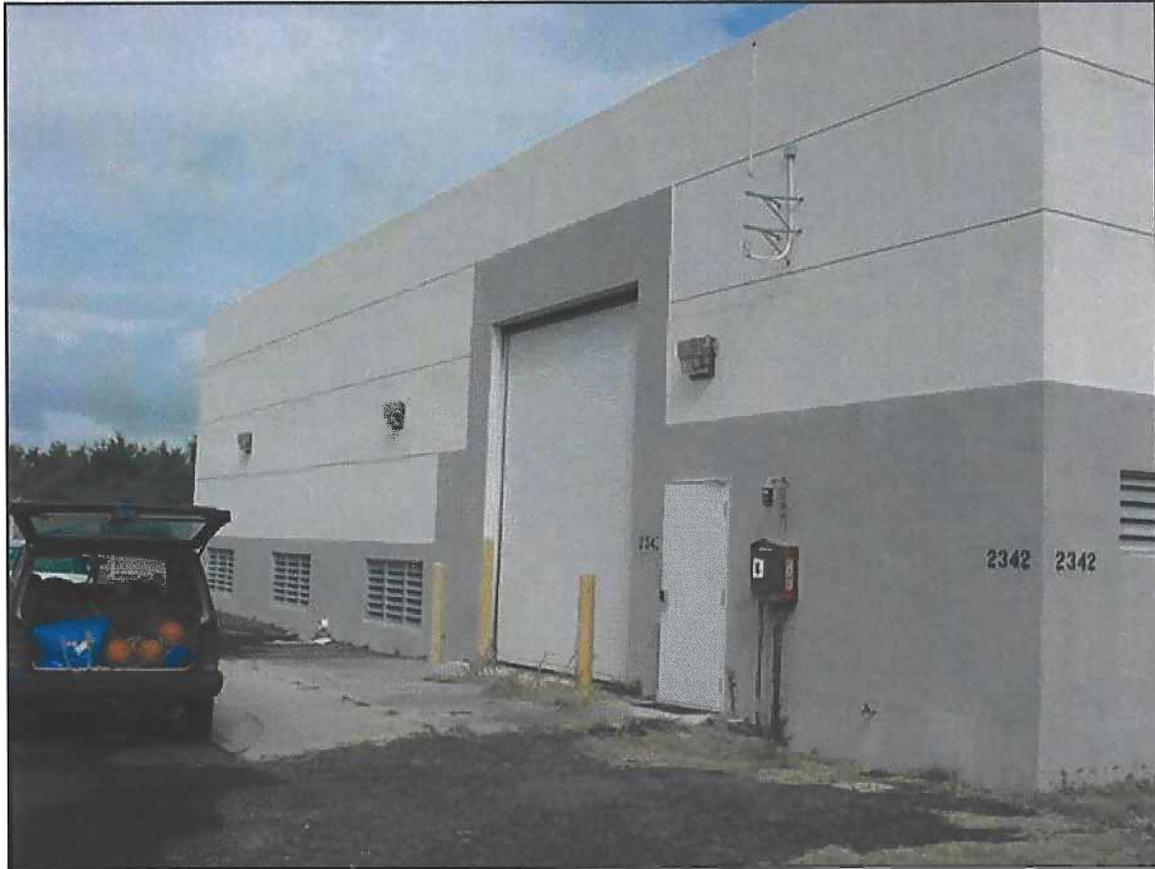
BUILDING 2342

Building 2342 is identified as “MOE Opn’l Stge by B-394” and is approximately 4,000 square feet in size. Six suspect homogeneous materials were identified and sampled. One material, roofing (Material #006), was assumed to be ACM.

MATERIAL NUMBER	MATERIAL TYPE (MATERIAL DESCRIPTION)	ASBESTOS CONTENT	MATERIAL LOCATION(S)	FRIABLE	CONDITION	QUANTITY	COMMENTS
006	ASPHALTIC ROOFING MATERIALS (ROOFING, UNKNOWN DESCRIPTION)	ASSUMED ACM	EXTERIOR	No	UNDAMAGED	3,000 SF	THIS MATERIAL WAS INACCESSIBLE AND IS ASSUMED TO BE ACM.

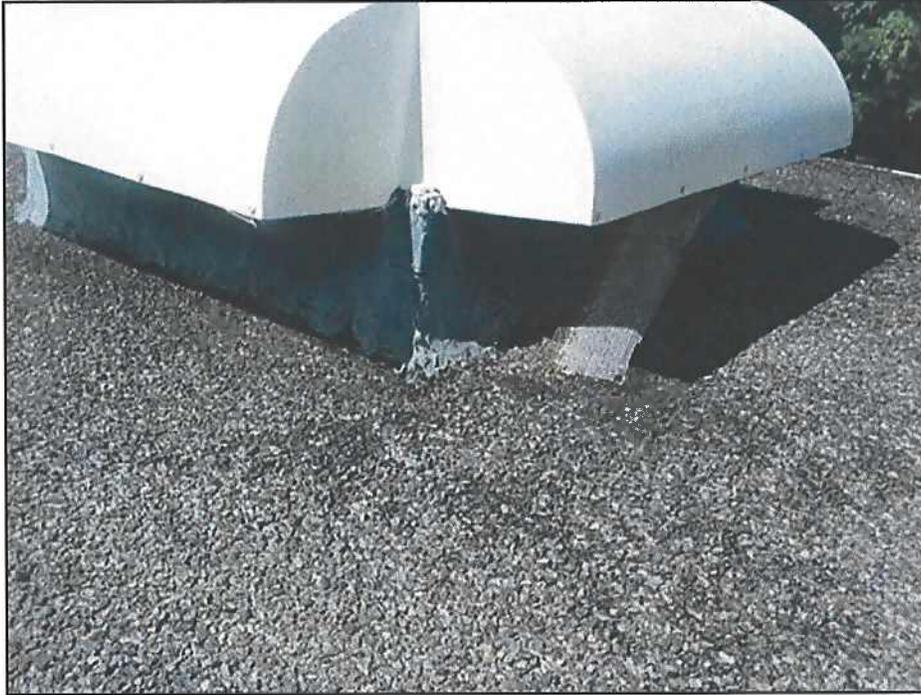
ACM PHOTOGRAPHS

Building 2365 is identified as “Flamm Supp Stge by B860” and is approximately 2,303 square feet in size. Three suspect homogeneous materials were identified and sampled. One material, asphaltic flashing (Material #003), was found to be an ACM. No friable, damaged, and accessible ACM was identified.

MATERIAL NUMBER	MATERIAL TYPE (MATERIAL DESCRIPTION)	ASBESTOS CONTENT	MATERIAL LOCATION(S)	FRIABLE	CONDITION	QUANTITY	COMMENTS
003	ASPHALTIC ROOFING MATERIALS (BLACK FLASHING)	12% CH	ROOF	No	UNDAMAGED	60 SF

Asphaltic flashing (Material # 003)

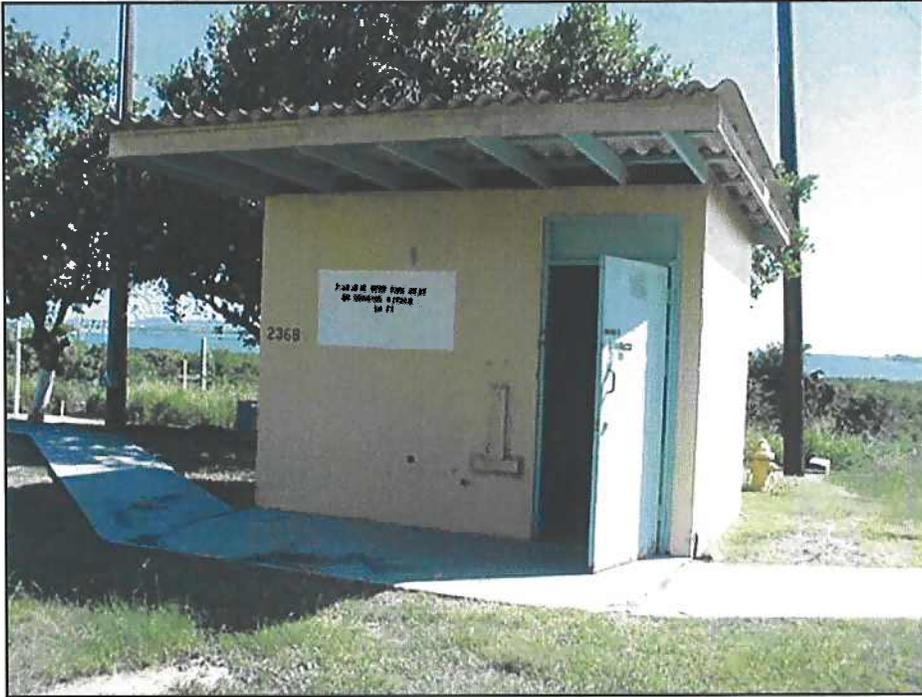
ACM PHOTOGRAPHS

Building 2368 is identified as “Flamm Stge Btwn 1708 & 1709” and is approximately 200 square feet in size. One suspect homogeneous material was identified and sampled. The material, corrugated roofing (Material #001), was found to be an ACM. No friable, damaged, and accessible ACM was identified.

Corrugated roofing (Material #001)

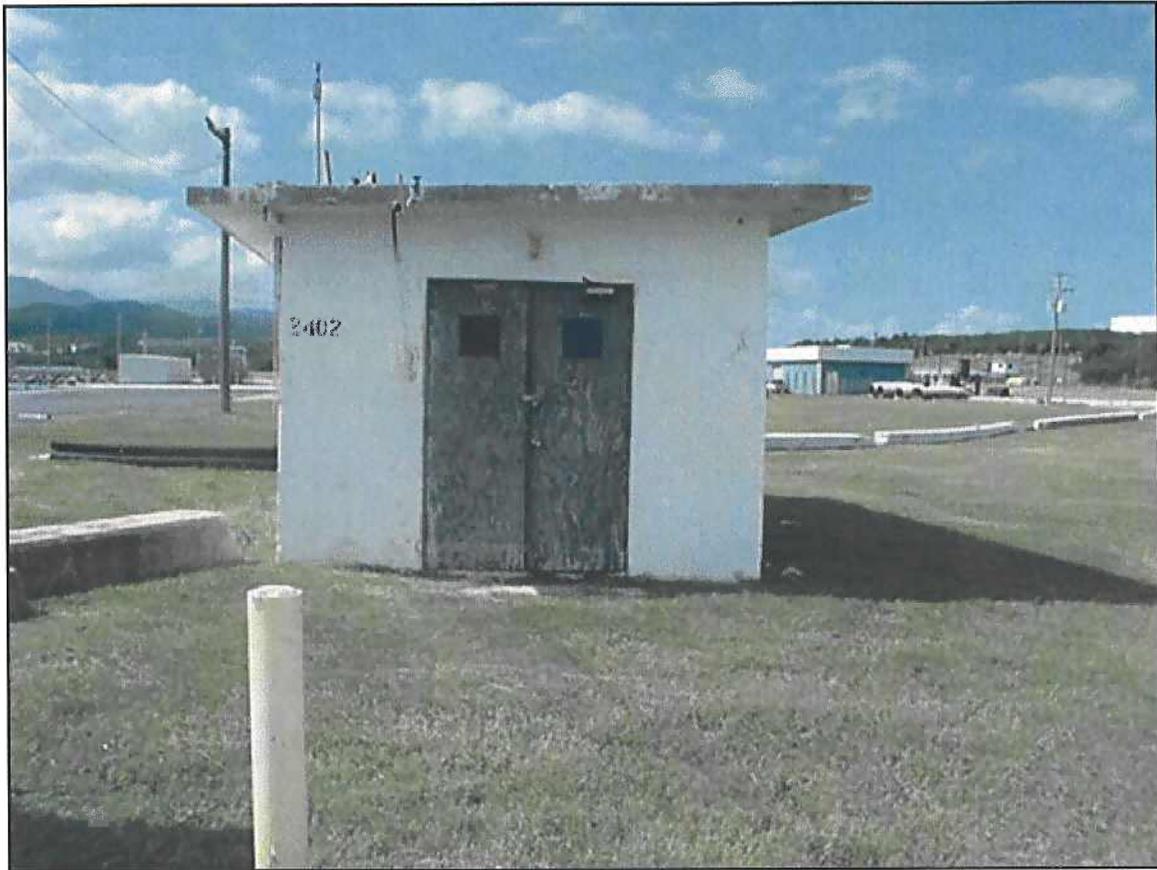
BUILDING 2402

Building 2402 is identified as “Tugboat Stge / Wk Space” and is approximately 560 square feet in size. Four suspect homogeneous materials were identified and sampled. Two of these materials, two types of floor adhesive (Materials #002 and #004), were found to be ACM. No friable, damaged, and accessible ACM was identified.

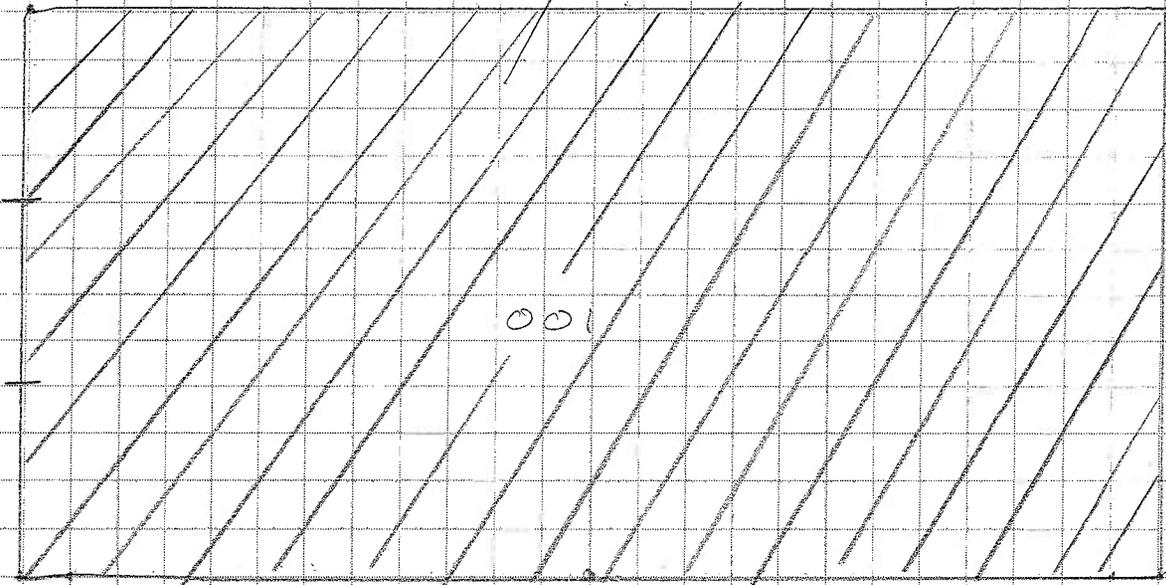
MATERIAL NUMBER	MATERIAL TYPE (MATERIAL DESCRIPTION)	ASBESTOS CONTENT	MATERIAL LOCATION(S)	FRIABLE	CONDITION	QUANTITY	COMMENTS
002	FLOOR ADHESIVE (TAN, UNDER 001)	Layer 1 ND Layer 2 2% CH	001	No	UNDAMAGED	288 SF	
004	FLOOR ADHESIVE (BLACK, UNDER 003)	10% CH	001	No	UNDAMAGED	288 SF

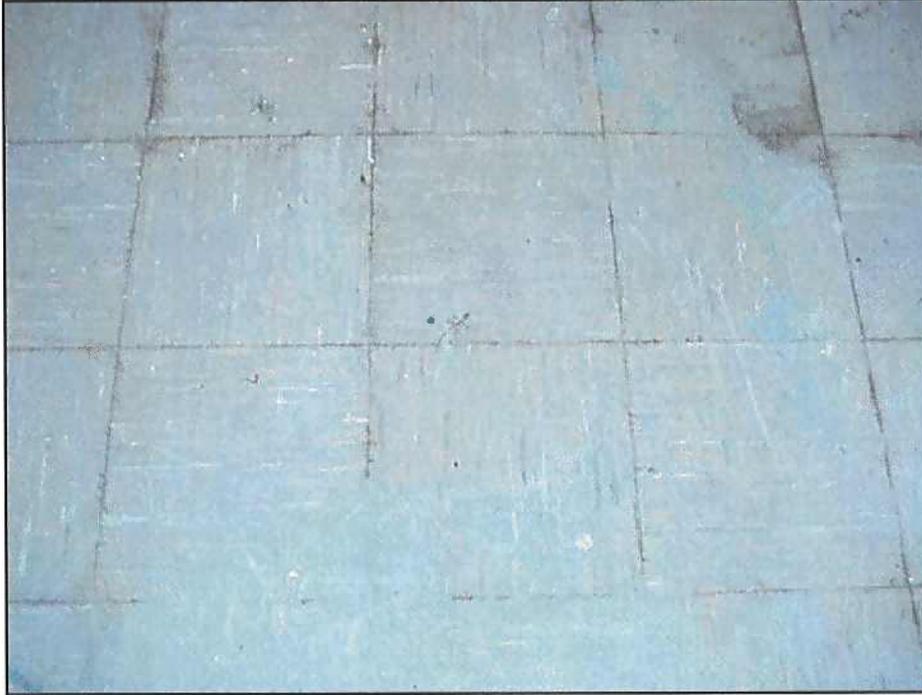
1'x1' brown with white and orange streaks vinyl floor tile (Material #001) over ACM floor adhesives (Materials #002 and #004)

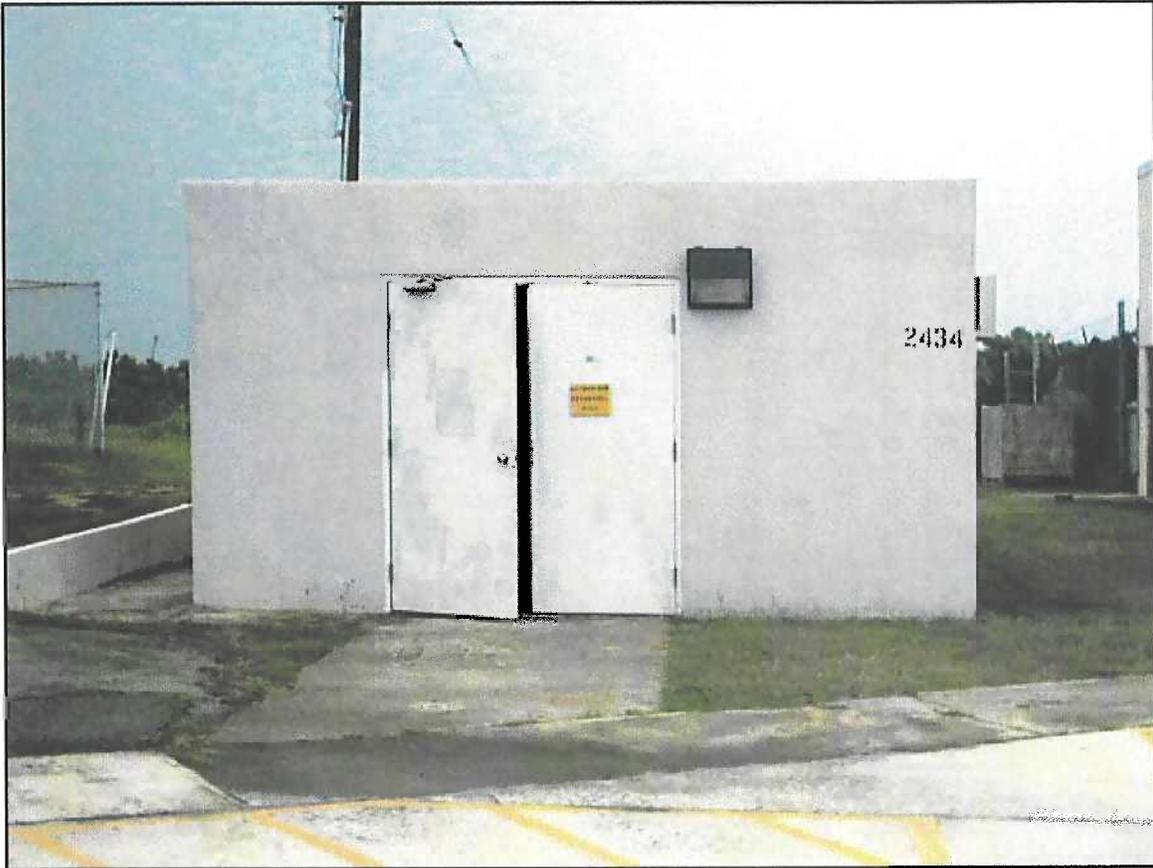
BUILDING 2434

Building 2434 is identified as “Biomed Waste Stge / Strlztm” and is approximately 503 square feet in size. One suspect homogeneous material was identified and sampled. This material is not an ACM.

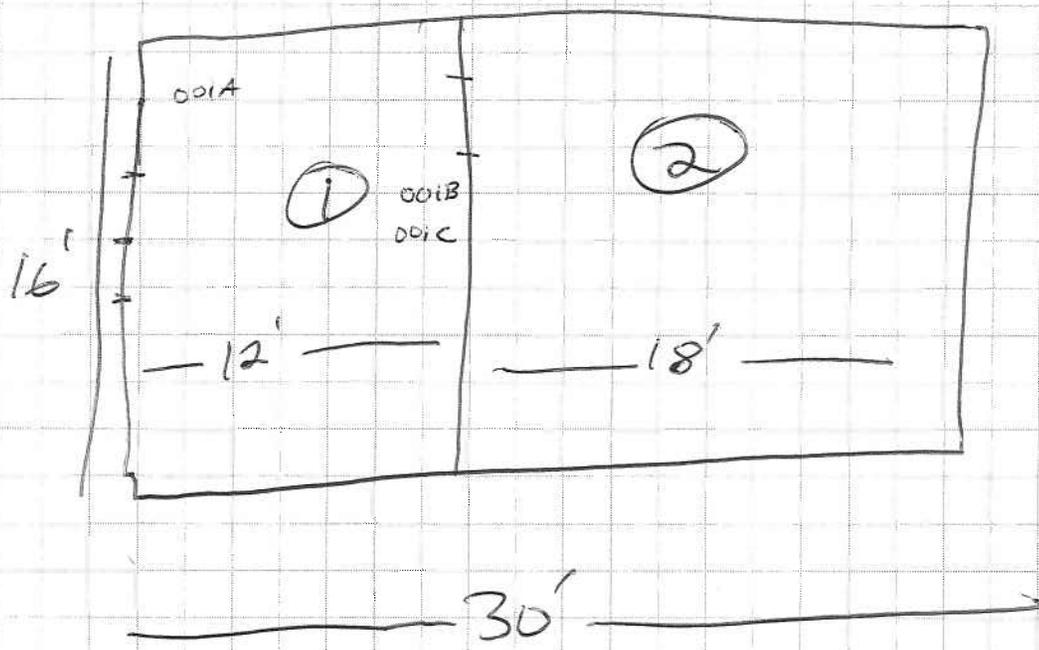
MATERIAL NUMBER	MATERIAL TYPE	MATERIAL DESCRIPTION	ANALYTICAL RESULTS
001	CEILING PLASTER	WHITE	Negative for Asbestos

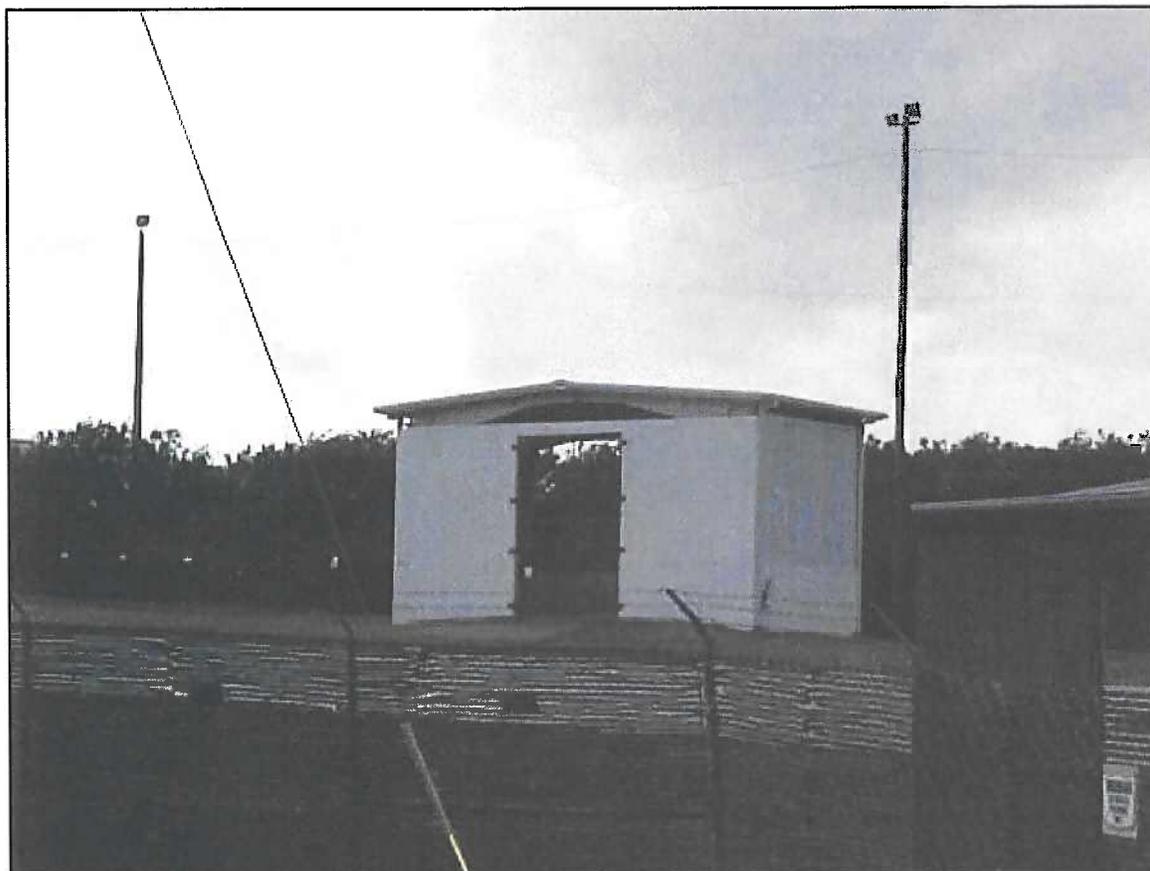
BUILDING 2435

Building 2435 is identified as “SPNT Lead Acid Bat Stge DRMO” and is approximately 800 square feet in size. No suspect materials were identified. Therefore, no sampling was conducted.

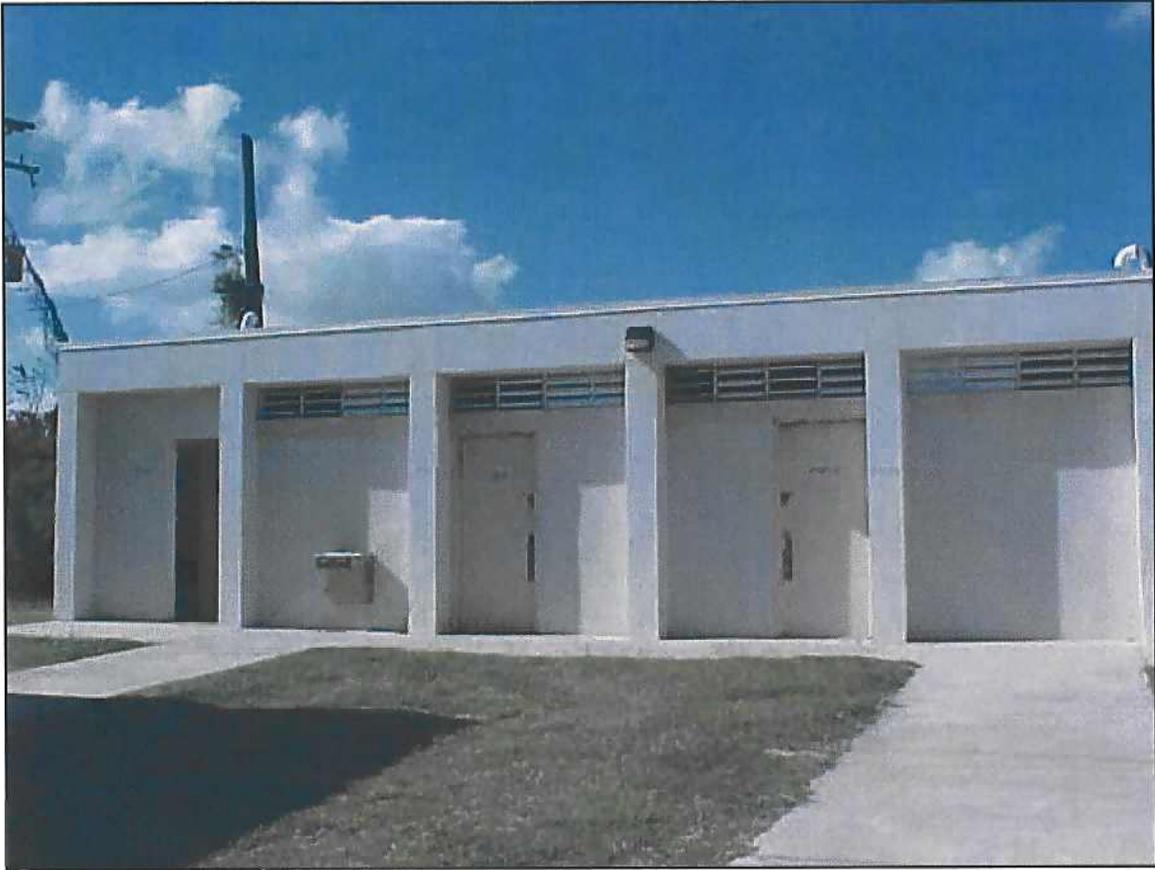
BUILDING 2440

Building 2440 is identified as “EM Beach Heads (All Hands)” and is approximately 1,778 square feet in size. No suspect materials were identified. Therefore, no sampling was conducted.

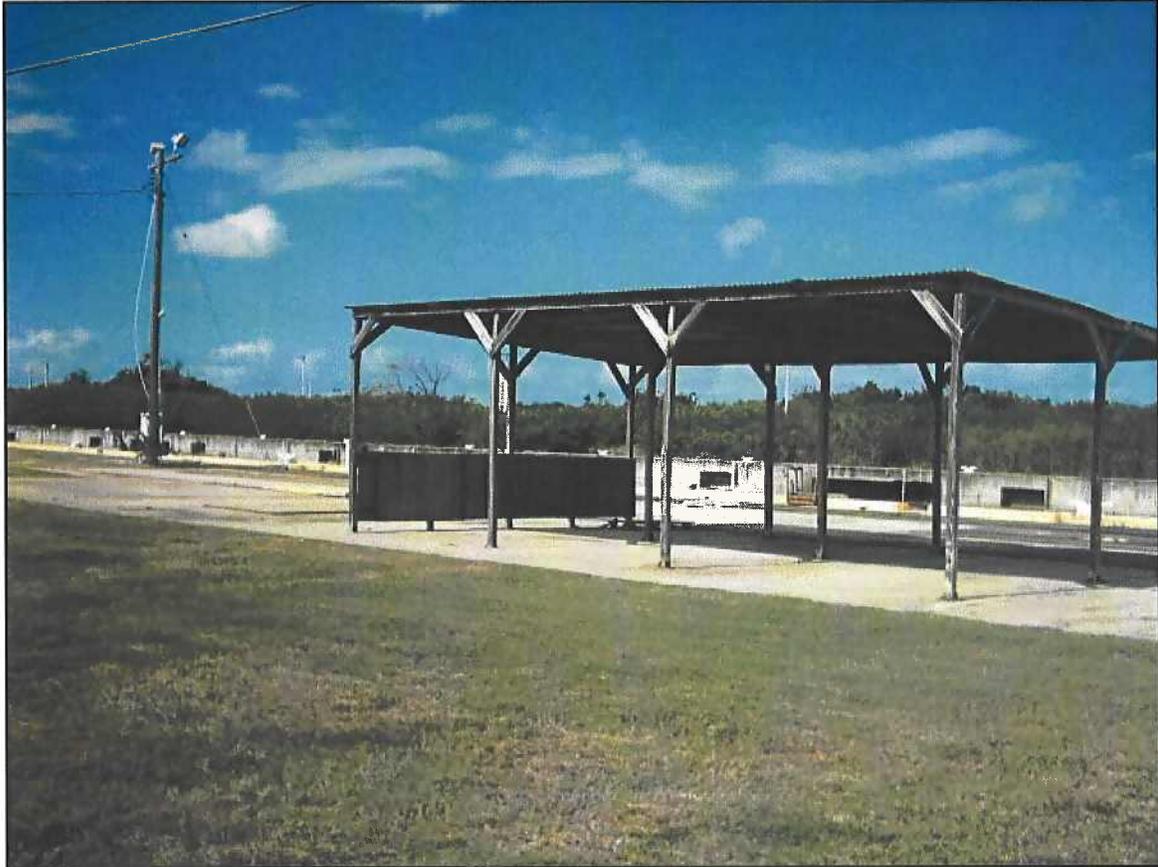
BUILDING 2449

Building 2449 is identified as “Boat Maint Sheds-Sqdn 2” and is approximately 3,478 square feet in size. No suspect materials were identified. Therefore, no sampling was conducted.

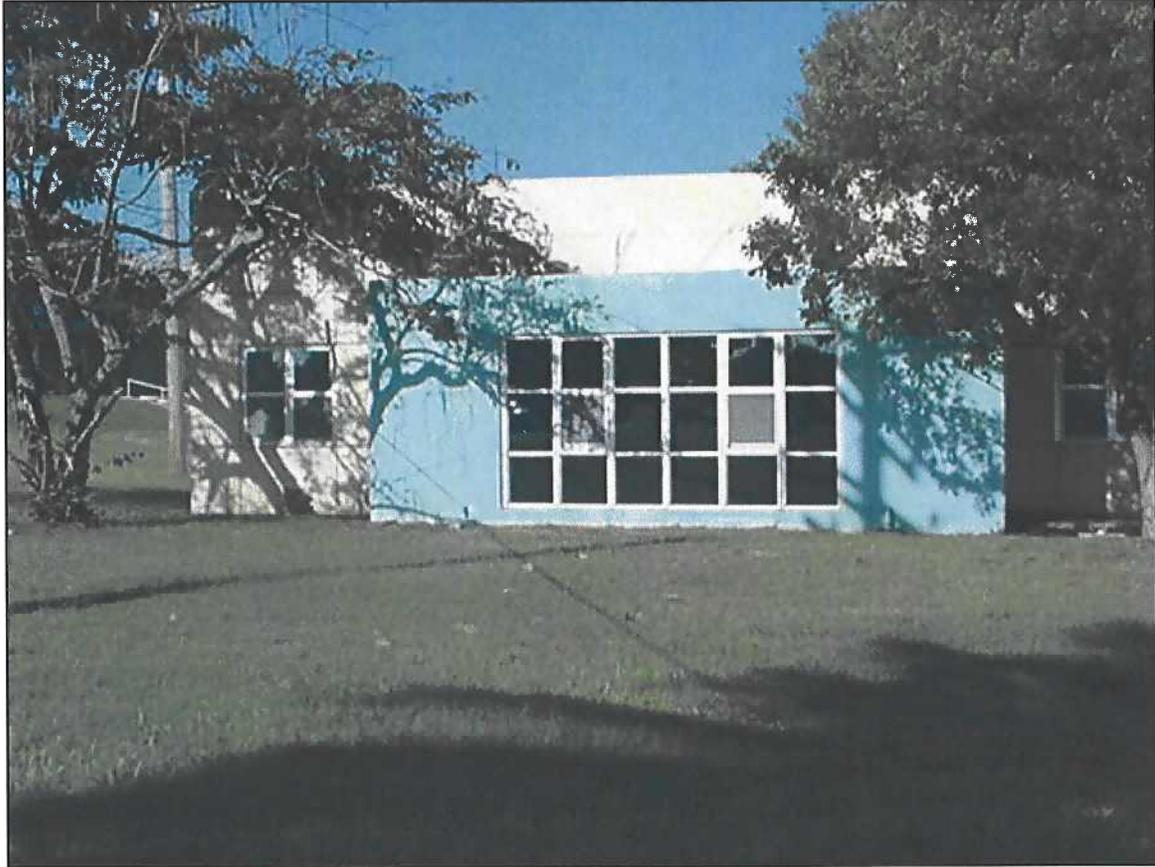
BUILDING 2450

Building 2450 is identified as “Wellness Center” and is approximately 3,000 square feet in size. Seven suspect homogeneous materials were identified and sampled. None of these materials were found to be ACM.

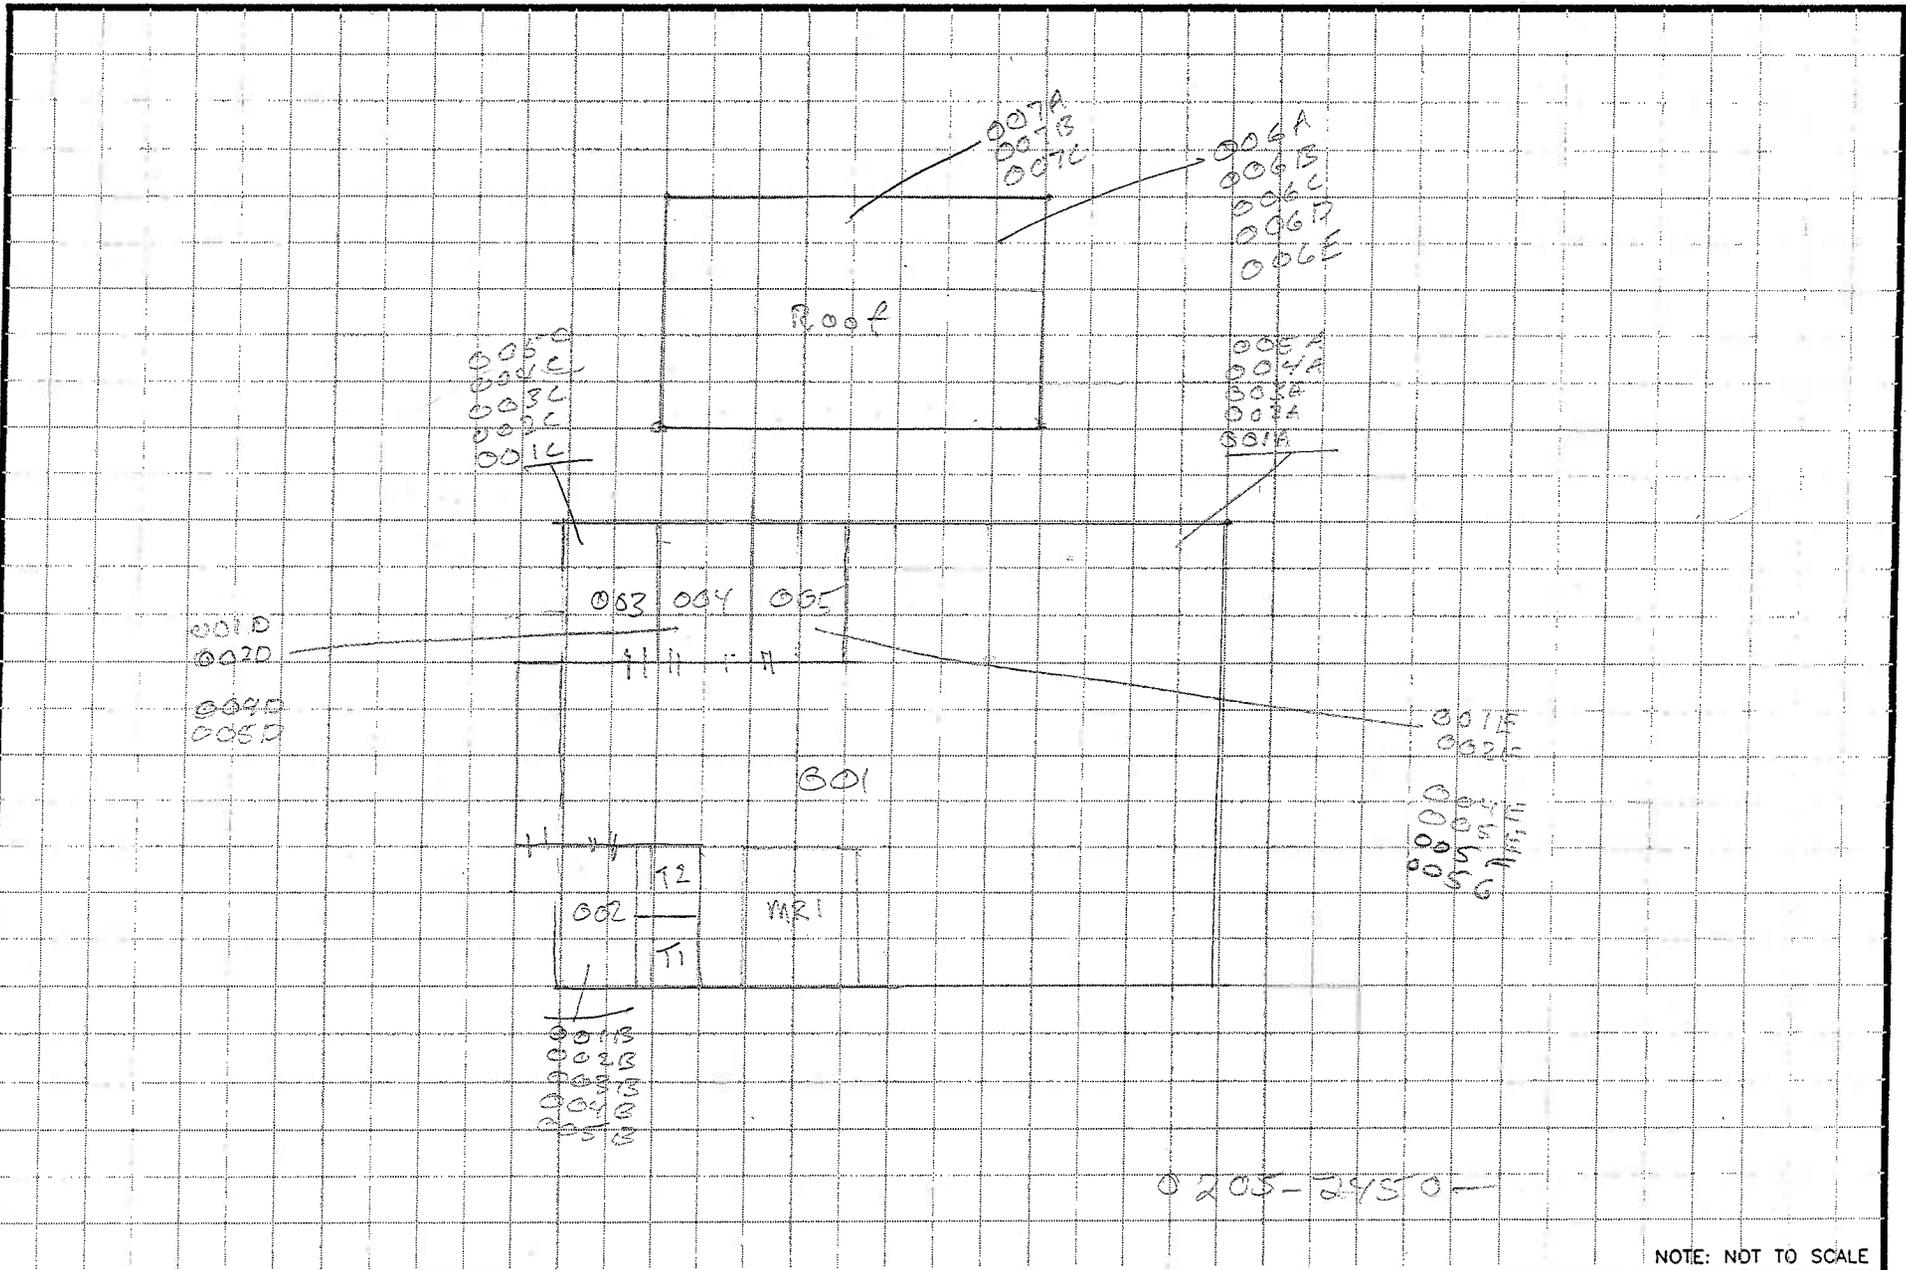
MATERIAL NUMBER	MATERIAL TYPE	MATERIAL DESCRIPTION	ANALYTICAL RESULTS
001	VINYL FLOOR TILE	1' X 1' WHITE WITH GRAY	Negative for Asbestos
002	FLOOR ADHESIVE	TAN, UNDER 001	Negative for Asbestos
003	COVE BASE ADHESIVE	TAN, UNDER GRAY 4" COVE BASE	Negative for Asbestos
004	CEILING TILES	2' X 2' SMOOTH, SUSPENDED	Negative for Asbestos
005	WALLBOARD	1/2" THICK, TAN PAPER, WHITE CORE, WHITE JOINT COMPOUND	Negative for Asbestos
006	ASPHALTIC ROOFING MATERIALS	ASPHALTIC ROLLED WITH WHITE STONE	Negative for Asbestos
007	ASPHALTIC ROOFING MATERIALS	ASPHALTIC FLASHING, FOIL FACED	Negative for Asbestos

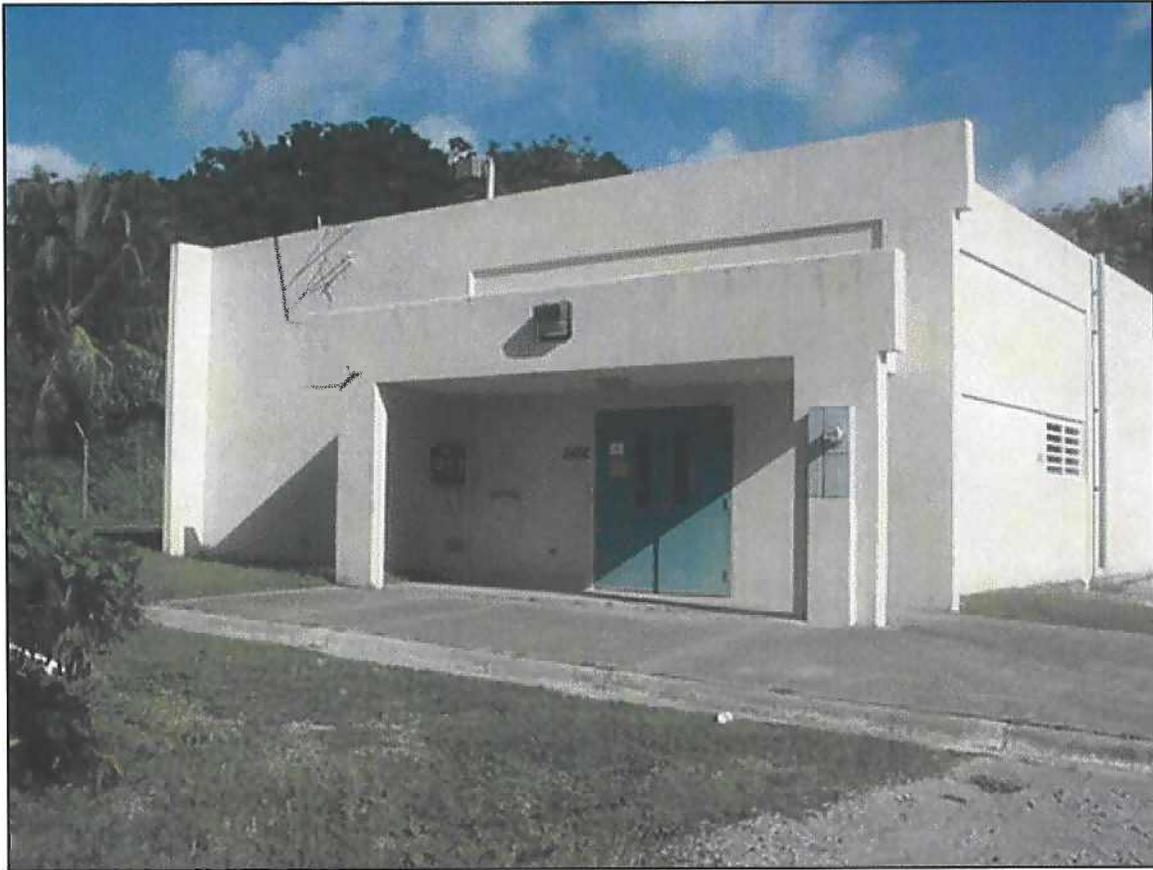
BUILDING 2452

Building 2452 is identified as “Admin Bldg by MK-30 Arfld A” and is approximately 4,000 square feet in size. Six suspect homogeneous materials were identified and sampled. None of these materials were found to be ACM.

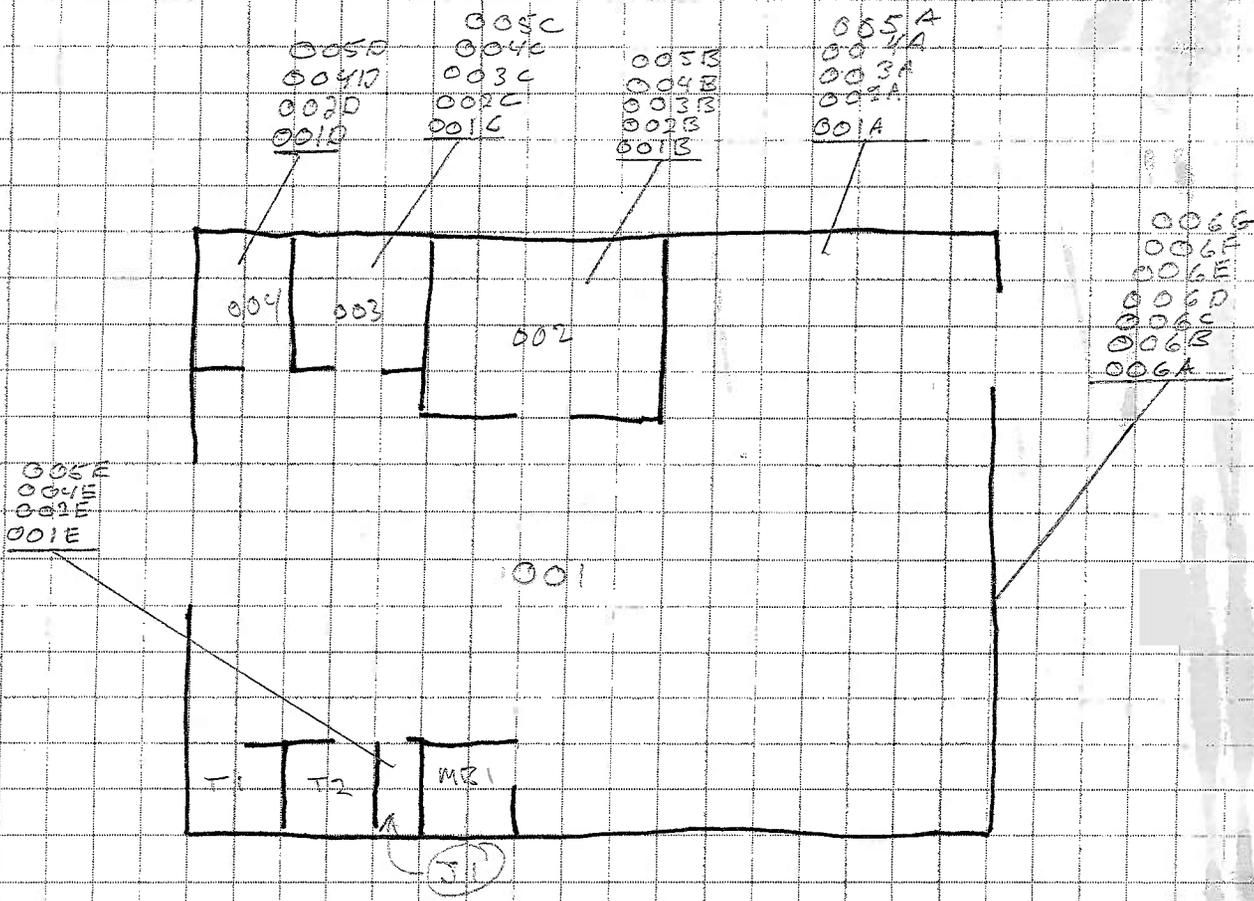
0205-2452-

MATERIAL NUMBER	MATERIAL TYPE	MATERIAL DESCRIPTION	ANALYTICAL RESULTS
001	VINYL FLOOR TILE	1' X 1' GREEN MOTTLE	Negative for Asbestos
002	FLOOR ADHESIVE	TAN, UNDER 001	Negative for Asbestos
003	COVE BASE ADHESIVE	TAN, UNDER GREEN 4" COVE BASE	Negative for Asbestos
004	CEILING TILES	2' X 4' PINHOLE, GOUGED, SUSPENDED	Negative for Asbestos
005	WALLBOARD	1/2" THICK, TAN PAPER, WHITE CORE, WITH WHITE JOINT COMPOUND	Negative for Asbestos
006	EXTERIOR PLASTERS	EXTERIOR SPRAY-ON COAT, 1/8" THICK	Negative for Asbestos

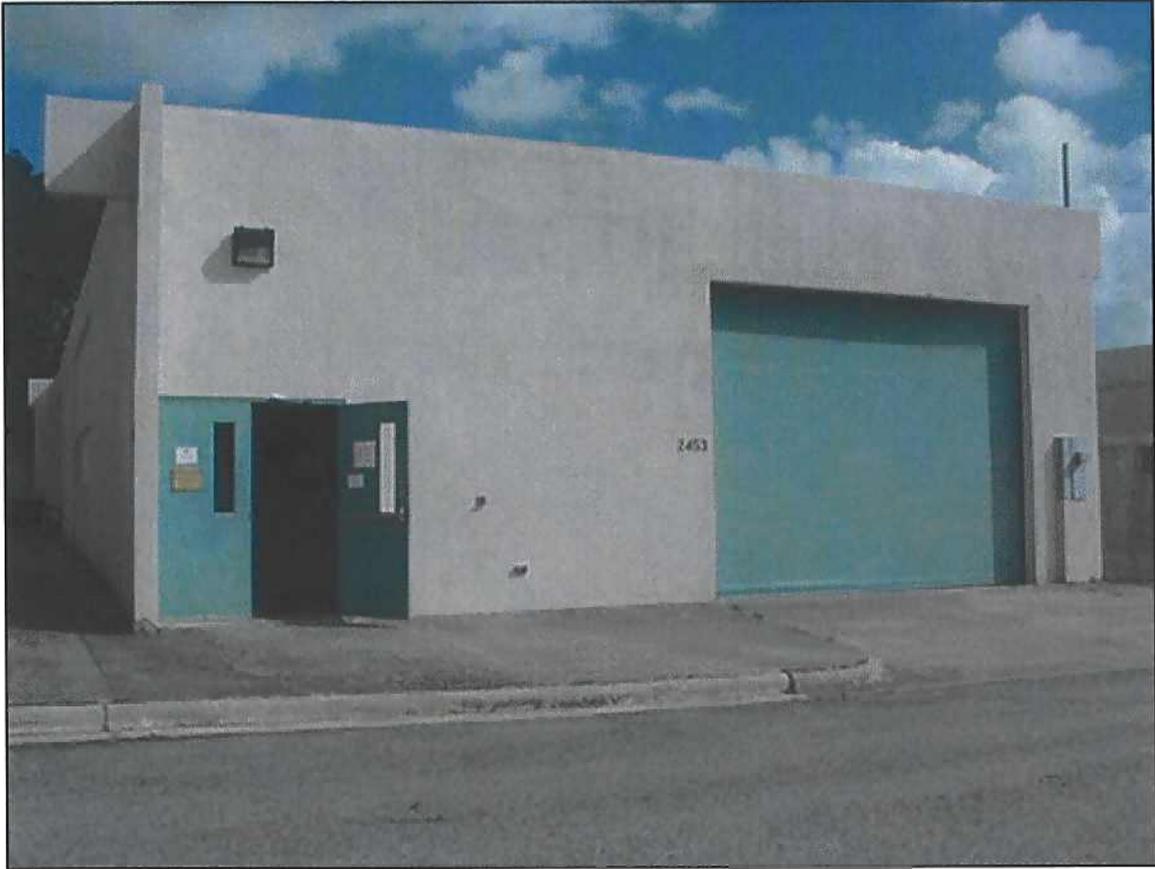
BUILDING 2453

Building 2453 is identified as “Maint Bldg by MK30 at Arfld” and is approximately 4,000 square feet in size. Three suspect homogeneous materials were identified and sampled. None of these materials were found to be ACM.

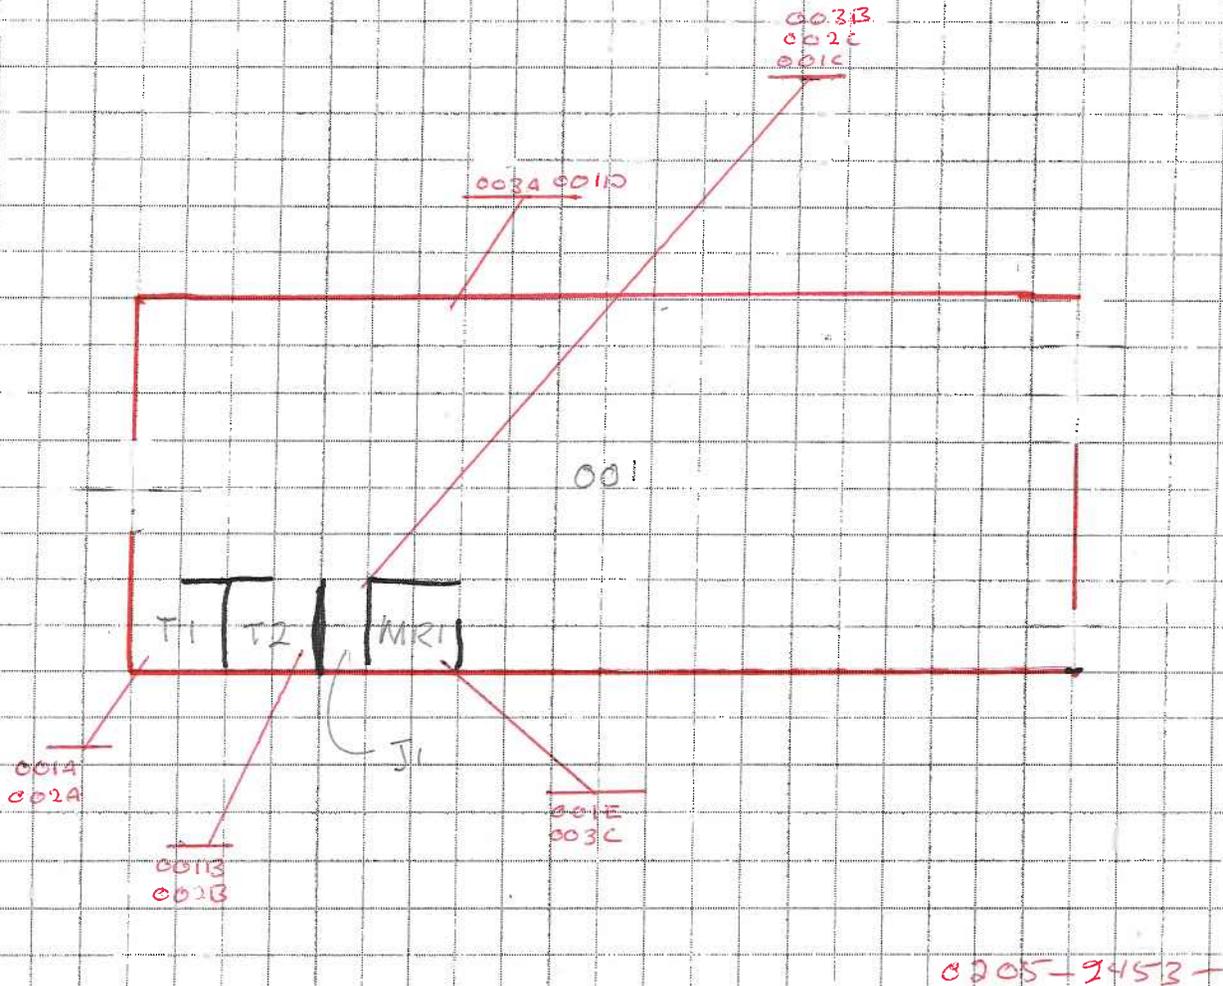
MATERIAL NUMBER	MATERIAL TYPE	MATERIAL DESCRIPTION	ANALYTICAL RESULTS
001	WALLBOARD	1/2" THICK, GREEN PAPER, WHITE CORE, WITH WHITE JOINT COMPOUND	Negative for Asbestos
002	CEILING TILES	2' X 4' PINHOLE, GOUGED, SUSPENDED	Negative for Asbestos
003	COVE BASE ADHESIVE	TAN, UNDER GREEN 4" COVE BASE	Negative for Asbestos

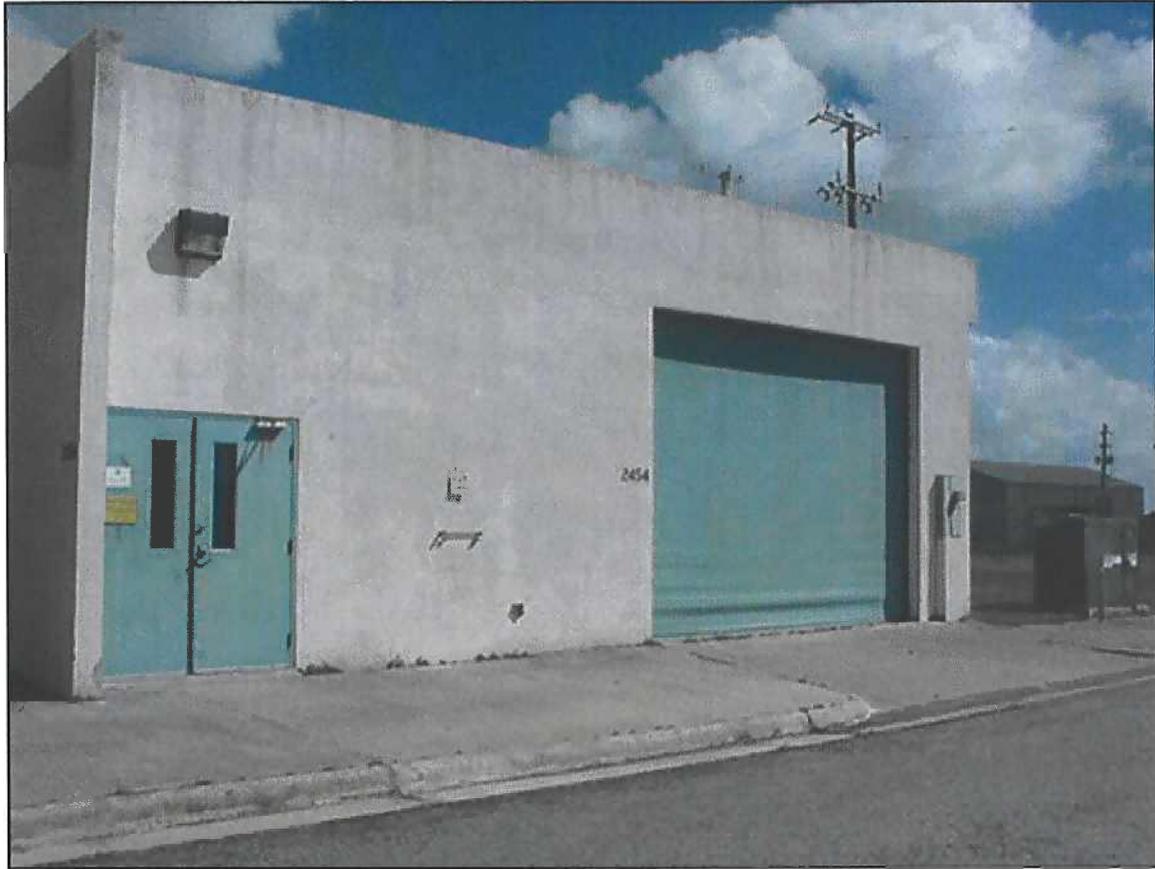
BUILDING 2454

Building 2454 is identified as “Whse Bldg by MK-30 at Arfld” and is approximately 4,000 square feet in size. Four suspect homogeneous materials were identified and sampled. None of these materials were found to be ACM.

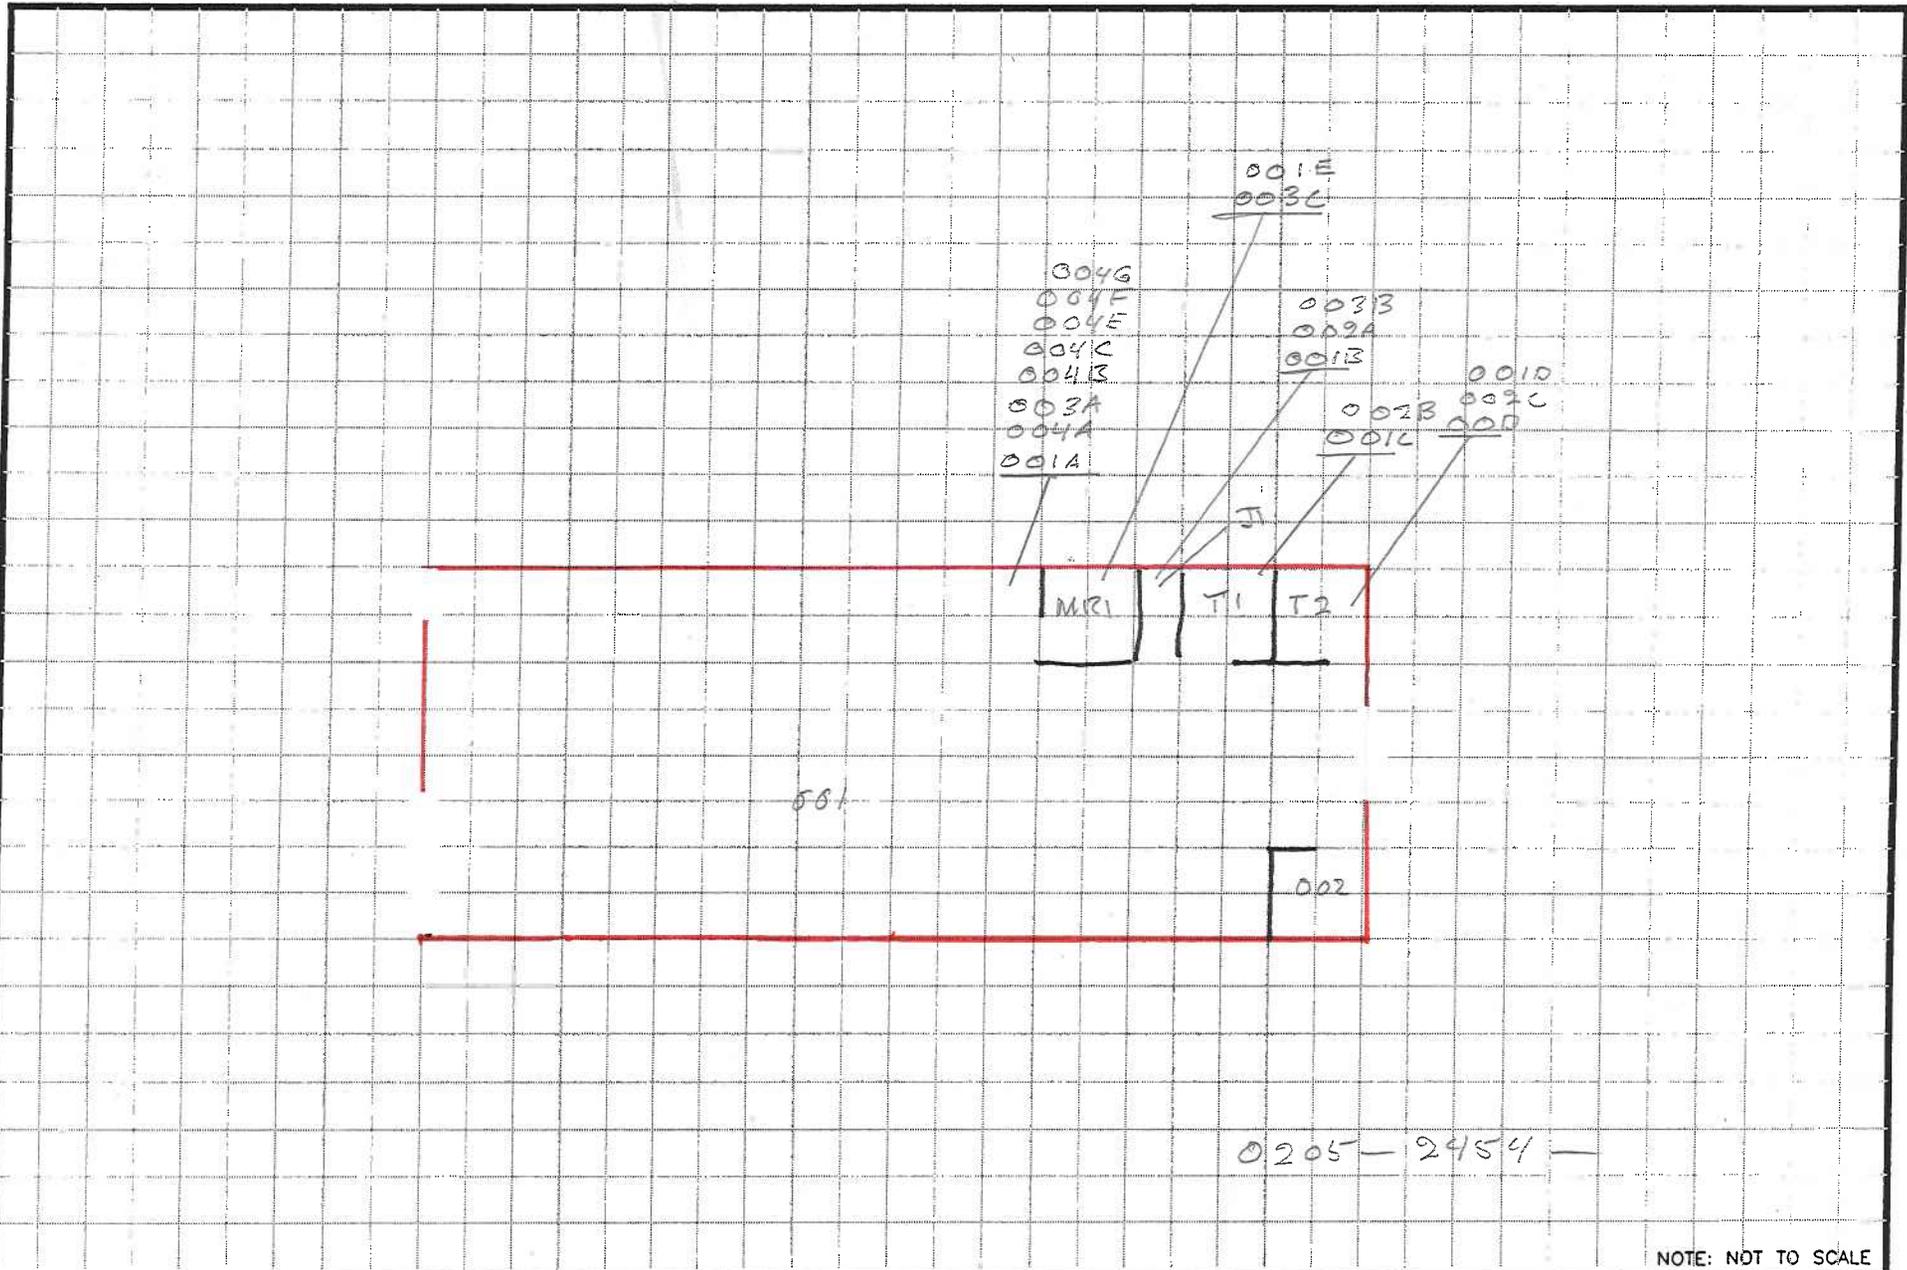
MATERIAL NUMBER	MATERIAL TYPE	MATERIAL DESCRIPTION	ANALYTICAL RESULTS
001	WALLBOARD	1/2" THICK, GREEN PAPER, WHITE CORE, WITH WHITE JOINT COMPOUND	Negative for Asbestos
002	CEILING TILES	2' X 4' PINHOLE, GOUGED, SUSPENDED	Negative for Asbestos
003	COVE BASE ADHESIVE	TAN, UNDER GREEN 4" COVE BASE	Negative for Asbestos
004	CEILING ROUGH FINISH	SPRAY-ON COATING, ROUGH	Negative for Asbestos

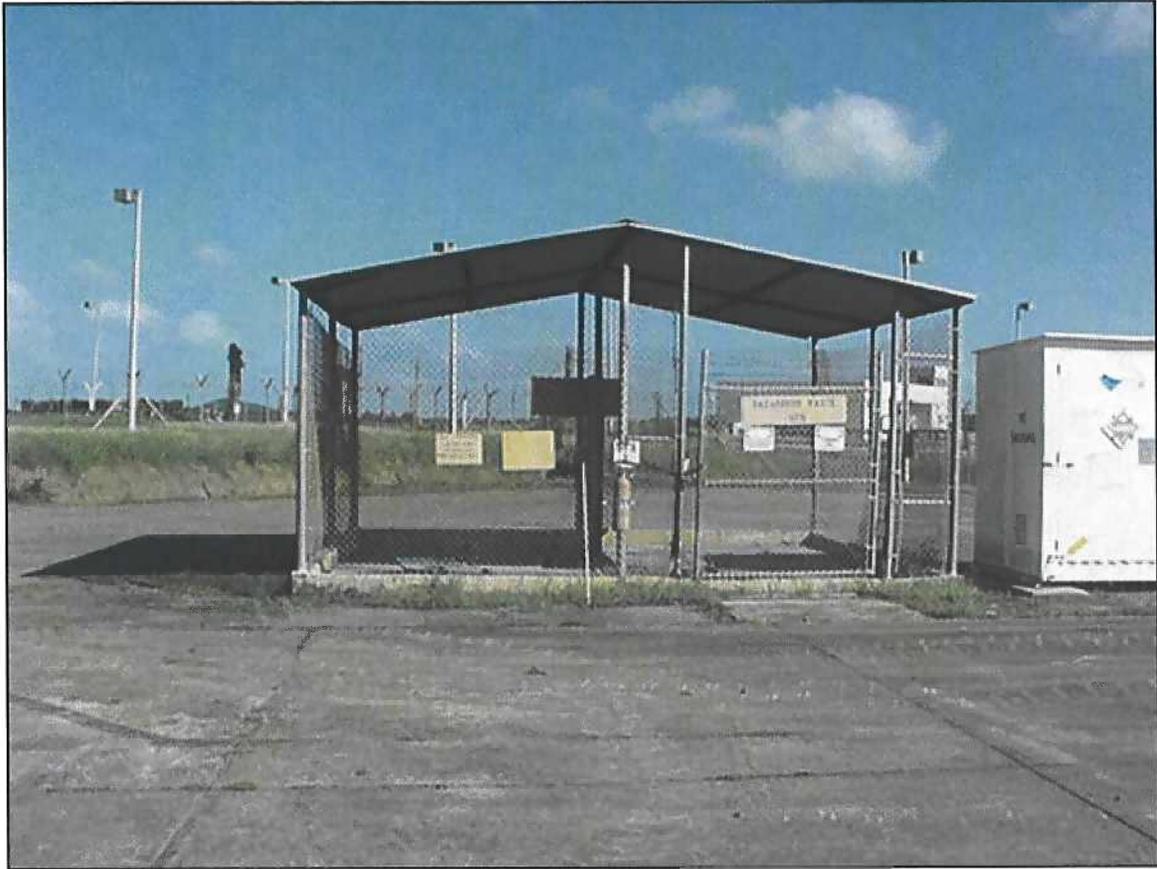
BUILDING 2457

Building 2457 is identified as “Haz Flamm Stge AIMD” and is approximately 228 square feet in size. No suspect materials were identified. Therefore, no sampling was conducted.
