Final
Asbestos Inspection Report
for

Naval Activity Puerto Rico
Ceiba, Puerto Rico

Volume 6 of 7

Buildings 2342 through 2684

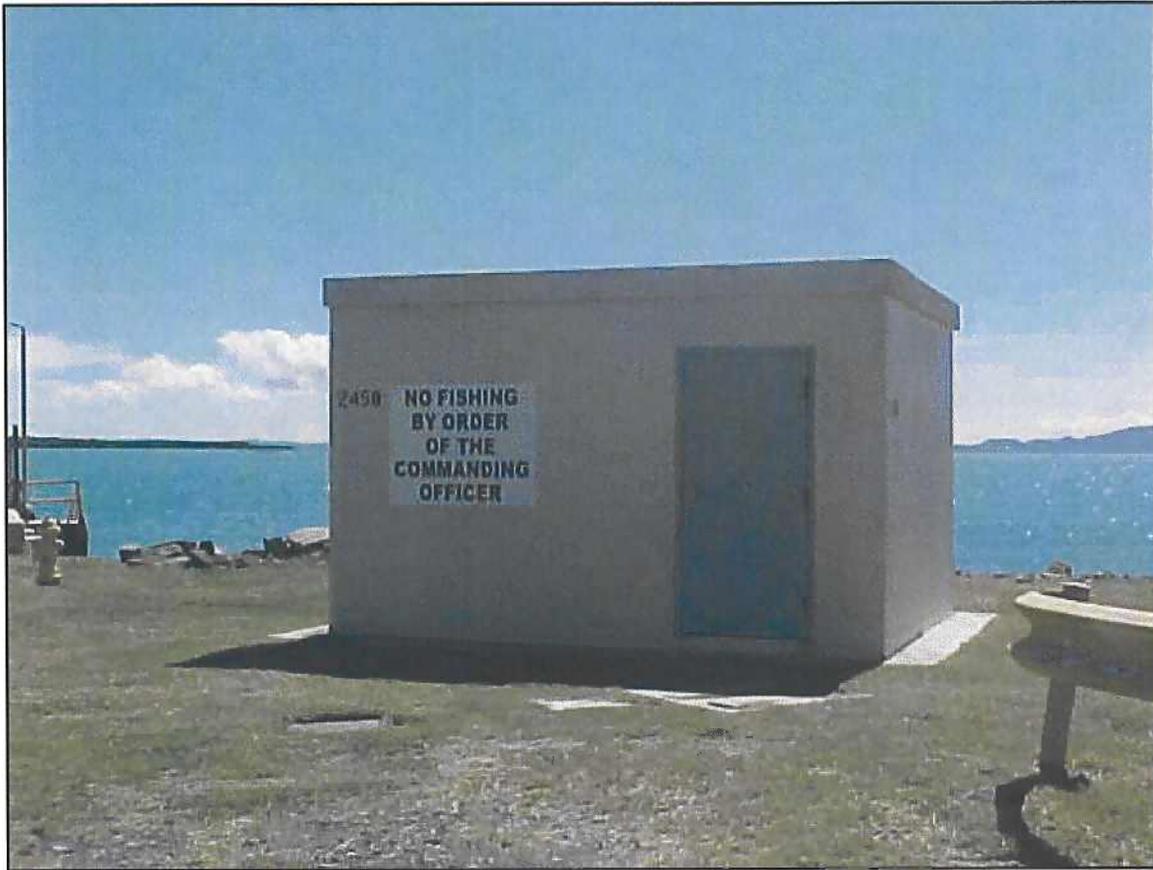
BUILDING 2458

Building 2458 is identified as “Pump Station” and is approximately 168 square feet in size. No suspect materials were identified. Therefore, no sampling was conducted.

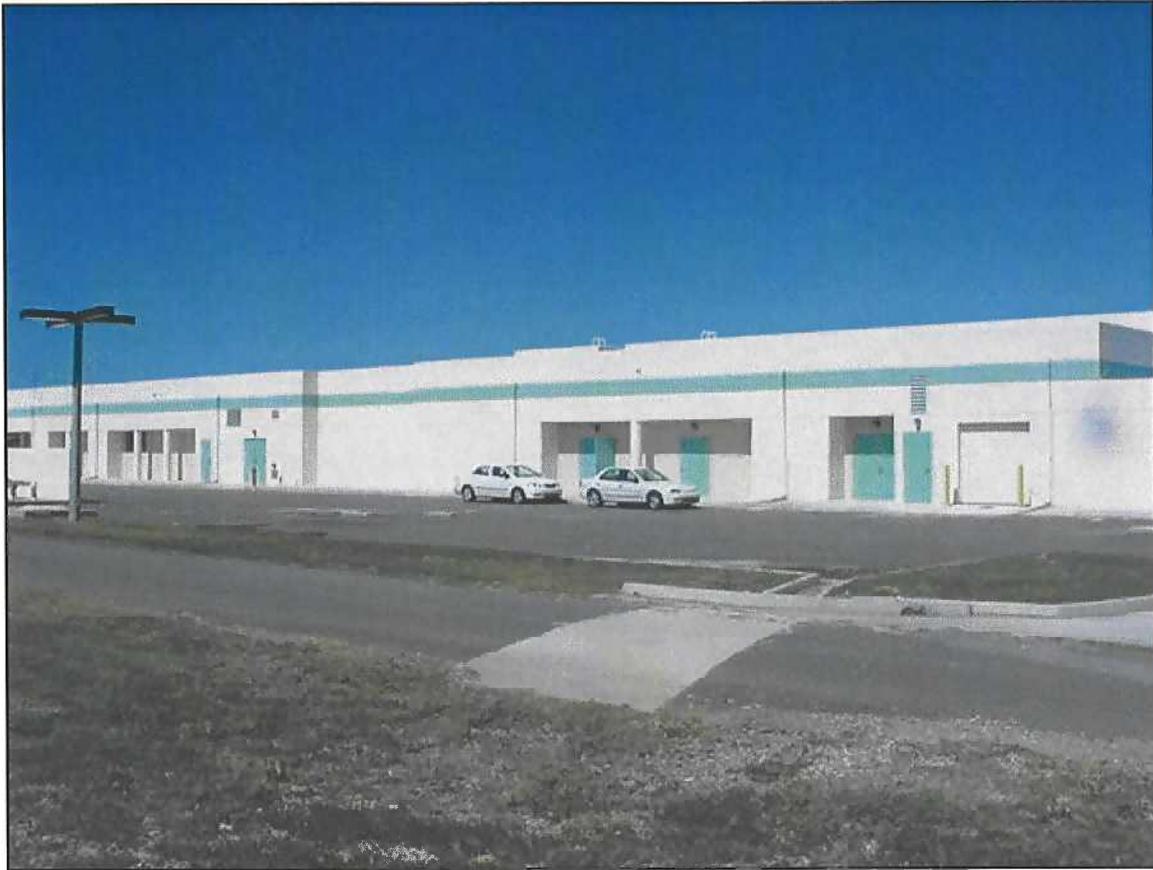
BUILDING 2468

Building 2468 is identified as “NSWU-4 Headquarters” and is approximately 26,880 square feet in size. Twelve suspect homogeneous materials were identified and sampled. None of the materials were found to be ACM.

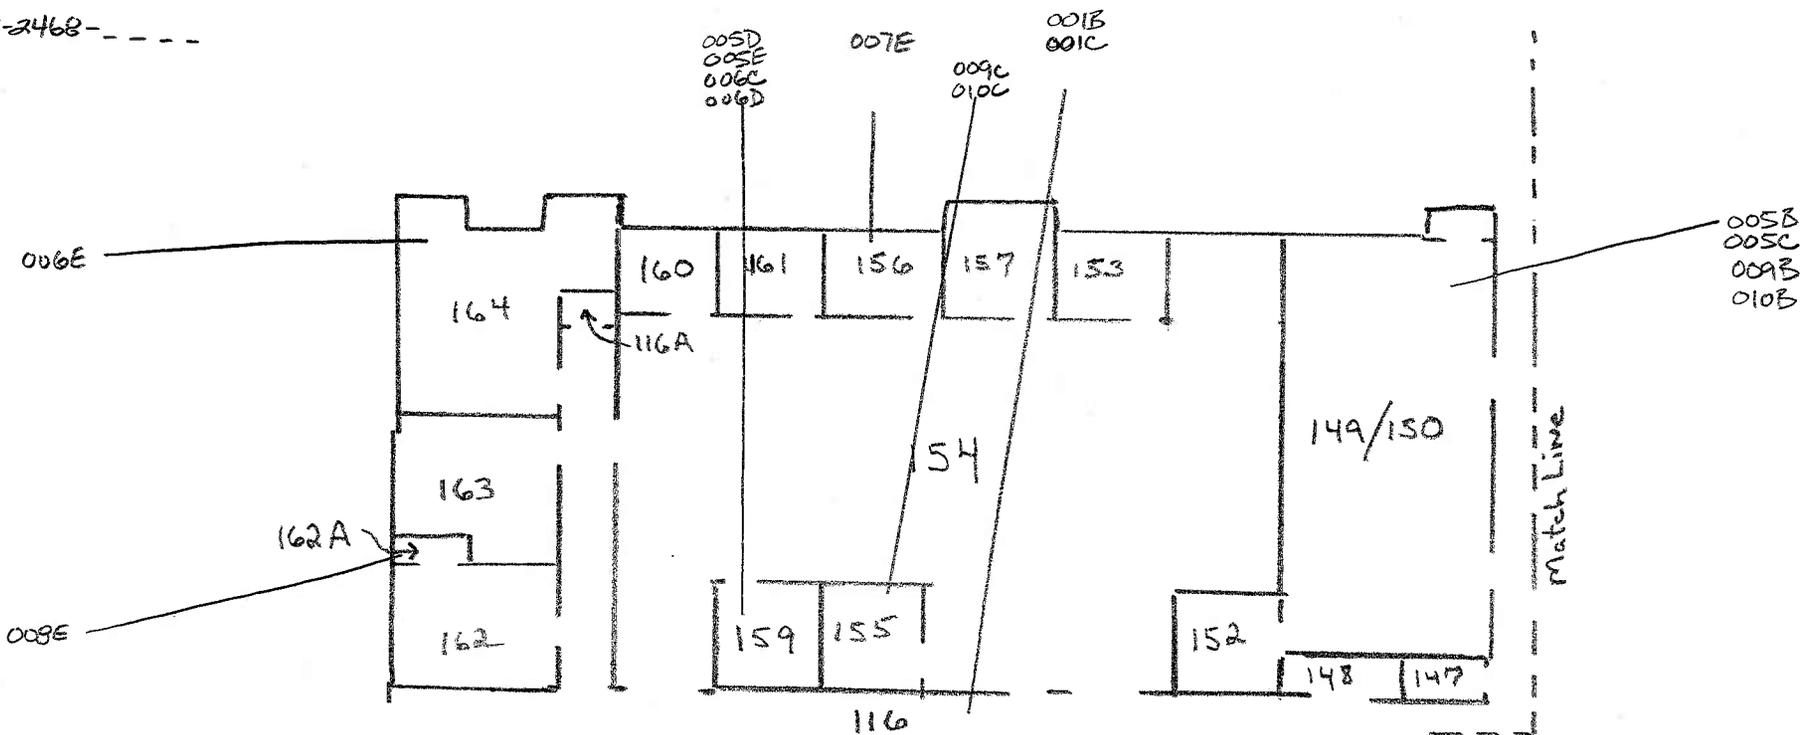
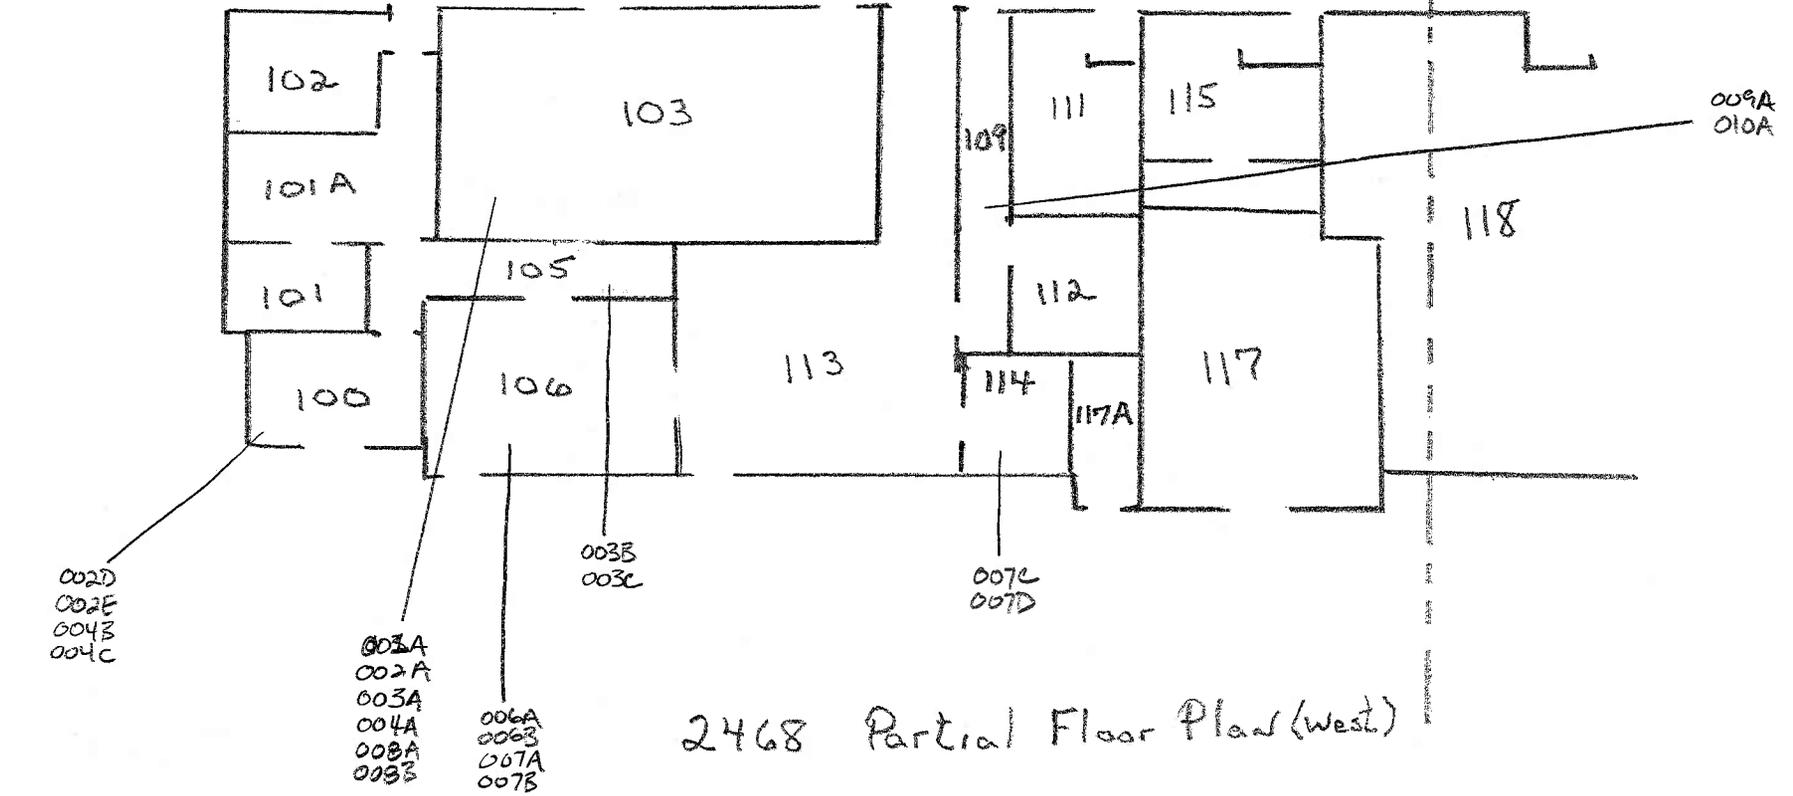
2468 Partial Floor Plan (west)

MATERIAL NUMBER	MATERIAL TYPE	MATERIAL DESCRIPTION	ANALYTICAL RESULTS
001	VINYL FLOOR TILE	1' X 1' GREEN	Negative for Asbestos
002	VINYL FLOOR TILE	1' X 1' GREY	Negative for Asbestos
003	VINYL FLOOR TILE	1' X 1' BLUE	Negative for Asbestos
004	FLOOR ADHESIVE	YELLOW, UNDER 1' X 1' GREEN, 1' X 1' GREY, AND 1' X 1' BLUE VINYL FLOOR TILES	Negative for Asbestos
005	COVE BASE ADHESIVE	WHITE, UNDER 4" GREY RUBBER COVE BASE	Negative for Asbestos
006	CEILING TILES	2' X 2' WHITE, PINHOLE, SUSPENDED	Negative for Asbestos
007	FLOOR ADHESIVE	YELLOW, UNDER BLUE WITH GREEN CARPET	Negative for Asbestos
008	CEILING TILES	2' X 2' WHITE, PINHOLE AND FISSURED, SUSPENDED	Negative for Asbestos
009	VINYL FLOOR TILE	2' X 2' WHITE WITH BLUE	Negative for Asbestos
010	FLOOR ADHESIVE	BLACK, UNDER 2' X 2' WHITE WITH BLUE VINYL FLOOR TILE	Negative for Asbestos
011	ASPHALTIC ROOFING MATERIALS	BLACK	Negative for Asbestos
012	ASPHALTIC ROOFING MATERIALS	FLASHING, SILVER COVER, BLACK CORE	Negative for Asbestos

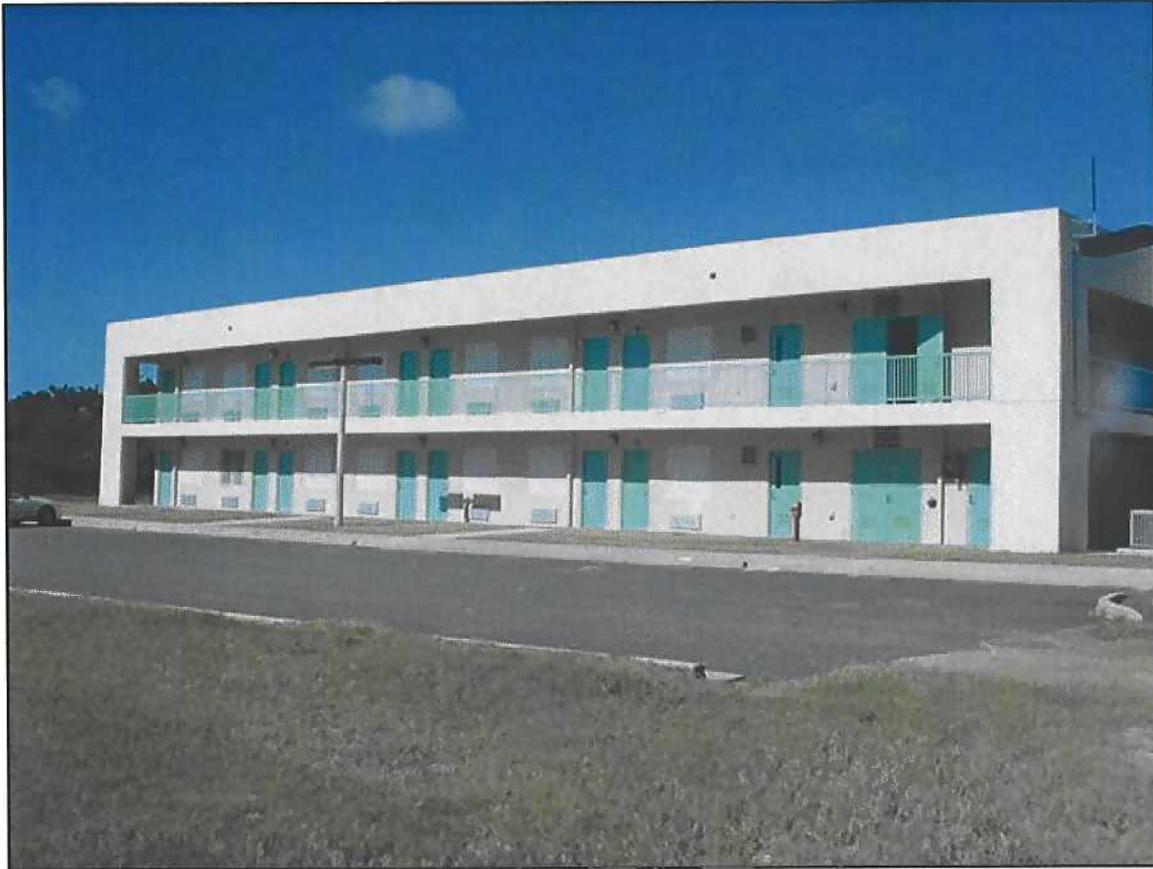
BUILDING 2469

Building 2469 is identified as “NSWU-4 Isolation Facility” and is approximately 8,448 square feet in size. Nine suspect homogeneous materials were identified and sampled. None of the materials were found to be ACM.

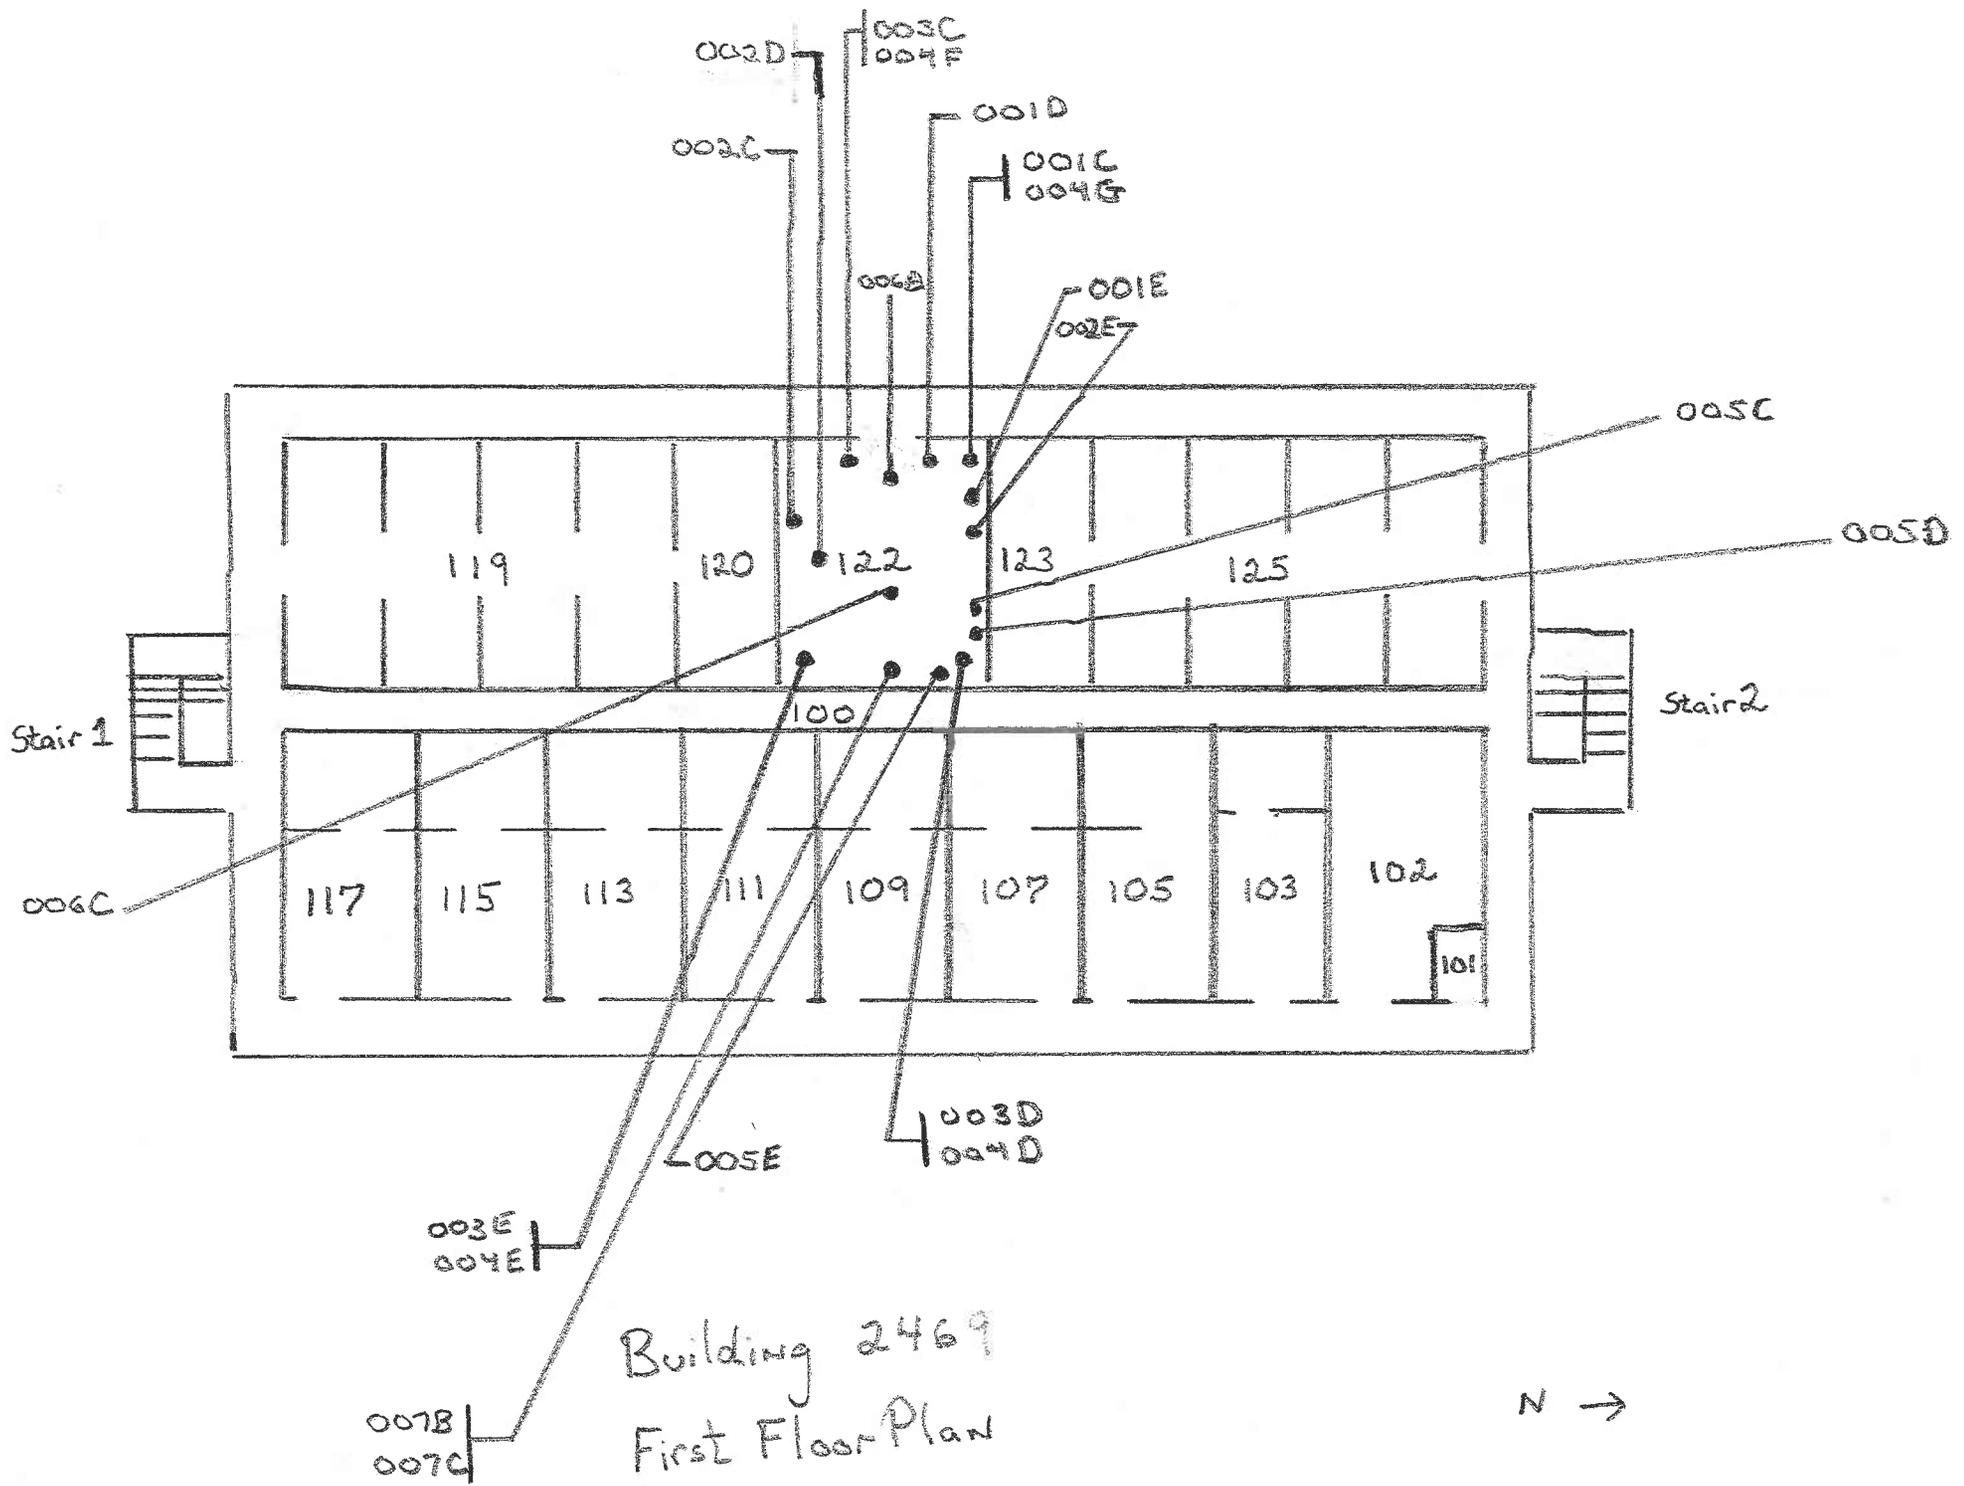
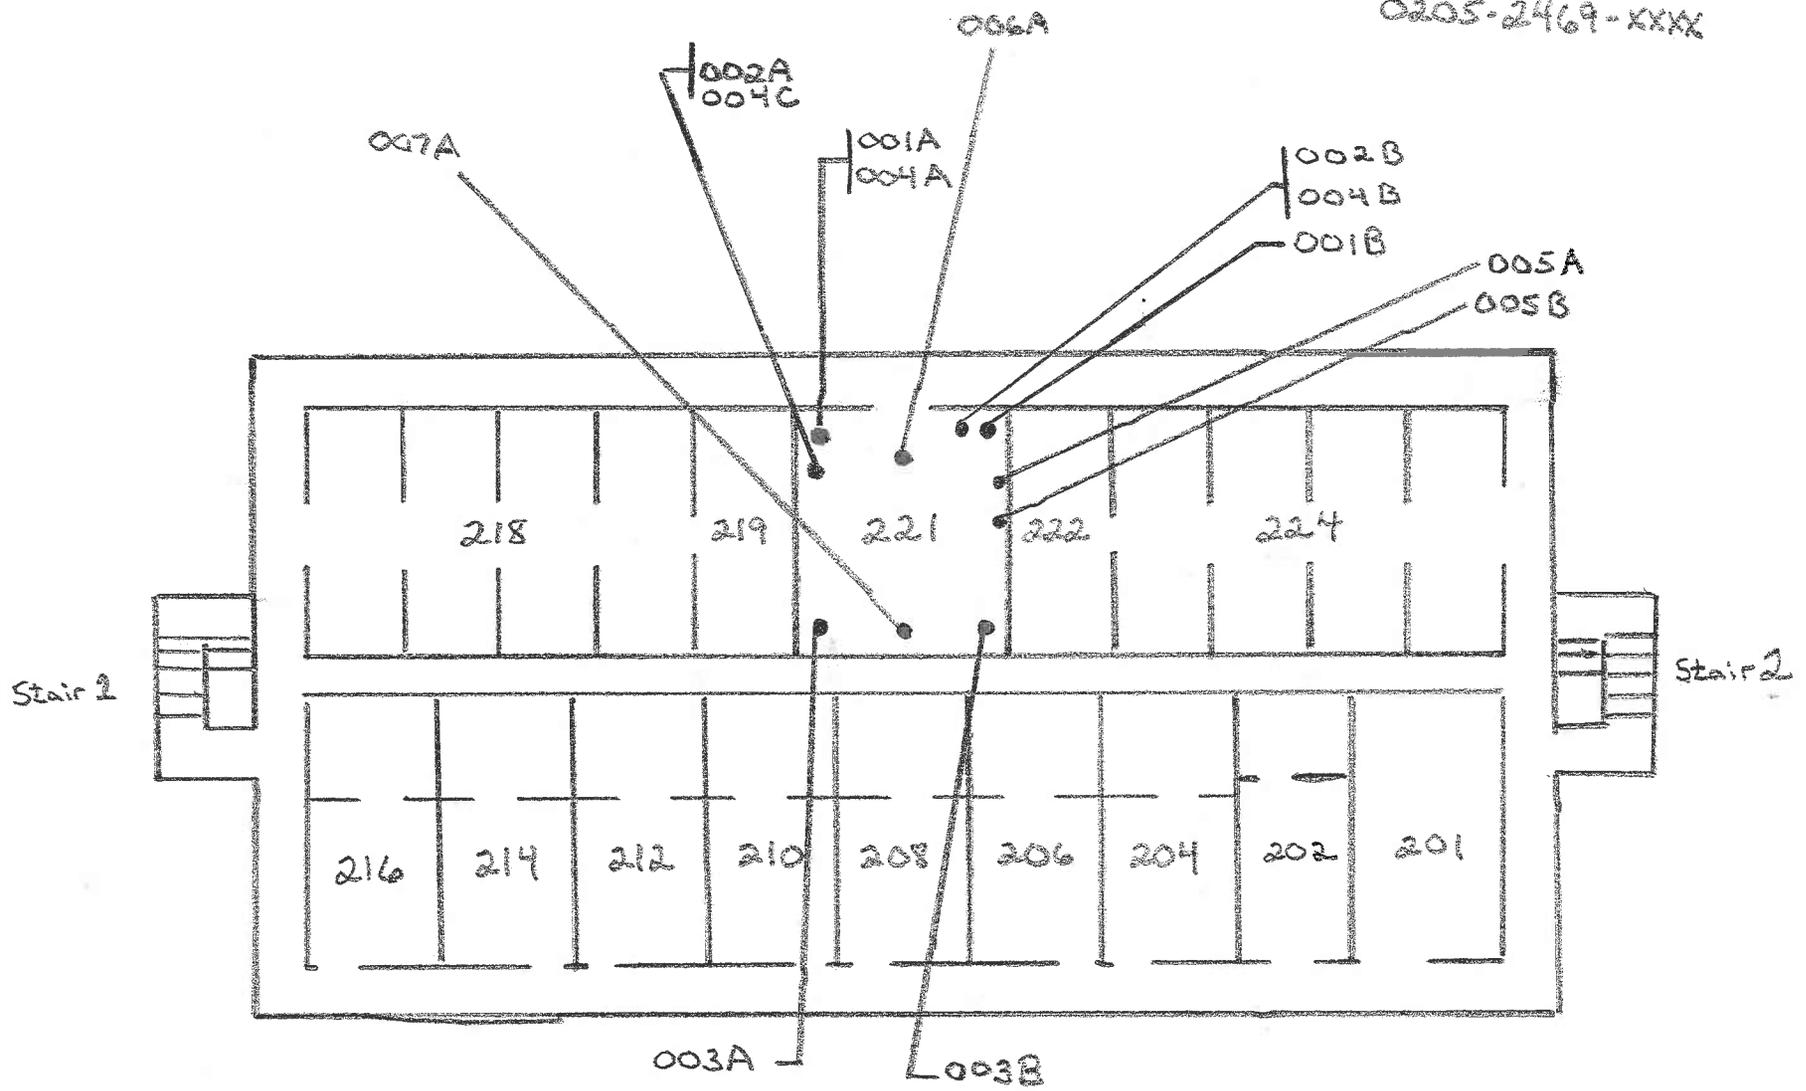
Building 2469
Second Floor Plan

MATERIAL NUMBER	MATERIAL TYPE	MATERIAL DESCRIPTION	ANALYTICAL RESULTS
001	VINYL FLOOR TILE	1' X 1' GREEN	Negative for Asbestos
002	VINYL FLOOR TILE	1' X 1' GREY	Negative for Asbestos
003	VINYL FLOOR TILE	1' X 1' BLUE	Negative for Asbestos
004	FLOOR ADHESIVE	YELLOW, UNDER 1' X 1' GREEN, 1' X 1' GREY, AND 1' X 1' BLUE VINYL FLOOR TILE	Negative for Asbestos
005	COVE BASE ADHESIVE	WHITE, UNDER 4" GREY RUBBER COVE BASE	Negative for Asbestos
006	CEILING TILES	2' X 2' WHITE, PINHOLE AND FISSURED	Negative for Asbestos
007	SINK COATING	BLACK	Negative for Asbestos
008	ASPHALTIC ROOFING MATERIALS	BLACK	Negative for Asbestos
009	ASPHALTIC ROOFING MATERIALS	FLASHING, FOIL SILVER COVER, BLACK CORE	Negative for Asbestos

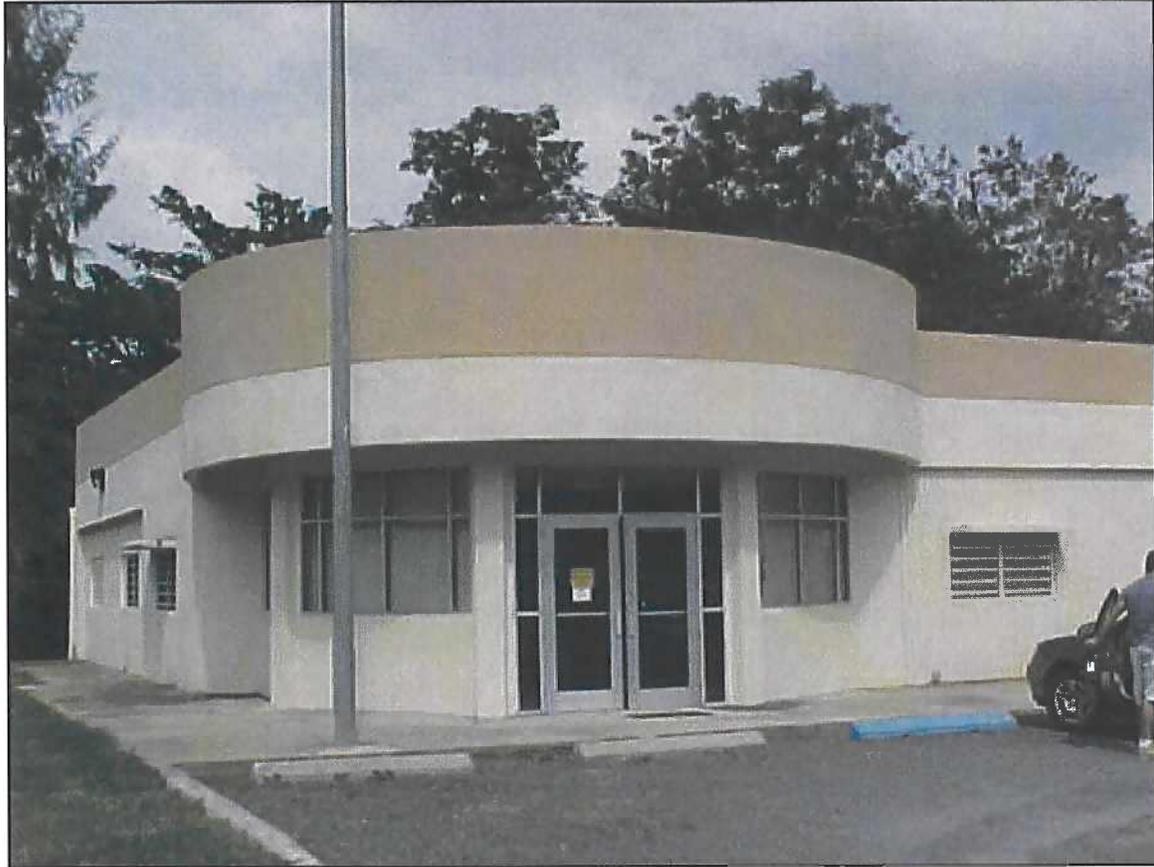
BUILDING 2474

Building 2474 is identified as “Zoonosis Control” and is approximately 3,120 square feet in size. Two suspect homogeneous materials were identified and sampled. Neither of these materials was found to be ACM.

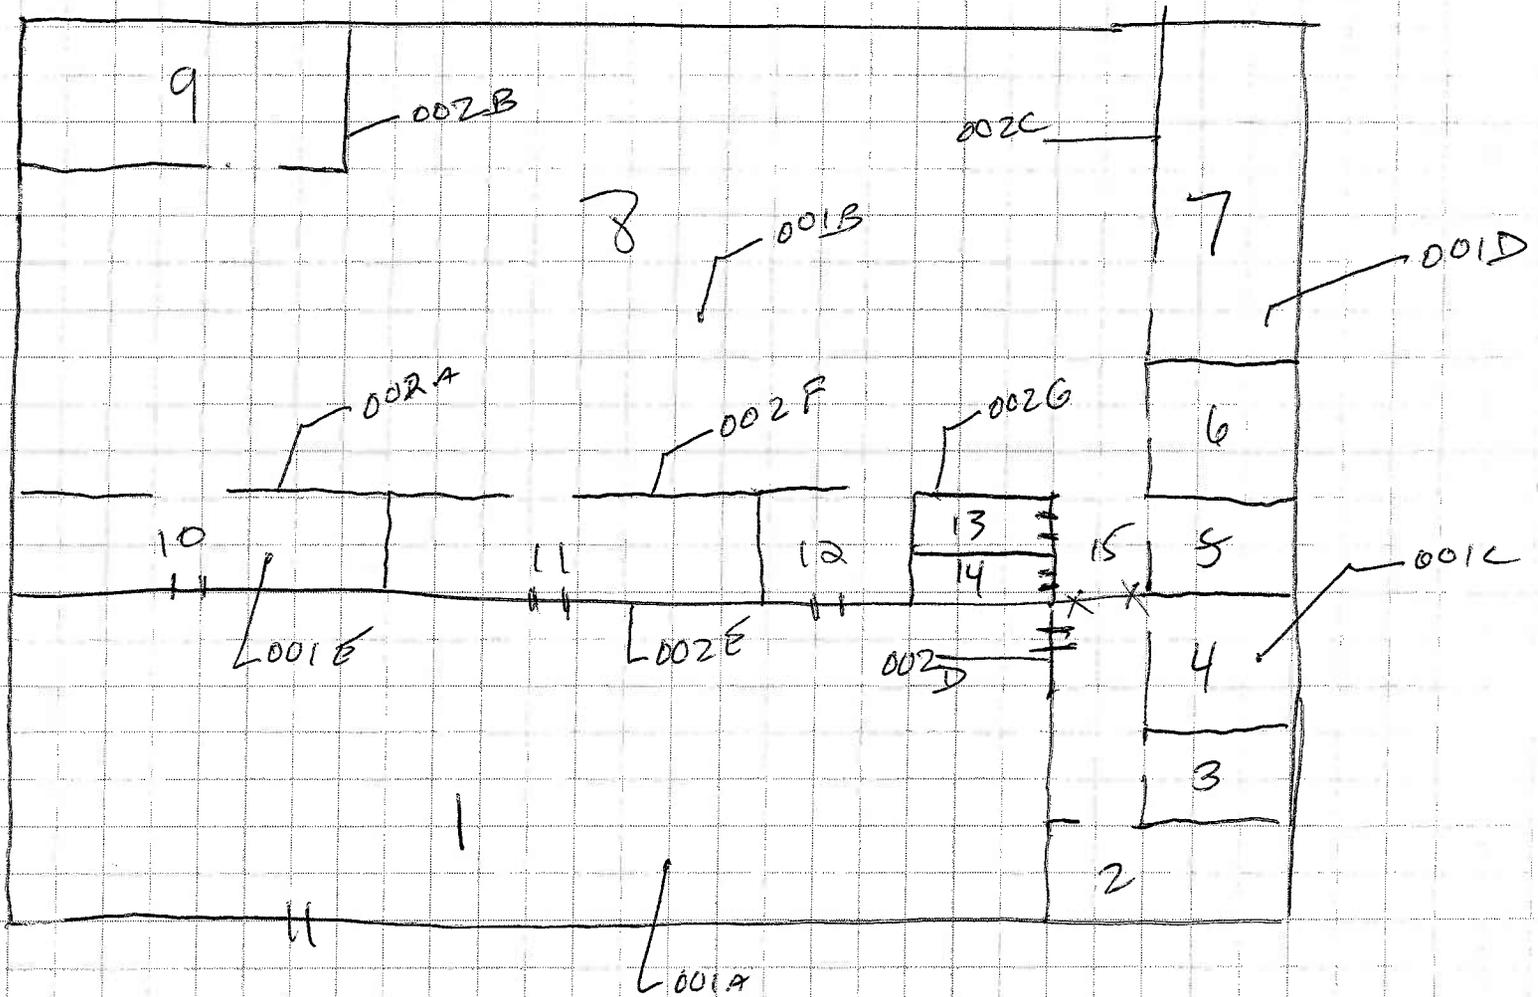
0205-2474

MATERIAL NUMBER	MATERIAL TYPE	MATERIAL DESCRIPTION	ANALYTICAL RESULTS
001	CEILING TILES	2'X2' WHITE, PINHOLE, SUSPENDED	Negative for Asbestos
002	WALLBOARD	1/4" THICK, GRAY PAPER, WHITE CORE	Negative for Asbestos

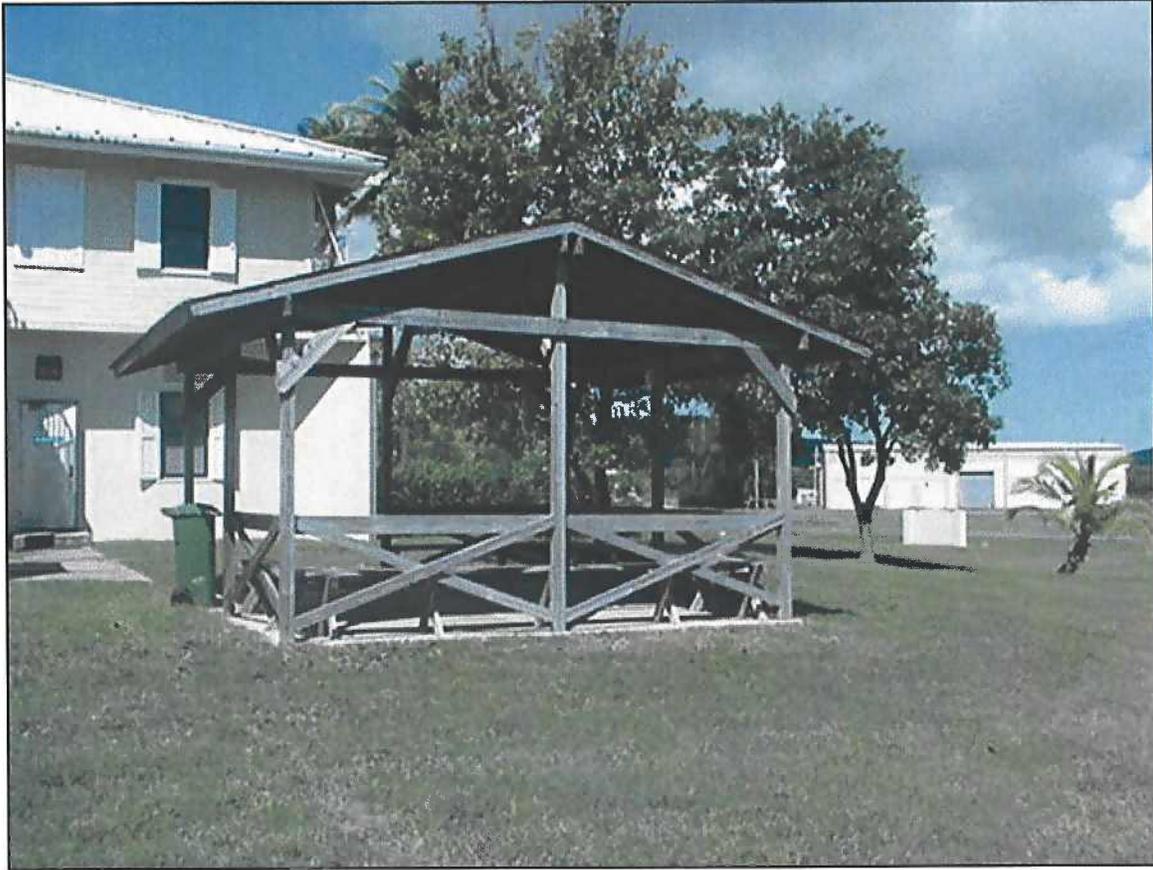
BUILDING 2479

Building 2479 is identified as “Pavilion” and is approximately 285 square feet in size. One suspect homogeneous material was identified and sampled. This material is not an ACM.

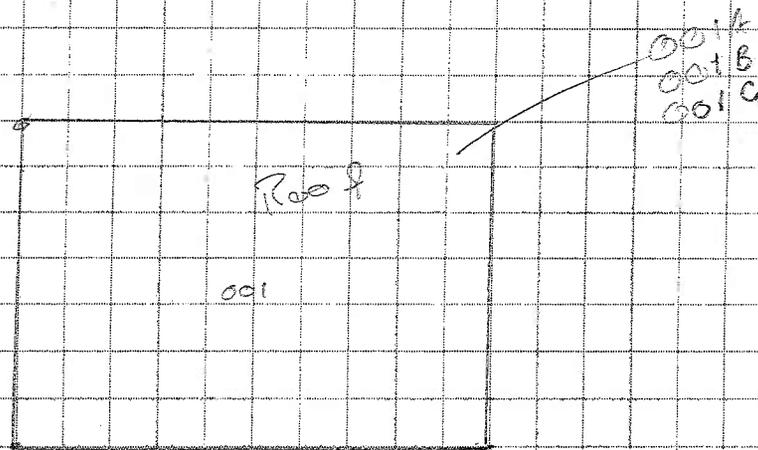
0205-2479-

MATERIAL NUMBER	MATERIAL TYPE	MATERIAL DESCRIPTION	ANALYTICAL RESULTS
001	ASPHALTIC ROOFING MATERIALS	GREEN TAB SHINGLES	Negative for Asbestos

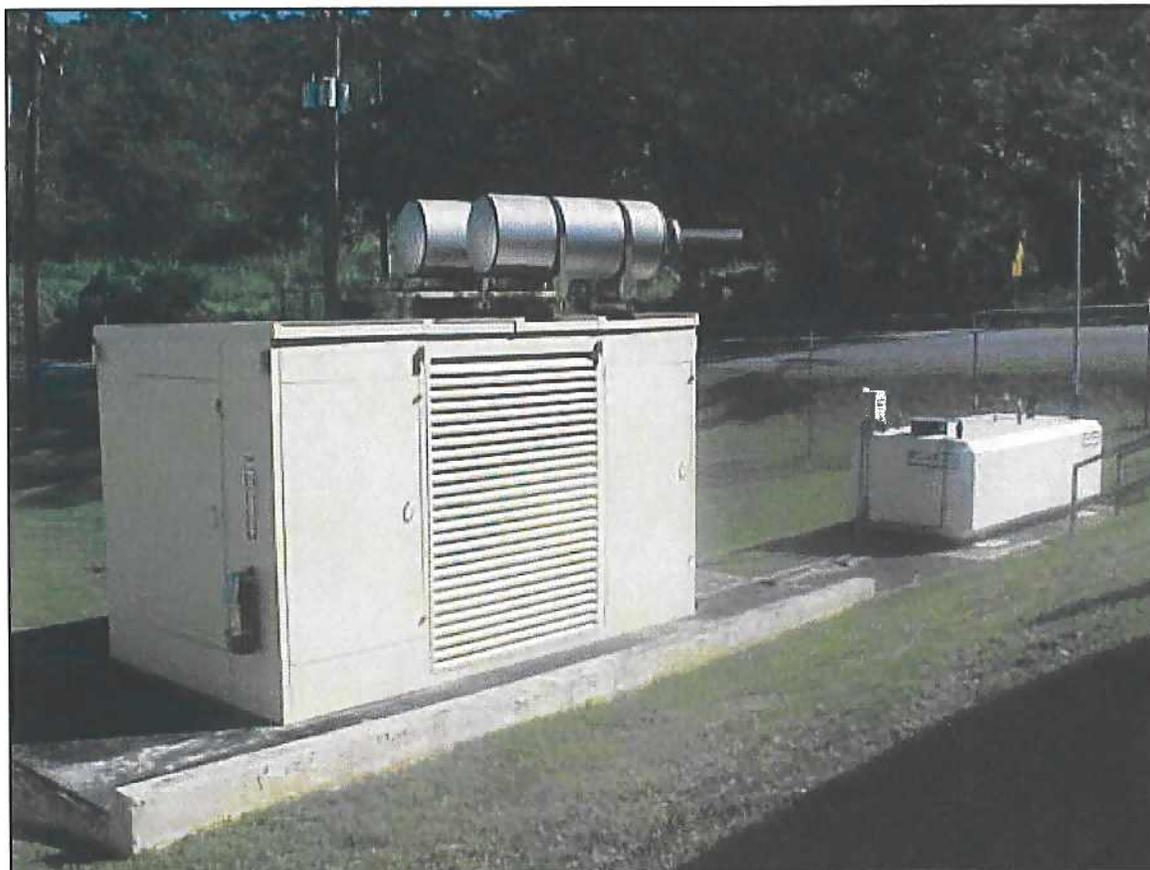
BUILDING 2481

Building 2481 is identified as “Generator Shelter at Bldg 88” and is approximately 72 square feet in size. No suspect materials were identified. Therefore, no sampling was conducted.

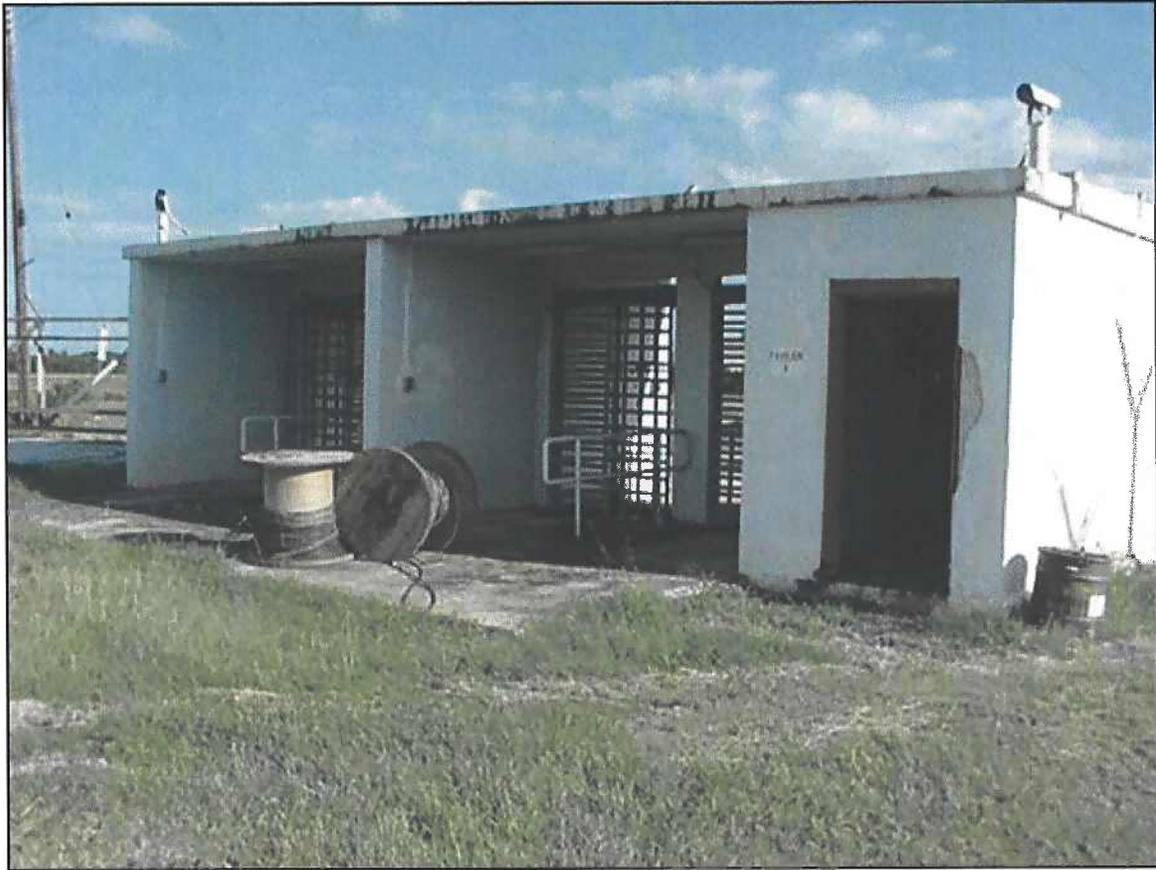
BUILDING 2485

Building 2485 is identified as “Gatehouse with Turnstiles” and is approximately 560 square feet in size. No suspect materials were identified. Therefore, no sampling was conducted.

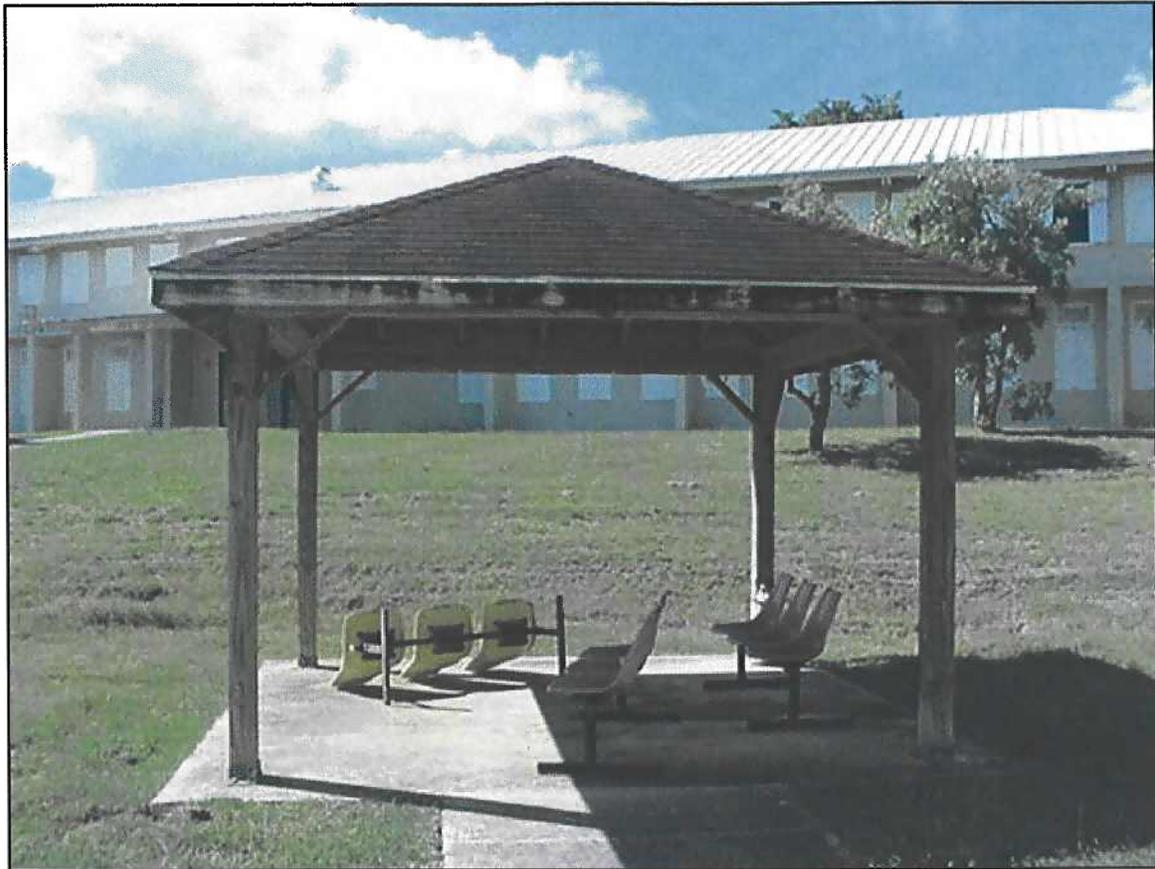
BUILDING 2486

Building 2486 is identified as “Pavilion by Bldg 202” and is approximately 196 square feet in size. One suspect homogeneous material was identified and sampled. This material was not an ACM. No friable, damaged, and accessible ACM was identified.

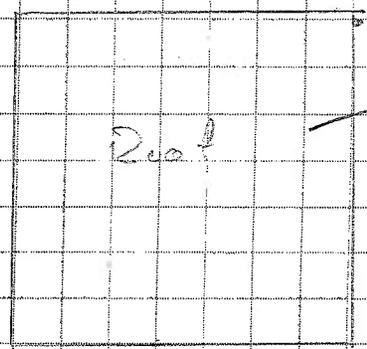
MATERIAL NUMBER	MATERIAL TYPE	MATERIAL DESCRIPTION	ANALYTICAL RESULTS
001	ASPHALTIC ROOFING MATERIALS	RED TAB SHINGLES	Negative for Asbestos

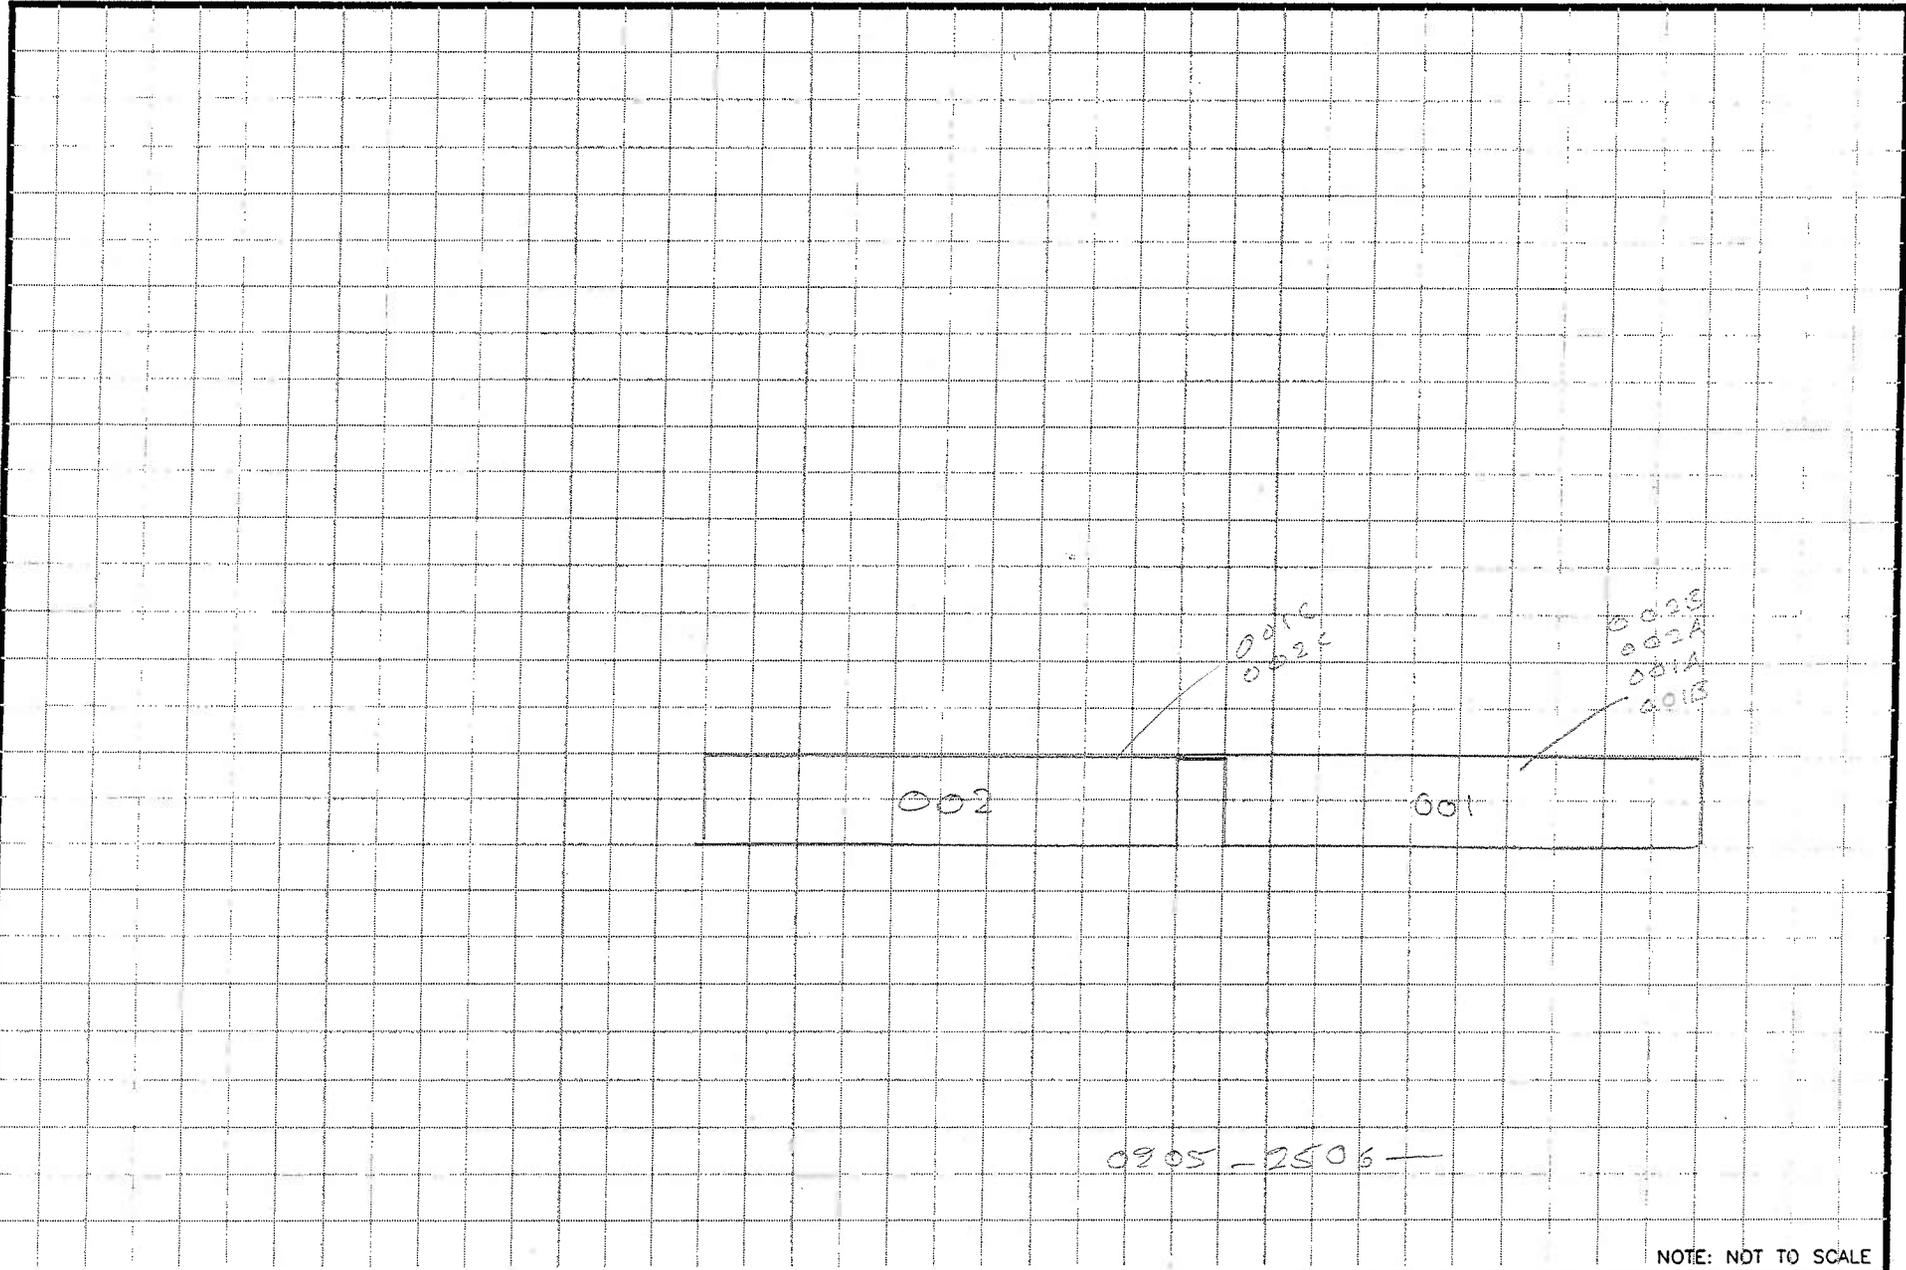
Building 2506 is identified as “Storage Shed near Bldg 825” and is approximately 1,760 square feet in size. Two suspect homogeneous materials were identified and sampled. Neither of the materials was found to be ACM.

MATERIAL NUMBER	MATERIAL TYPE	MATERIAL DESCRIPTION	ANALYTICAL RESULTS
001	VINYL FLOOR SHEETING	DARK GRAY	Negative for Asbestos
002	FLOOR ADHESIVE	TAN, UNDER DARK GRAY VINYL FLOOR SHEETING	Negative for Asbestos

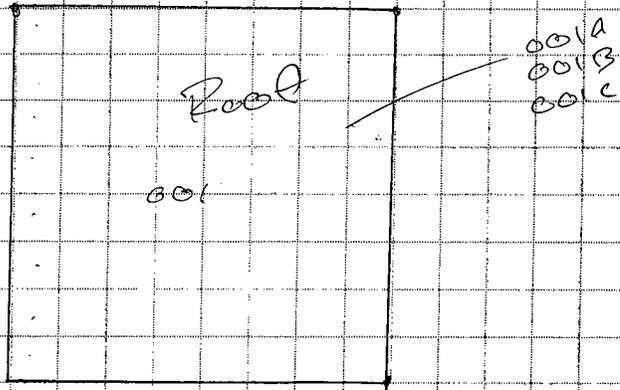
BUILDING # 2534
NAVAL ACTIVITY PUERTO RICO

Building 2534 is identified as “Weather Shelter” and is approximately 169 square feet in size. One suspect homogeneous material was identified and sampled. This material is not an ACM.

MATERIAL NUMBER	MATERIAL TYPE	MATERIAL DESCRIPTION	ANALYTICAL RESULTS
001	ASPHALTIC ROOFING	ASPHALTIC TAB SHINGLES (RED)	Negative for Asbestos

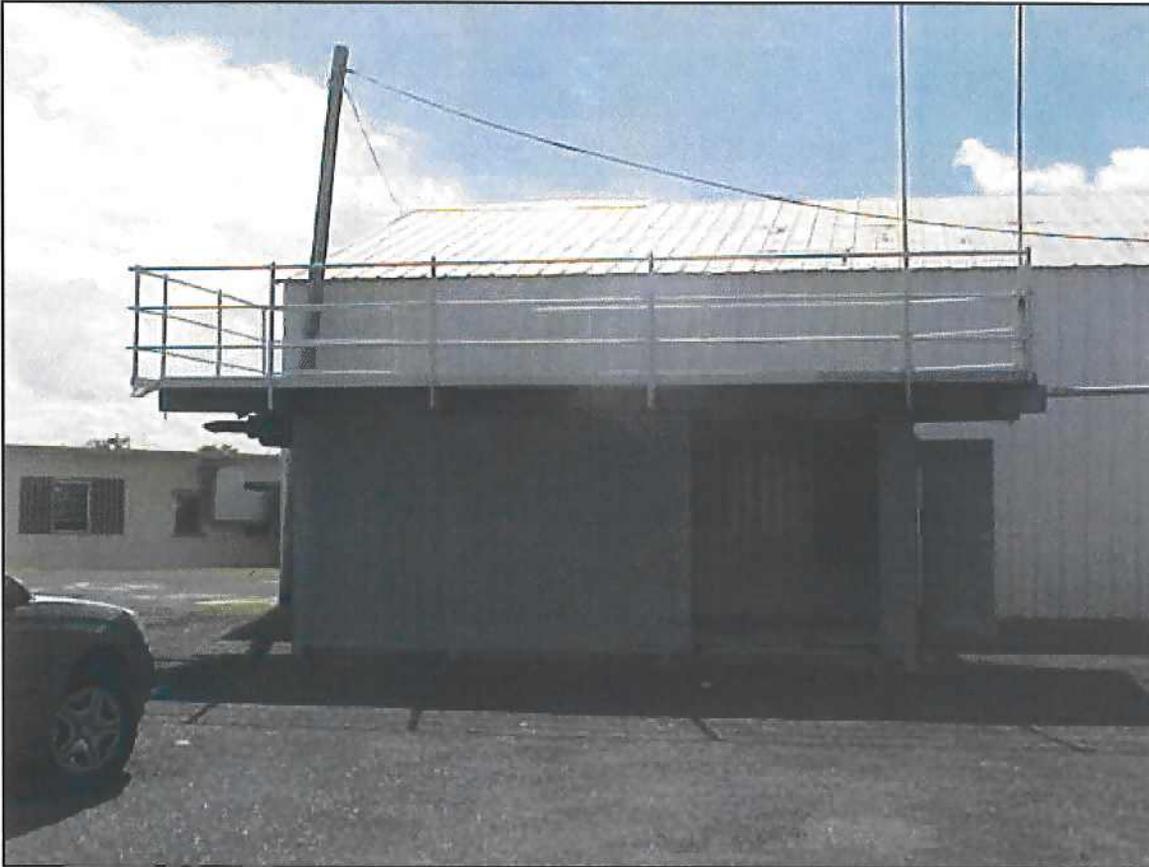
BUILDING 2557

Building 2557 is identified as “Flammable Strg Shed Nr 825” and is approximately 204 square feet in size. One suspect homogeneous material was identified and sampled. This material, 3” diameter sheet gasket (Material #001), was found to be an ACM. No friable, damaged, and accessible ACM was identified.

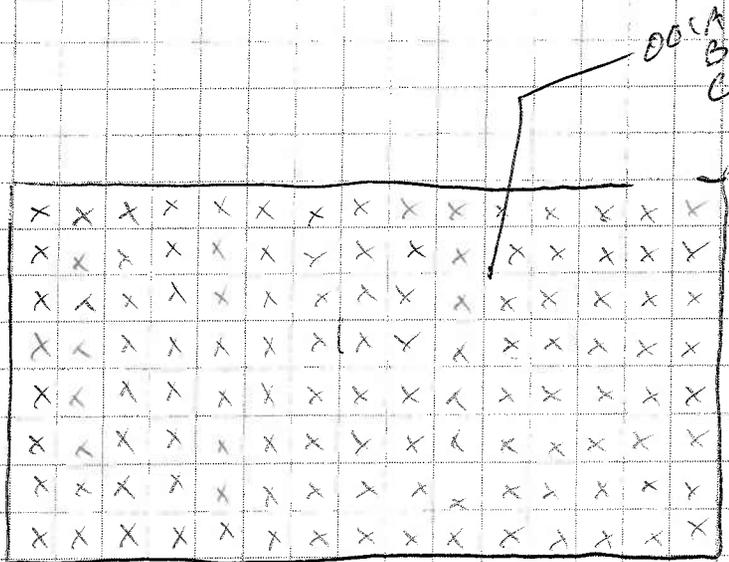
BUILDING # 2557
NAVAL ACTIVITY PUERTO RICO

MATERIAL NUMBER	MATERIAL TYPE (MATERIAL DESCRIPTION)	ASBESTOS CONTENT	MATERIAL LOCATION(S)	FRIABLE	CONDITION	QUANTITY	COMMENTS
001	SHEET GASKET (3" DIAMETER, GRAY)	55% CH	1	No	UNDAMAGED	1 EA
