Final
Asbestos Inspection Report
for

Naval Activity Puerto Rico
Ceiba, Puerto Rico

Volume 6 of 7

Buildings 2342 through 2684

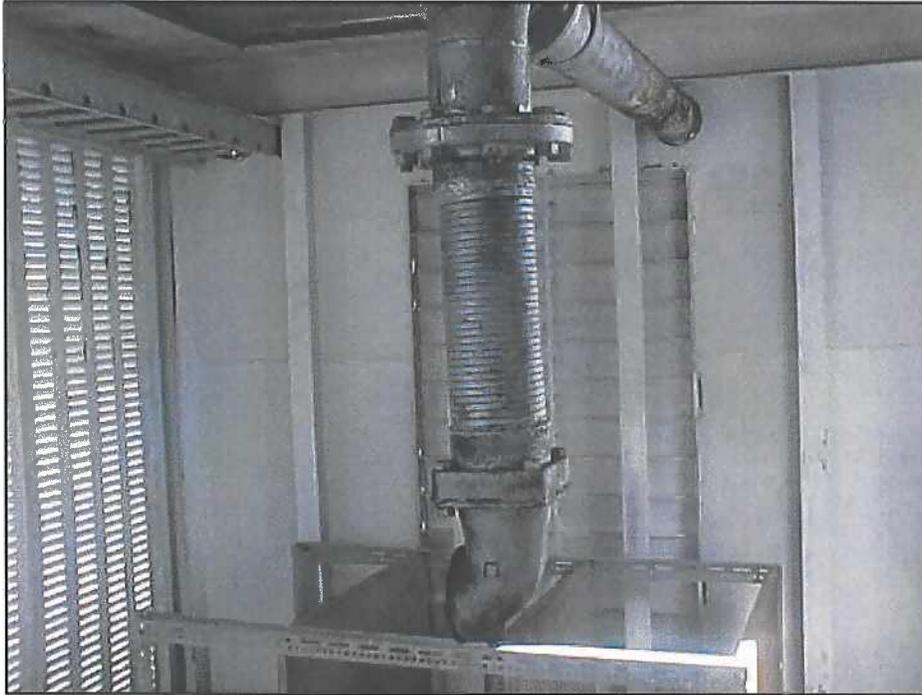
Building 2557 is identified as “Flammable Strg Shed Nr 825” and is approximately 204 square feet in size. One suspect homogeneous material was identified and sampled. This material, 3” diameter sheet gasket (Material #001), was found to be an ACM. No friable, damaged, and accessible ACM was identified.

Gray, 3" diameter sheet gasket (Material #001)

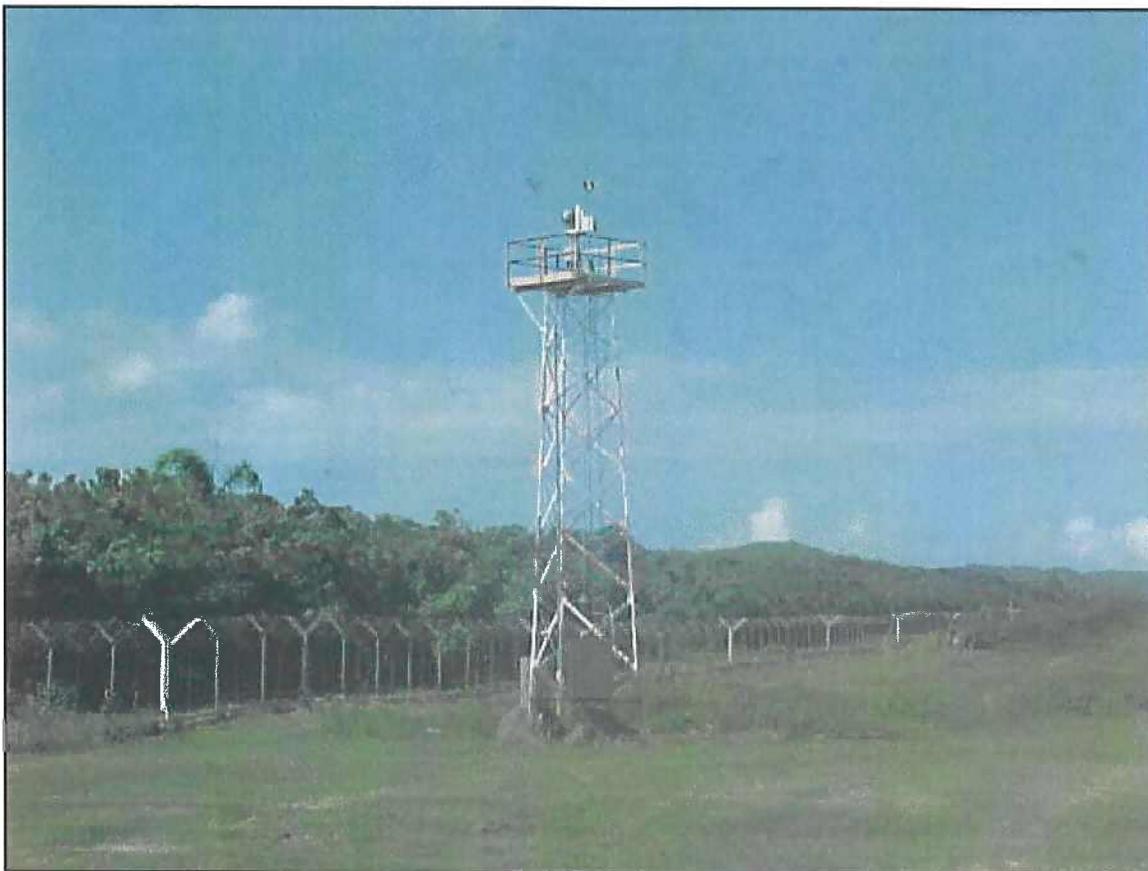
BUILDING 2635

Building 2635 is identified as “Surveillance Camera Tower” and is approximately 64 square feet in size. No suspect materials were identified. Therefore, no sampling was conducted.

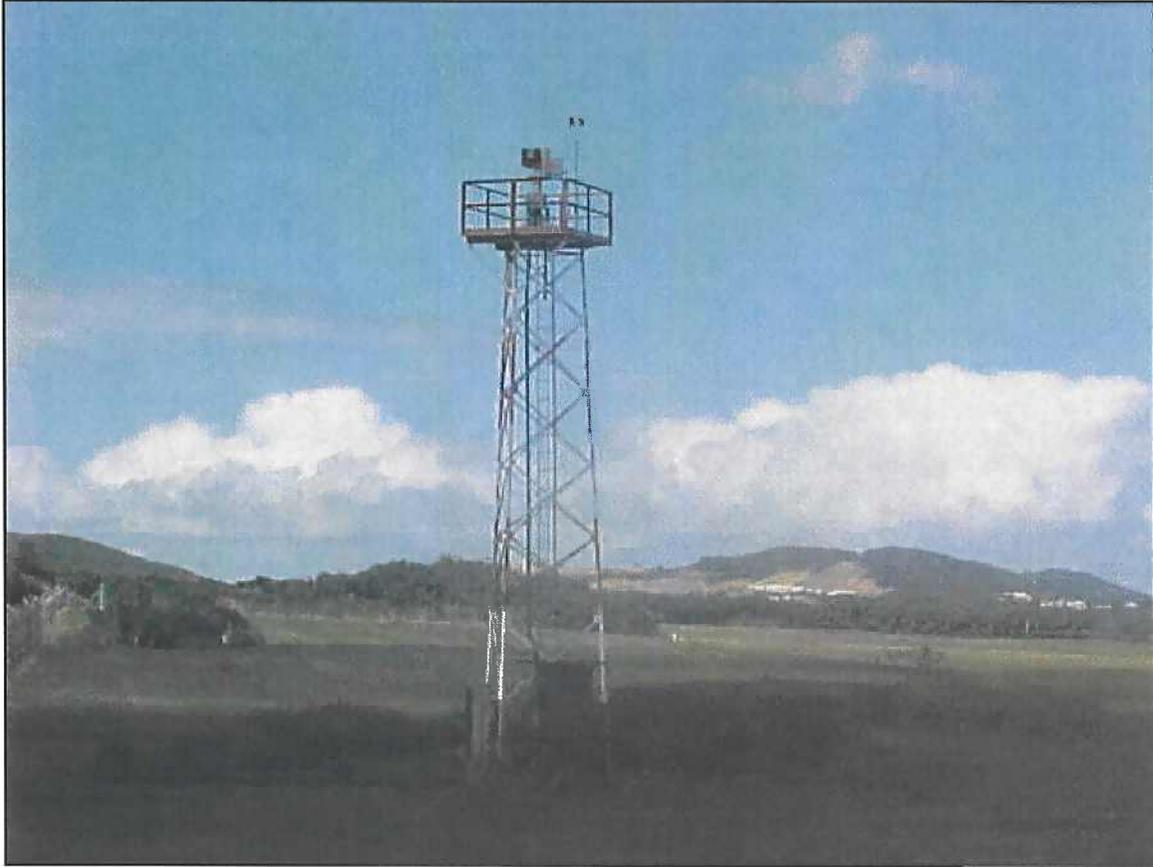
BUILDING 2637

Building 2637 is identified as “Surveillance Camera Tower” and is approximately 100 square feet in size. No suspect materials were identified. Therefore, no sampling was conducted.

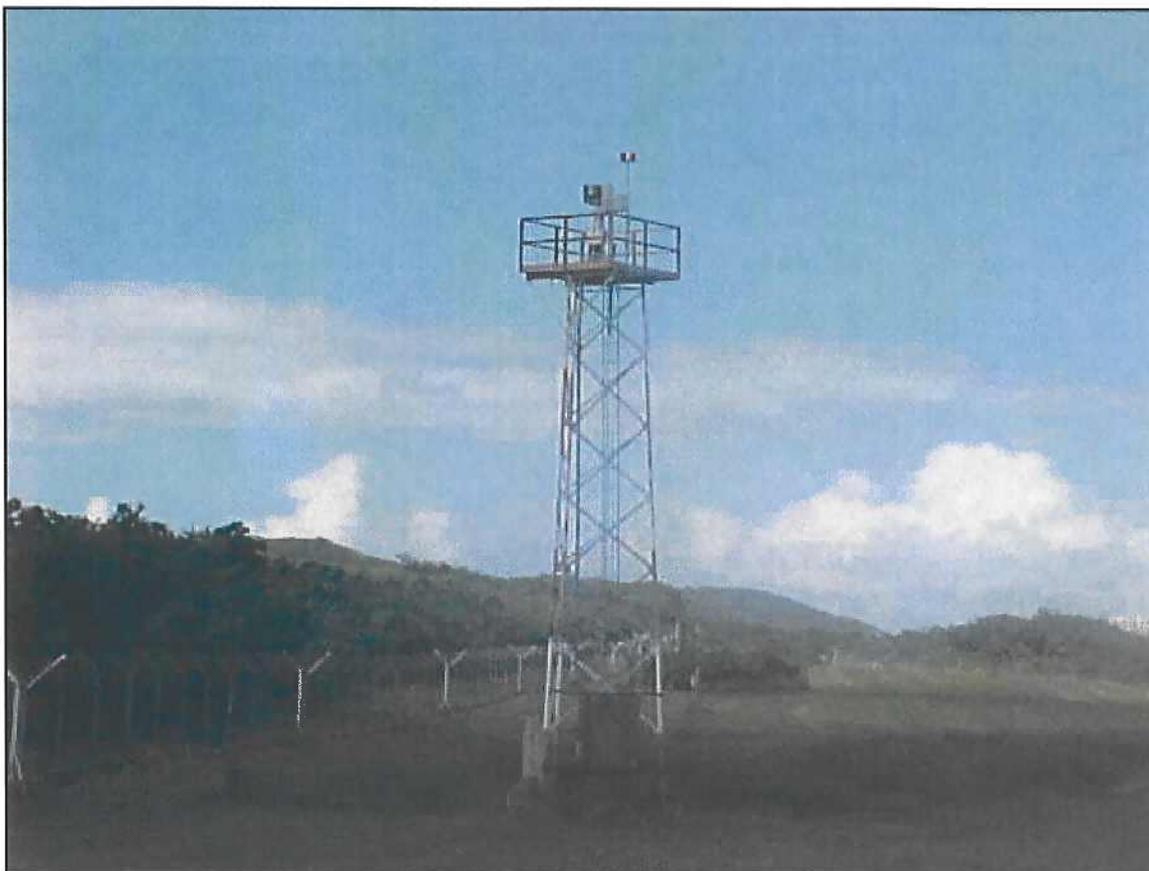
BUILDING 2639

Building 2639 is identified as “Surveillance Camera Tower” and is approximately 64 square feet in size. No suspect materials were identified. Therefore, no sampling was conducted.

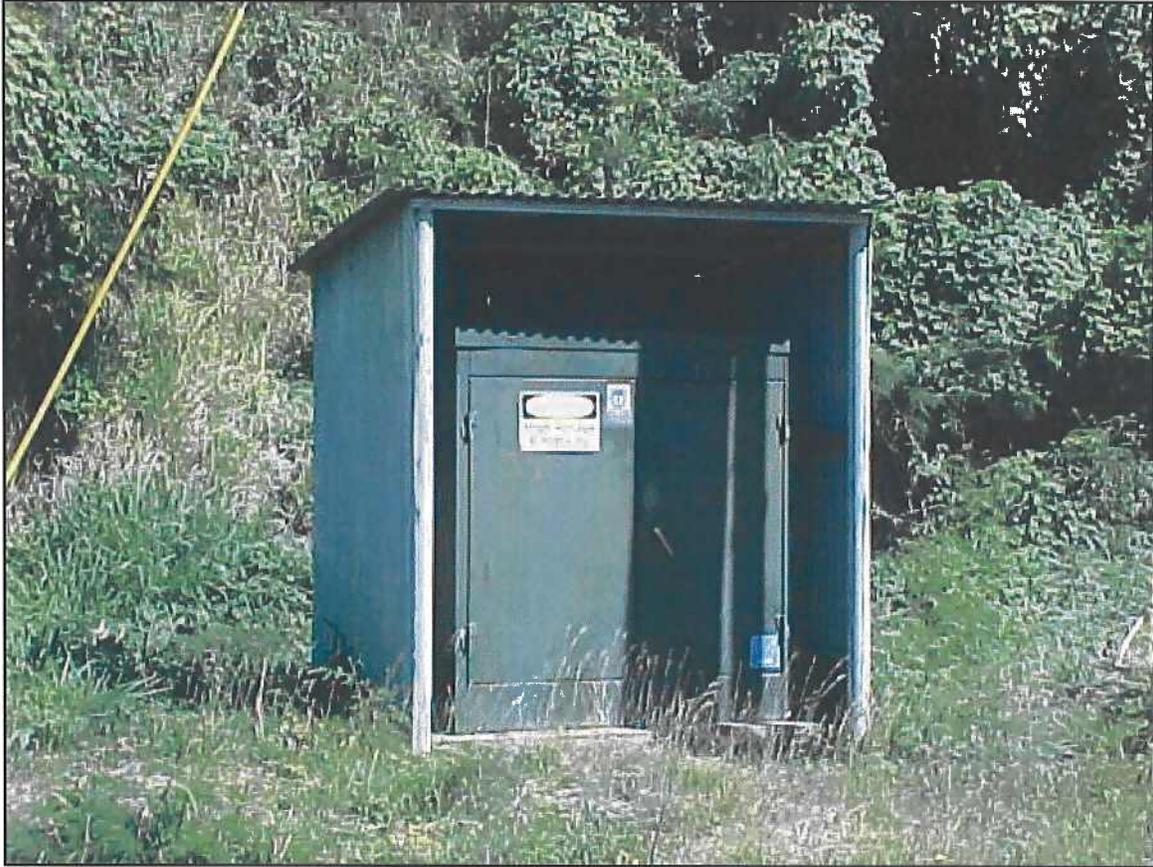
BUILDING 2651

Building 2651 is identified as “Transformer Shed” and is approximately 49 square feet in size. No suspect materials were identified. Therefore, no sampling was conducted.

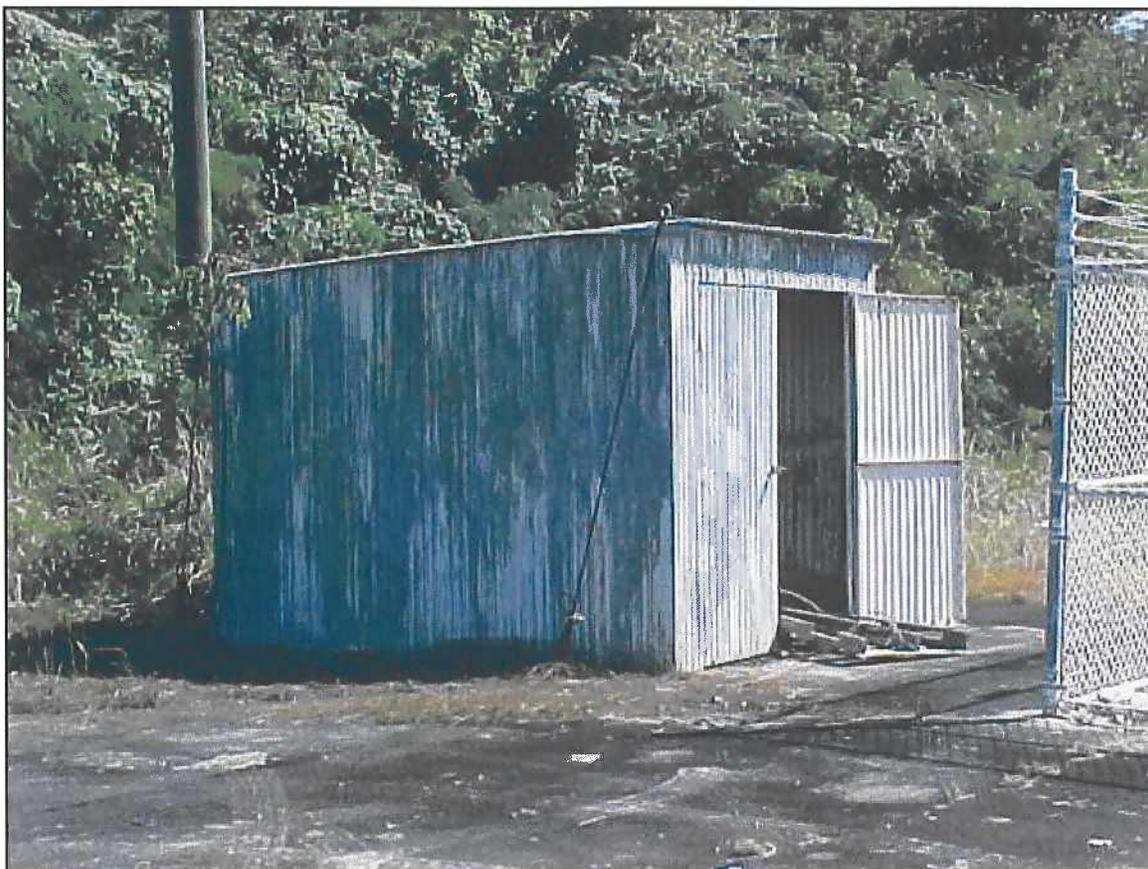
BUILDING 2652

Building 2652 is identified as “Storage Shed” and is approximately 88 square feet in size. No suspect materials were identified. Therefore, no sampling was conducted.

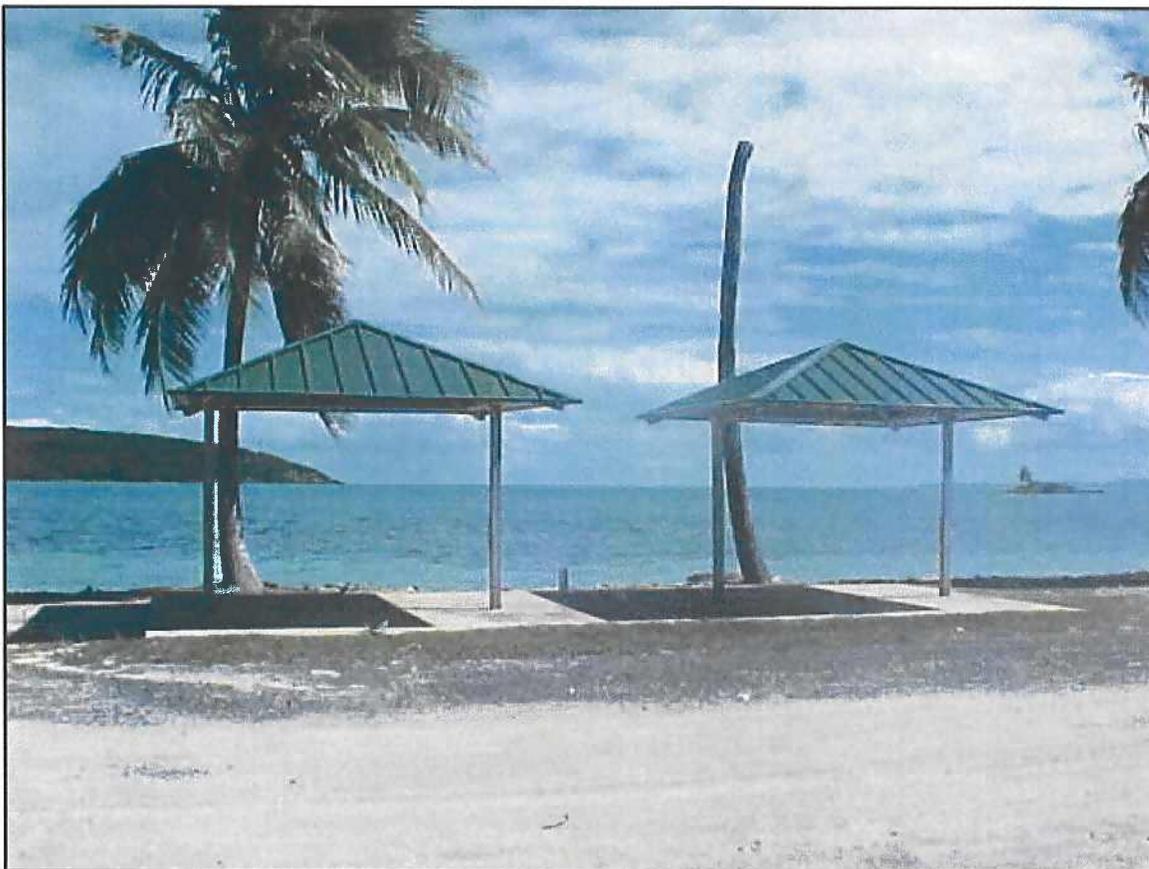
BUILDINGS 2655

Buildings 2655 through 2658 are each identified as “Enlisted Beach Shelter” and are approximately 80 square feet in size. No suspect materials were identified or sampled for any of these structures. The photograph above is typical of all of these shelters.

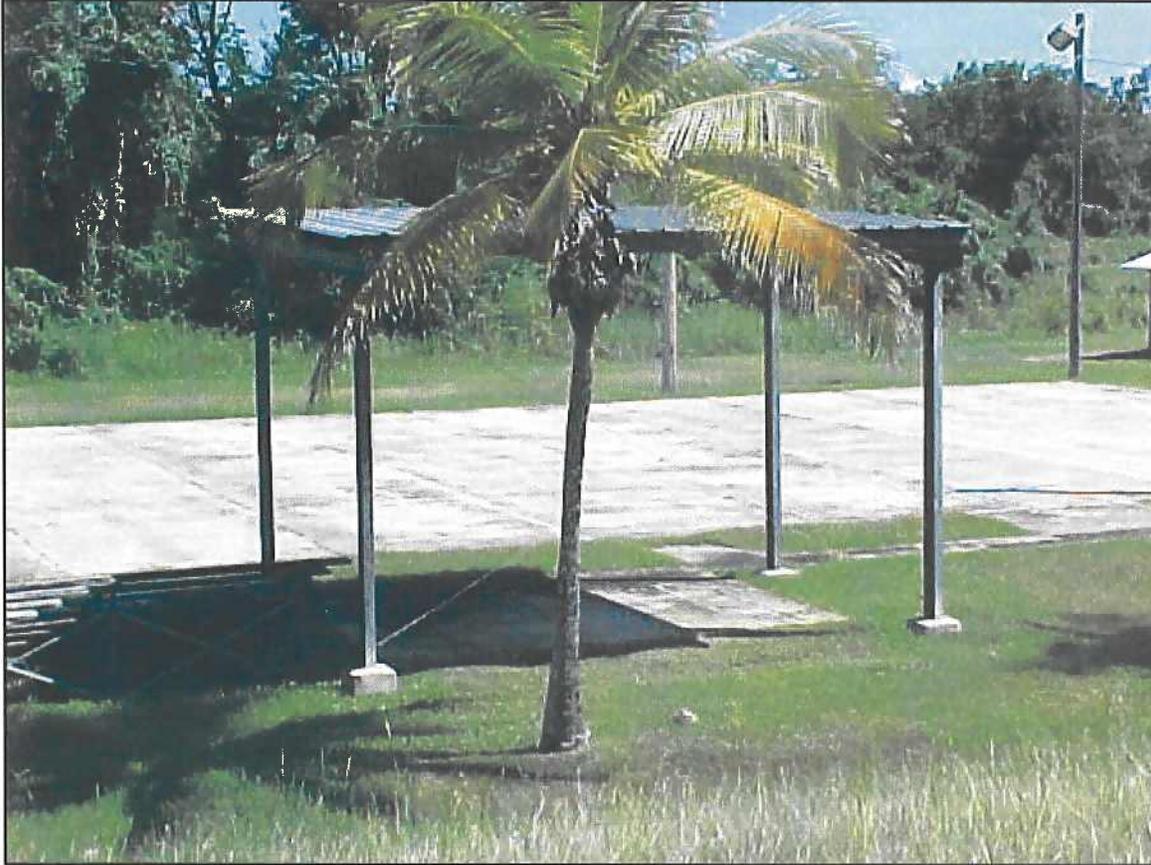
BUILDING 2668

Building 2668 is identified as “Recreational Pavilion” and is approximately 315 square feet in size. No suspect materials were identified. Therefore, no sampling was conducted.

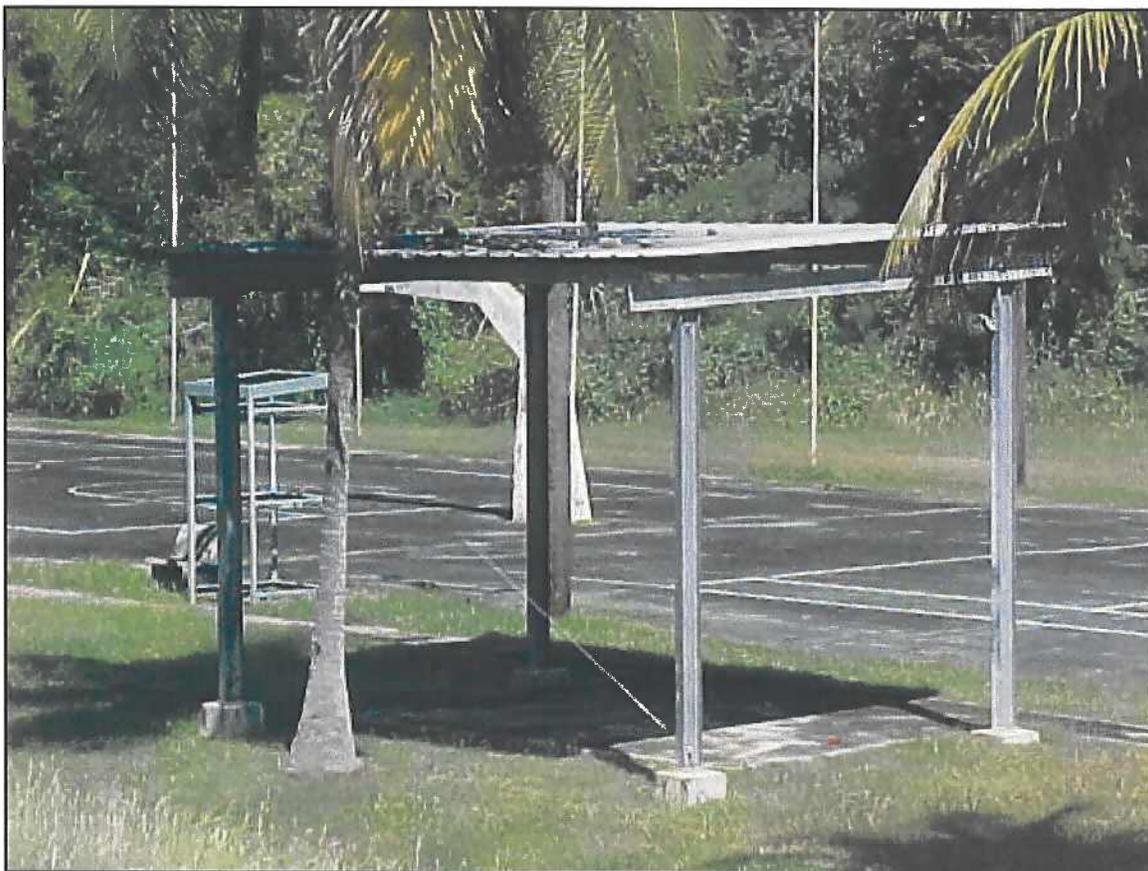
BUILDING 2669

Building 2669 is identified as “Recreational Pavilion” and is approximately 315 square feet in size. No suspect materials were identified. Therefore, no sampling was conducted.

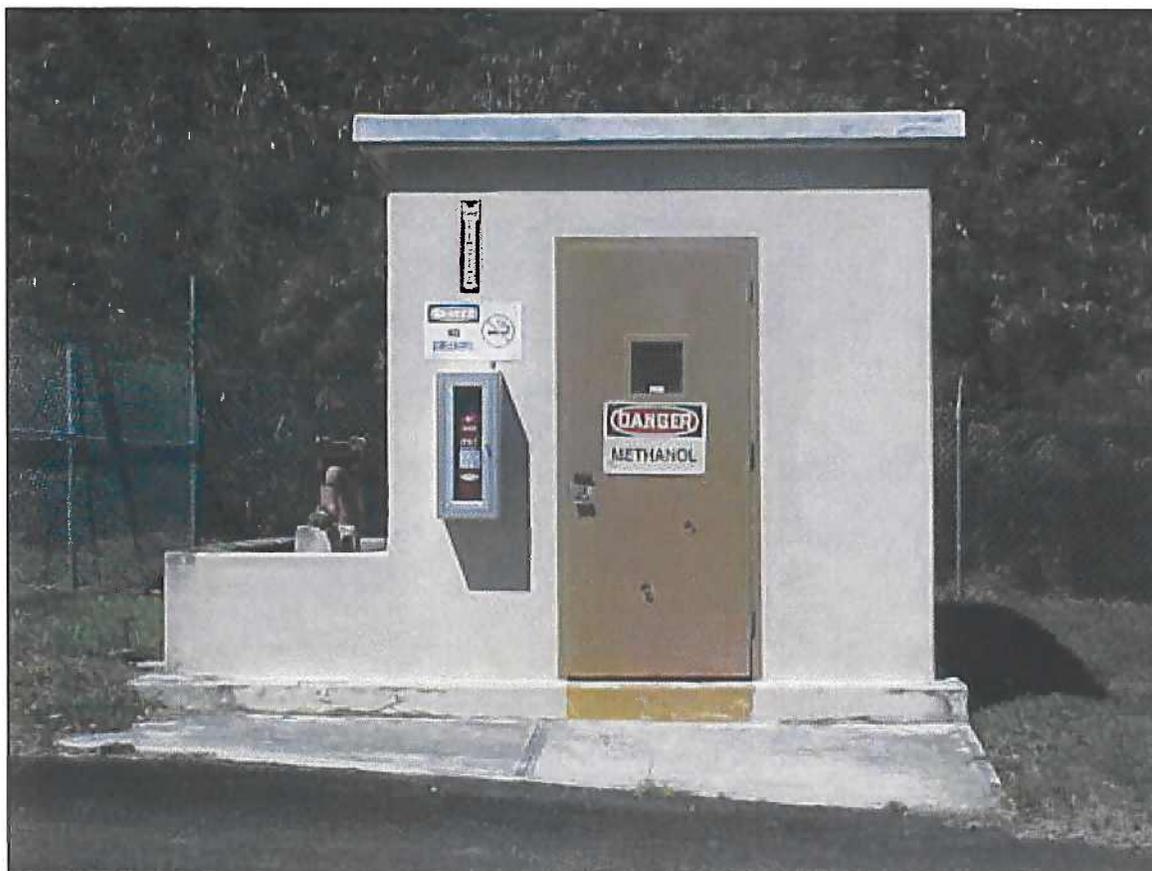
BUILDING 2673

Building 2673 is identified as “Pumping Station at WTF” and is approximately 108 square feet in size. No suspect materials were identified. Therefore, no sampling was conducted.

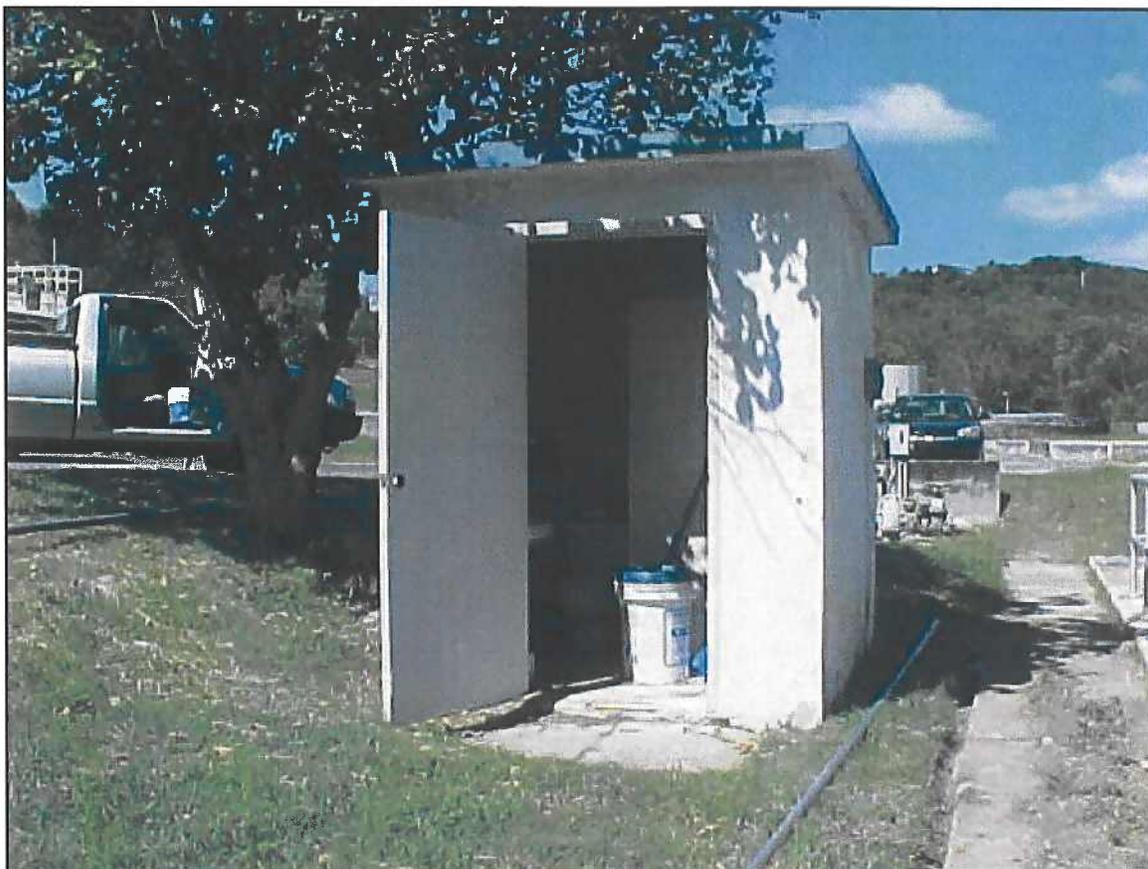
BUILDING 2674

Building 2674 is identified as “Latrine Facility at WTF” and is approximately 49 square feet in size. No suspect materials were identified. Therefore, no sampling was conducted.

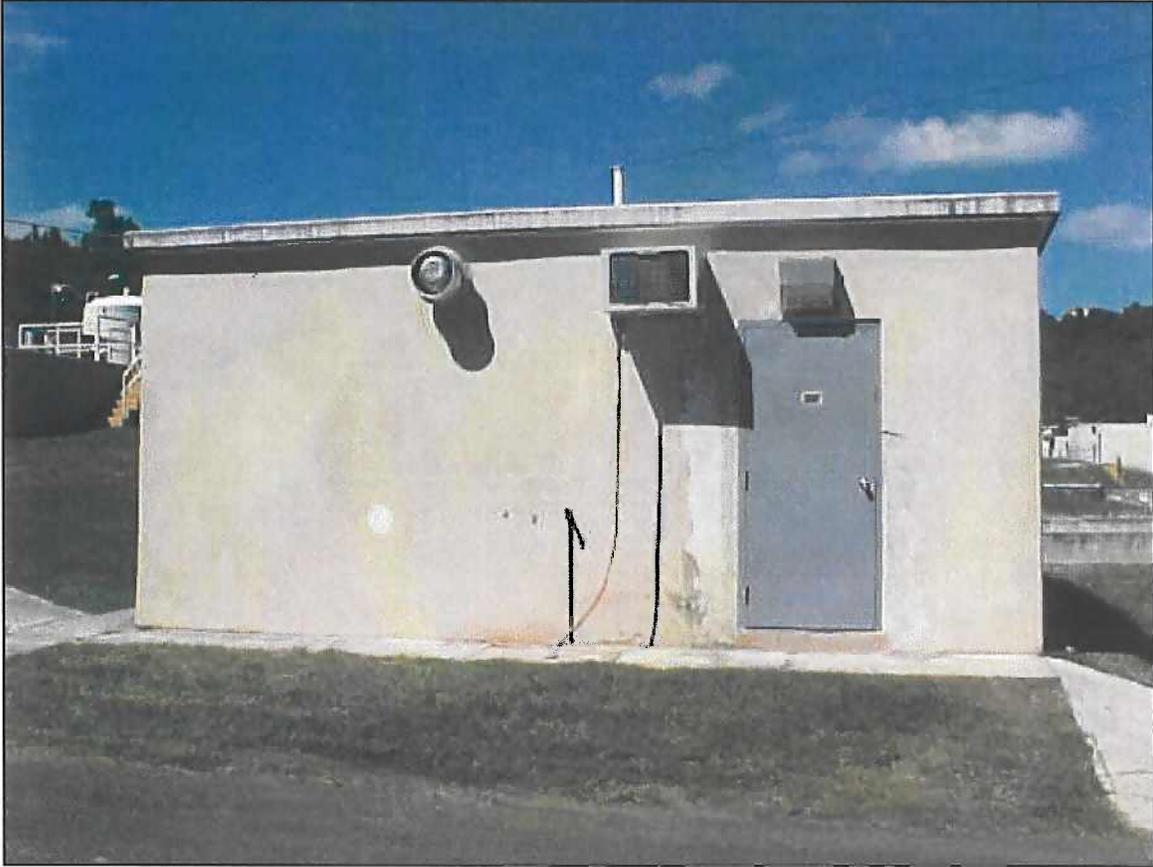
BUILDING 2675

Building 2675 is identified as “Water Treatment Fac Office” and is approximately 483 square feet in size. Two suspect homogeneous materials were identified and sampled. Neither of these materials was found to be ACM.

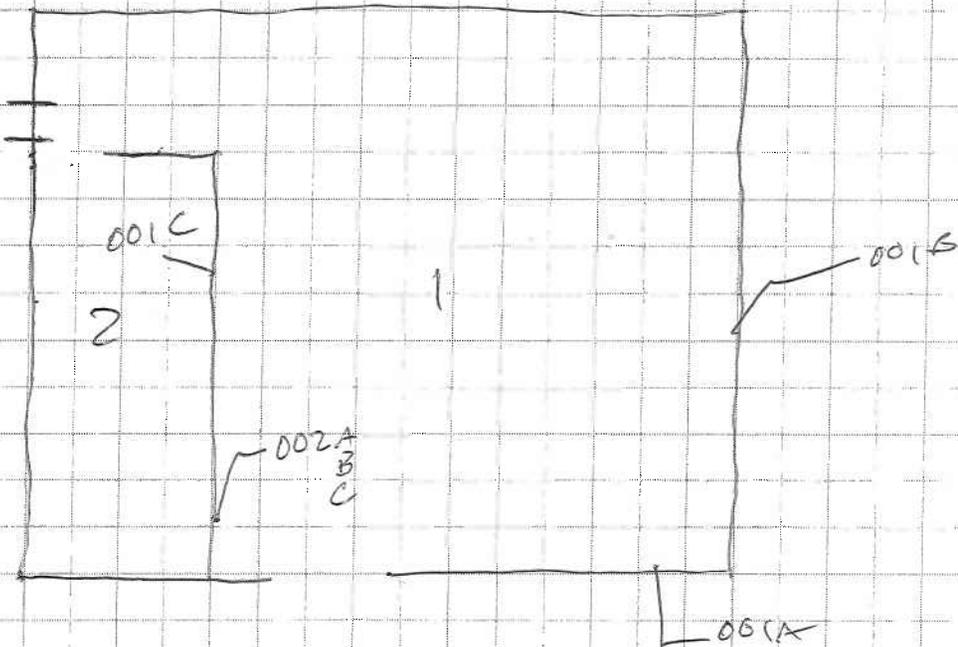
0205-2675-

MATERIAL NUMBER	MATERIAL TYPE	MATERIAL DESCRIPTION	ANALYTICAL RESULTS
001	COVE BASE ADHESIVE	GRAY, UNDER BROWN 4" RUBBER BASE COVE	Negative for Asbestos
002	SINK COATING	GRAY, ROUGH	Negative for Asbestos

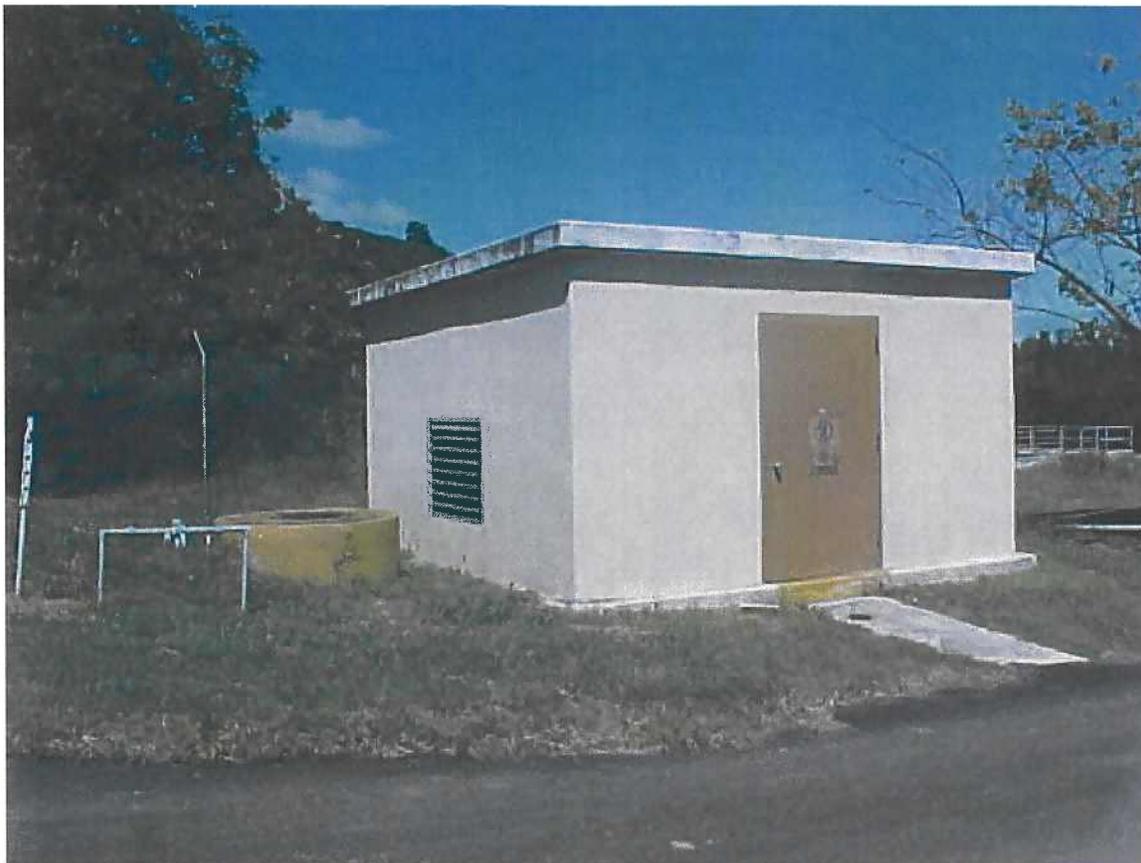
BUILDING 2676

Building 2676 is identified as “Compressor Shelter WTF” and is approximately 210 square feet in size. No suspect materials were identified. Therefore, no sampling was conducted.

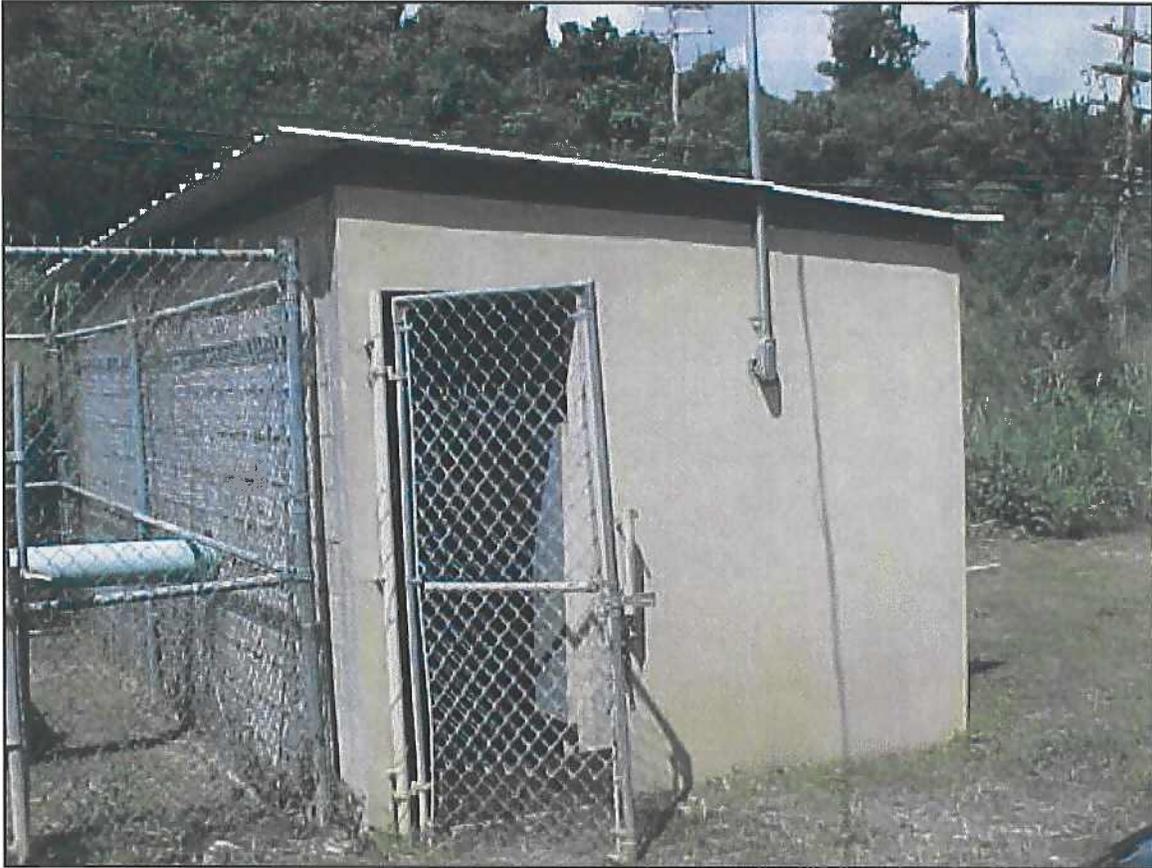
BUILDING 2680

Building 2680 is identified as “Generator Shelter at 1796” and is approximately 200 square feet in size. One suspect homogeneous material was identified and sampled. This material is not an ACM.

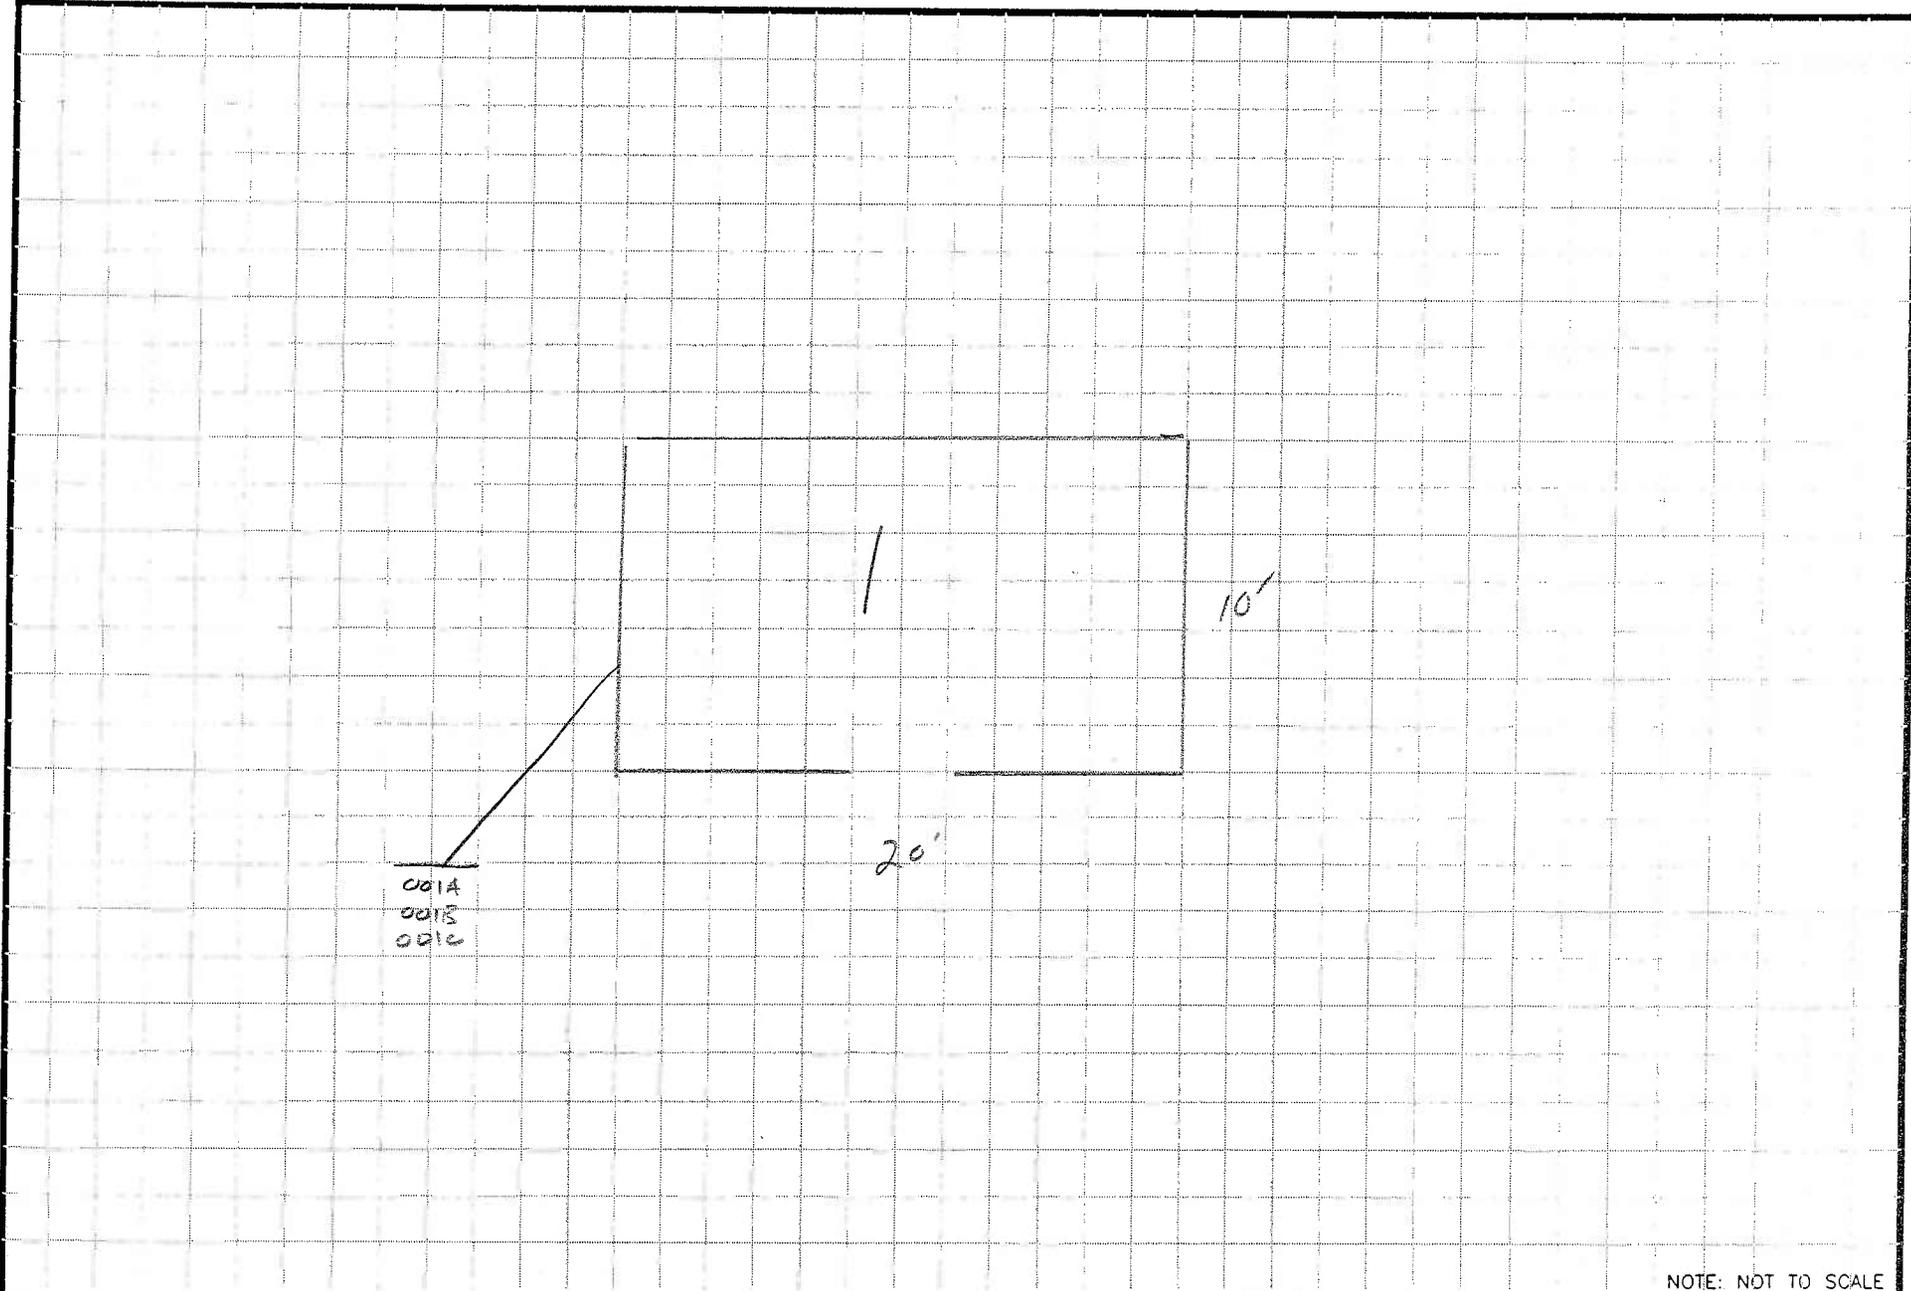
MATERIAL NUMBER	MATERIAL TYPE	MATERIAL DESCRIPTION	ANALYTICAL RESULTS
001	THERMAL PIPE & FITTING INSULATION	GRAY	Negative for Asbestos

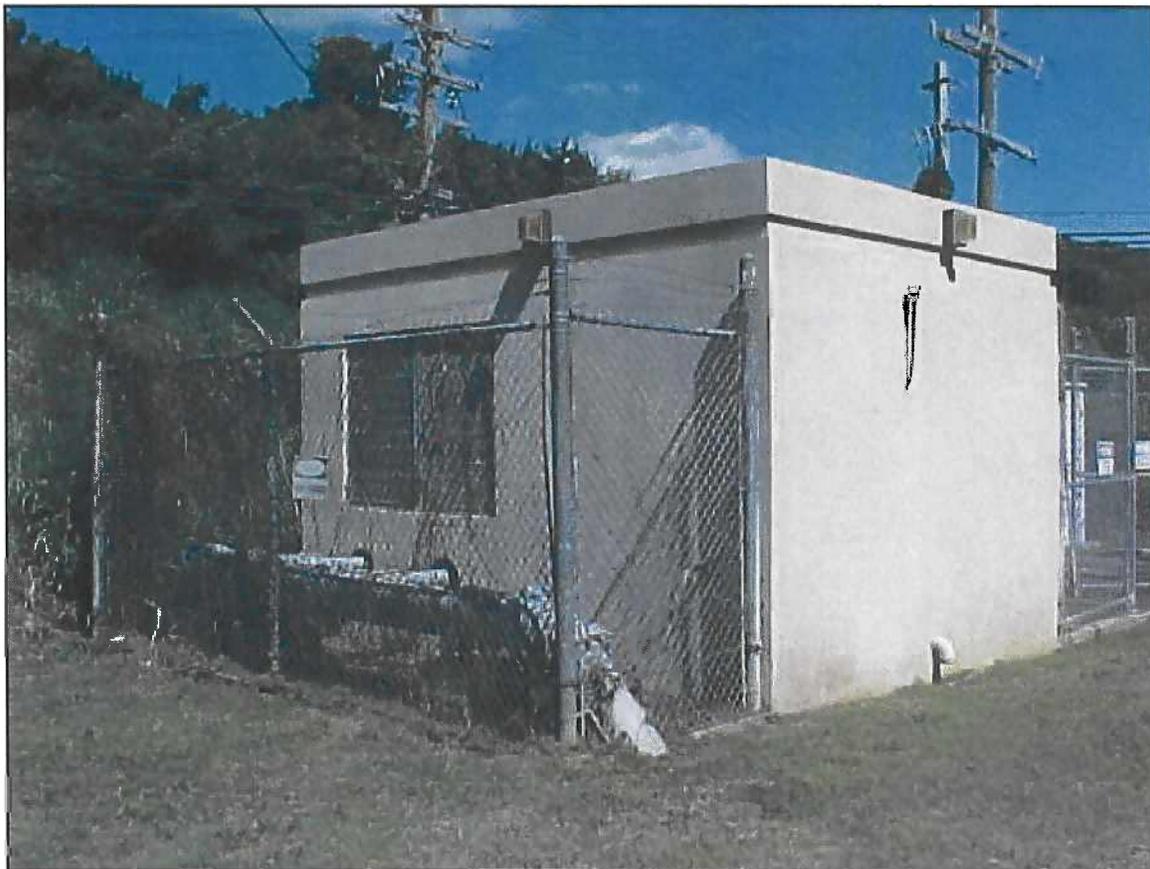
BUILDING 2684

Building 2684 is identified as “Water Pump Station at 1796” and is approximately 165 square feet in size. No suspect materials were identified. Therefore, no sampling was conducted.
