Final
Asbestos Inspection Report
for

Naval Activity Puerto Rico
Ceiba, Puerto Rico

Volume 7 of 7

Buildings 3015 through 3195

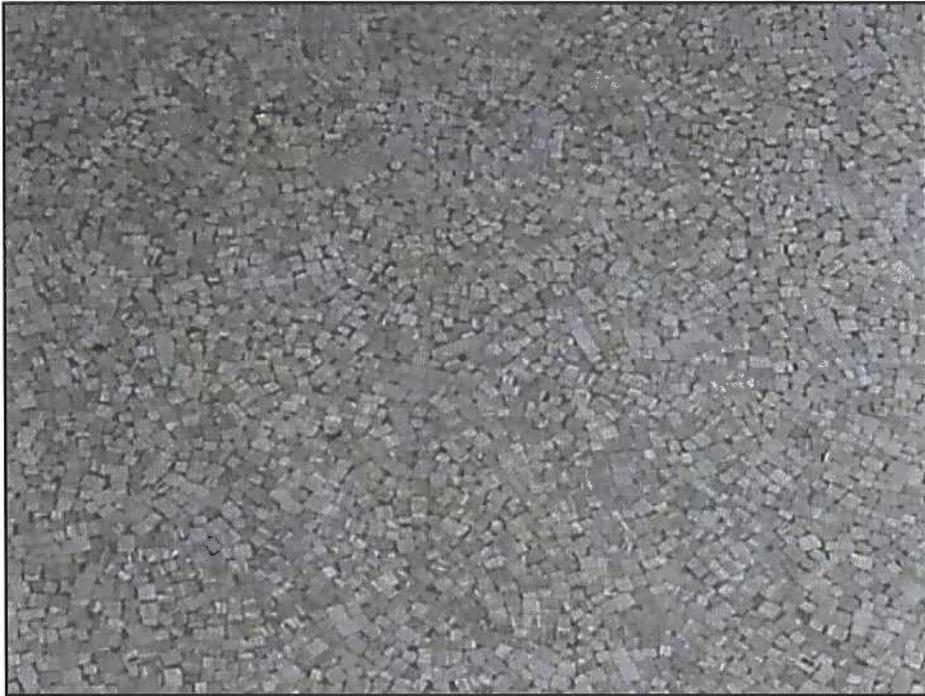
| MATERIAL NUMBER | MATERIAL TYPE | MATERIAL DESCRIPTION | ANALYTICAL RESULTS |
|---|---|---|---|
| 002 | VINYL FLOOR SHEETING | SMALL SQUARES PATTERN | Positive for Asbestos |

Small squares pattern vinyl floor sheeting (Material #002)

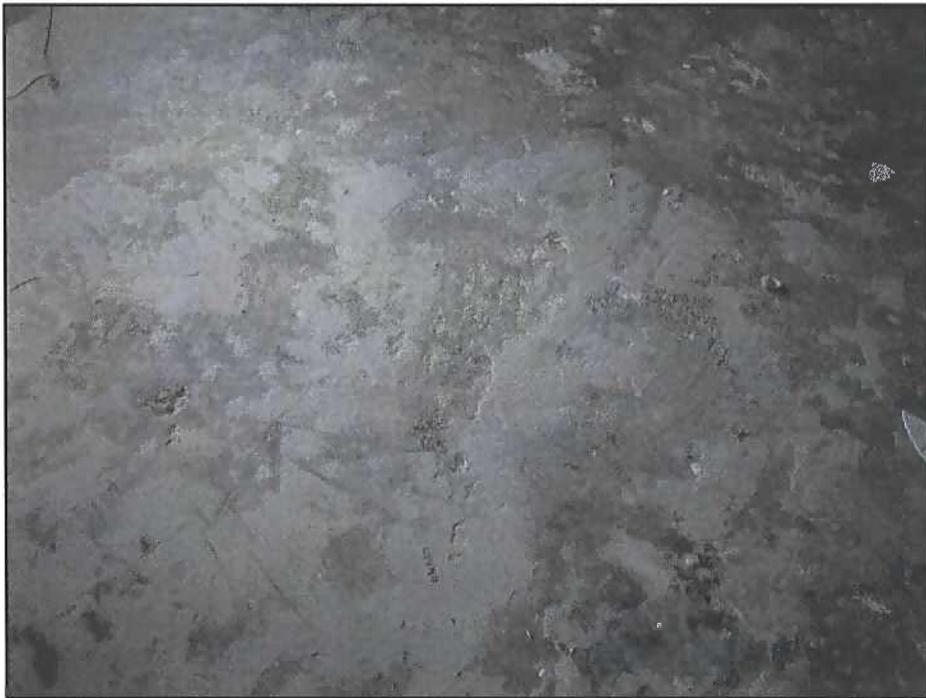
Floor leveling compound (Material #006)

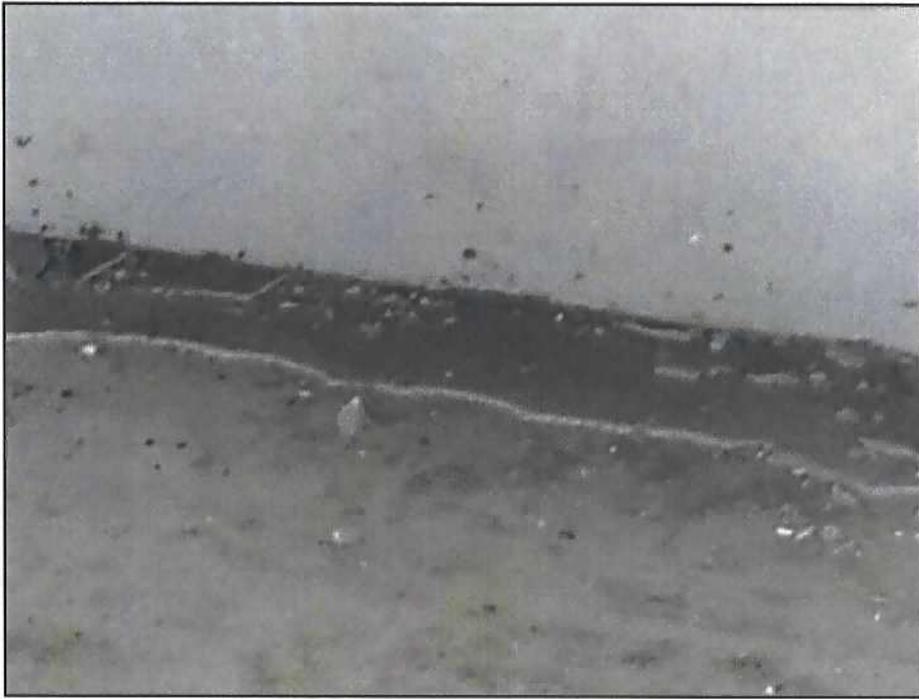
| MATERIAL NUMBER | MATERIAL TYPE (MATERIAL DESCRIPTION) | ASBESTOS CONTENT | MATERIAL LOCATION(S) | FRIABLE | CONDITION | QUANTITY | COMMENTS |
|---|--|---|---|---|---|---|---|
| 007 | VINYL FLOOR TILE (1' X 1' TAN WITH BROWN MOTTLE) | 7% CH | RECORDS | No | UNDAMAGED | 24 SF | |
| 008 | FLOOR ADHESIVE (BLACK, UNDER 007) | 6% CH | RECORDS | No | UNDAMAGED | 24 SF | |

1' x 1' tan with brown mottle vinyl floor tile (Material #007) over associated floor adhesive (Material #008)

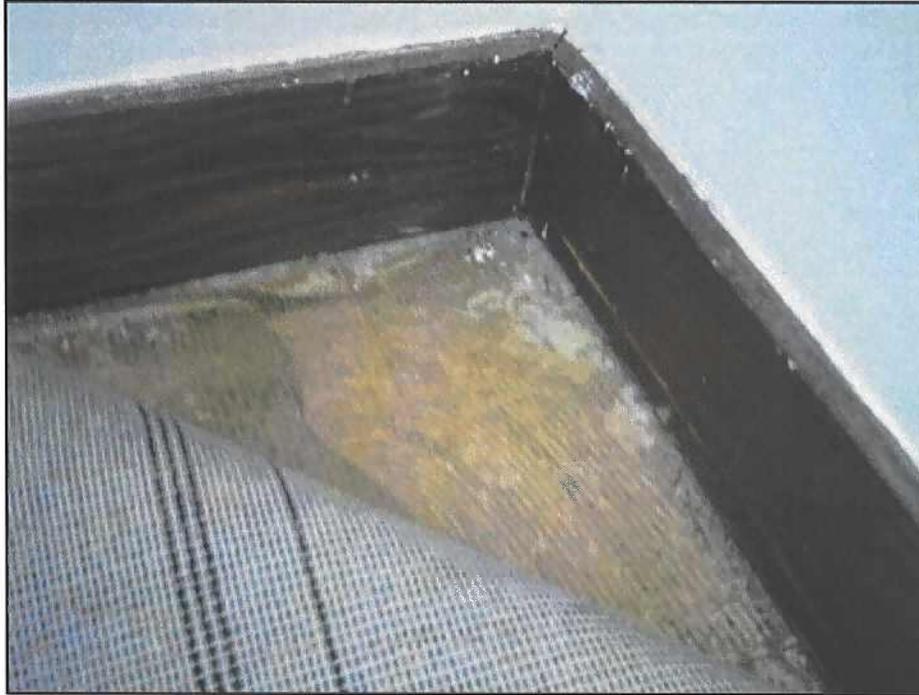
| MATERIAL NUMBER | MATERIAL TYPE (MATERIAL DESCRIPTION) | ASBESTOS CONTENT | MATERIAL LOCATION(S) | FRIABLE | CONDITION | QUANTITY | COMMENTS |
|---|---|---|---|---|---|---|---|
| 002 | FLOOR ADHESIVE (UNDER 001) | 8% CH | 1 2 3 5 6 7 8 | No | UNDAMAGED | 1,579 SF | |

1'x1' tan, brown, and white mottle vinyl floor tile over asbestos floor adhesive (Material #002)

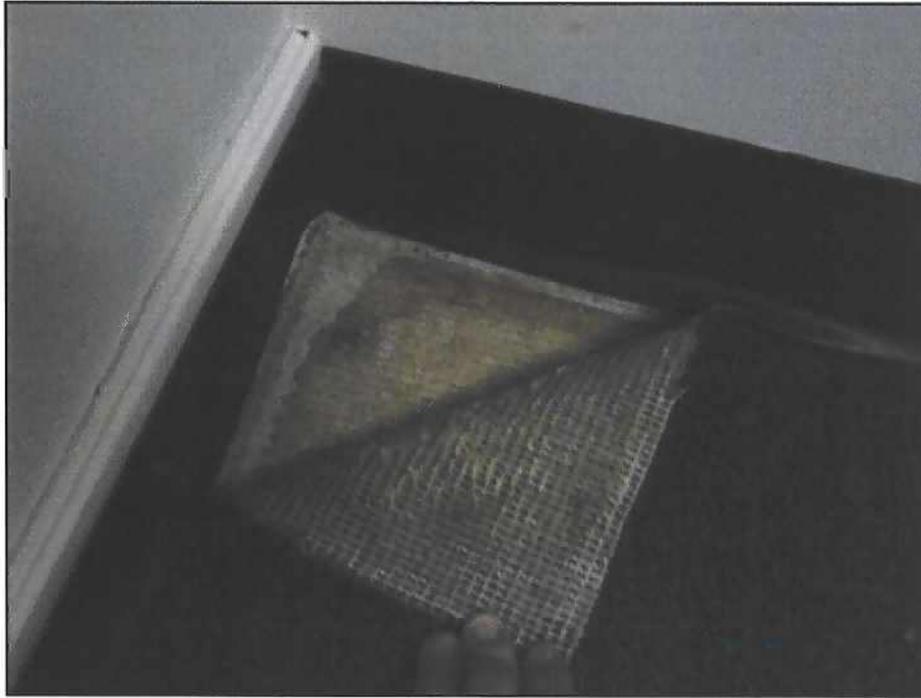
| MATERIAL NUMBER | MATERIAL TYPE (MATERIAL DESCRIPTION) | ASBESTOS CONTENT | MATERIAL LOCATION(S) | FRIABLE | CONDITION | QUANTITY | COMMENTS |
|---|---|---|---|---|---|---|---|
| 003 | FLOOR ADHESIVE (CARPET ADHESIVE) | 2% CH | 1 2 3 7 8 | No | UNDAMAGED | 1,073 SF | |

Carpet adhesive (Material #003)

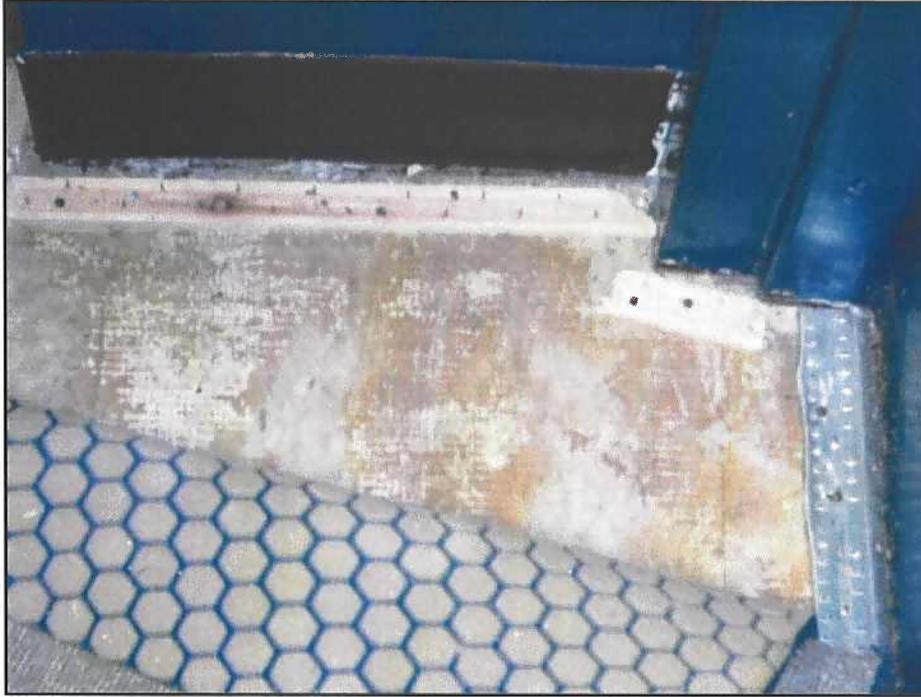
| MATERIAL NUMBER | MATERIAL TYPE (MATERIAL DESCRIPTION) | ASBESTOS CONTENT | MATERIAL LOCATION(S) | FRIABLE | CONDITION | QUANTITY | COMMENTS |
|---|---|---|---|---|---|---|---|
| 002 | FLOOR ADHESIVE (TAN, UNDER 001) | 3% CH | 1 2 3 4 5 6 7 | No | UNDAMAGED | 1,824 SF | |

1'x1' tan mottled vinyl floor tile (Material #001) over ACM floor adhesive (Material #002)

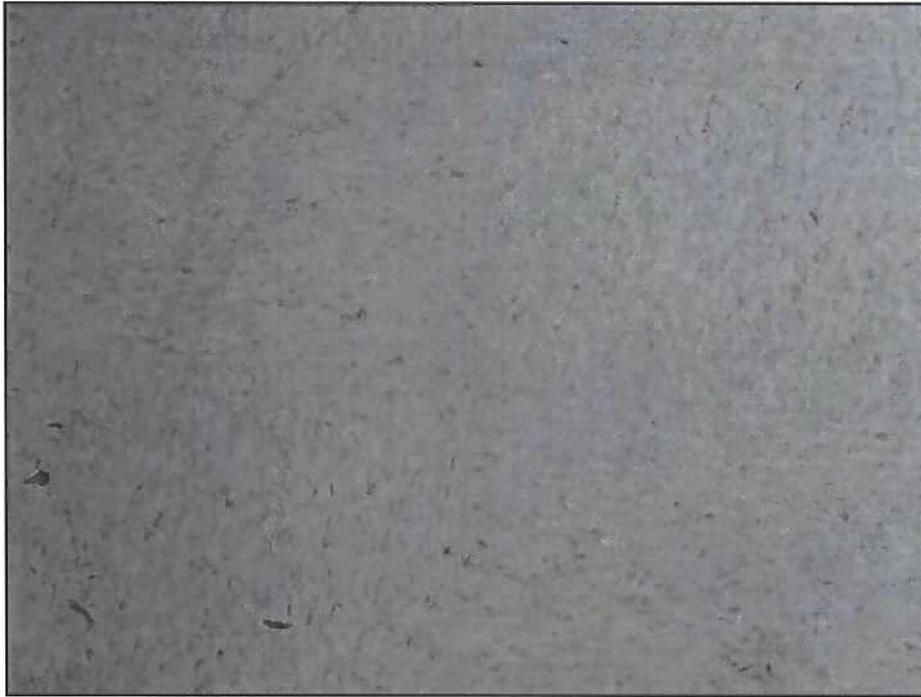
| MATERIAL NUMBER | MATERIAL TYPE (MATERIAL DESCRIPTION) | ASBESTOS CONTENT | MATERIAL LOCATION(S) | FRIABLE | CONDITION | QUANTITY | COMMENTS |
|---|--|---|---|---|---|---|---|
| 002 | FLOOR ADHESIVE (BROWN/ BLACK, UNDER 001) | 4% CH | BARBER SHOP OFFICE POST OFFICE | No | UNDAMAGED | 810 SF | |

1'x1' tan, white, and black mottled vinyl floor tile (Material #001) over ACM floor adhesive (Material #002)

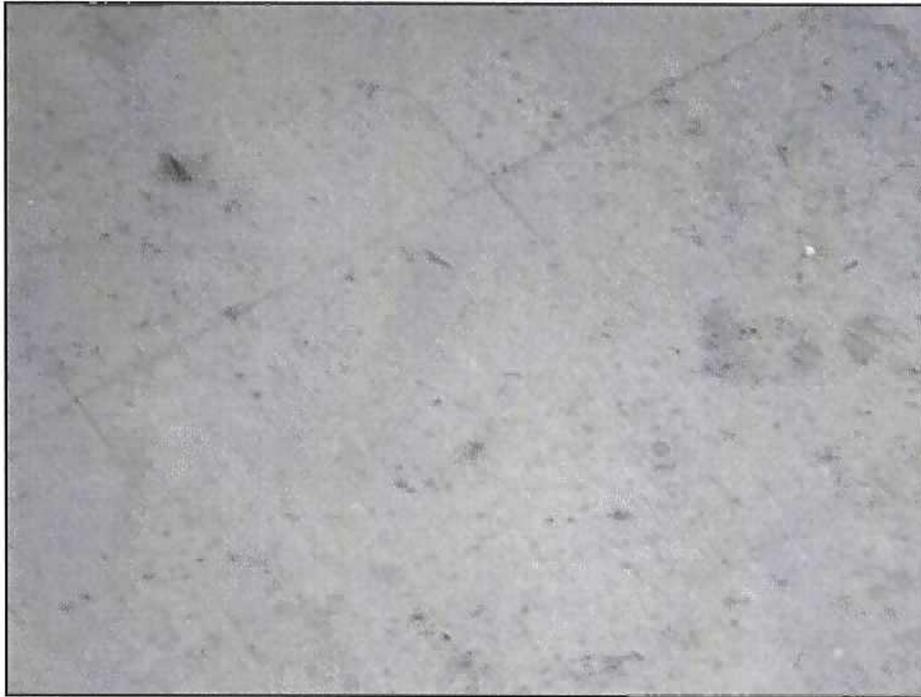
| MATERIAL NUMBER | MATERIAL TYPE (MATERIAL DESCRIPTION) | ASBESTOS CONTENT | MATERIAL LOCATION(S) | FRIABLE | CONDITION | QUANTITY | COMMENTS |
|---|---|---|---|---|---|---|---|
| 005 | VINYL FLOOR TILE (1' X 1' TAN) | 2% CH | ROOM 3 | No | UNDAMAGED | 84 SF | |

1' x 1' tan vinyl floor tile (Material #005)

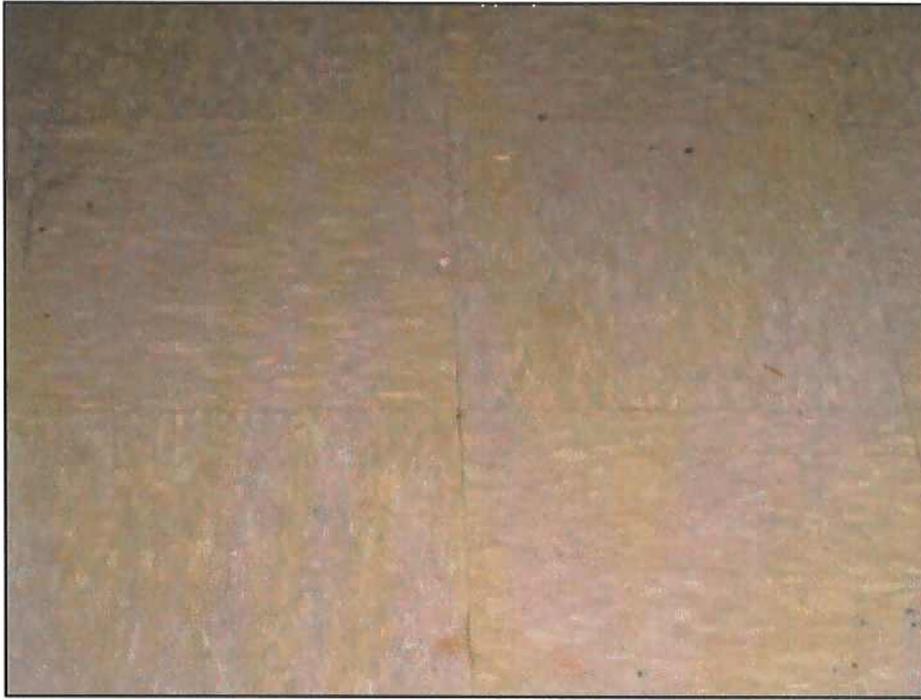
| MATERIAL NUMBER | MATERIAL TYPE (MATERIAL DESCRIPTION) | ASBESTOS CONTENT | MATERIAL LOCATION(S) | FRIABLE | CONDITION | QUANTITY | COMMENTS |
|---|--|---|---|---|---|---|---|
| 005 | FLOOR ADHESIVE (BLACK/ BEIGE, UNDER 004) | 4% CH | SUPPLY | No | UNDAMAGED | 529 SF | |

1'x1' tan with white mottle vinyl floor tile (Material #004) over ACM floor adhesive (Material #005)

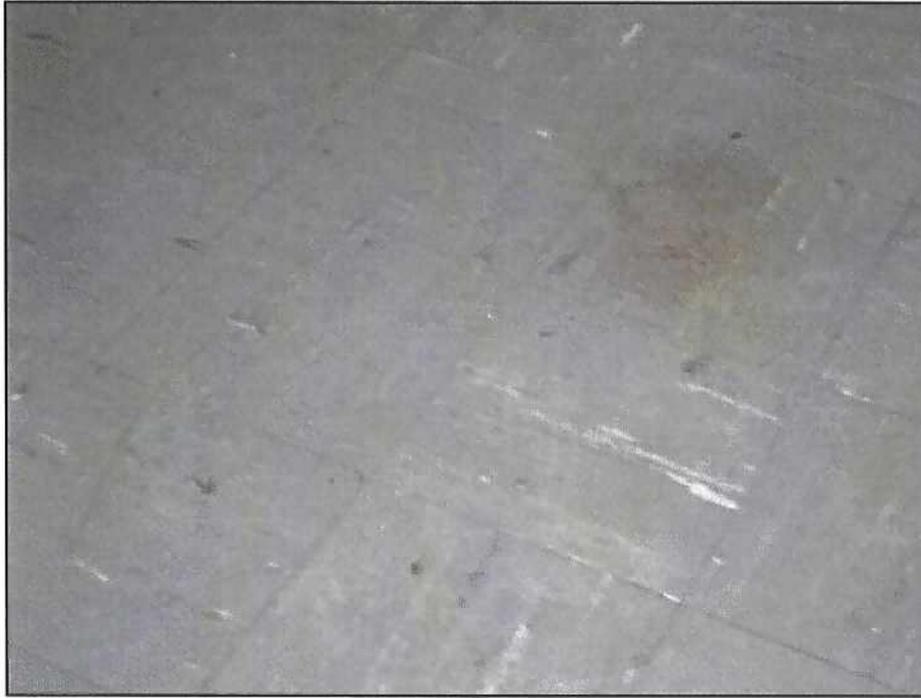
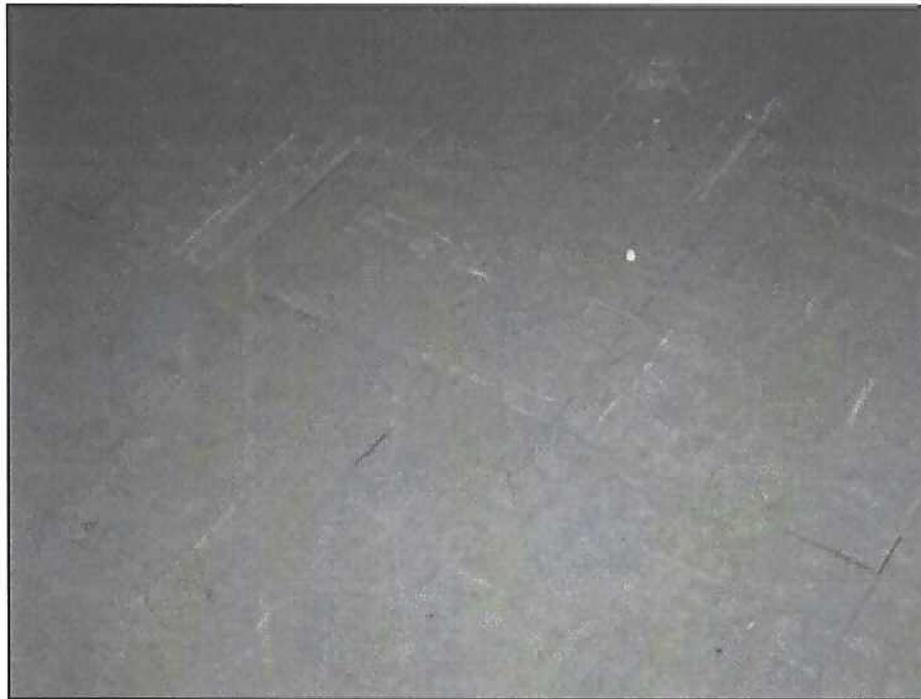
| MATERIAL NUMBER | MATERIAL TYPE (MATERIAL DESCRIPTION) | ASBESTOS CONTENT | MATERIAL LOCATION(S) | FRIABLE | CONDITION | QUANTITY | COMMENTS |
|---|---|---|---|---|---|---|---|
| 003 | FLOOR ADHESIVE (BLACK, UNDER 001 AND 002) | 8% CH | 1 2 3 4 | No | UNDAMAGED | 952 SF | |

Two types of vinyl floor tile (Materials #001 and #002) over ACM floor adhesive (Material #003)

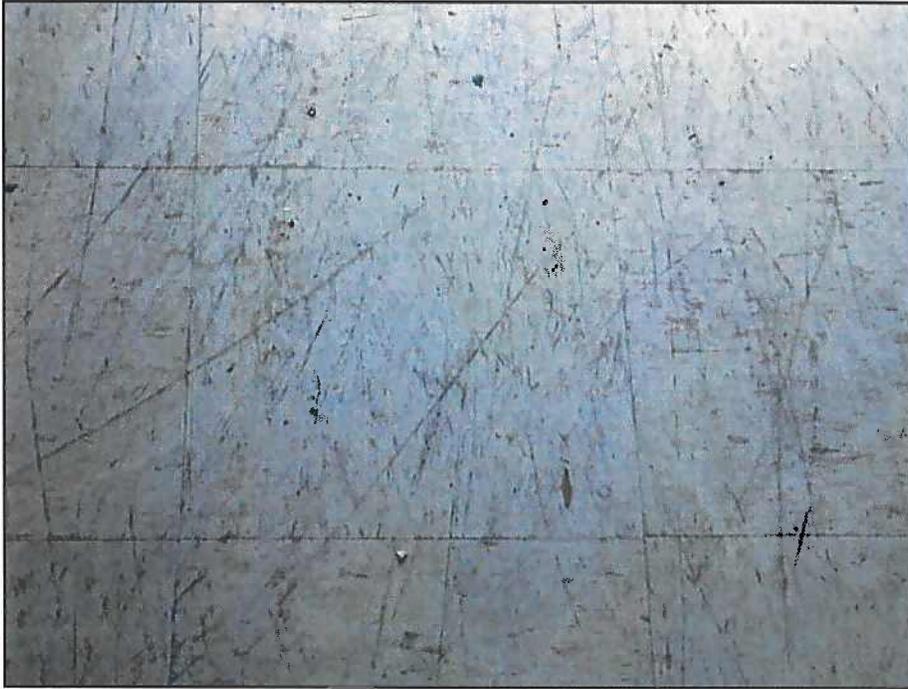
1'x1' cream with brown mottle vinyl floor tile (Material #001) over ACM floor adhesive (Material #002)

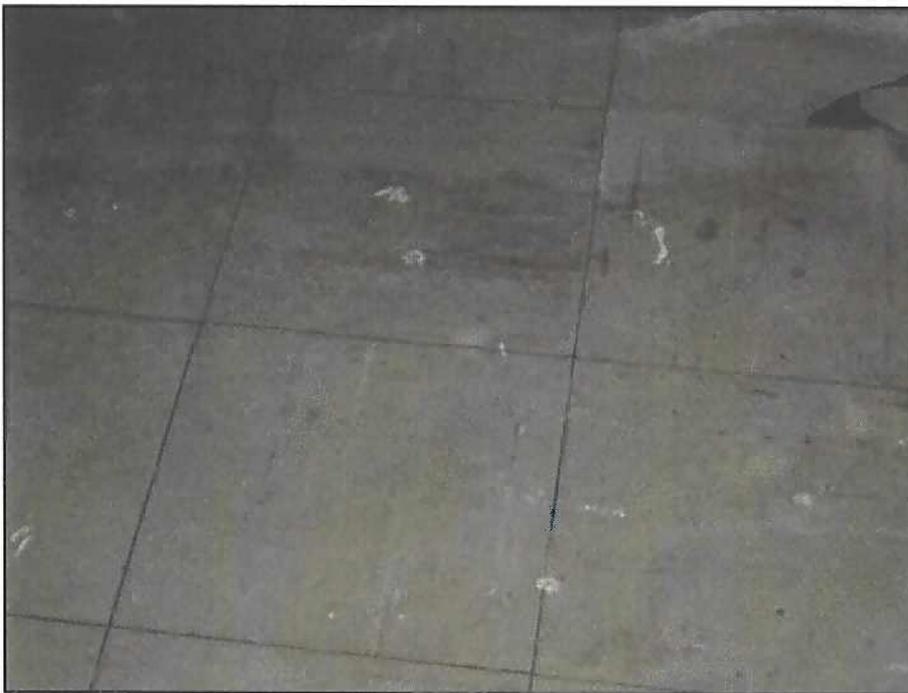
| MATERIAL NUMBER | MATERIAL TYPE (MATERIAL DESCRIPTION) | ASBESTOS CONTENT | MATERIAL LOCATION(S) | FRIABLE | CONDITION | QUANTITY | COMMENTS |
|---|--|---|---|---|---|---|---|
| 003 | VINYL FLOOR TILE (1' X 1' TAN WITH WHITE, BROWN, AND ORANGE STREAKS) | 2% CH | 2 | No | UNDAMAGED | 32 SF | |
| 004 | FLOOR ADHESIVE (BLACK, UNDER 003) | 6% CH | 2 | No | UNDAMAGED | 32 SF | |

1'x1' tan with white, brown, and orange streaks vinyl floor tile (Material #003) over floor adhesive (Material #004)

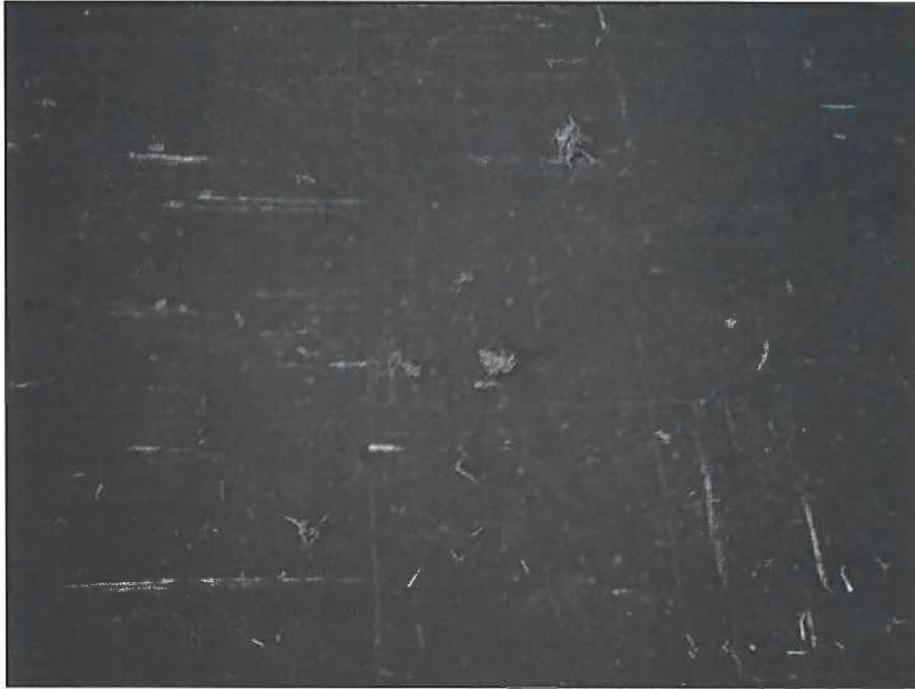
| MATERIAL NUMBER | MATERIAL TYPE (MATERIAL DESCRIPTION) | ASBESTOS CONTENT | MATERIAL LOCATION(S) | FRIABLE | CONDITION | QUANTITY | COMMENTS |
|---|--|---|---|---|---|---|---|
| 004 | FLOOR ADHESIVE (UNDER 001, 002, AND 003) | 8% CH | 1 2 | No | UNDAMAGED | 893 SF | |

1'x1' brown with white and red streaks vinyl floor tile (Material #002) over ACM adhesive (Material #004)

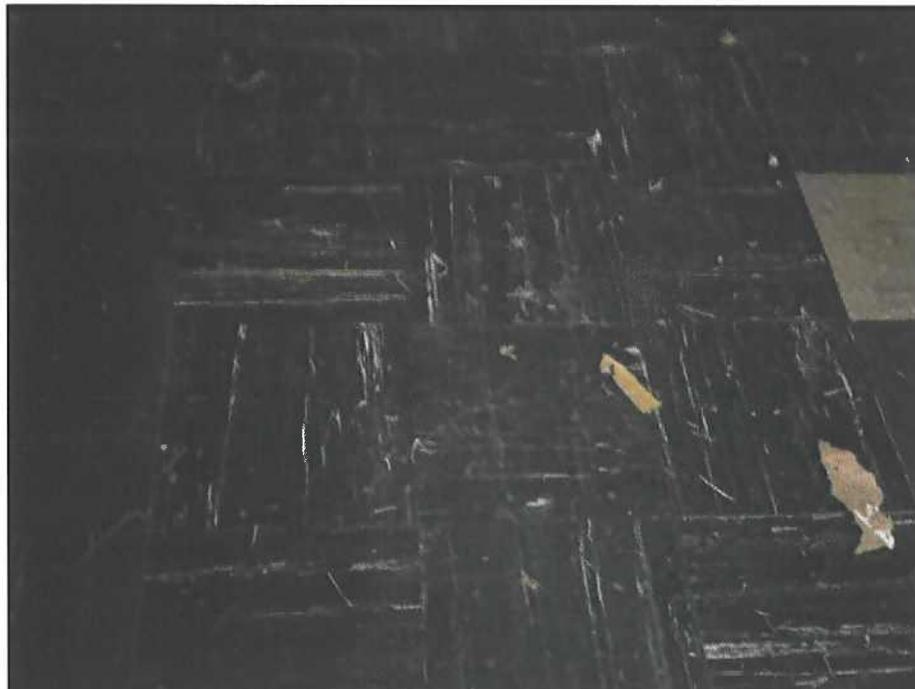
| MATERIAL NUMBER | MATERIAL TYPE (MATERIAL DESCRIPTION) | ASBESTOS CONTENT | MATERIAL LOCATION(S) | FRIABLE | CONDITION | QUANTITY | COMMENTS |
|---|--|---|---|---|---|---|---|
| 003 | VINYL FLOOR TILE (1' X 1' GREEN WITH WHITE STREAKS) | 2% CH | 1 | No | UNDAMAGED | 63 SF | |

1'x1' green with white streaks vinyl floor tile (Material #003) over ACM adhesive (Material #004)

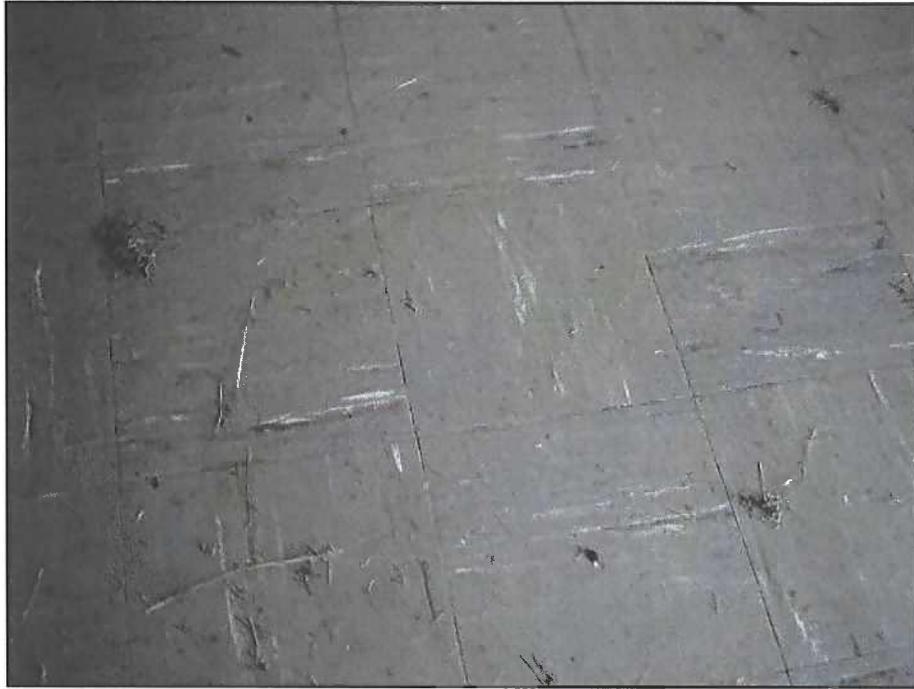
1'x1' tan vinyl floor tile (non-asbestos) over ACM adhesive (Material #004)

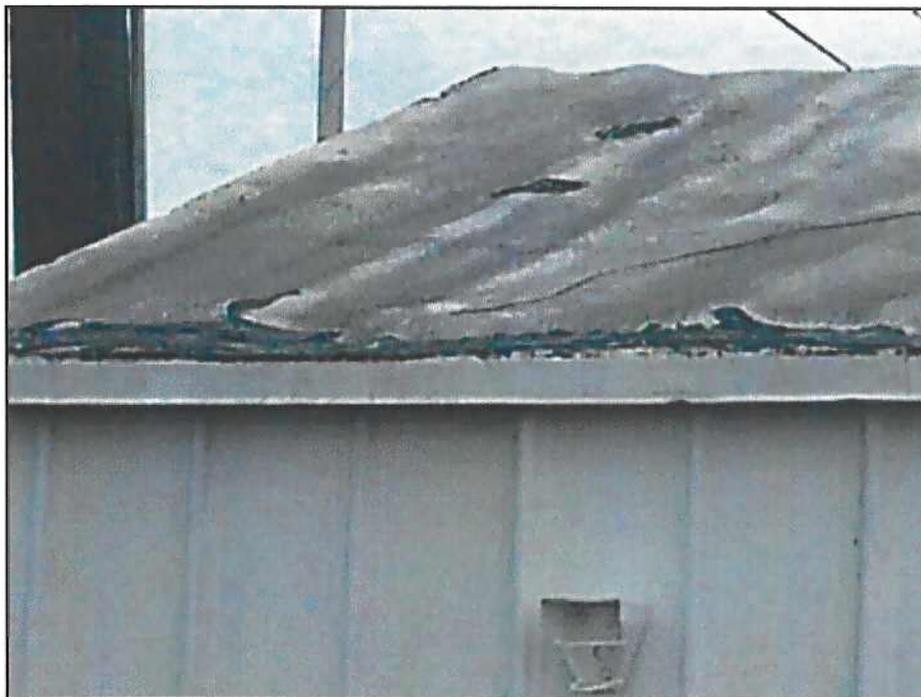
Asphaltic patch on foam roofing material (Material #005)

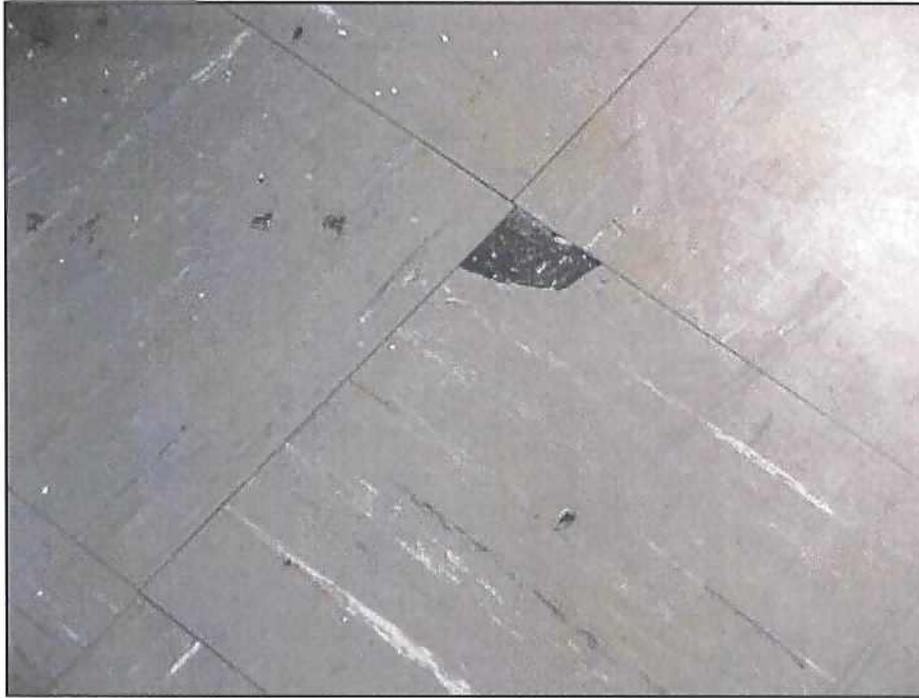
1' x 1' brown vinyl floor tile (Material #001) over ACM floor adhesive (Material #002)

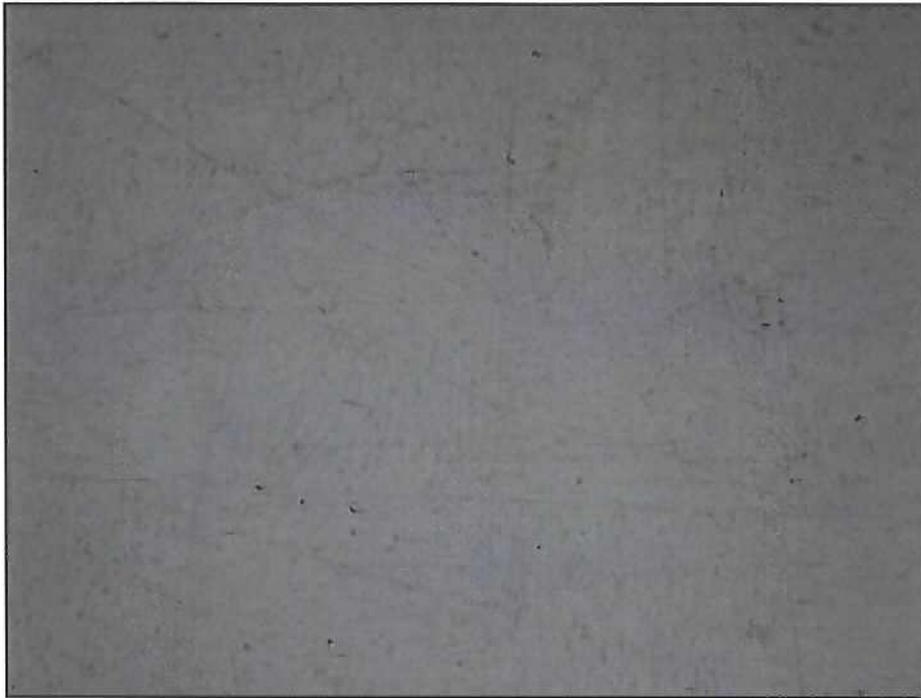
| MATERIAL NUMBER | MATERIAL TYPE (MATERIAL DESCRIPTION) | ASBESTOS CONTENT | MATERIAL LOCATION(S) | FRIABLE | CONDITION | QUANTITY | COMMENTS |
|---|--|---|---|---|---|---|---|
| 002 | FLOOR ADHESIVE (BEIGE/BLACK, UNDER 001) | 5% CH | 1 2 | No | UNDAMAGED | 960 SF | |

Vinyl floor tile (Material #001) over ACM floor adhesive (Material #002)

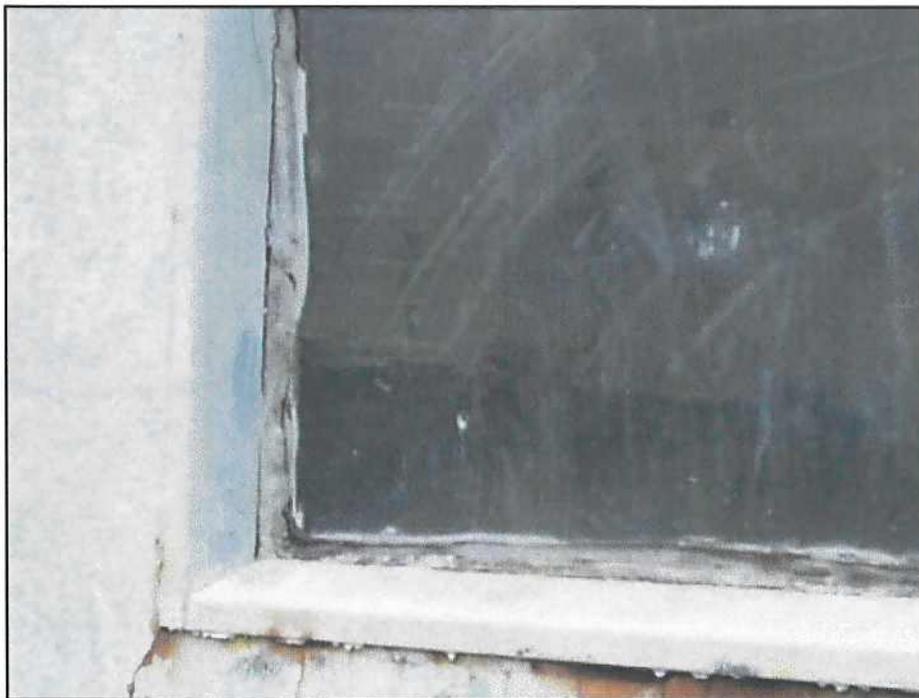
| MATERIAL NUMBER | MATERIAL TYPE (MATERIAL DESCRIPTION) | ASBESTOS CONTENT | MATERIAL LOCATION(S) | FRIABLE | CONDITION | QUANTITY | COMMENTS |
|---|--|---|---|---|---|---|---|
| 006 | EXTERIOR CAULKS (GRAY, ON WINDOWS AND DOORS) | 3% CH | 1 2 | No | UNDAMAGED | 4 LF | |

Exterior window caulking on windows and doors (Material #006)

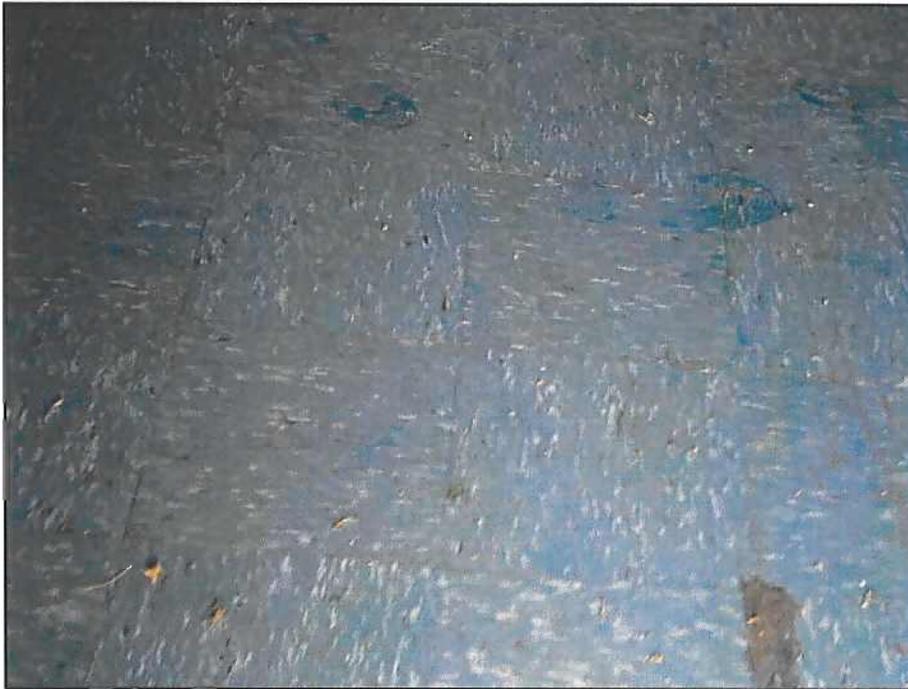
1'x1' blue with white mottle vinyl floor tile (Material #001) over floor adhesive (Material #002)

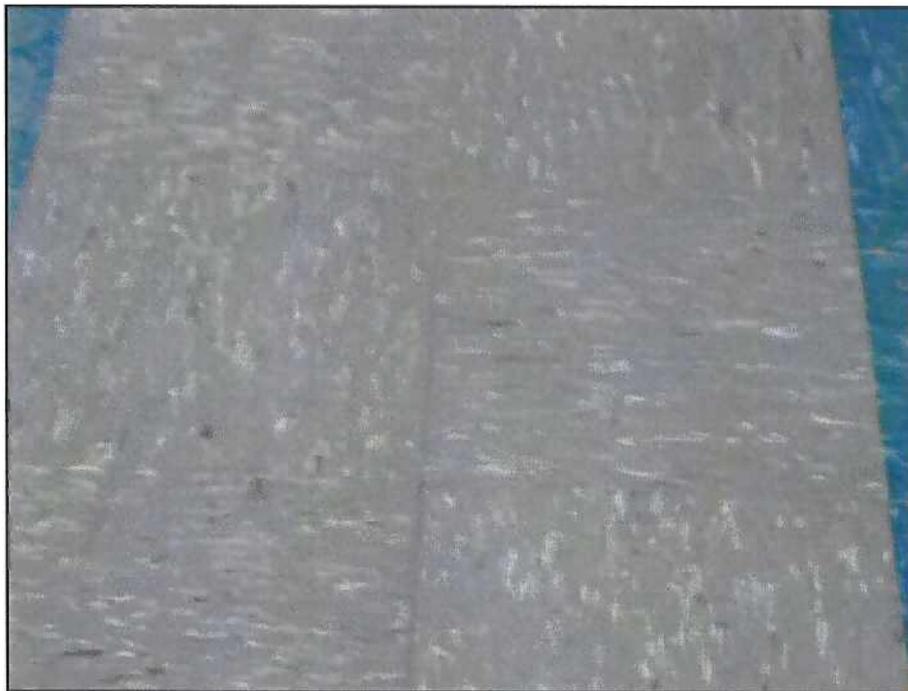
| MATERIAL NUMBER | MATERIAL TYPE (MATERIAL DESCRIPTION) | ASBESTOS CONTENT | MATERIAL LOCATION(S) | FRIABLE | CONDITION | QUANTITY | COMMENTS |
|---|--|---|---|---|---|---|---|
| 008 | VINYL FLOOR TILE (1' X 1' GRAY WITH WHITE MOTTLE) | 2% CH | BAR | No | UNDAMAGED | 30 SF | |

1' X 1' gray with white mottle vinyl floor tile (Material #008)

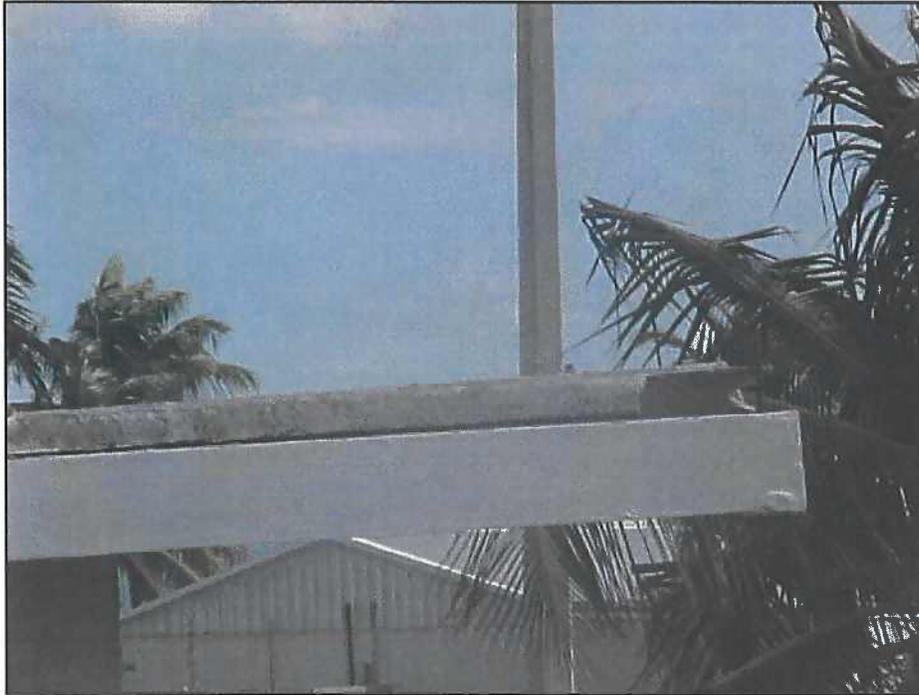
| MATERIAL NUMBER | MATERIAL TYPE (MATERIAL DESCRIPTION) | ASBESTOS CONTENT | MATERIAL LOCATION(S) | FRIABLE | CONDITION | QUANTITY | COMMENTS |
|---|---|---|---|---|---|---|---|
| 001 | CEMENT CORRUGATED ROOF (GRAY) | 12% CH | ROOF | No | UNDAMAGED | 112 SF | |

Cement corrugated roof (Material #001)

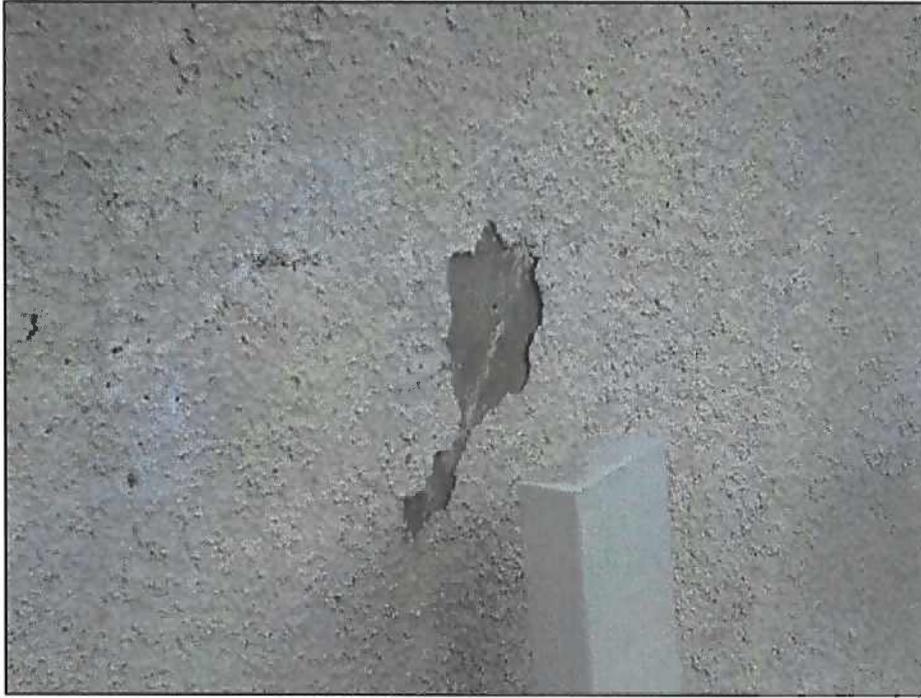
| MATERIAL NUMBER | MATERIAL TYPE (MATERIAL DESCRIPTION) | ASBESTOS CONTENT | MATERIAL LOCATION(S) | FRIABLE | CONDITION | QUANTITY | COMMENTS |
|---|--|---|---|---|---|---|---|
| 001 | EXTERIOR PLASTERS (CREAM STUCCO ON CONCRETE) | 5% CH | EXTERIOR | No | UNDAMAGED | 620 SF | |

Exterior stucco on concrete (Material #001)

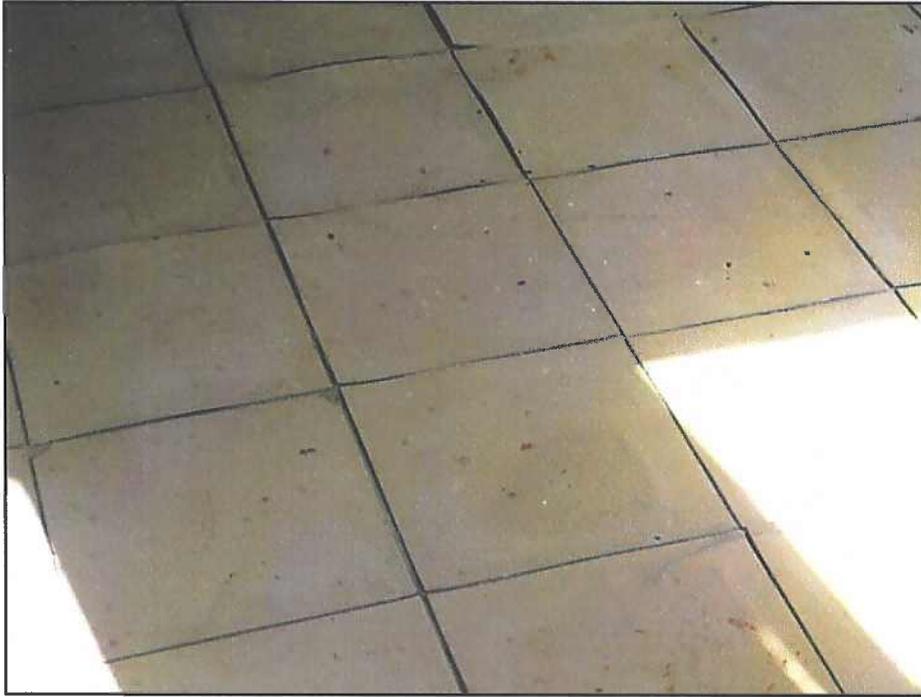
Building 3152 is identified as “Pest Control Building” and is approximately 324 square feet in size. Three suspect homogeneous materials were identified and sampled. One material, floor adhesive (Material #002), was found to be ACM. No friable, damaged, and accessible ACM was identified.

1'x1' tan with brown and orange streaks vinyl floor tile (Material #001) over ACM floor adhesive (Material #002)

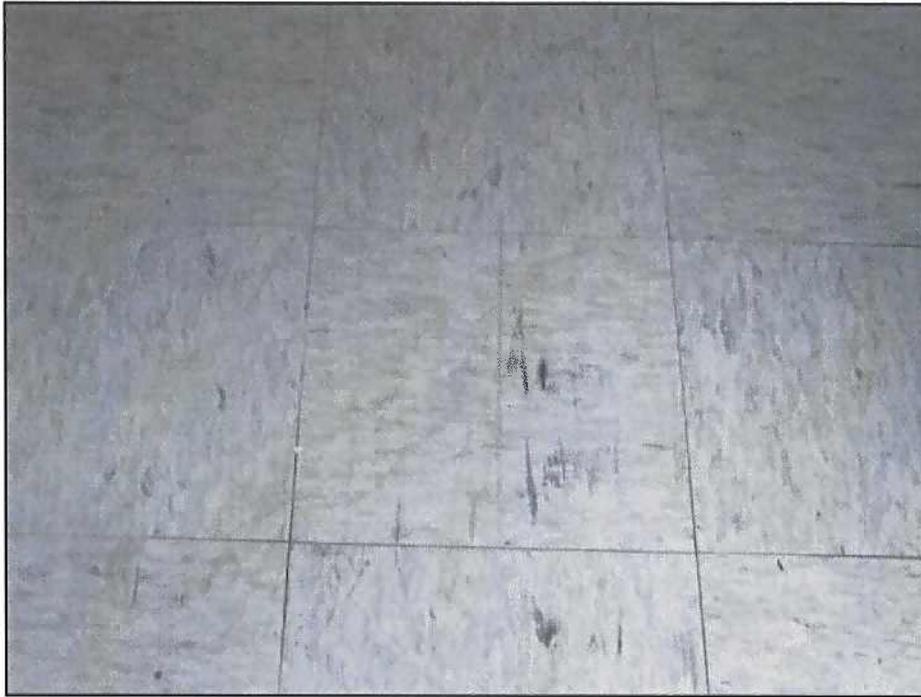
Building 3166 is identified as “Bravo Carpenter Shop” and is approximately 5,706 square feet in size. Seventeen suspect homogeneous materials were identified and sampled. One material, floor adhesive (Material #016), was found to be an ACM. No friable, damaged, and accessible ACM was identified.

1'x1' white with tan and black mottle vinyl floor tile (Material #015) over ACM floor adhesive (Material #016)

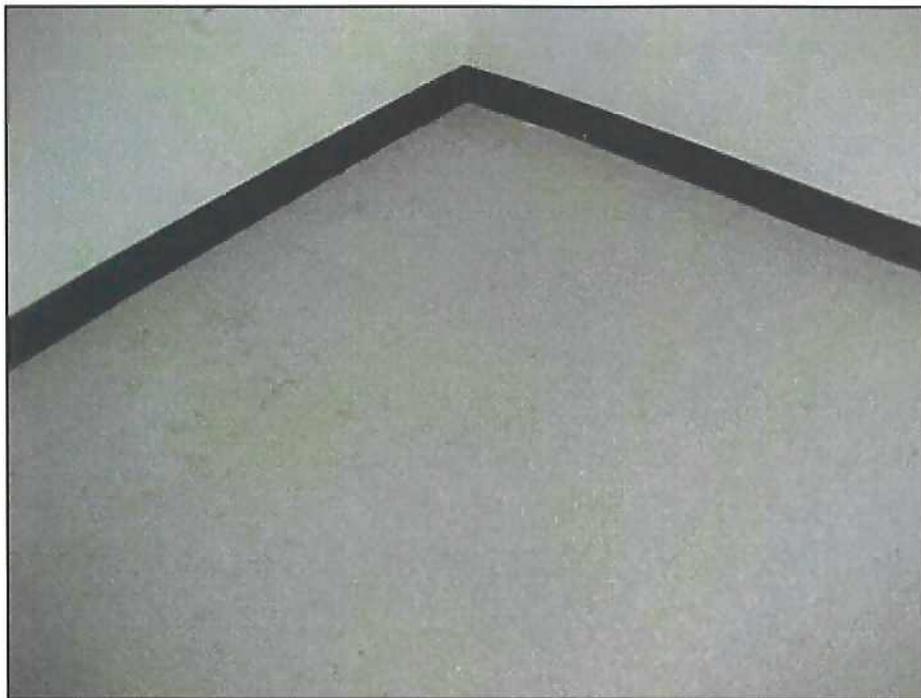
| MATERIAL NUMBER | MATERIAL TYPE (MATERIAL DESCRIPTION) | ASBESTOS CONTENT | MATERIAL LOCATION(S) | FRIABLE | CONDITION | QUANTITY | COMMENTS |
|---|---|---|---|---|---|---|---|
| 002 | FLOOR ADHESIVE (BLACK, UNDER 1' X 1' GRAY VINYL FLOOR TILE) | 2% CH | 1 2 3 | No | UNDAMAGED | 900 SF | |

1'x1' gray vinyl floor tile (Material #001) over ACM adhesive (Material #002)

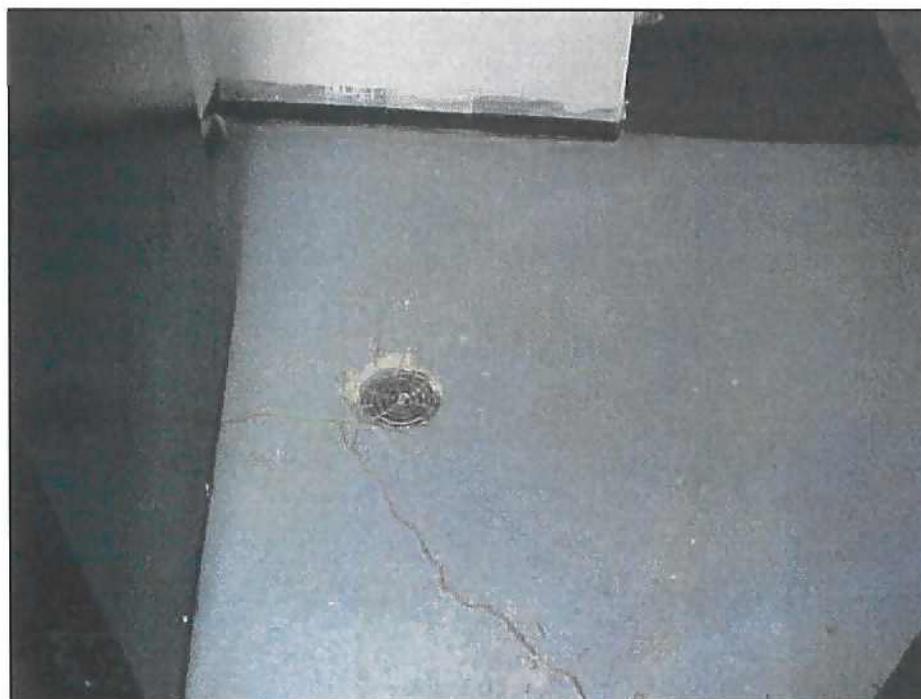
| MATERIAL NUMBER | MATERIAL TYPE (MATERIAL DESCRIPTION) | ASBESTOS CONTENT | MATERIAL LOCATION(S) | FRIABLE | CONDITION | QUANTITY | COMMENTS |
|---|---|---|---|---|---|---|---|
| 004 | FLOOR ADHESIVE (BLACK, UNDER 1' X 1' BLUE VINYL FLOOR TILE) | 2% CH | 4 | No | UNDAMAGED | 64 SF | |

1'x1' blue vinyl floor tile (Material #003) over ACM adhesive (Material #004)

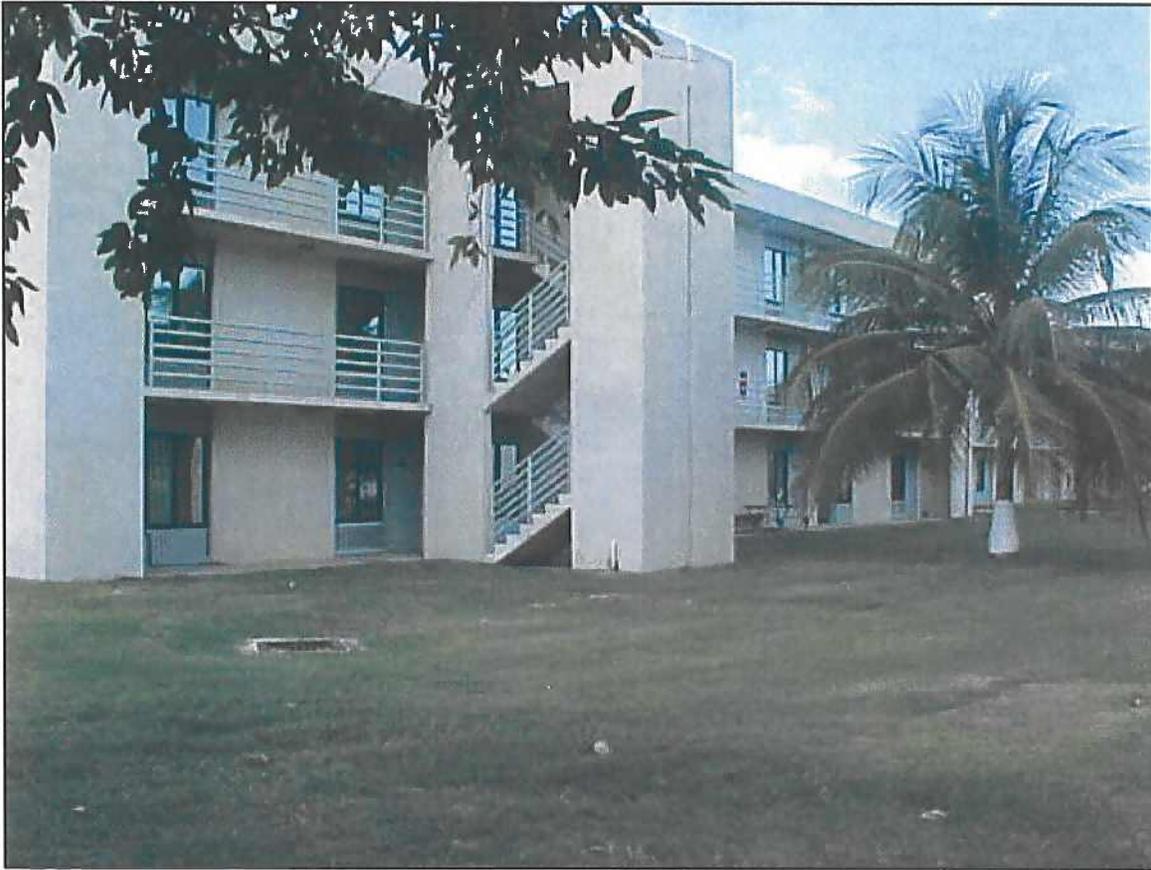
BUILDING 3181

Building 3181 is identified as “BEQ 1A” and is approximately 38,002 square feet in size. Three suspect homogeneous materials were identified and sampled. None of the materials were found to be ACM.

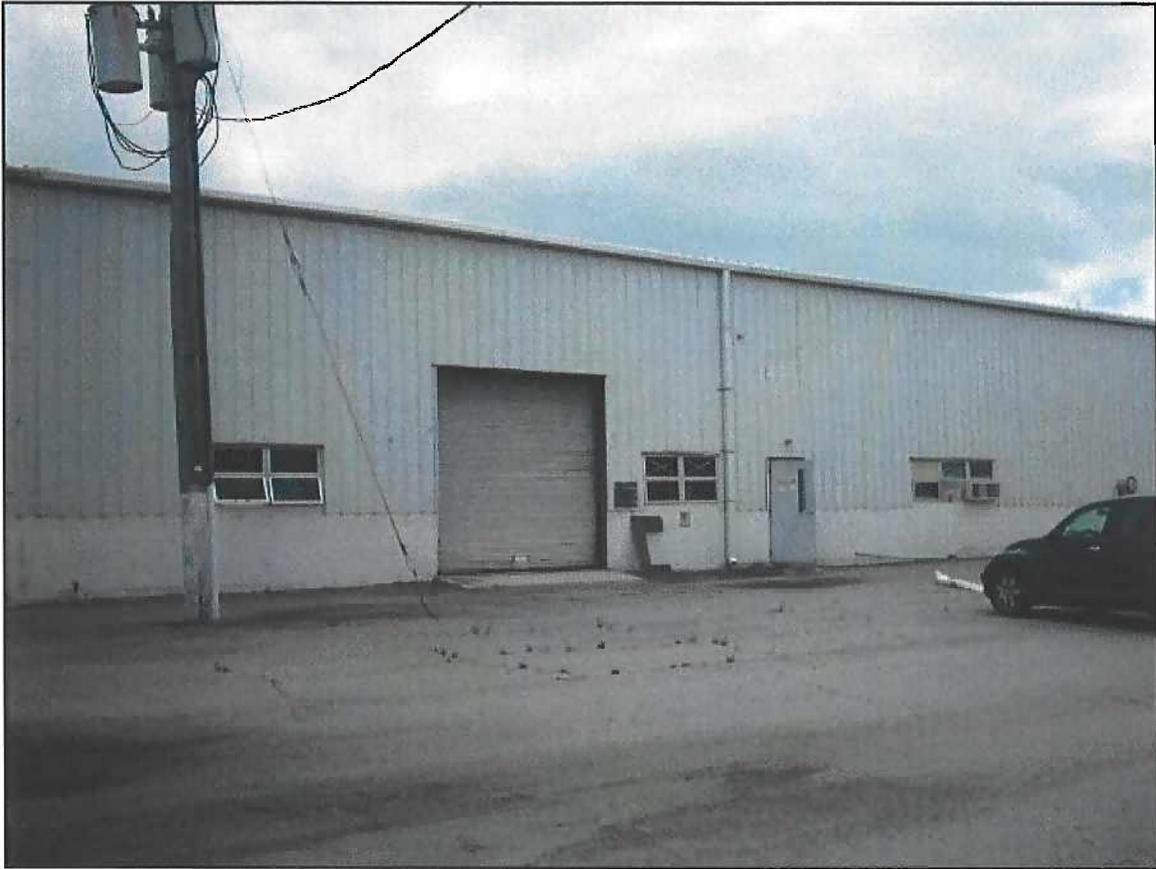
BUILDING 3190

Building 3190 is identified as “U.T. Shop Bravo Co.” and is approximately 5,706 square feet in size. Twelve suspect homogeneous materials were identified and sampled. None of the materials were found to be ACM.
