Final
Asbestos Inspection Report
for

Naval Activity Puerto Rico
Ceiba, Puerto Rico

Volume 7 of 7

Buildings 3015 through 3195

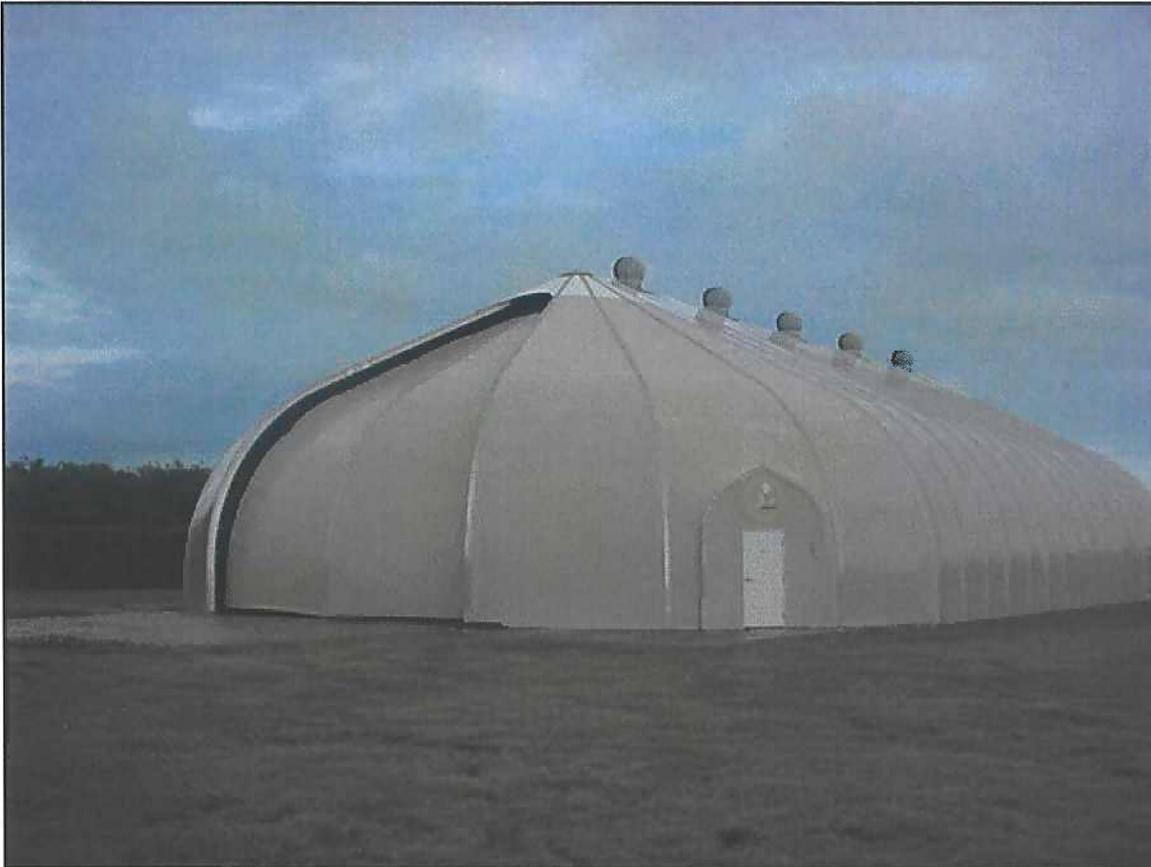
BUILDING 3192

Building 3192 is identified as “Sea Bees Supplies Whse” and is approximately 11,200 square feet in size. One suspect homogeneous material was identified and sampled. The material is not ACM.

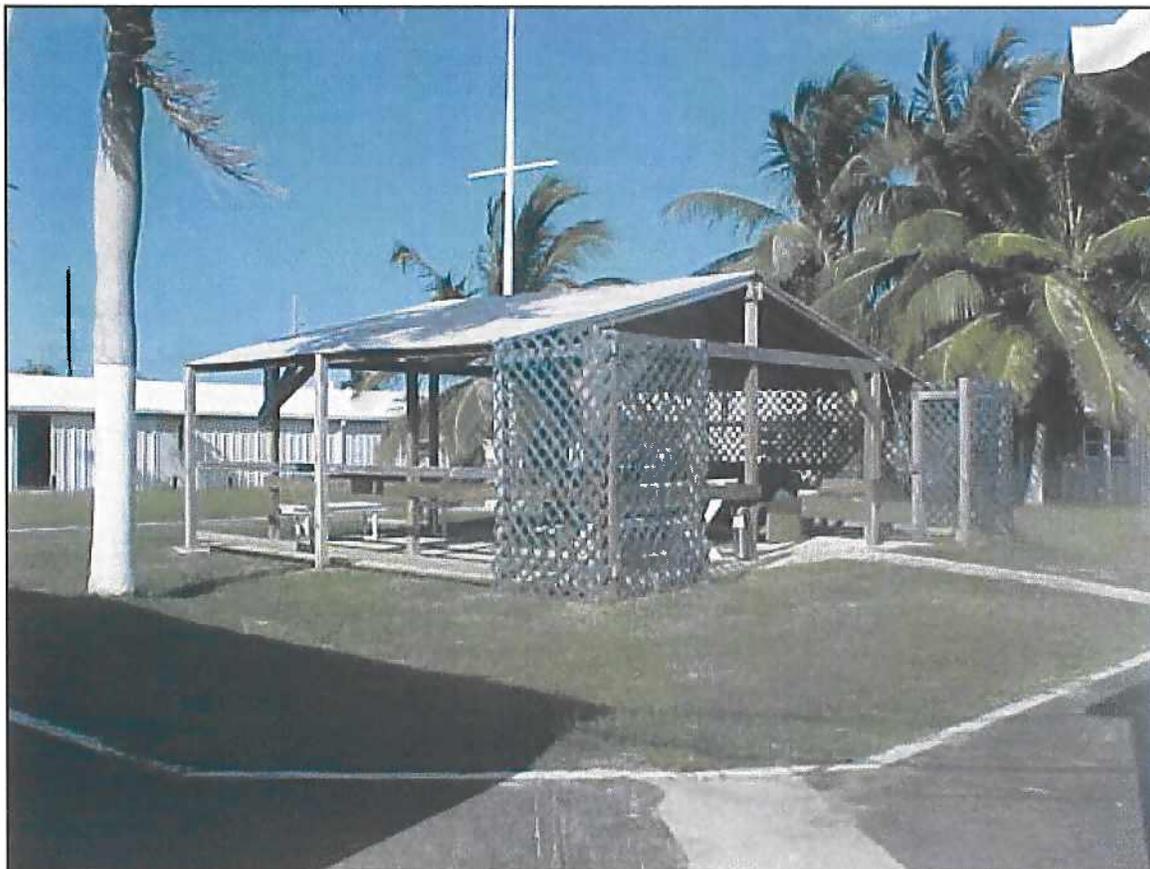
BUILDING 3193

Building 3193 is identified as “Pavilion by Bldg 3019” and is approximately 432 square feet in size. No suspect materials were identified. Therefore, no sampling was conducted.

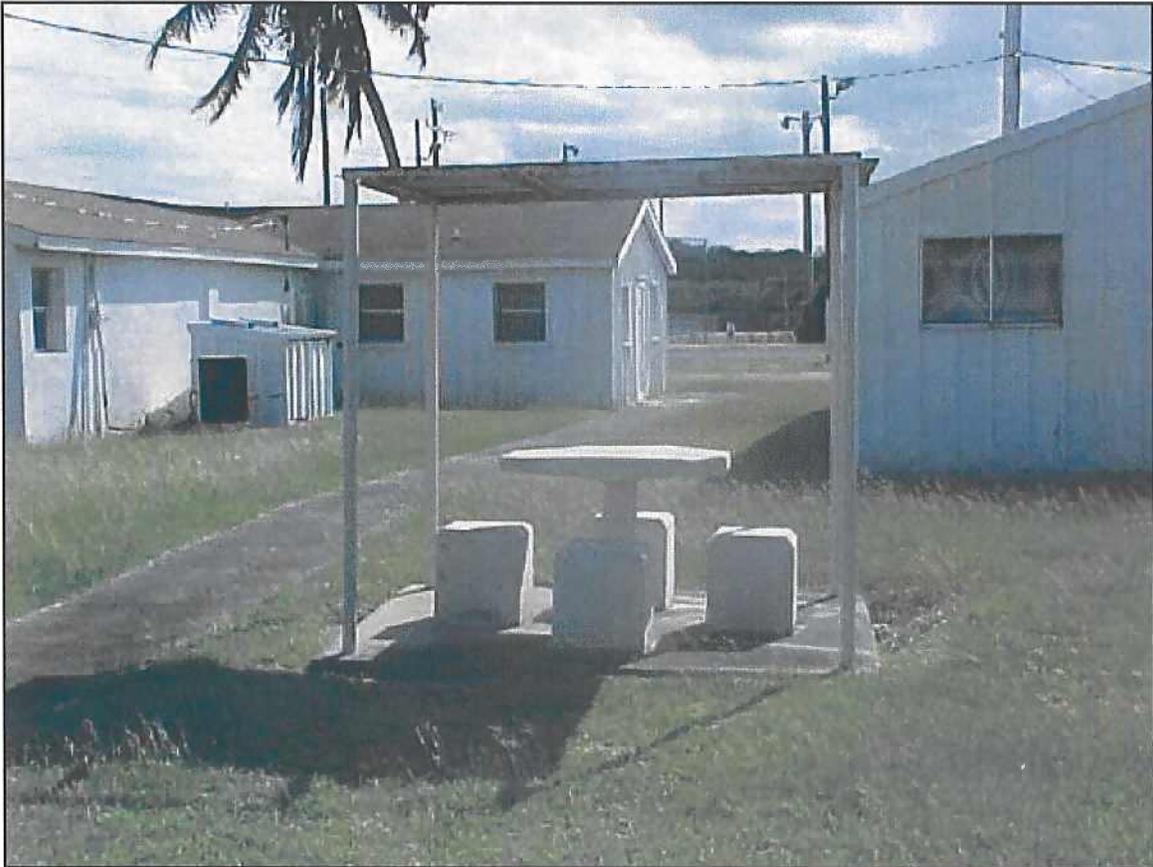
BUILDING 3194

Building 3194 is identified as “Pavilion by Bldg 3168” and is approximately 49 square feet in size. No suspect materials were identified. Therefore, no sampling was conducted.

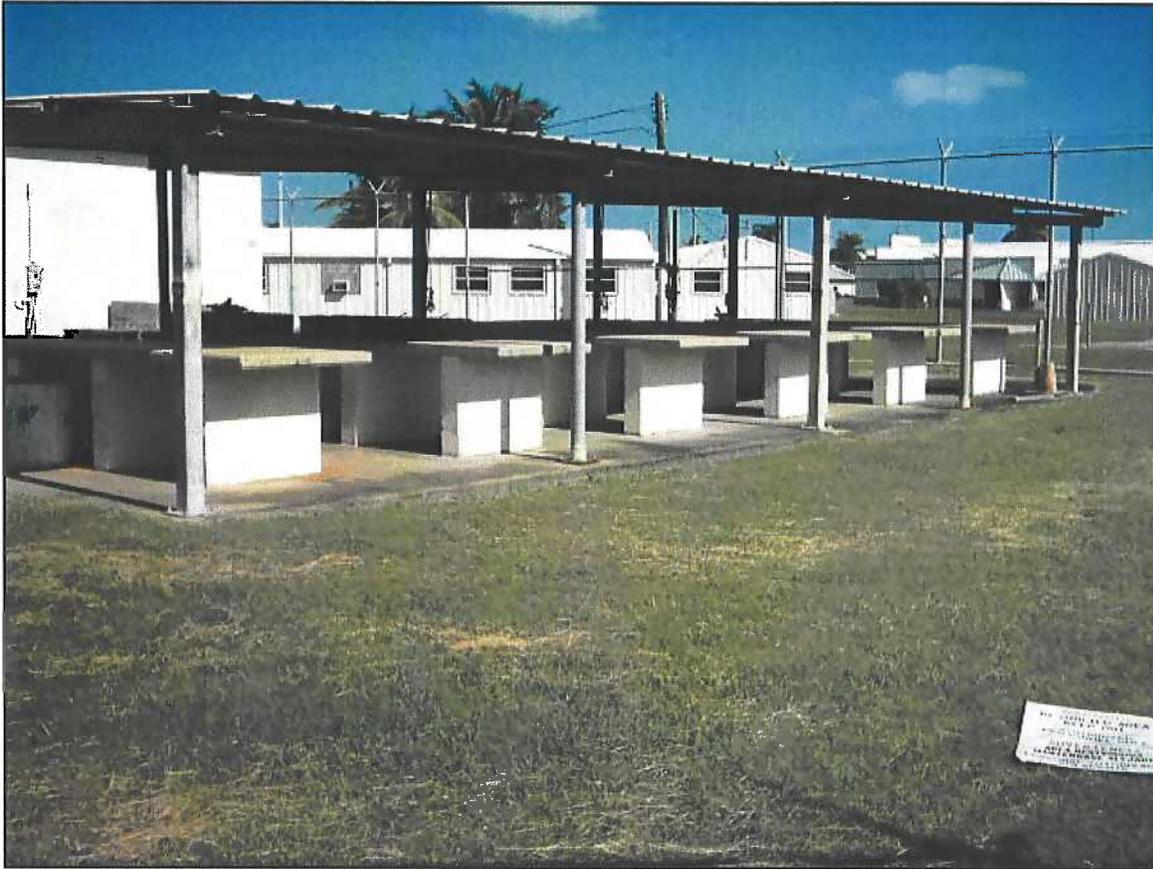
BUILDING 3195

Building 3195 is identified as “Weapons Cleaning Shelter” and is approximately 960 square feet in size. No suspect materials were identified. Therefore, no sampling was conducted.
