DRAAFT FINAL RESOURCE CONSERVATION AND RECOVERY ACT FACILITY
INVESTIGATION REPORT FOR SOLID WASTE MANAGEMENT UNIT 11 NAVAL ACTIVITY
PUERTO RICO (DRAFT ACTING AS FINAL)
5/18/2004
CH2M HILL

RCRA Facility Investigation Report

SWMU 11

Naval Activity Puerto Rico
RCRA/HSWA Permit No. PR2170027203
Ceiba, Puerto Rico

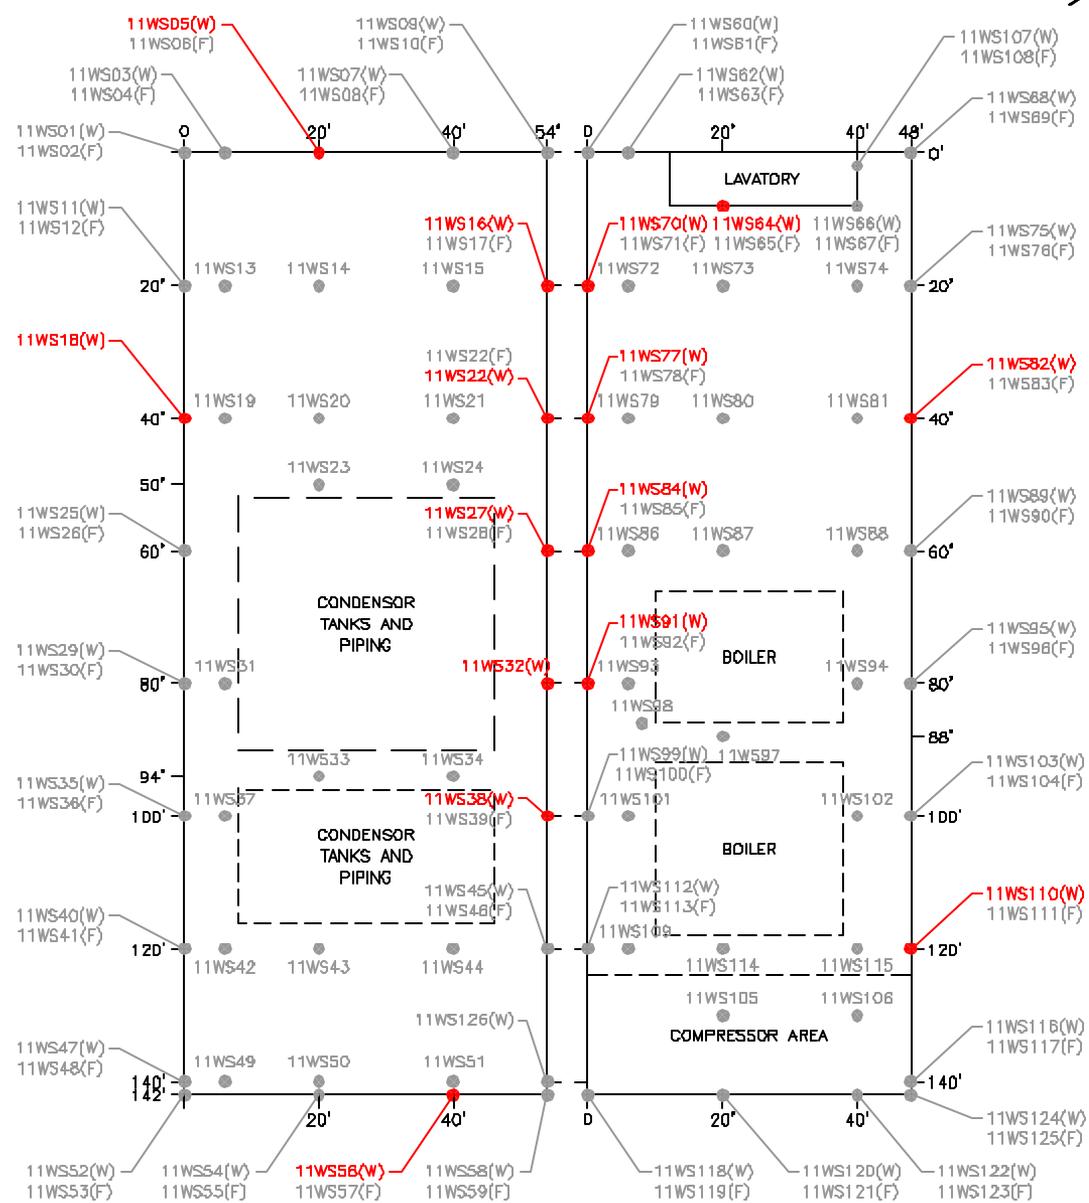
- Wipe samples at 15 locations along the interior walls of Building 38 (see Figure 2-1).
- Wipe samples at 20 locations along the interior floor of Building 38 (see Figure 2-2).
- Wipe samples at 10 locations located inside Building 38, located in the field after visible signs of residue from the fire were observed (see Figure 2-3).
- Concrete chip samples at 6 locations along the interior walls (see Figure 2-4).
- Concrete chip samples at 13 locations along the interior floors (see Figure 2-5).

All 17-wipe samples collected from the walls were analyzed for PCBs using Contract Laboratory Protocols (CLP) with a 28-day turnaround time. These analytes were selected based on the results of the previous investigation, along with the occurrence of the fire. The samples collected from locations 11WS32(W) and 11WS38(W) were also analyzed for dioxin/furans based on visual observations (i.e., smoke stains from the 1997 fire). The additional analysis requested was based on Section 3.1.2.3 of the EPA approved Recharacterization Work Plan (Baker, 2003b).

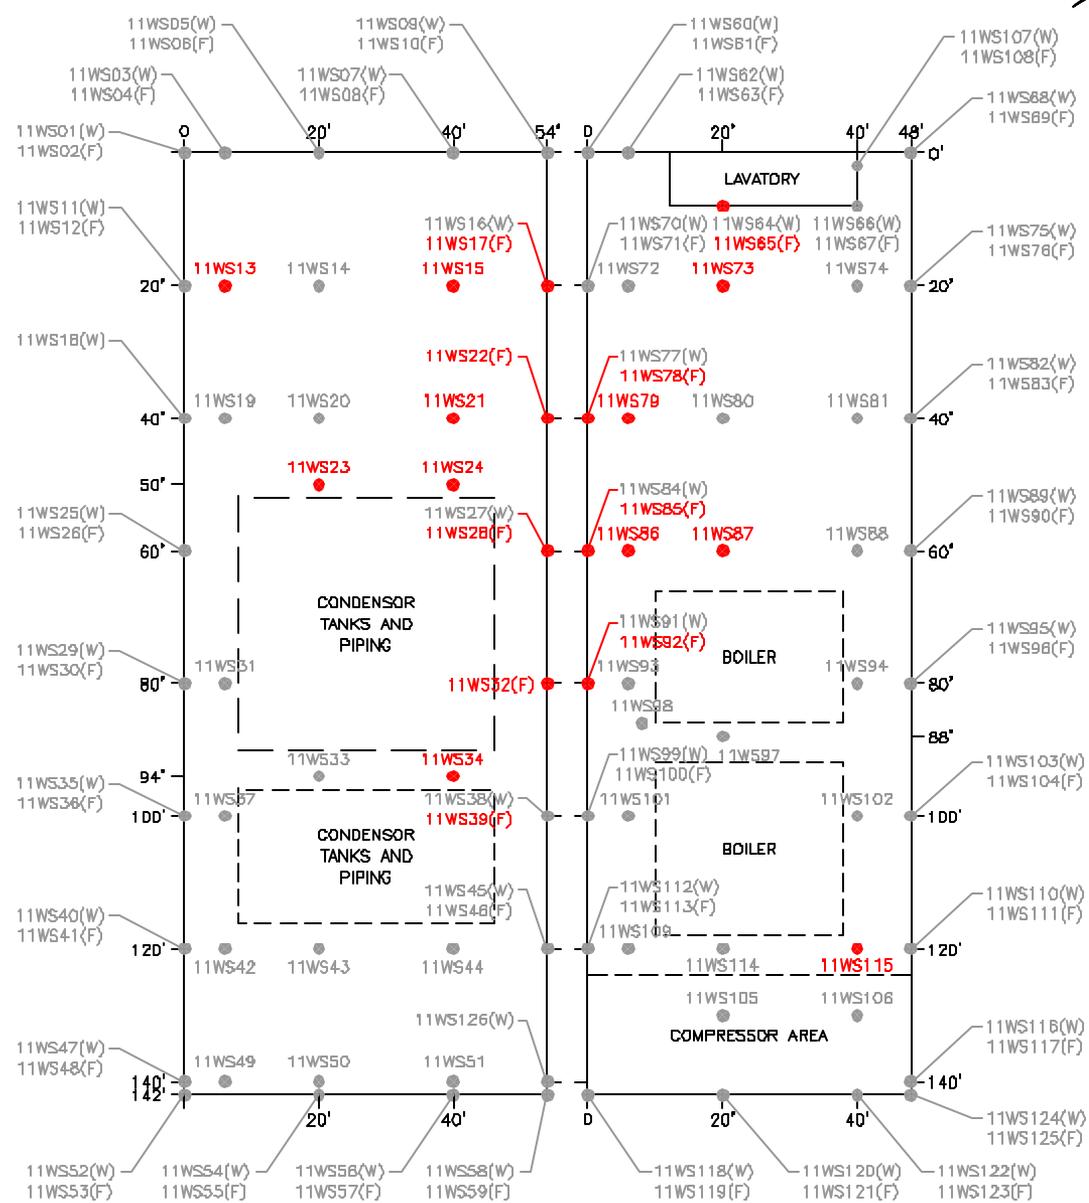
All 22-wipe samples from the floor were analyzed for PCBs using CLP with a 28-day turnaround time. These analytes were selected based on the results of the previous investigation, along with the occurrence of the fire. The sample collected from sample location 11WS32(F) was also analyzed for dioxin/furans based on visual observations (i.e., smoke stains from the 1997 fire). The additional analysis requested was based on Section 3.1.2.3 of the EPA approved Recharacterization Work Plan (Baker, 2003b).

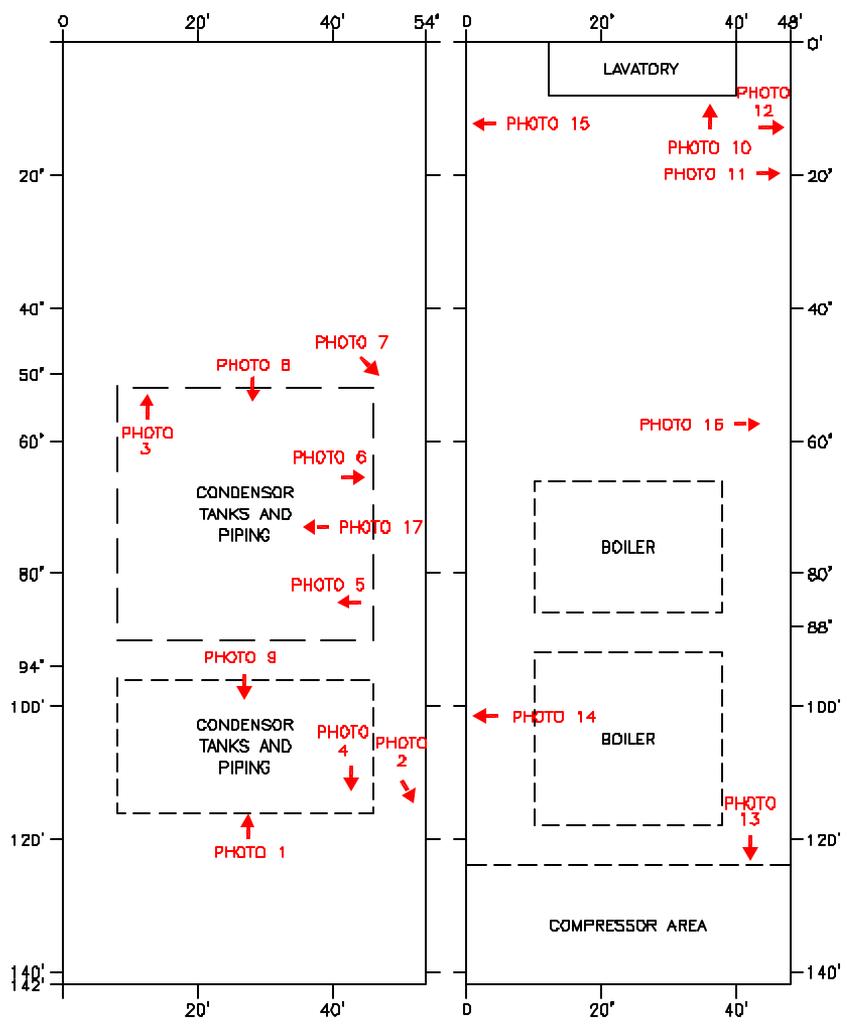
A total of nine additional wipe samples were collected along with one duplicate sample from areas inside the building, which demonstrated visual signs (i.e., black residue) of smoke staining from the 1997 fire. The nine additional wipe samples were collected based on Section 3.1.2.3 of the EPA approved Recharacterization Work Plan (Baker, 2003b). The areas where these additional samples were collected included the sides of concrete support beams, a concrete doorframe, steel end cap, etc. These samples were collected and analyzed for dioxins/furans only to make a determination if dioxins/furans were generated from the presence of PCBs inside the building along with the fire. These 10 samples were not co-located with the PCB wipe samples mentioned in the above two sections. All nine-sample locations were approximated in the field and recorded. Due to the locations of these samples, photographs were taken in the field to document their locations. Figure 2-3 presents the approximate location in which the ten samples were collected, as well as presents the direction in which the photographs were taken of each location. Appendix A.1 provides photographs documenting the exact location that all ten samples were collected, as well as a detailed description of each location.

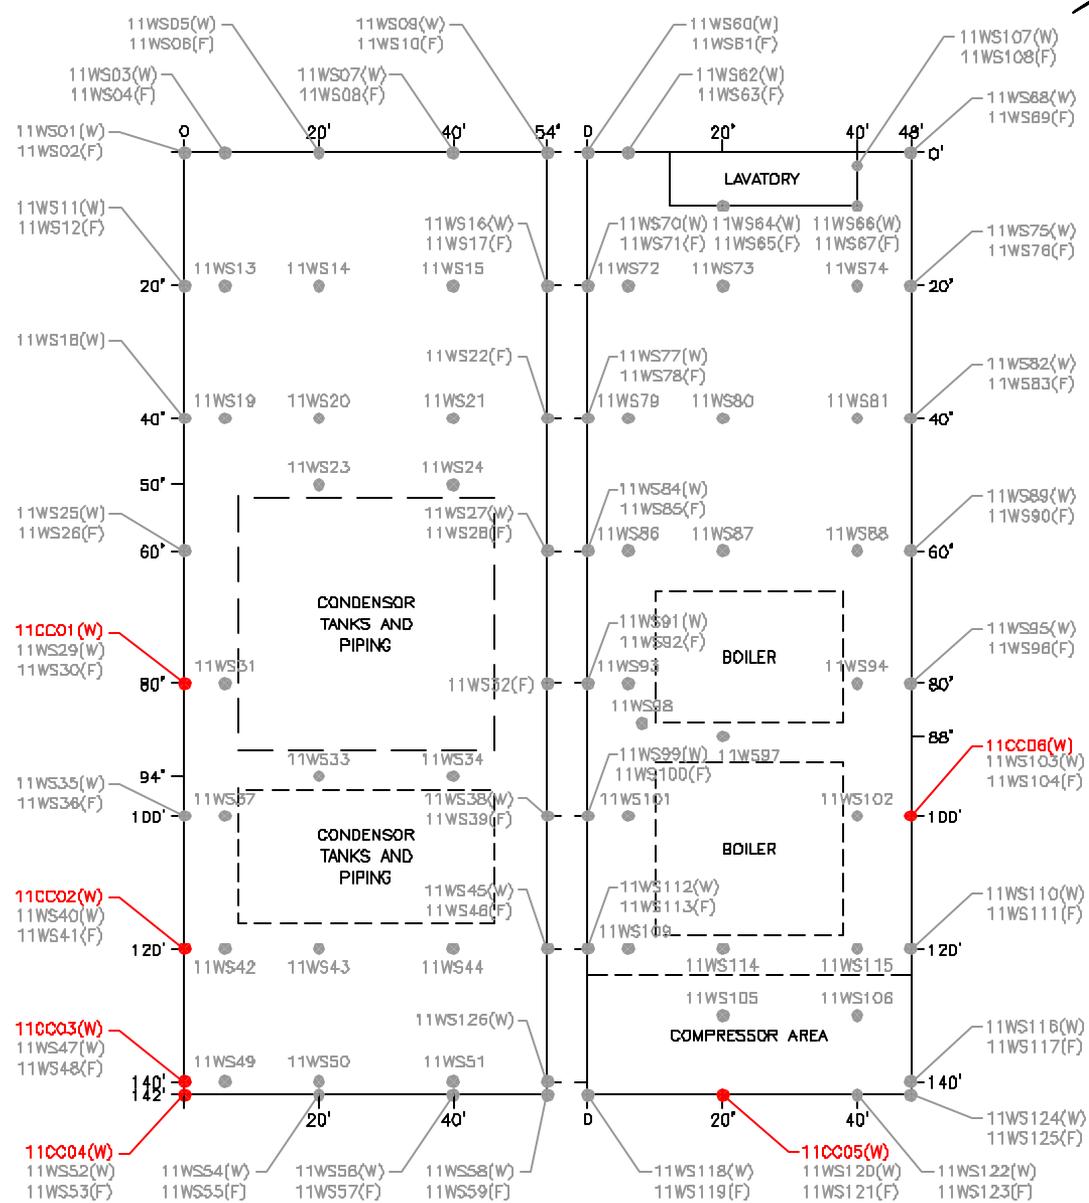
FIGURE 2-4
CONCRETE CHIP SAMPLING
LOCATIONS FOR WALLS
SWMU 11 - BUILDING 38 INTERIOR
NAVAL STATION ROOSEVELT ROADS
PUERTO RICO

A total of six concrete chip samples along with one duplicate sample were collected from the walls inside Building 38, as presented on Figure 2-4. The concrete chip samples along the walls were collected within two feet of the floor, to a depth of approximately ½ inch, as requested by the EPA (EPA, 2002).

A total of seven concrete chip samples, including one duplicate sample, were collected along the walls at SWMU 11 and analyzed for PCBs. Aroclor-1260 was the only PCB detected in each of the seven samples collected, with concentrations ranging from 180 micrograms per kilogram ($\mu\text{g}/\text{kg}$) in sample 11CC05(W) and its duplicate 11CC05D(W), to 1,800 $\mu\text{g}/\text{kg}$ in sample 11CC02(W), as presented in Table 3-5. Figure 2-4 presents the concrete chip sample locations on the walls. An analysis of the concrete chip sample results was conducted by comparing the results to High Occupancy Area Cleanup Level (1,000 $\mu\text{g}/\text{kg}$) and the Low Occupancy Area Cleanup Level (25,000 $\mu\text{g}/\text{kg}$) as outlined in 40CFR761.61(a)(4)(i). Two of the 7 concrete chip samples from the walls collected during the recharacterization investigation were greater than the High Occupancy Area Cleanup Level at concentrations ranging from 180 to 1,800 $\mu\text{g}/\text{kg}$ but below the Low Occupancy Area Cleanup Level.

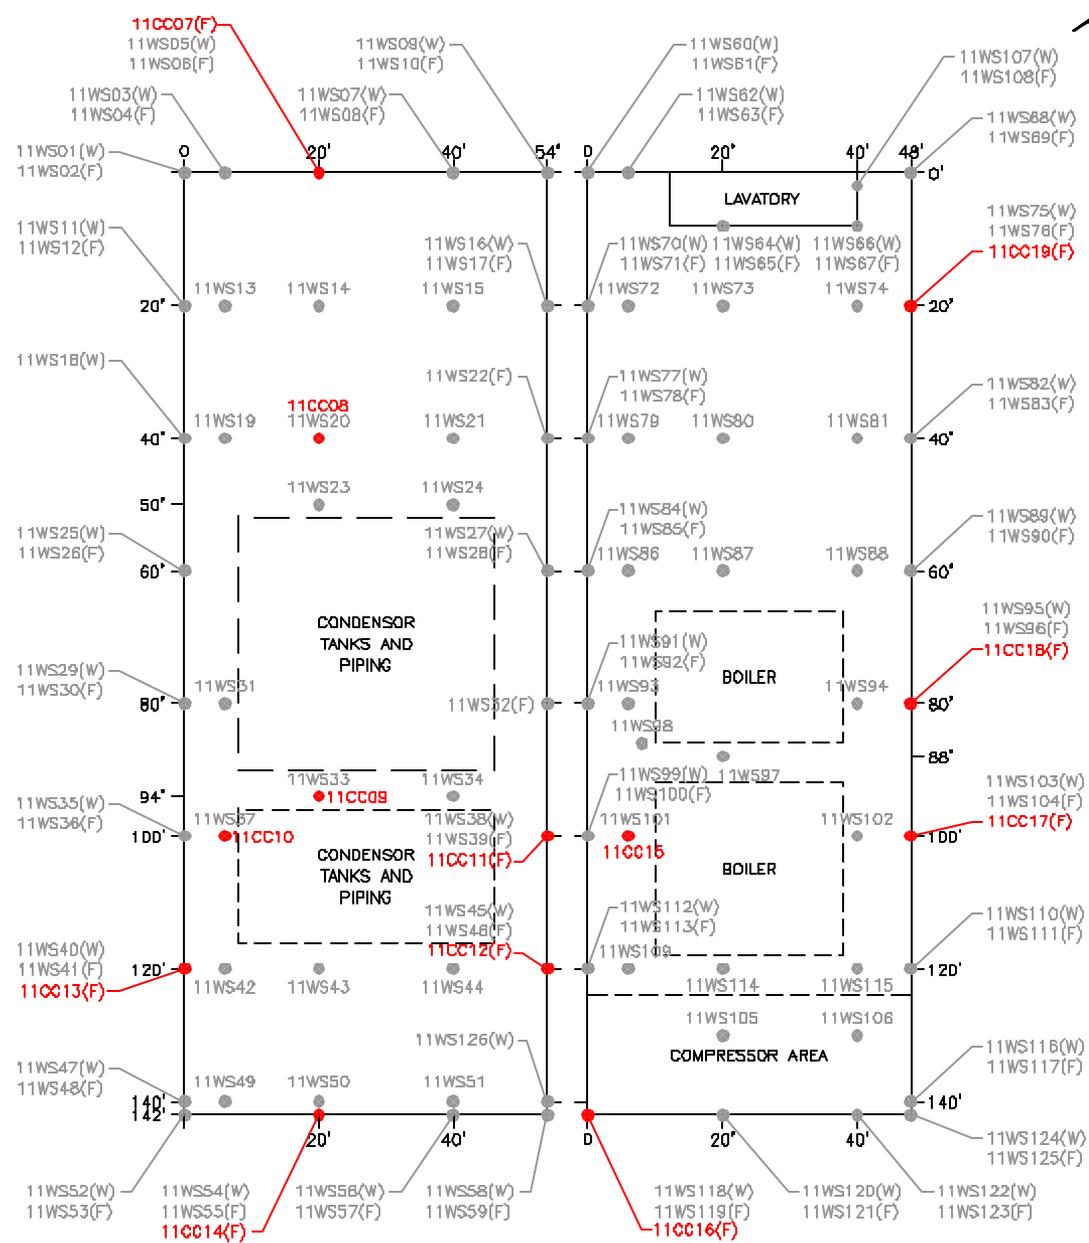
A total of 19 concrete chip samples along with two duplicate samples were collected from various areas (walls and floors) that were impacted by prior contamination based on visual observation (i.e. chemical and/or staining on walls/floor). The areas sampled were established in the EPA approved recharacterization work plan (Baker, 2003b), and are presented on Figures 2-4 and 2-5.
