ENGINEERING INVESTIGATION

TELEVISION INSPECTION
AND
ENGINEERING STUDY OF STORM SEWERS

AT
ALAMEDA NAVAL AIR STATION
ALAMEDA, CALIFORNIA

DECEMBER 1990

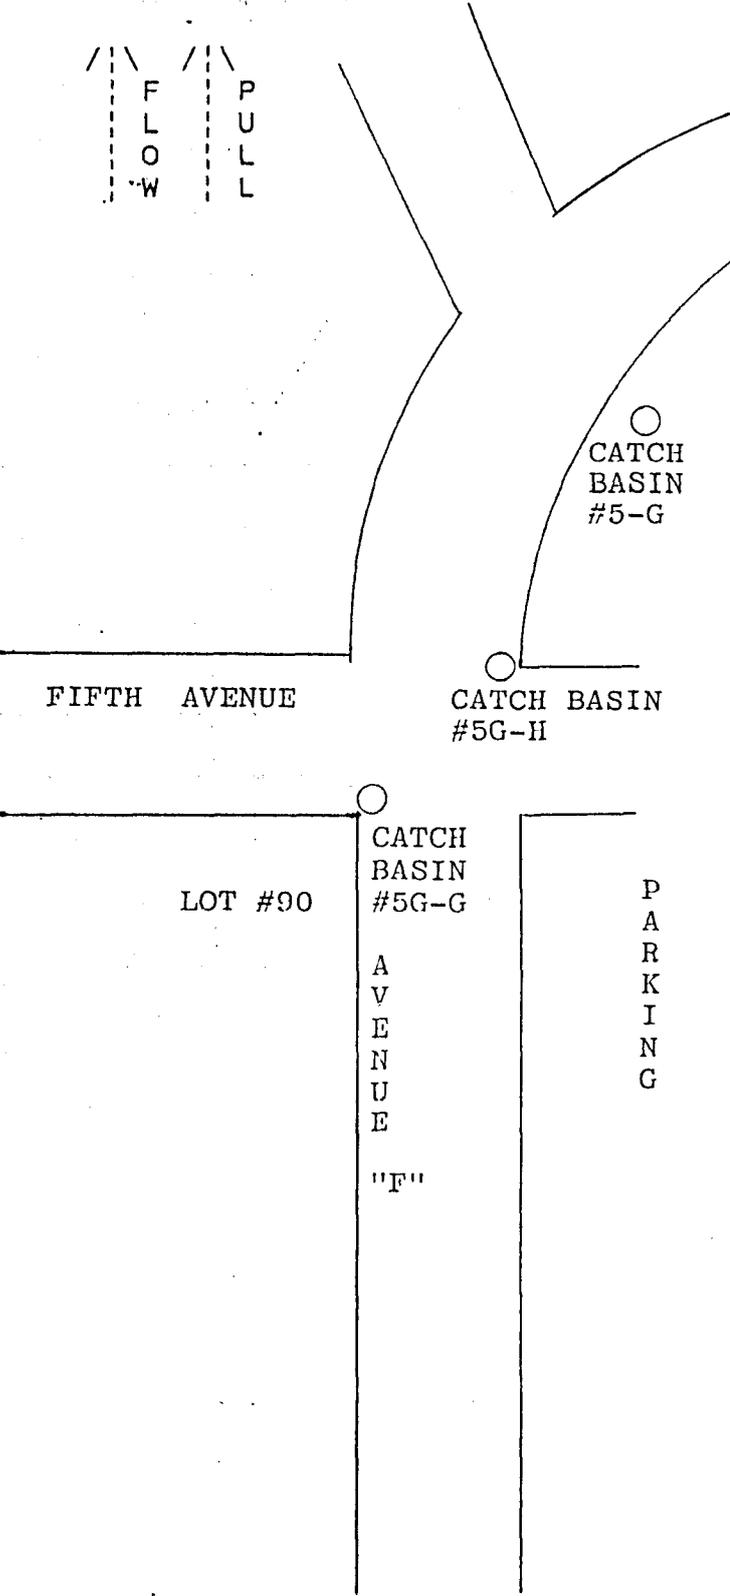
GRADE: GOOD

REMARKS: PIPE SIZE IS 8" AT CATCH
BASIN 5G-G AND 12" AT CATCH BASIN
5G-H. WILL PUSH CAMERA WITH ROD
AS FAR AS POSSIBLE FROM BOTH CATCH
BASINS
