THE NAVY'S UNDERESTIMATION OF
SOLVENT CONTAMINATION
AT THE MCAS EL TORO, CALIFORNIA

January 2000

**PES Environmental, Inc.
2030 East 4th Street, Suite 213
Santa Ana, California 92705**

The City of Irvine

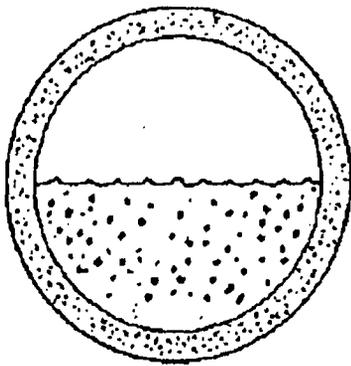
A. Bacteria in the slime under flowing sewage converts to sulfides.

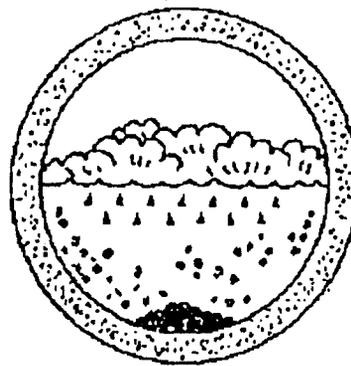
B. Sulfides in the liquid make their way to the surface and are released into the sewer atmosphere as hydrogen sulfide gas.

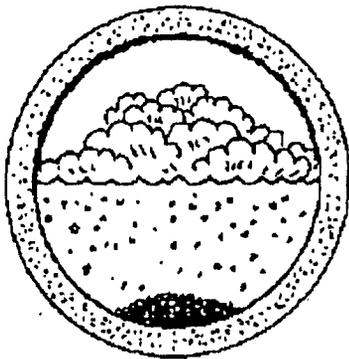
C. Hydrogen sulfide gas in atmosphere makes contact with moisture in arch in pipe which contains more bacteria. Bacterial action converts gas to sulfuric acid.
