Final Report
Aerial Photograph Assessment
MCAS El Toro
Contract No. N68711-91-D-4658
Delivery Order 0002
SAIC Project No. 01-0817-02-0817

August 2, 1993

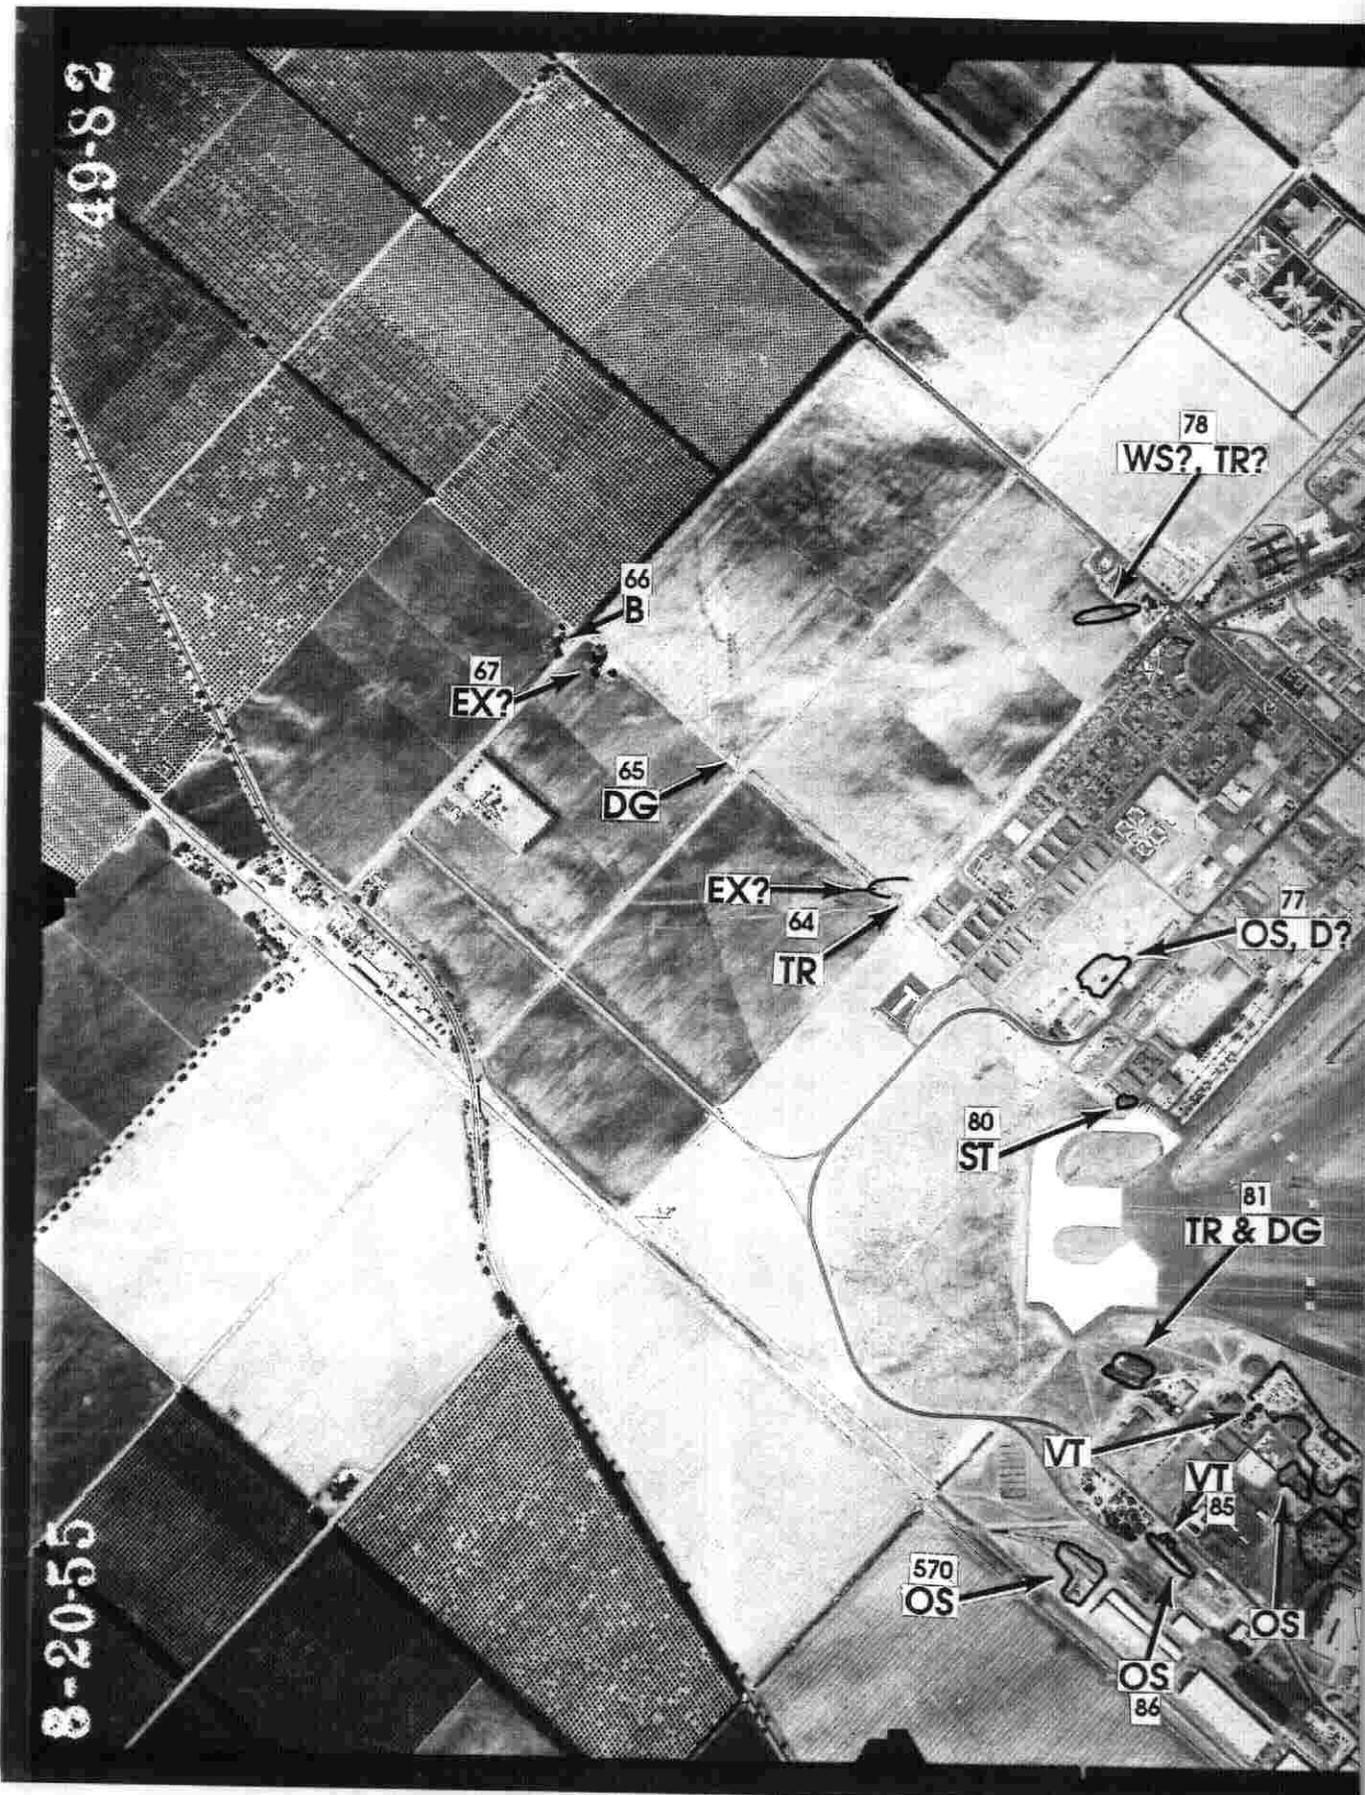
Figure 4

FIGURE: 4
DATE: 20 AUGUST 1955
PHOTOGRAPH: PAI 49V,49-82
NOTE: Partial coverage of area, partial stereographic coverage.
