2.4 1958 PHOTOGRAPHS

Aerial Photographic Interpretation
 MCAS El Toro
 Santa Ana, California
 1960

Figure 6

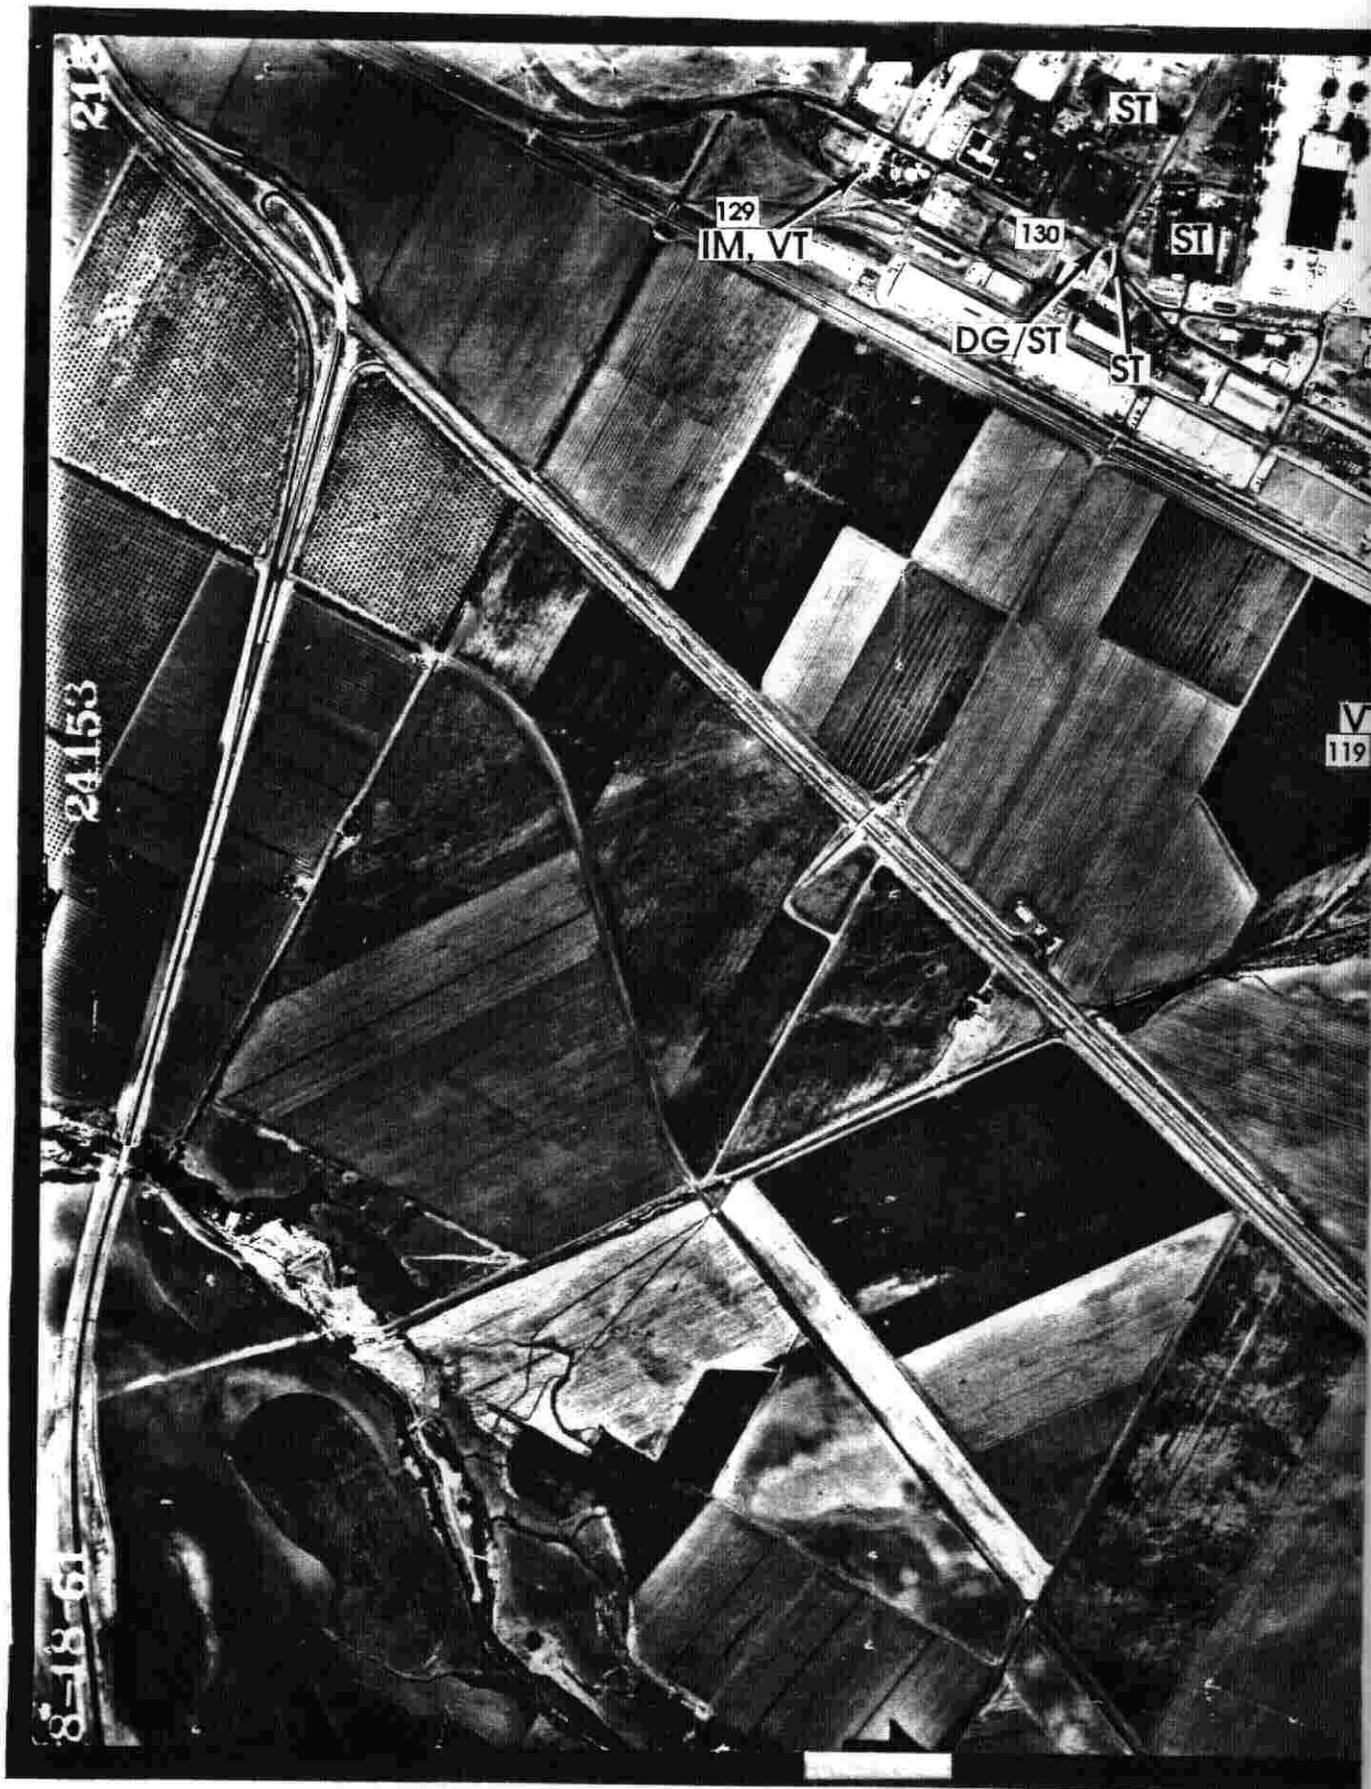
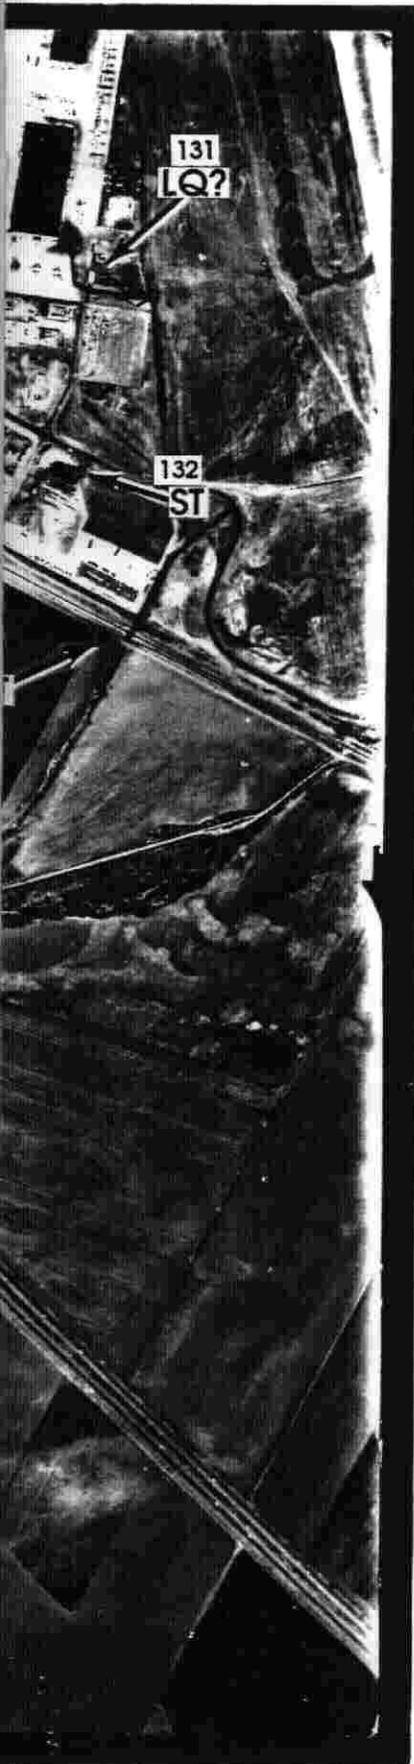
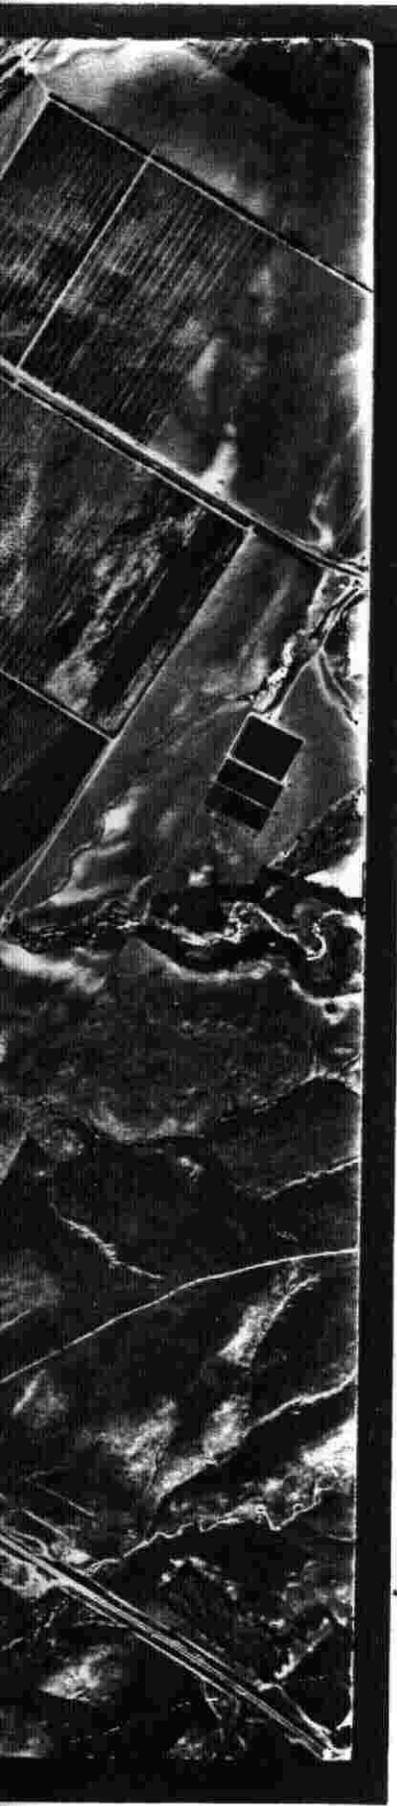
Figure 7

FIGURE: 7
DATE: 18.AUGUST 1961
PHOTOGRAPHS: C-24153-215 and C-24153-217
NOTE: The original negatives for these photographs no longer exist. The photographs have poor resolution, in part, because they are copies of a photograph, rather than being made from an original negative. There is only partial coverage of the site.

b 131. Liquid (LQ) appears to be flowing from hangar (Building 296) at the southeast corner of the aircraft parking apron. The flow discharges into the ditch east of the apron. Investigation of the ditch is advisable.

b 132. There are stains (ST) in the proximity of Building 1749, near South Marine Way and R Street. The site may not be wholly contained within the DRMO Storage Yard investigation area. Because the staining persists for several years, additional investigation is recommended.

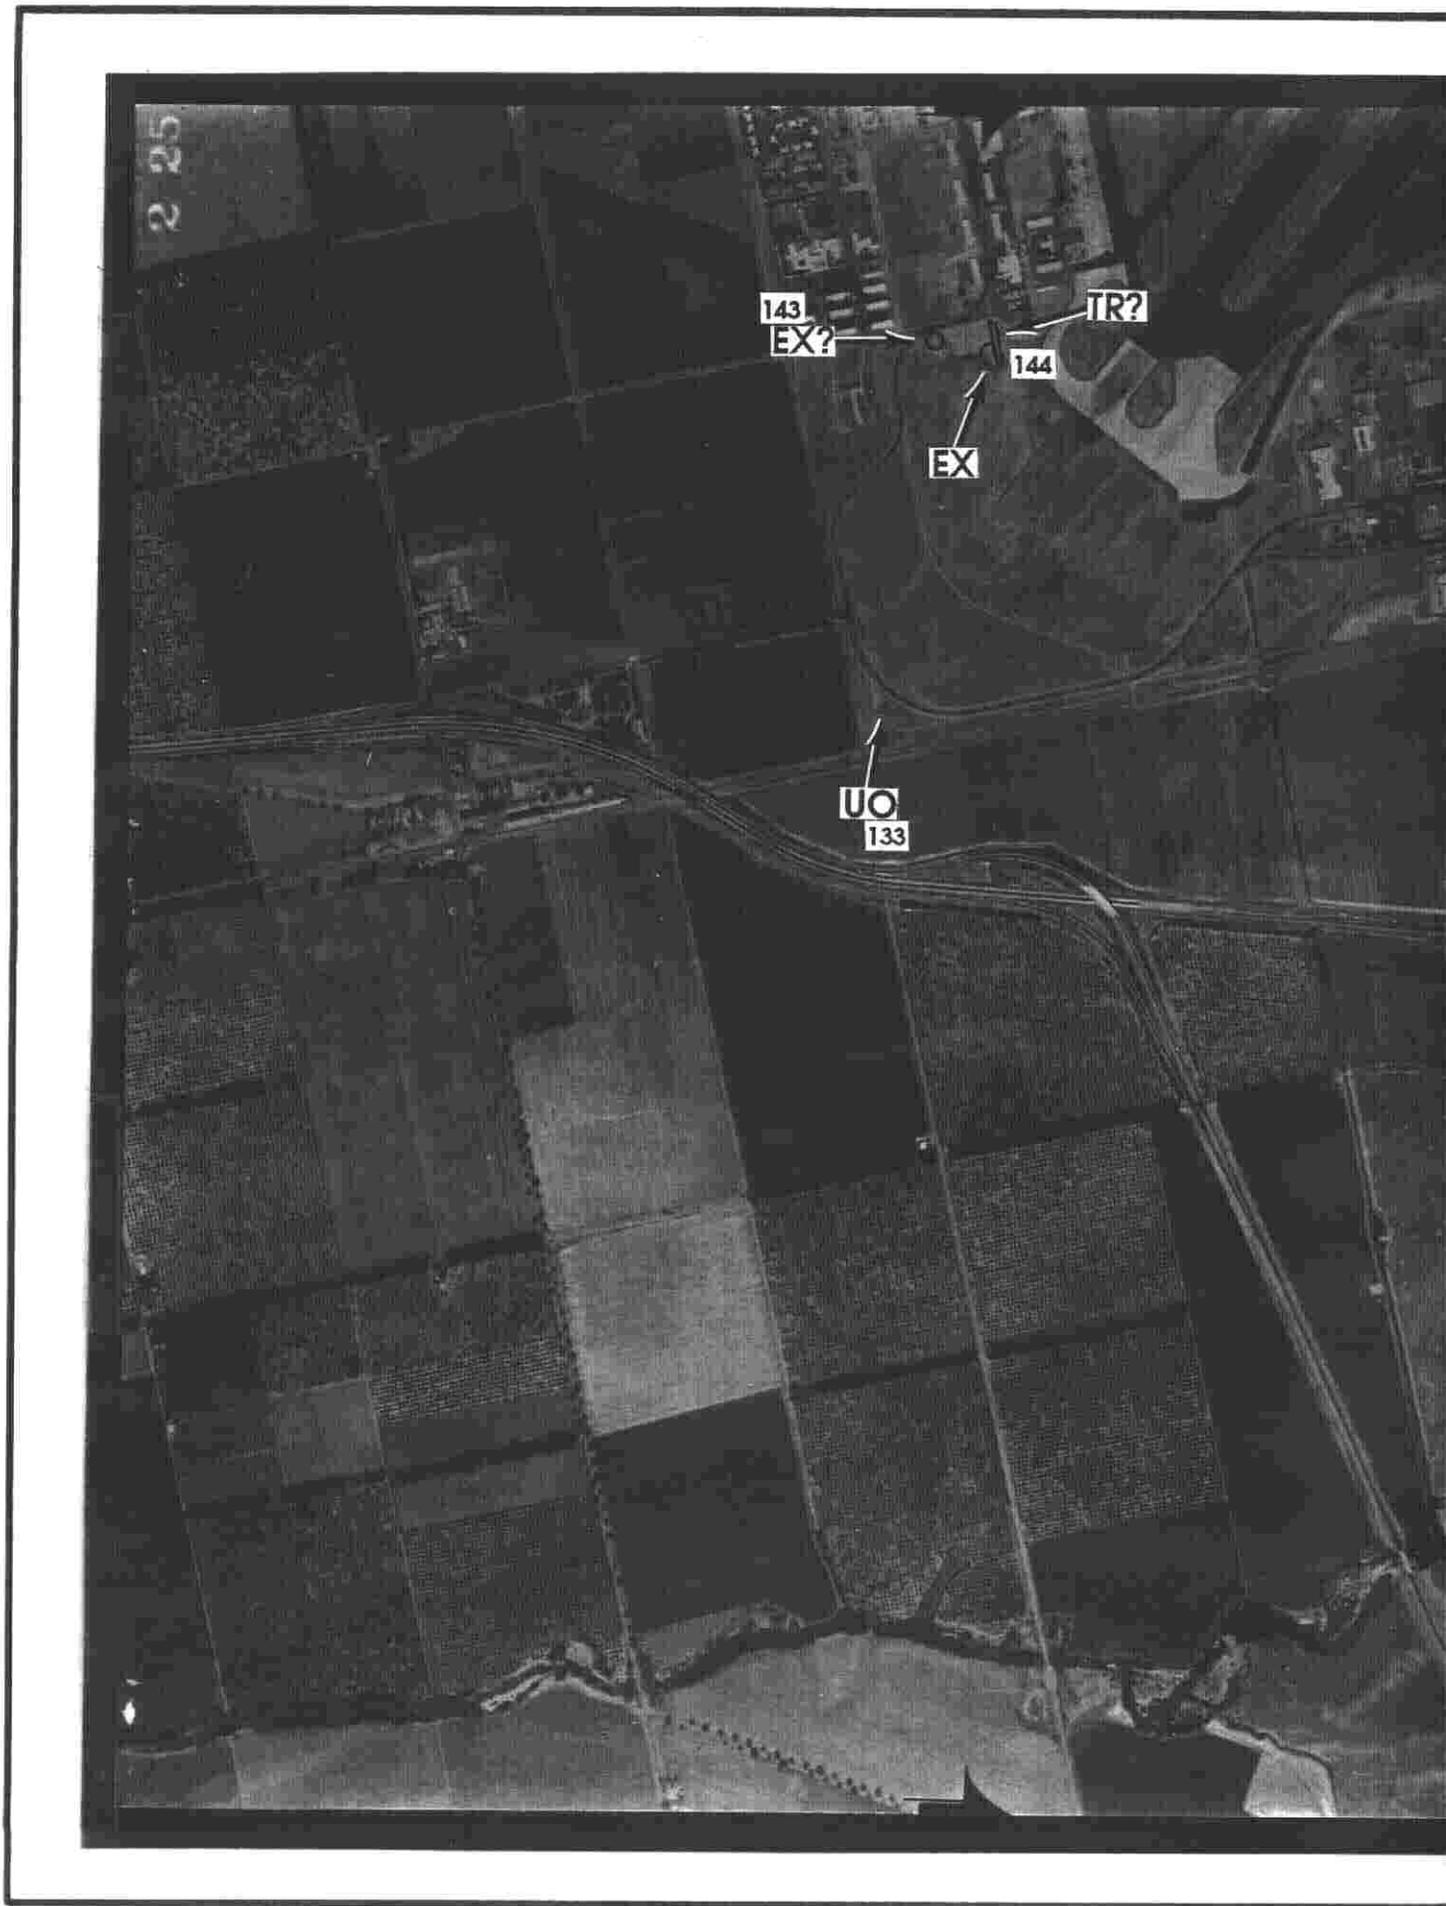
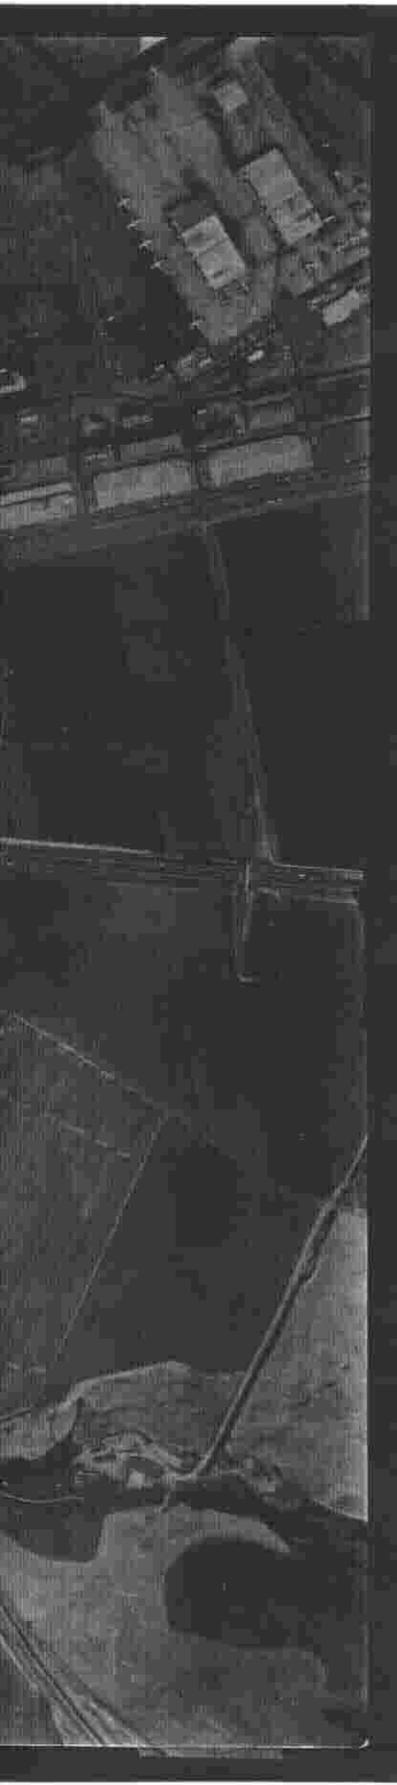
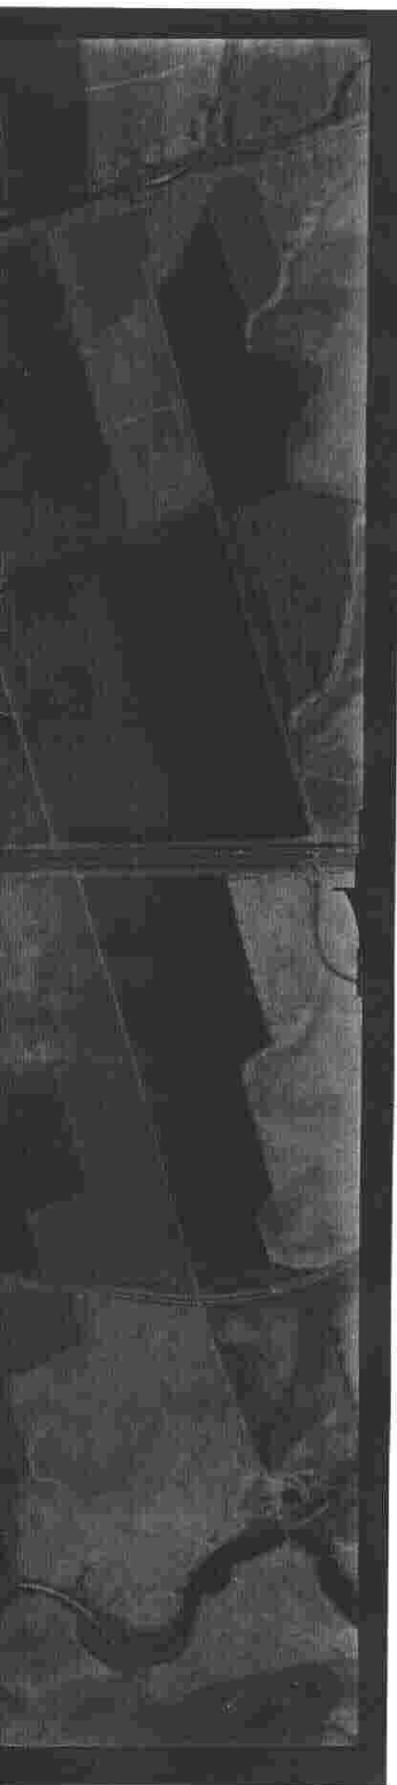
Figure 8

FIGURE: 8
DATE: 16 SEPTEMBER 1964
PHOTOGRAPHS: C24848, VII-ORA-5-225 and C24848, VII-ORA-5-227
NOTE: The photographs have poor resolution, do not cover the entire site, and provide only partial stereographic coverage.
