Summary Report

*Former Temporary Accumulation Area (TAA) 761
Solid Waste Management Unit (SWMU) 236
Former Marine Corps Air Station, El Toro, California*

20 September 2002

Prepared by:
Southwest Division, Naval Facilities Engineering Command
BRAC Programs Office
San Diego, CA 92101-2404

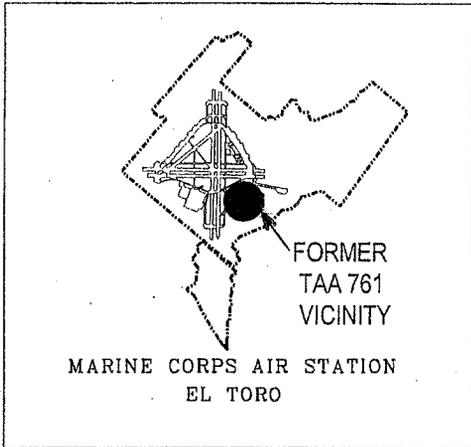
Figure 1.
FORMER TEMPORARY ACCUMULATION AREA (TAA) 761
VICINITY MAP
FORMER MARINE CORPS AIR STATION, EL TORO

★ THE APPROXIMATE LOCATION OF FORMER TAA 761 IS IDENTIFIED WITH A STAR SYMBOL.

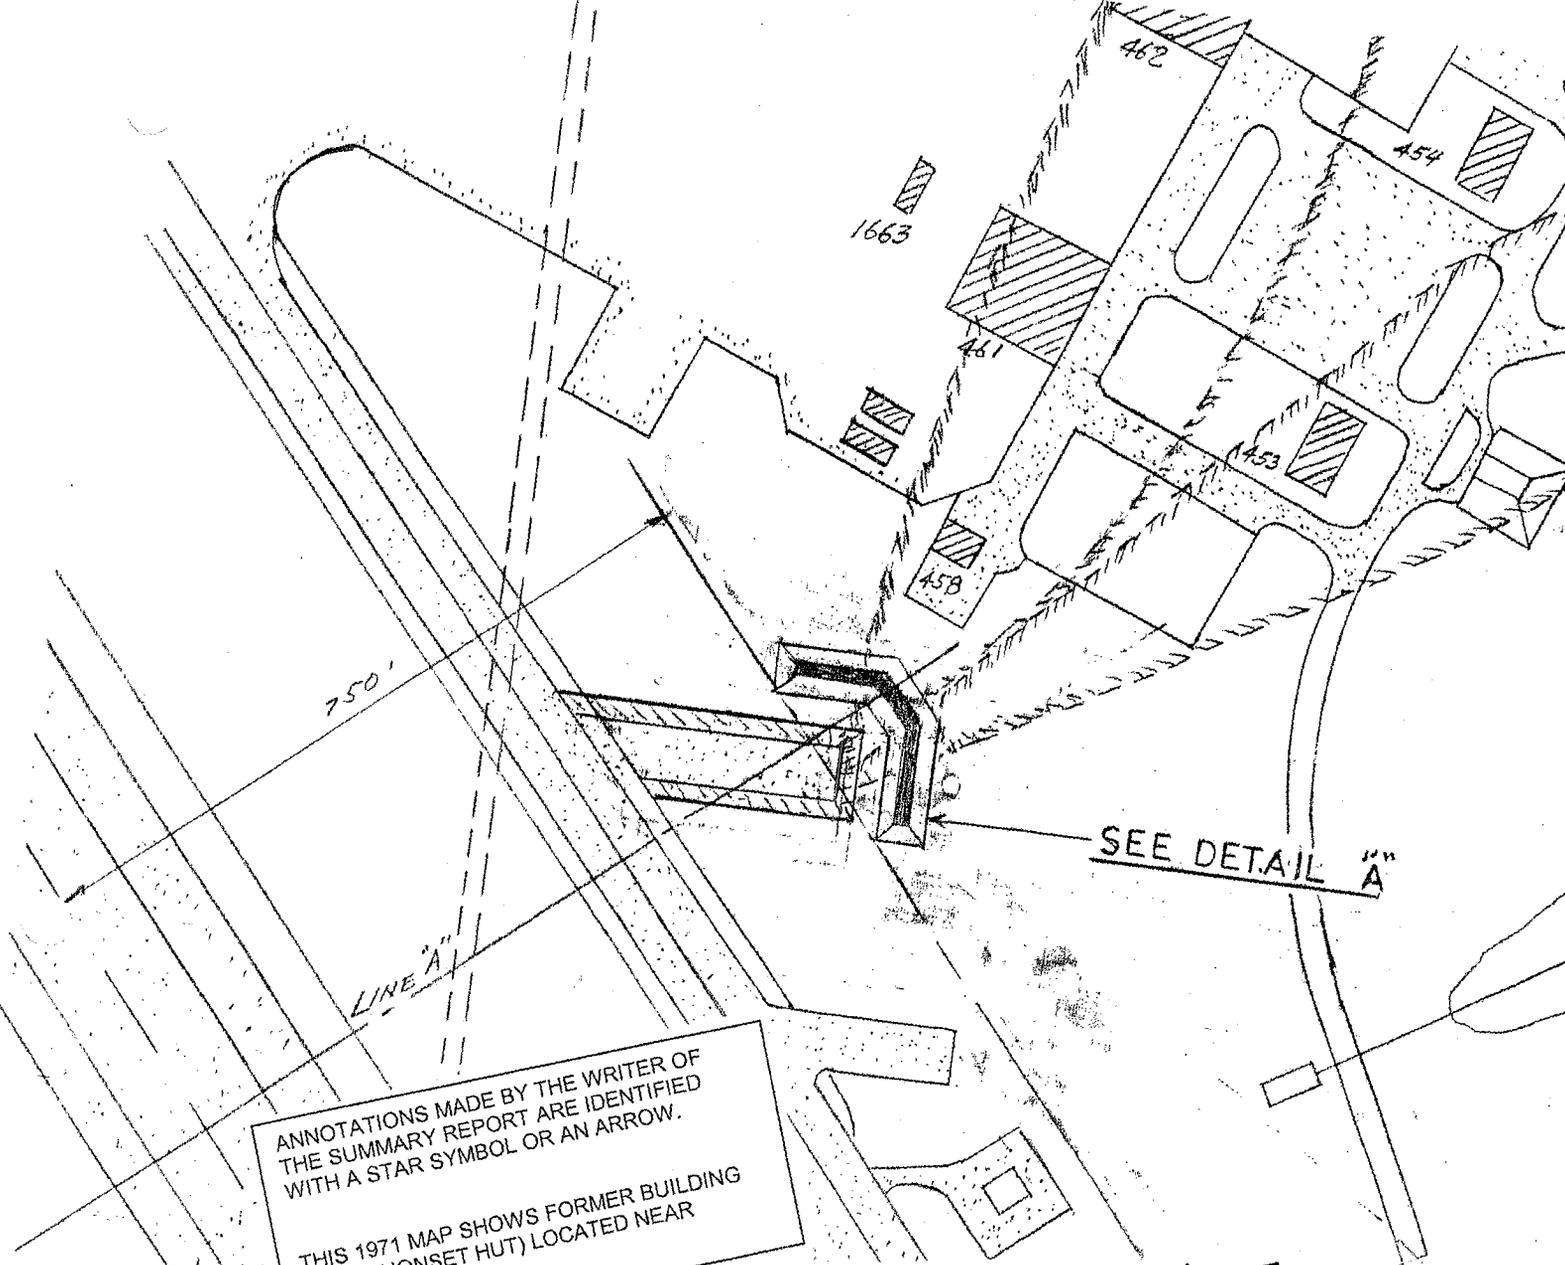
THIS 1971 MAP SHOWS FORMER BUILDING 1663 (QUONSET HUT) LOCATED NEAR BUILDING 461.

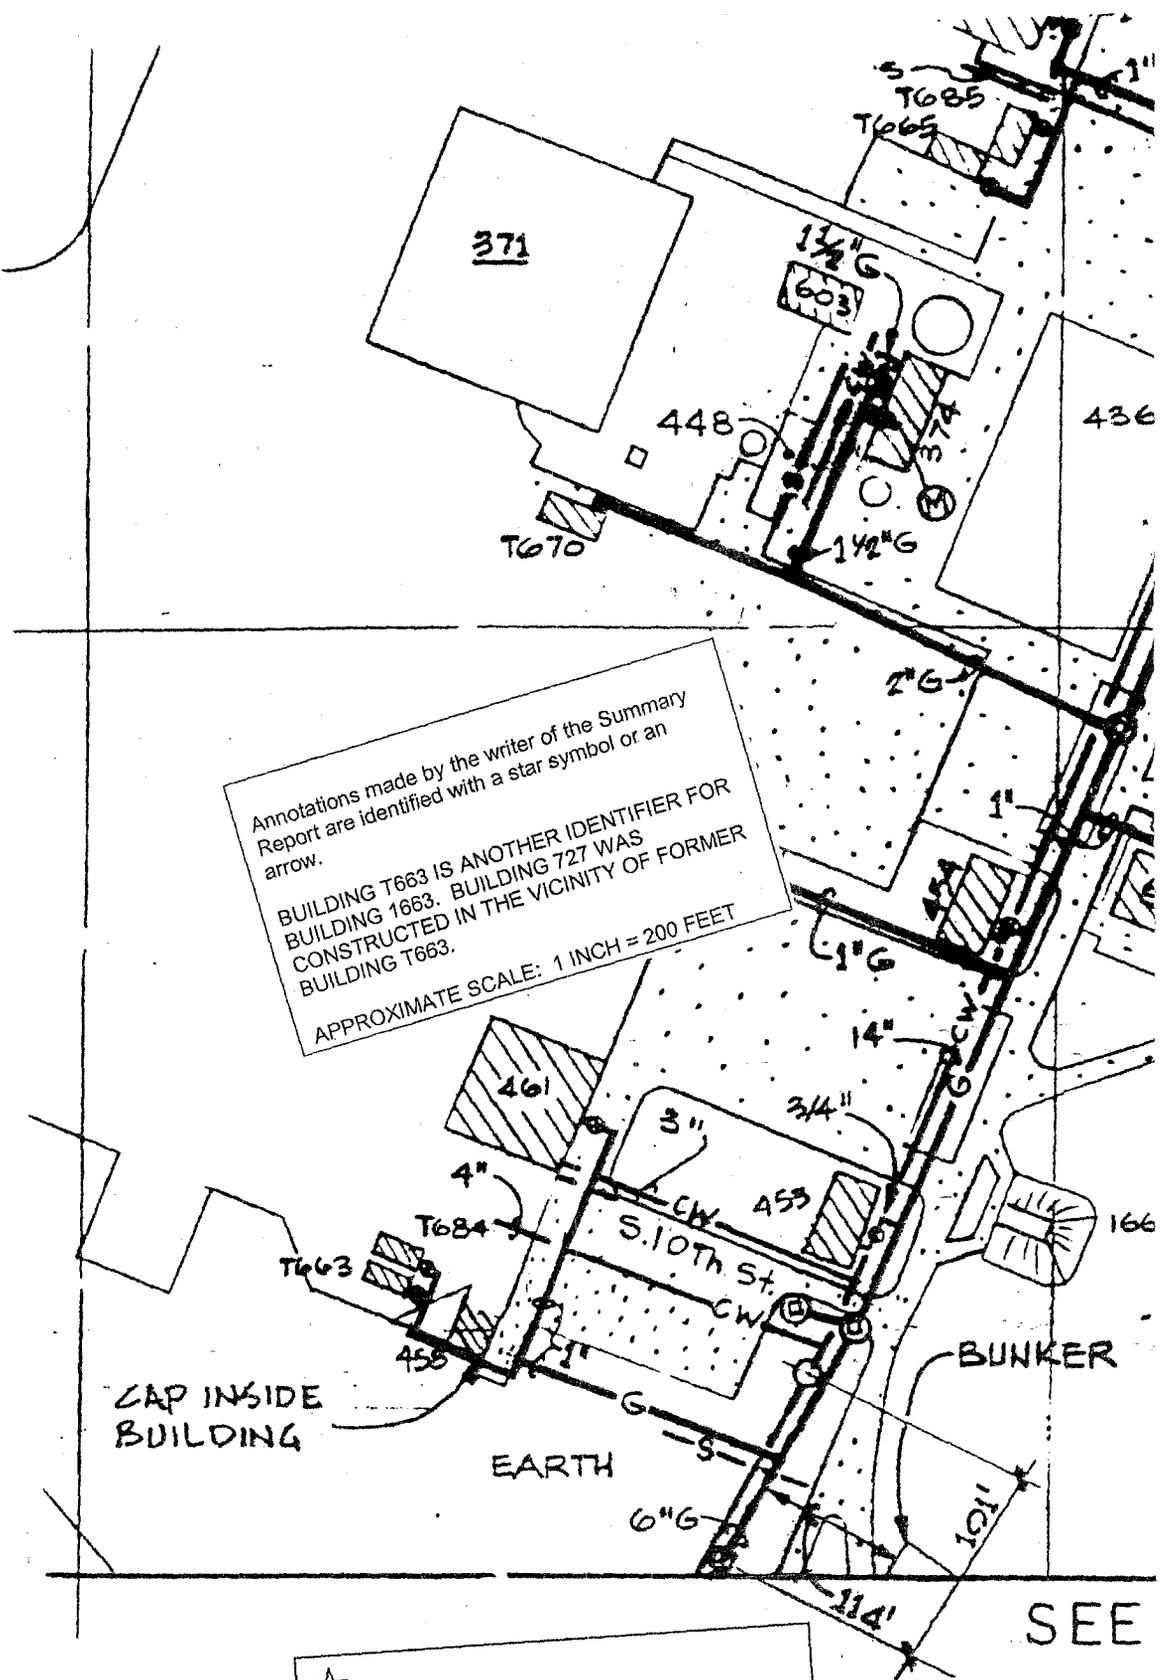
BUILDING T663 IS ANOTHER IDENTIFIER FOR BUILDING 1663. BUILDING 727 WAS CONSTRUCTED IN THE VICINITY OF FORMER BUILDING T663.

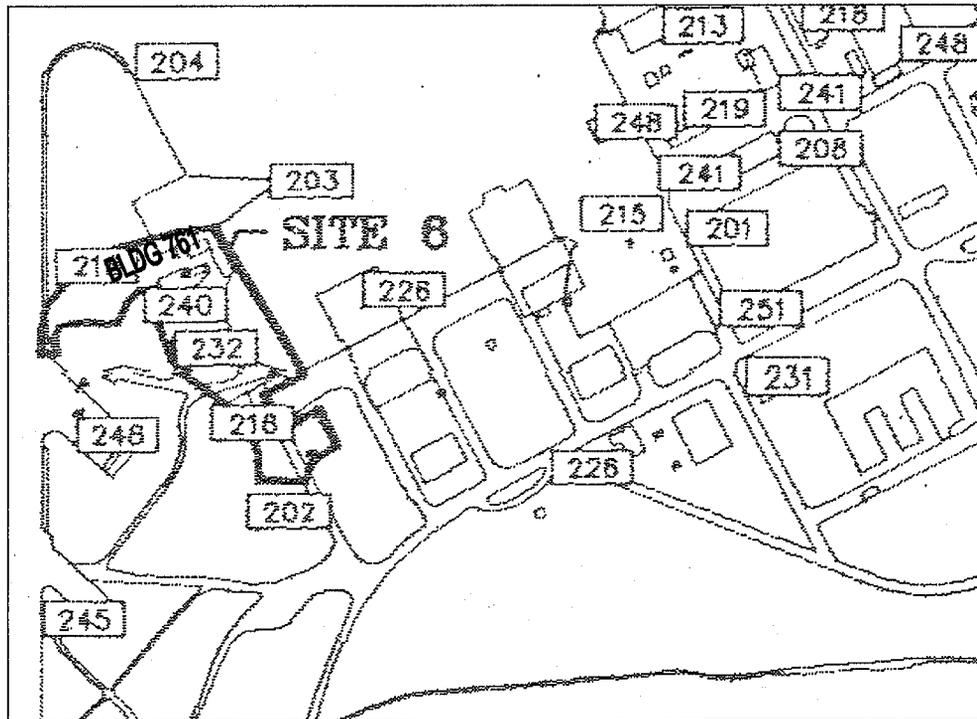
USEPA Anomaly 232 is located in the vicinity of Former TAA 761 (SWMU 236). USEPA Anomaly 232 is described as probable drums, open storage on a photograph taken in 1970.

USEPA Anomaly 240 is located in the vicinity of Former TAA 761 (SWMU 236). USEPA Anomaly 240 is described as a graded area, disturbed ground on a photograph taken in 1980.

Comment by the writer of the Summary Report: During the visual inspection of Former TAA 761 (SWMU 236) and vicinity in September 2002, no stains were observed on the concrete apron near Former TAA 761 or on the unpaved surfaces at Former TAA 761. The anomalies, USEPA 232 and USEPA 240, are located in the vicinity of Former TAA 761, within the area that was investigated during the remedial investigation of IRP Site 6.

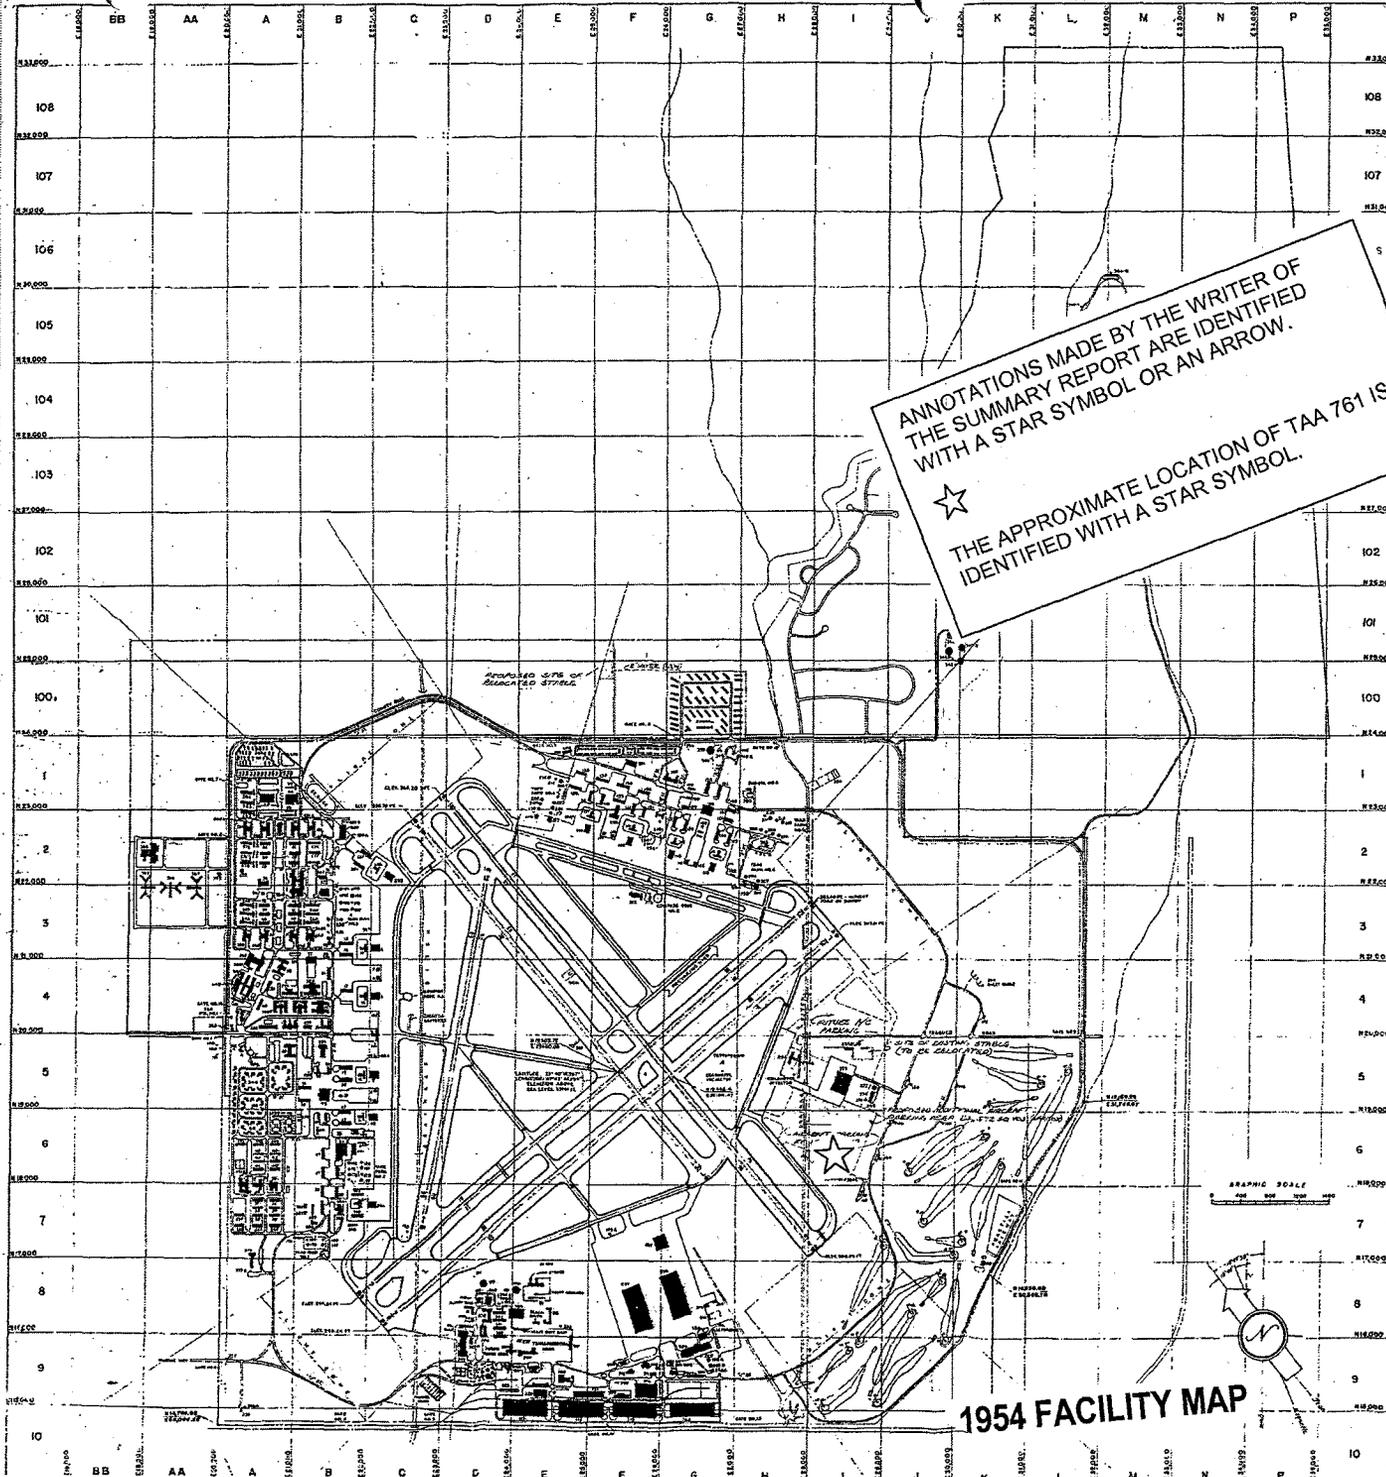
★ THE APPROXIMATE LOCATION OF TAA 761 IS IDENTIFIED WITH A STAR SYMBOL.

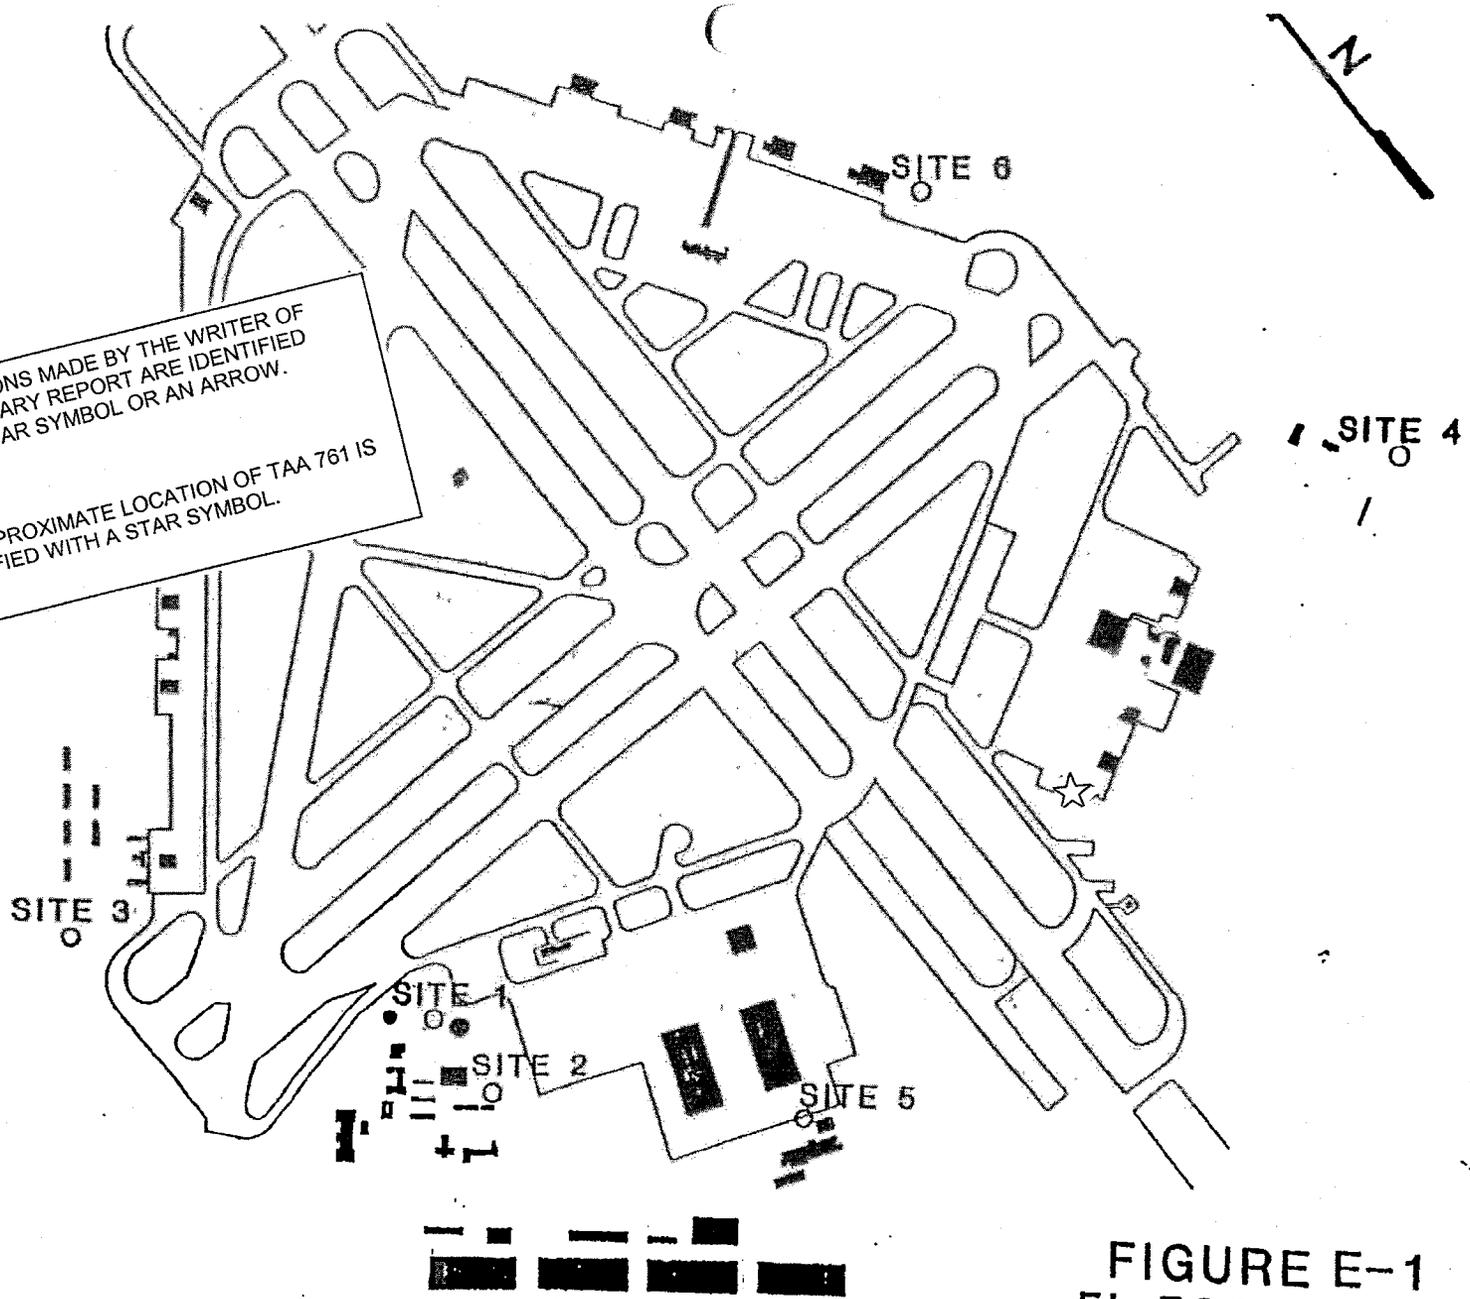
FIGURE E-1
EL TORO MCAS
HW STORAGE AREAS

☆
THE APPROXIMATE LOCATION OF TAA 761 IS IDENTIFIED WITH A STAR SYMBOL.

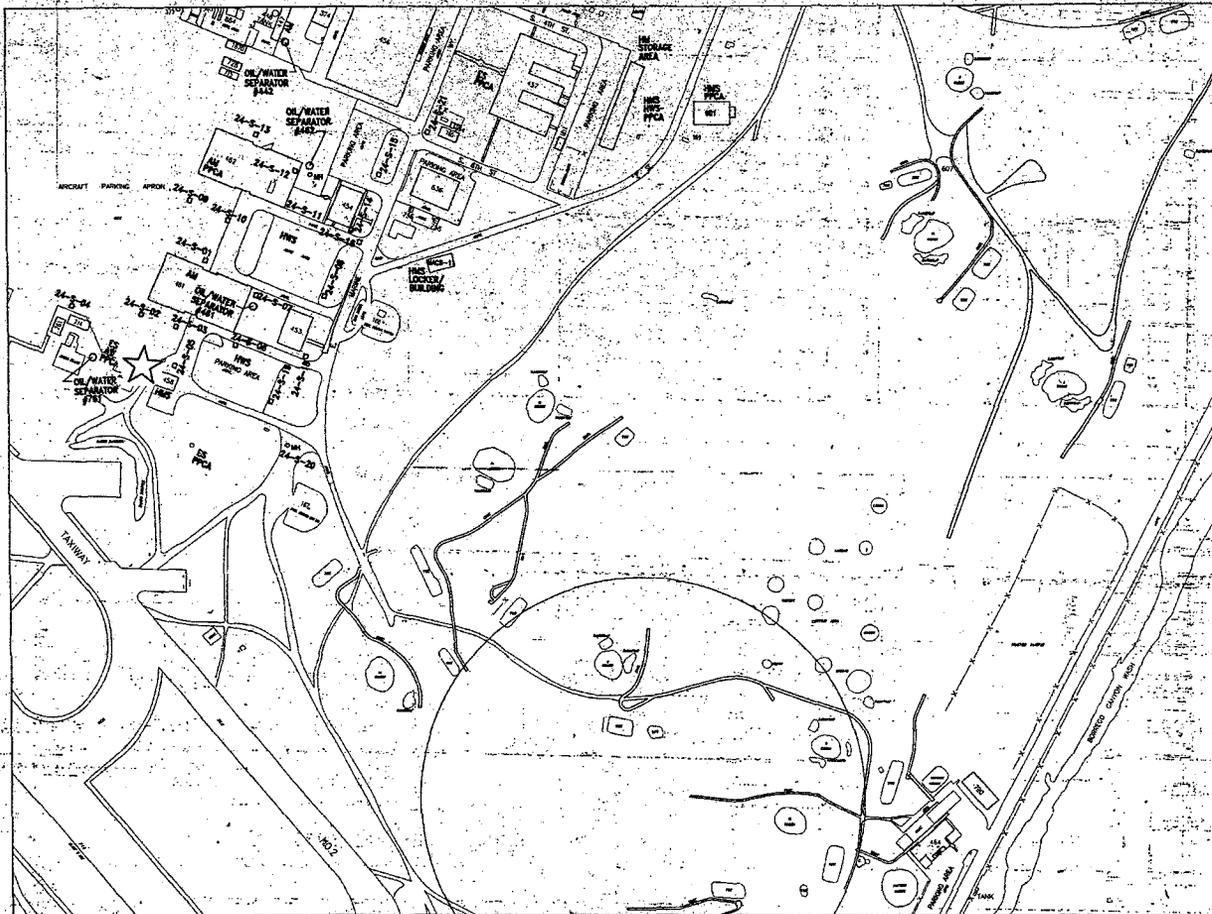
"MCAS" EL TORO - AREA 24
SCALE: 1"=150'-0"

ANNOTATIONS MADE BY THE WRITER OF THE SUMMARY REPORT ARE IDENTIFIED WITH A STAR SYMBOL OR AN ARROW.
THE APPROXIMATE LOCATION OF TAA 761 (SWMU 236) IS IDENTIFIED WITH A STAR SYMBOL
