Summary Report

Temporary Accumulation Area (TAA) 769
Solid Waste Management Unit (SWMU) 222
Marine Corps Air Station, El Toro, California

18 March 2002

Prepared by:
Southwest Division, Naval Facilities Engineering Command
BRAC Programs Office
San Diego, CA 92101-2404

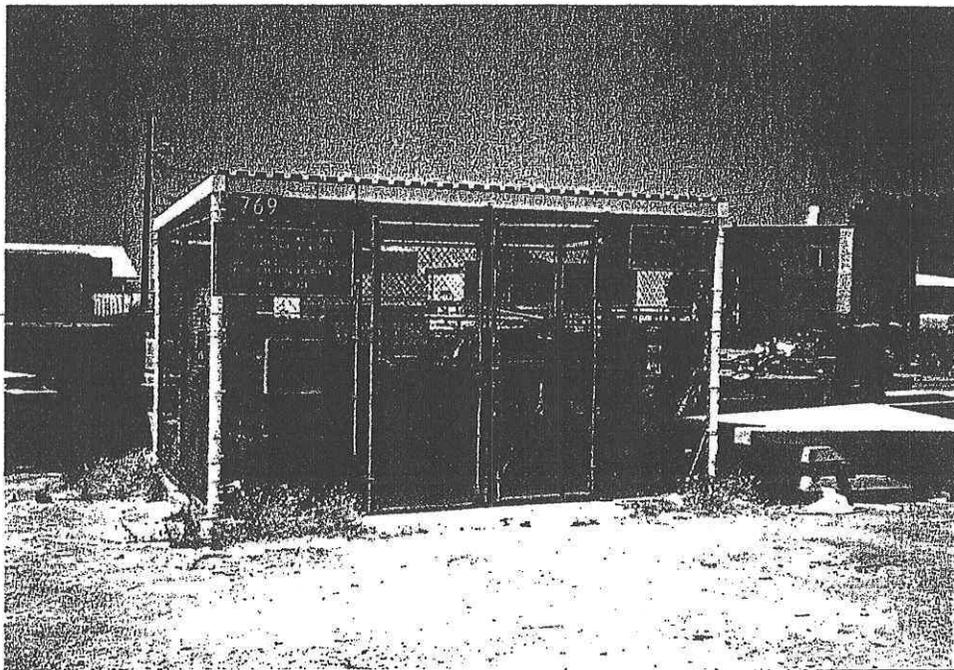
Date of Site Visit: 23 April 91

This Hazardous Waste Storage Area (HWSA) is one of the six DHS-permitted HWSAs at MCAS El Toro. These six HWSAs (SWMU/AOC Numbers 222 through 227) are not planned for future use. Historically, these six HWSAs have had drums stored outside of the storage area. The HWSA is located in a storage yard east of Building 306. The HWSA is built with a concrete storage pad surrounded by a 6-in. concrete berm. The storage area is protected by a chain-link fence and covered by an aluminum roof. At the time of our visit, the HWSA was not being used to store hazardous waste. Various types of electrical equipment (e.g. fans, conduit, copper wire, light fixtures) were being stored inside the storage area. There was also about 4 inches of ponding water covering the storage surface. Because of the ponding water and electrical equipment, the storage surface or berm could not be inspected for cracks or stains.

None observed

Although there was no evidence of a release during the site visit and hazardous waste was not currently stored in the area, the past and present HWSAs at MCAS El Toro are recommended for a sampling visit.
