N62604.AR.001204
NCBC GULFPORT
5090.3a

MINUTES FROM TECHNICAL REVIEW COMMITTEE MEETING 23 AUGUST 1989 NCBC GULFPORT MS
10/5/1989
NCBC GULFPORT

COMMENTS FOR THE PHASE II FINAL VERIFICATION REPORT NAVAL CONSTRUCTION BATTALION CENTER (NCBC) GULFPORT, MISSISSIPPI

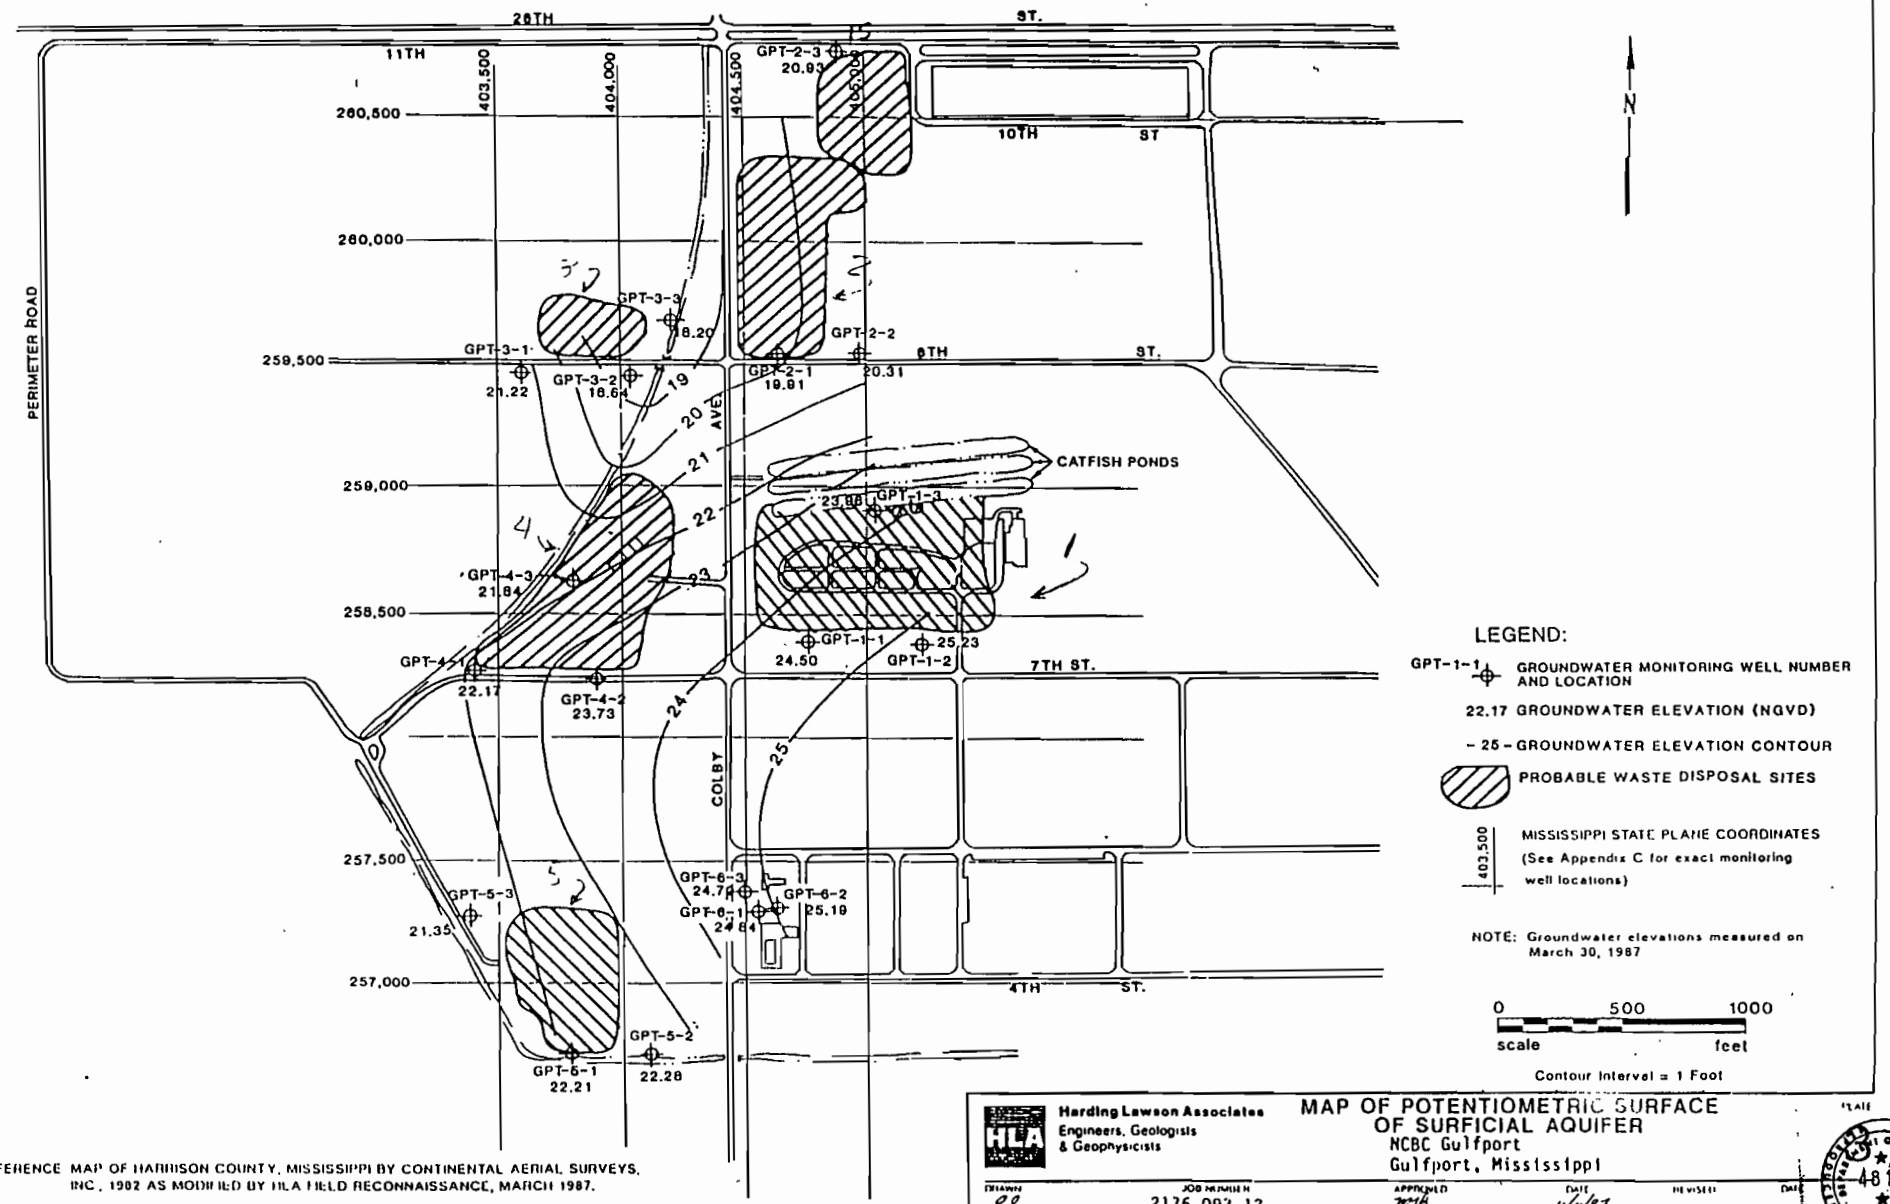
Figure 2

Only one round of water level measurements were taken in the surficial aquifer at the NCBC facility. These measurements indicate that the hydraulic gradient slopes in a direction different than originally presumed (figure 2). This has resulted in the placement of an inadequate number of downgradient monitoring wells at Sites 1 through 5, and possibly at Site 6. The Final Verification Report recommends that before additional monitoring wells are installed at these locations, further rounds of water level measurements should be collected. It was noted in the report that several inches of precipition had occurred at the facility in the weeks that preceeded the water level measurements. This rainfall had the effect of raising water levels to above normal and may have also affected the slope of the potentiometric surface. Quarterly water level measurements would determine if seasonal and/or local effects cause significant variations in the hydraulic gradient and the direction in which it slopes. This information is necessary to determine if future monitoring wells are correctly placed and that an adequate number are installed.

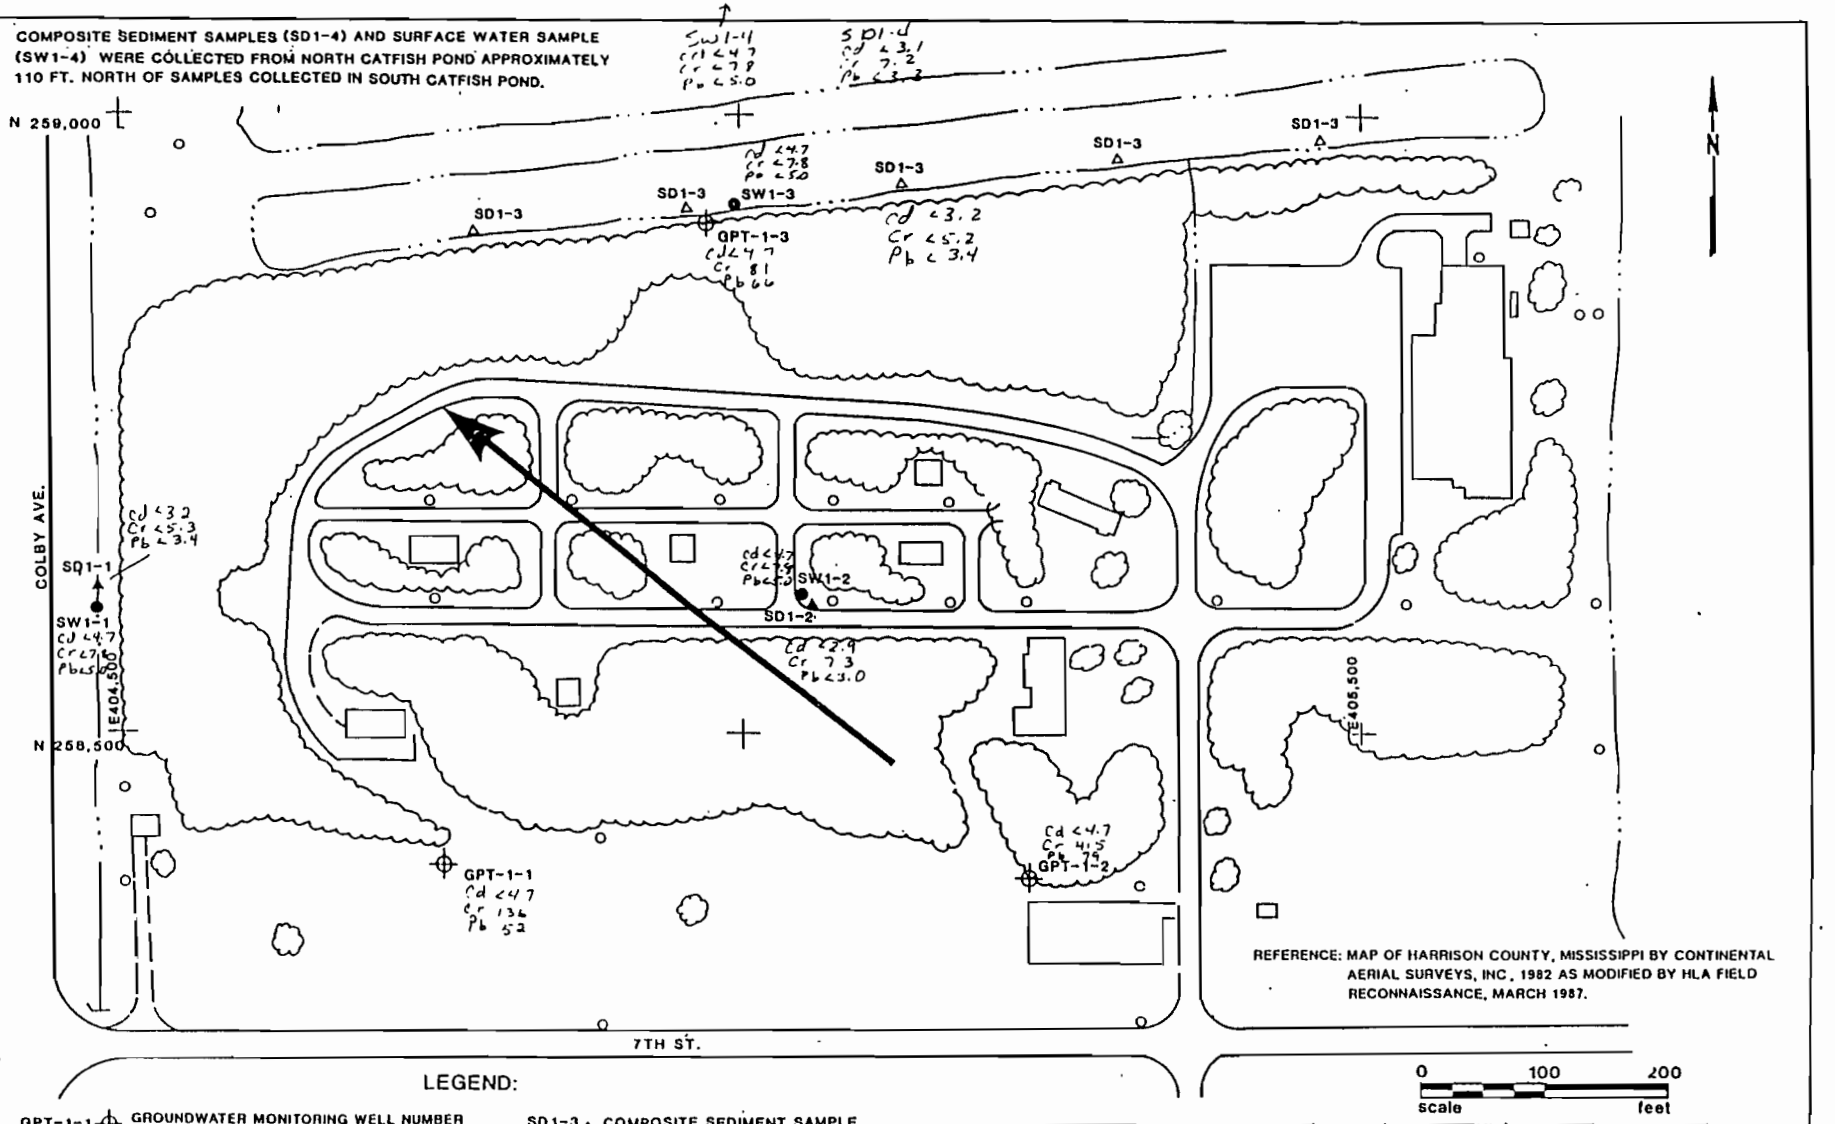
Site 1 is currently used as a disaster recovery training area. From 1942 to 1948, before being used as a training area, chemical wastes were disposed of at this site primarily by trench burial of containerized materials, reportedly 55 gallon drums. The principal wastes disposed of include paints, oils, solvents, paint strippers and cleaning compounds. Excavation in this area is 1984 revealed several drums containing xylene, toluene, and 1,2 dichloroehtane.

Analytical results for groundwater samples taken from all three monitoring wells at site 1 indicate that levels of chromium and lead are above the Maximum Concentration Levels (MCLs) as specified in the Safe Drinking Water Act (figure 3). The highest concentrations of chromium and lead were encountered in well GPT-1-2. As stated previously, the report recommends that the wells be resampled to verify contaminant concentrations. The installation of additional

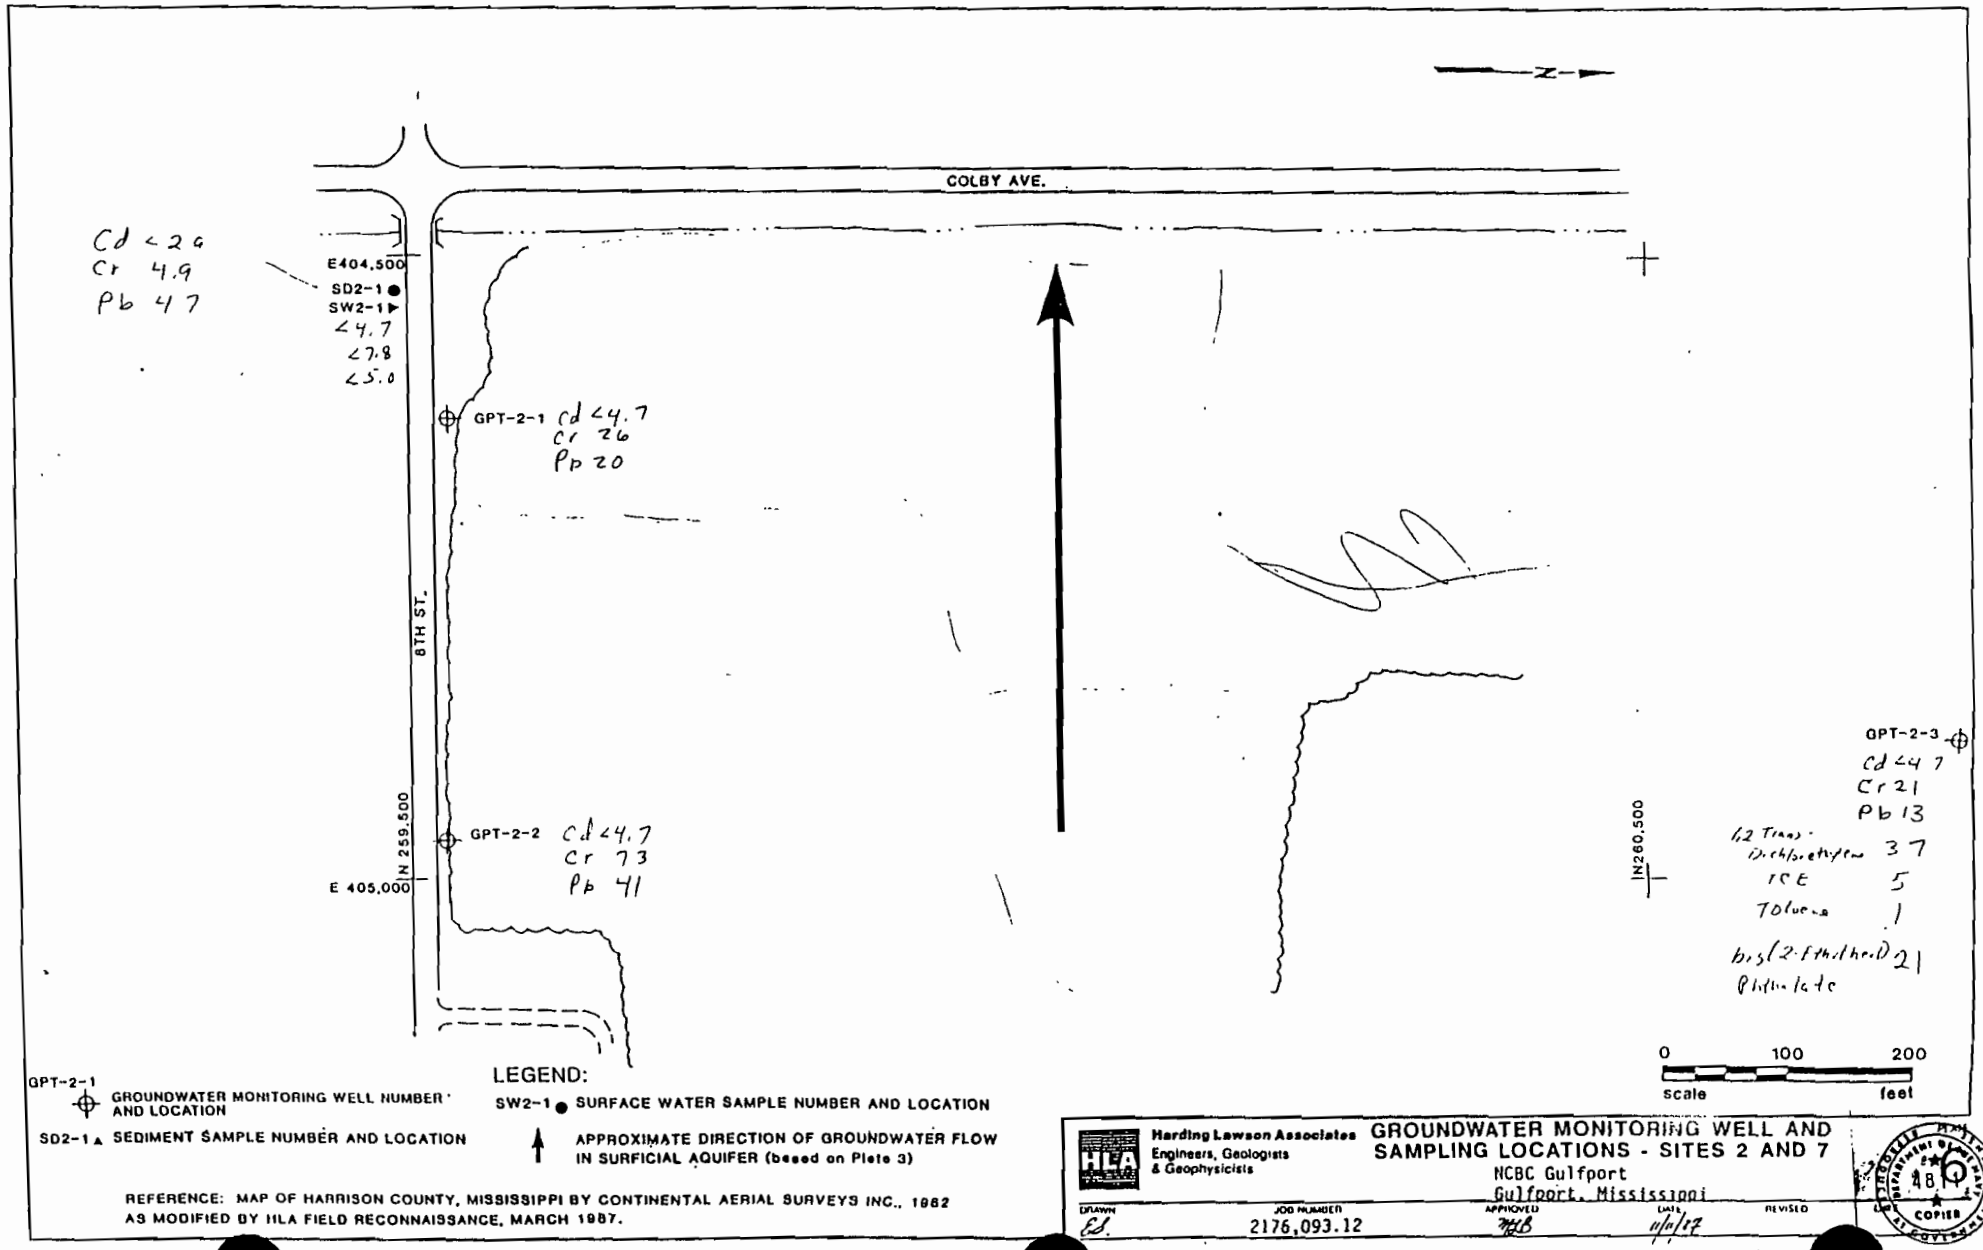
In addition, 1,2-trans-Dichloroethylene was detected in well GPT-2-3 at a concentration of 37 ppb, as was a trace of toluene and chloroform. The Bureau concurs with the report which recommends additional sampling in order to evaluate the significance of the contamination in these wells.

Low levels of lead and chromium were detected in the sediment sample at the site. The level of chromium detected in this sample is below the RFI health-based criteria for systemic toxicants. There is no RFI level for lead.

None of the monitoring wells at Site 2 were in the downgradient direction. Pending further water level measurements, additional monitoring wells will be necessary to fully assess this site.

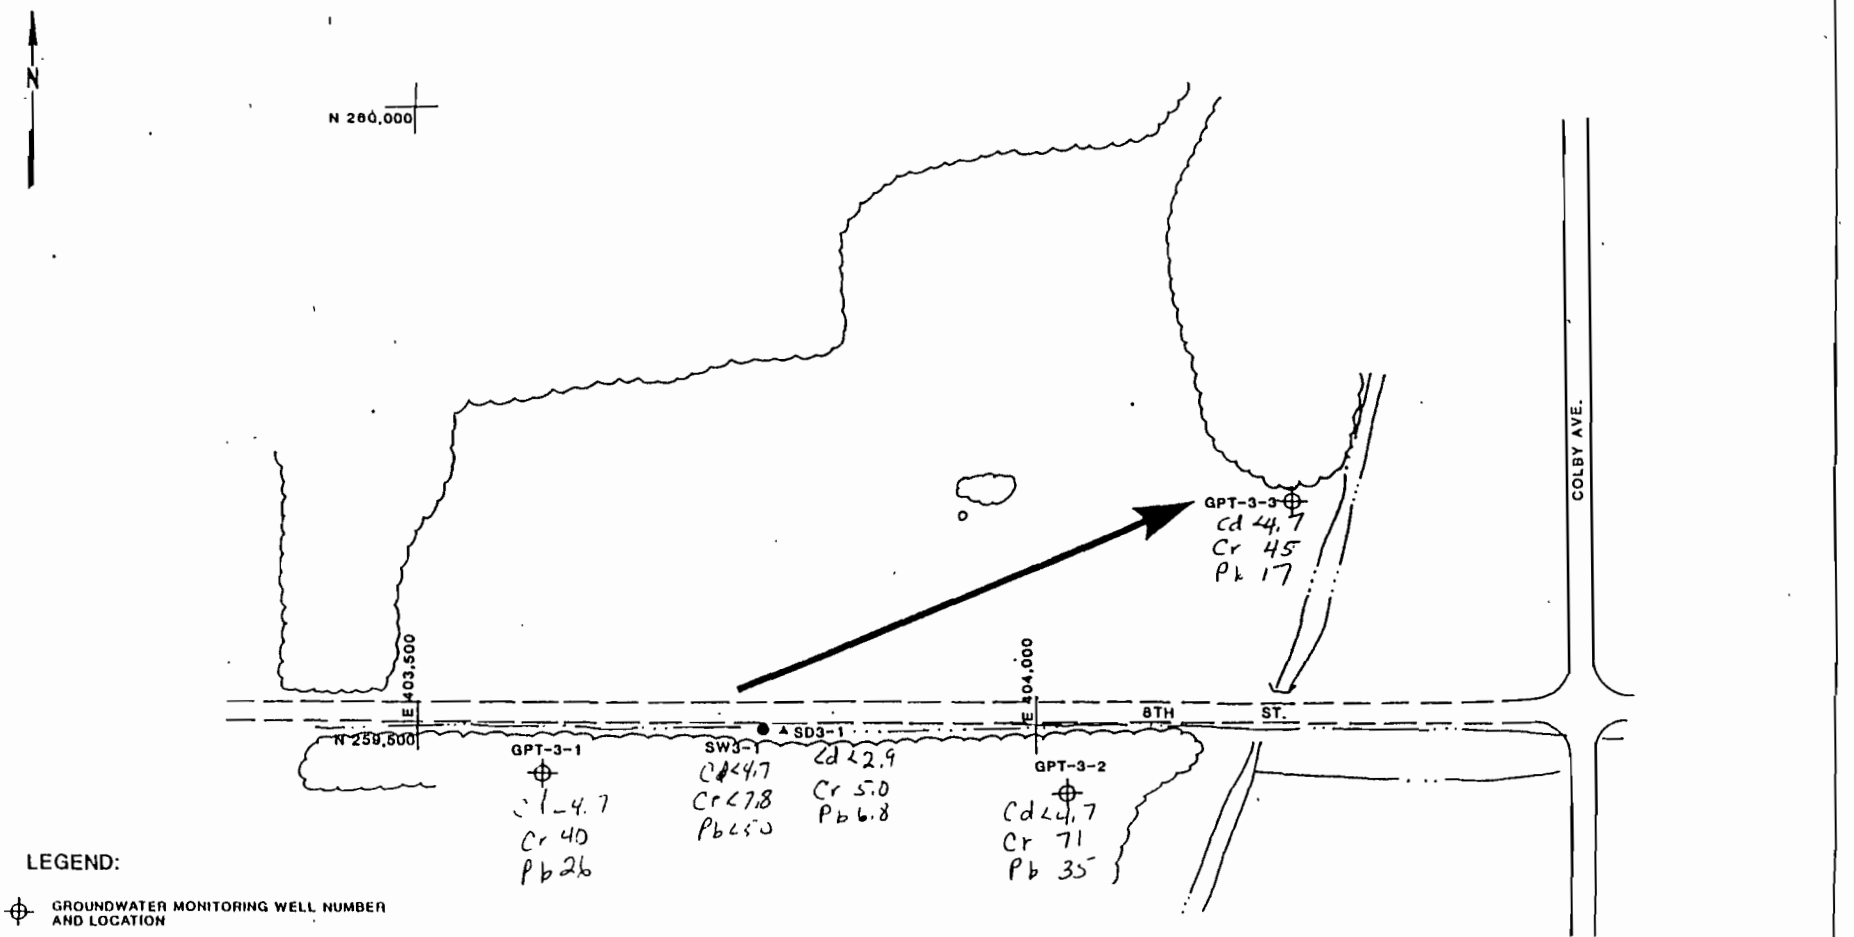
Figure 5

Metals were the only contaminants detected in the groundwater samples from Site 3 (figure 5), and all metals levels were below the MCL. Resampling to verify contaminant concentrations is recommended, as is installation of additional downgradient monitoring wells after confirmation of the configuration of the potentiometric surface.

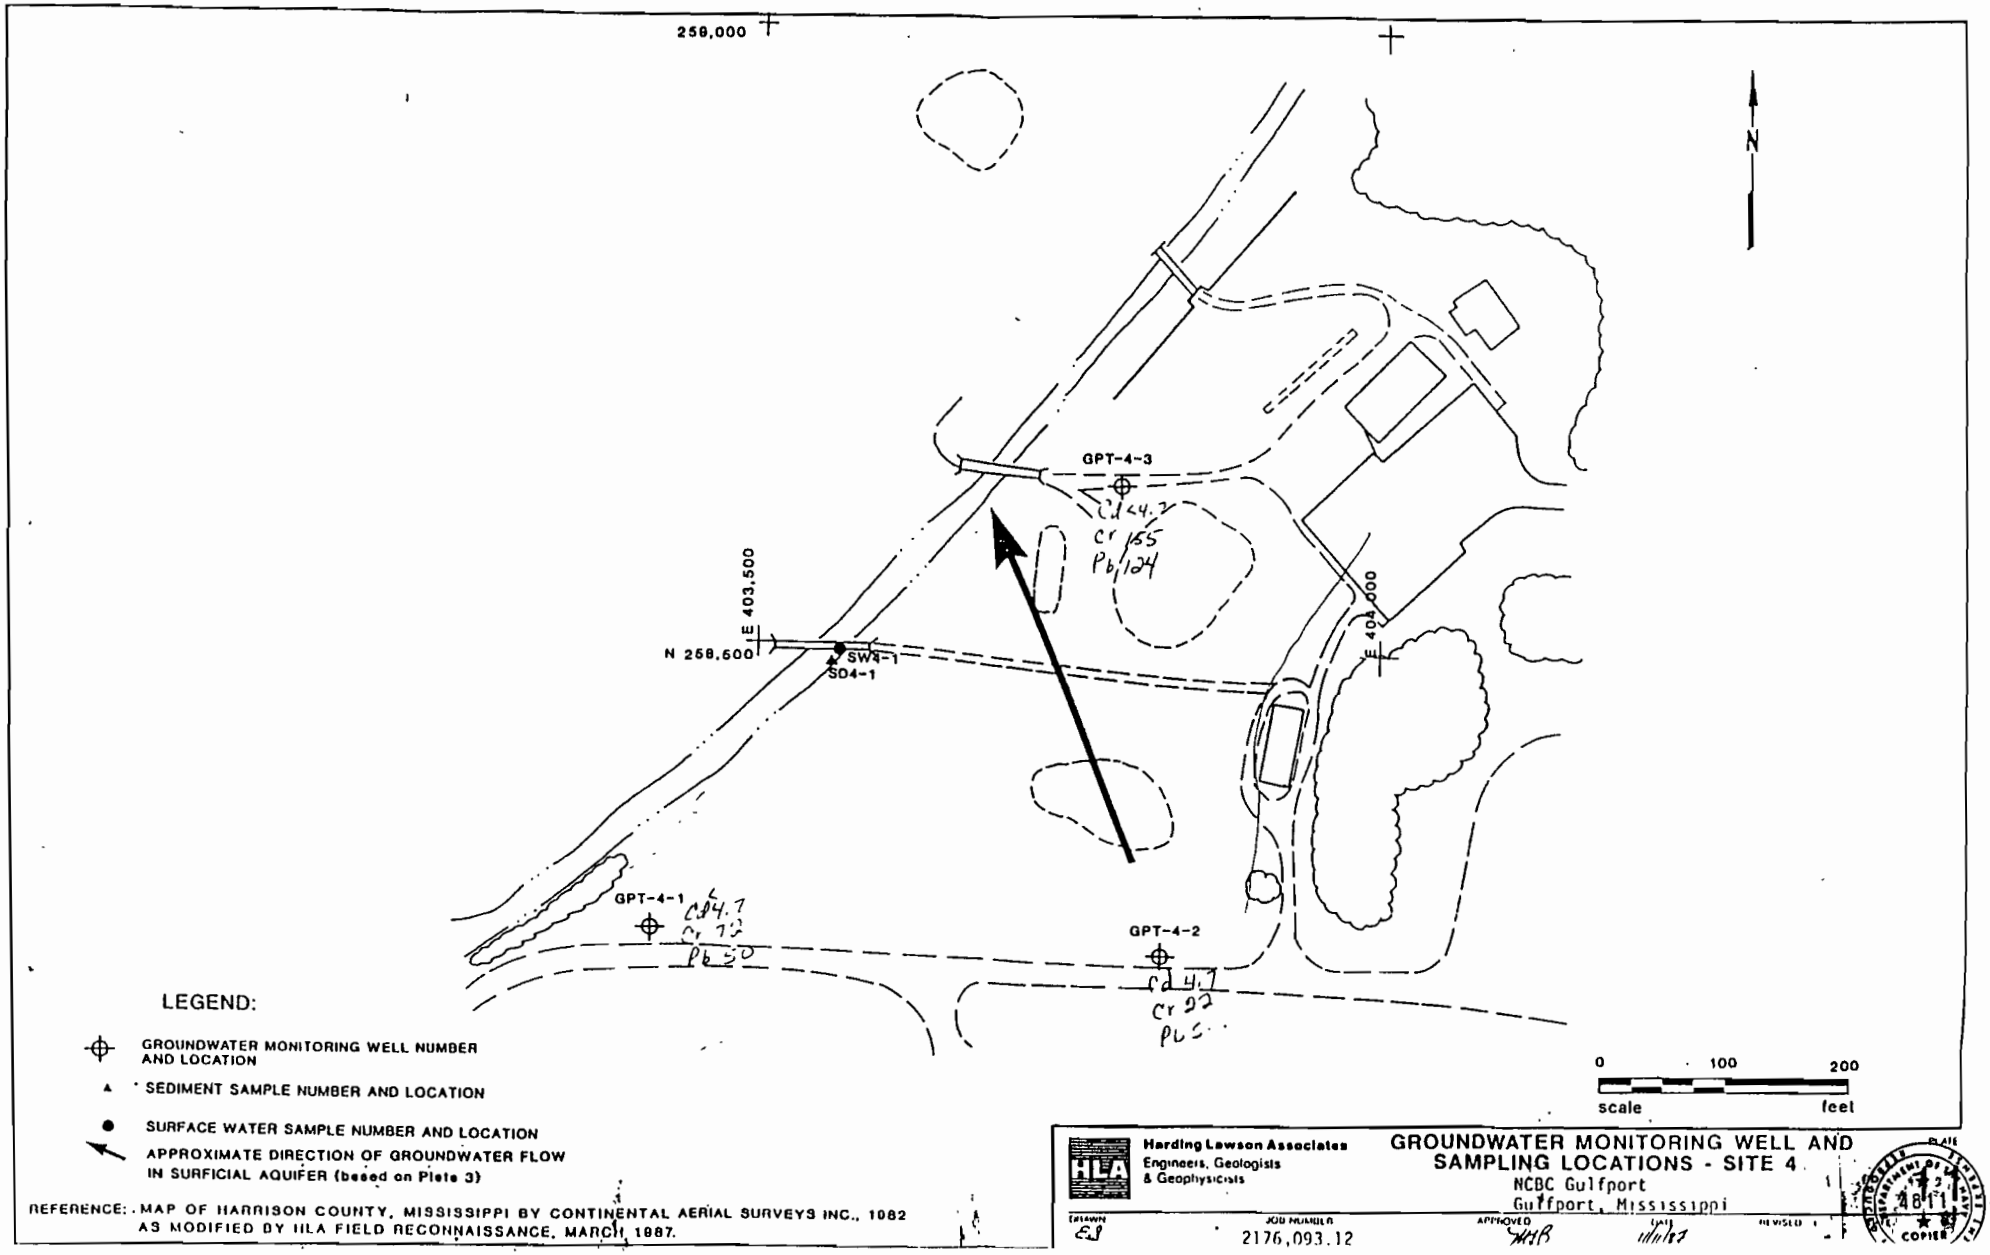
There were no volatile organic, acid-extractable, or base-neutral contaminants above detection limits for all monitoring wells at Site 4 (figure 6). Chromium concentrations for samples taken from wells GPT-4-1 and GPT-4-3, however, were above the MCL of 50 ppb at concentrations of 72 ppb and 155 ppb, respectively. Lead concentrations for the same two wells were 50 ppb and 124 ppb (MCL = 50 ppb). Levels of chromium and lead below the MCL were detected at well GPT-4-2 and levels below the RFI health based criteria were found in sediment sample SD4-1. Resampling of all wells is recommended to confirm these contaminant levels. Additional downgradient wells are needed, but as always should be installed only after further groundwater measurements confirm slope of the potentiometric surface at this site.

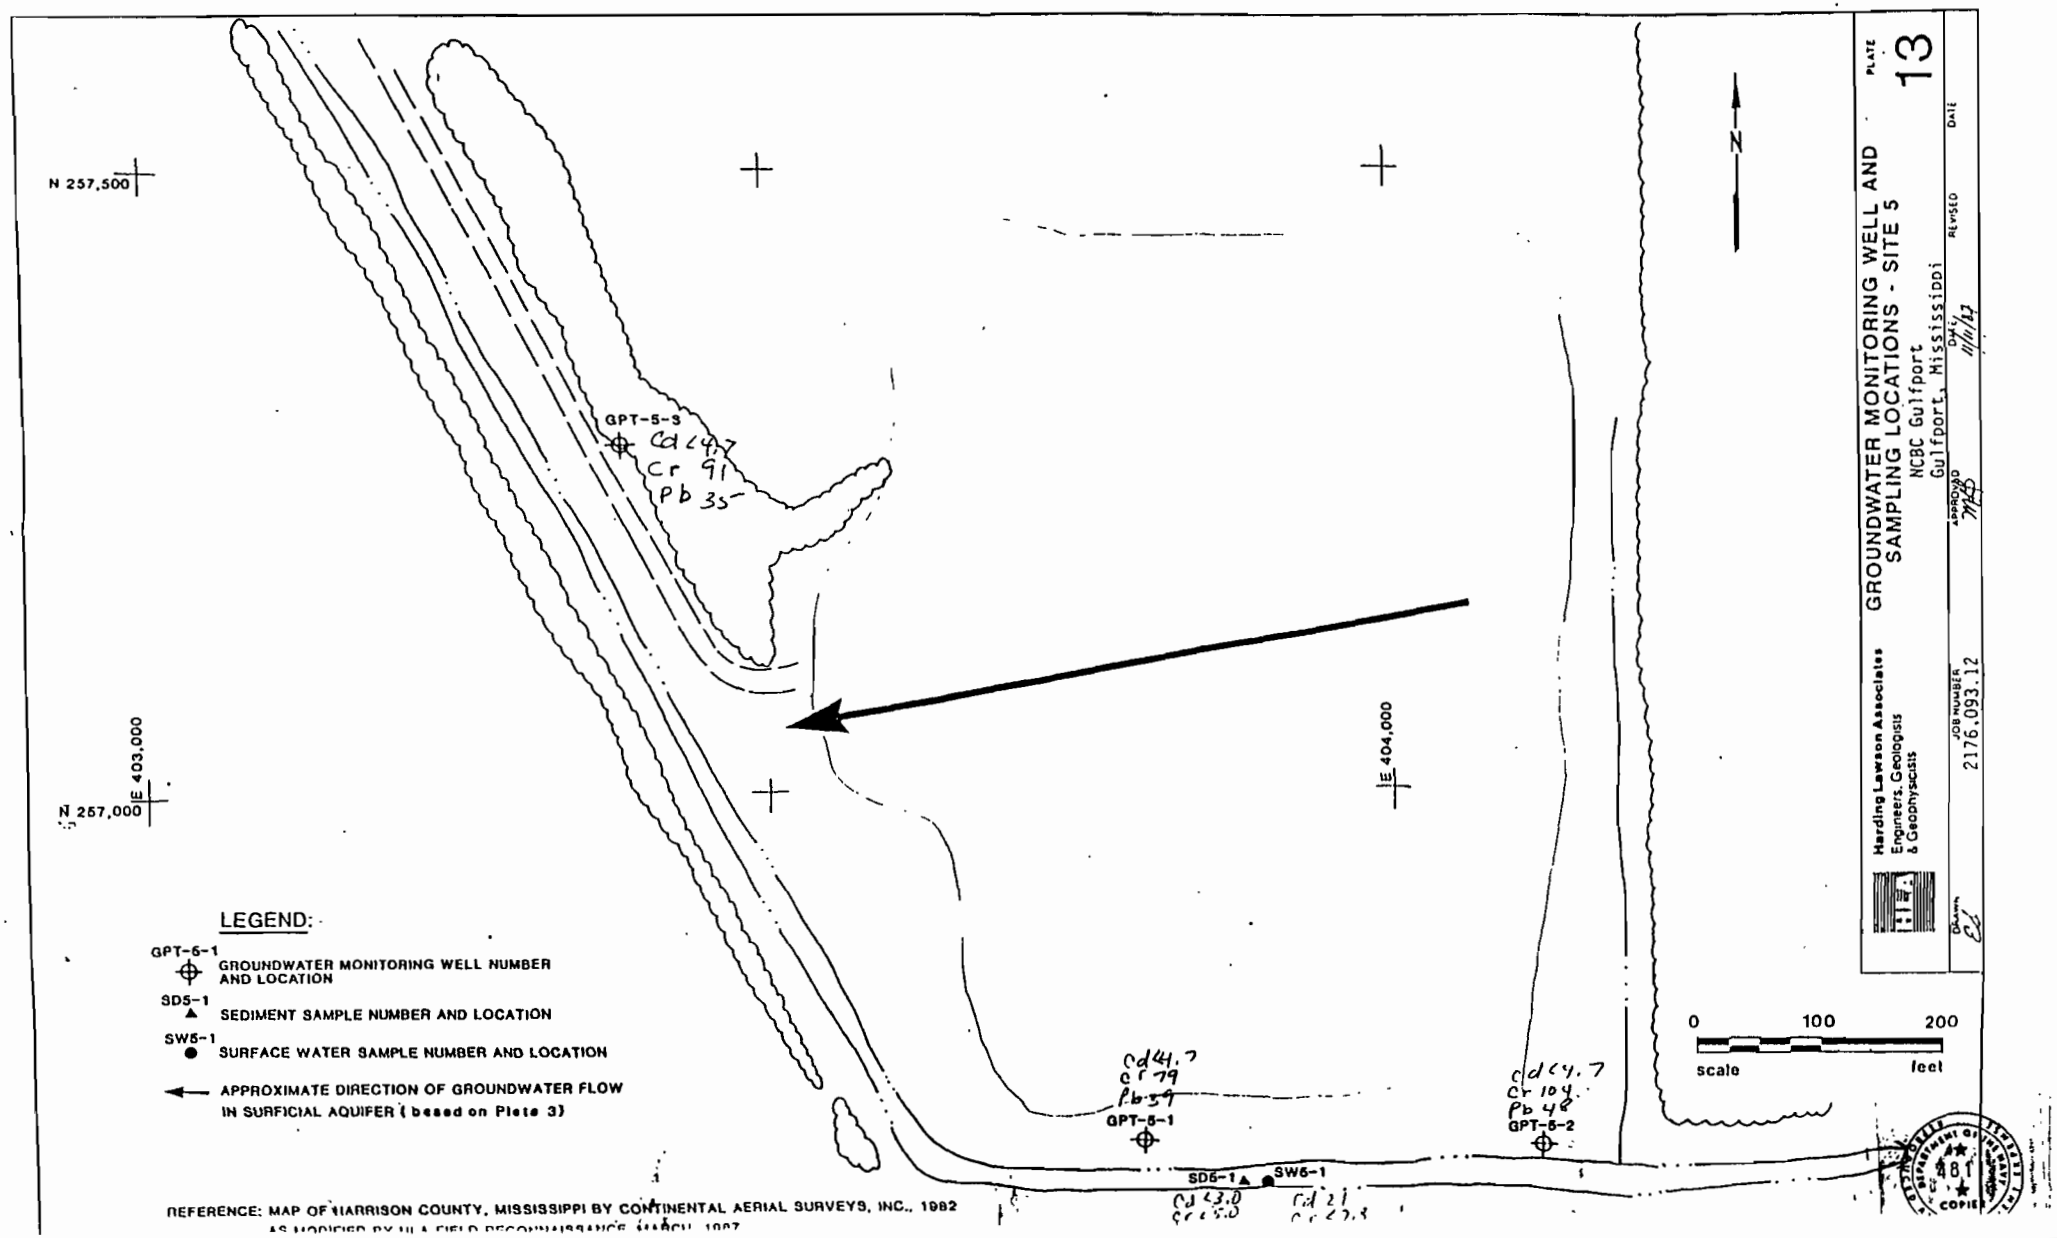
Elevated levels of chromium were detected at Site 5 (figure 7). Analytical results for groundwater samples from GPT-5-1, GPT-5-2 and GPT-5-3 indicate chromium concentrations of 79 ppb, 104 ppb, and 91 ppb, respectively. Lead levels were all below the MCL, but are high enough (38 to 48 ppb) to be of concern. As for the other sampling sites, resampling as recommended in the report should be done, but in a manner that reduces the dilution of groundwater samples. Additional downgradient wells are needed.

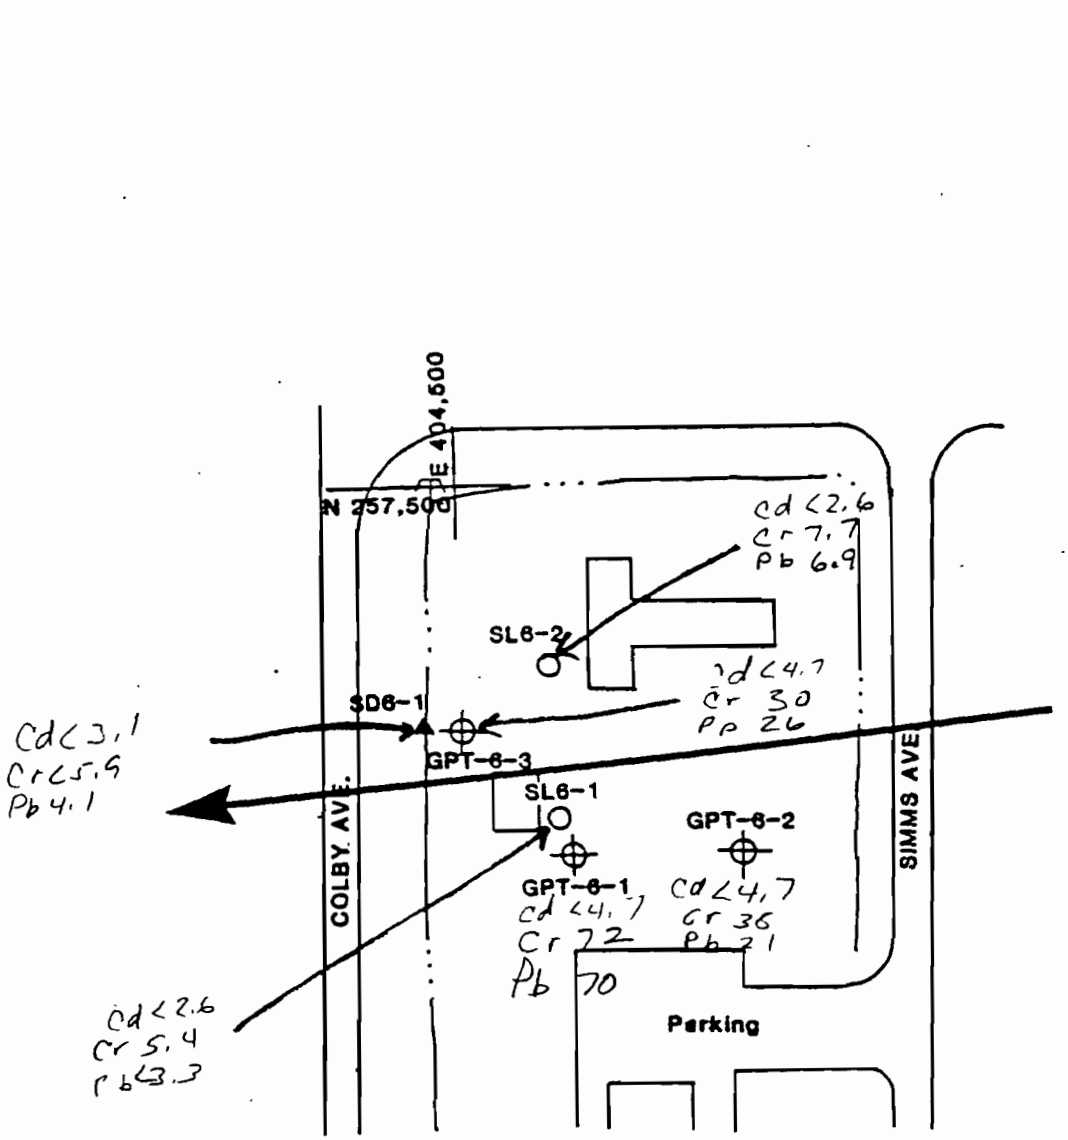
The concerns at Site 6 are much the same as those at Sites 4 and 5 (figure 8). Concentrations of chromium and lead in GPT-6-1 are 72 ppb and 70 ppb, repectively. Levels of these two metals are below the MCL of 50 ppb in each of the other two monitoring wells, but they are high enough to be of concern. As stated previously, sampling of discrete intervals is recommended to confirm the level of contamination and to determine if there is vertical variations in their concentrations.
