FINAL RESOURCE CONSERVATION AND RECOVERY ACT PARTIAL CLOSURE REPORT
FOR BUILDING 635 WITH TRANSMITTAL LETTER NAS BRUNSWICK ME
3/14/2011
NAS BRUNSWICK

RCRA PARTIAL CLOSURE REPORT
for
BUILDING 635 – NMCB-27/VEHICLE MAINTENANCE BUILDING
NAVAL AIR STATION BRUNSWICK, MAINE
USEPA IDENTIFICATION NUMBER ME8170022018
MARCH 2011

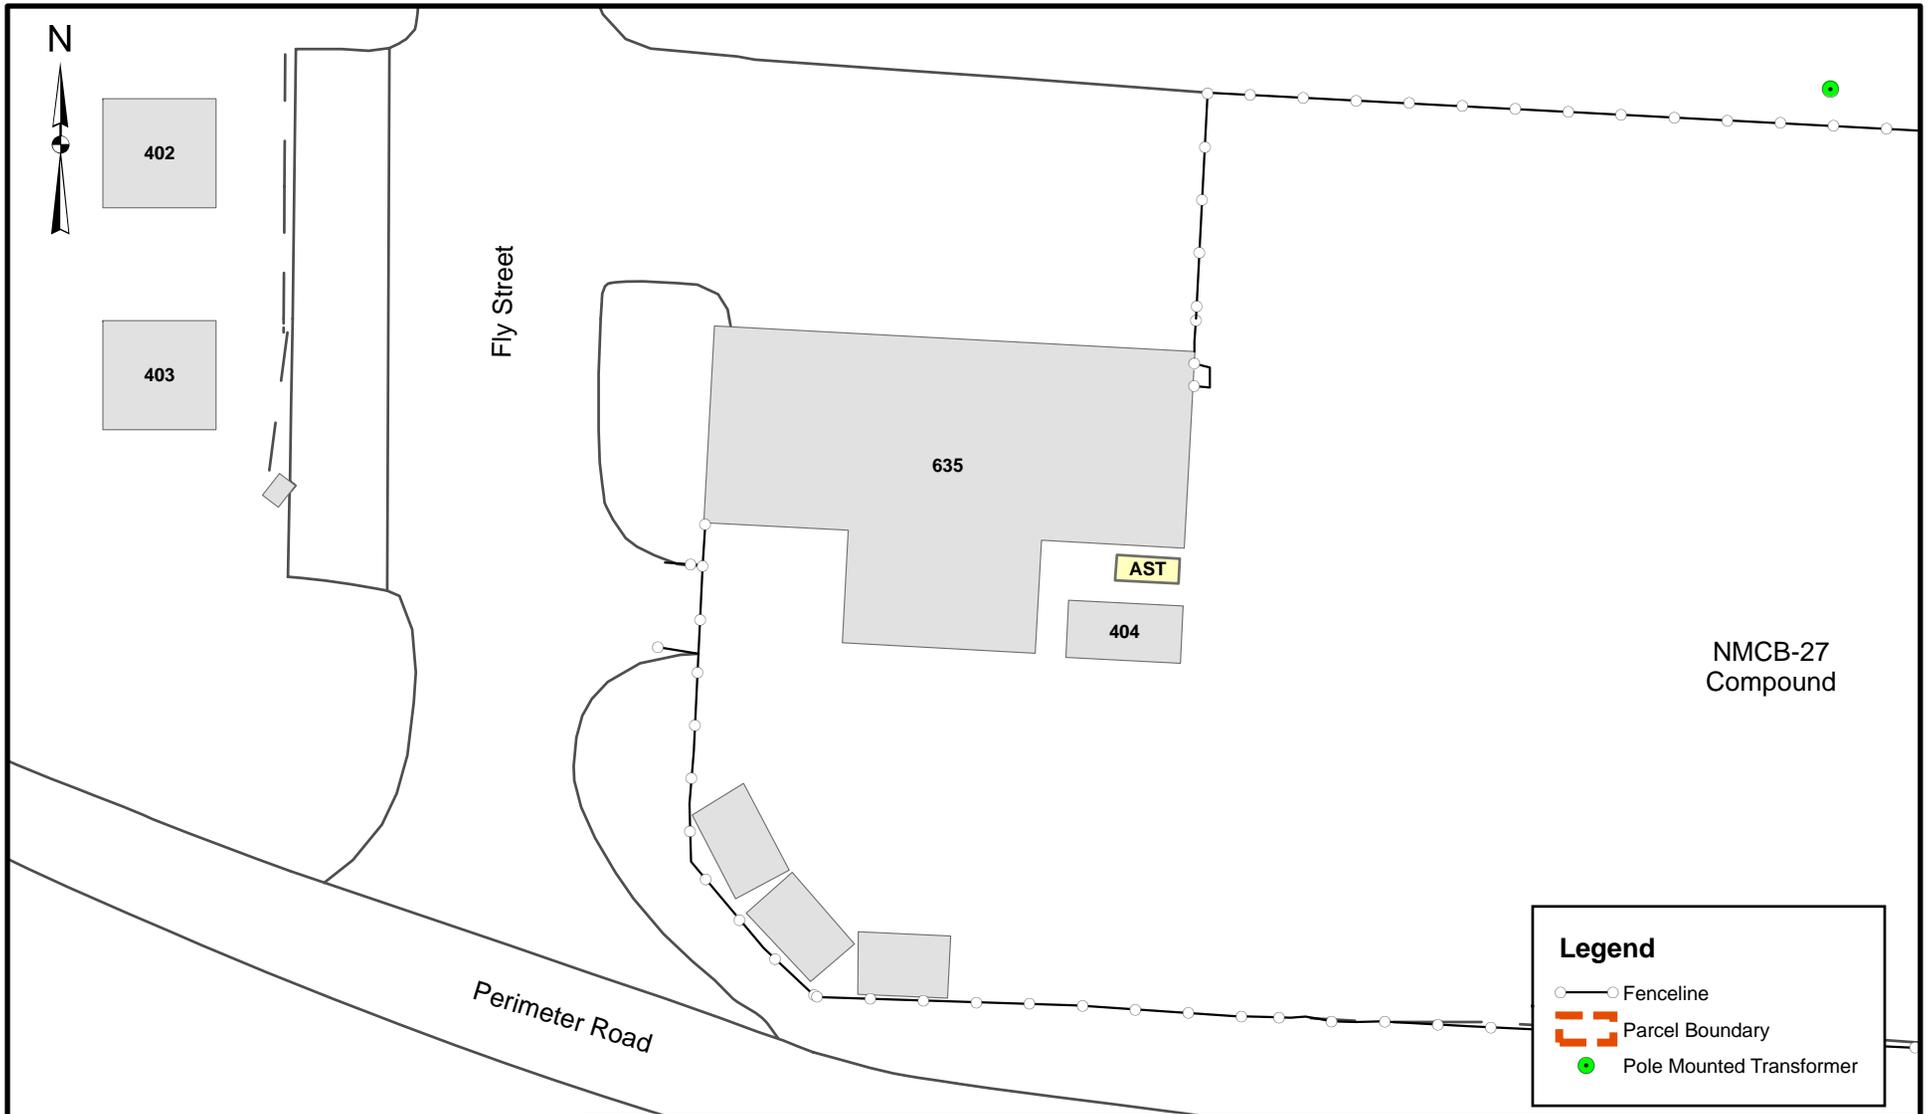
SCALE AS NOTED	
FILE \\NASB_BLDG_635_SITE_MAP.MXD	
REV 0	DATE 03/04/11
FIGURE NUMBER 2

SITE MAP
 BUILDING 635 - NMCB-27/VEHICLE MAINTENTANCE BUILDING
 RCRA PARTIAL CLOSURE REPORT
 NAVAL AIR STATION BRUNSWICK, MAINE

This investigation of the hazardous waste closure requirement applies to the building footprint of Building 635 (building footprint as shown on Figure 2) only. It does not apply to the land surrounding or the groundwater underlying Building 635.
