ASBESTOS CONTAINING MATERIAL RE-INSPECTION BUILDING 35 VOLUME 7 CNC  
CHARLESTON SC  
2/15/2000  
BAT ASSOCIATES, INC.

**Asbestos-Containing Material Re-inspection  
For Building 35  
Charleston Naval Shipyard  
Charleston, South Carolina**

Contract No. N2467-96-D-0998  
Delivery Order No. 0013

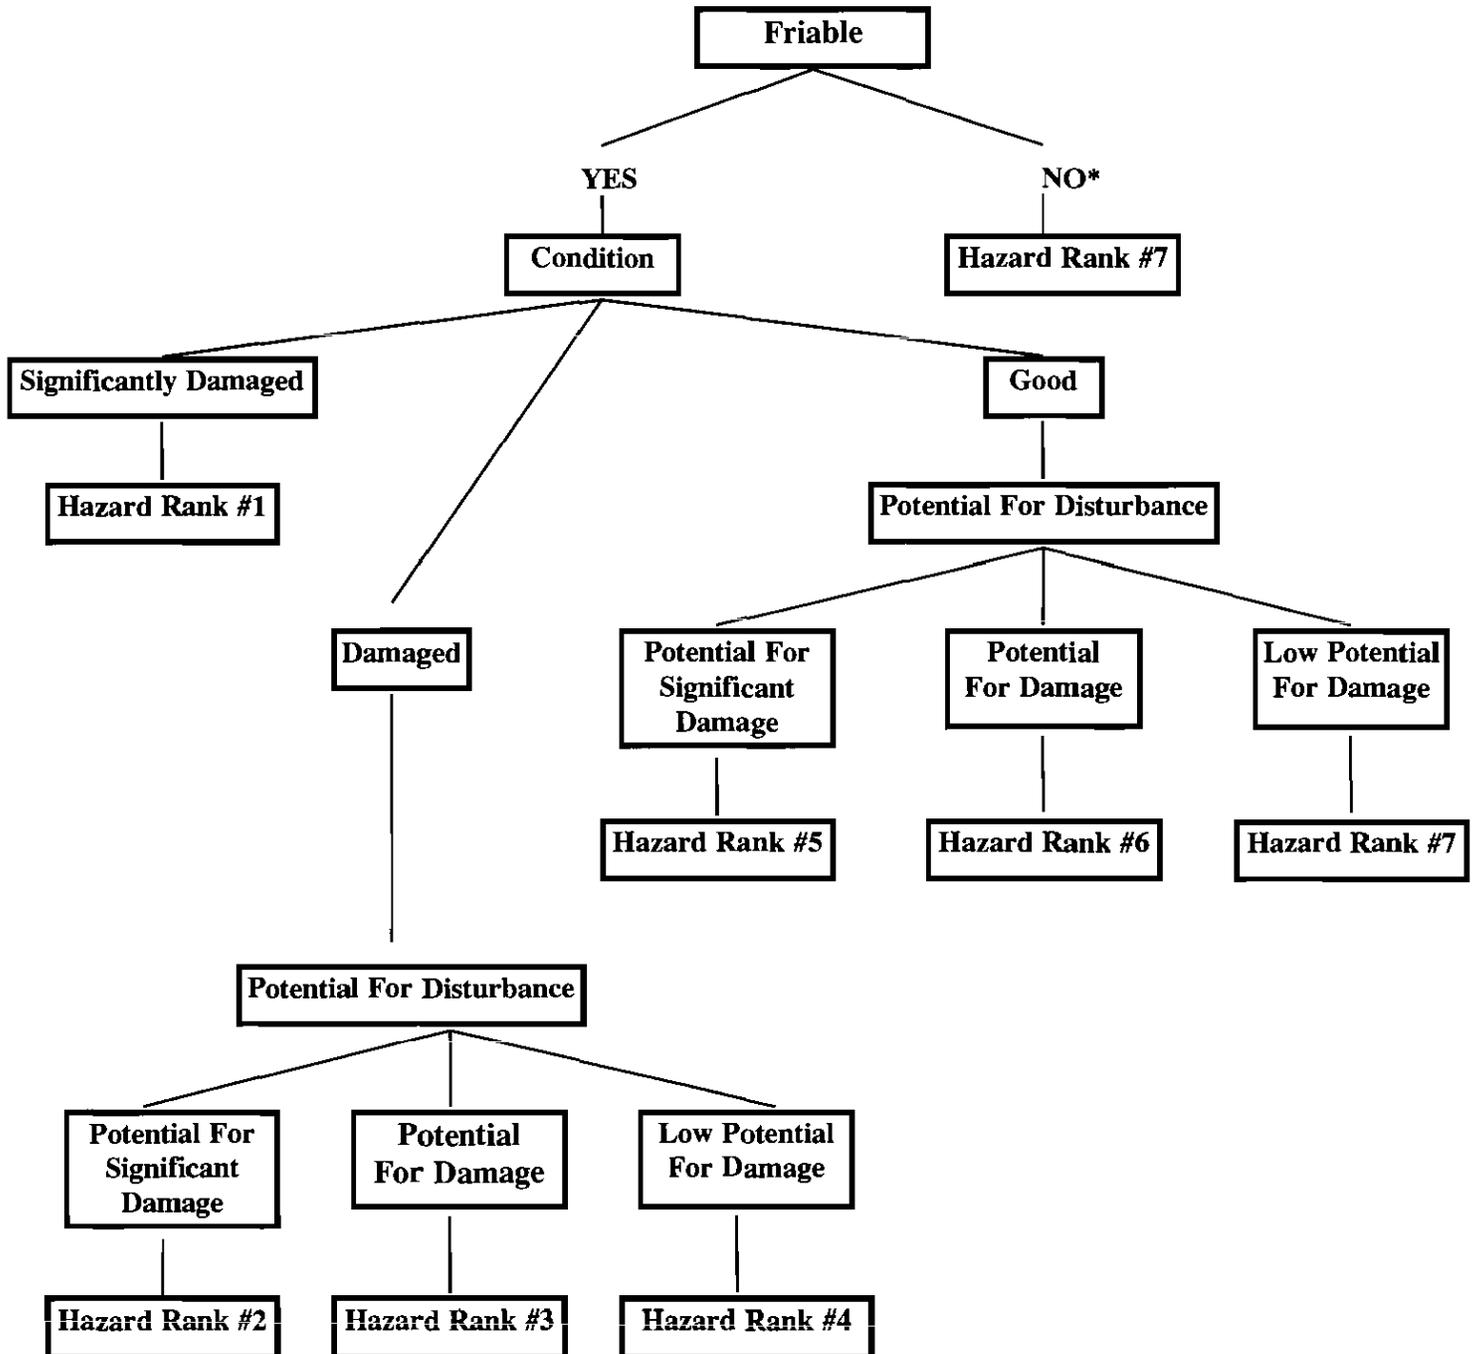
**Figure 1.0 Decision Tree Diagram For Hazard Assessment**

Hazard rank #1 are materials of highest concern, and hazard rank #7 are the materials least likely to release asbestos fibers to the work area.

\*Miscellaneous materials that are considered non-friable were placed in the Hazard Rank #8 category, which is in good condition with a low potential for damage.

BAT adopted for this re-inspection one of the four general classes of hazard assessment models considered during the AHERA rule-making process. This method for hazard assessment is a modified decision tree as detailed in the USEPA, *Guidance for Assessing and Managing Exposure to Asbestos in Buildings*, or the *Pink Book*. Based on the physical assessment responses documented in the field, the BAT Management Planner proceeded through the decision tree process depicted in Figure 1.0 on the following page.
