Subject: MCON Project P-183, Solid Waste Disposal System, Naval Air  
Station, Alameda, California; closure plan

TIME FOR WATER TO PENETRATE 12" OF SOIL  
 Sanitary Landfill  
 NAS Alameda, California

HARDING LAWSON ASSOCIATES Consulting Engineers and Geologists DESIGN: WFF, DR. [ ] SUPV.: AJW, [ ] DRAWN BY: [ ] CHECKED BY: [ ] DATE: 2/15/85 SCALE: AS SHOWN	DEPARTMENT OF THE NAVY NAVAL FACILITIES ENGINEERING COMMAND WESTERN DIVISION SAN DIEGO, CALIFORNIA ALAMEDA HAS ALAMEDA, CALIFORNIA P 183 SOLID WASTE DISPOSAL SYSTEM GENERAL PLAN DRAWING NO. 6161496 CODE: 80091 CONTRACT NO. M42474-BC-8054 SHEET 3 OF 10
---	--

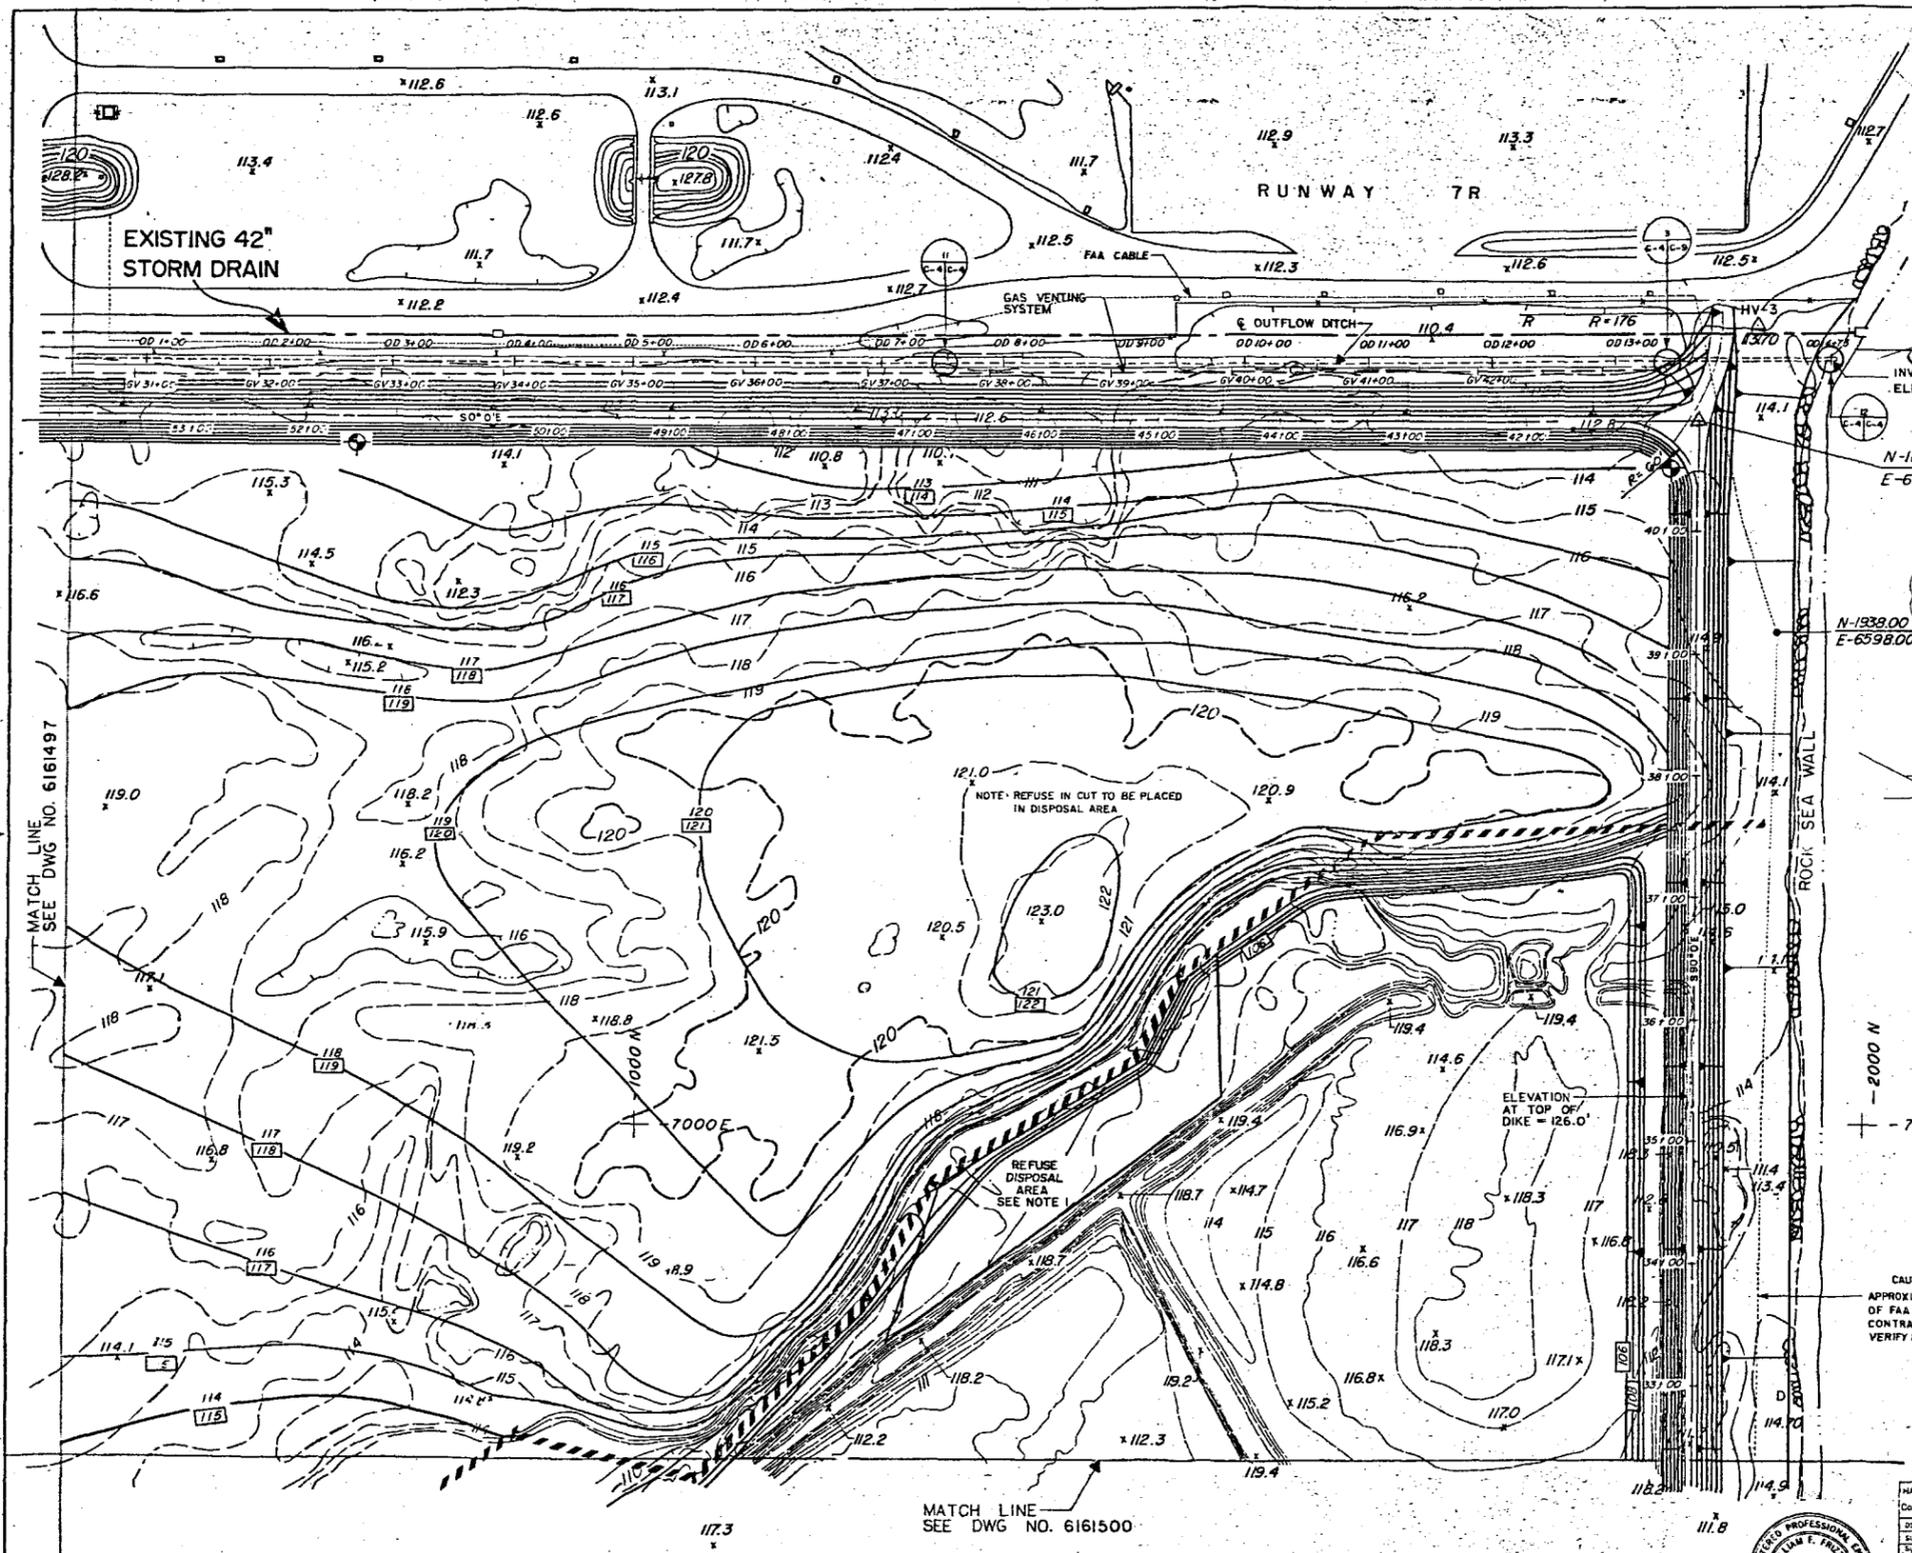
- NOTES:
- Borrow material to be excavated before placing refuse in refuse disposal area.
  - Top of dike is of elevation 126'. Contour interval on dike slopes is 2'.

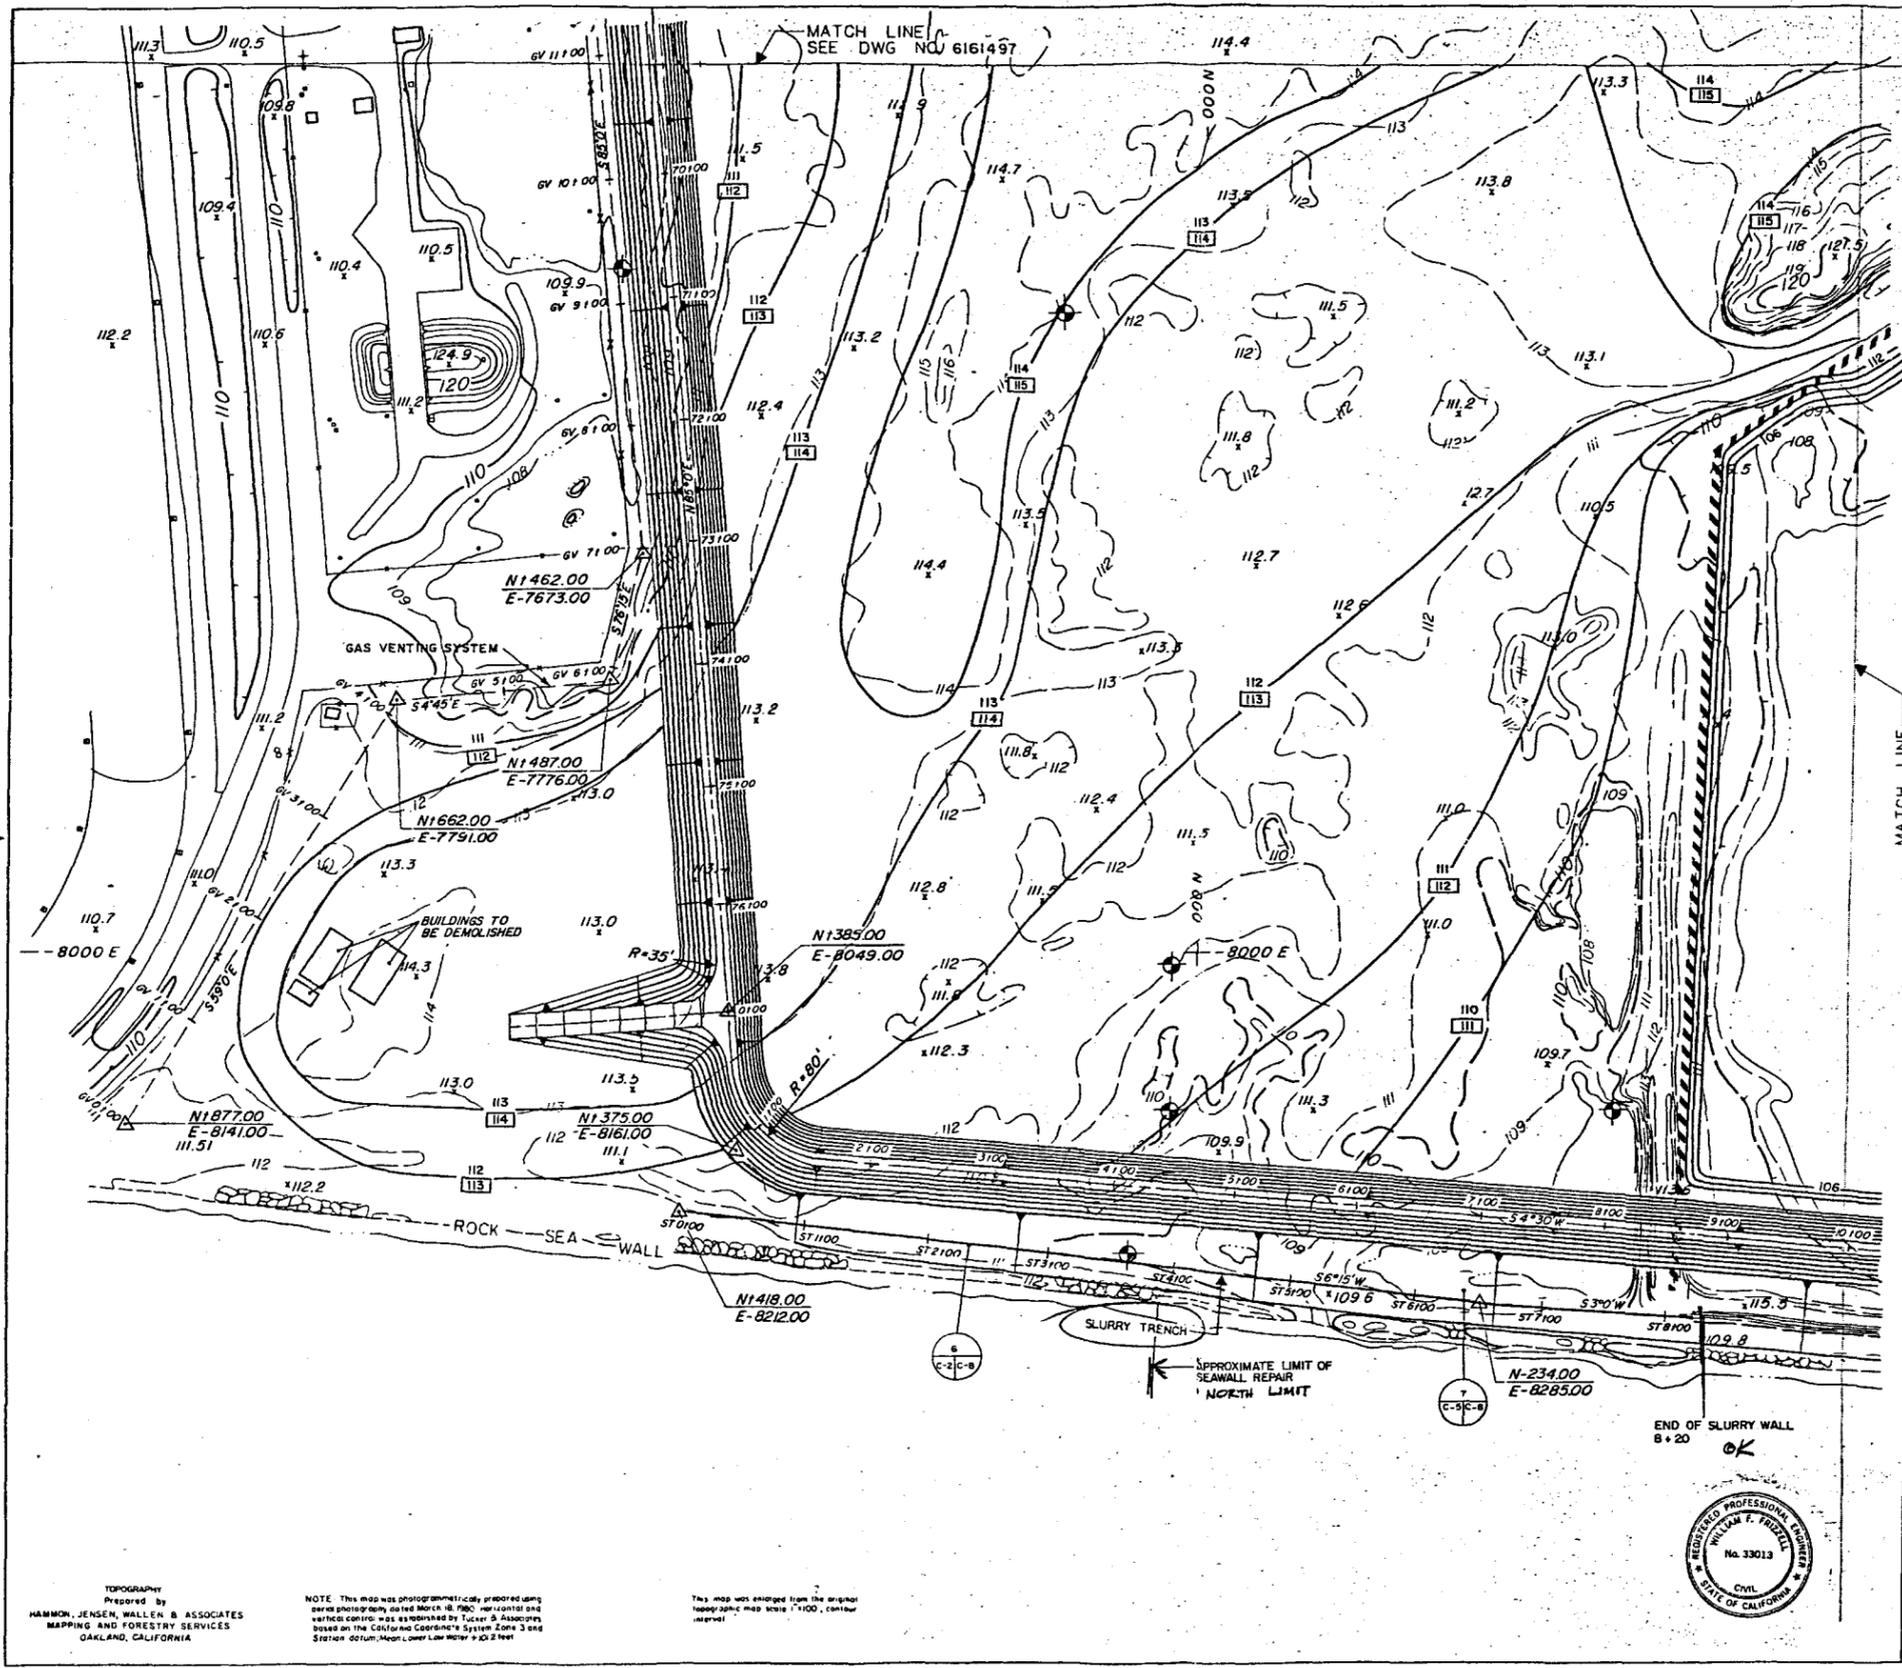
NOTE:  
Top of dike at elevation 126'. Contour interval on dike slopes is 2'.

HARDING-LAWSON ASSOCIATES Consulting Engineers and Geologists		DEPARTMENT OF THE NAVY WESTERN DIVISION SAN BRUNO, CALIFORNIA	
DESIGN WFF: DR	CHE. WFF	ALAMEDA NAS ALAMEDA, CALIFORNIA	
SUPV. WFF: WFF	CHK. ENGR: JCD	P 183	
DESIGNED BY: WFF	DATE: 2/3/82	SOLID WASTE DISPOSAL SYSTEM	
ENGR. WFF: WFF	DATE: 2/3/82	PLAN - N.W. QUADRANT	
DATE: 2/3/82	SCALE: AS SHOWN	NAVAFAC DRAWING NO.: 6161499	CONTRACT NO.: 182244-80-C-9034
APPROVED: WFF	DATE: 2/3/82	SHEET 6 OF 10

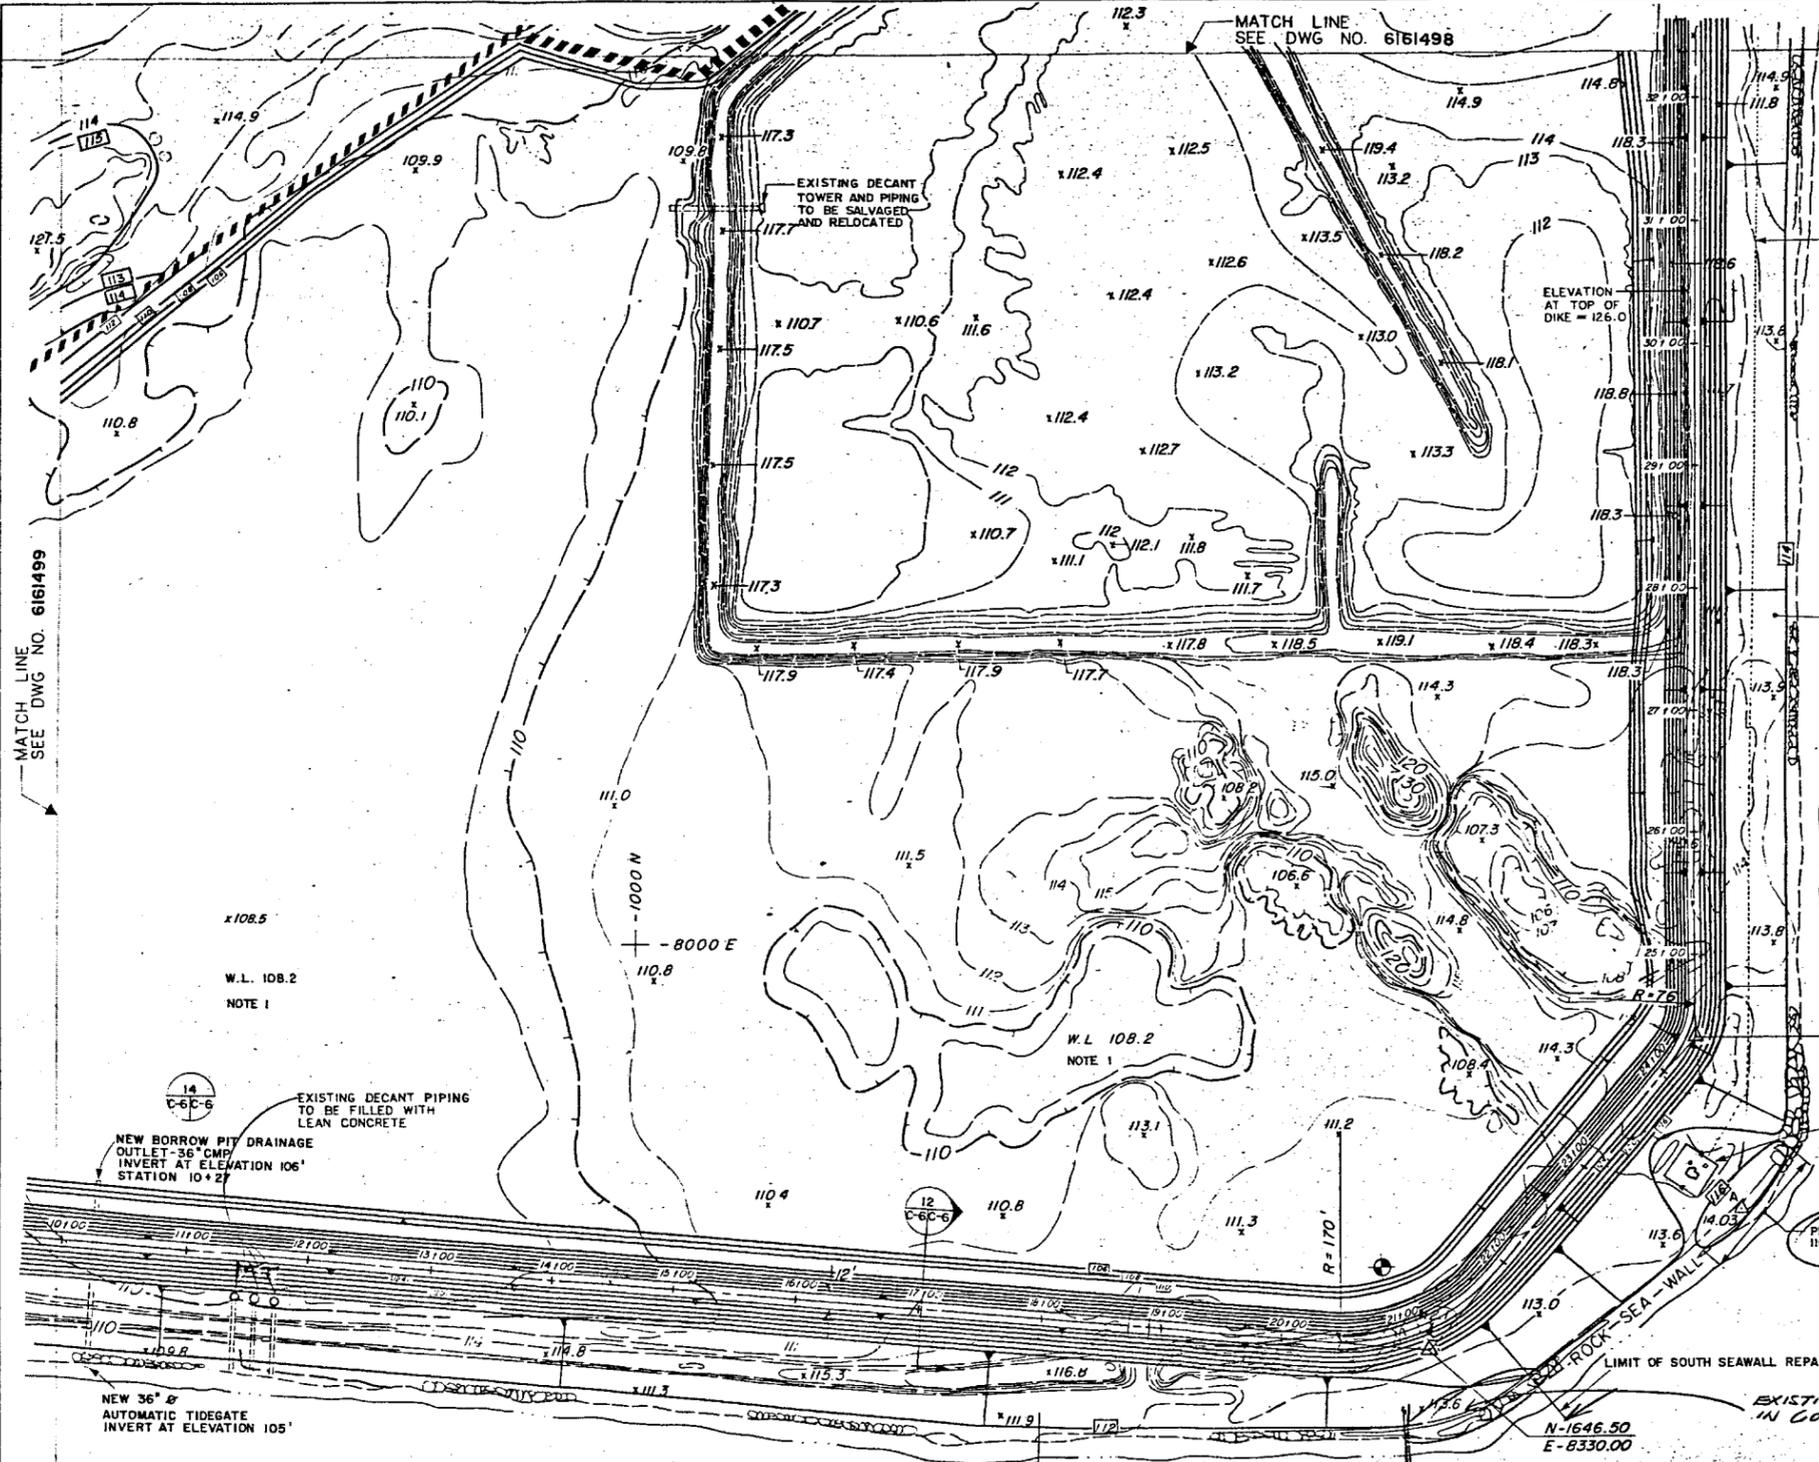
- NOTES
1. Water level show is due to ponding from rainfall. The elevations of the ground water at time of drilling was about 106'.
  2. Top of dike at elevation 126'. Contour interval on dike slopes is 2'.

CAUTION: APPROXIMATE LOCATION OF FAA CABLE - CONTRACTOR TO VERIFY IN FIELD.

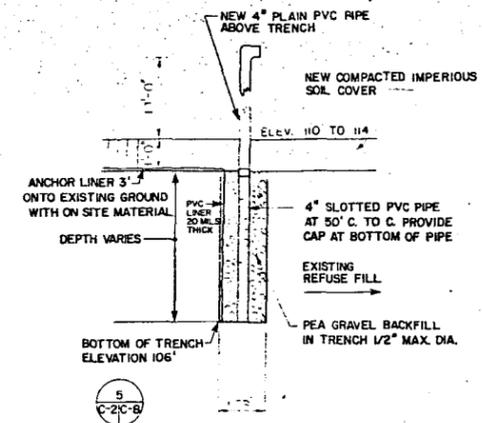
DETAIL — PERIMETER GAS VENTING SYSTEM

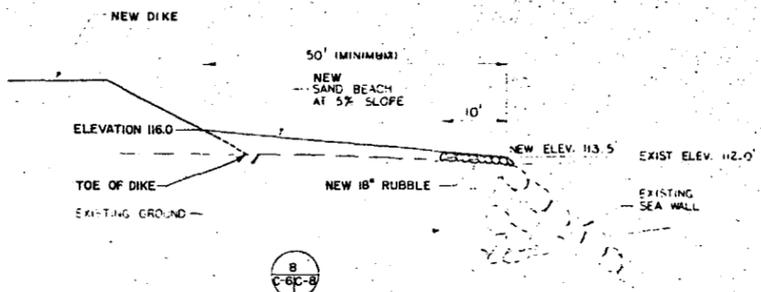
DETAIL — SLOPE REPAIR — SOUTH SEA WALL

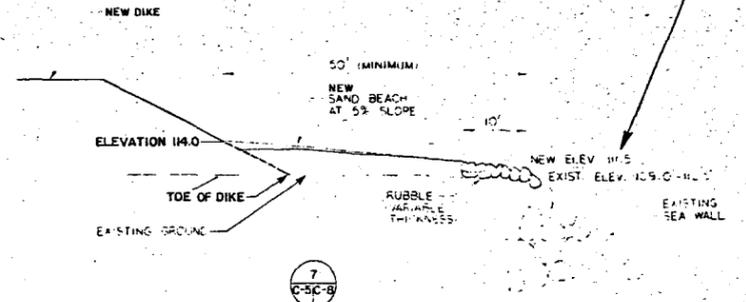
DETAIL — SLOPE REPAIR — WEST SEA WALL

NOTE:  
REPAIR WORK SHALL BE DONE ONLY UP TO ELEVATION 111.5

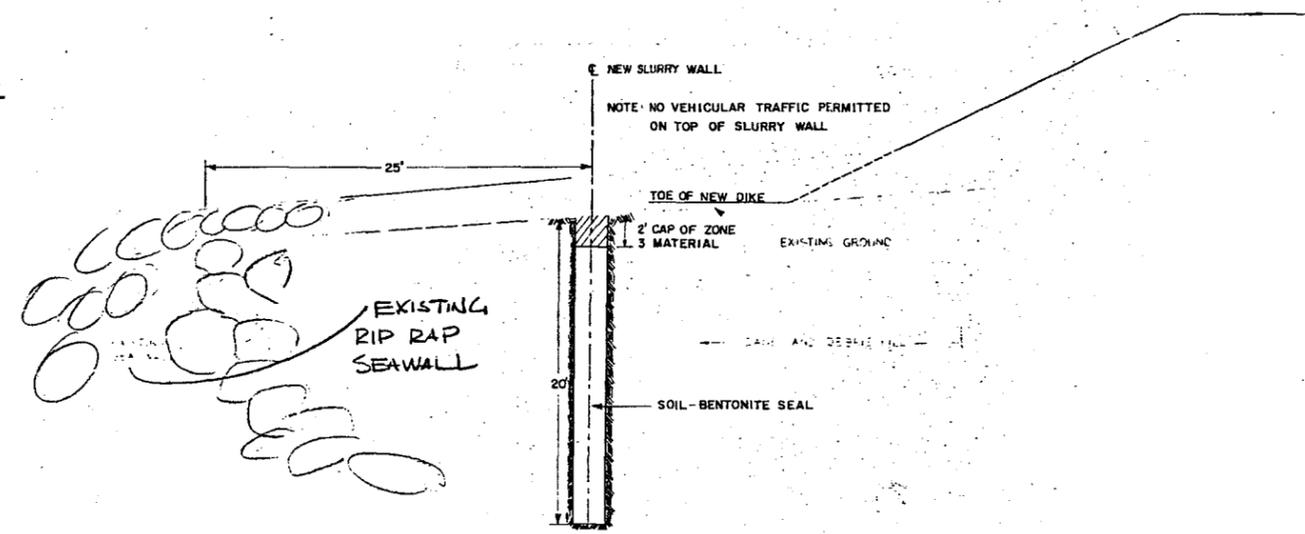
DETAIL — SEEPAGE CONTROL SLURRY WALL
