Subject: Moffett Field Base Closure

Recently the City of Sunnyvale Public Works Department Solid Waste Division reviewed a copy of the Operable Unit 1 (OU1) Final Feasibility Study Report. This review followed a public notice that was printed in the San Jose Mercury News that indicated that the Navy is planning to close two landfills, the runway landfill (Site 1) and the golf course landfill (Site 2), with a three foot soil cap. Our review of the report and knowledge of state and federal solid waste regulations for municipal solid waste landfills has led to the conclusion that the proposed method of closing the two landfills does not meet the most minimal standards of the state and federal governments. The proposed closure method is far less protective of the environment and the public health and safety than the methods recently used to close the Sunnyvale Landfill, a nonhazardous municipal solid waste site. Sites 1 and 2, which are known to have received significant quantities of hazardous waste, should be closed to a higher, not lower, standard than the Sunnyvale Landfill and other recently closed Landfills.

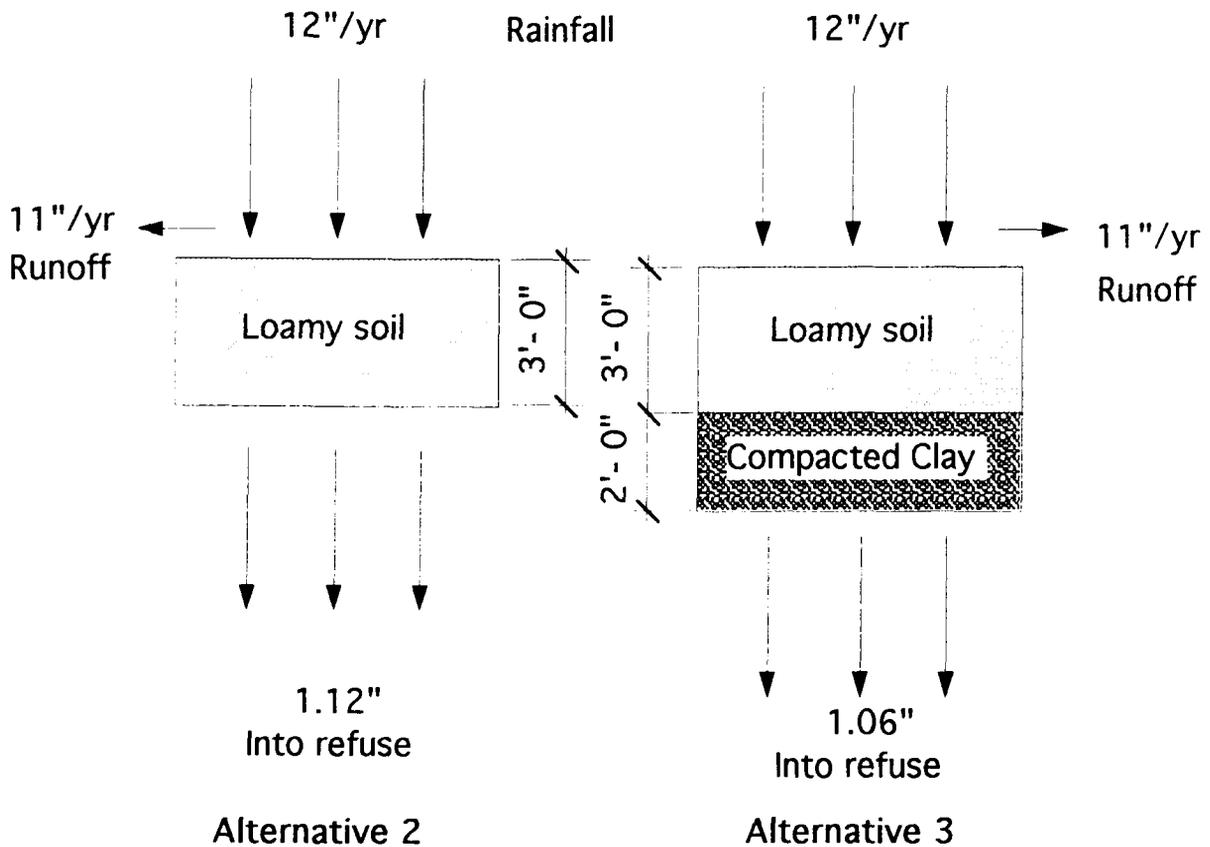
The HELP Model results seem flawed. Intuitively a site with 3 feet of loamy soil should allow much greater stormwater infiltration than a site with 3 feet of loamy soil over 2 feet of clay. To assist in explaining this concept the following sketch illustrating the report's comparison of Alternatives 2 and 3 is provided.

It is likely that one or more of the assumptions fed into the HELP model, such as soil characteristics, plant characteristics or evaporative zone/climateological data is flawed. These should be reviewed.
