SAMPLING AND ANALYSIS OUTLINE FOR BUILDING 1 BASE REALIGNMENT AND
CLOSURE ZONE C DEVELOPED NON-INDUSTRIAL AREA GROUP 9 NAS CECIL FIELD FL
6/1/1997
ABB ENVIRONMENTAL SERVICES INC

SAMPLING AND ANALYSIS OUTLINE
BUILDING 1
BASE REALIGNMENT AND CLOSURE
ZONE C, DEVELOPED NONINDUSTRIAL AREA
GROUP IX
NAVAL AIR STATION CECIL FIELD
JACKSONVILLE, FLORIDA

June 1997

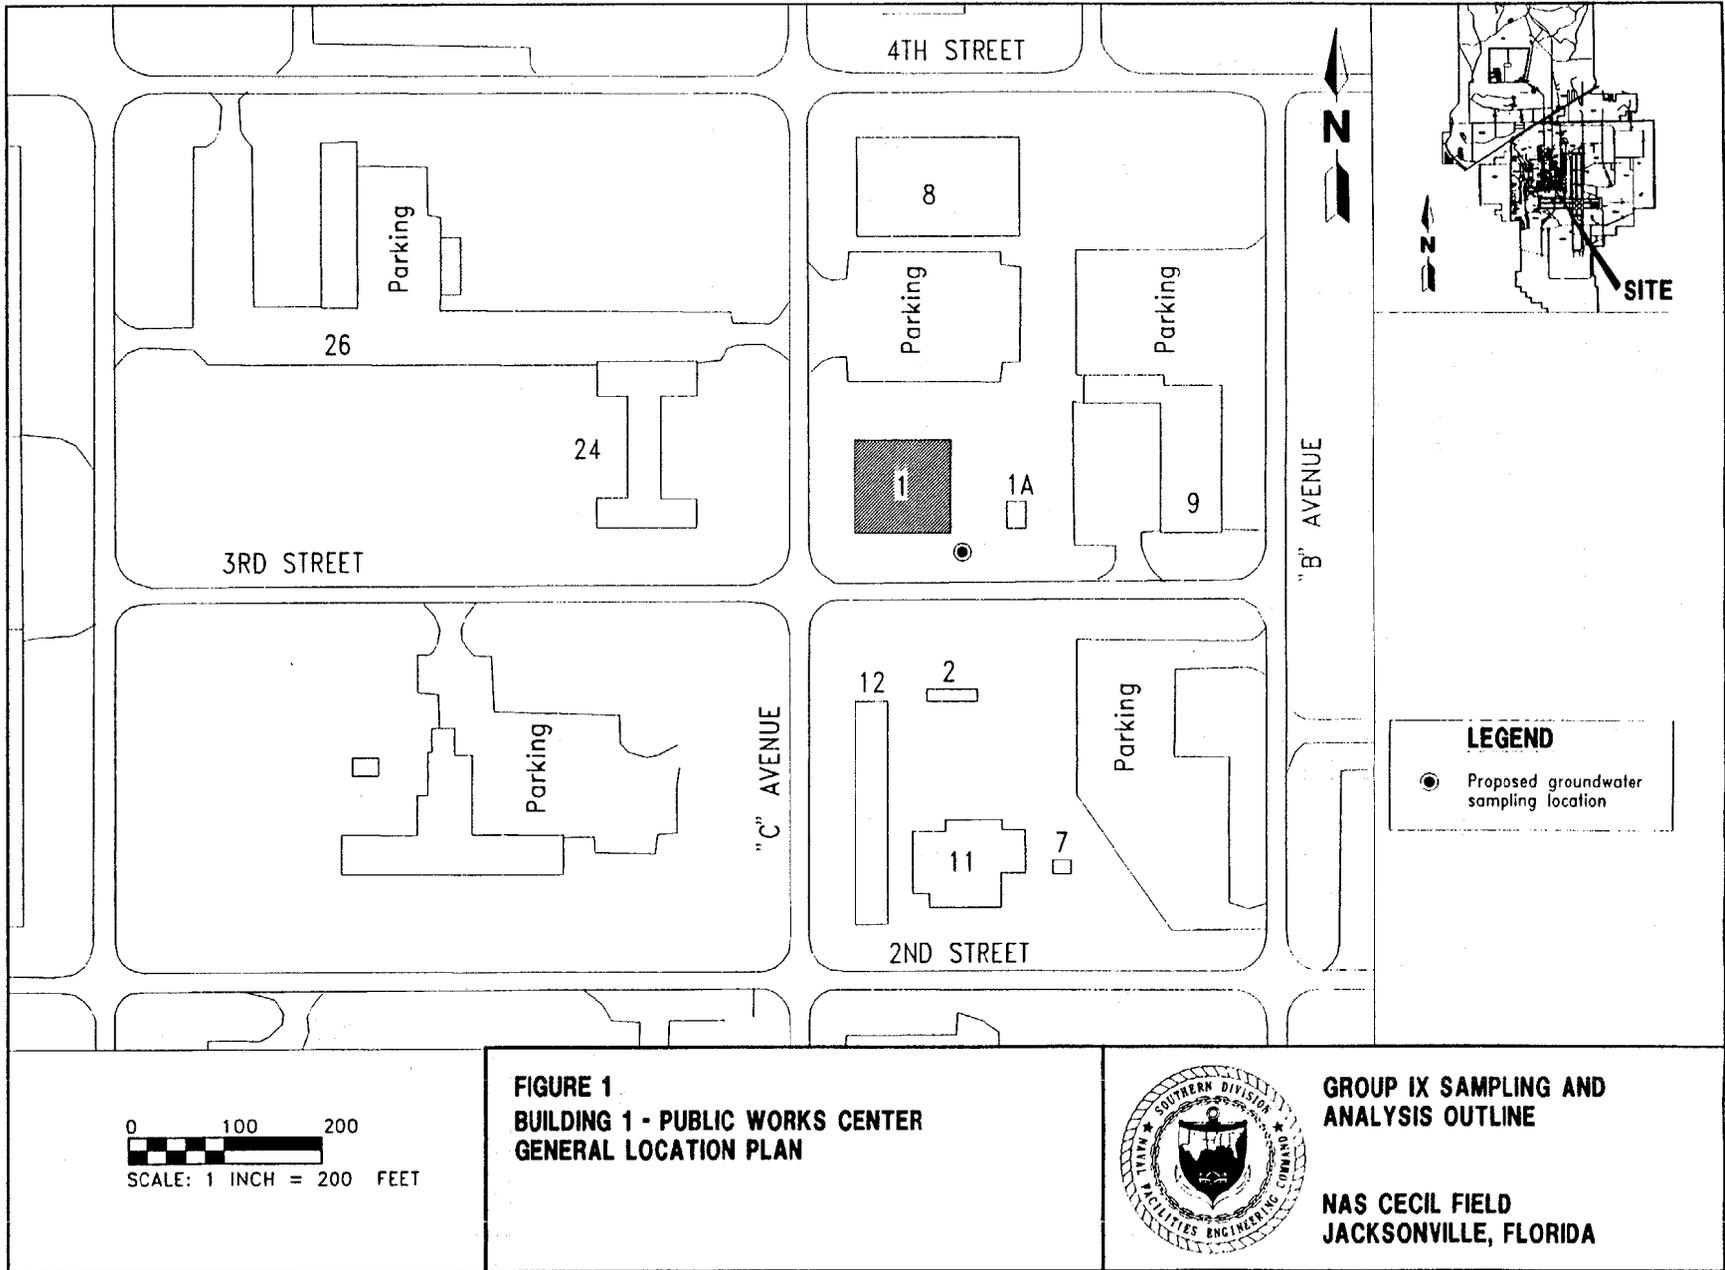
<u>Figure</u>	<u>Title</u>	<u>Page No.</u>
1	Building 1, Public Works Center	3

As-built construction drawings for the facility indicate sheetmetal, blacksmith, and paint-and-varnish shops were located in Building 1, prior to its conversion to administrative offices. A sump drain was located in the paint-and-varnish shop at the southeast corner of the building. This sump, and other floor drains noted on the construction drawings, was connected to the sanitary sewer system.

A Phase II Sampling and Analysis program is recommended to assess whether or not groundwater has been affected by potential releases from former activities or potential leaks from the sump in the former paint-and-varnish shop. Analytical results, a contamination assessment, and recommendations for reclassification of
