LEAD ACTIVITY SUMMARY CNC CHARLESTON SC  
1/1/1996  
CNC CHARLESTON

# LEAD ACTIVITY SUMMARY

NAVAL BASE CHARLESTON  
CHARLESTON, SOUTH CAROLINA

JANUARY 1996

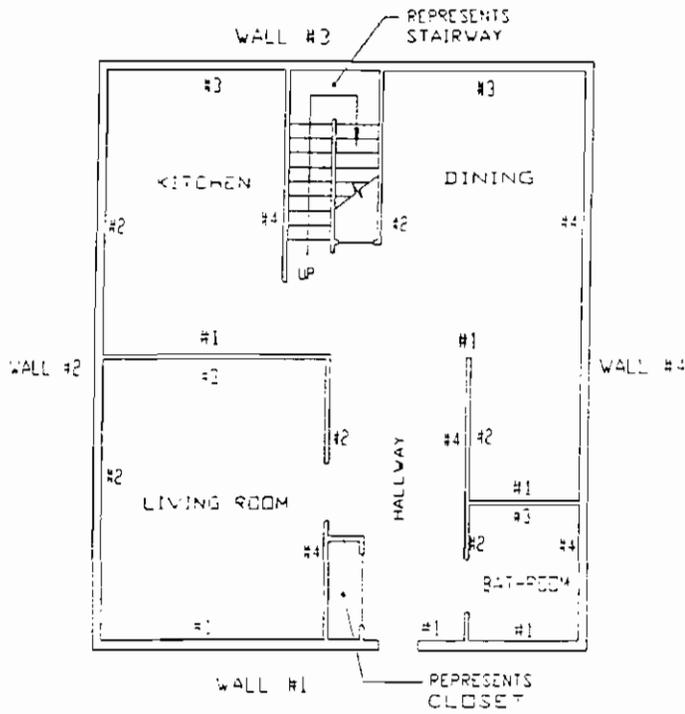
WALL NUMBERING SCHEME

**Note:** The following pages contain pictorial representations of wall/room designations and component descriptions.

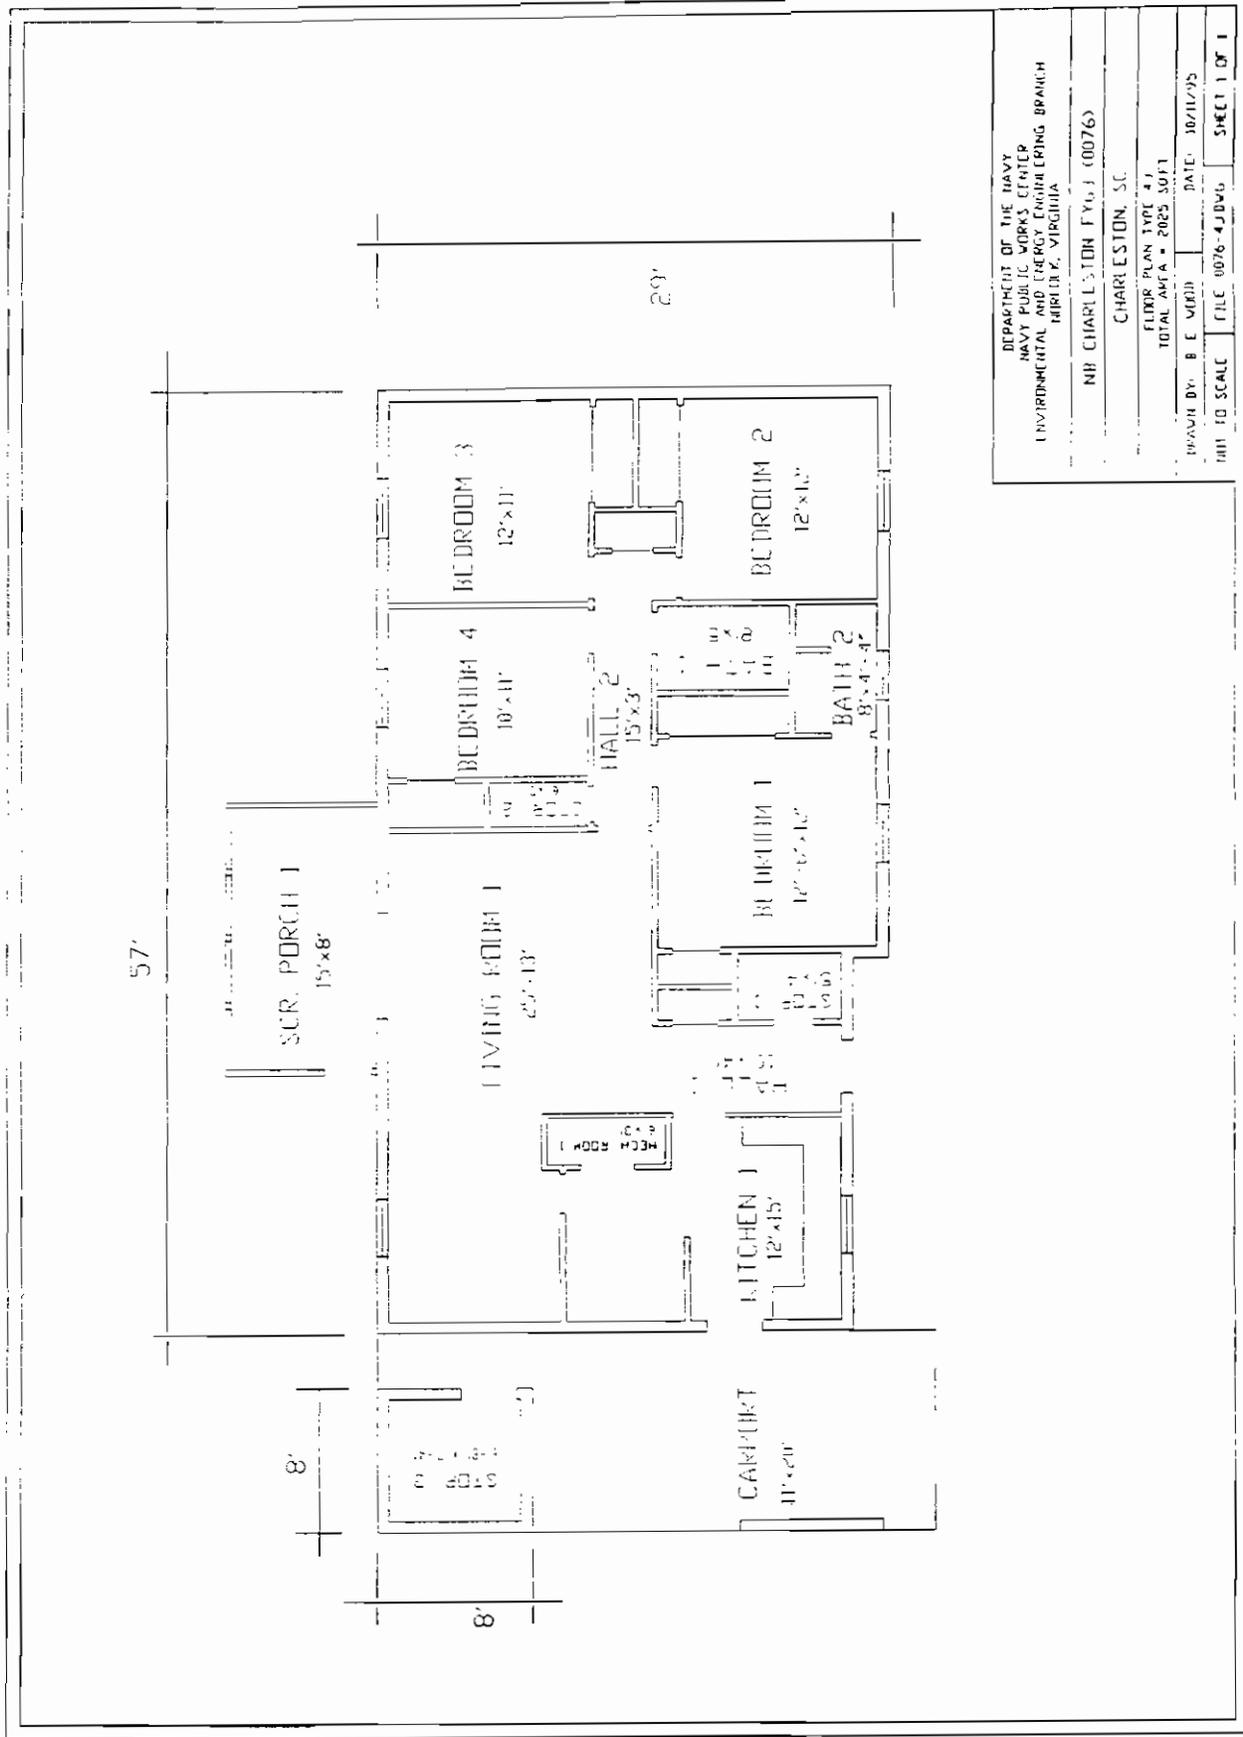
DEPARTMENT OF THE NAVY NAVY PUBLIC WORKS CENTER ENVIRONMENTAL AND ENERGY ENGINEERING BRANCH HARRISBURG, VIRGINIA			
NR CHARLESTON FY63 (0076)			
CHARLESTON, SC			
FLOR PLAN TYPE 4J			
TOTAL AREA = 2025 SQFT			
DRAWN BY: B. E. WOOD	DATE: 10/11/75		
1/11 TO SCALE	FILE 0076-4J/DWG	SHEET 1 OF 1

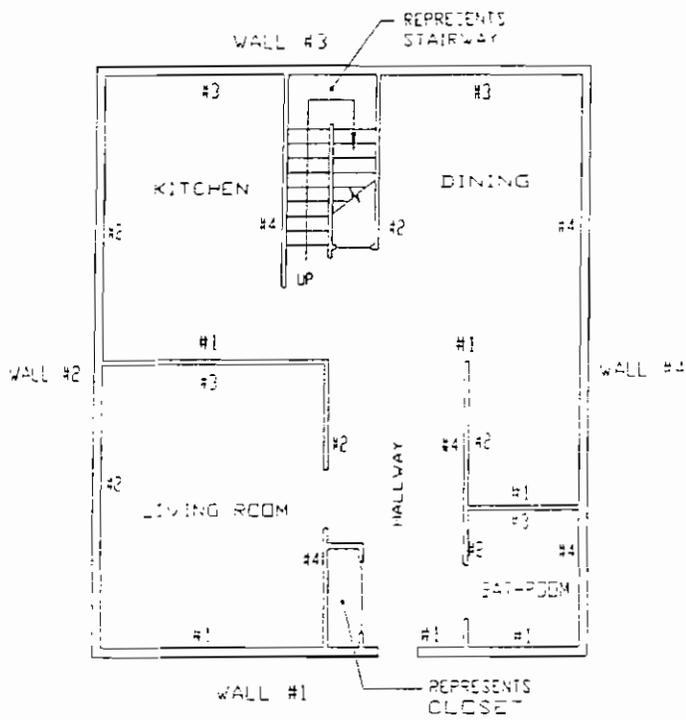
WALL NUMBERING SCHEME

**Note:** The following is a pictorial representations of wall/room designations and component descriptions.

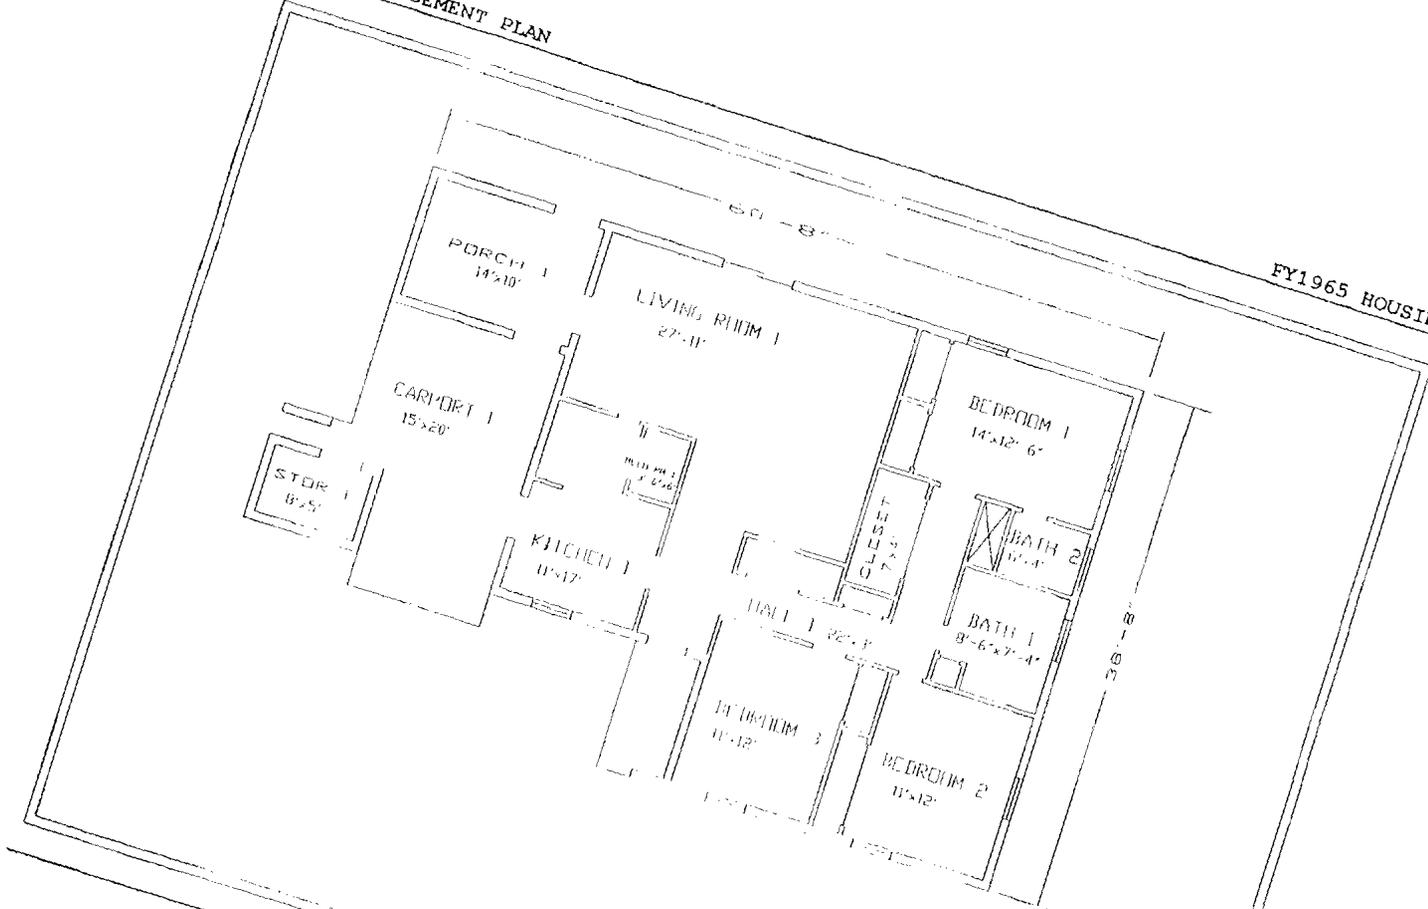
DEPARTMENT OF THE NAVY			
NAVY PUBLIC WORKS CENTER			
NINETEEN VIRGINIA			
NB CHARLESTON, FY65 (0077)			
CHARLESTON, SC			
FLOOR PLAN TYPE 35			
IDIAL AREA - 210 SQT			
DRAWN BY: B. C. WIND	DATE: 10/21/55		
FILE NO: 6077-330V1	SHEET 1 OF 1

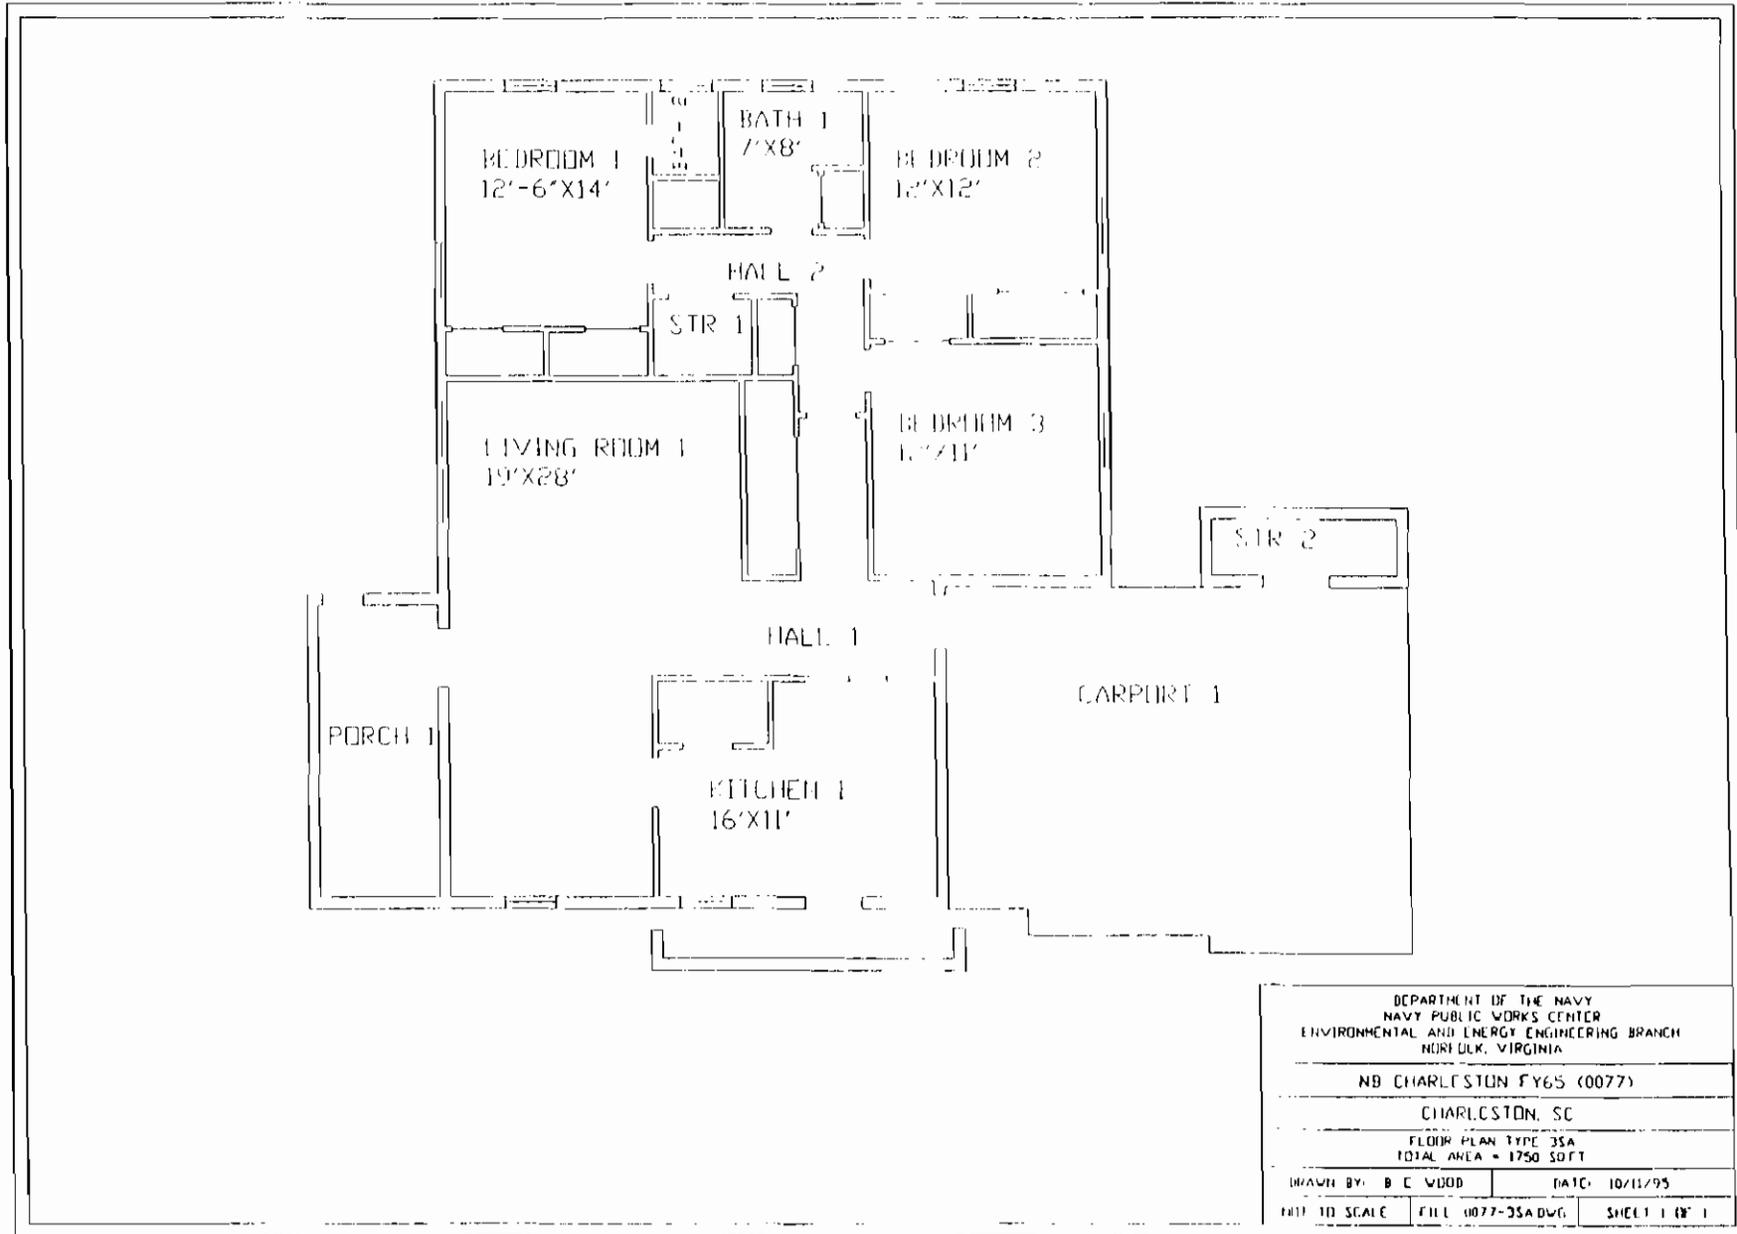
DEPARTMENT OF THE NAVY NAVY PUBLIC WORKS CENTER ENVIRONMENTAL AND ENERGY ENGINEERING BRANCH NORFOLK, VIRGINIA		
NB CHARLESTON FY65 (0077)		
CHARLESTON, SC		
FLOOR PLAN TYPE 35A TOTAL AREA = 1750 SQ FT		
DRAWN BY: B E WOOD	DATE: 10/11/95	
NOT TO SCALE	FILL 0077-35ADWG	SHEET 1 OF 1

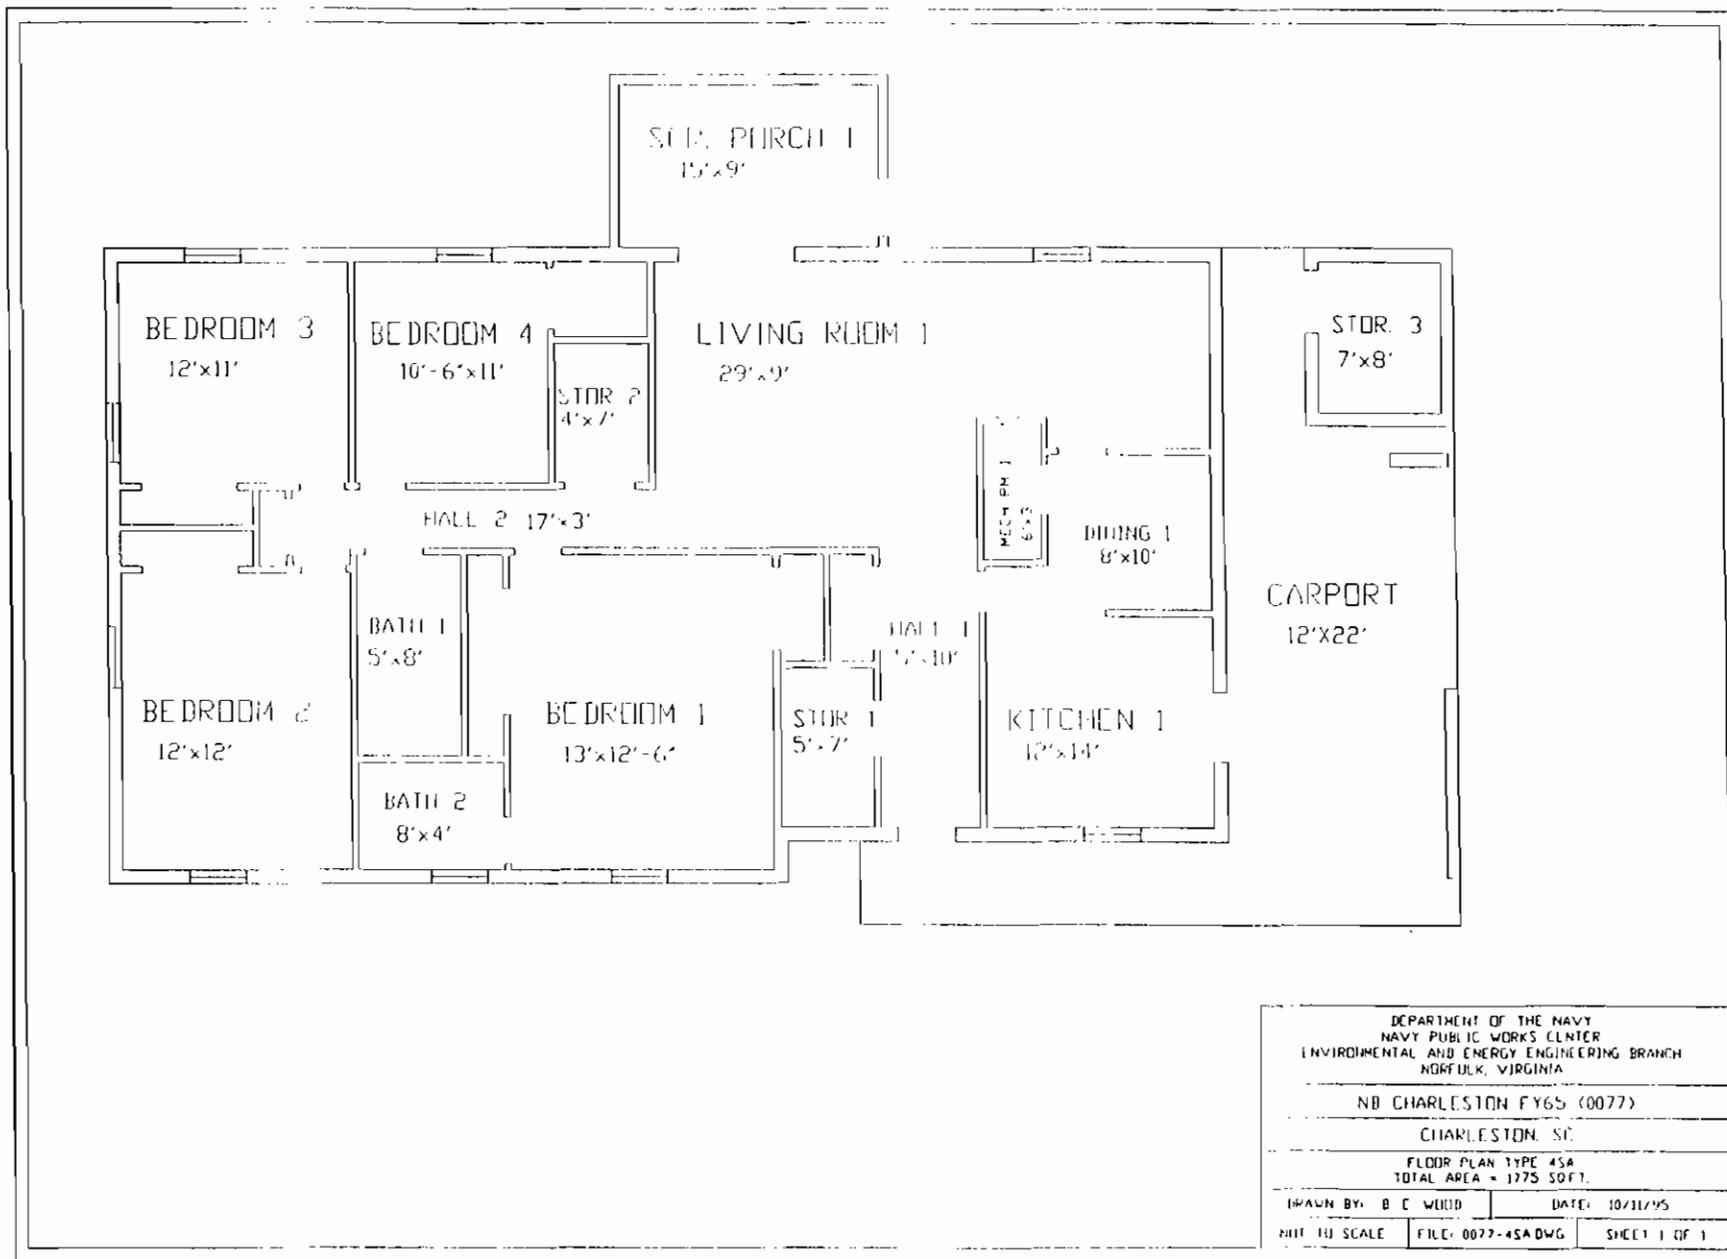
DEPARTMENT OF THE NAVY NAVY PUBLIC WORKS CENTER ENVIRONMENTAL AND ENERGY ENGINEERING BRANCH NORFOLK, VIRGINIA		
NO CHARLESTON FY65 (0077)		
CHARLESTON, SC		
FLOOR PLAN TYPE 45A TOTAL AREA = 1775 SQFT.		
DRAWN BY: B E WOOD	DATE: 10/11/65	
UNIT 1/3 SCALE	FILE: 0077-45ADWG	SHEET 1 OF 1

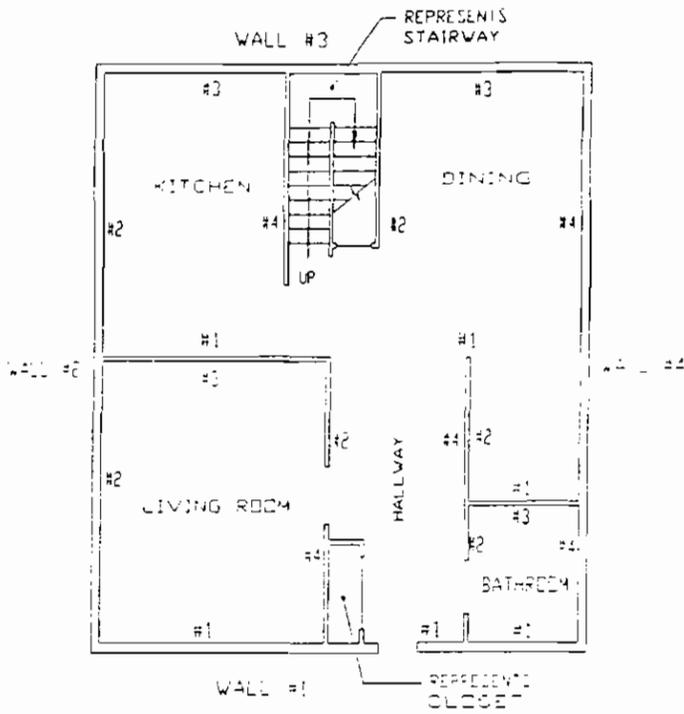
WALL NUMBERING SCHEME

**Note:** The following pages contain pictorial representations of wall/room designations and component descriptions.

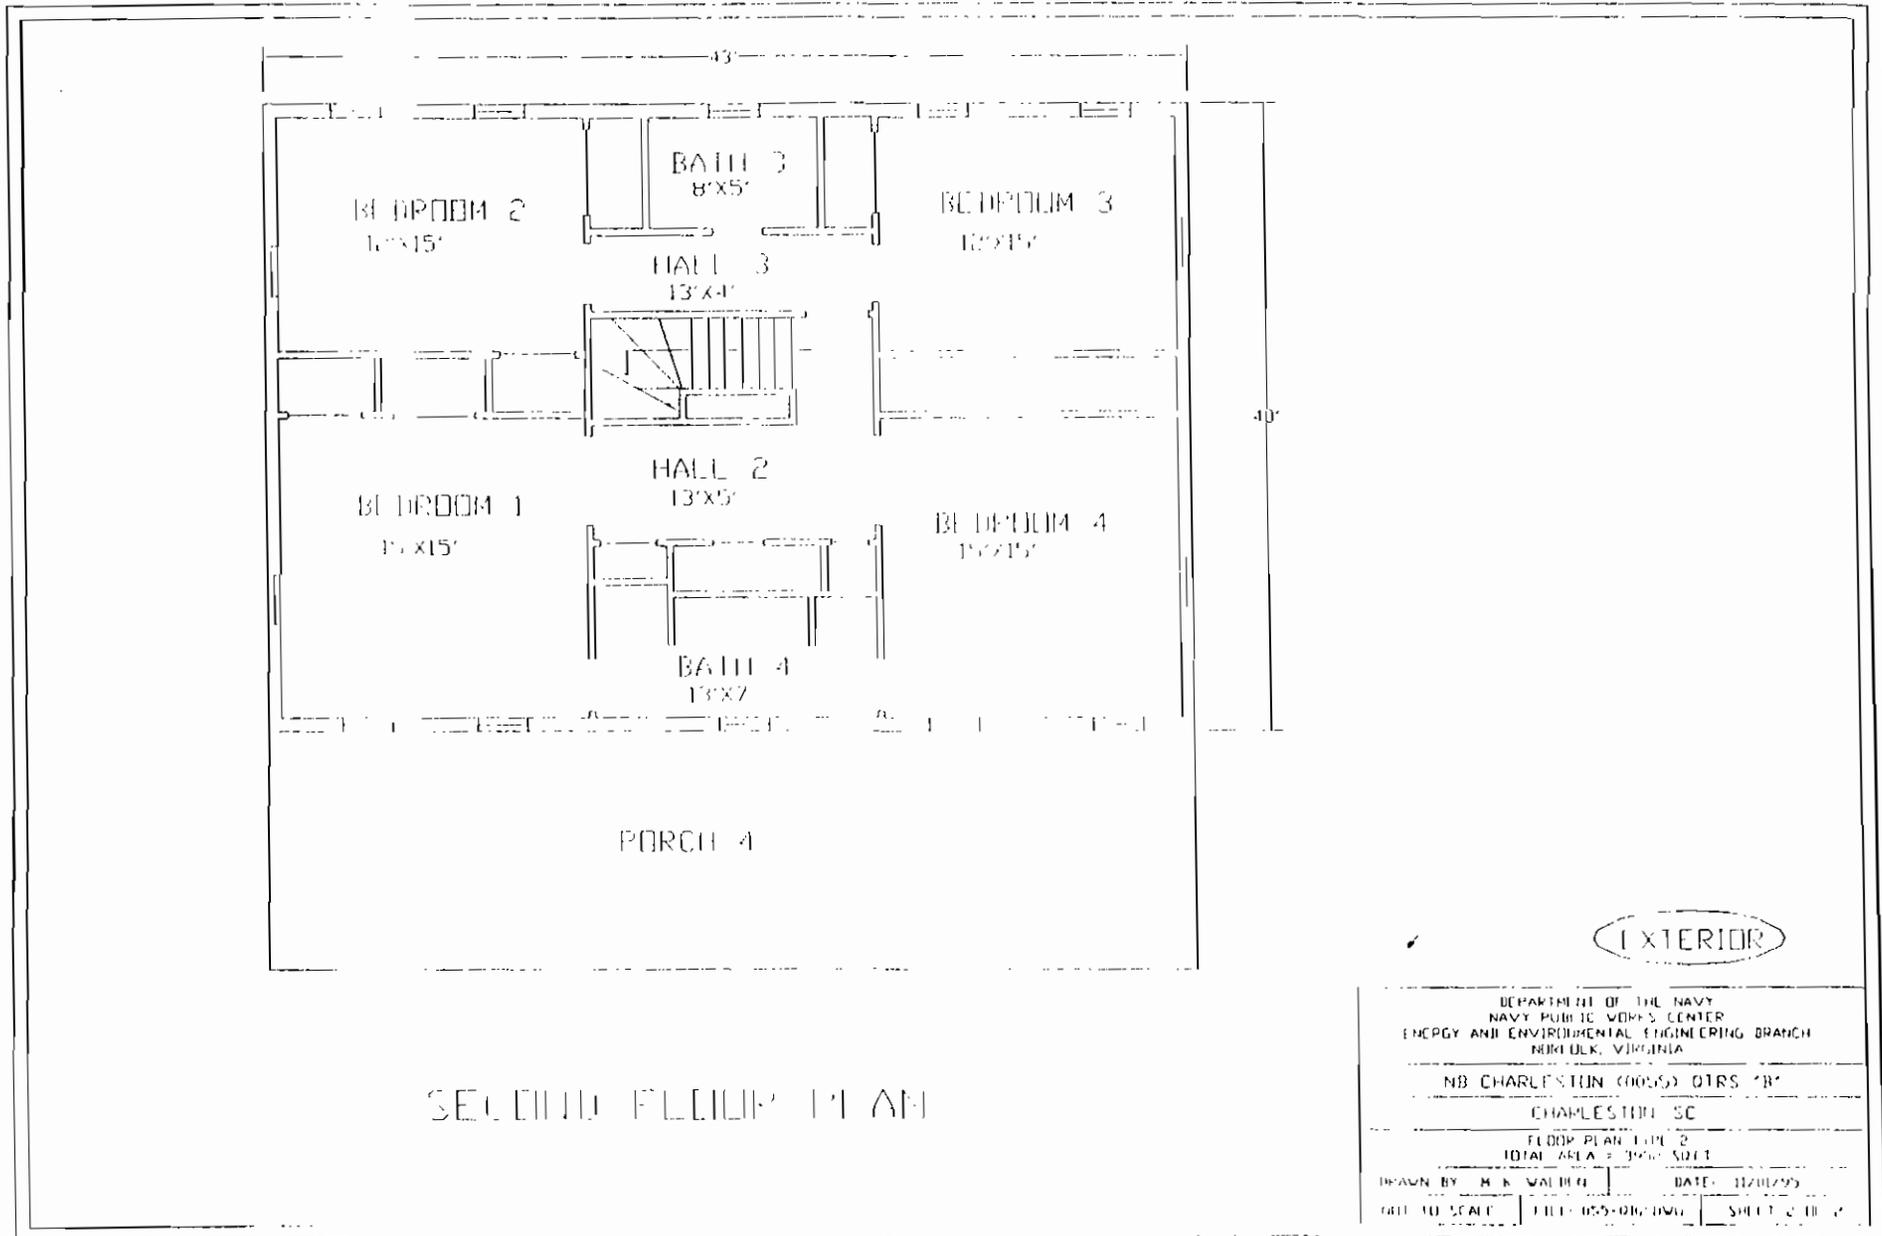
DEPARTMENT OF THE NAVY NAVY PUBLIC WORKS CENTER ENERGY AND ENVIRONMENTAL ENGINEERING BRANCH NORFOLK, VIRGINIA		
NB CHARLESTON (0005) QTRS "B"		
CHARLESTON, SC		
FLOOR PLAN TYPE 2 TOTAL AREA = 3952 SQFT		
DRAWN BY: M. K. WALDEN	DATE: 11/01/95	
DWG TO SCALE	DWG NO: 055-001DWG	SHEET 1 OF 2

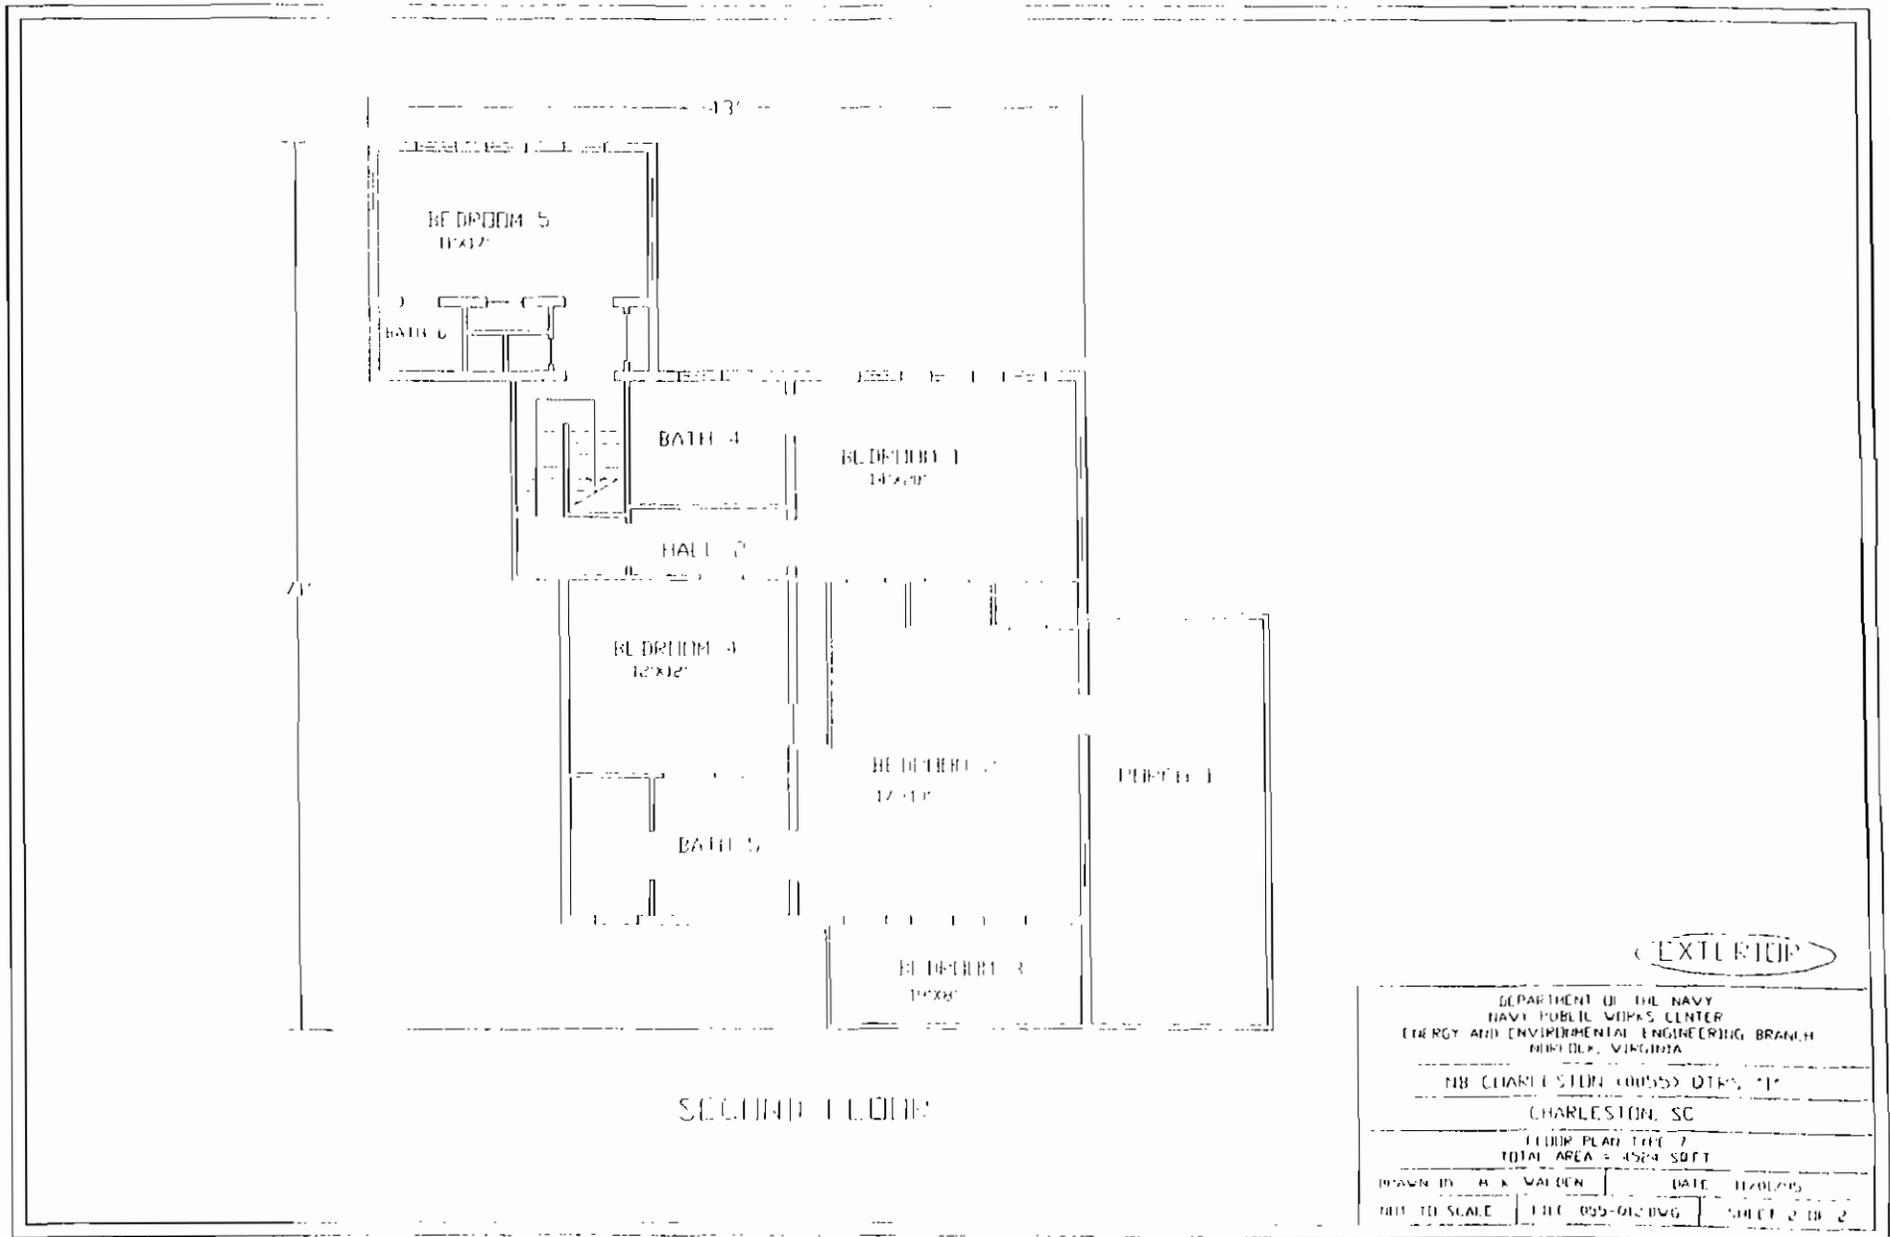
DEPARTMENT OF THE NAVY NAVAL PUBLIC WORKS CENTER ENERGY AND ENVIRONMENTAL ENGINEERING BRANCH NOFDDX, VIRGINIA	
NB CHARLESTON (0055) DTR, 11	
CHARLESTON, SC	
FLOOR PLAN TYPE 7 TOTAL AREA = 4524 SQFT	
DRAWN BY: B. K. WALDEN	DATE: 11/20/95
REV. TO SCALE	FIG. 055-012 DMG
	SHEET 2 OF 2

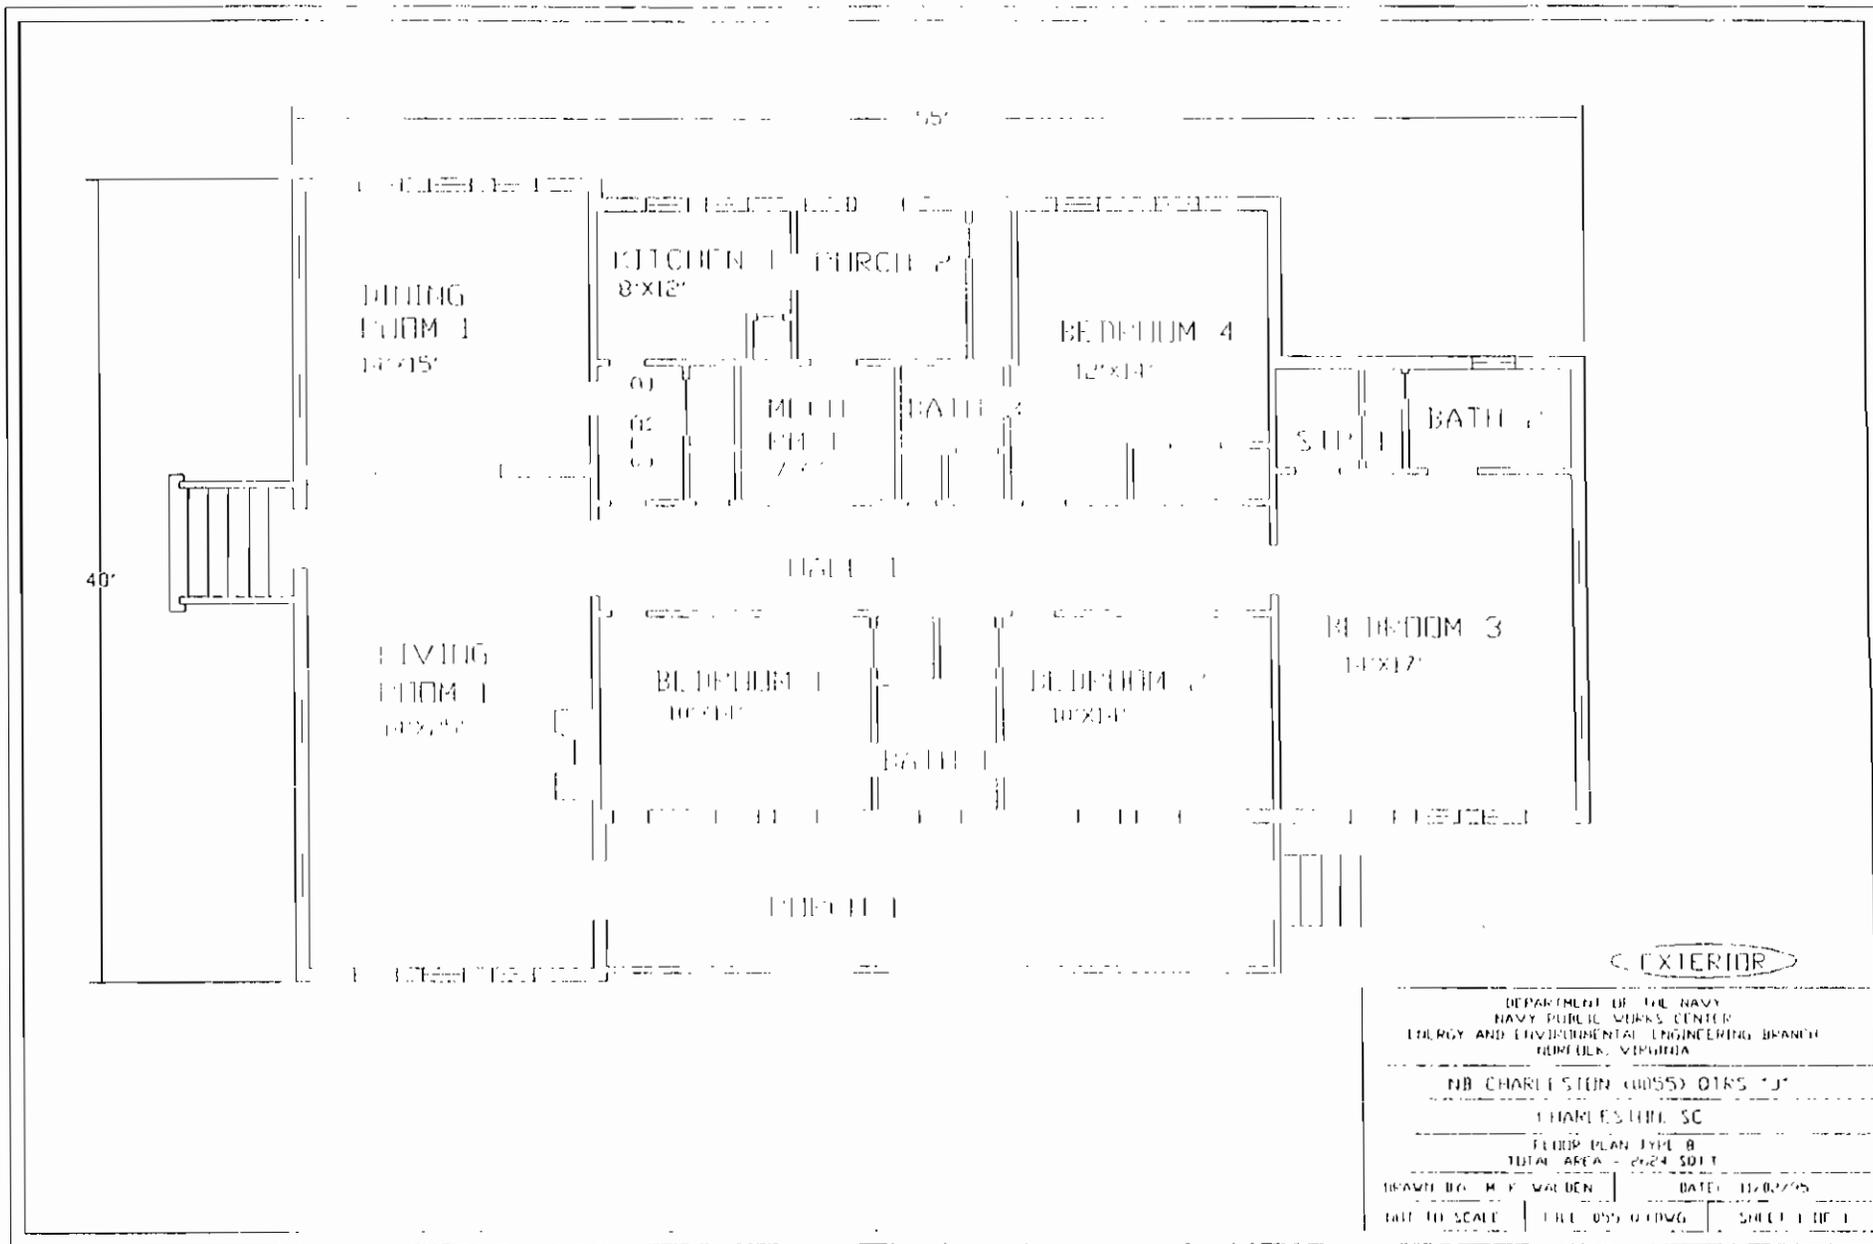
DEPARTMENT OF THE NAVY  
 NAVY PUBLIC WORKS CENTER  
 ENERGY AND ENVIRONMENTAL ENGINEERING BRANCH  
 NORFOLK, VIRGINIA

NB CHARLESTON (0055) 01RS 1J1  
 CHARLESTON, SC  
 FLOOR PLAN TYPE B  
 TOTAL AREA - 2624 SQ FT

DRAWN BY: M. F. WALDEN      DATE: 11/07/95  
 DATE TO SCALE: FEB. 055 01R06      SHEET 1 OF 1

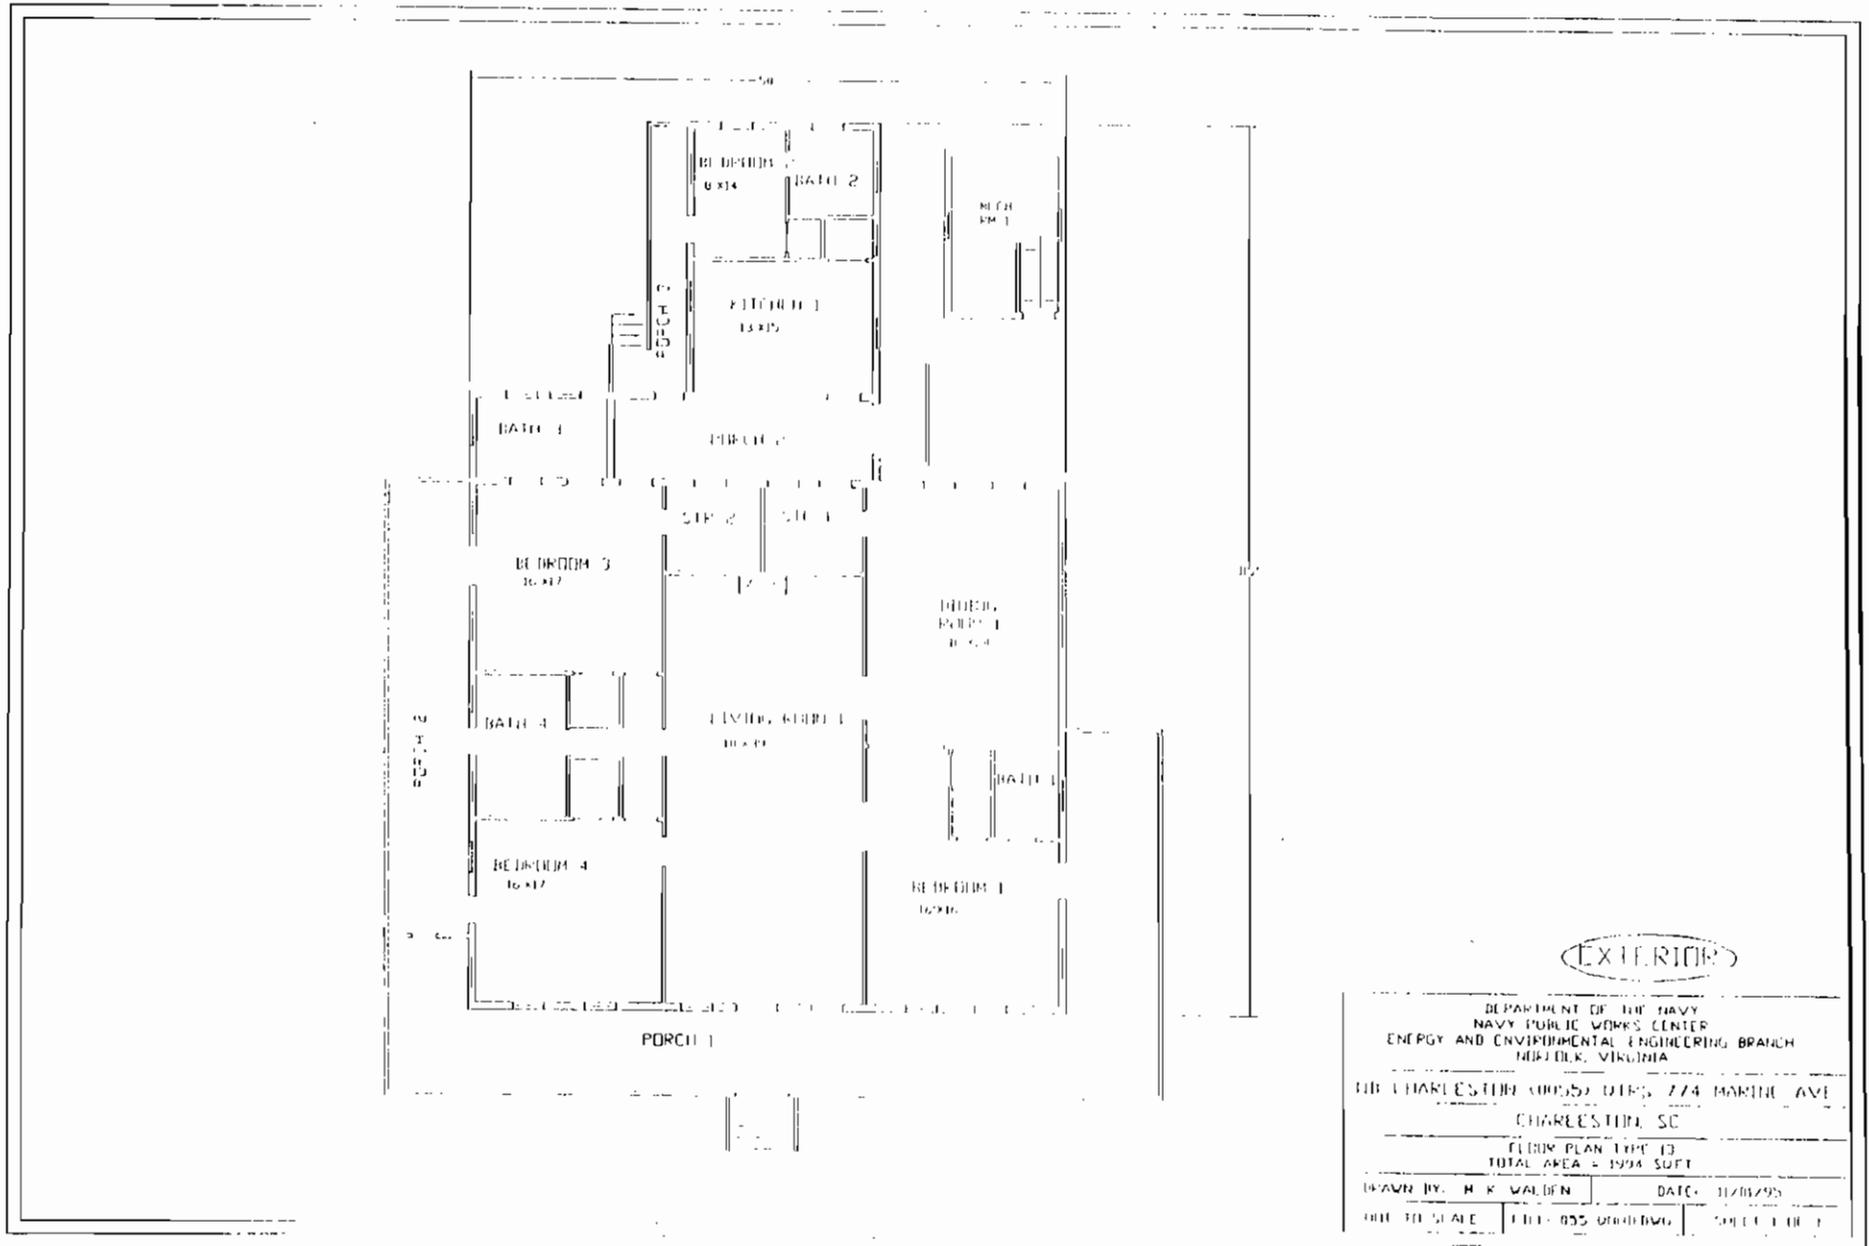
FLOOR PLAN LFL 12  
TOTAL AREA = 2048 SQFT

DRAWN BY: H. K. VALLEN	DATE: 11/01/95
PROJ. NO. SCALE	FILE: 055-NH-DWG
SHEET 1 OF 1

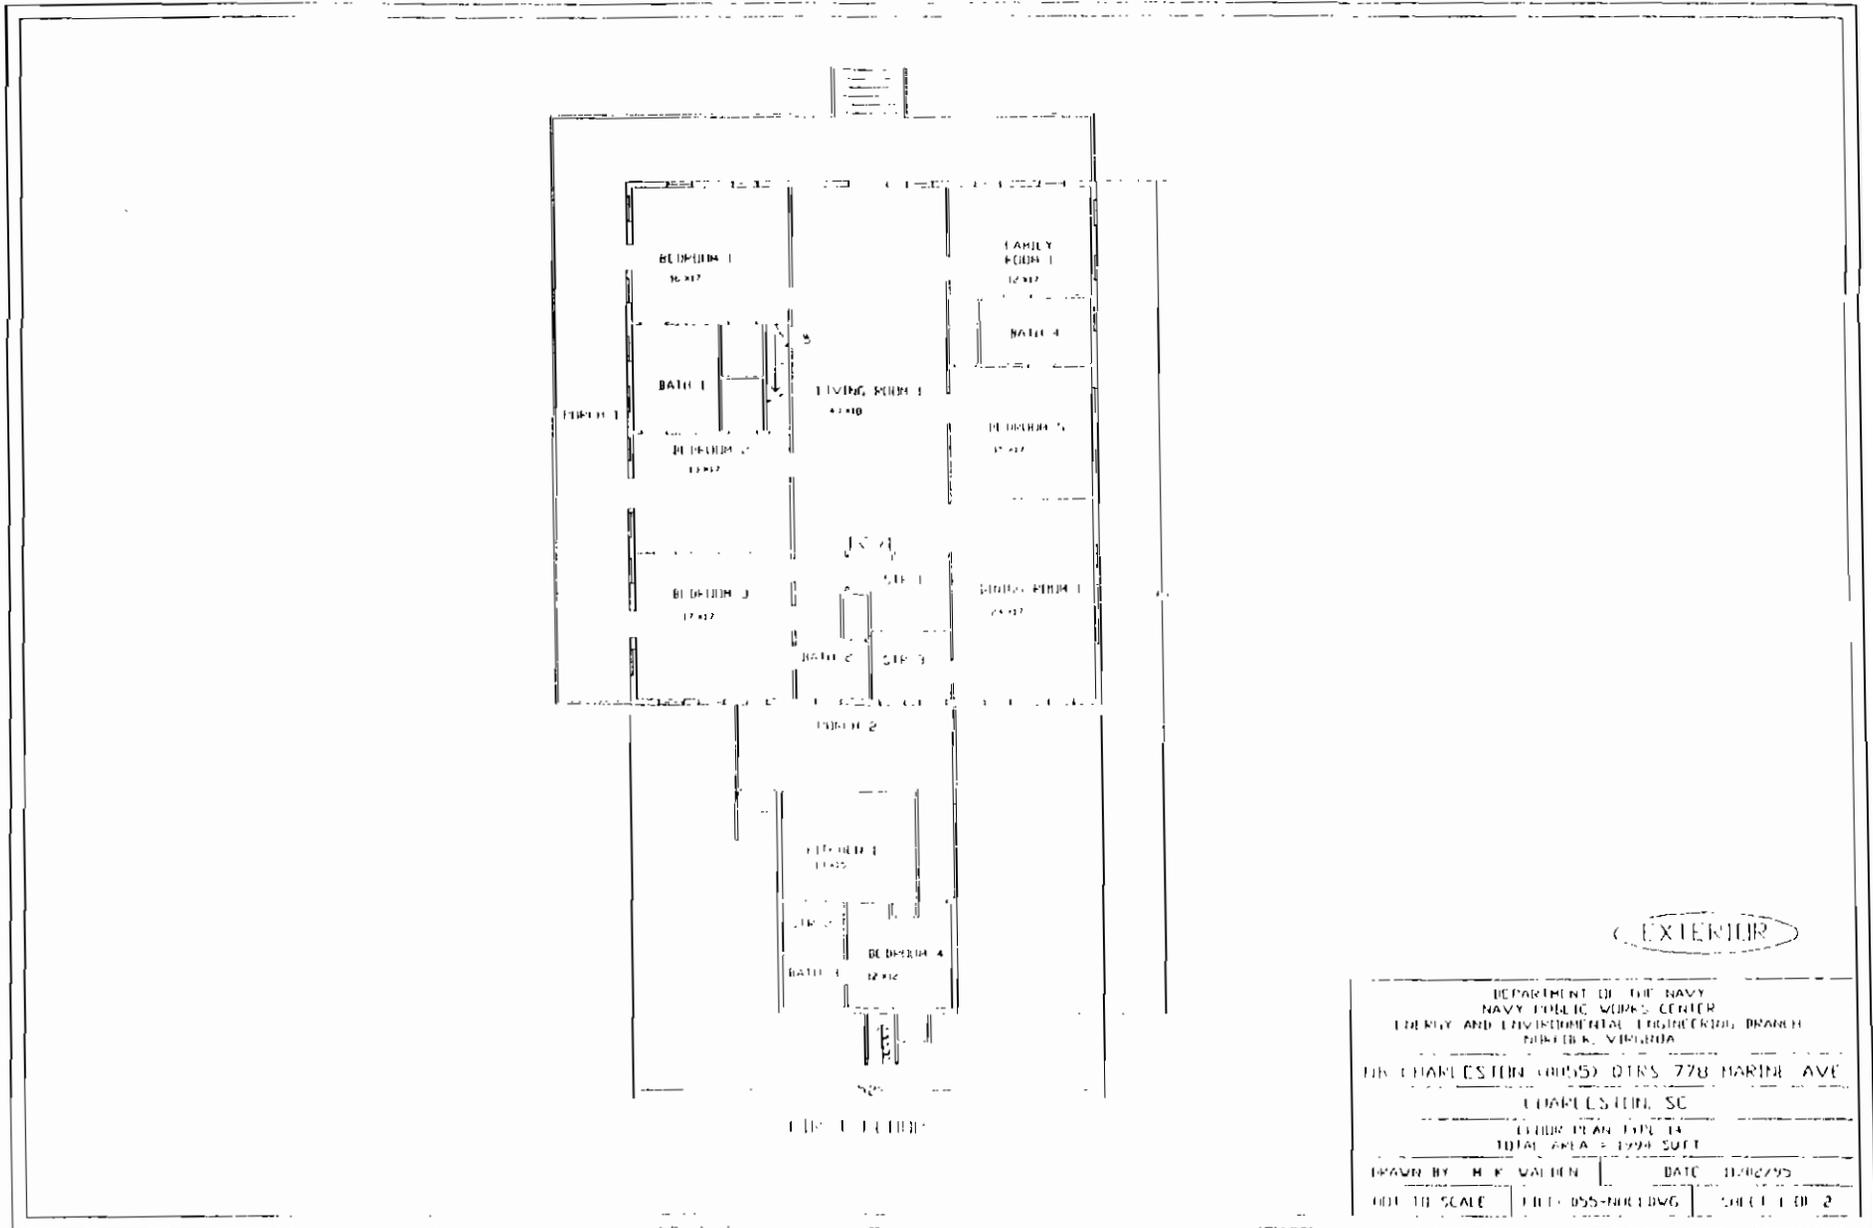
LEAD PLAN 1501 14  
 TOTAL AREA = 1994 SQ FT

DRAWN BY H. K. WALDEN | DATE 11/02/95  
 001 TO SCALE | FILE 055-NOR10WG | SHEET 1 OF 2

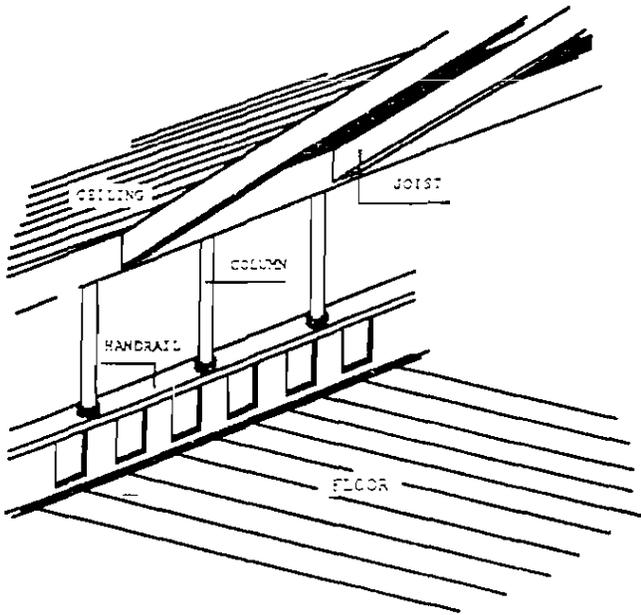
PORCH/SUNROOM

**Note:** The following pages contain pictorial representations of wall/room designations and component descriptions.

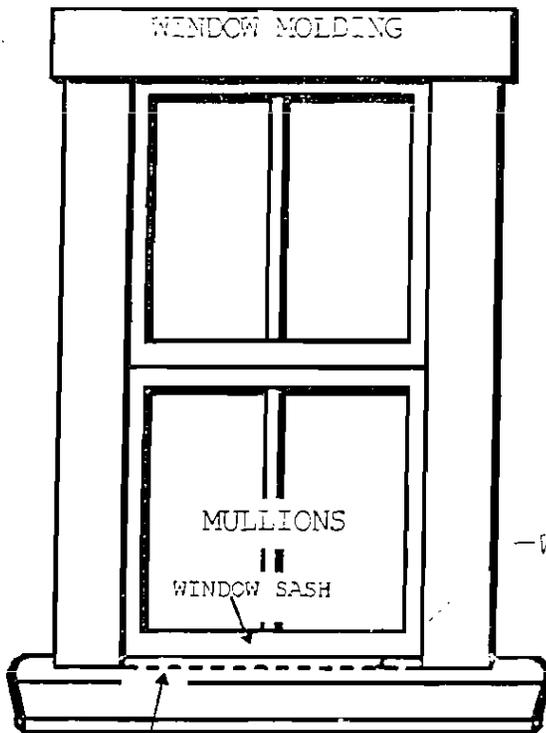
WINDOW SILL

-WINDOW WELL

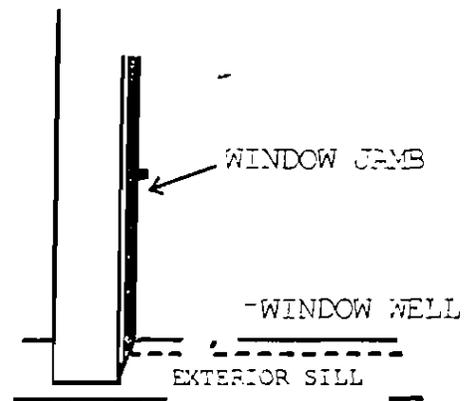
WINDOW JAMB

-WINDOW WELL
