RESPONSE TO COMMENTS ON THE PRELIMINARY CONTAMINATION ASSESSMENT
REPORT CONTAMINATION ASSESSMENT PLAN FOR CHICORA TANK FARM CNC
CHARLESTON SC
07/17/1992
KEMRON ENVIRONMENTAL SERVICES, INC

Project 819-300

RE: Chicora Tank Farm
Charleston Naval Shipyard
GWPD Site #A-10-AA-13350

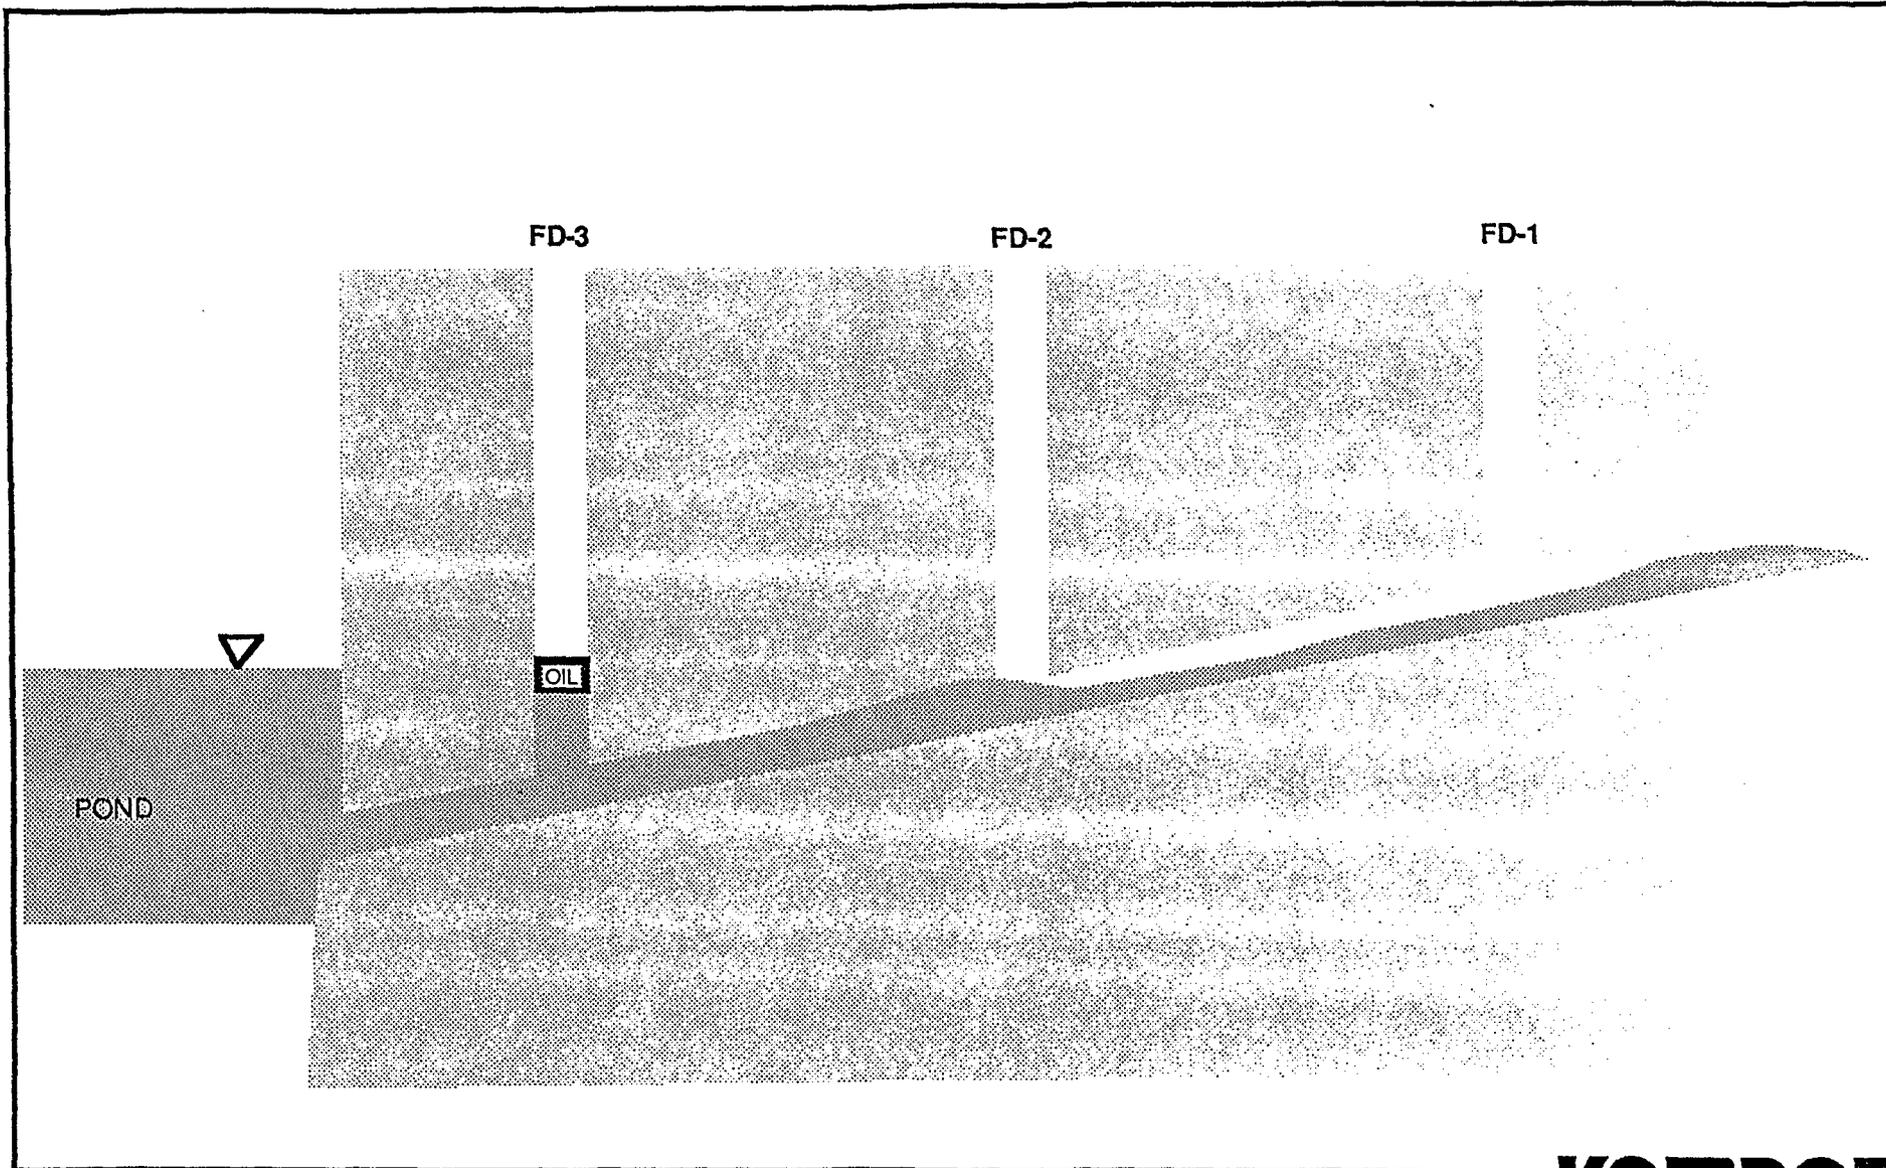
Figure 1. French drain manhole schematic with vertical exaggeration

2. Free-product removal (§3.1.2.2) is planned for french drain manhole FD-3 only. Free product has not been observed in FD-1; only a sheen was observed in FD-2. Oil only accumulates in FD-3; it does so because it functions, in some ways, like an oil/water separator. See attached figure. Consequently, no changes have been made to this section.
