FIGURE 3-1
SITES, ZONES, AND OUs
CURRENTLY UNDER INVESTIGATION

MCAS EL TORO BCP

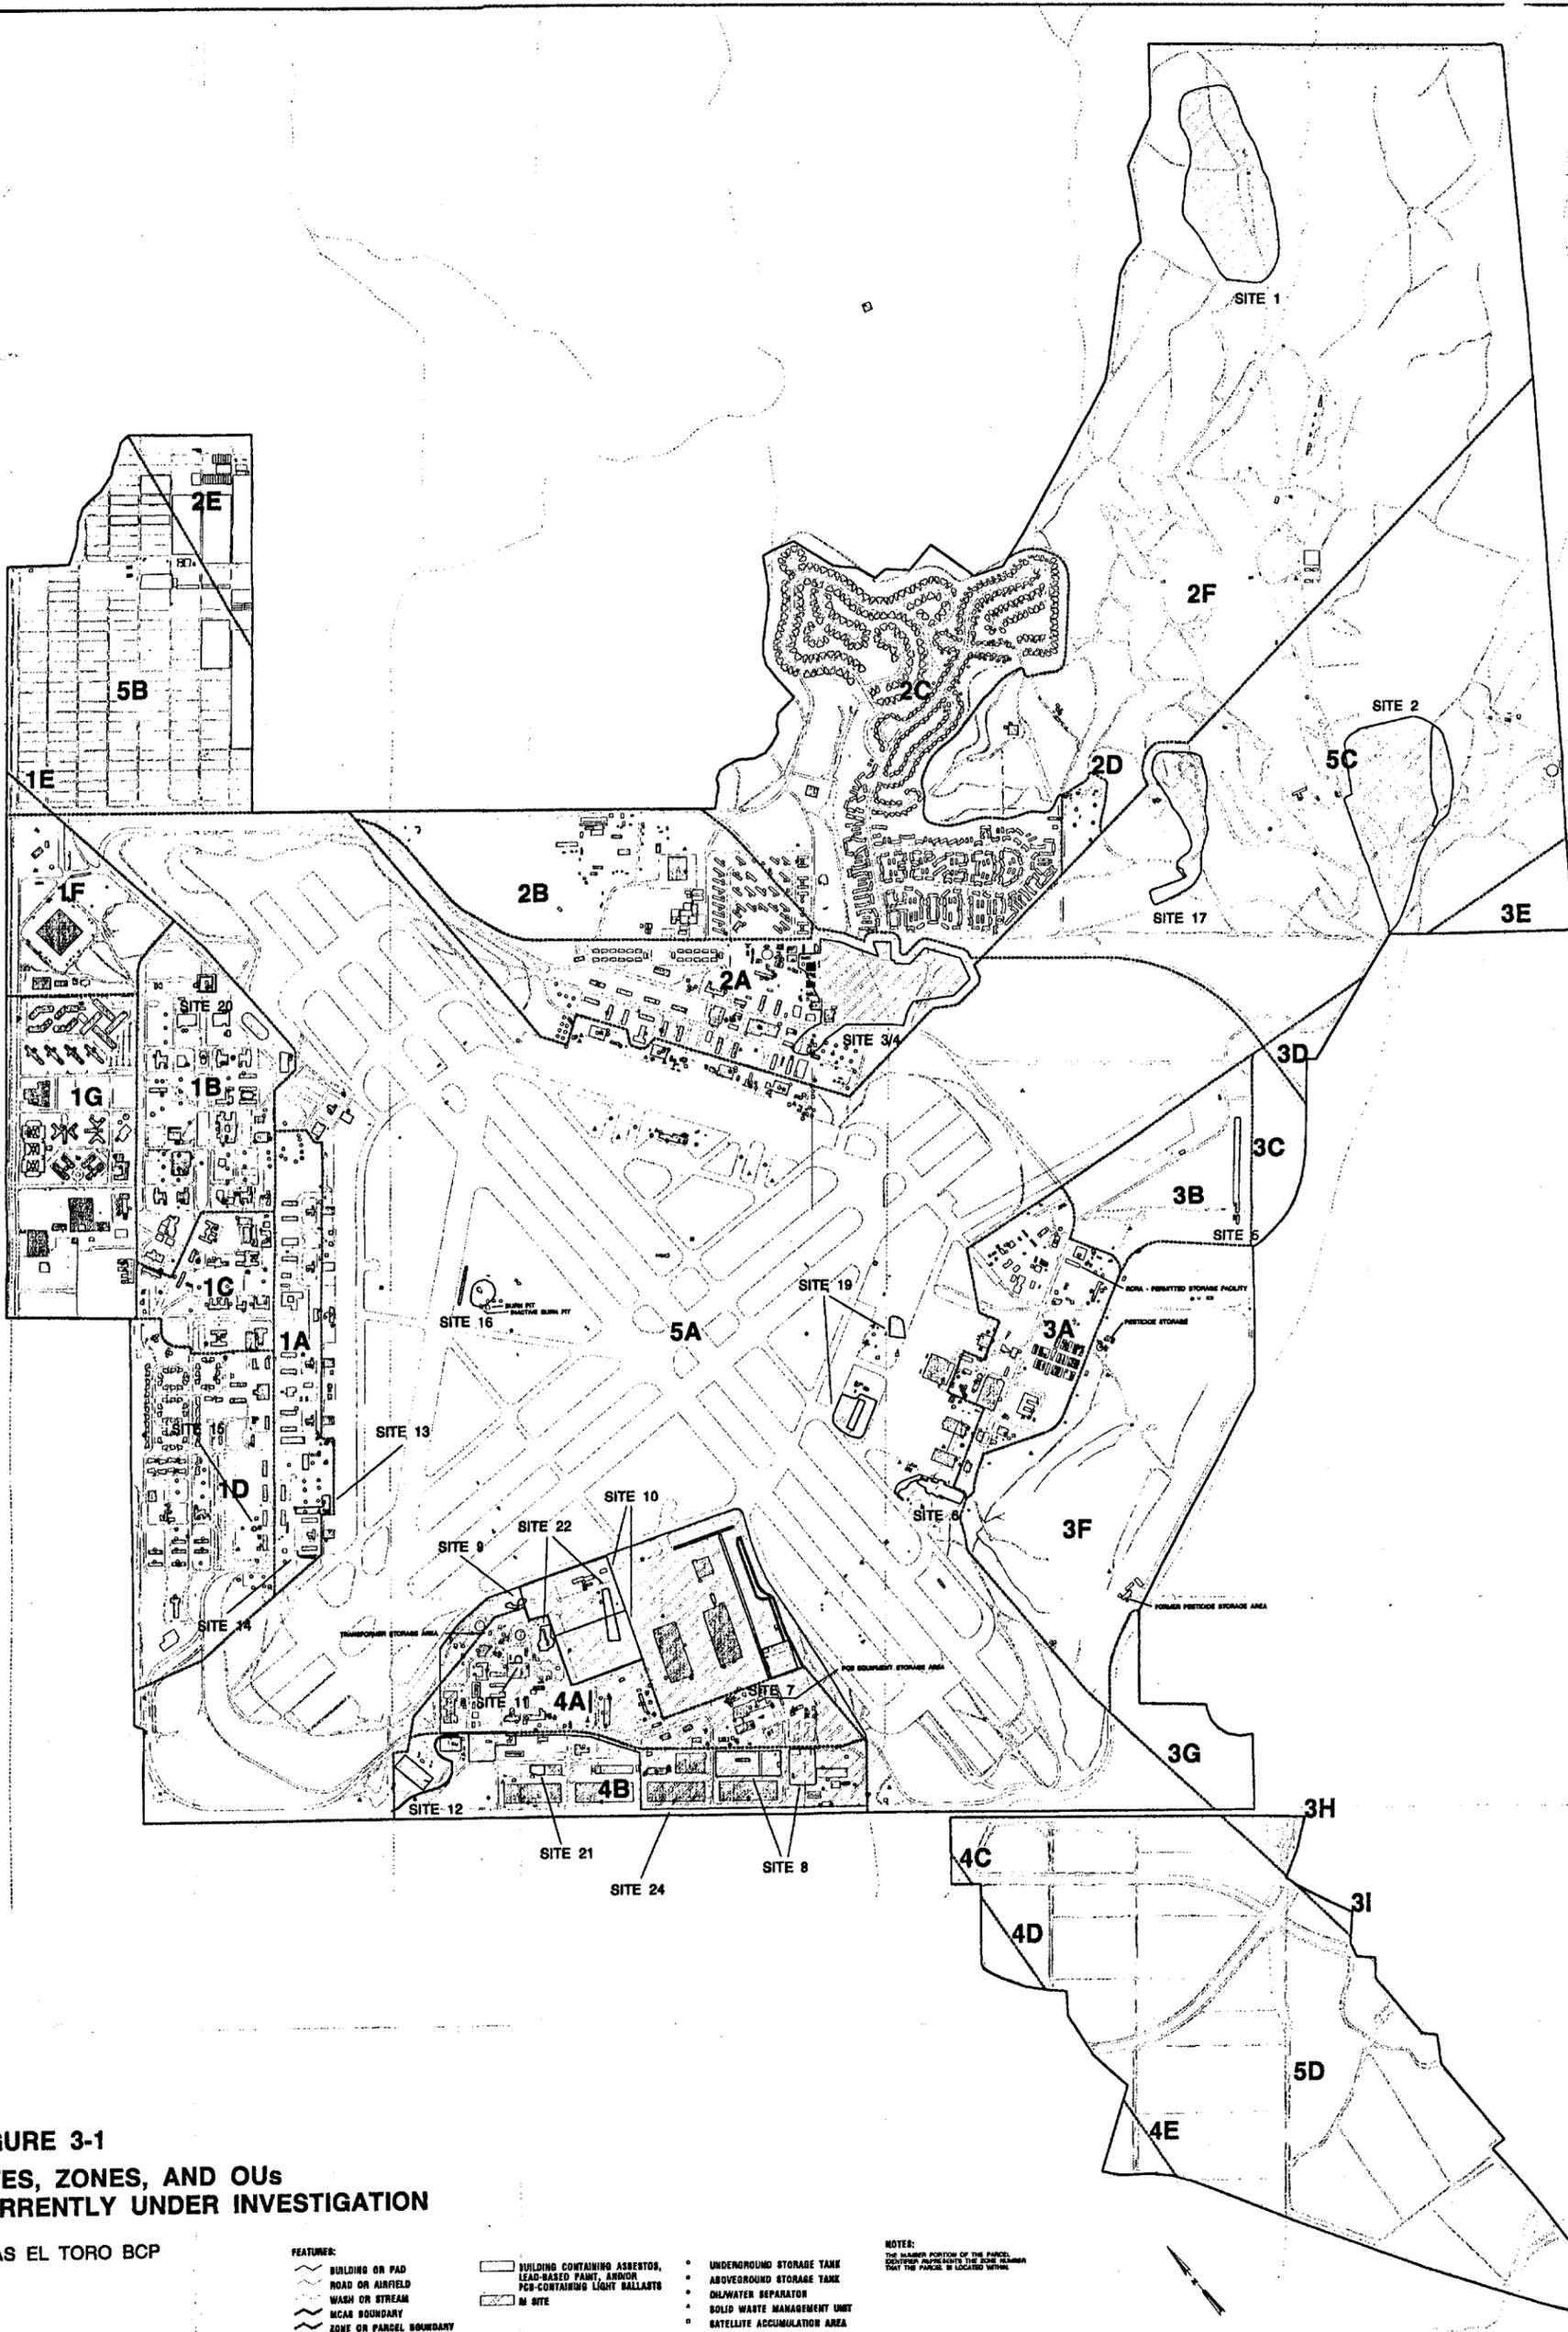
NOTE:
 THE NUMBER PORTION OF THE PARCEL IDENTIFIER INDICATES THE ZONE NUMBER THAT THE PARCEL IS LOCATED WITHIN.

the absence of a reuse plan, parcelization was based on current land use at MCAS El Toro. Zone and parcel divisions for the Station are shown in Figure 3-1. A description of each zone is provided below.

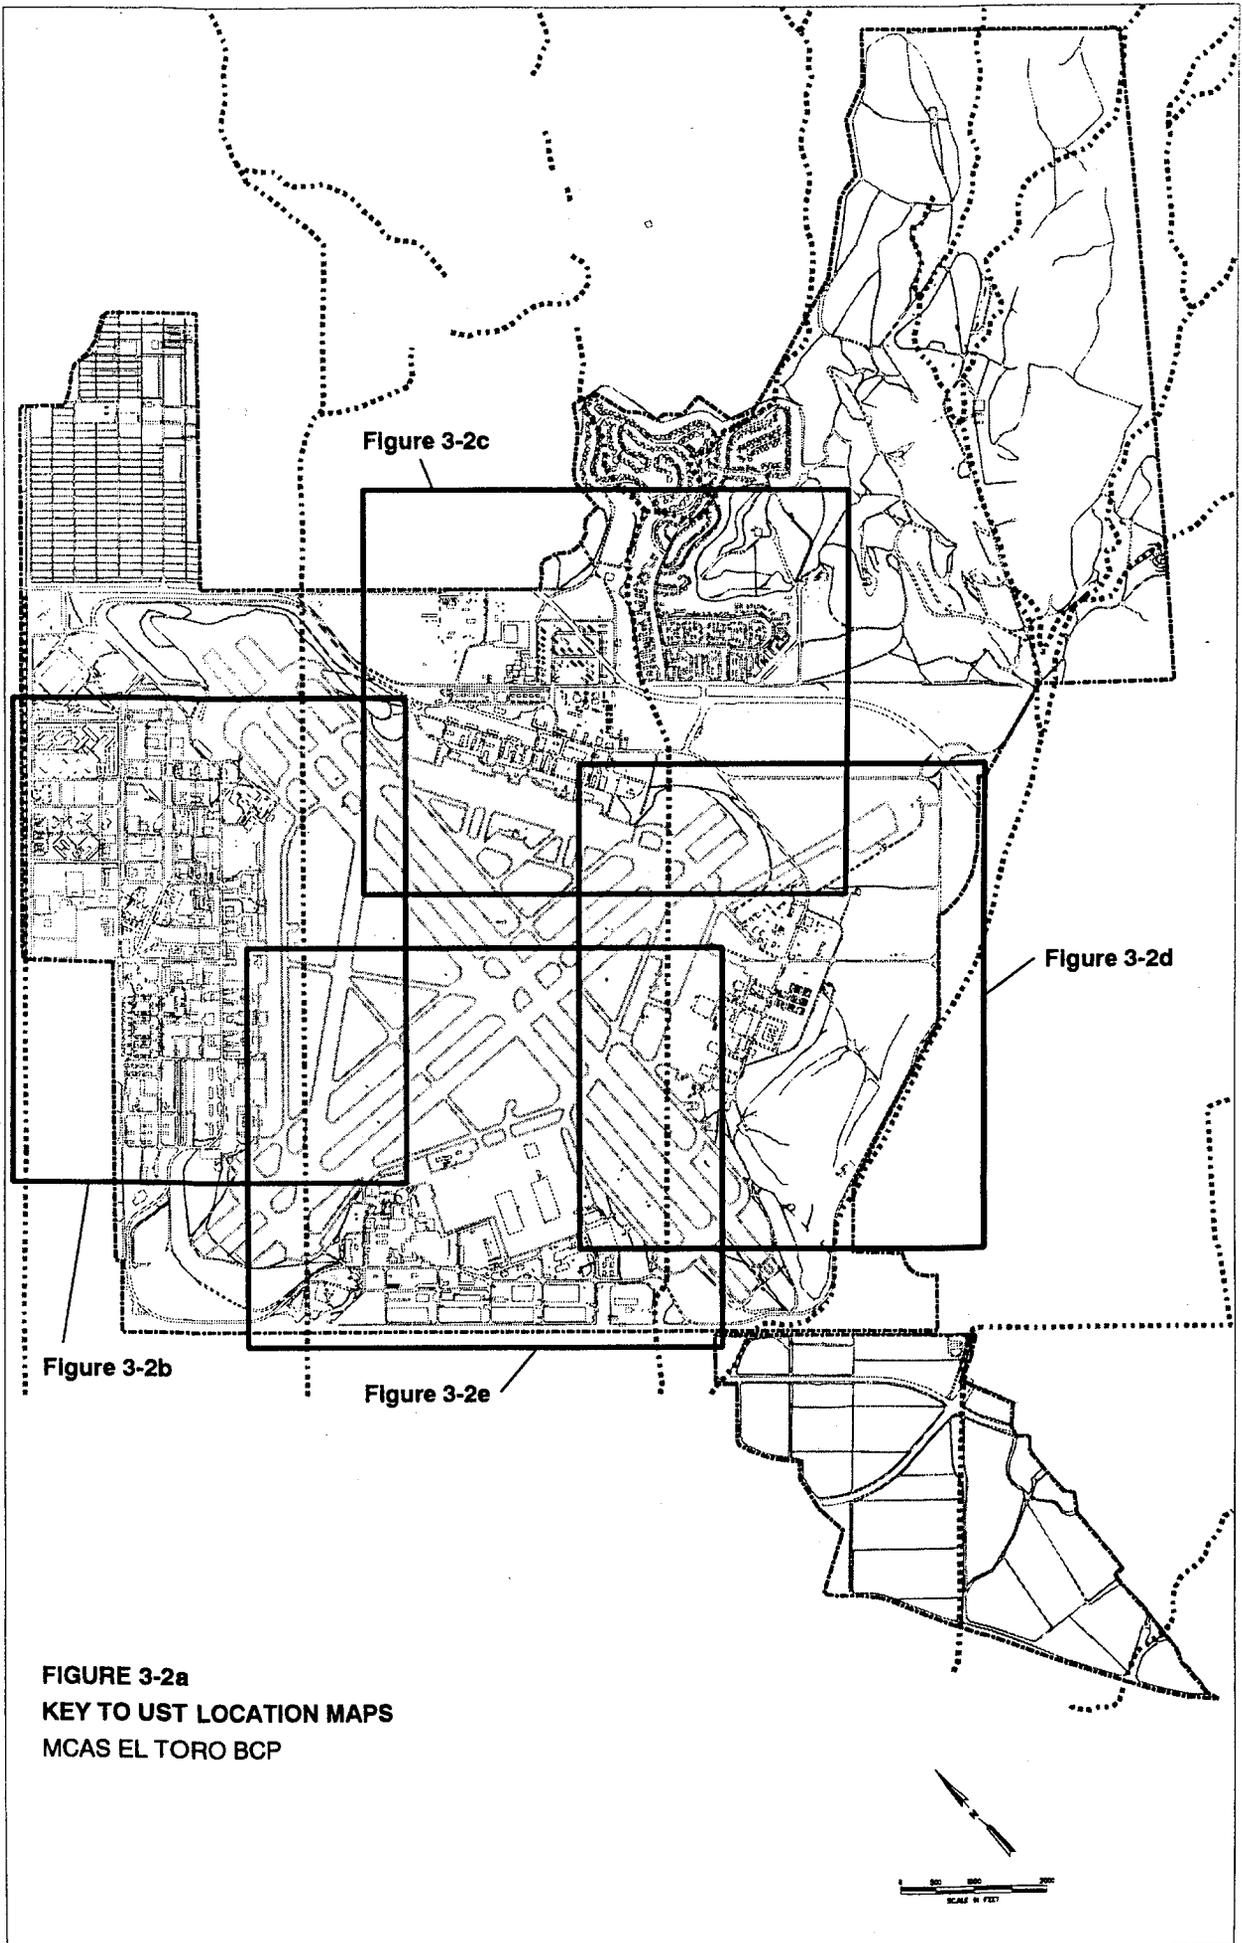
FIGURE 3-2a
KEY TO UST LOCATION MAPS
MCAS EL TORO BCP

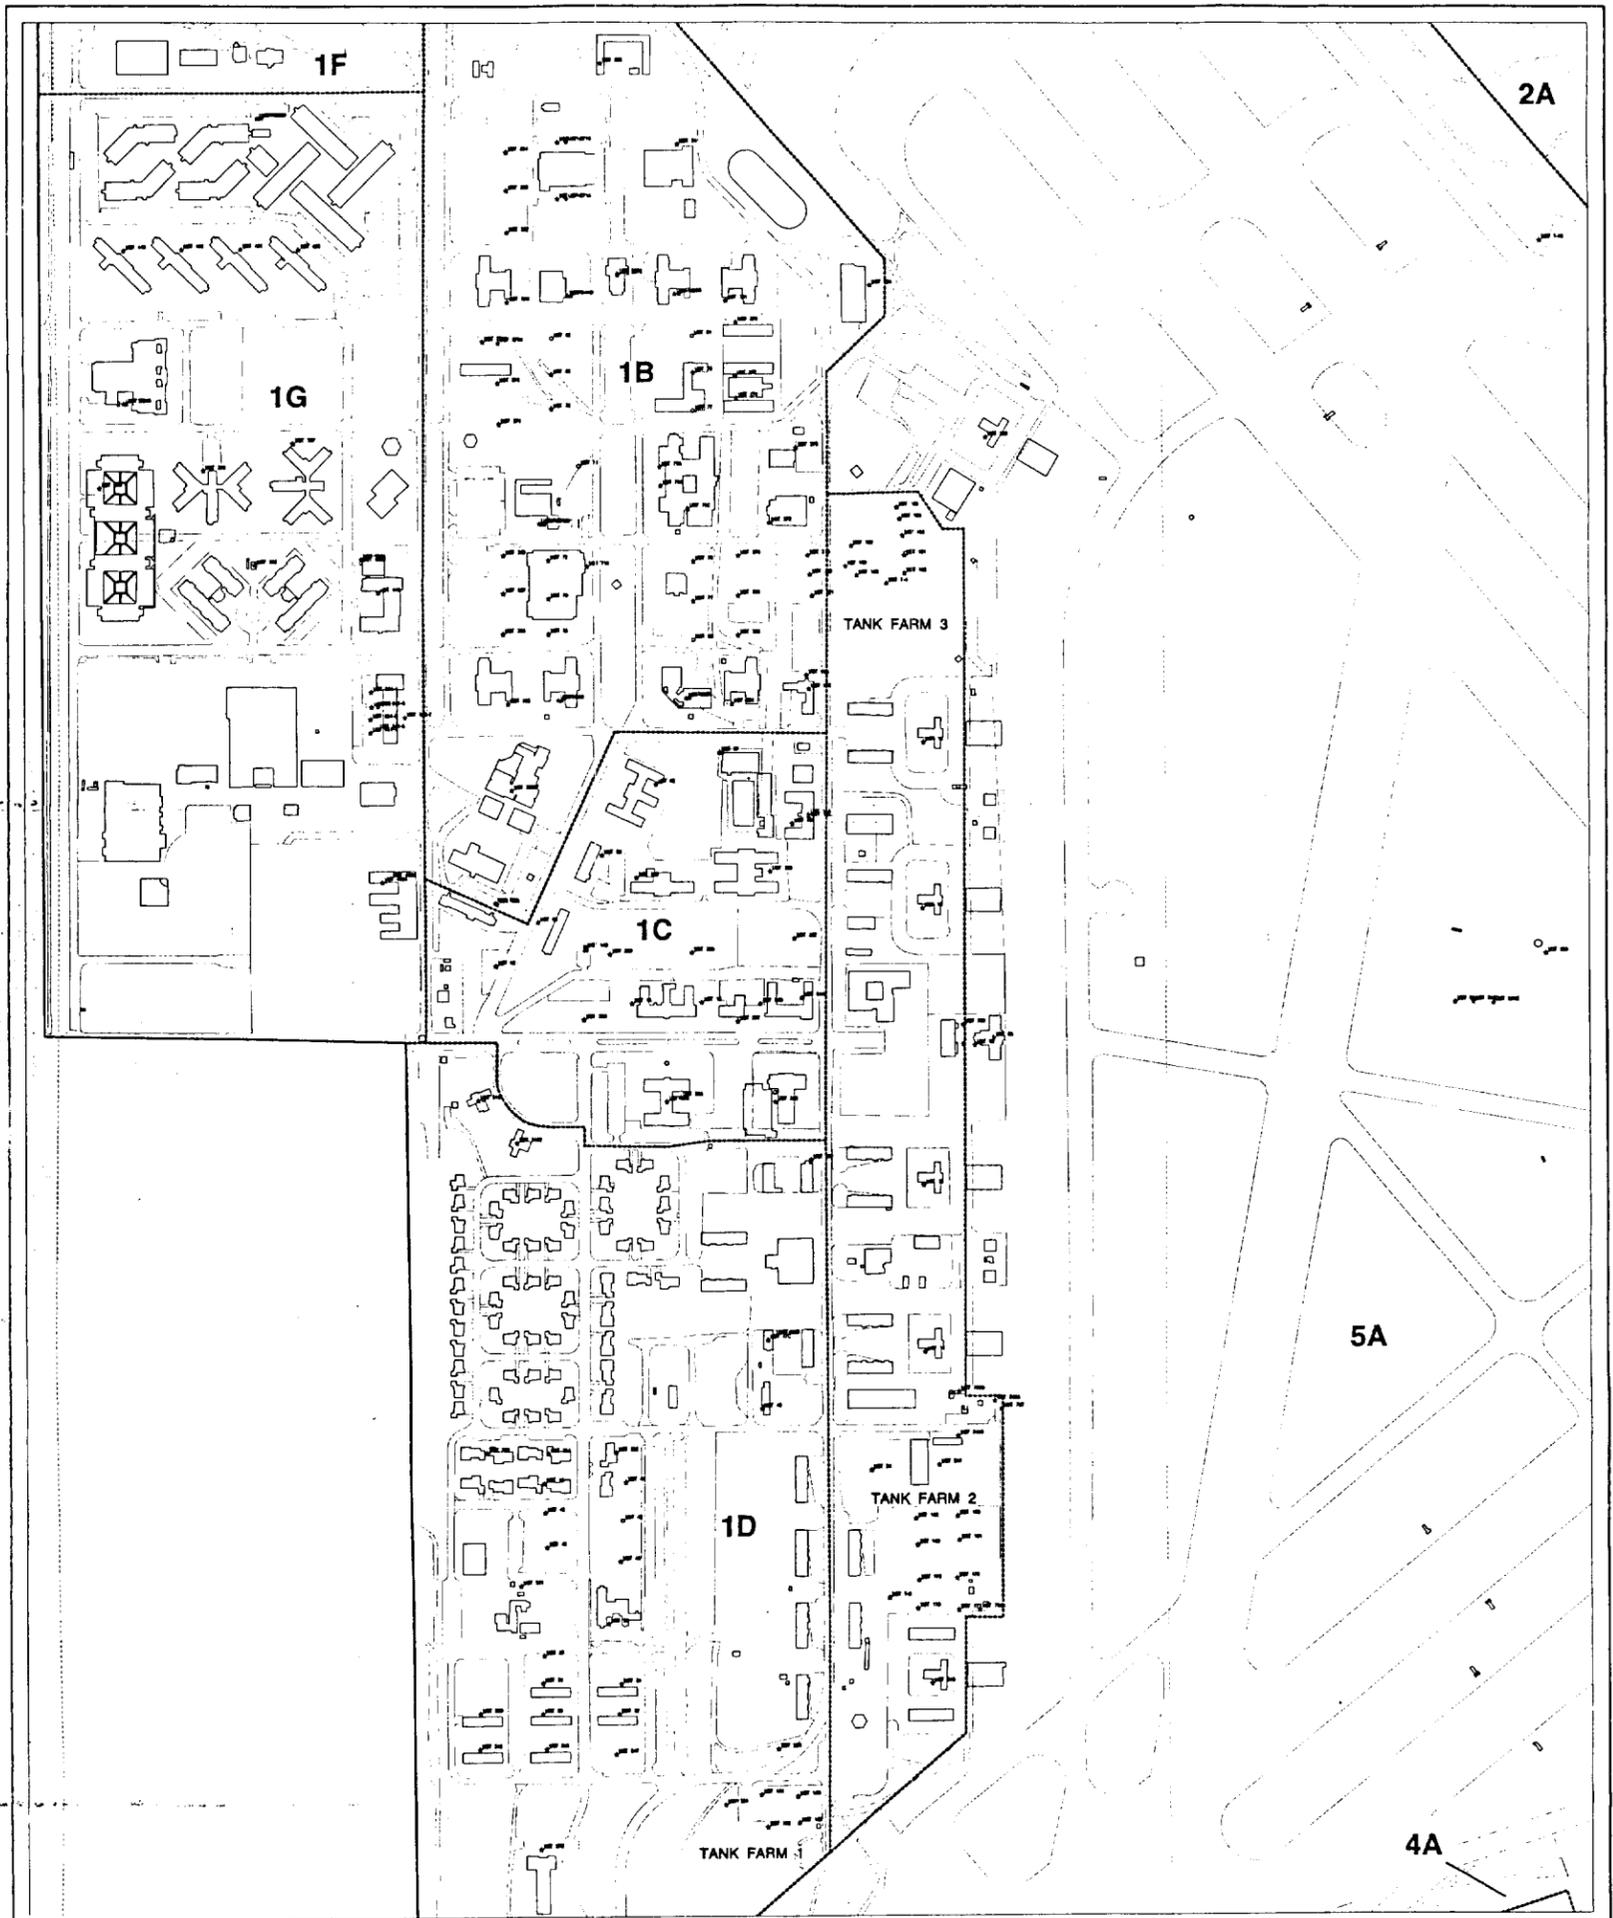
FIGURE 3-2b
UST LOCATIONS
 MCAS EL TORO BCP

- FEATURES:**
- ▭ BUILDING OR PAD
 - ROAD OR AIRFIELD
 - ~ WASH OR STREAM
 - ~ FUEL LINE
 - ~ MCAS BOUNDARY
 - ~ ZONE OR PARCEL BOUNDARY

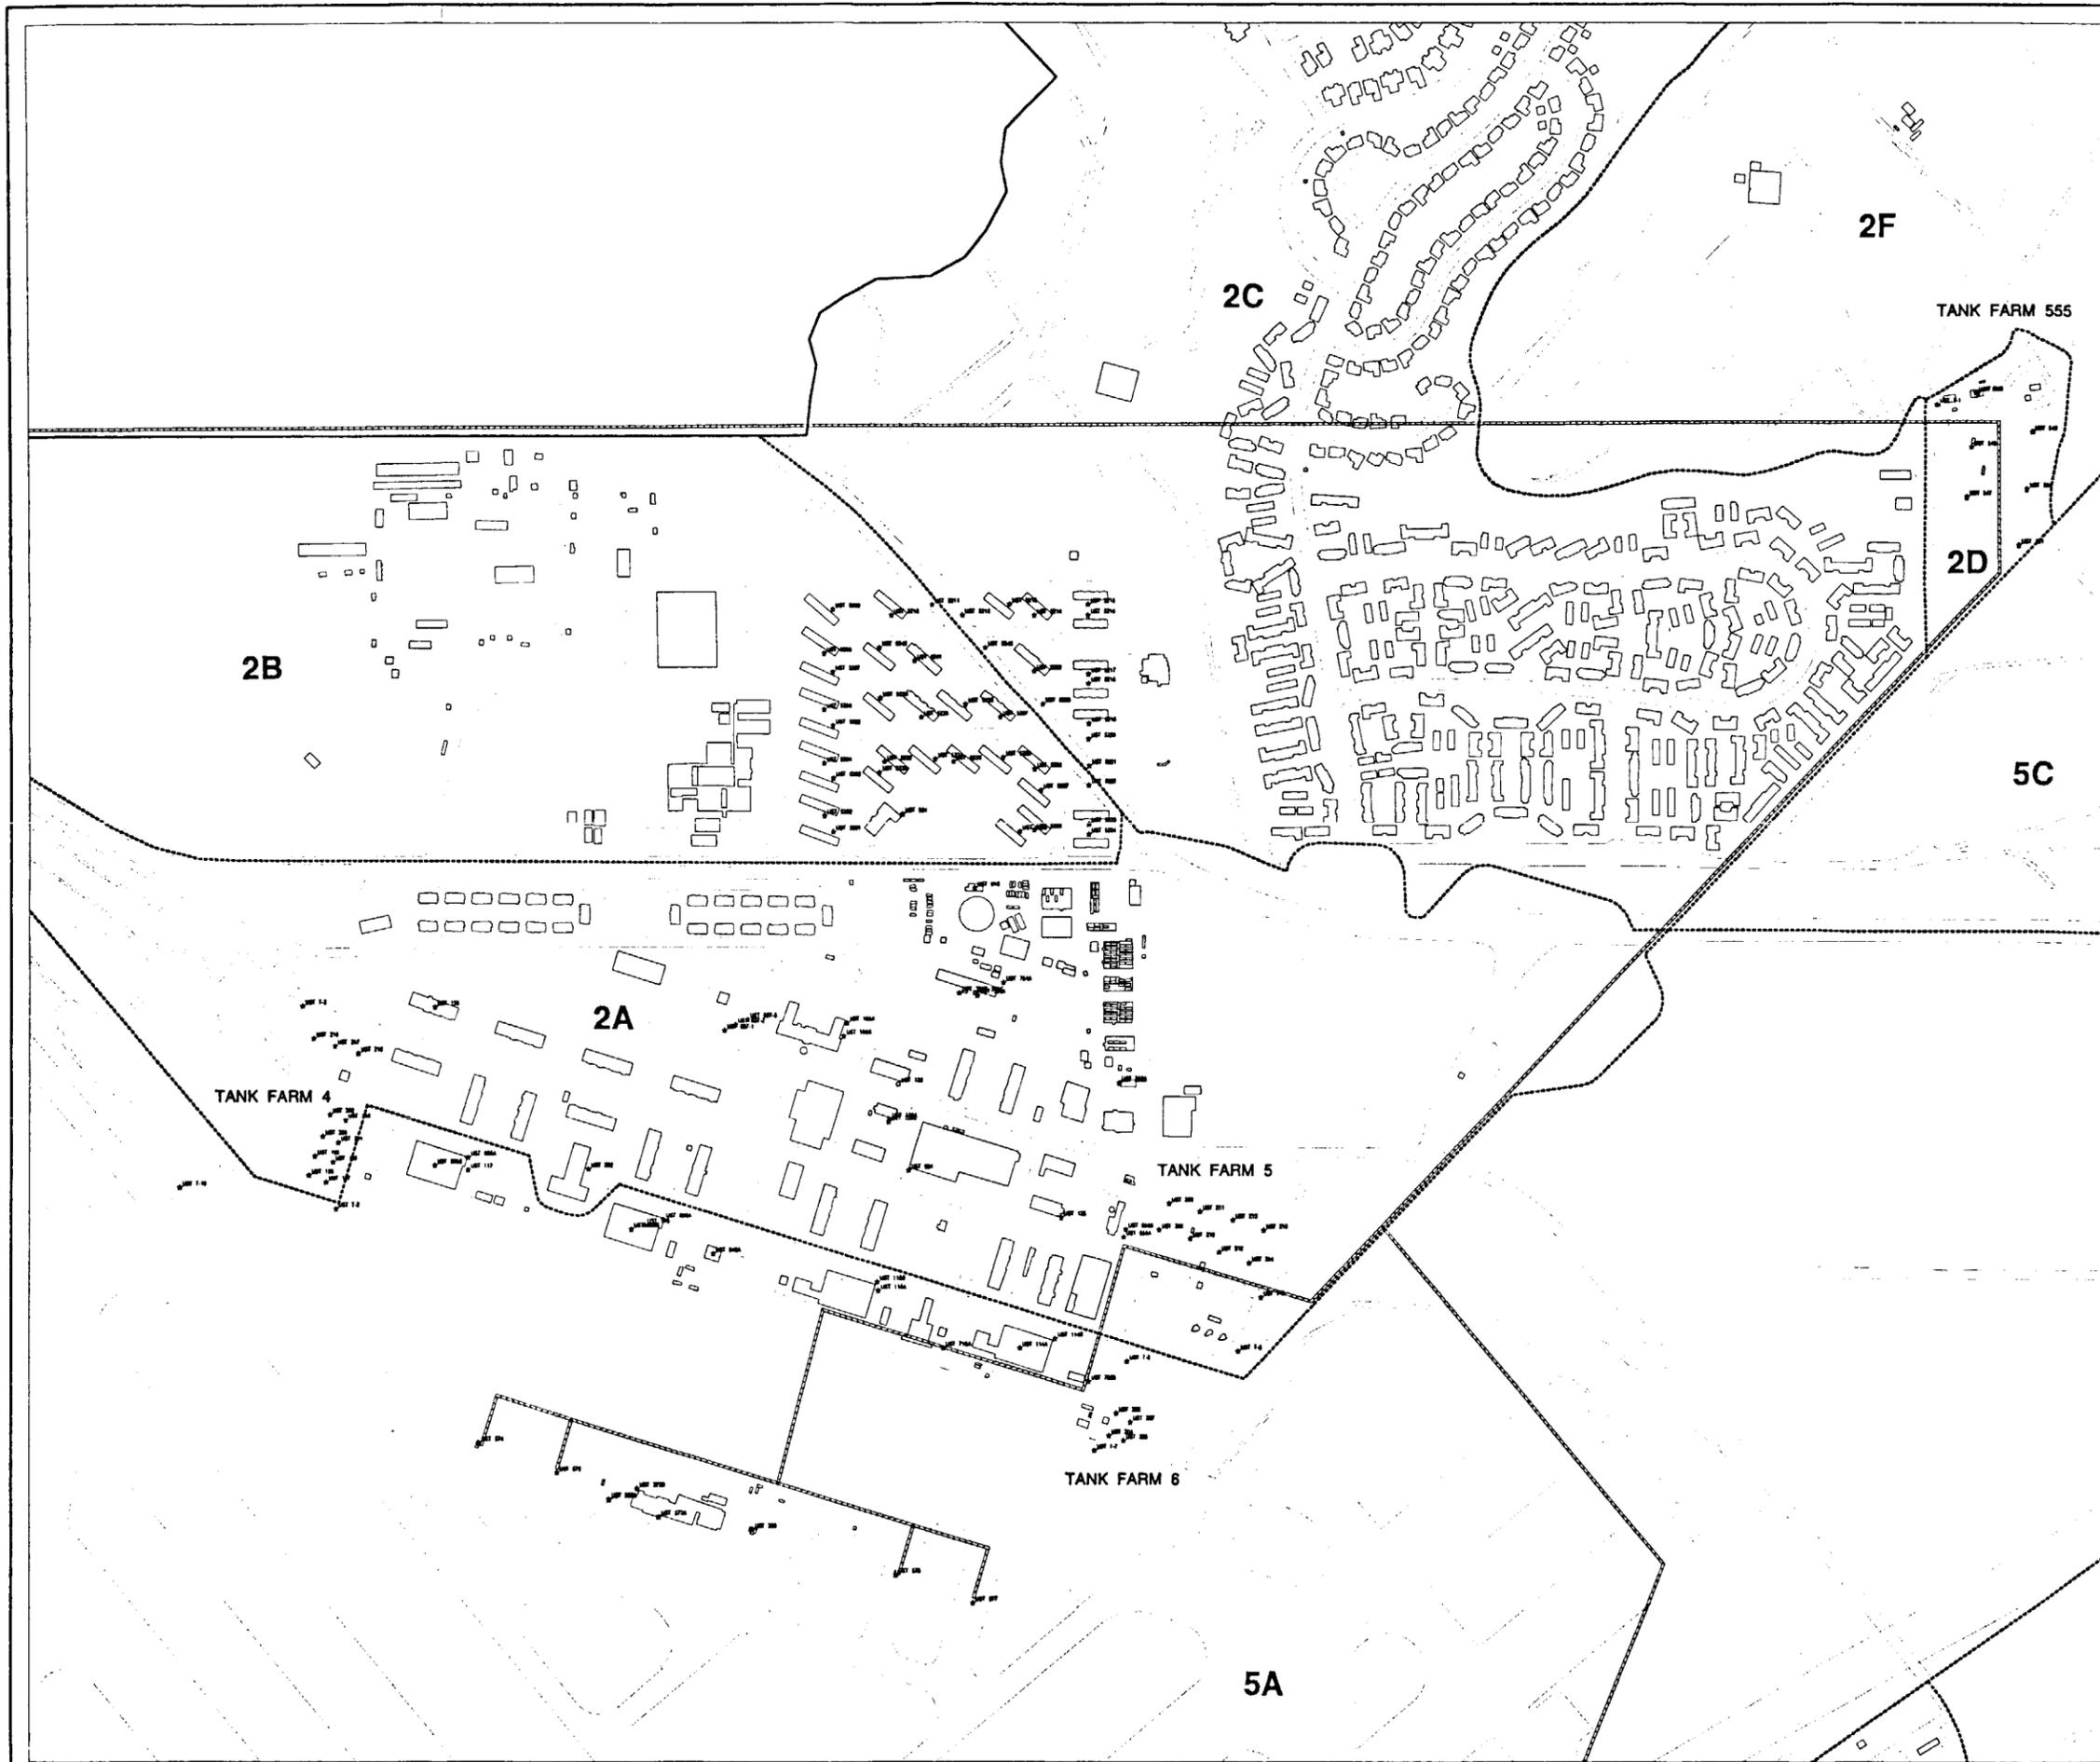
FIGURE 3-2c
UST LOCATIONS
 MCAS EL TORO BCP

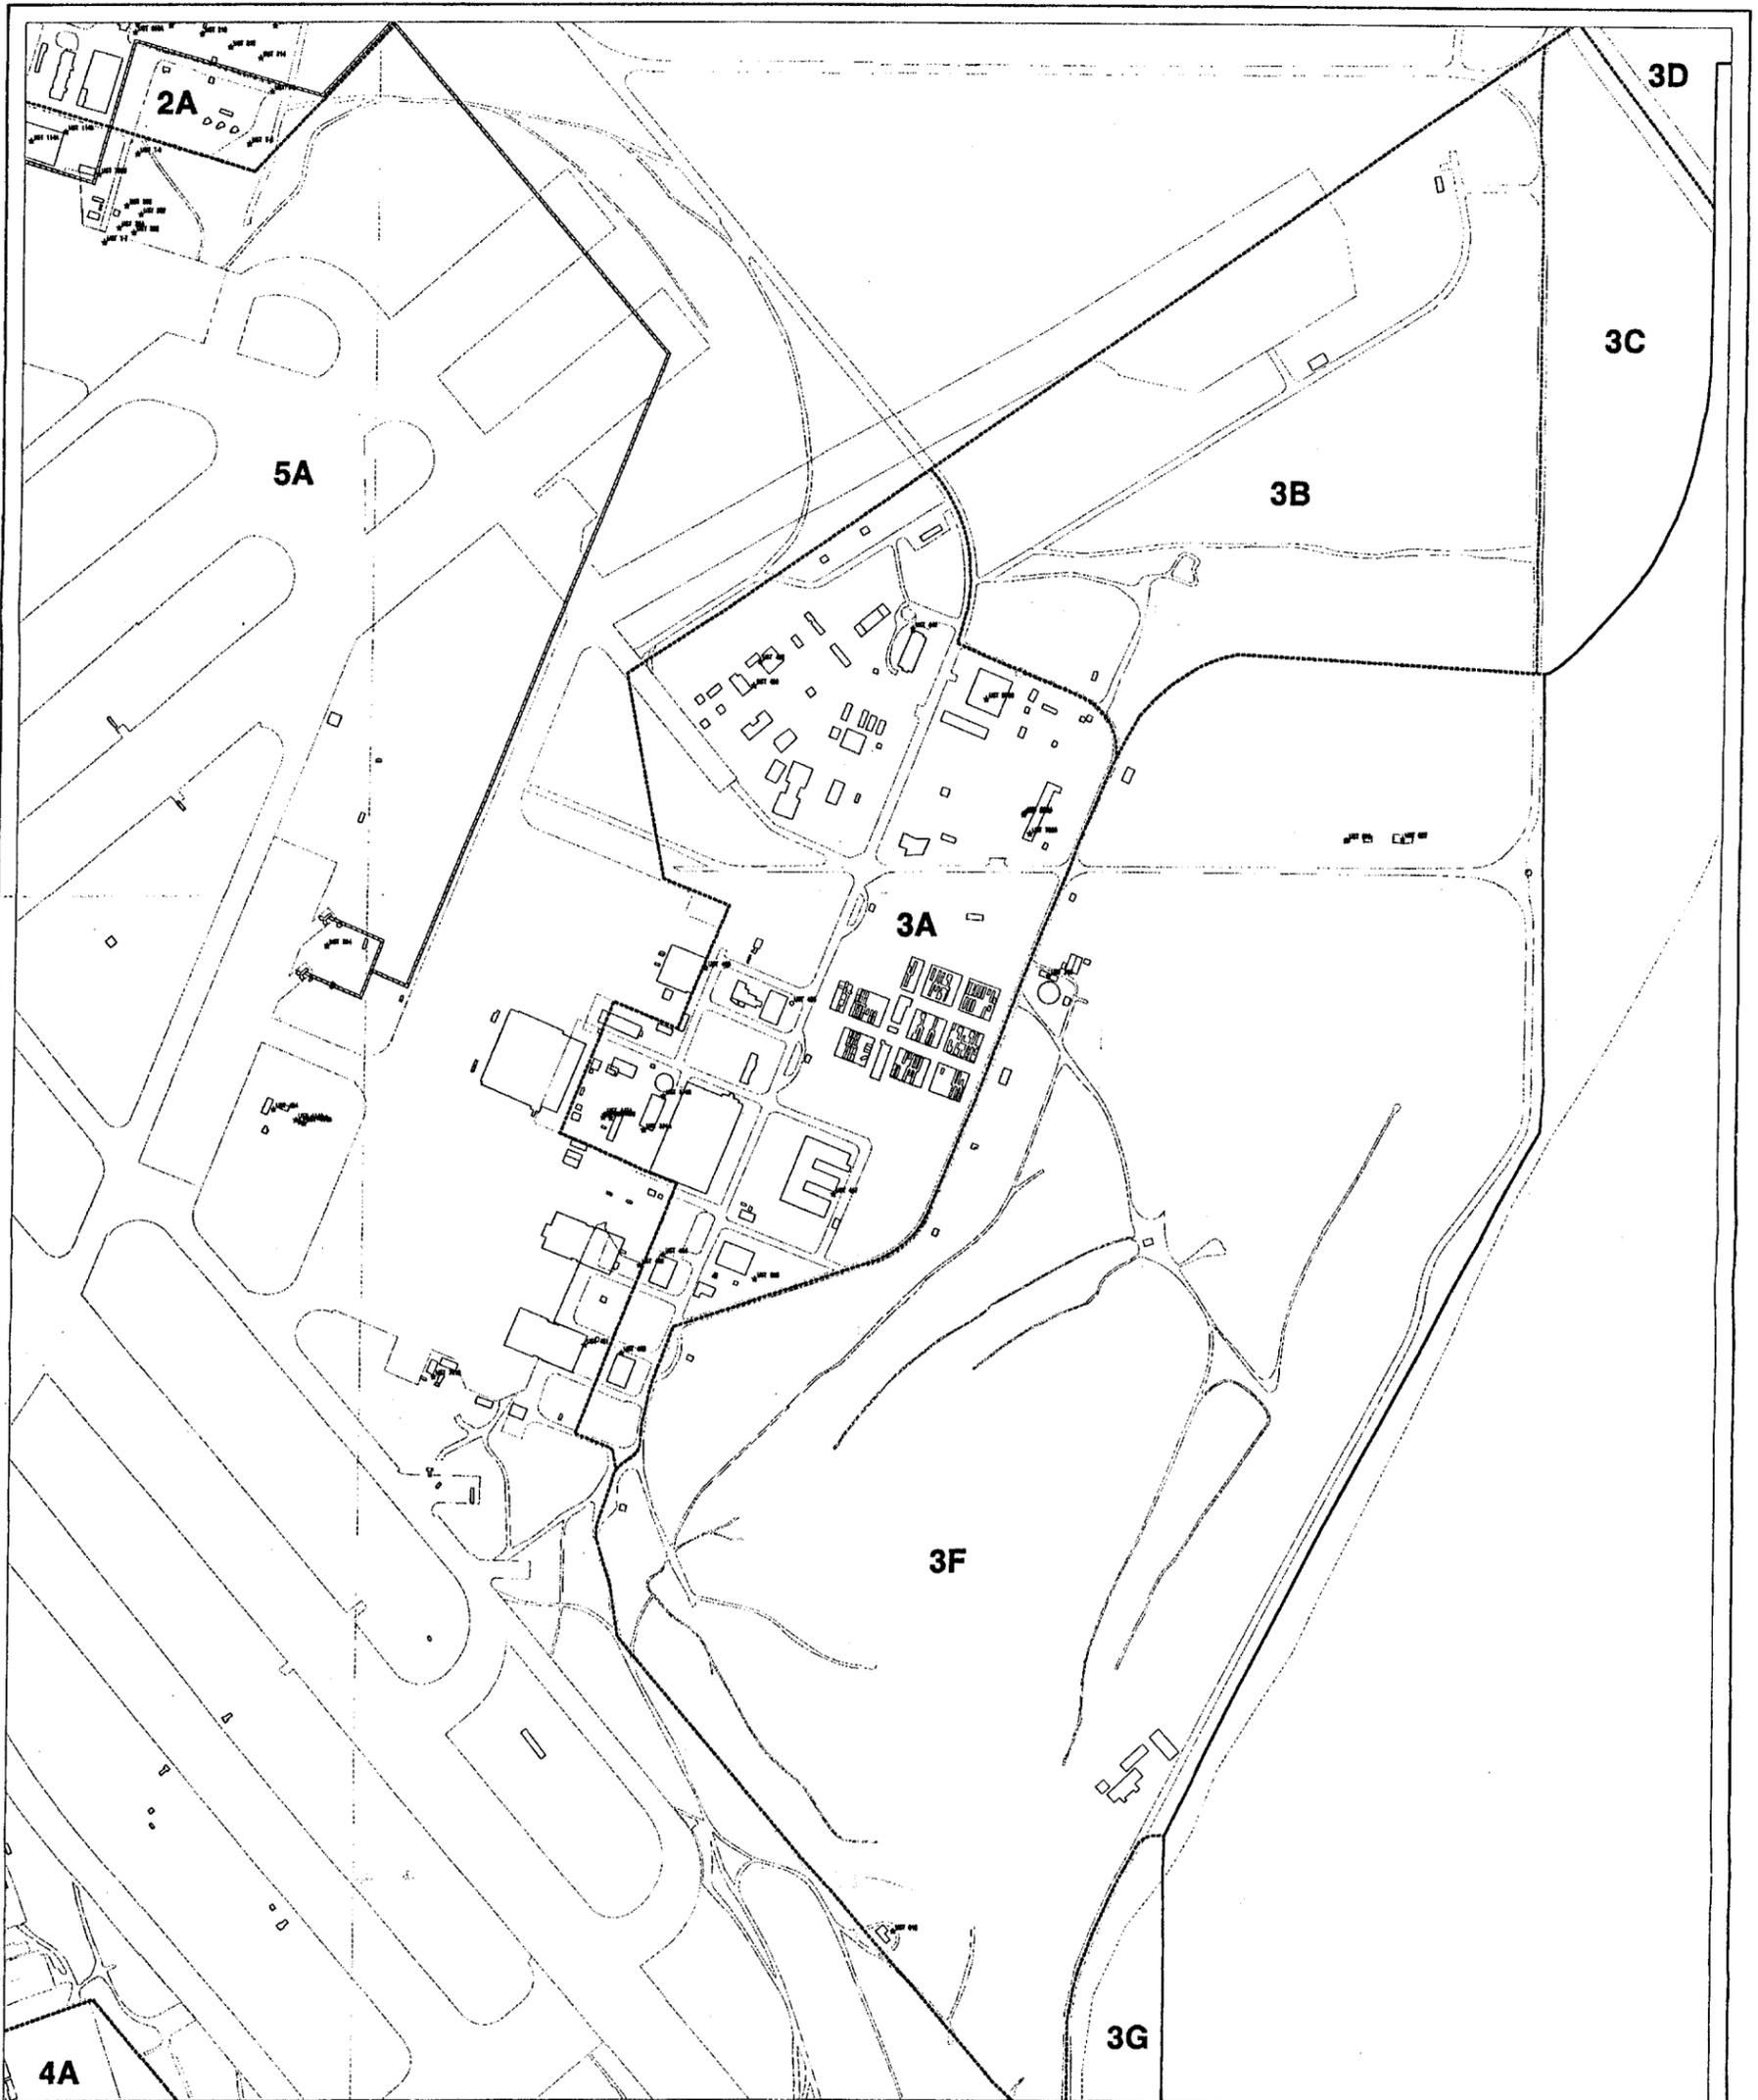
FIGURE 3-2d
UST LOCATIONS

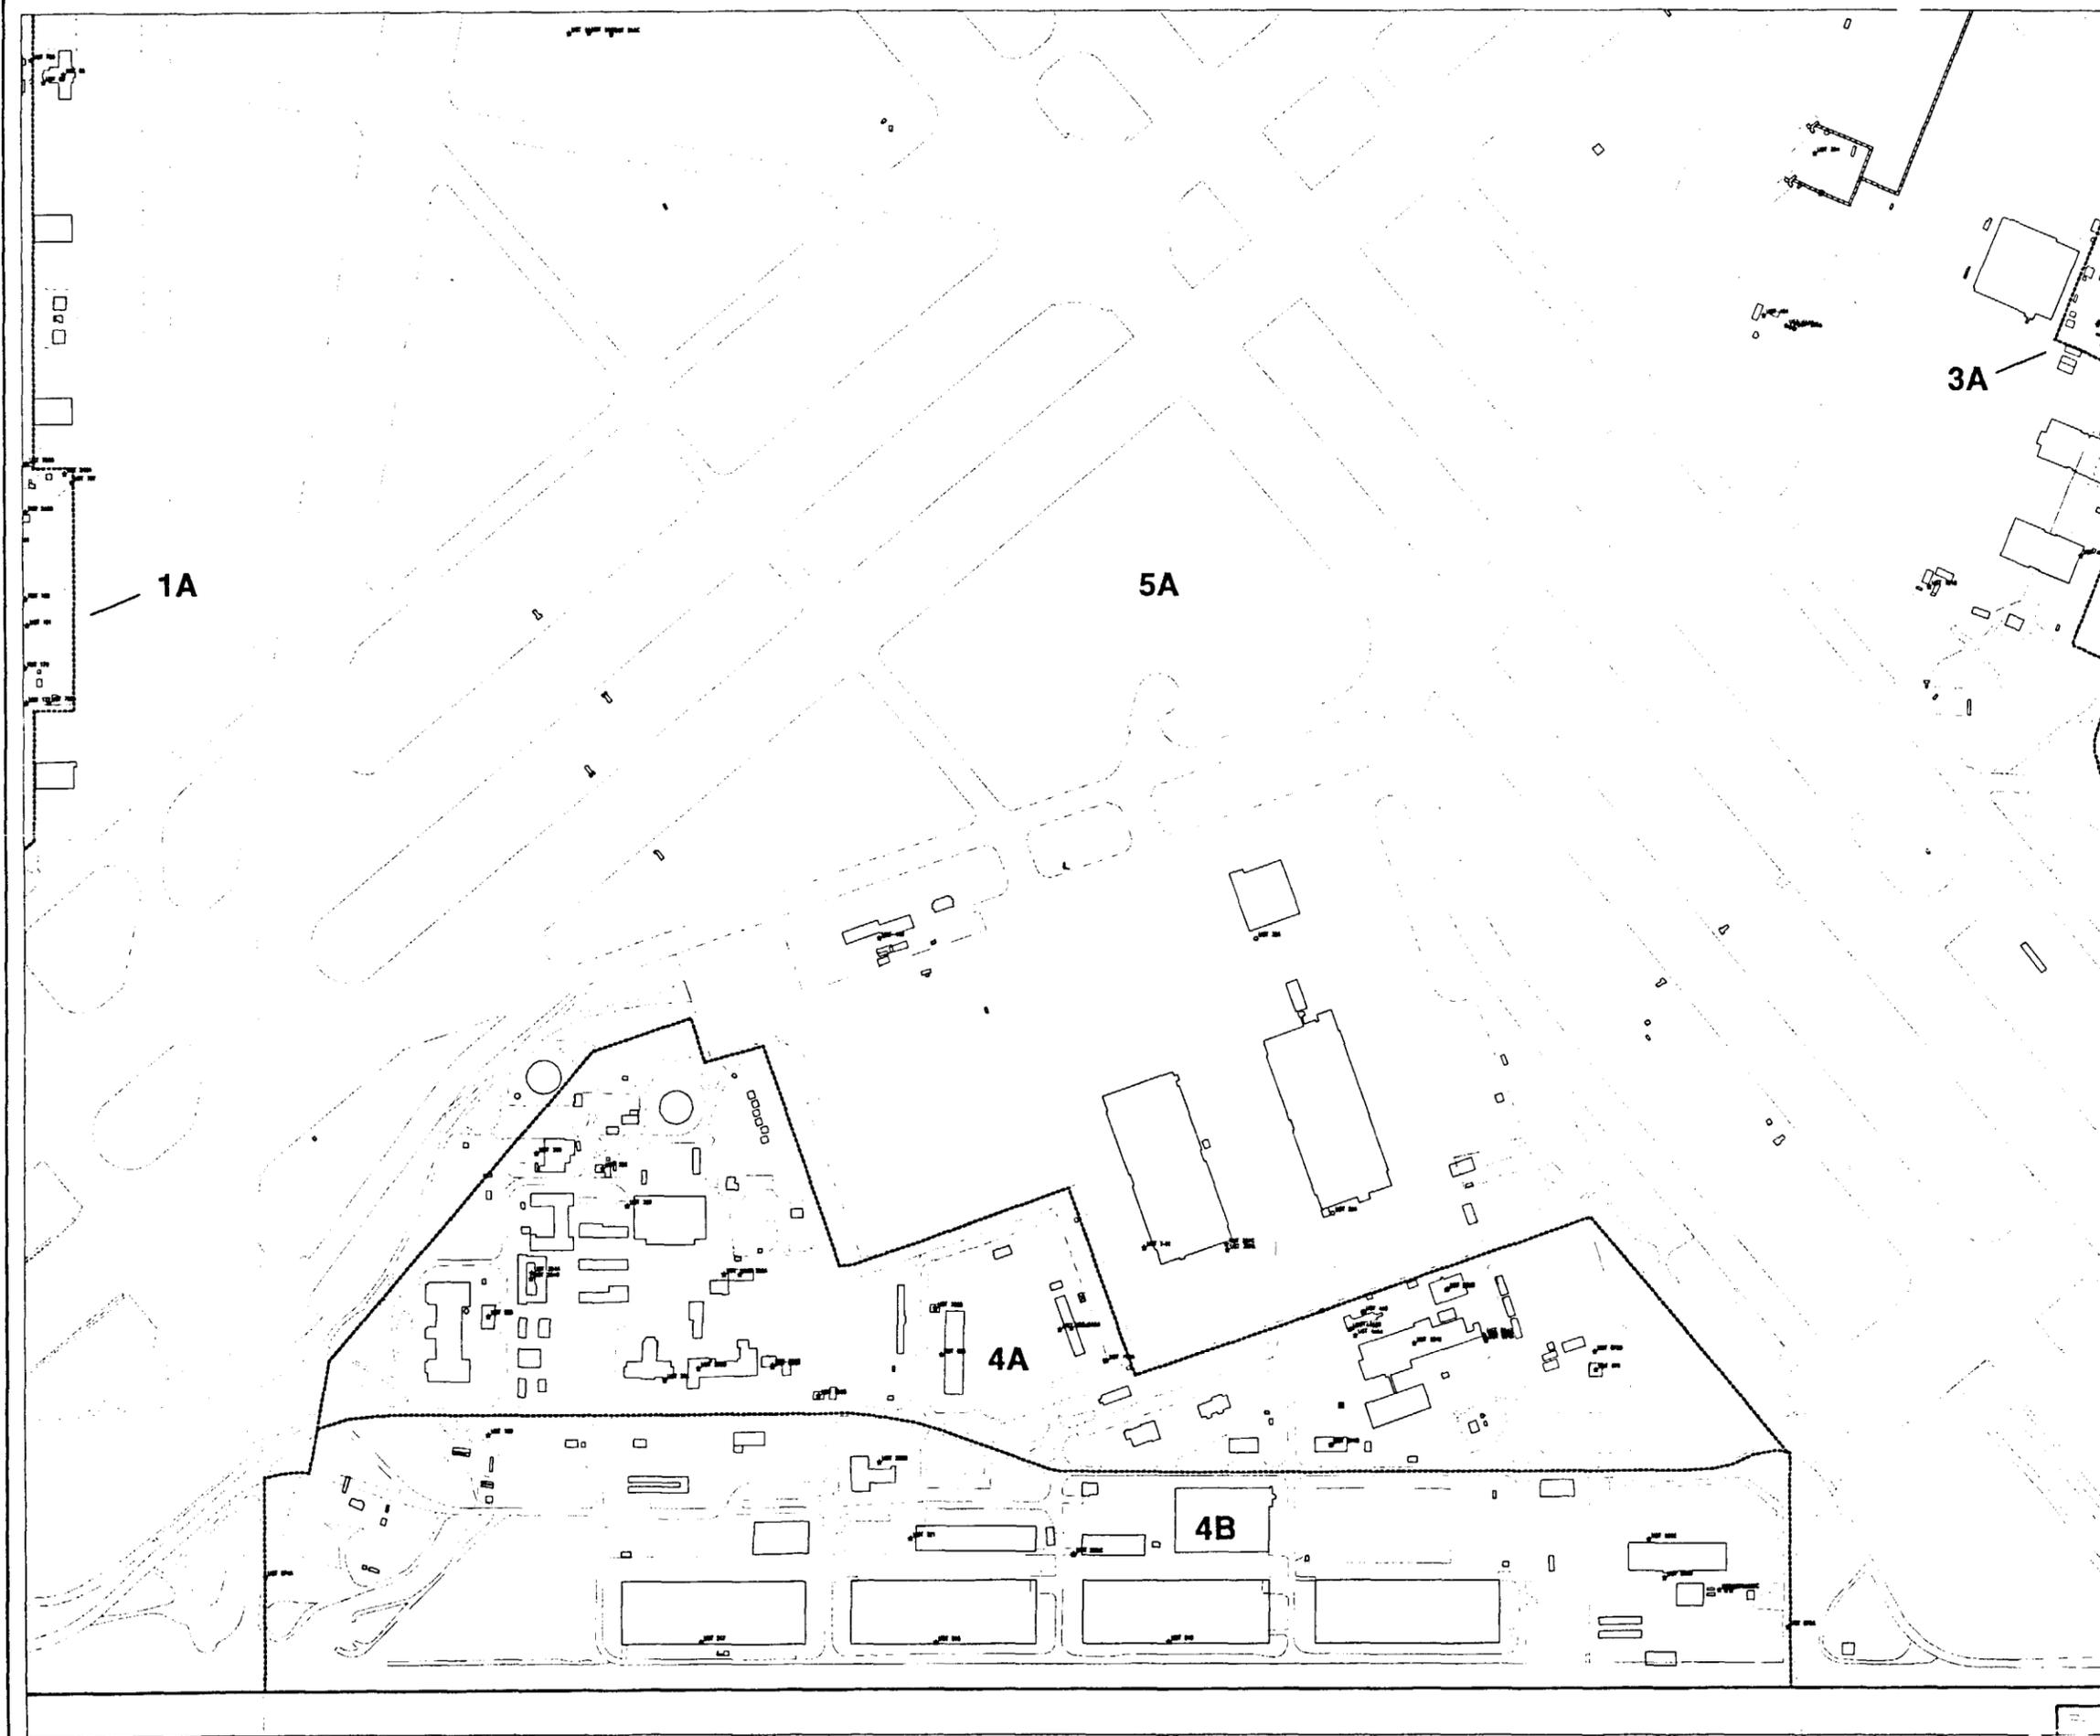
- FEATURES:**
- BUILDING OR PAD
 - - - ROAD OR AIRFIELD
 - ~ ~ ~ WASH OR STREAM
 - ~ ~ ~ FUEL LINE
 - - - MCAS BOUNDARY
 - - - ZONE OR PARCEL BOUNDARY
- CONTAMINATED UST LOCATION
 - CLEAN UST LOCATION
 - ◐ UNEVALUATED UST LOCATION

FIGURE 3-2e
UST LOCATIONS
 MCAS EL TORO BCP
