FIGURE 3-1
SITES, ZONES, AND OUs
CURRENTLY UNDER INVESTIGATION

MCAS EL TORO BCP

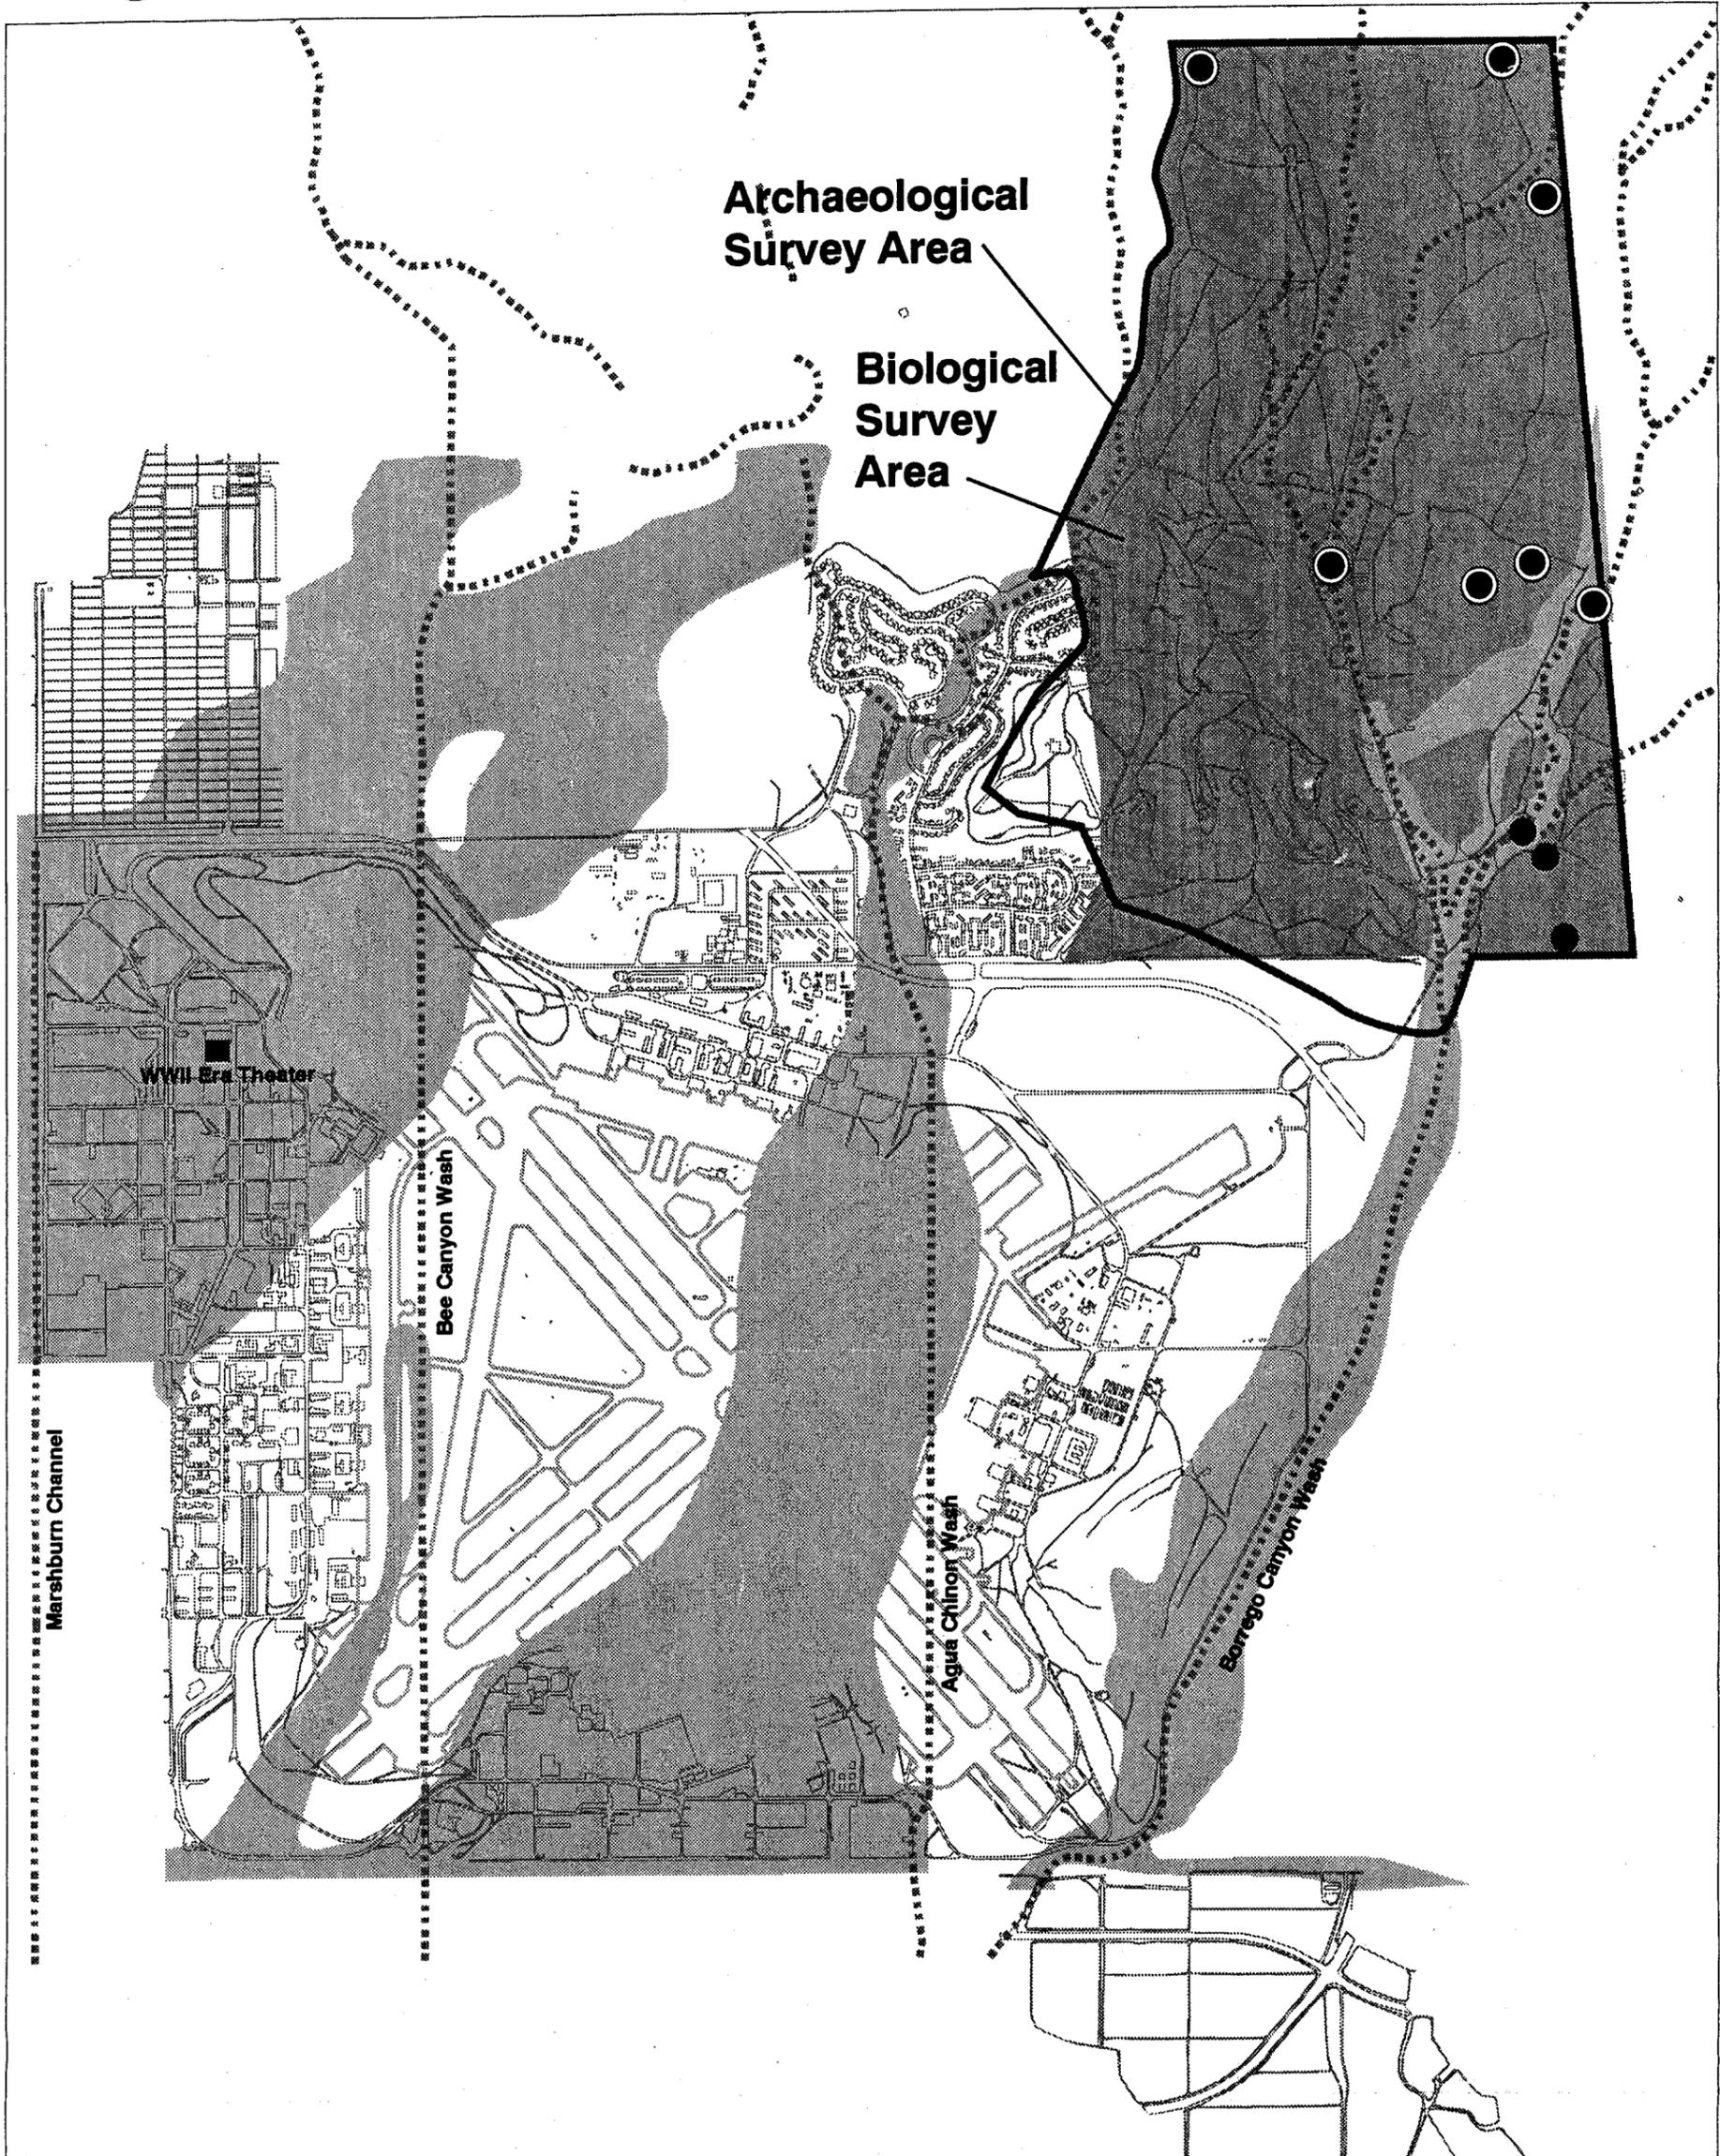
FIGURE 3-3
NATURAL AND CULTURAL
RESOURCES FEATURES
MCAS EL TORO BCP

- Archaeological Sites
- Archaeological Sites Recommended for Further Evaluation for Eligibility for Nomination to the National Register of Historic Places
- ▨ 100-Year Floodplain

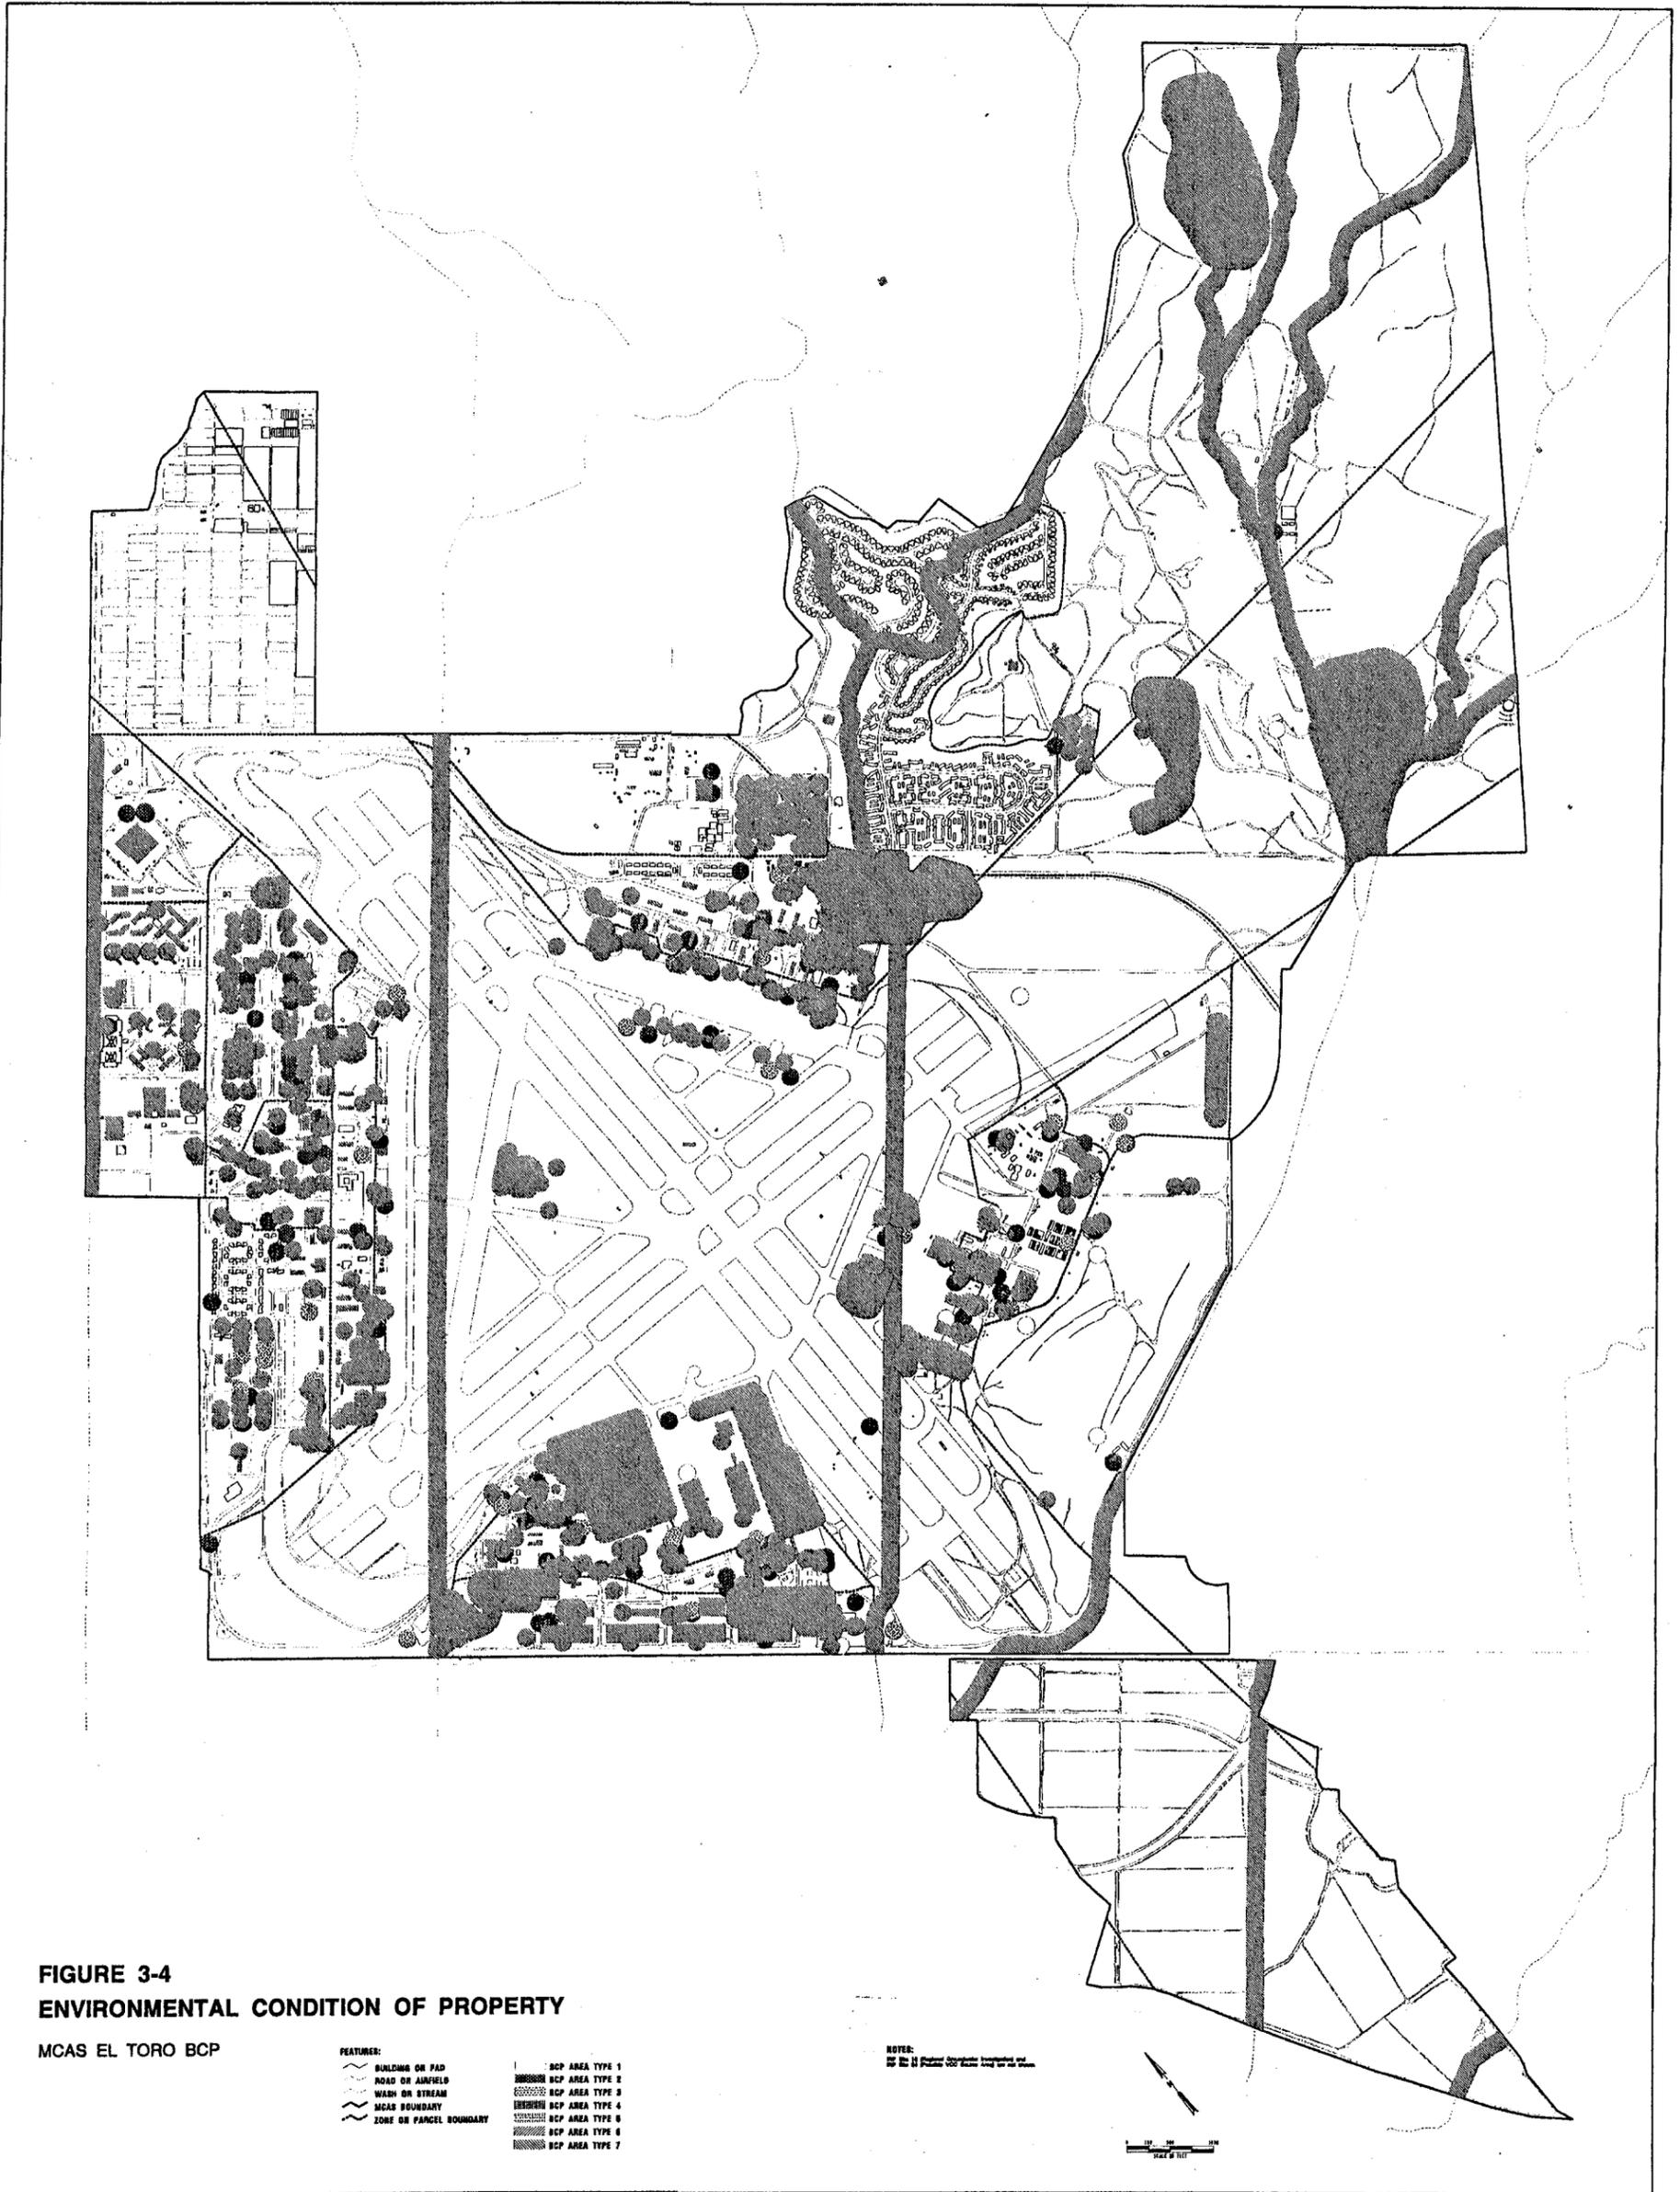
FIGURE 3-4
ENVIRONMENTAL CONDITION OF PROPERTY

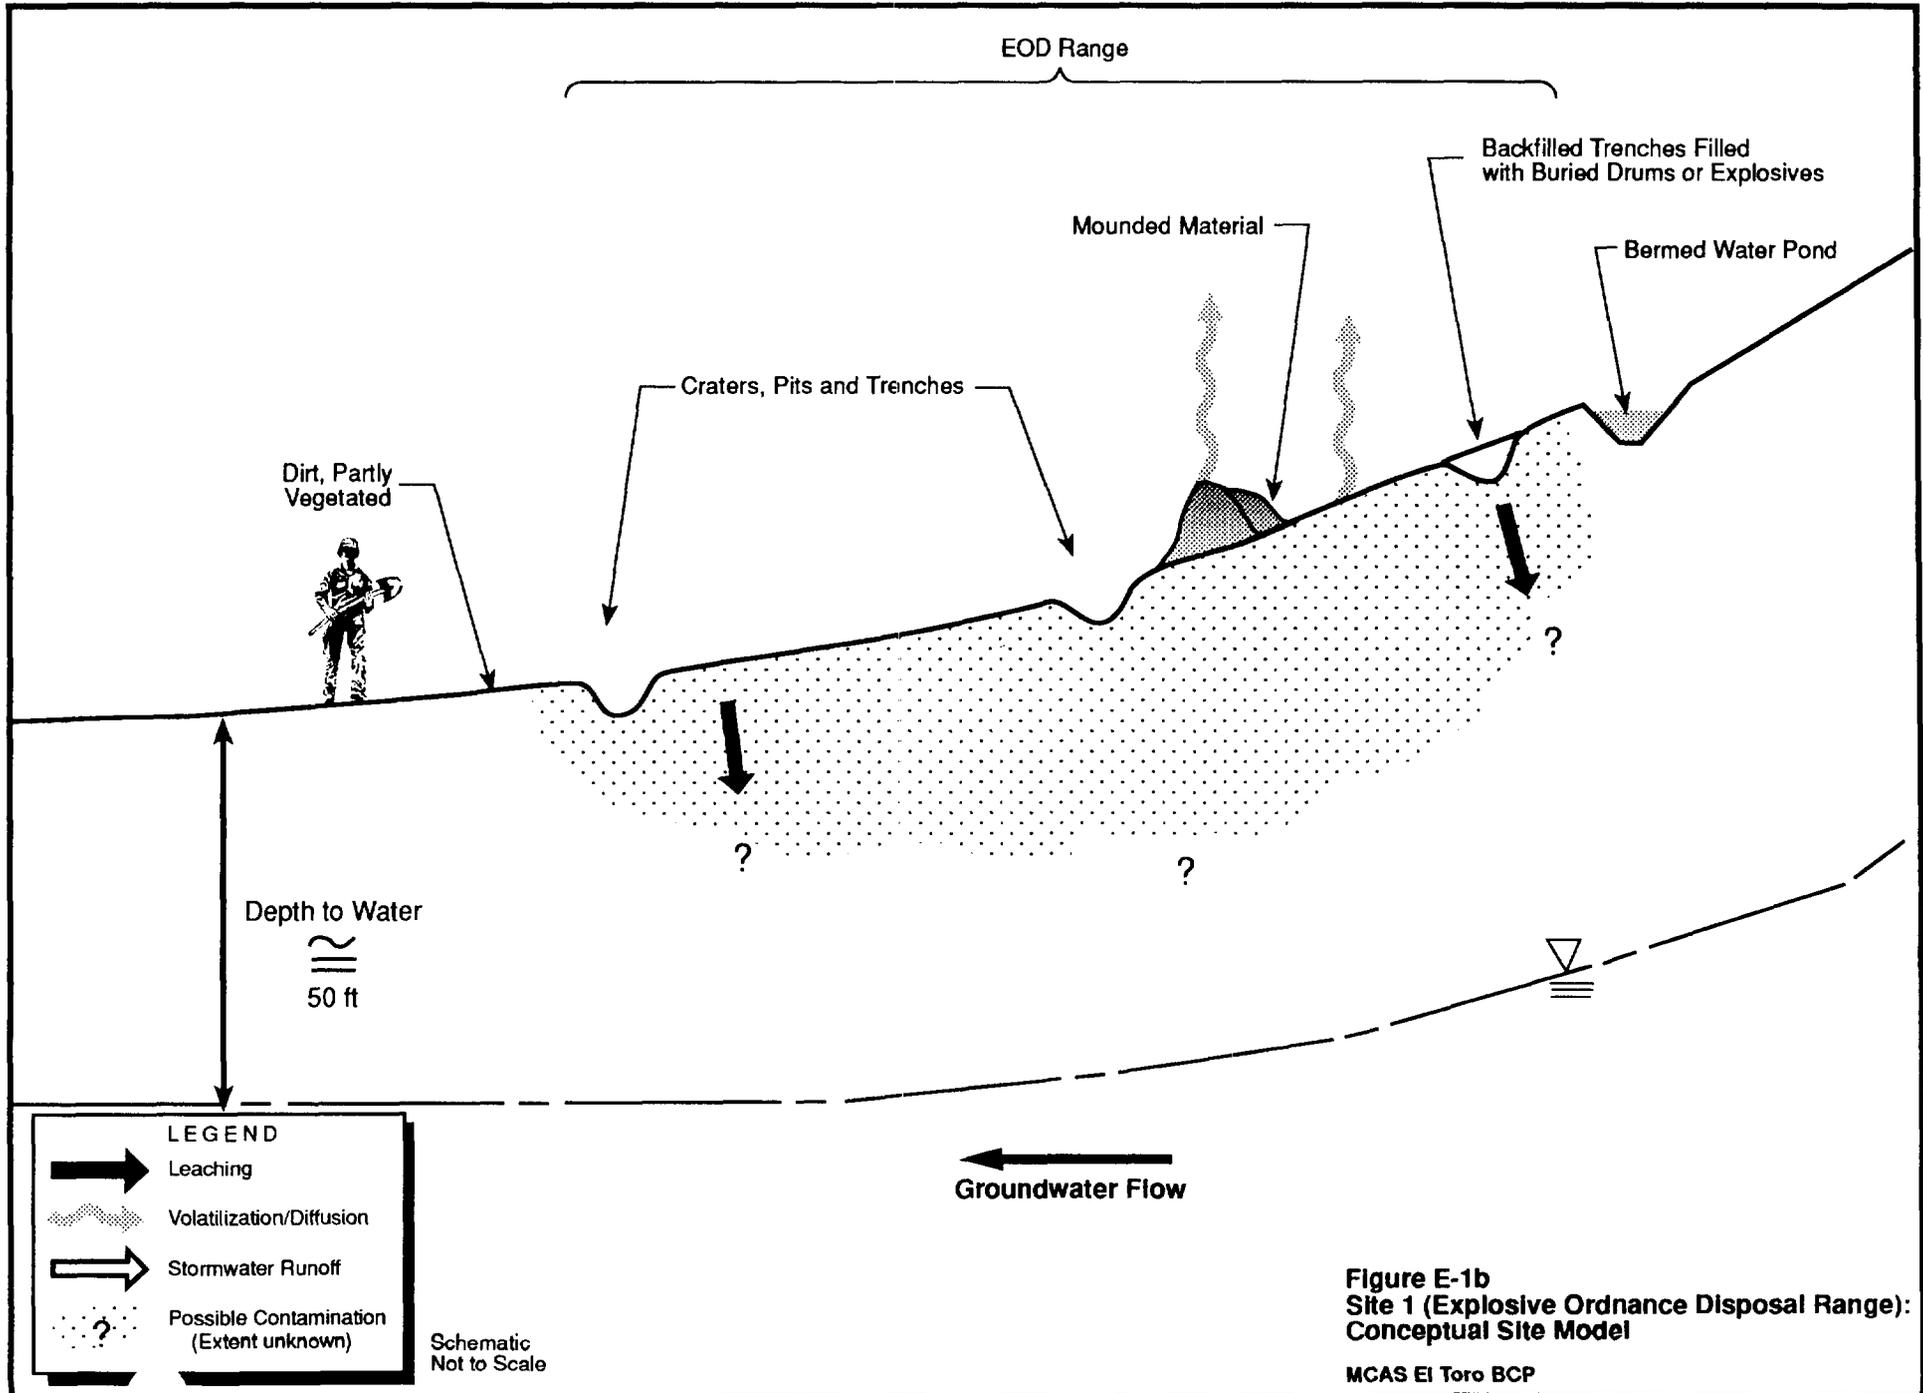
EOD Range

Backfilled Trenches Filled with Buried Drums or Explosives

Figure E-1b
Site 1 (Explosive Ordnance Disposal Range):
Conceptual Site Model

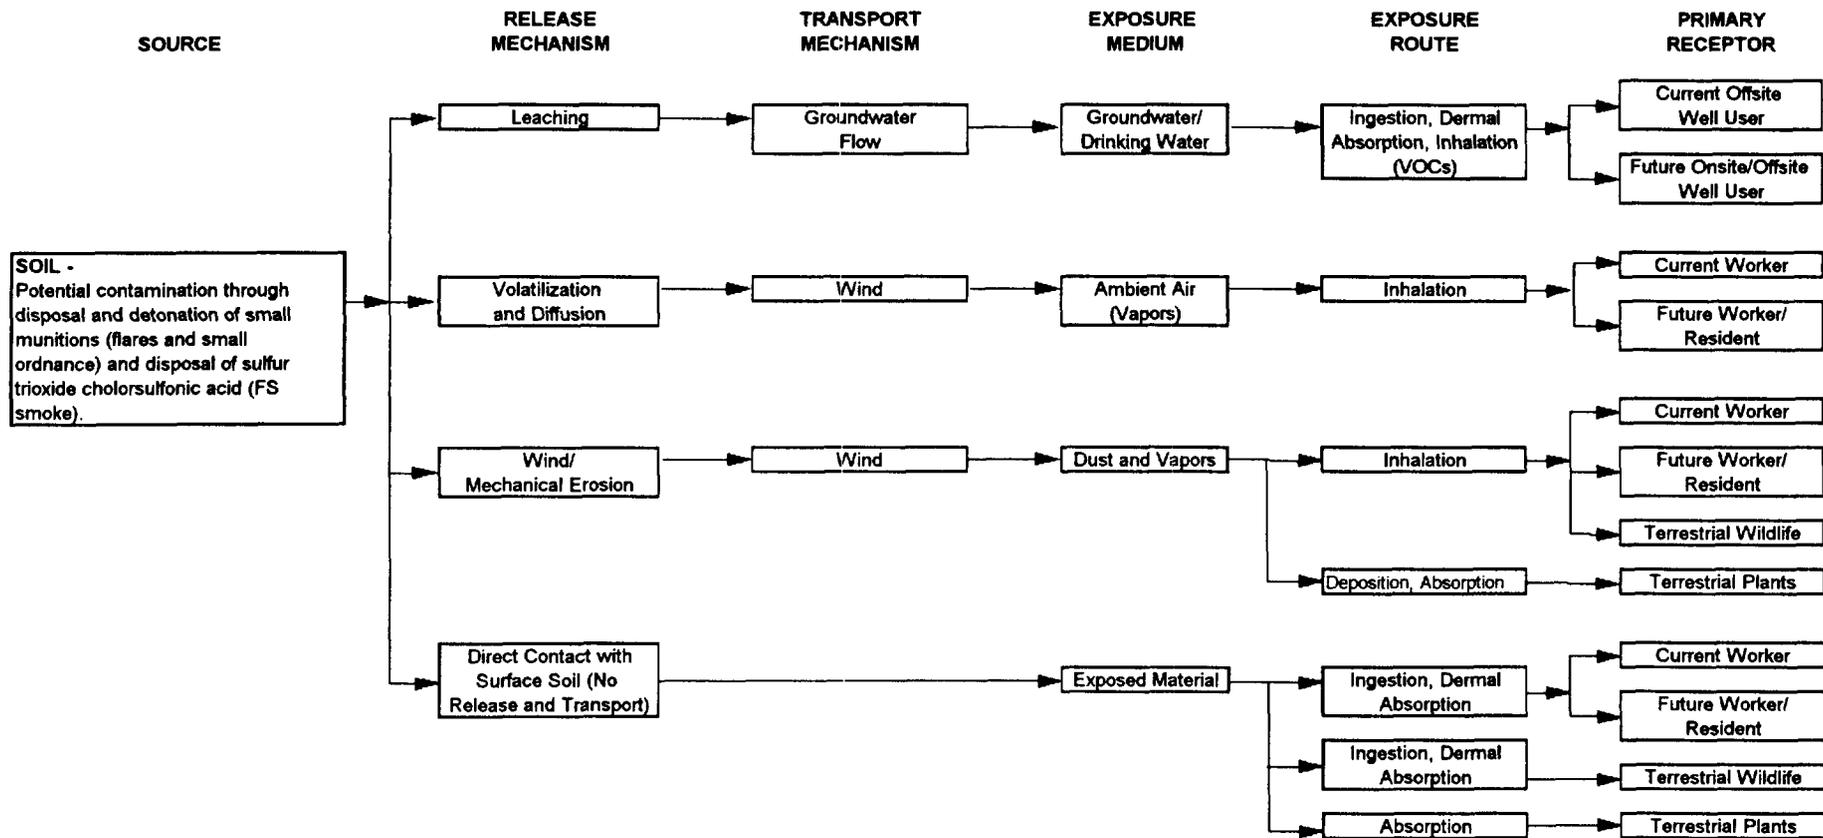
Figure E-1c
Site 1 (Explosive Ordnance Disposal Range):
Potential Exposure Routes and Pathways for Human and Ecological Receptors
 MCAS EI Toro BCP

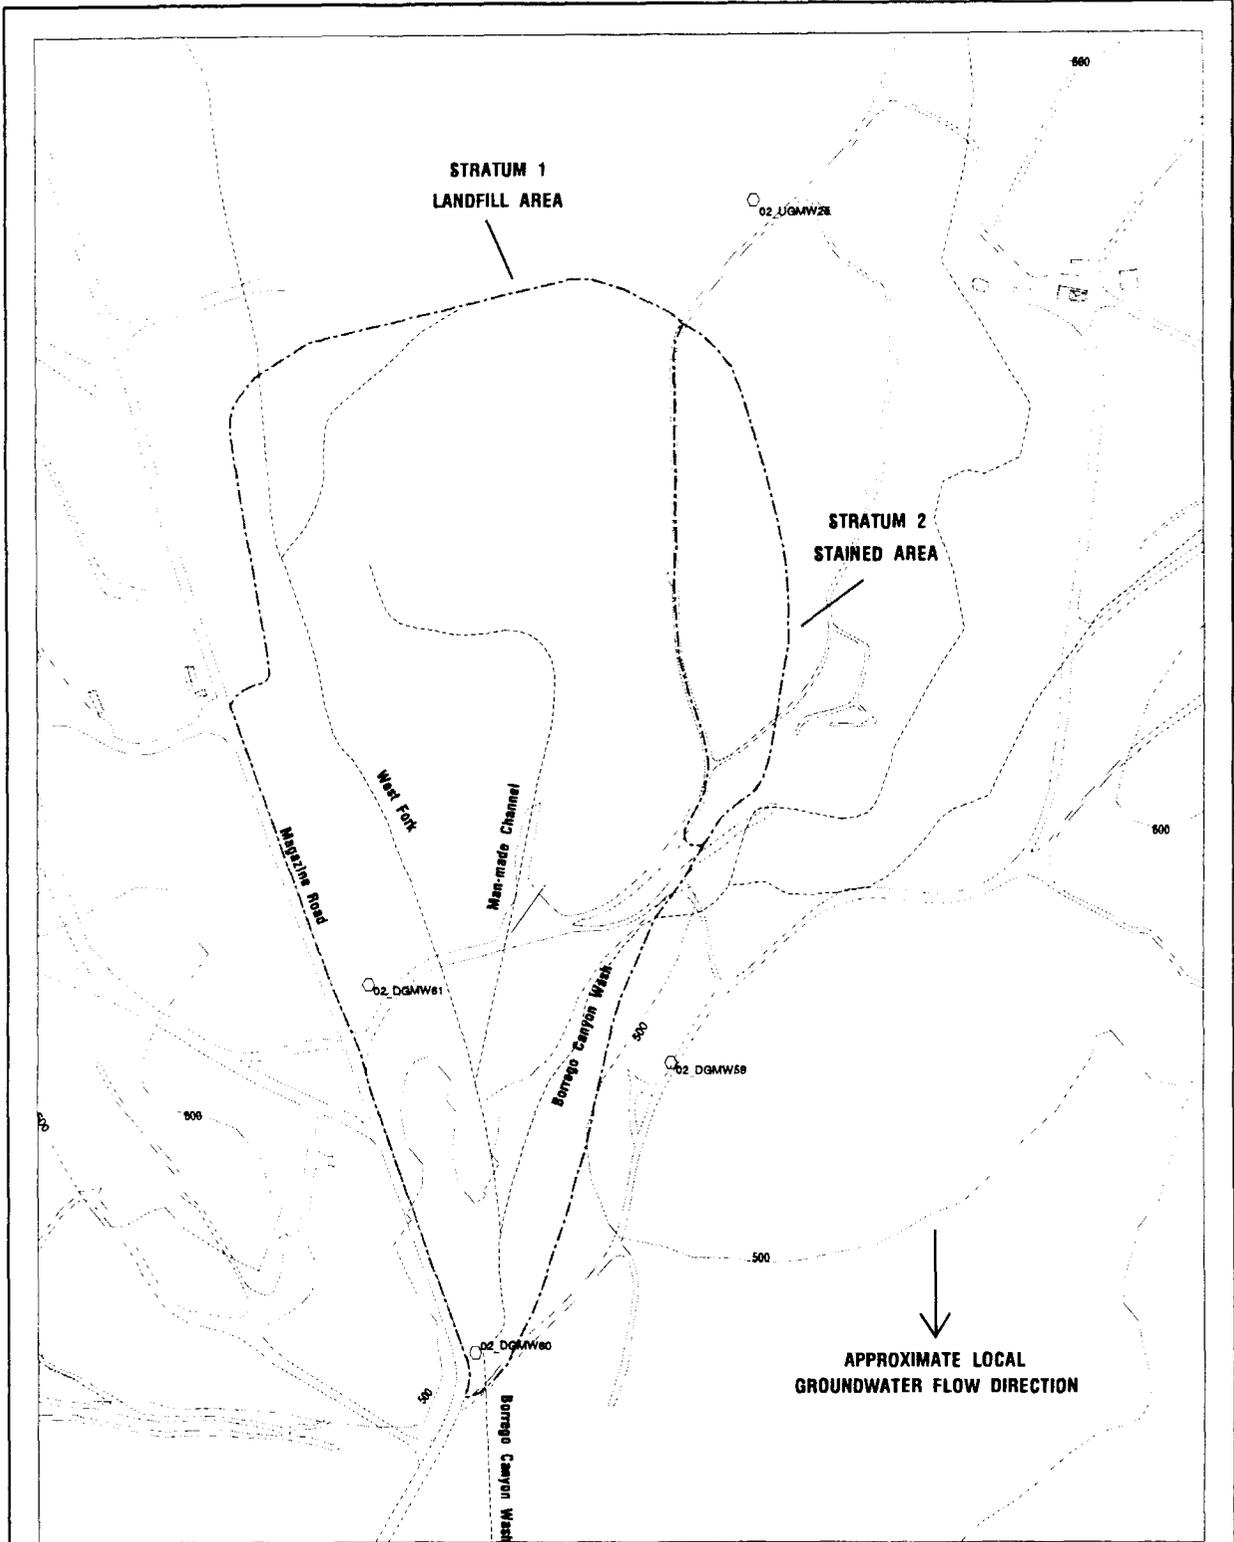
- FEATURES:
- BUILDING OR PAD
 - MONITORING WELL
 - ROAD
 - STRATUM BOUNDARY
 - WASH OR STREAM
 - ELEVATION CONTOUR

FIGURE E-2a
SITE 2 (MAGAZINE
ROAD LANDFILL):
SITE LAYOUT

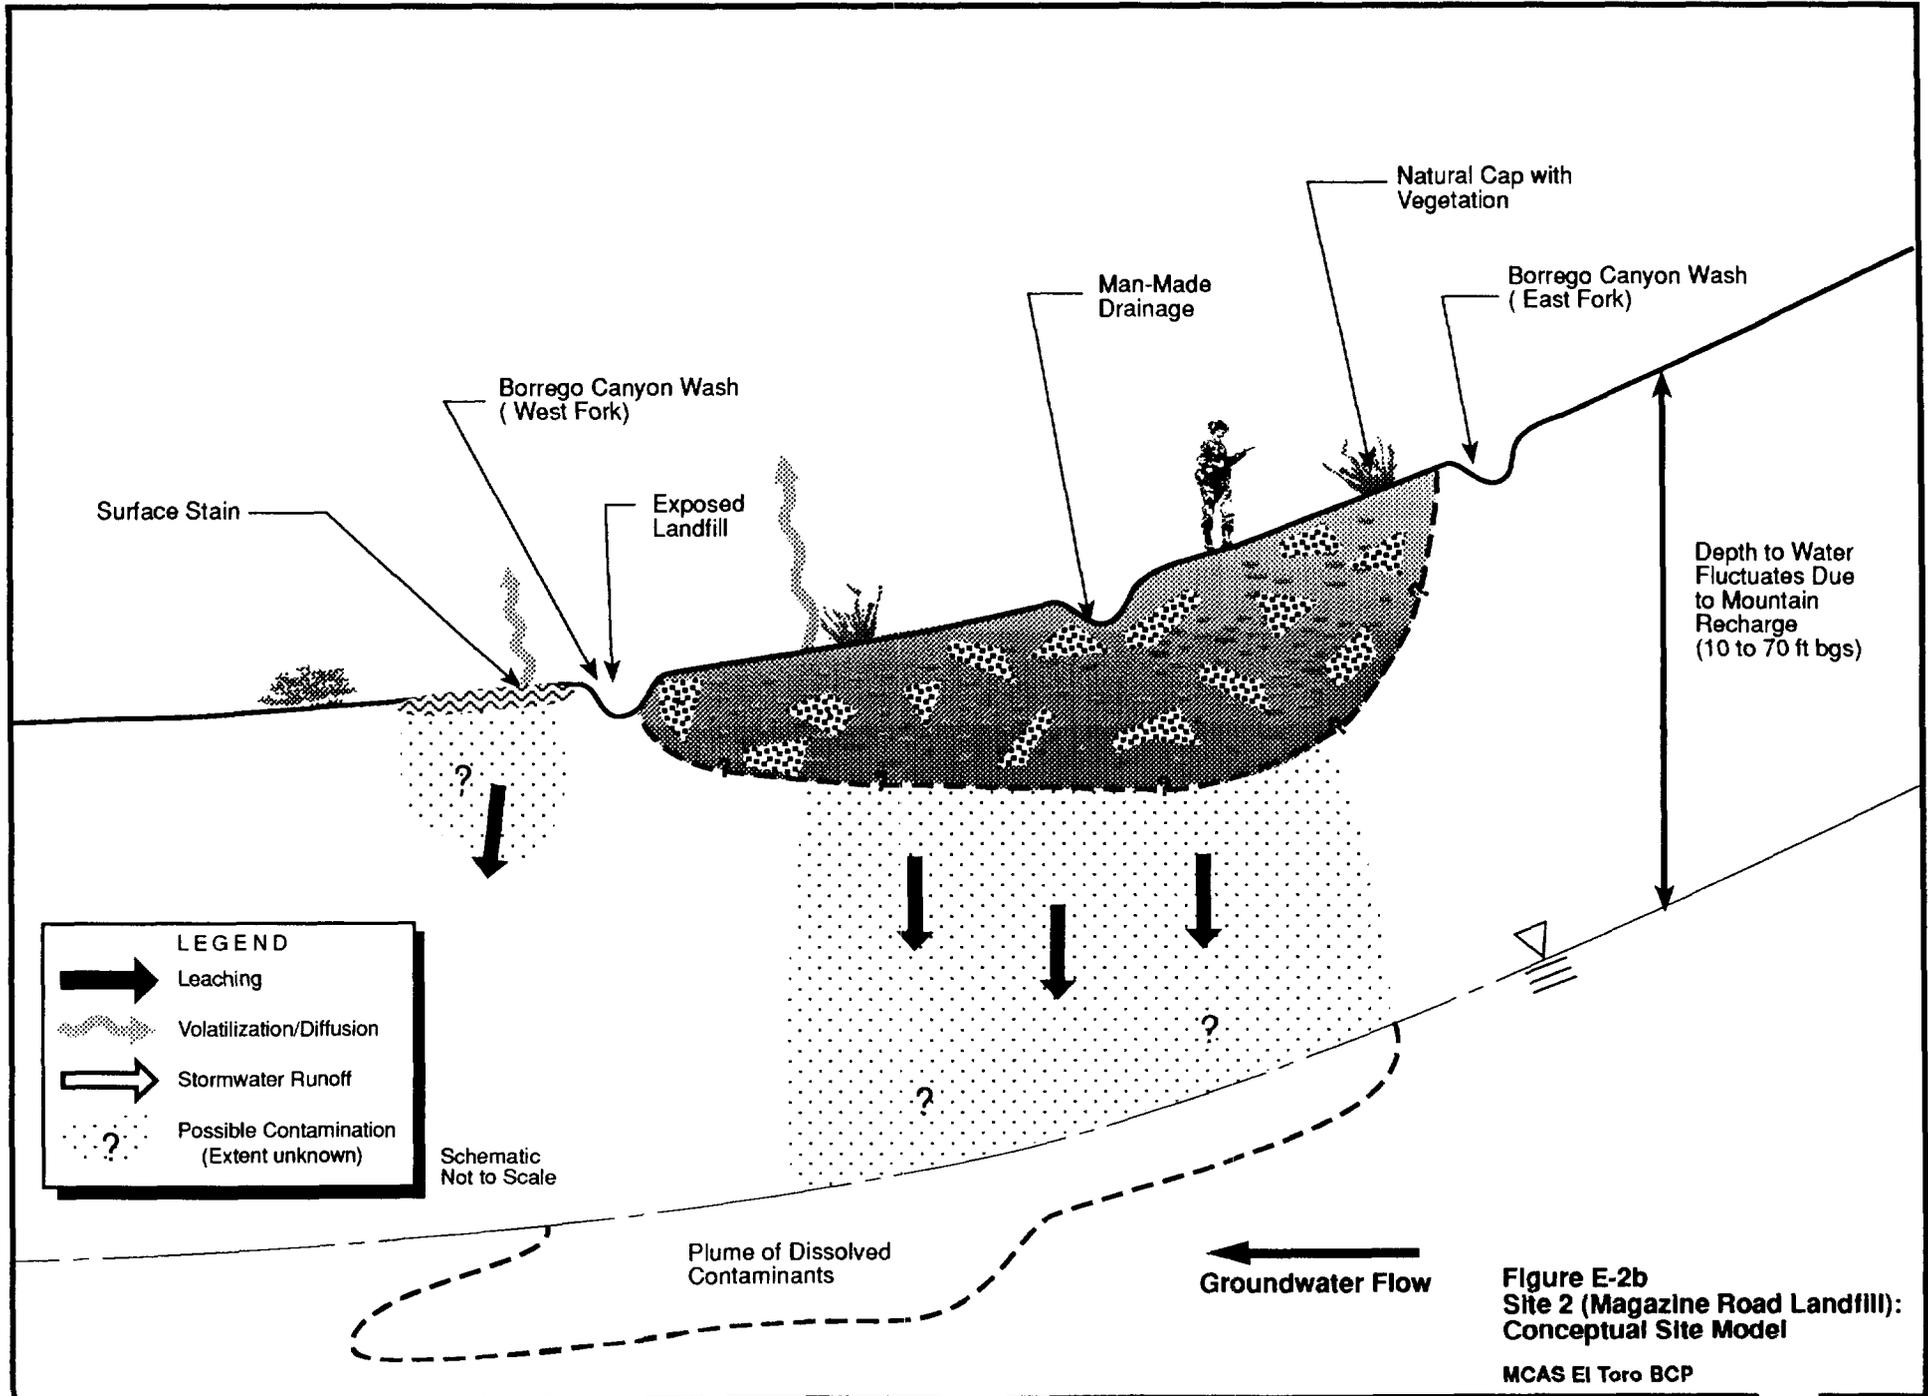
Figure E-2b
Site 2 (Magazine Road Landfill):
Conceptual Site Model

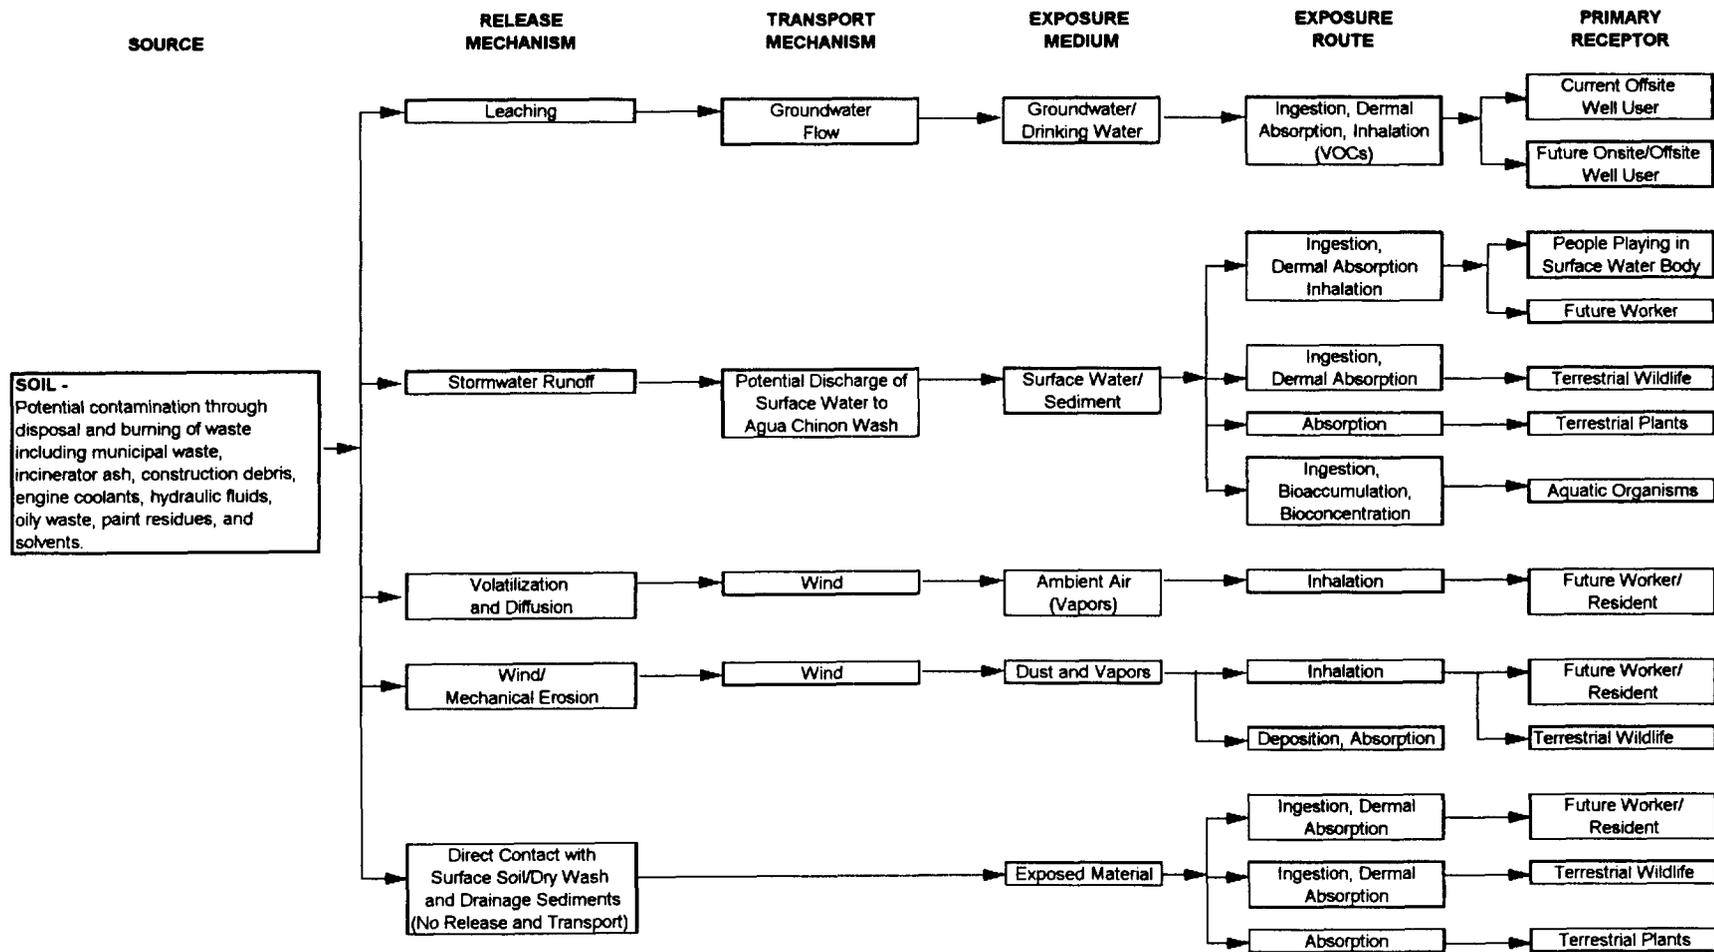
Figure E-3/4c
Site 3/4 (Original Landfill and Ferrocene Spill Area):
Potential Exposure Routes and Pathways for Human and Ecological Receptors
MCAS El Toro BCP

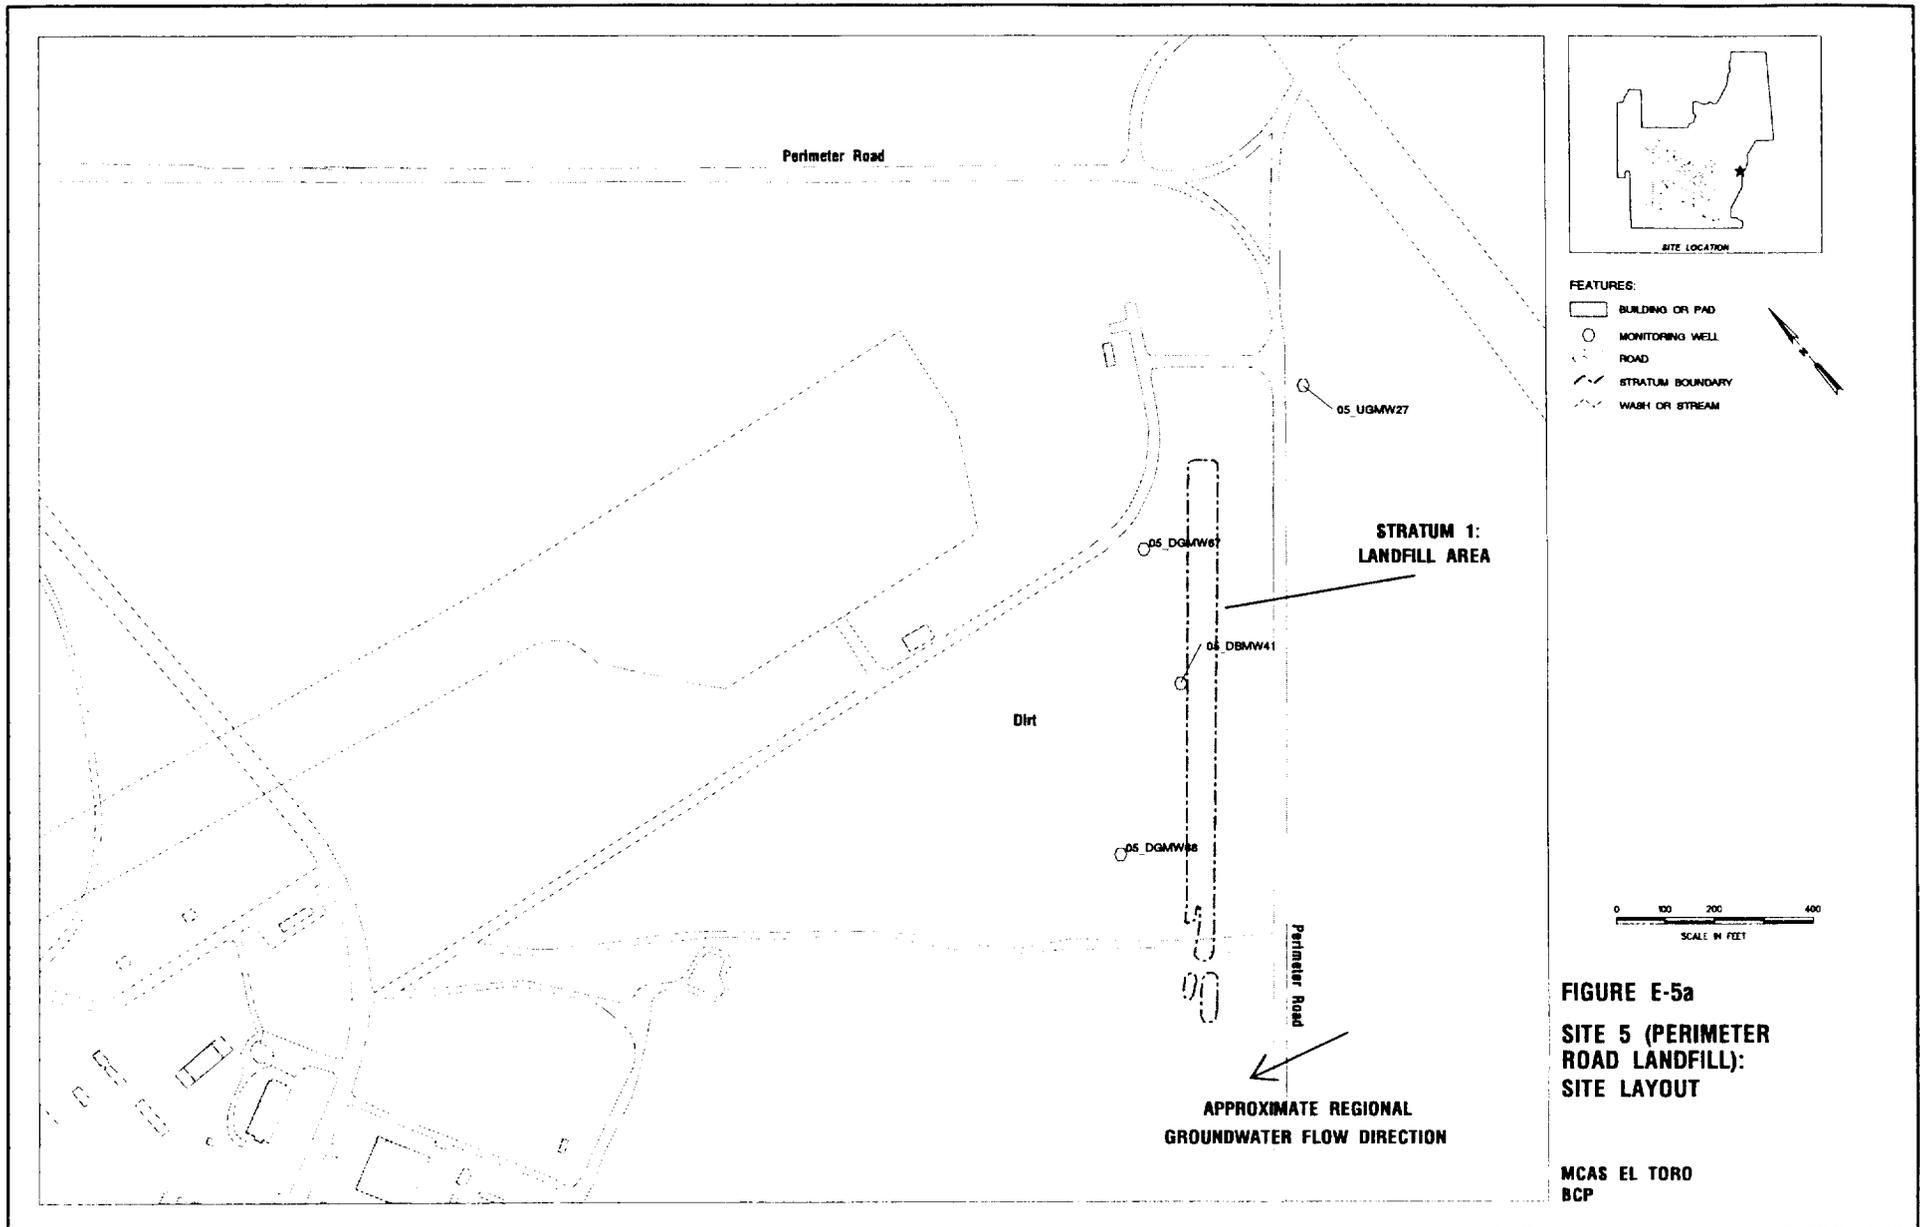
FIGURE E-5a
SITE 5 (PERIMETER ROAD LANDFILL):
SITE LAYOUT

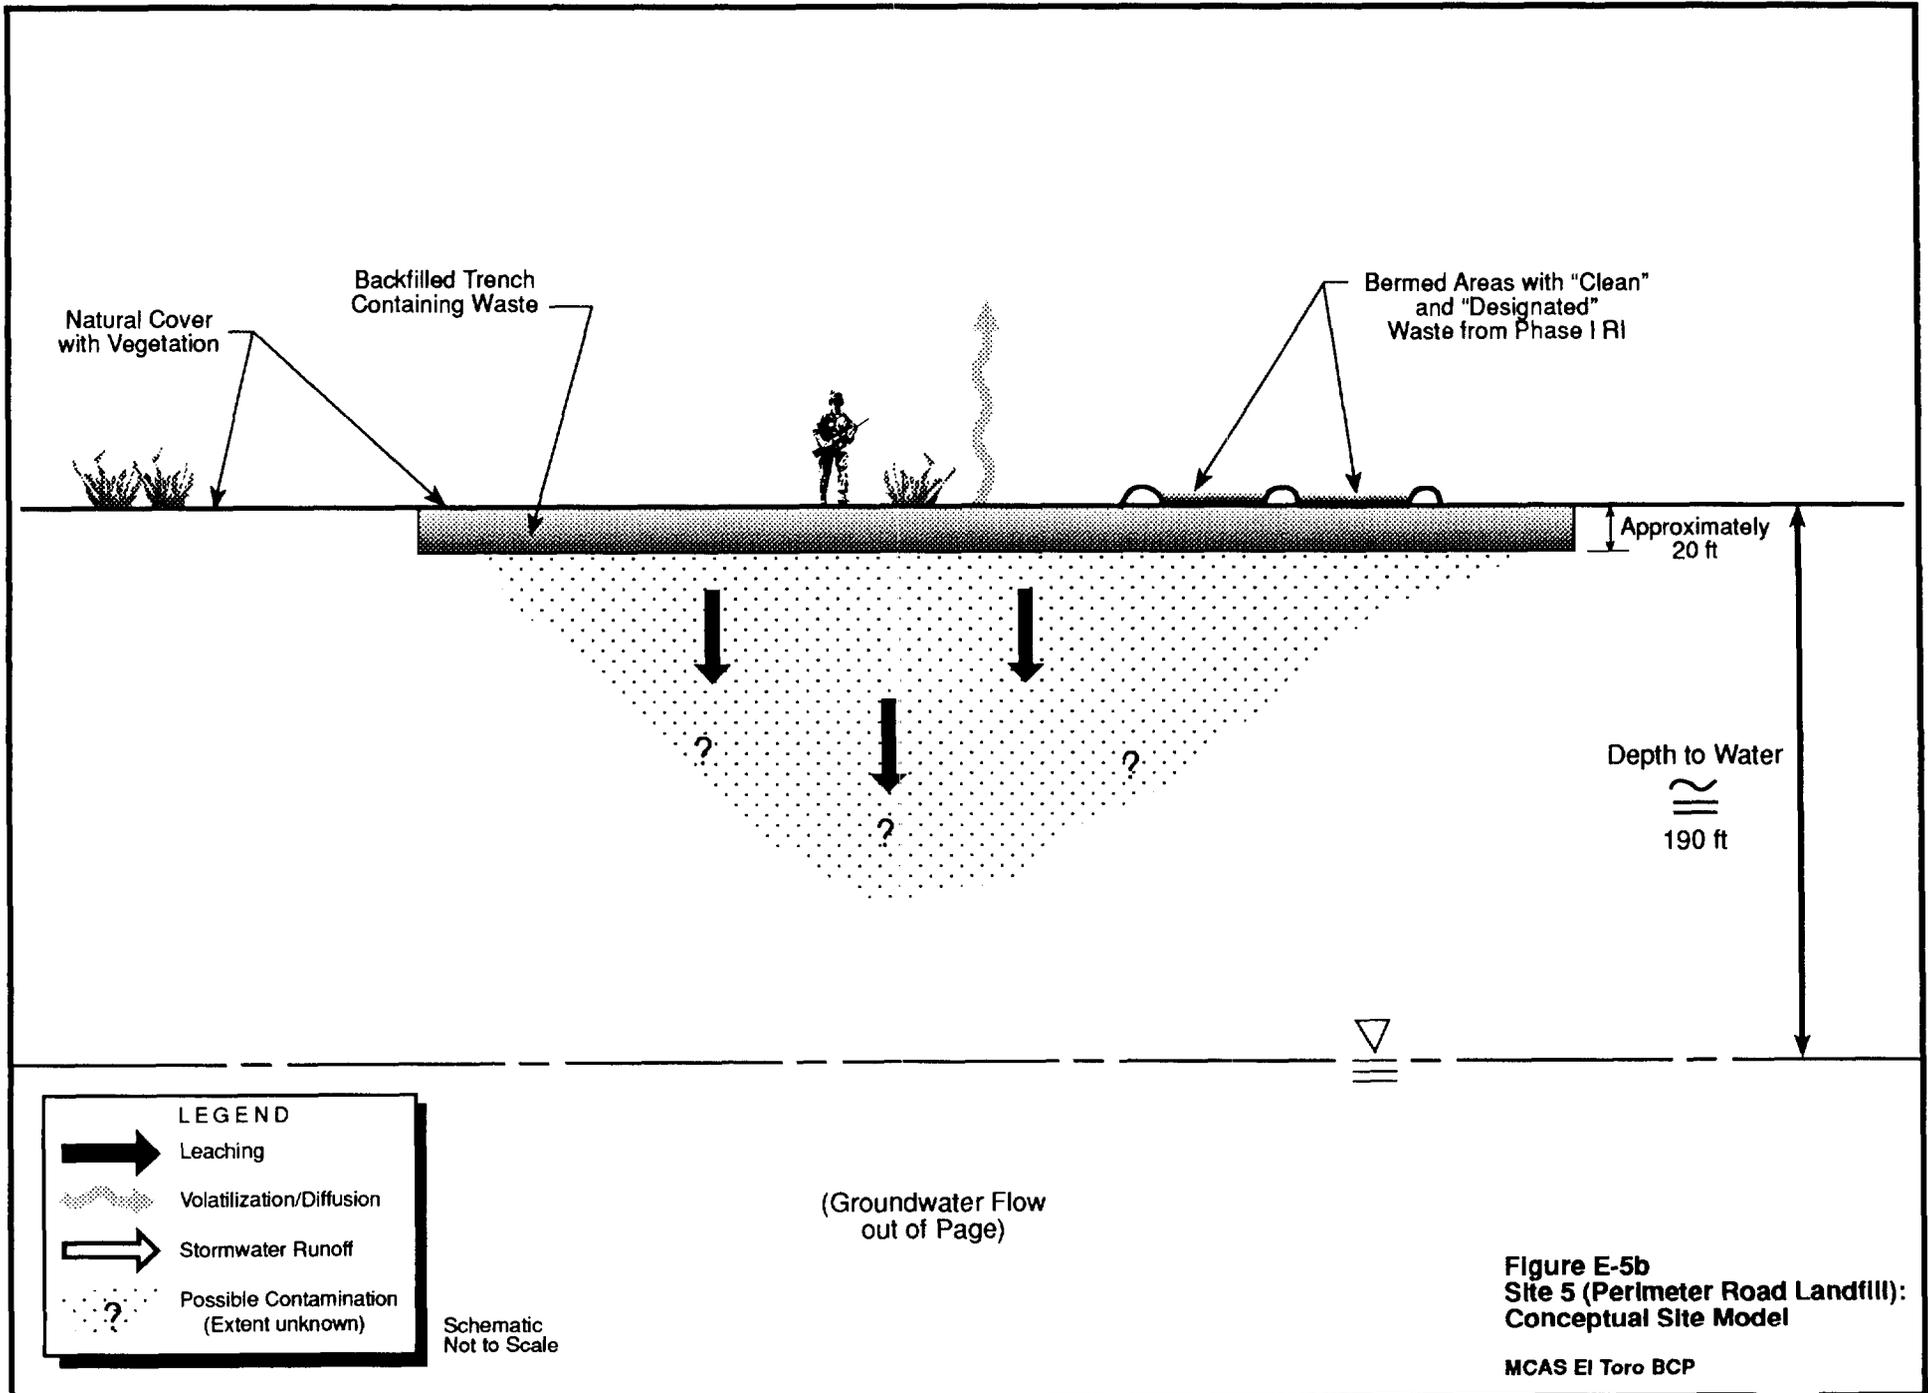
Figure E-5b
Site 5 (Perimeter Road Landfill):
Conceptual Site Model
