FIGURE 3-1
SITES, ZONES, AND OUs
CURRENTLY UNDER INVESTIGATION

MCAS EL TORO BCP

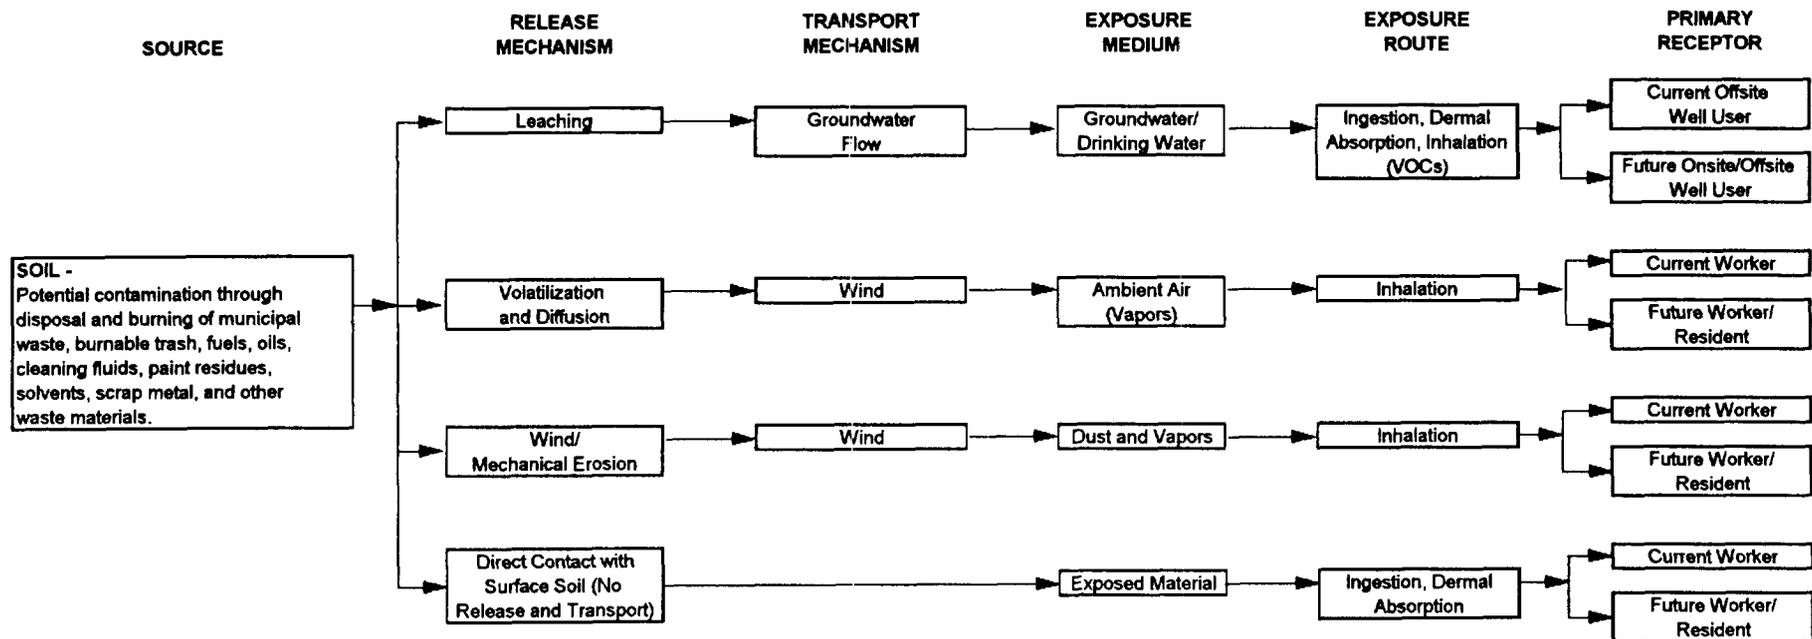
Figure E-5c
Site 5 (Perimeter Road Landfill):
Potential Exposure Routes and Pathways for Human Receptors
MCAS El Toro BCP

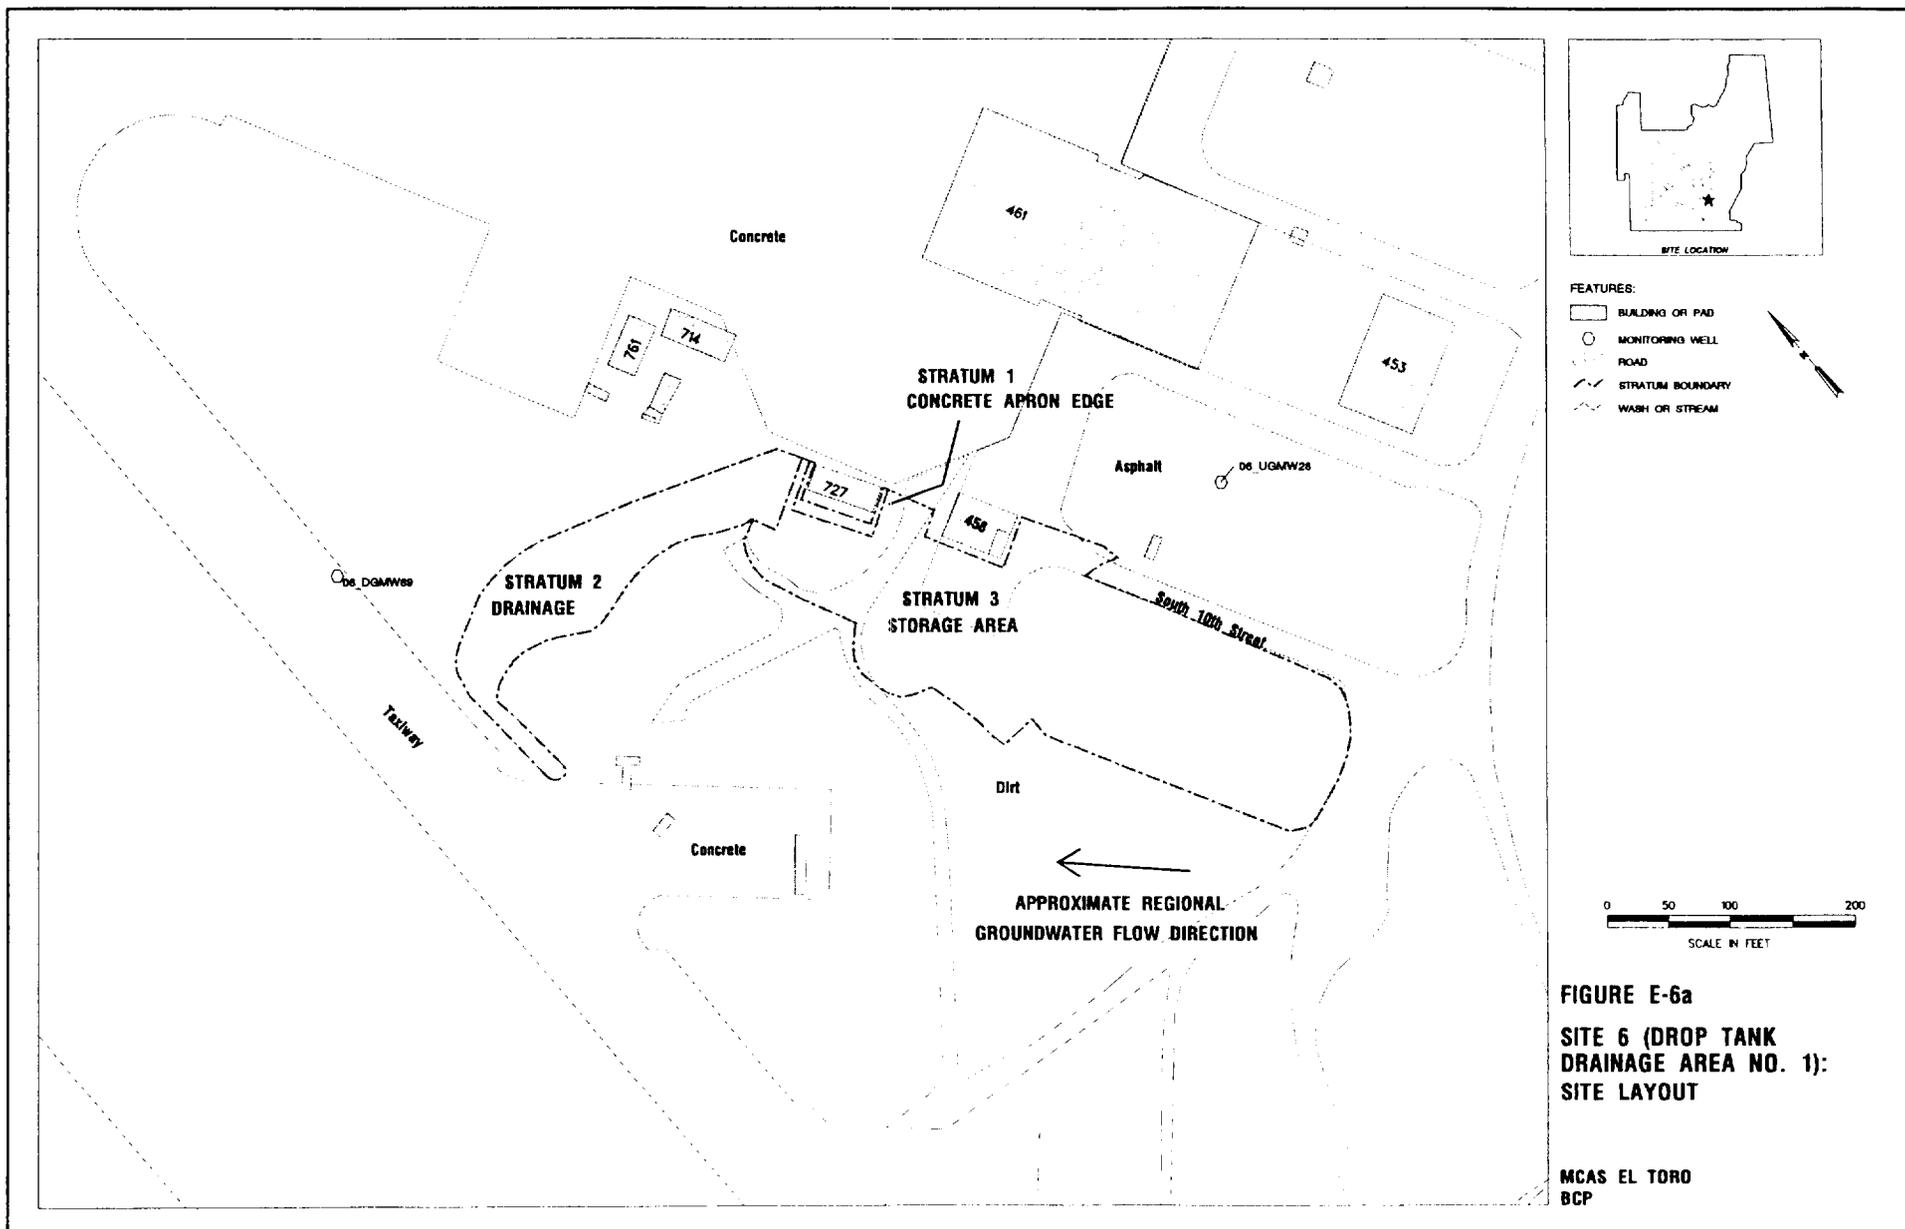
FIGURE E-6a
SITE 6 (DROP TANK
DRAINAGE AREA NO. 1):
SITE LAYOUT

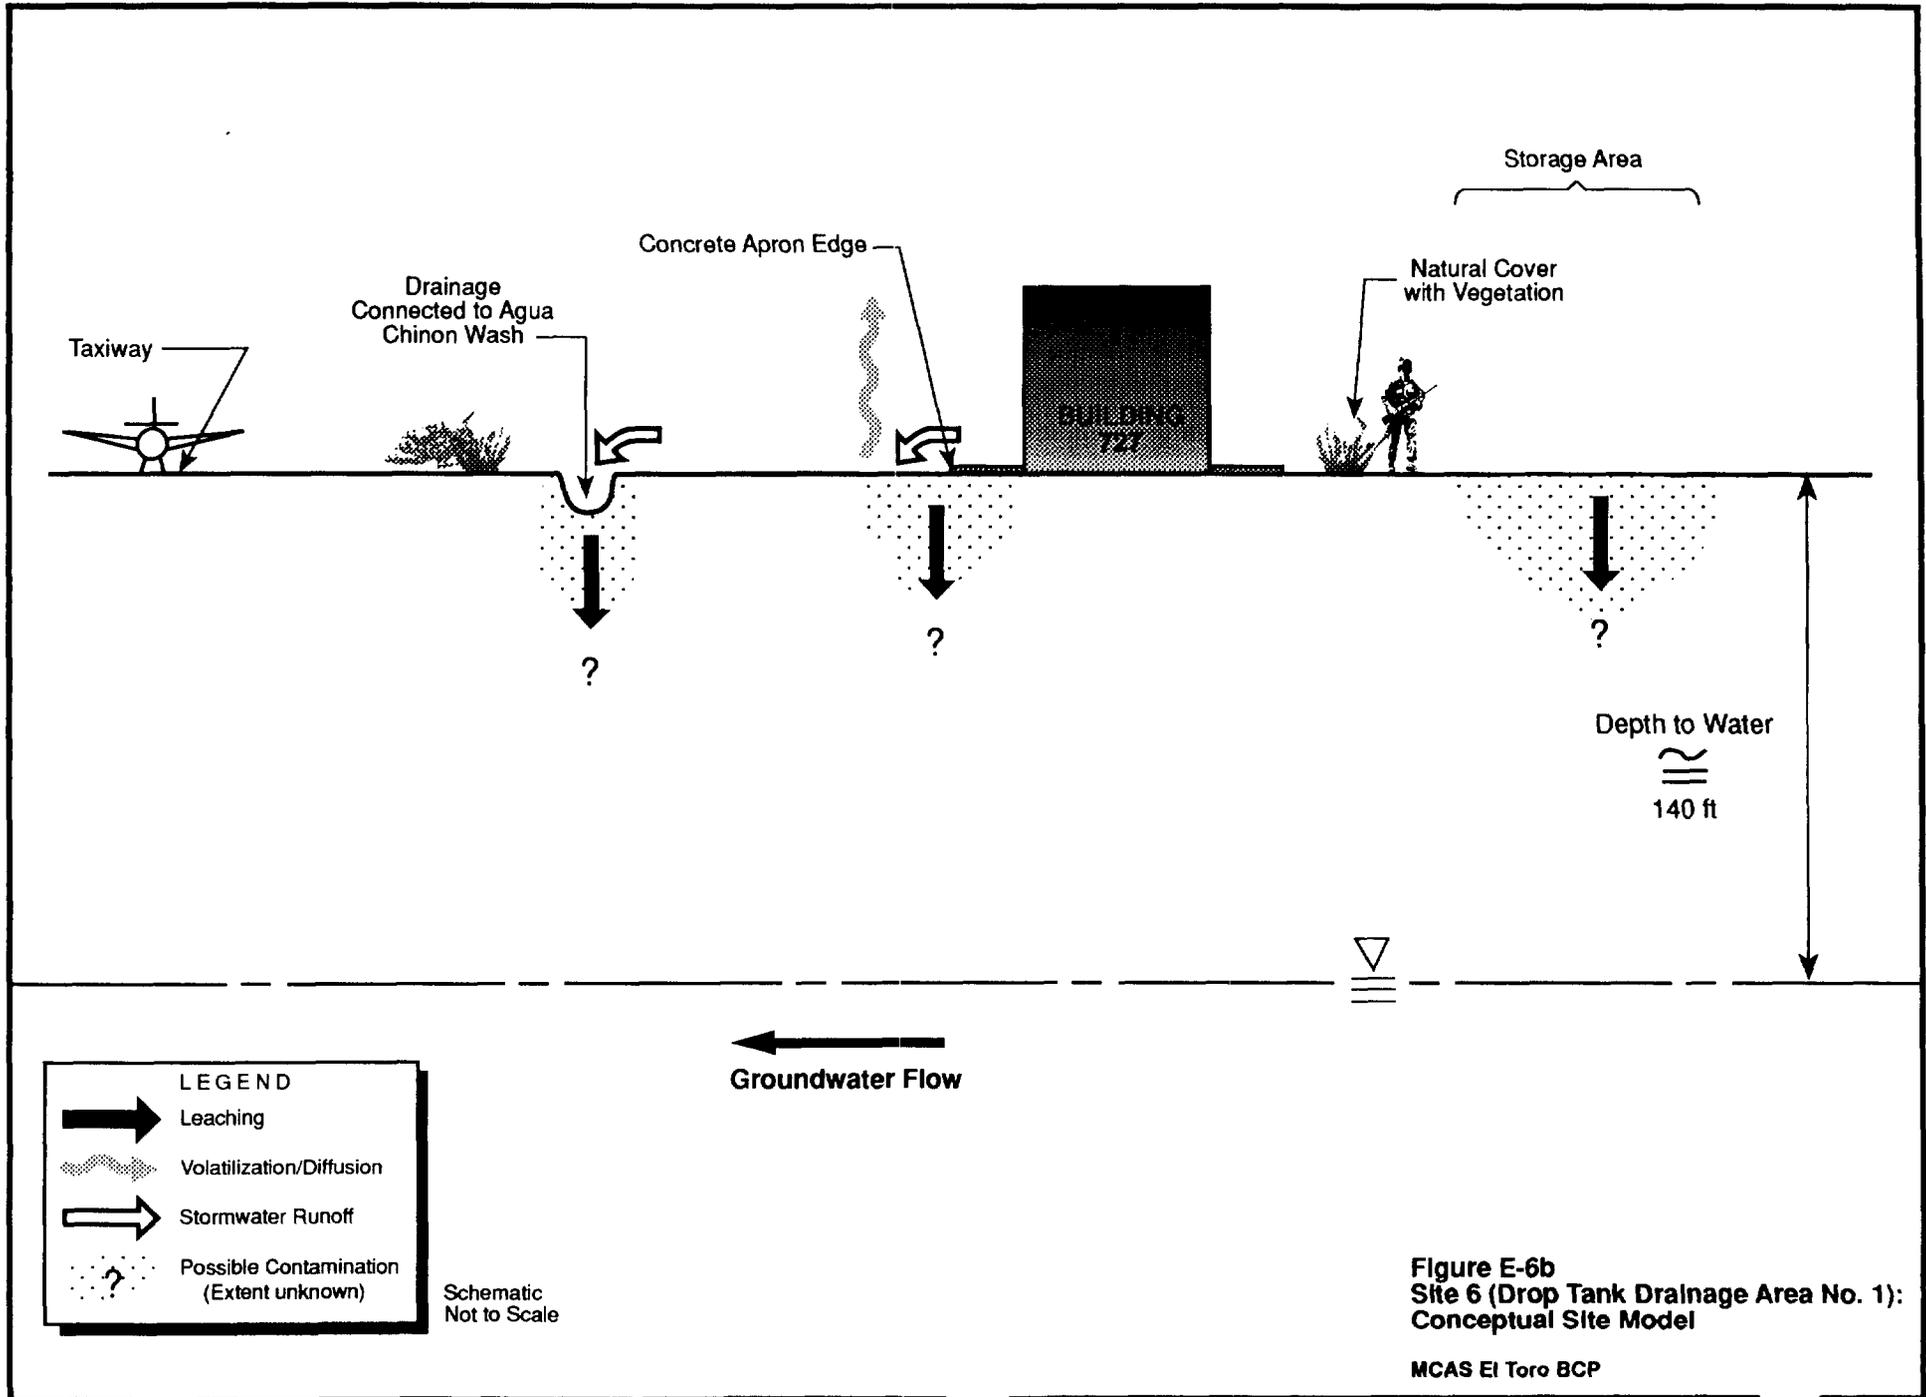
- Leaching
- Volatilization/Diffusion
- Stormwater Runoff
- Possible Contamination (Extent unknown)

Figure E-6b
Site 6 (Drop Tank Drainage Area No. 1):
Conceptual Site Model

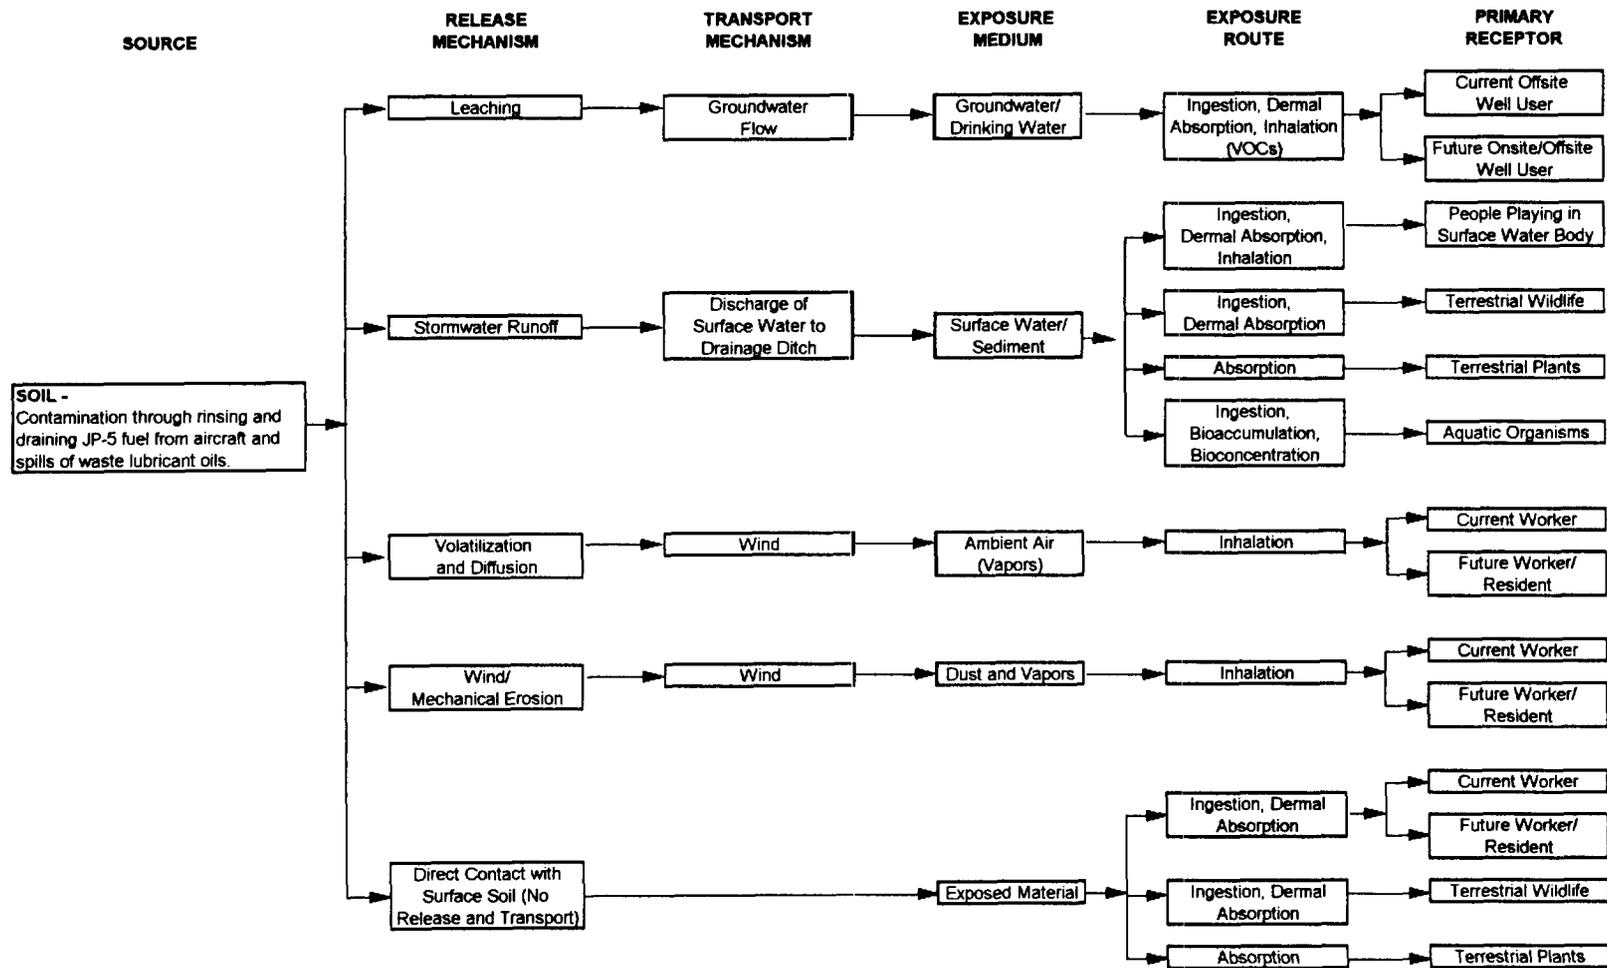
Figure E-6c
Site 6 (Drop Tank Drainage Area No.1):
Potential Exposure Routes and Pathways for Human and Ecological Receptors
MCAS El Toro BCP

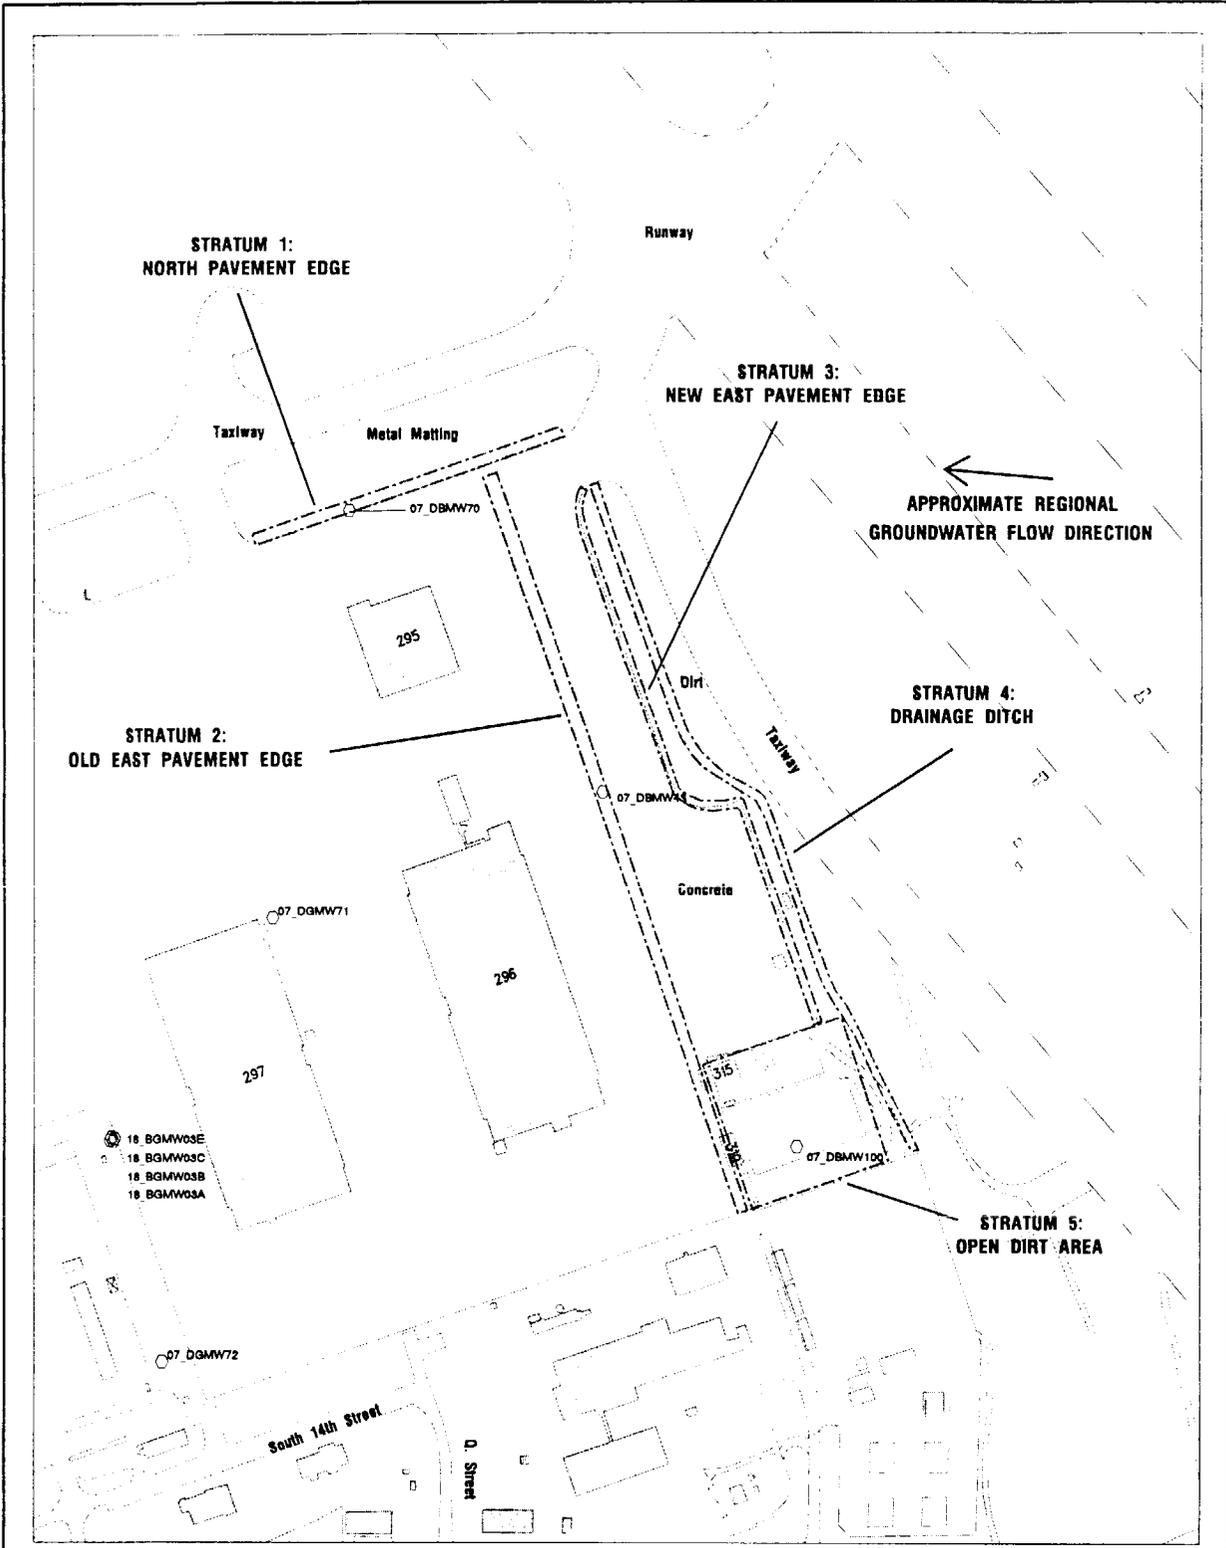
- FEATURES:**
- BUILDING OR PAD
 - MONITORING WELL
 - ROAD
 - STRATUM BOUNDARY
 - WASH OR STREAM

FIGURE E-7a
SITE 7 (DROP TANK
DRAINAGE AREA NO. 2):
SITE LAYOUT

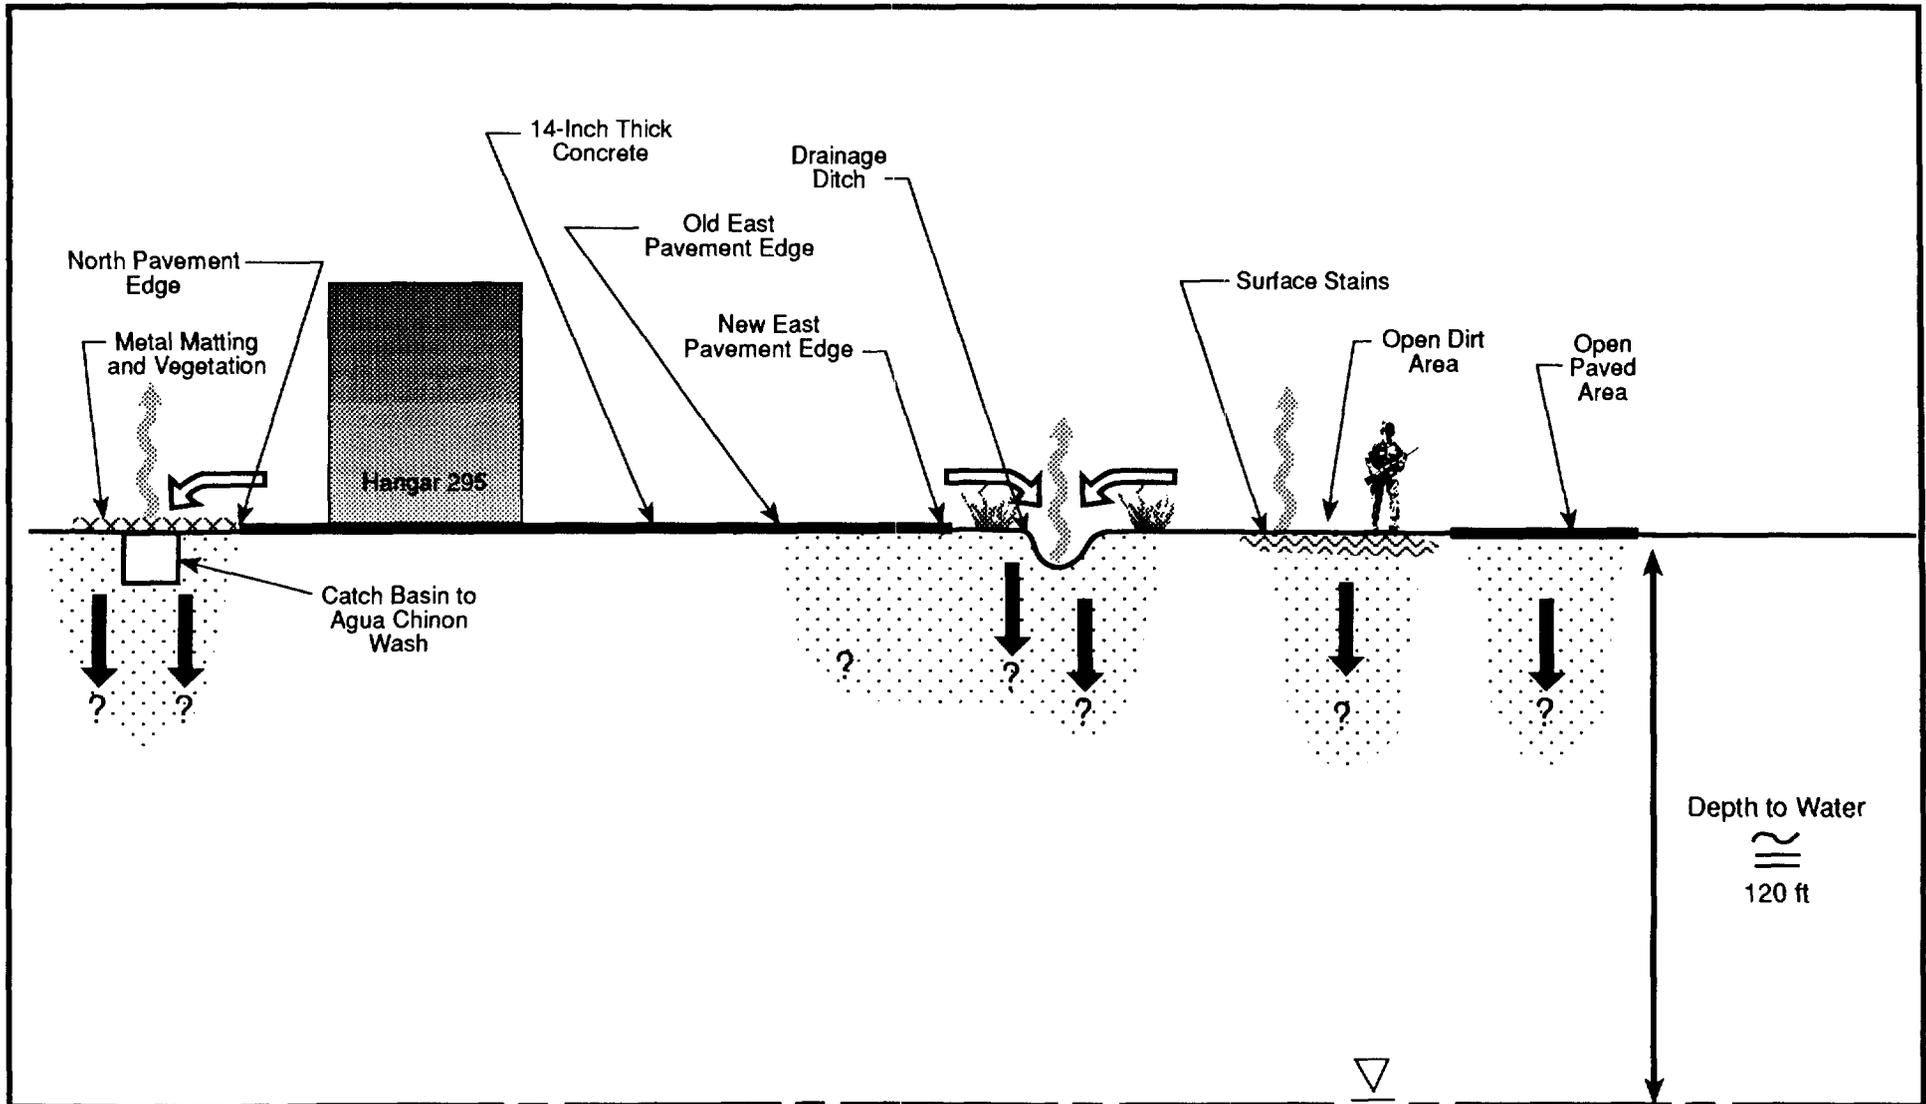
- Leaching
- Volatilization/Diffusion
- Stormwater Runoff
- Possible Contamination (Extent unknown)

Figure E-7b
Site 7 (Drop Tank Drainage Area No. 2):
Conceptual Site Model

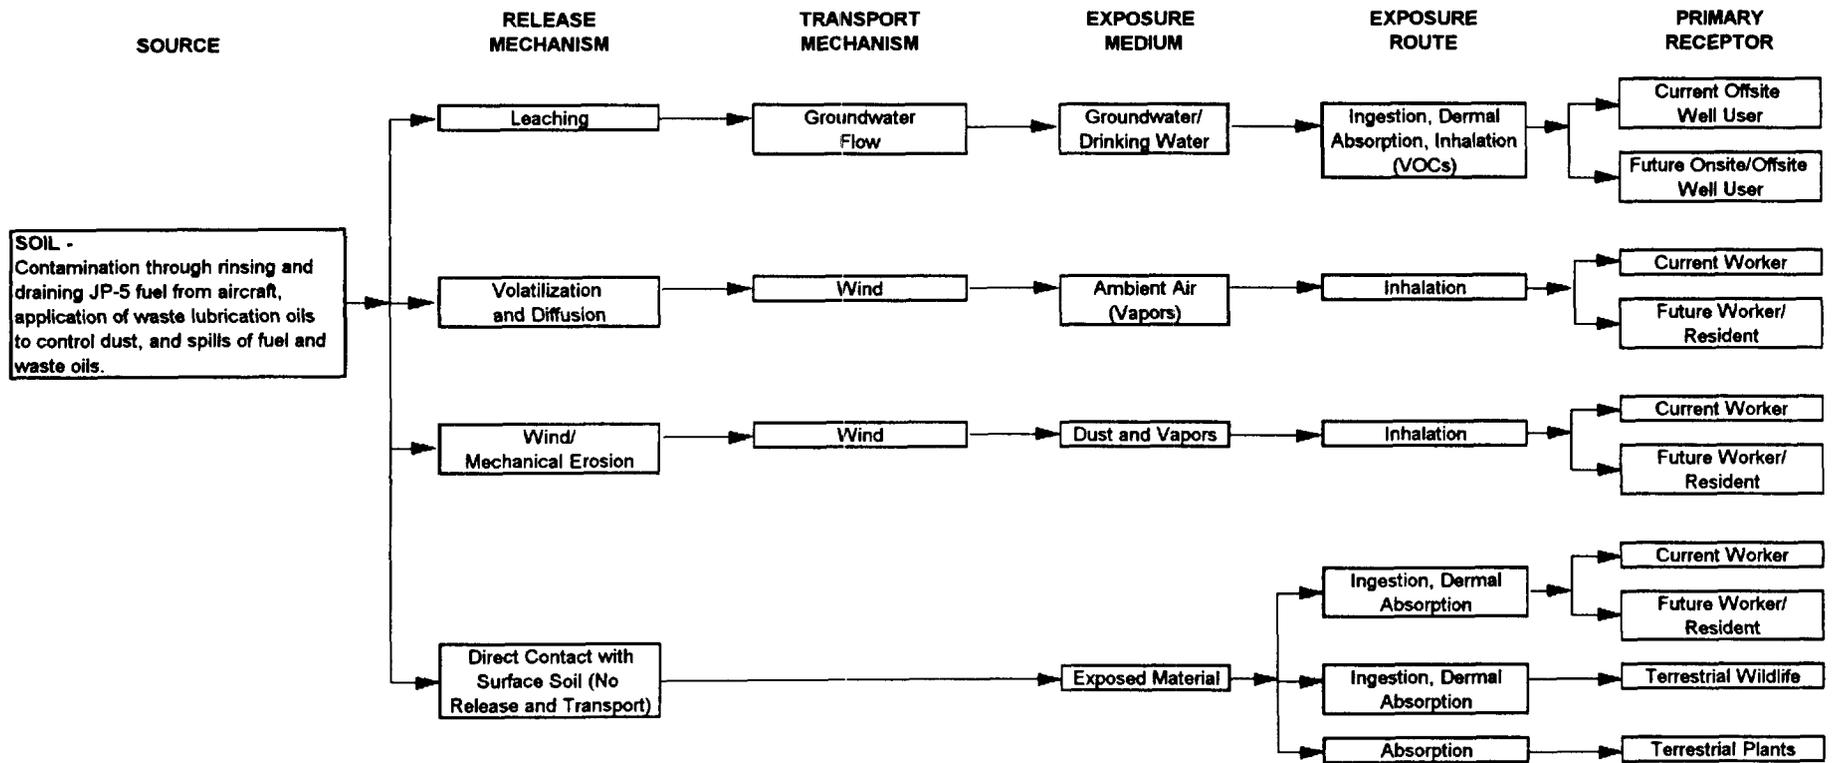
Figure E-7c
 Site 7 (Drop Tank Drainage Area No. 2):
 Potential Exposure Routes and Pathways for Human and Ecologic
 MCAS El Toro BCP

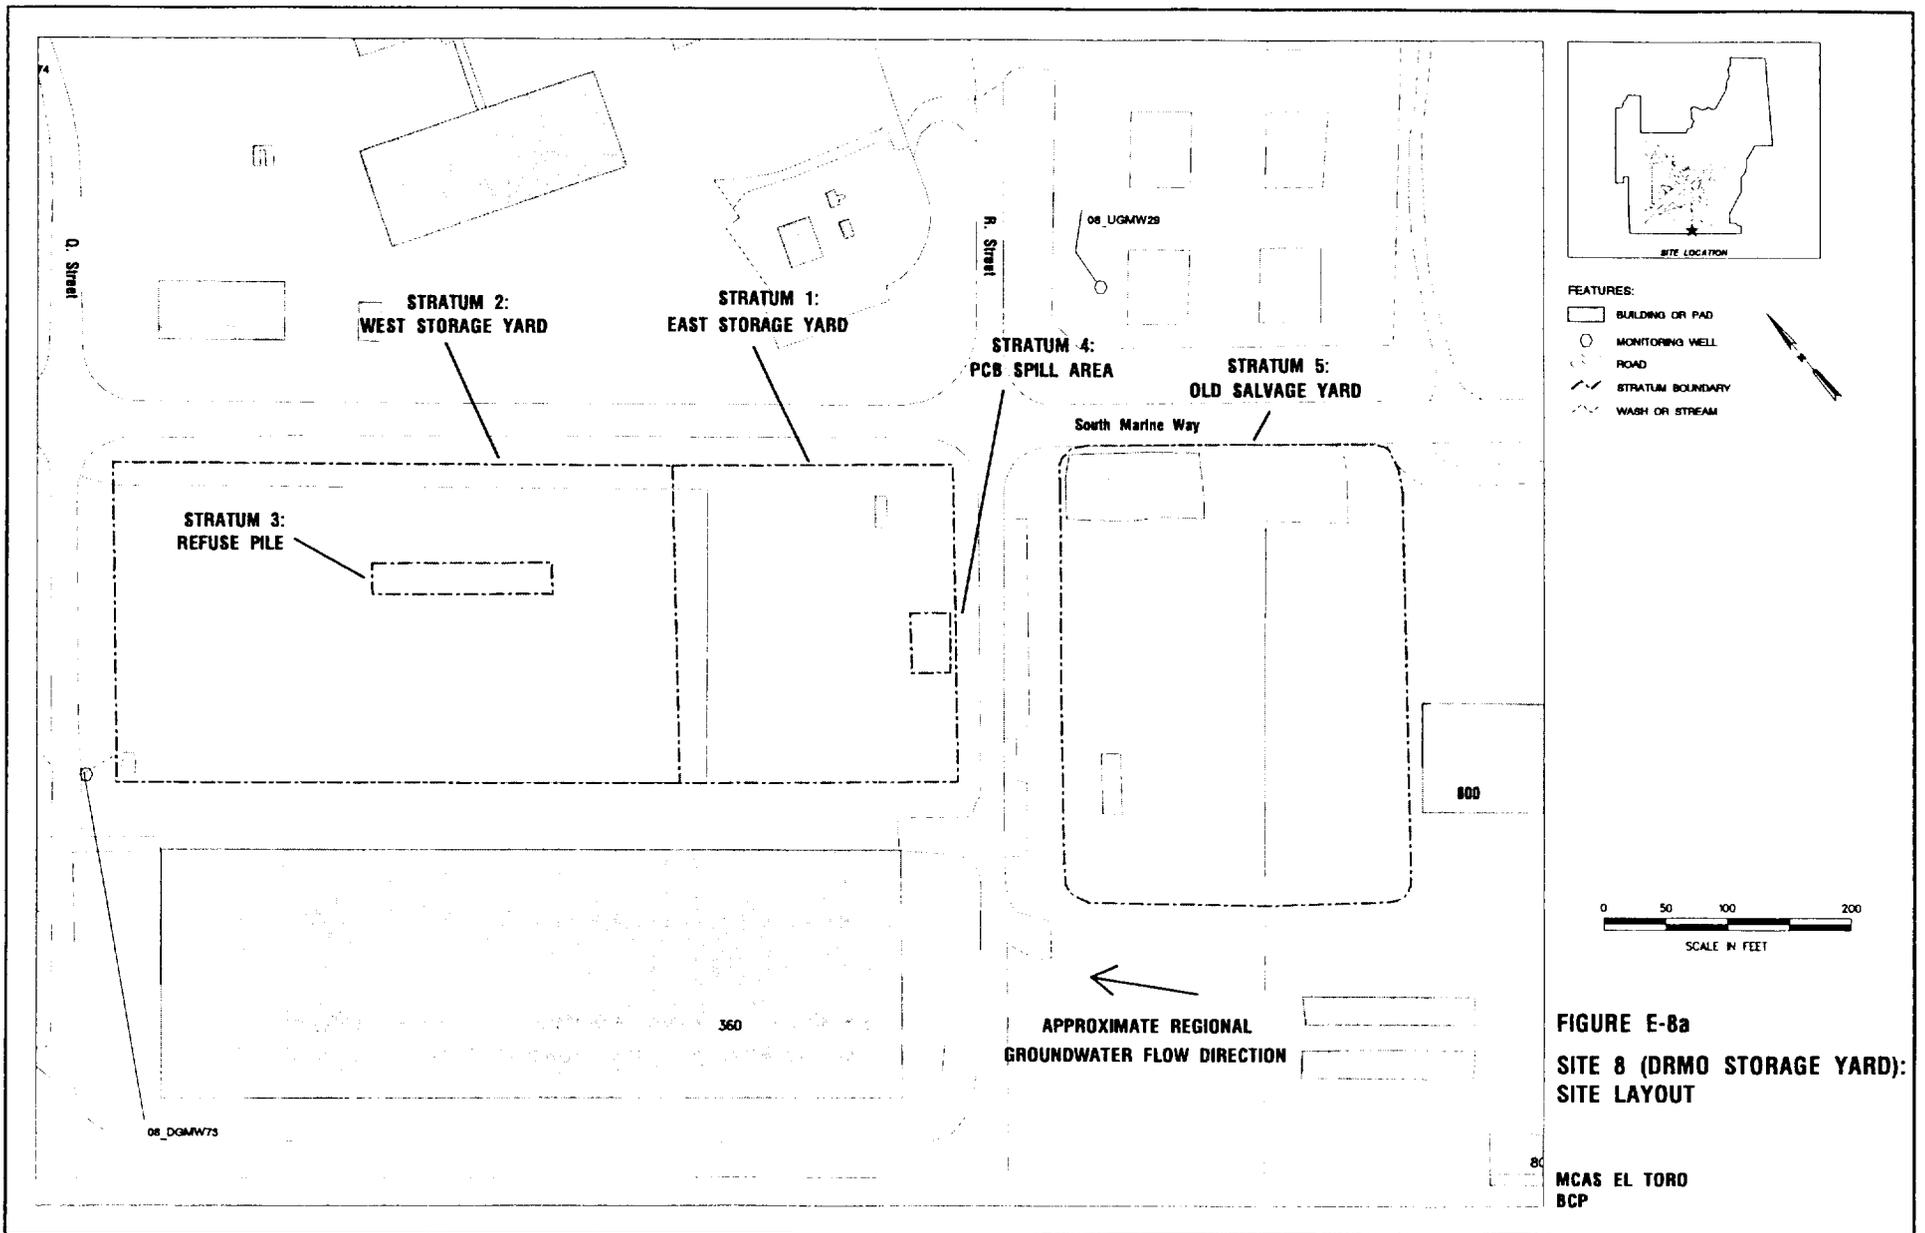
FIGURE E-8a
SITE 8 (DRMO STORAGE YARD):
SITE LAYOUT

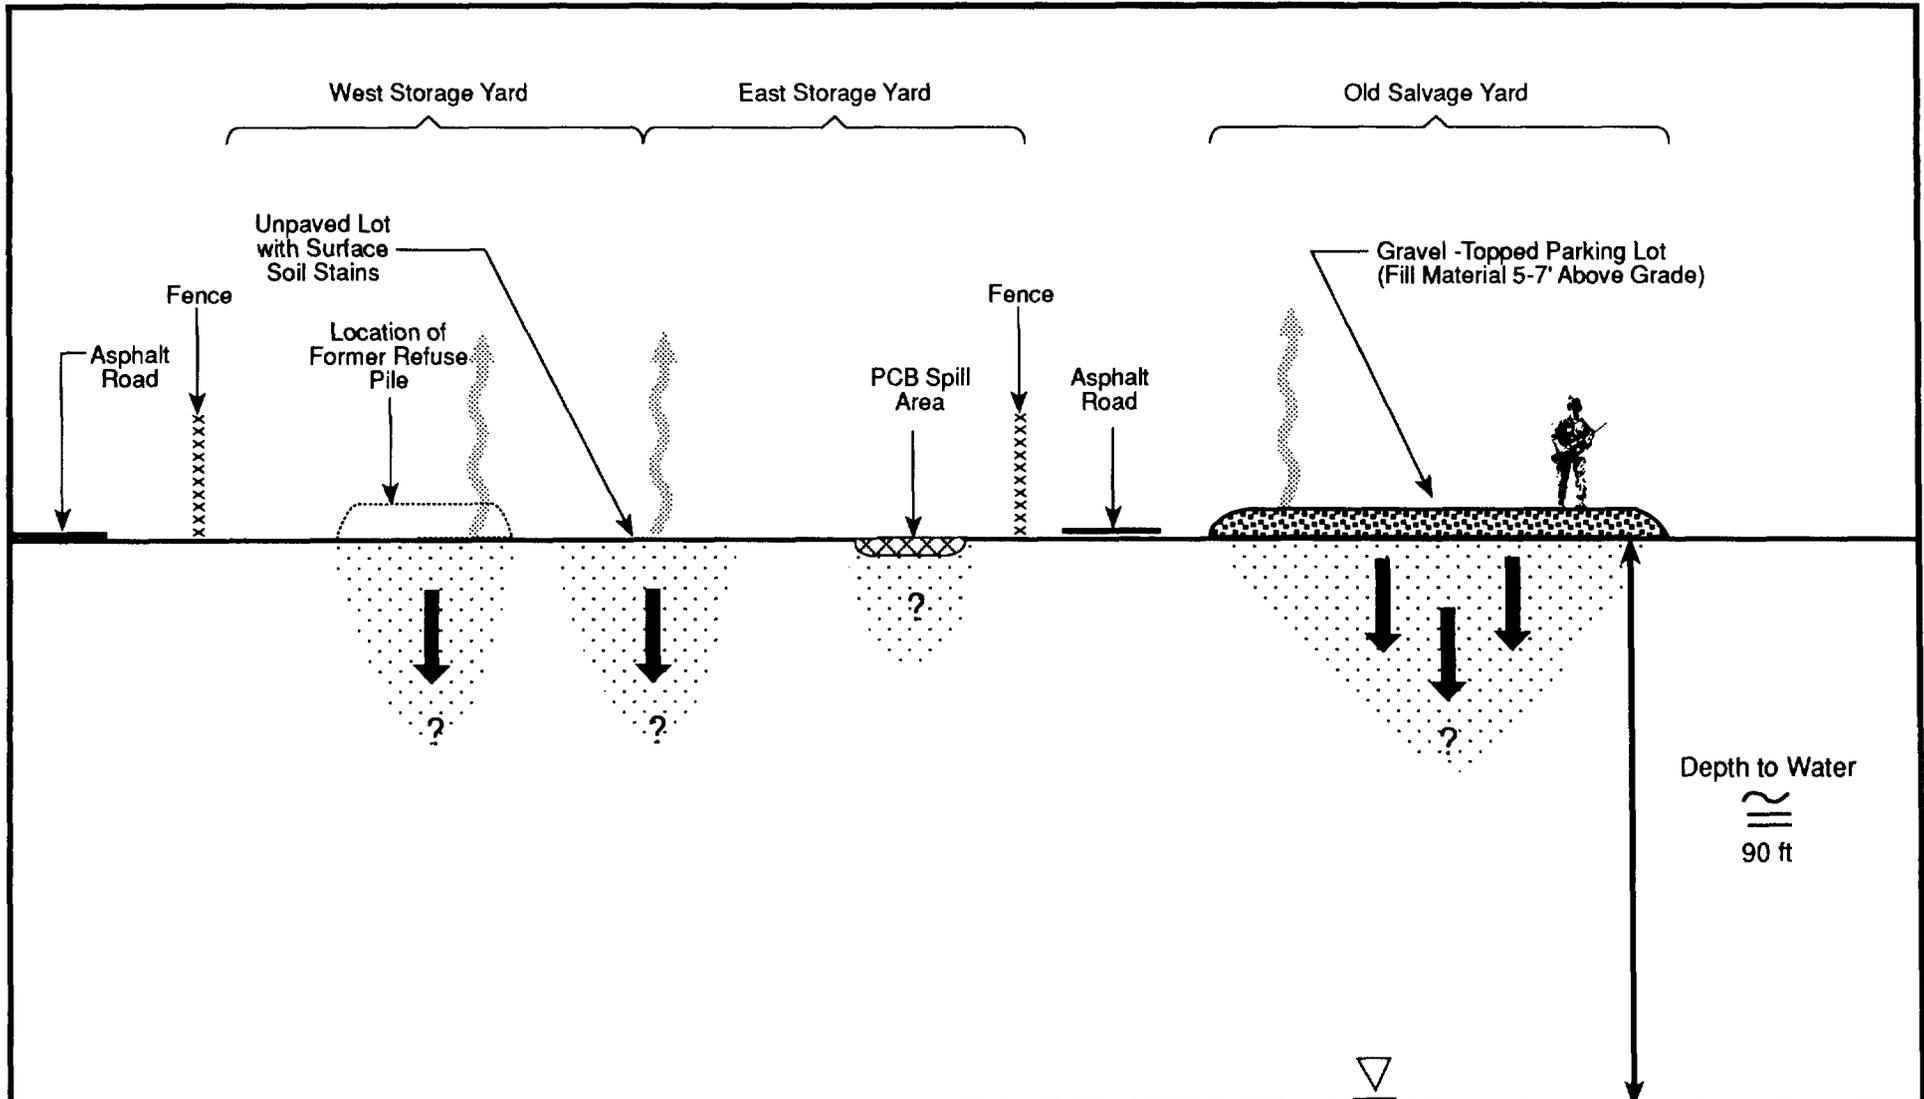
- Leaching
- Volatilization/Diffusion
- Stormwater Runoff
- Possible Contamination (Extent unknown)

Figure E-8b
Site 8 (DRMO Storage Yard):
Conceptual Site Model

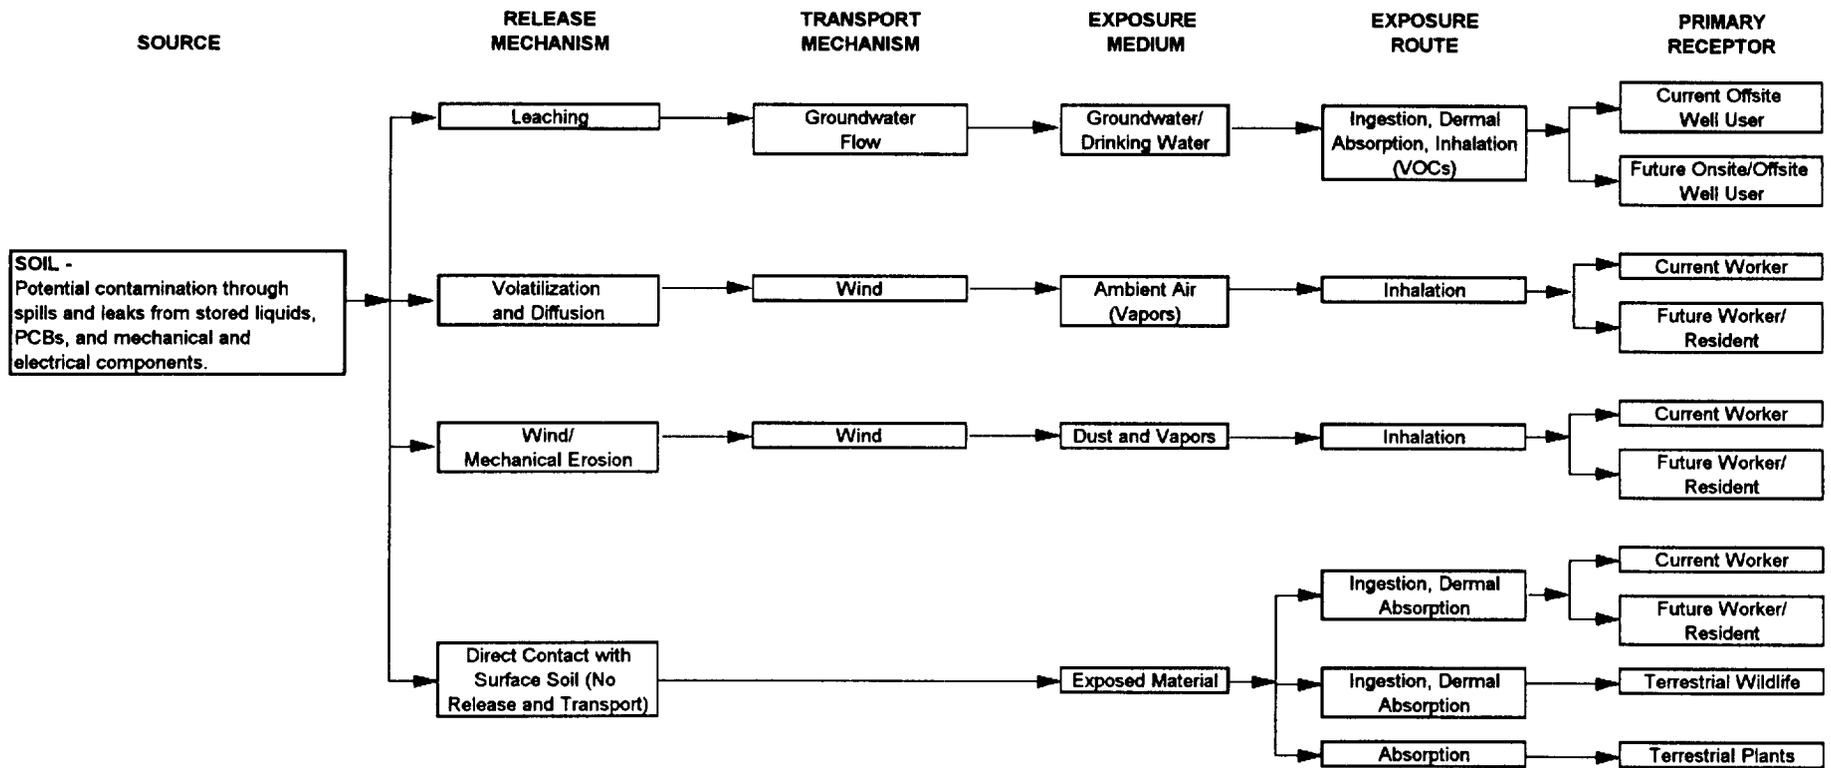
Figure E-8c
Site 8 (DRMO Storage Yard):
Potential Exposure Routes and Pathways for Human and Ecologic
MCAS EI Toro BCP

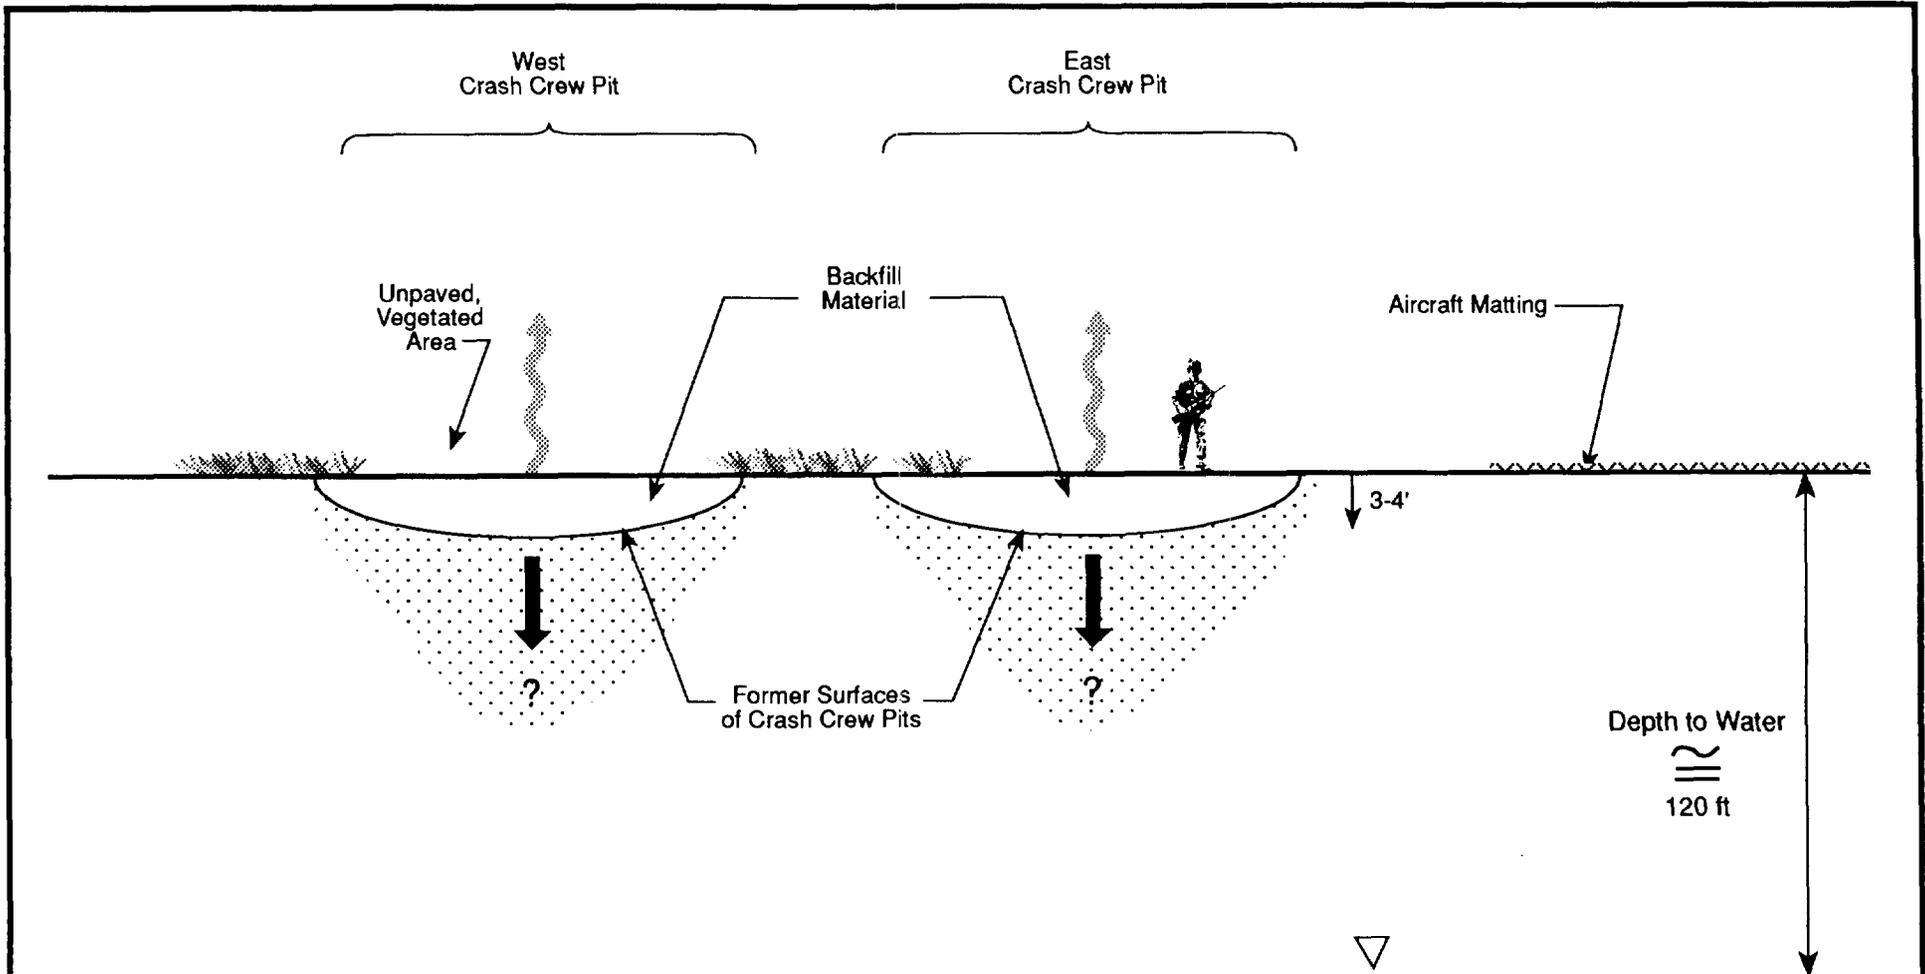
- Leaching
- Volatilization/Diffusion
- Stormwater Runoff
- Possible Contamination (Extent unknown)

Figure E-9b
Site 9 (Crash Crew Pit No. 1):
Conceptual Site Model

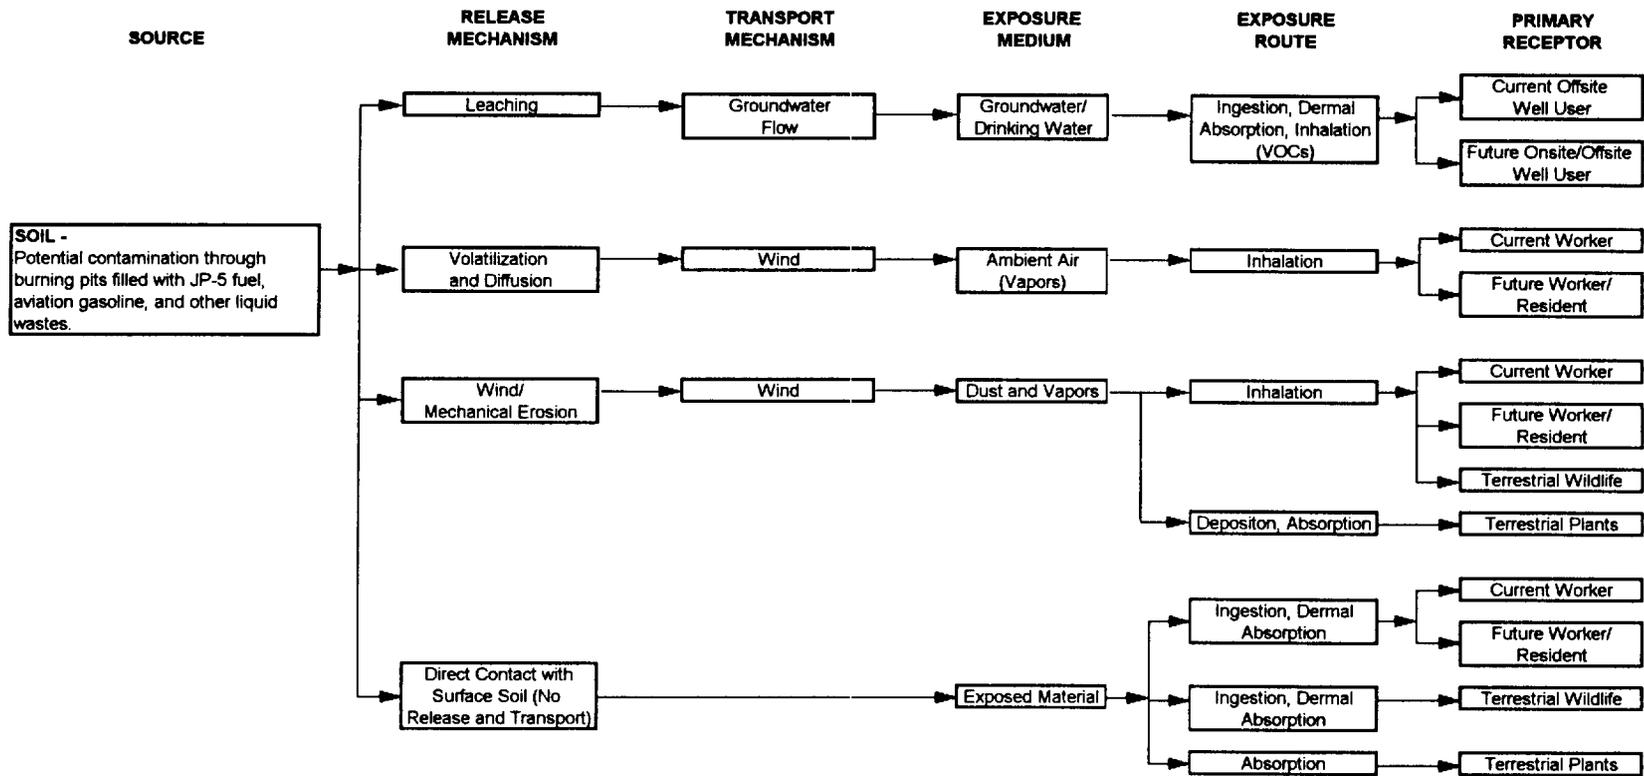
Figure E-9c
Site 9 (Crash Crew Pit No. 1):
Potential Exposure Routes and Pathways for Human and Ecological Receptors
MCAS EI Toro BCP
